Washington Metropolitan Area Transit Authority
ANNUAL INTERNAL REVIEW 2017

Metrorail Car Track Equipment Maintenance (CTEM)
QICO Internal Review
September 13, 2017

Metrorail Car Track Equipment Maintenance (CTEM)

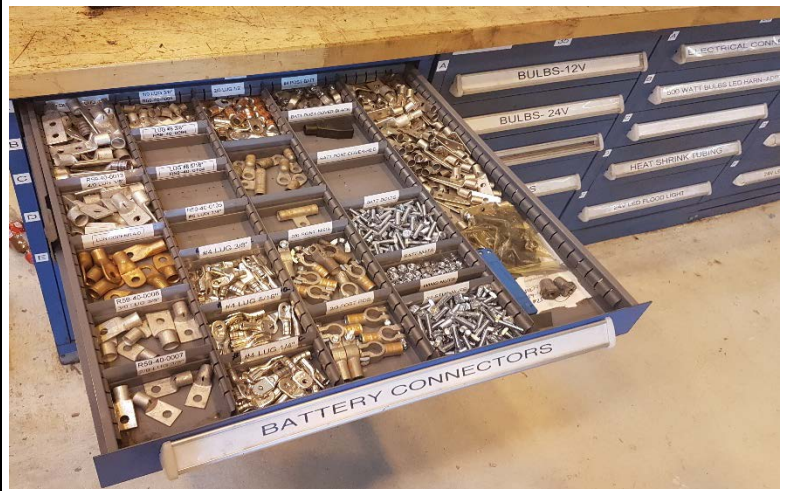
The photograph shows an example of the parts drawers used in CTEM facilities, all parts are clearly labelled and organized.

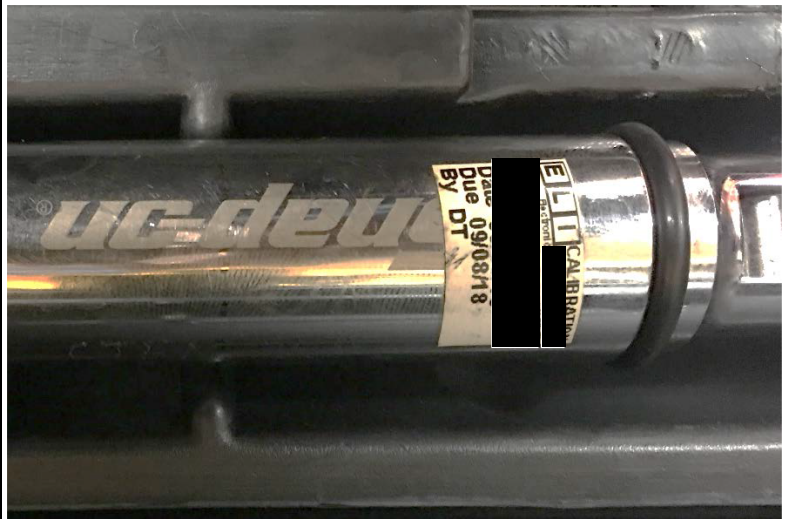
Photograph #2

The photograph shows an example of a torque indicating tool (torque wrench) with compliant calibration dates.

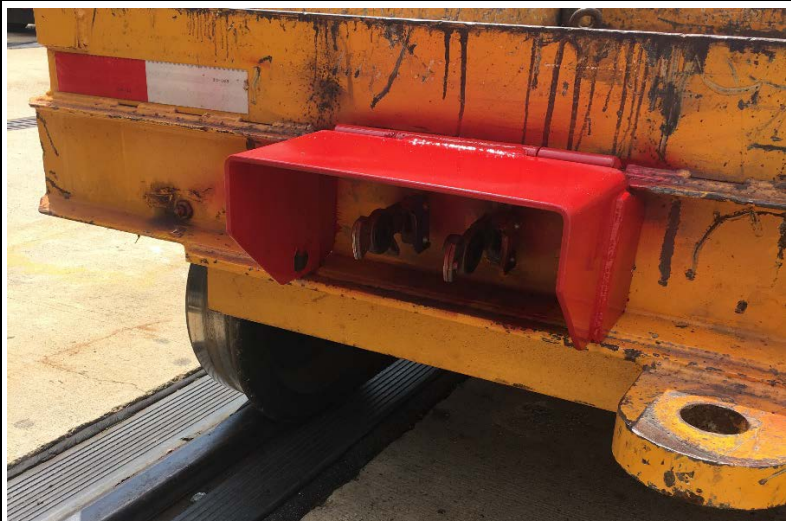
Photograph #3

At Branch Avenue CTEM facility, QICO observed a completed modification to a rail tie car without the involvement of Vehicle Engineering (CENV).

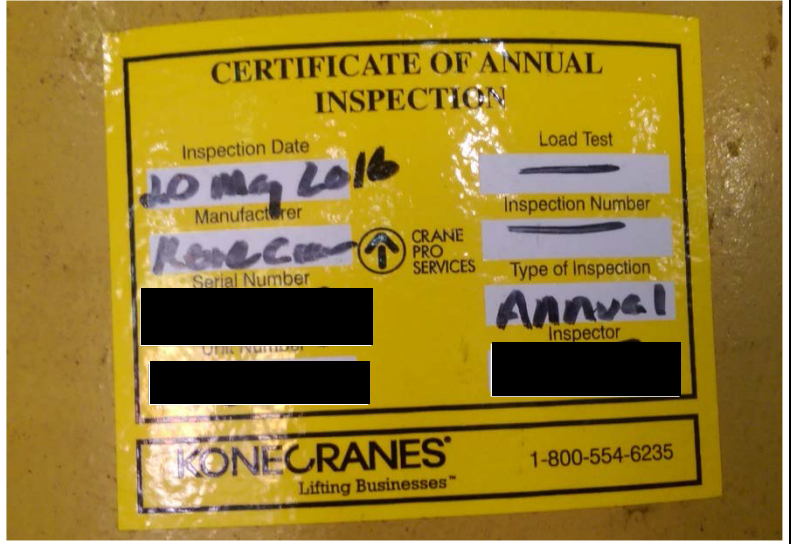
Measure	Finding	Description
Safety	<p>F-CTE-17-04</p> <p>Select heavy lifting equipment was out of compliance with inspection requirements, introducing safety concerns for equipment operation.</p> <p><i>Safety Risk</i> <i>Elevated (4.4)</i> ■</p>	<ul style="list-style-type: none"> - QICO observed at New Carrollton portable gantry and pedestal cranes with overdue annual rig inspection labels, indicating a last inspections date of 20 May 2016. - Both cranes have been labelled out of service by CTEM management after it was brought to their attention by QICO. CTEM has notified Plant Maintenance (PLNT) and a work order has been created to have the equipment inspected. Annual rigging inspections are completed by outside contractor (Appendix D: Photograph #4). <p>(Source: New Carrollton Field Assessment)</p> <p>Recommendation: To provide for the safe operation of shop equipment, establish methods to ensure all heavy lifting equipment that require regular inspection are monitored for compliance.</p>

Finding & Description	Photos
<p>Photograph #4</p> <p>F-CTE-17-04</p> <p>QICO observed at New Carrollton a portable gantry and pedestal cranes with overdue annual rig inspection labels indicating a last inspections date of 20 May 2016.</p>

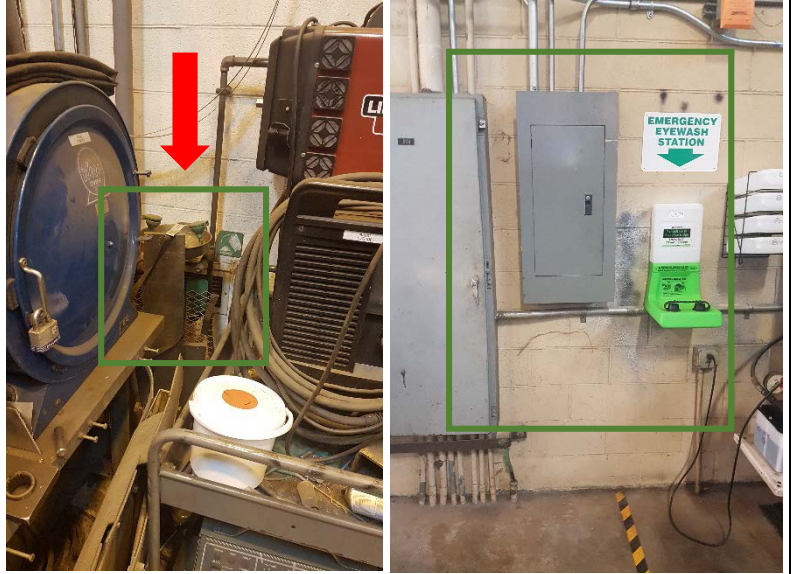
<p>F-CTE-17-05</p> <p>Current placement of emergency eyewash stations presents accessibility and safety concerns.</p> <p><i>Safety Risk</i> <i>Elevated (4.4)</i> ■</p>	<ul style="list-style-type: none"> - QICO observed an eyewash station in the welding room in Greenbelt facility that was inaccessible for immediate, emergency use. - At Alexandria facility, QICO observed a wall mounted eyewash station placed adjacent to electric panels, which imposes a risk of electrical shock and serious bodily injury (Appendix D: Photograph #5). <p>(Source: Field Assessments – Greenbelt and Alexandria)</p> <p>Recommendation: To ensure eyewash stations are accessible and safely located, assess current the location and placement of all CTEM eyewash stations and establish formal measures to resolve, maintain and inspect the stations on a periodic basis.</p>
Compliance with Standards	<p>F-CTE-17-06</p> <p>Shelf life considerations for parts and materials are inadequately monitored and controlled, increasing the likelihood expired materials are available for use.</p> <p><i>Governance Risk</i> <i>Low (3.2)</i> ■</p>	<ul style="list-style-type: none"> - QICO observed deteriorated rubber bushings in a storage drawer along with newer bushings. - QICO discovered expired adhesives and lubricants stored in a flame resistant cabinet (Appendix D: Photograph #6). - Although CTEM conducts shelf life inspection, the findings indicate that the criterion is not sufficient <p>(Source: New Carrollton Field Assessment)</p> <p>Recommendation: Develop tracking mechanisms to ensure materials and components with shelf life limitations or other expirations are used or replaced appropriately.</p>

<p>Photograph #5</p> <p>F-CTE-17-05</p> <p>QICO observed an inaccessible eyewash station in the welding room in Greenbelt facility and a wall mounted eyewash station placed adjacent to electric panels in Alexandria facility, which imposes a risk of serious bodily injury.</p>

CTEM will assess locations of eye wash stations and relocate or remove any deemed improperly placed. Inspection and maintenance of eyewash stations is reviewed and addressed during the monthly 12 point inspection procedure.

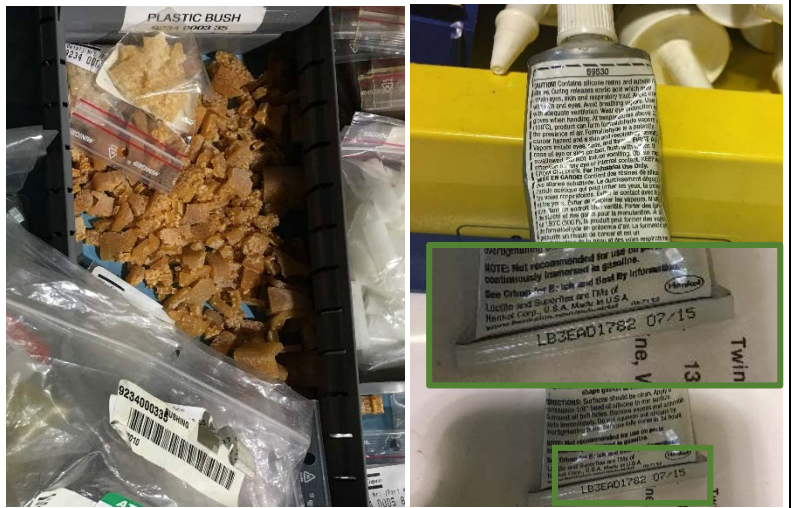
F-CTE-17-06: Shelf life considerations for parts and materials are inadequately monitored and controlled, increasing the likelihood expired materials are available for use.

<p>Photograph #6</p> <p>F-CTE-17-06</p> <p>QICO observed deteriorated rubber bushings in a storage drawer along with newer bushings as well as expired adhesives and lubricants stored in a flame resistant cabinet.</p>

- Develop tracking mechanisms to ensure materials and components with shelf life limitations or other expirations are used or replaced appropriately.

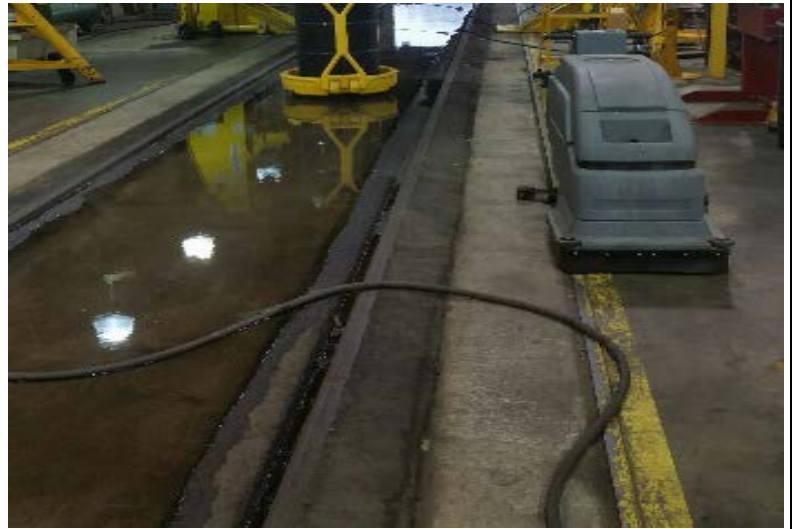
It was reported by CTEM management and observed by QICO at the New Carrollton CTEM facility that during heavy rainfall the shop gets flooded due to the shop floor being lower than the outside ground.

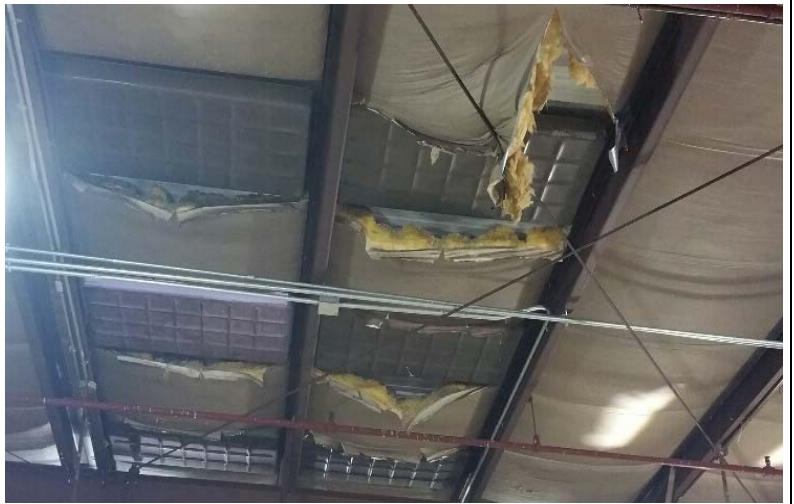
Photograph #8

QICO observed badly damaged ceiling insulation due to birds nesting.

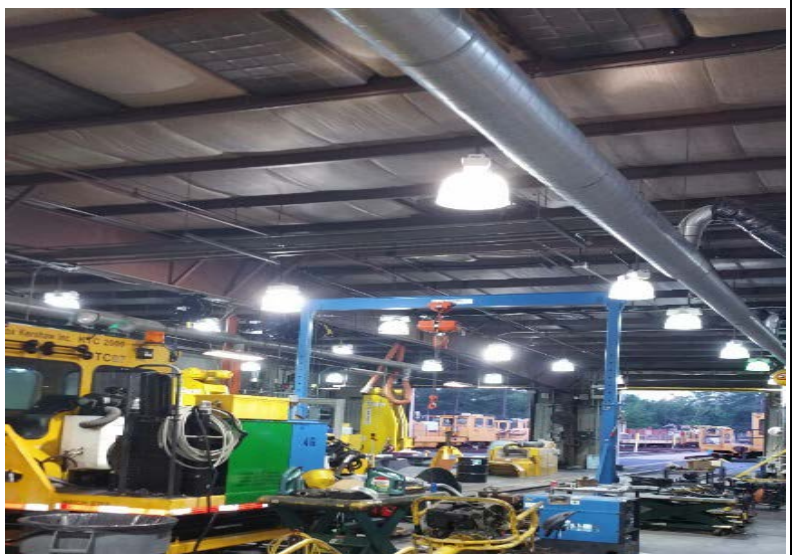
Photograph #9

New Carrollton CTEM Facility has no overhead crane for heavy lifting which poses a challenge for mechanics.

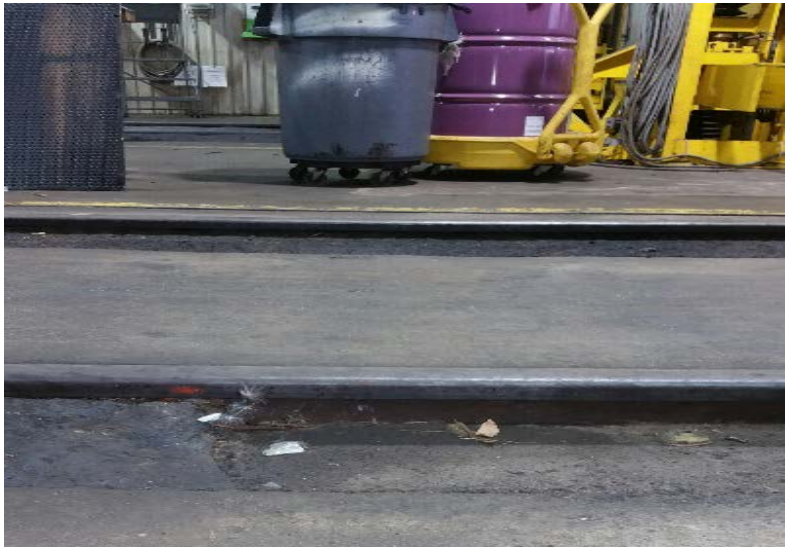
Finding & Description	Photos
<p>Photograph #10</p> <p>OBSERVATION O-CTE-17-01</p> <p>Tracks are protruding above the shop floor level posing a tripping, and lacks a pit to work under equipment.</p>

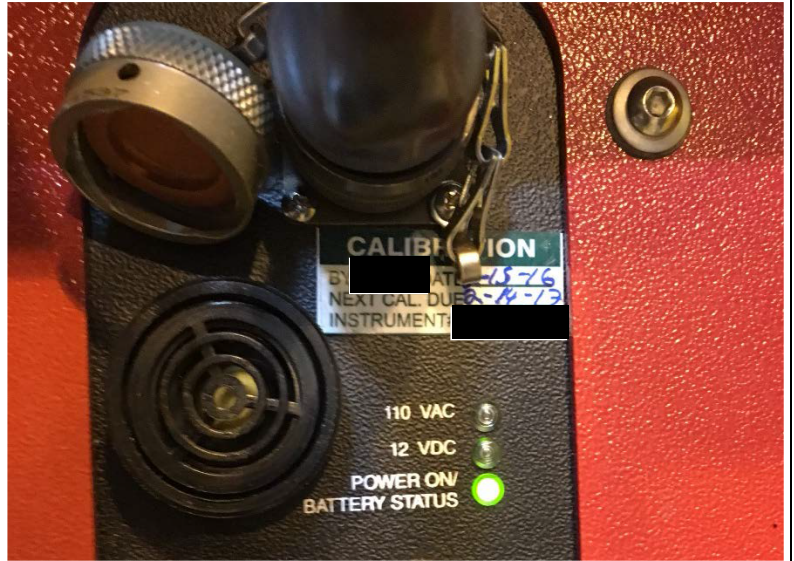
At Branch Ave, QICO discovered the Wabtec Automated Single Car Brake Test Device (ASCTD) had an overdue calibration date of 2/14/2017.

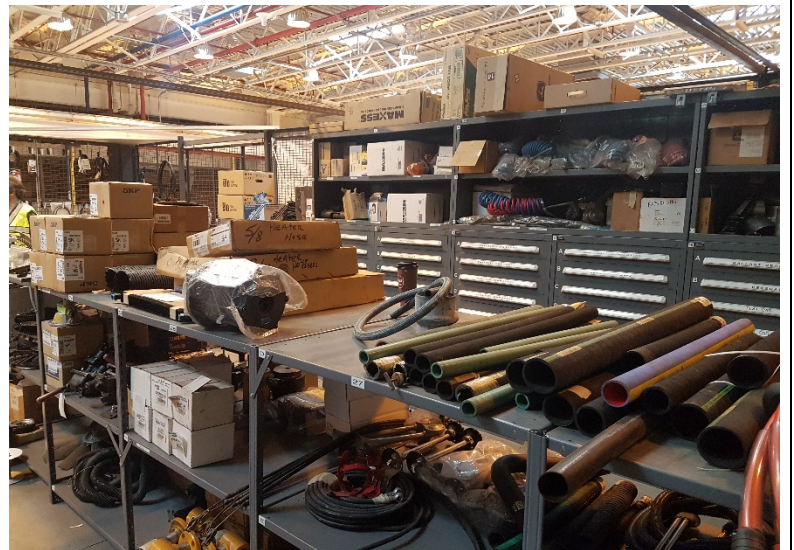
Photograph #14

At all locations, CTEM maintained and managed their own inventory of parts in uncontrolled rooms with no dedicated store room controller.

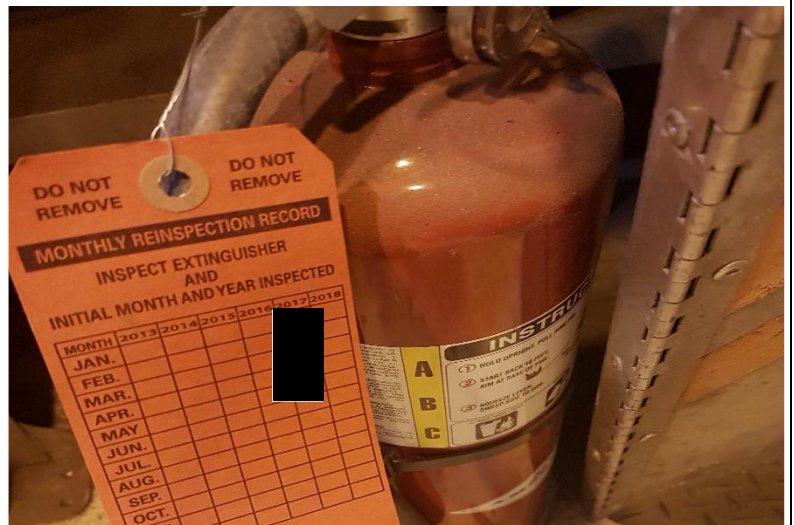
Photograph #15

QICO observed fire extinguishers in welding rooms at Alexandria, Branch Ave and Greenbelt CTEM facilities with overdue monthly inspections. As per CTEM management, inspections of fire extinguishers are completed during preventative maintenance (PM).

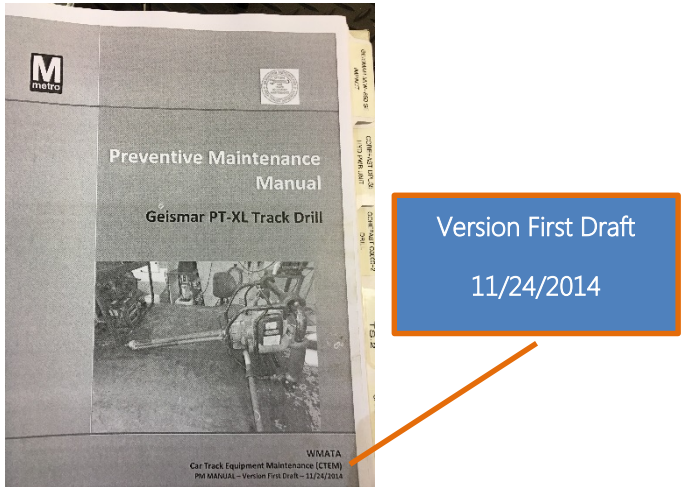
Finding & Description	Photos
<p>Photograph #1</p> <p>Reference hard copy manuals were discovered out of date.</p> <p><i>Source: QICO performing field observation on 7/7/2017 09:27 AM – New Carrollton CTEM Shop)</i></p>

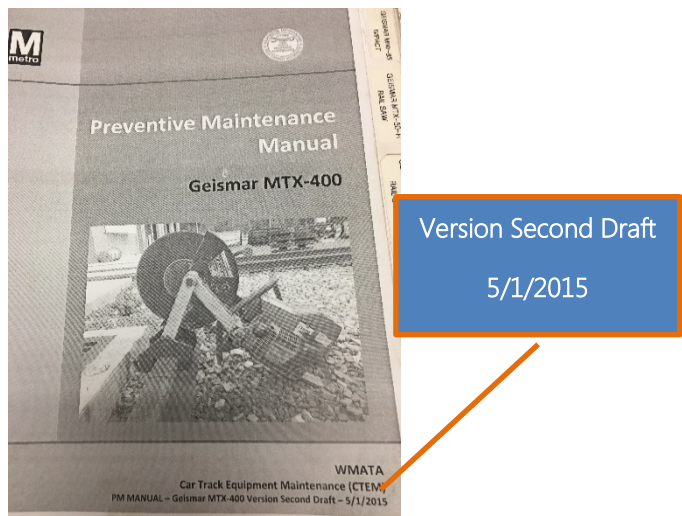
<p>Photograph #2</p> <p>Reference hard copy manuals were discovered out of date.</p> <p><i>Source: QICO performing field observation on 7/7/2017 12:20 PM – New Carrollton CTEM Shop)</i></p>

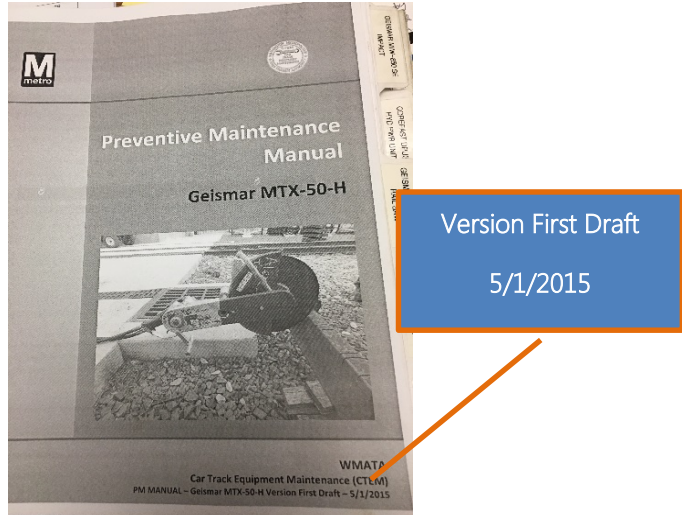
<p>Photograph #3</p> <p>Reference hard copy manuals were discovered out of date.</p> <p><i>Source: QICO performing field observation on 7/7/2017 12:20 PM – New Carrollton CTEM Shop)</i></p>

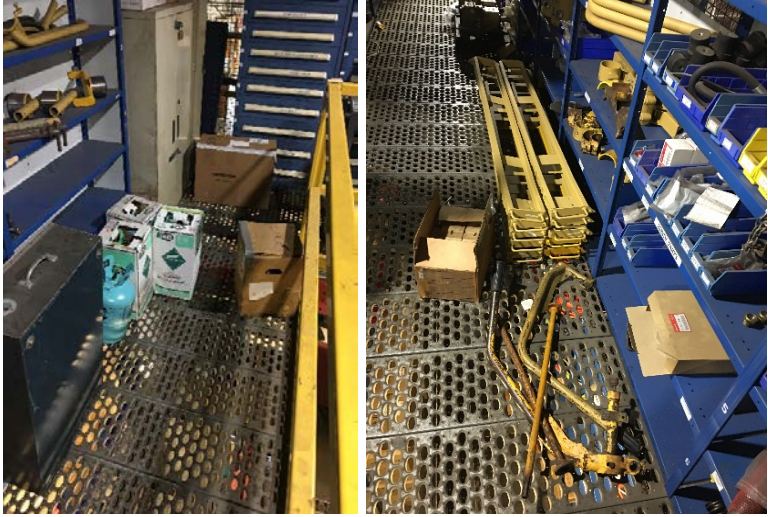
Finding & Description	Photos
<p>Photograph #7</p> <p>Various items laying on the storage room floor, obstructing walkways.</p> <p><i>(Source: QICO performing field observation on 7/7/2017 11:35 AM – New Carrollton CTEM Shop)</i></p>

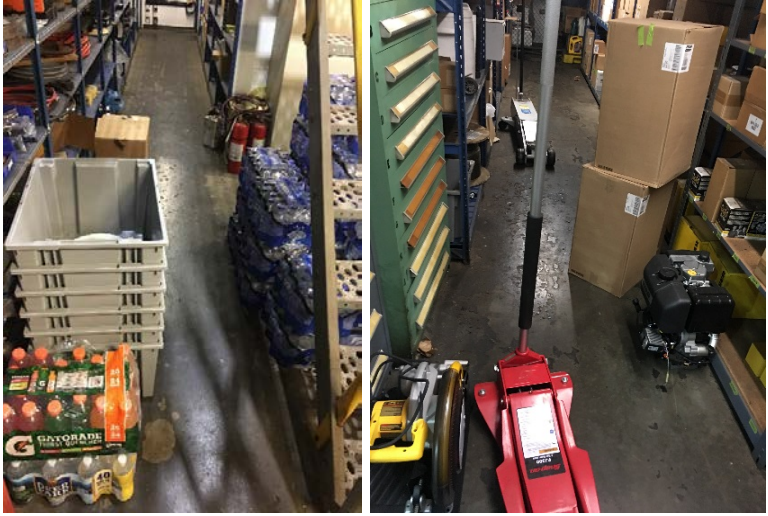
<p>Photograph #8</p> <p>Various items laying on the storage room floor, obstructing walkways.</p> <p><i>(Source: QICO performing field observation on 7/7/2017 11:38 AM – New Carrollton CTEM Shop)</i></p>

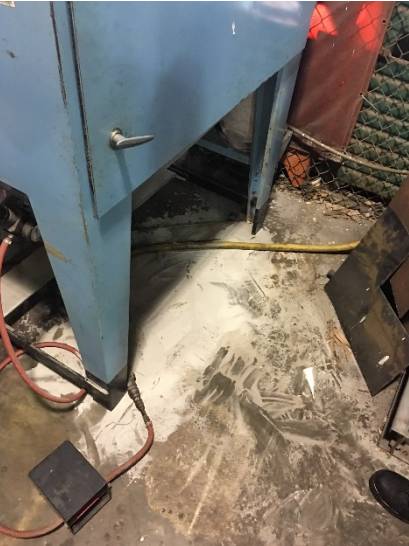
<p>Photograph #9</p> <p>Dust on the floor surrounding the sandblaster, poses risk and creates a slipping hazard.</p> <p><i>(Source: QICO performing field observation on 7/7/2017 11:15 AM – New Carrollton CTEM Shop)</i></p>

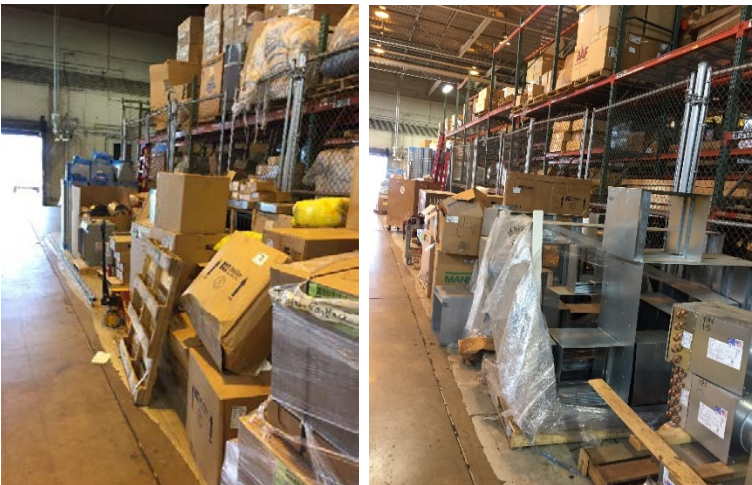
<p>Photograph #3</p> <p>HVAC material is stored alongside Plant Maintenance (PLNT) cage.</p> <p><i>(Source: QICO performing field observation on 7/11/2017 Alexandria CTEM Shop)</i></p>

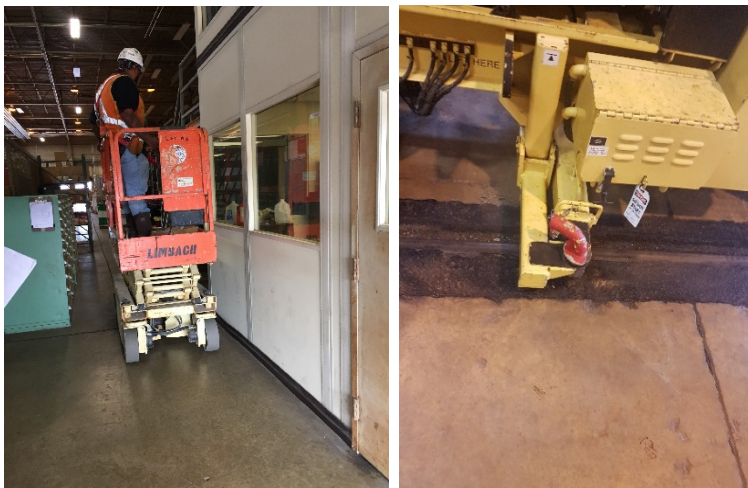
<p>Photograph #9 and #10</p> <p>Contractor is operating a scissor lift without a WMATA escort.</p> <p>Heavy equipment that is tagged out but not locked.</p> <p><i>(Source: QICO performing field observation on 7/11/2017 Alexandria CTEM Shop)</i></p>

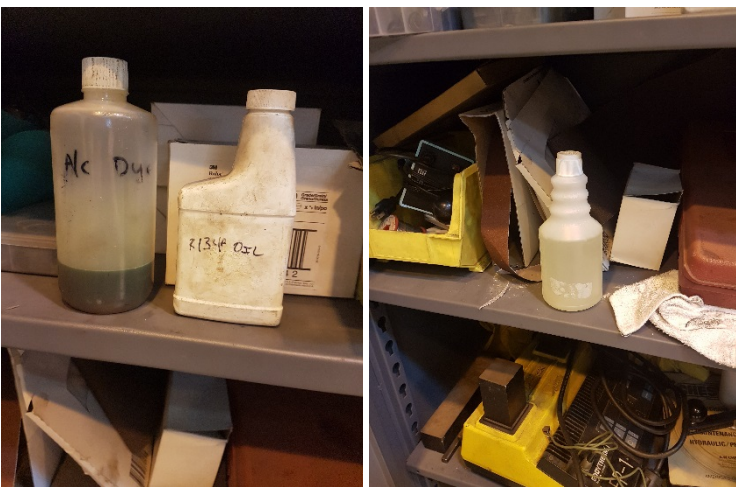
<p>Photograph #3 and #4</p> <p><i>Un-identified and improperly labelled fluid found in non-flame resistant cabinet.</i></p> <p><i>(Source: QICO performing field observation on 7/12/2017 – Greenbelt CTEM Shop)</i></p>

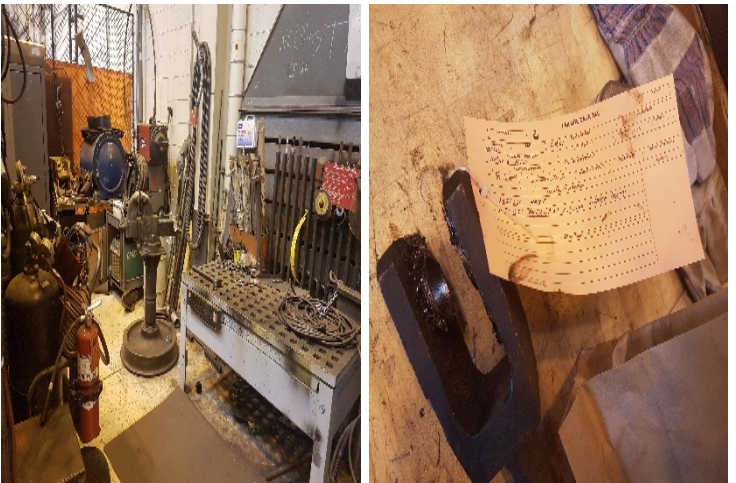
<p>Photograph #5 and #6</p> <p><i>Welding area has clutter, first aid kit (white box on wall) and the eye wash are obstructed.</i></p> <p><i>Salvaged part has an identification/status tag.</i></p> <p><i>(Source: QICO performing field observation on 7/12/2017 – Greenbelt CTEM Shop)</i></p>
