**Washington Metropolitan Area Transit Authority
Board Action/Information Summary**

Red Line Incident Response

Safety and Security Committee

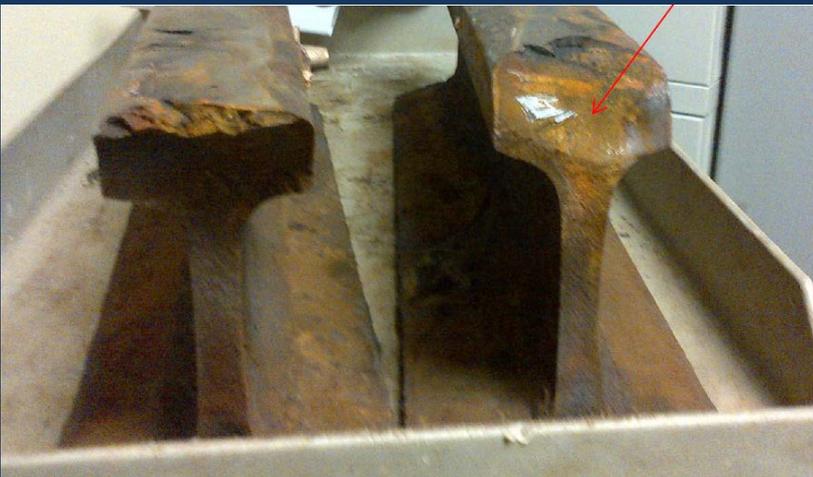
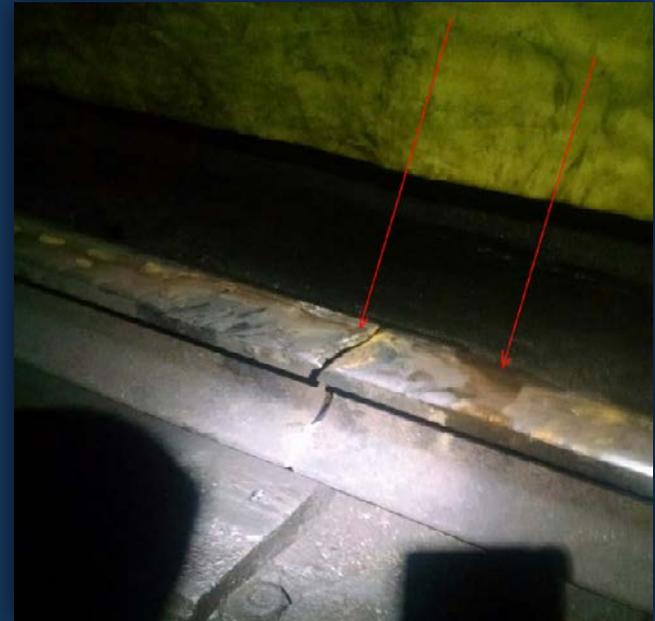
Cause of Incident

- Defect rail was a compound fissure
- Water leaks have caused damage to the rail

Subsequent investigation concluded that the type of defect on the cracked rail was a compound fissure, which is defined as a progressive fracture in the head of the rail.

Excessive moisture in this track section had caused damage to the rail over time. Calcite contained in the water promoted corrosion and accelerated deterioration of the rail. This caused a surface area defect to the rail that eventually migrated internally, developing an internal fissure and ultimately breaking the rail under the load of railcar traffic.

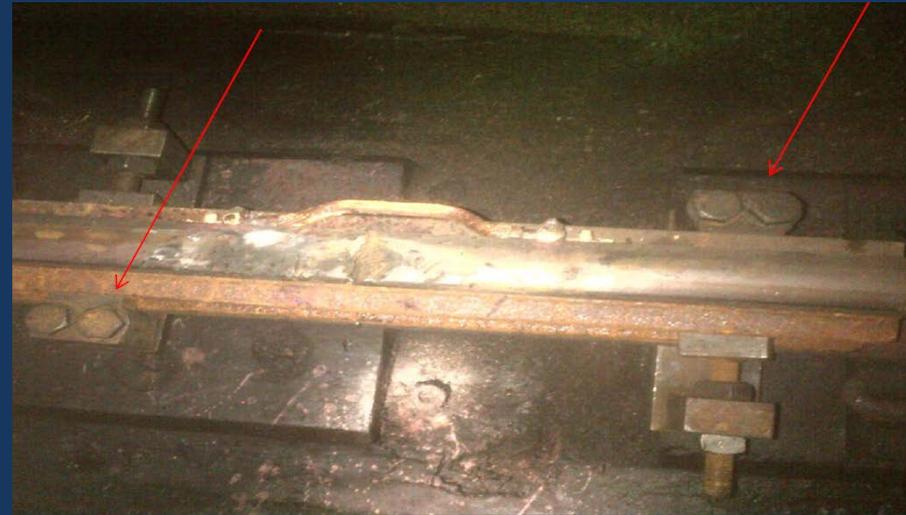
During Revenue Service

- ✓ Installed set of joint bars and two emergency rail clamps

The emergency response team made temporary repairs during revenue service by installing a set of joint bars and two emergency rail clamps. After revenue service, crews removed the section of cracked rail and installed a 39-foot section of rail.

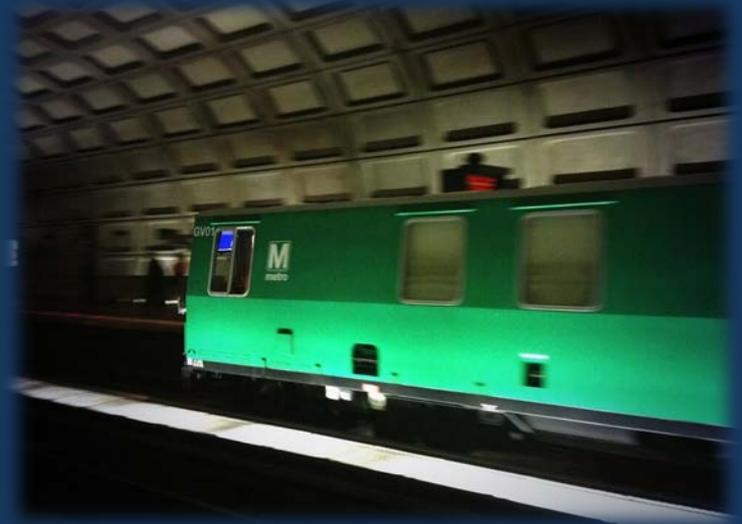
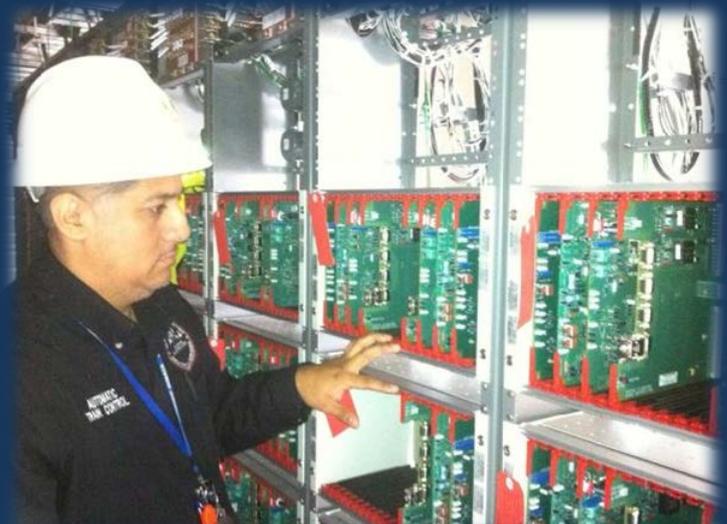
- ✓ Ultrasound tests conducted 5 times per year with the Track Geometry Vehicle
- ✓ Walking inspections performed twice per week
- ✓ Track Circuits tests conducted regularly

According to the Code of Federal Regulations (CFR) under the Federal Railroad Administration (FRA) Standards 213.234, Metro is required to conduct an ultrasound test once per year. However, ultrasound tests are conducted five times per year using the Track Geometry Vehicle (TGV).

Walking inspections are performed twice per week on all mainline tracks, and the data collected is captured in our tracking system called Maximo.

Metro tested this track section using the TGV on September 17, 2014 and found that the rail had surface defects. When the TGV detected the potential issue, technicians hand tested the rail. The test was documented as a “negative hand test,” which means the crew could not verify any internal defects.
