**Safety and Operations Committee**

**Board Information Item III-C**

**Update on Derailment and  
2000/3000 Series Railcars**

Washington Metropolitan Area Transit Authority

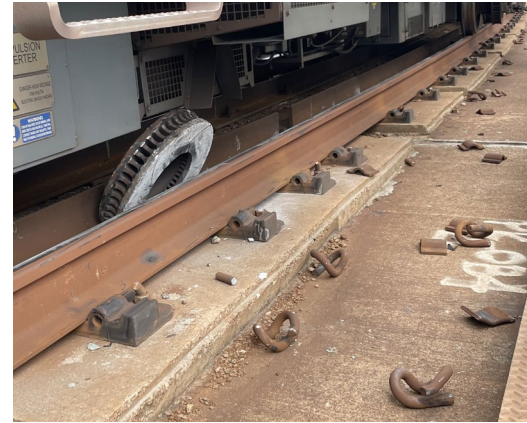
Track Damage

# Track repairs completed on 310 feet of damaged area

The derailment caused 310 feet of damaged area. After Car Maintenance staff re-railed the derailed train (which was a challenging task due to the superelevation of the track on an aerial structure), Track and Structures personnel began work on replacing studs and rail fasteners. In less than three days, the team drilled 494 holes in concrete and installed new studs and replaced 247 direct fixation rail fasteners.

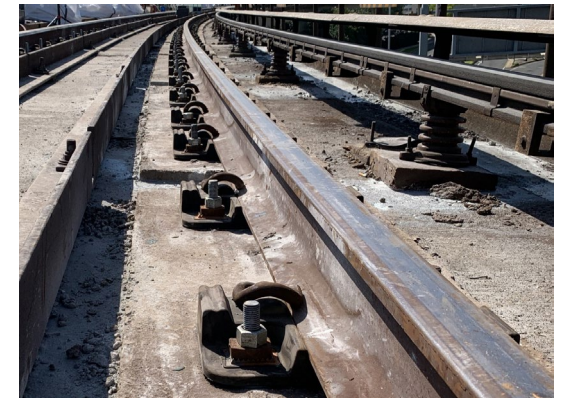
Repaired Track

Throughout the work, engineers were methodical and precise in order to protect the integrity of the aerial structure itself. After the work was completed, Track and Structures ran the Track Geometry Vehicle, which verified no ultrasonic defects in the rail and proper rail alignment, track gauge, and third rail gauge.

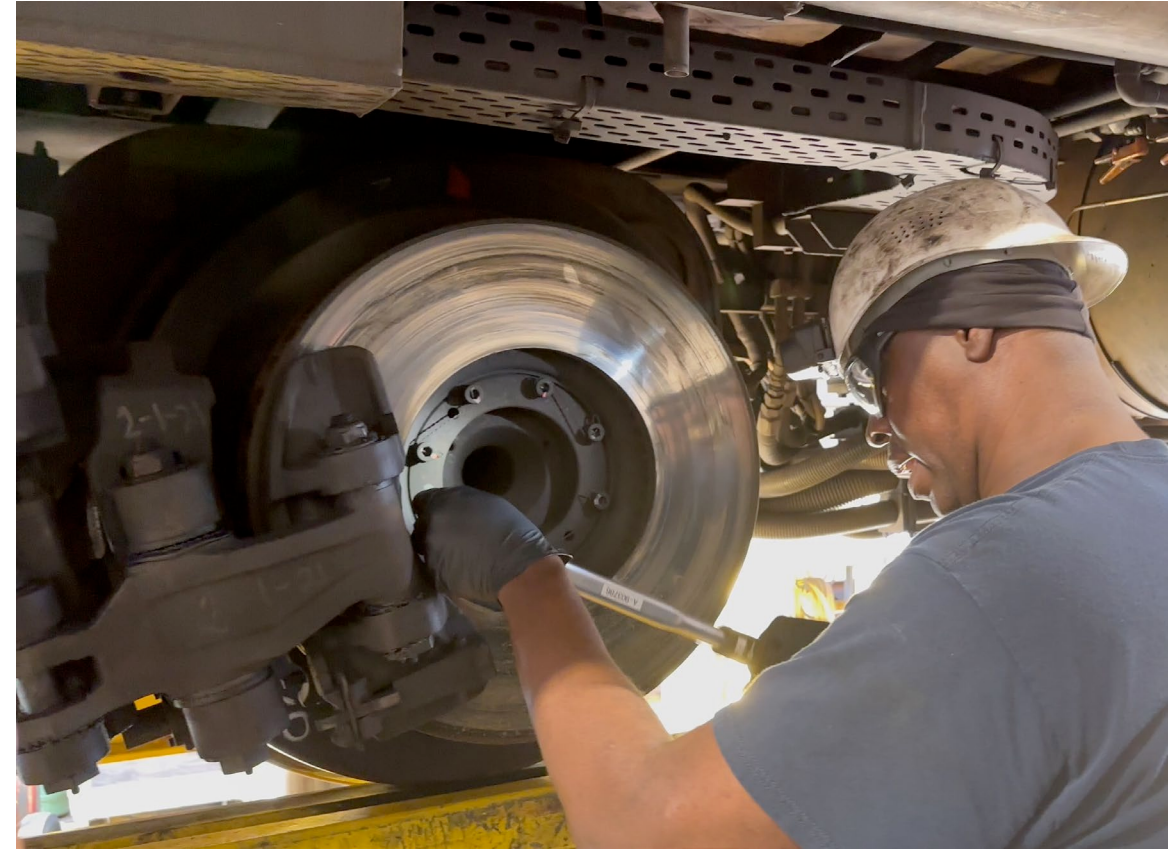
- Inspected brake disc bolts on entire fleet
- Continue to visually inspect daily
- Implemented new requirement to torque check using a wrench every periodic inspection (every 60 days)
- Industry-leading procedure and conservative mitigation

To help to ensure safe operation of the fleet after the derailment, all 2000- and 3000-series railcars were removed from service on September 30. The security of all 2K/3K disc bolts were verified under Service Bulletin SBB-649, which is an enhanced, more conservative maintenance inspection. The brake bolts are installed with applied bolt torque of 70 ft-lb. The Service Bulletin incorporates an additional verification for every bolt to be torque checked using a wrench at 60 ft-lb to verify all disc bolts meet the minimum torque requirement.
