# Northern Bus Garage

## Noise, Vibration, and Dust Monitoring Report (October 2023)

Noise, Vibration, and Dust levels were monitored as part of the reconstruction of Northern Bus Garage, 4615 14<sup>th</sup> Street, NW, Washington, DC, for the month of October 2023.

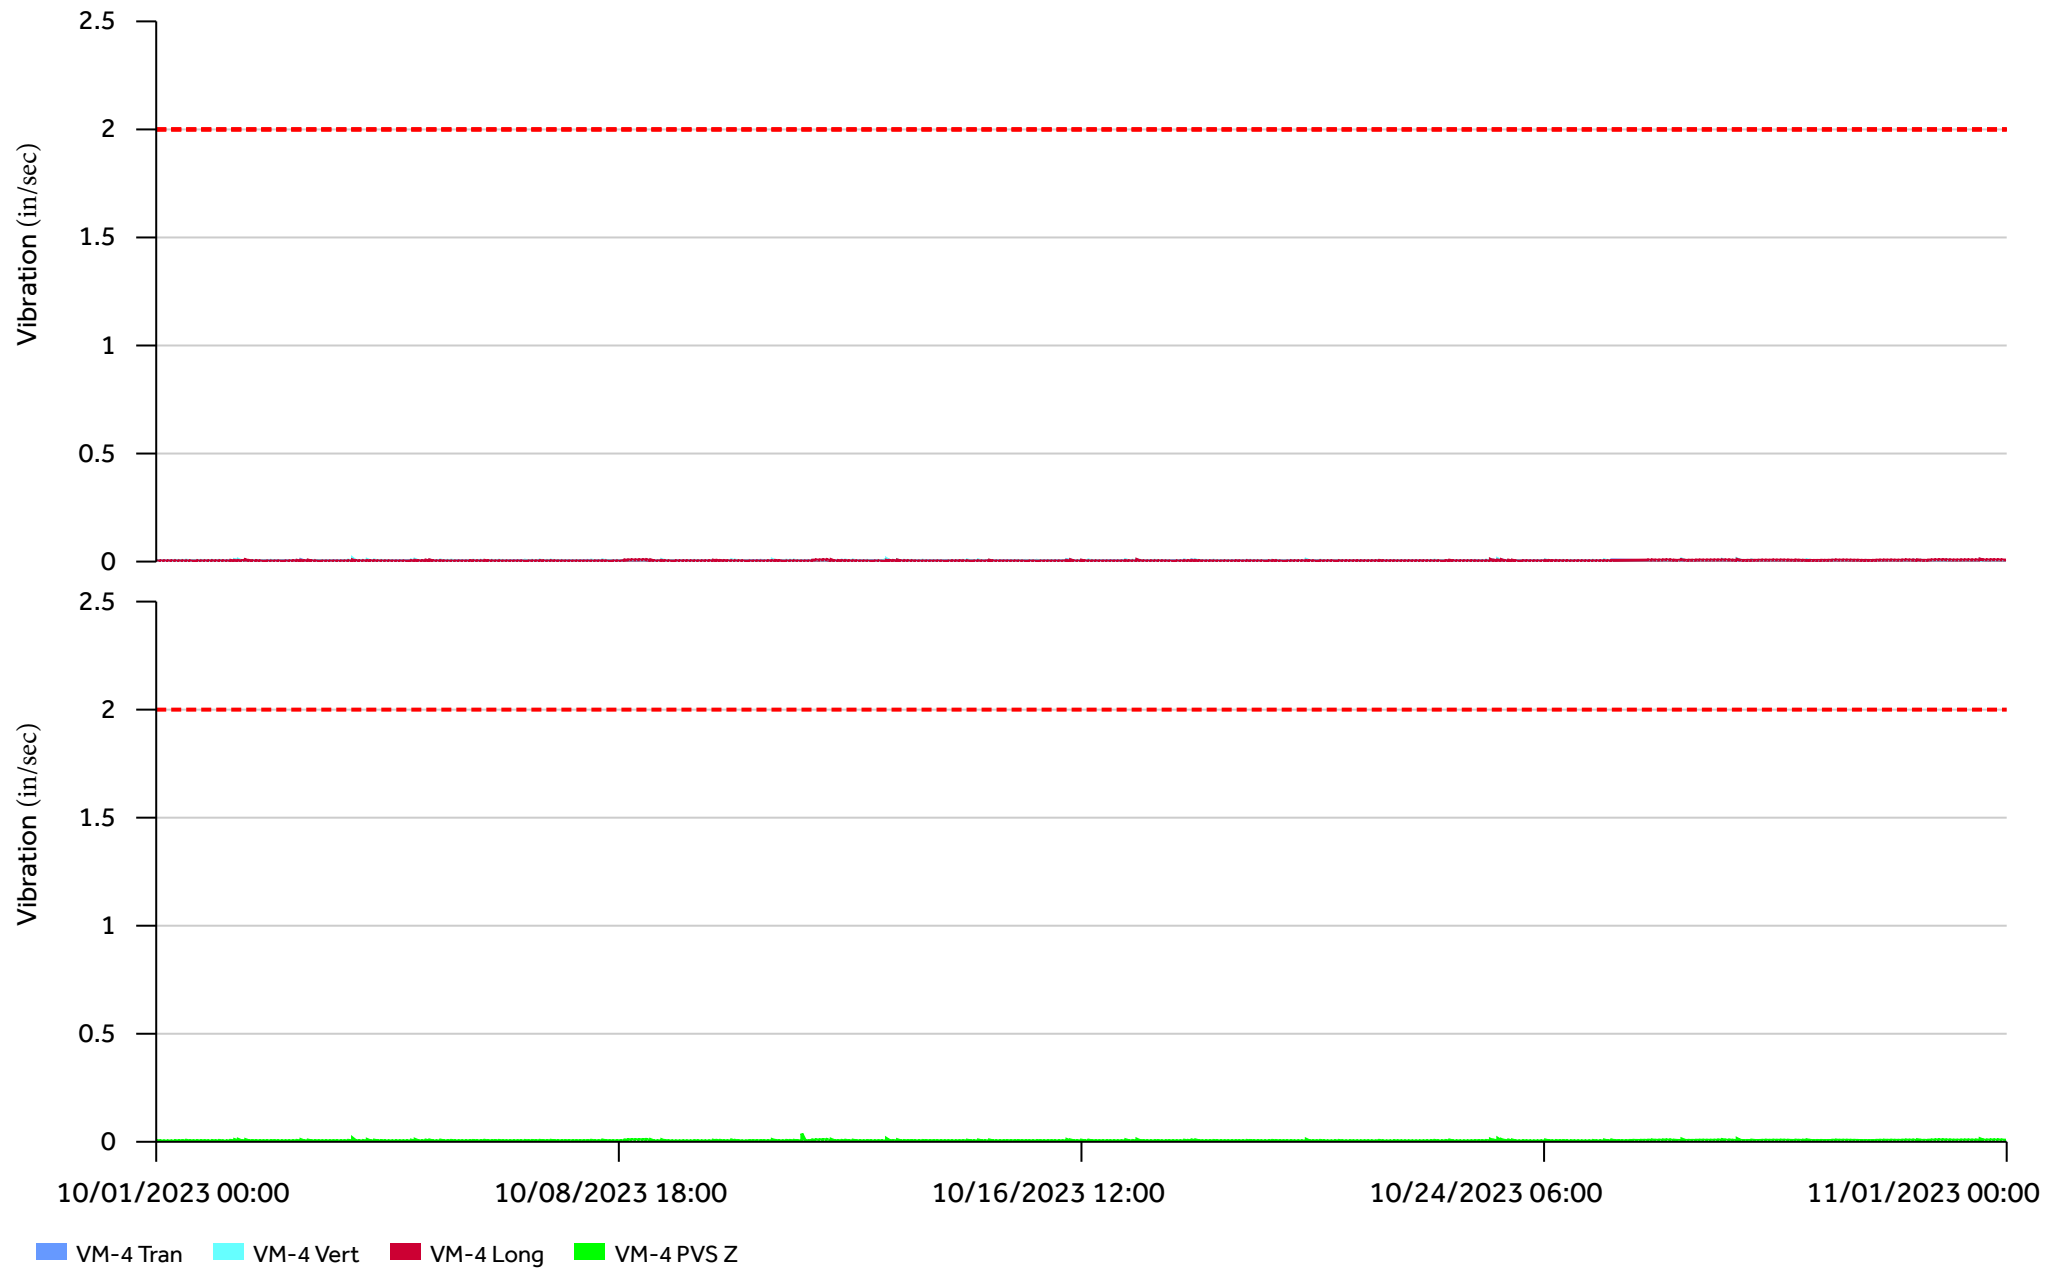
Graph 4:  
VM-4- Vibration Monitor

| Instrument Type | Monitoring Threshold |
|---|---|
| Vibration Monitor (VM-4) | 2.0 in/sec |

No vibration exceedance was reported during the month.

No operating issue with the monitoring instruments was identified. The seismographs at locations VM-1, VM-3, VM-4, and VM-5 were due for annual calibration. These were exchanged with newly calibrated units.
