## Northern Bus Garage

### Noise, Vibration, and Dust Monitoring Report (September 2024)

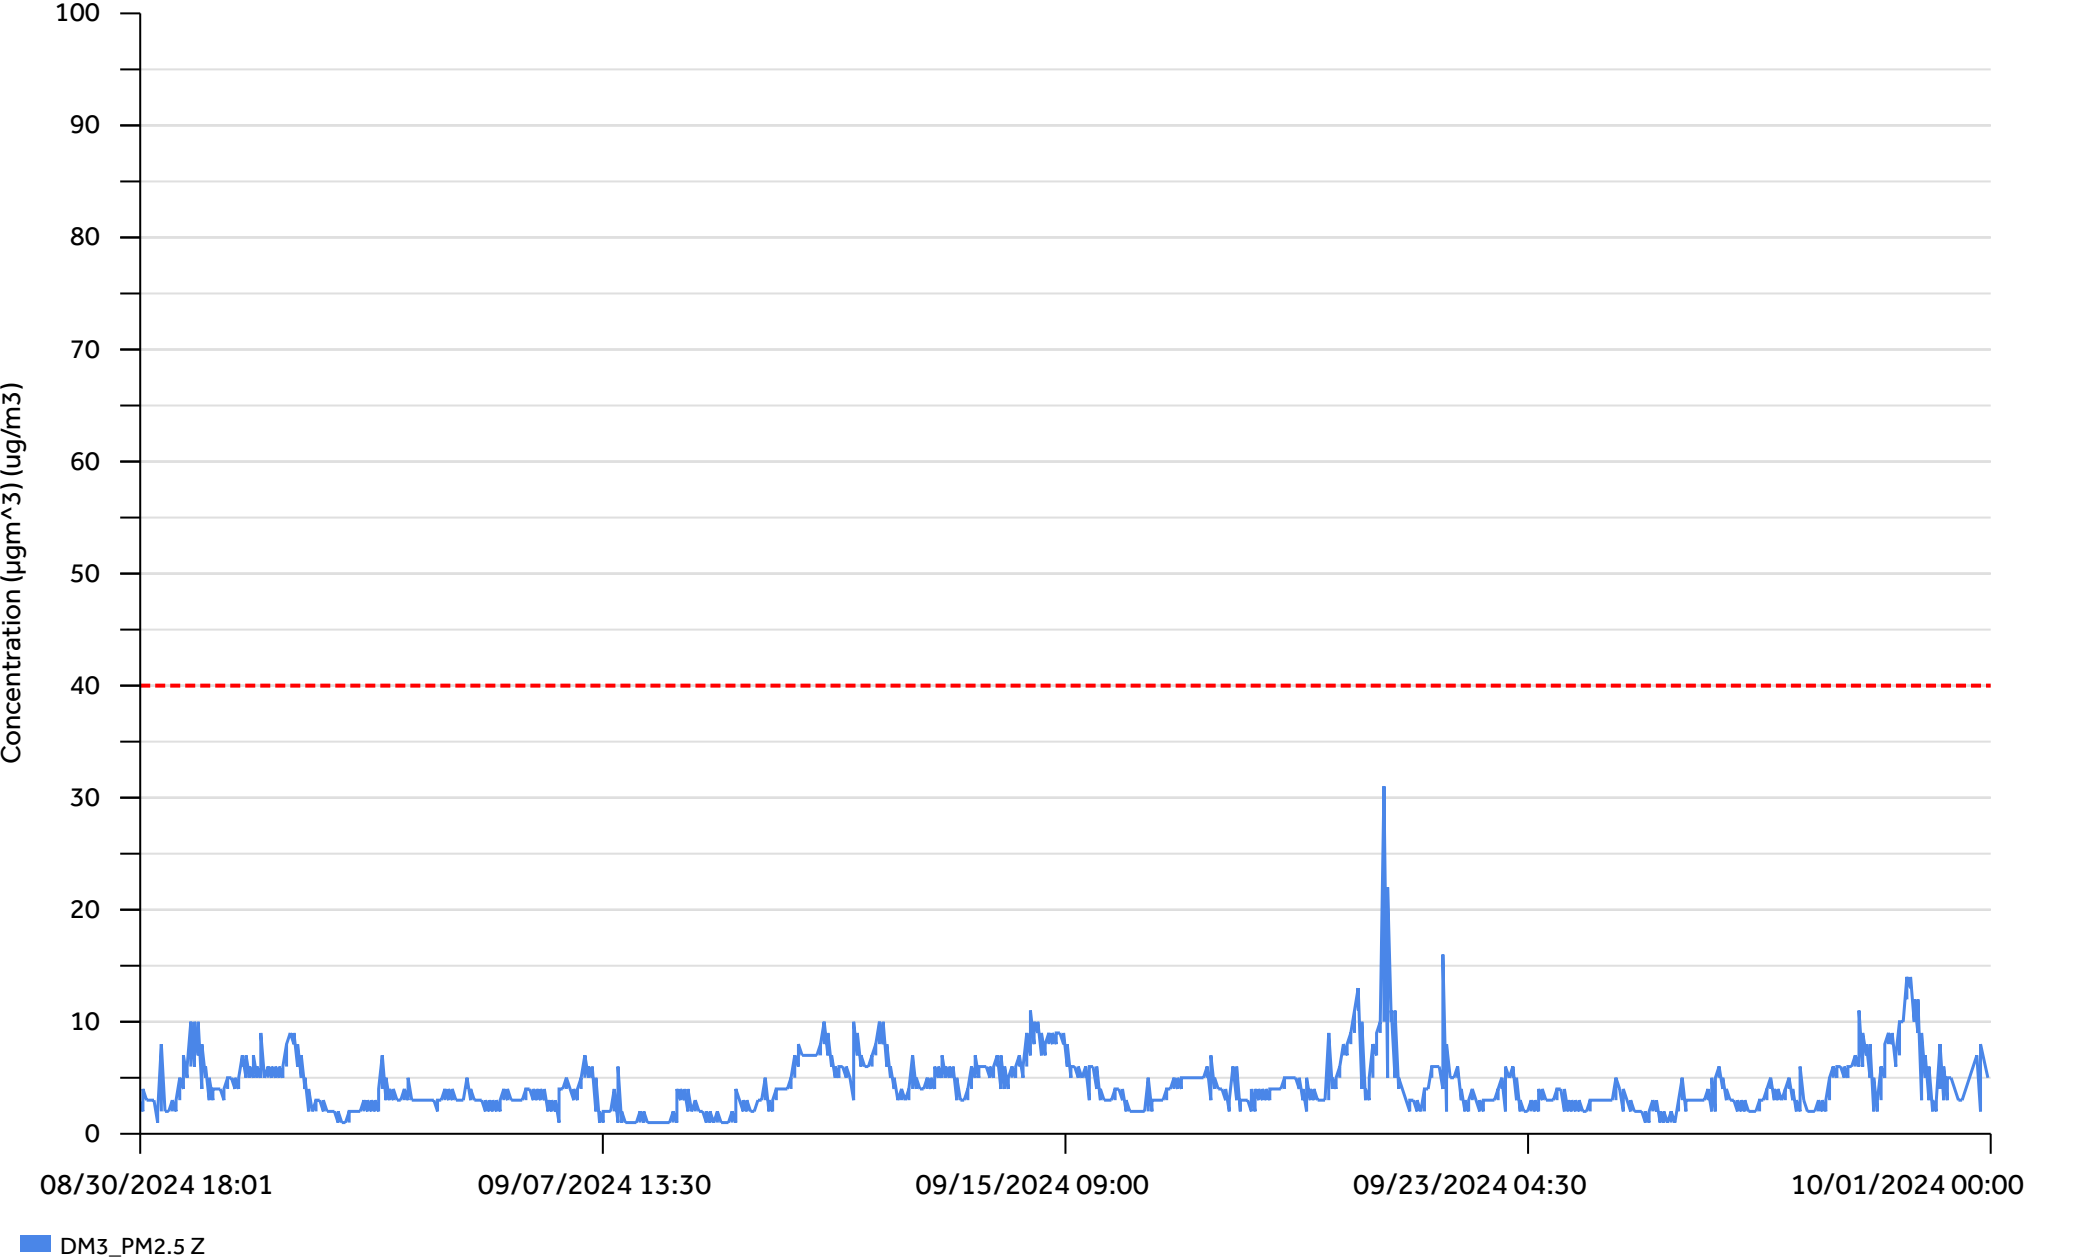
Graph 11

DM3-PM2.5
