# Northern Bus Garage

## Noise, Vibration, and Dust Monitoring Report (November 2024)

Noise, Vibration, and Dust levels were monitored as part of the reconstruction of Northern Bus Garage, 4615 14<sup>th</sup> Street, NW, Washington, DC, for the month of November 2024.

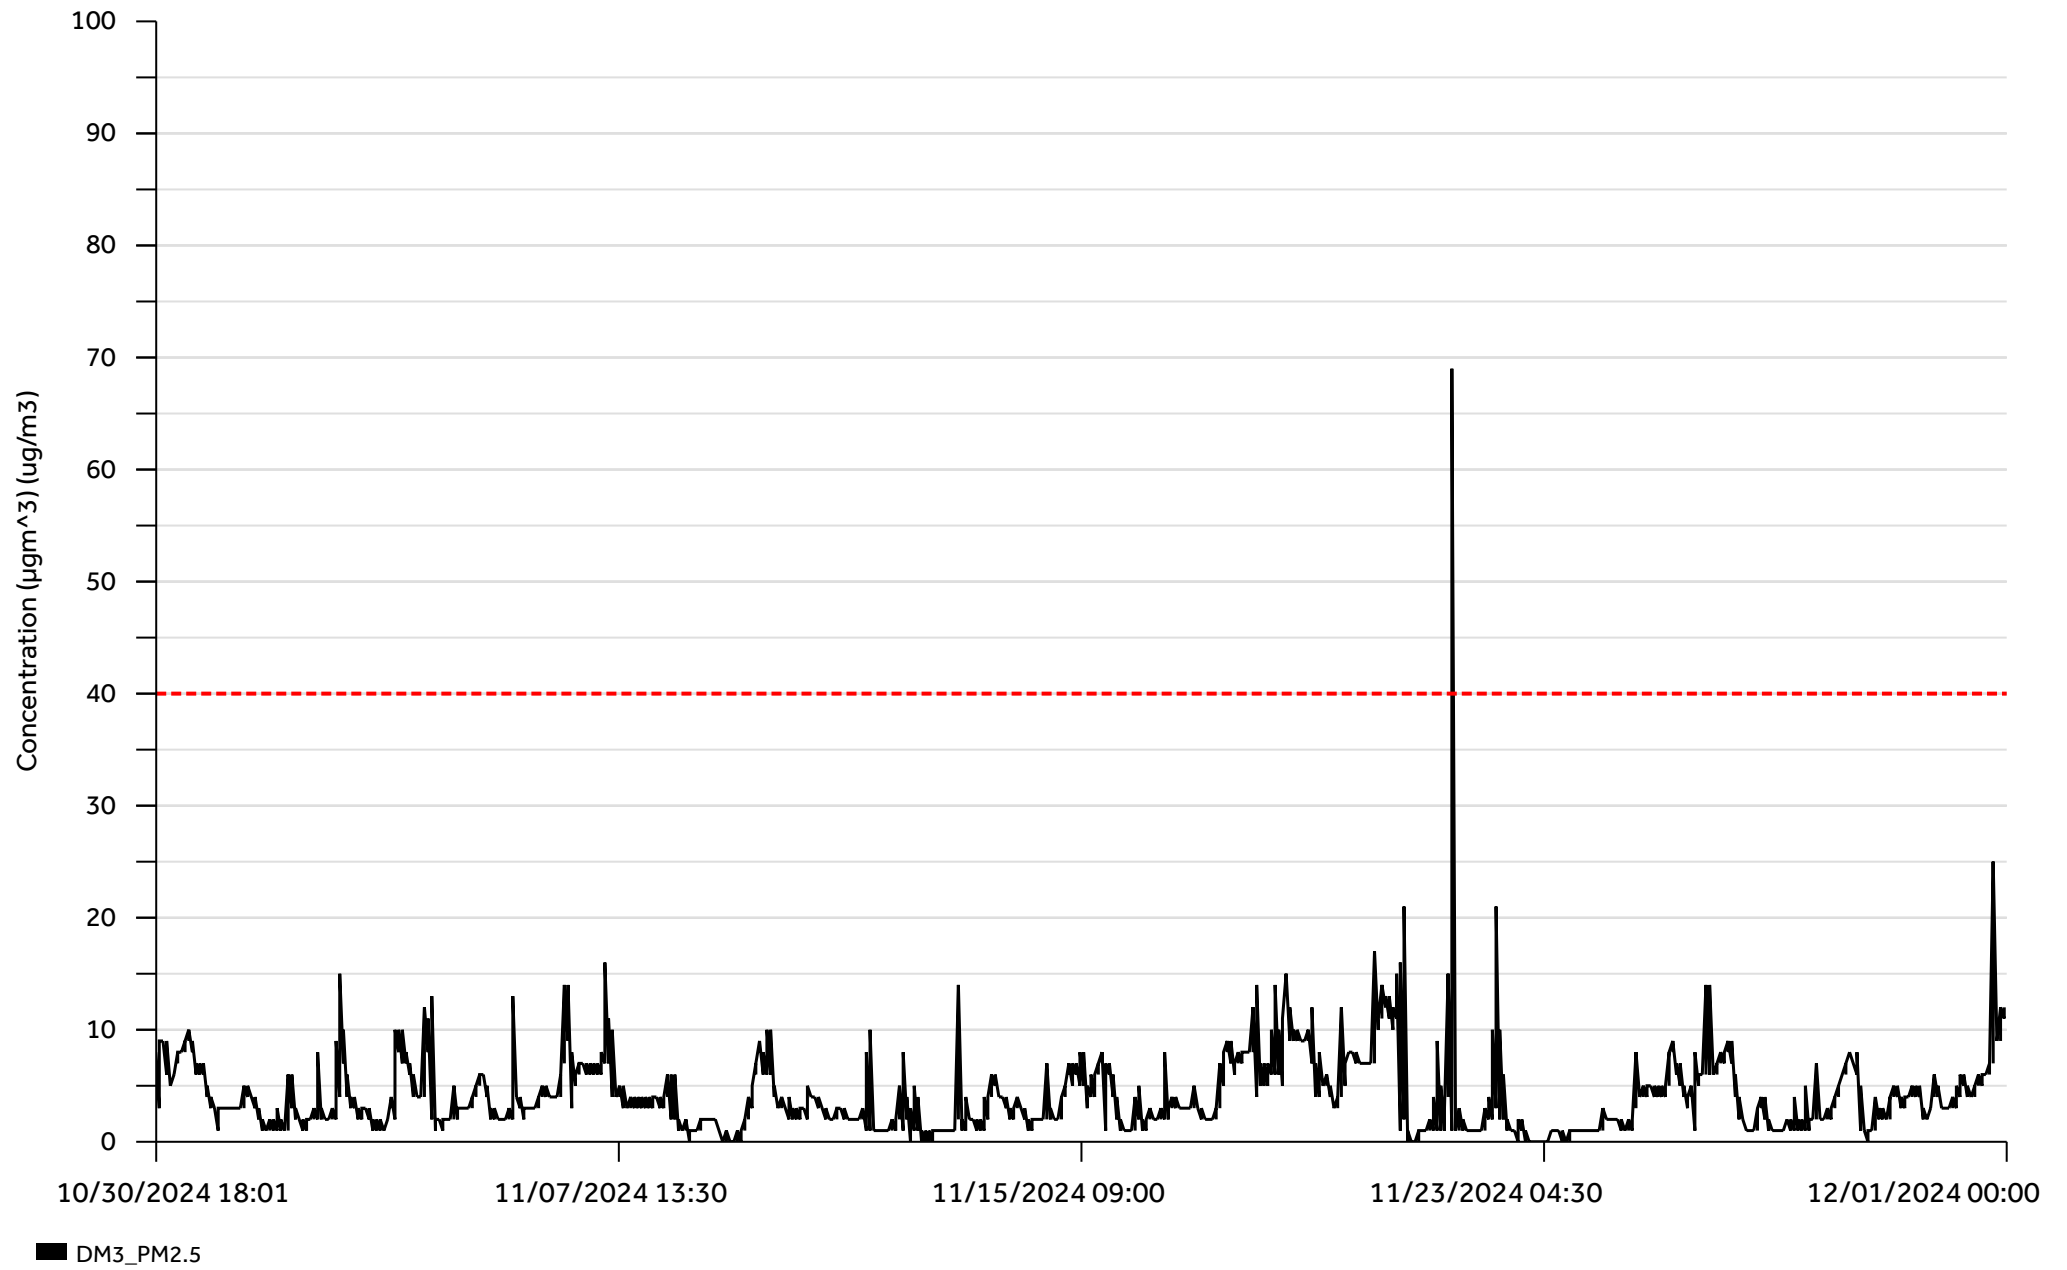
Graph 11

- DM3 – Exceedance of the PM2.5 limit on 11/21 at 15:34 with a reading of 69  $\mu\text{g}/\text{m}^3$ .
  - Weather history shows wind gusts of 22 MPH during this period.
