# Northern Bus Garage

## Noise, Vibration, and Dust Monitoring Report (April 2025)

Noise, Vibration, and Dust levels were monitored as part of the reconstruction of Northern Bus Garage, 4615 14<sup>th</sup> Street, NW, Washington, DC, for the month of April 2025.

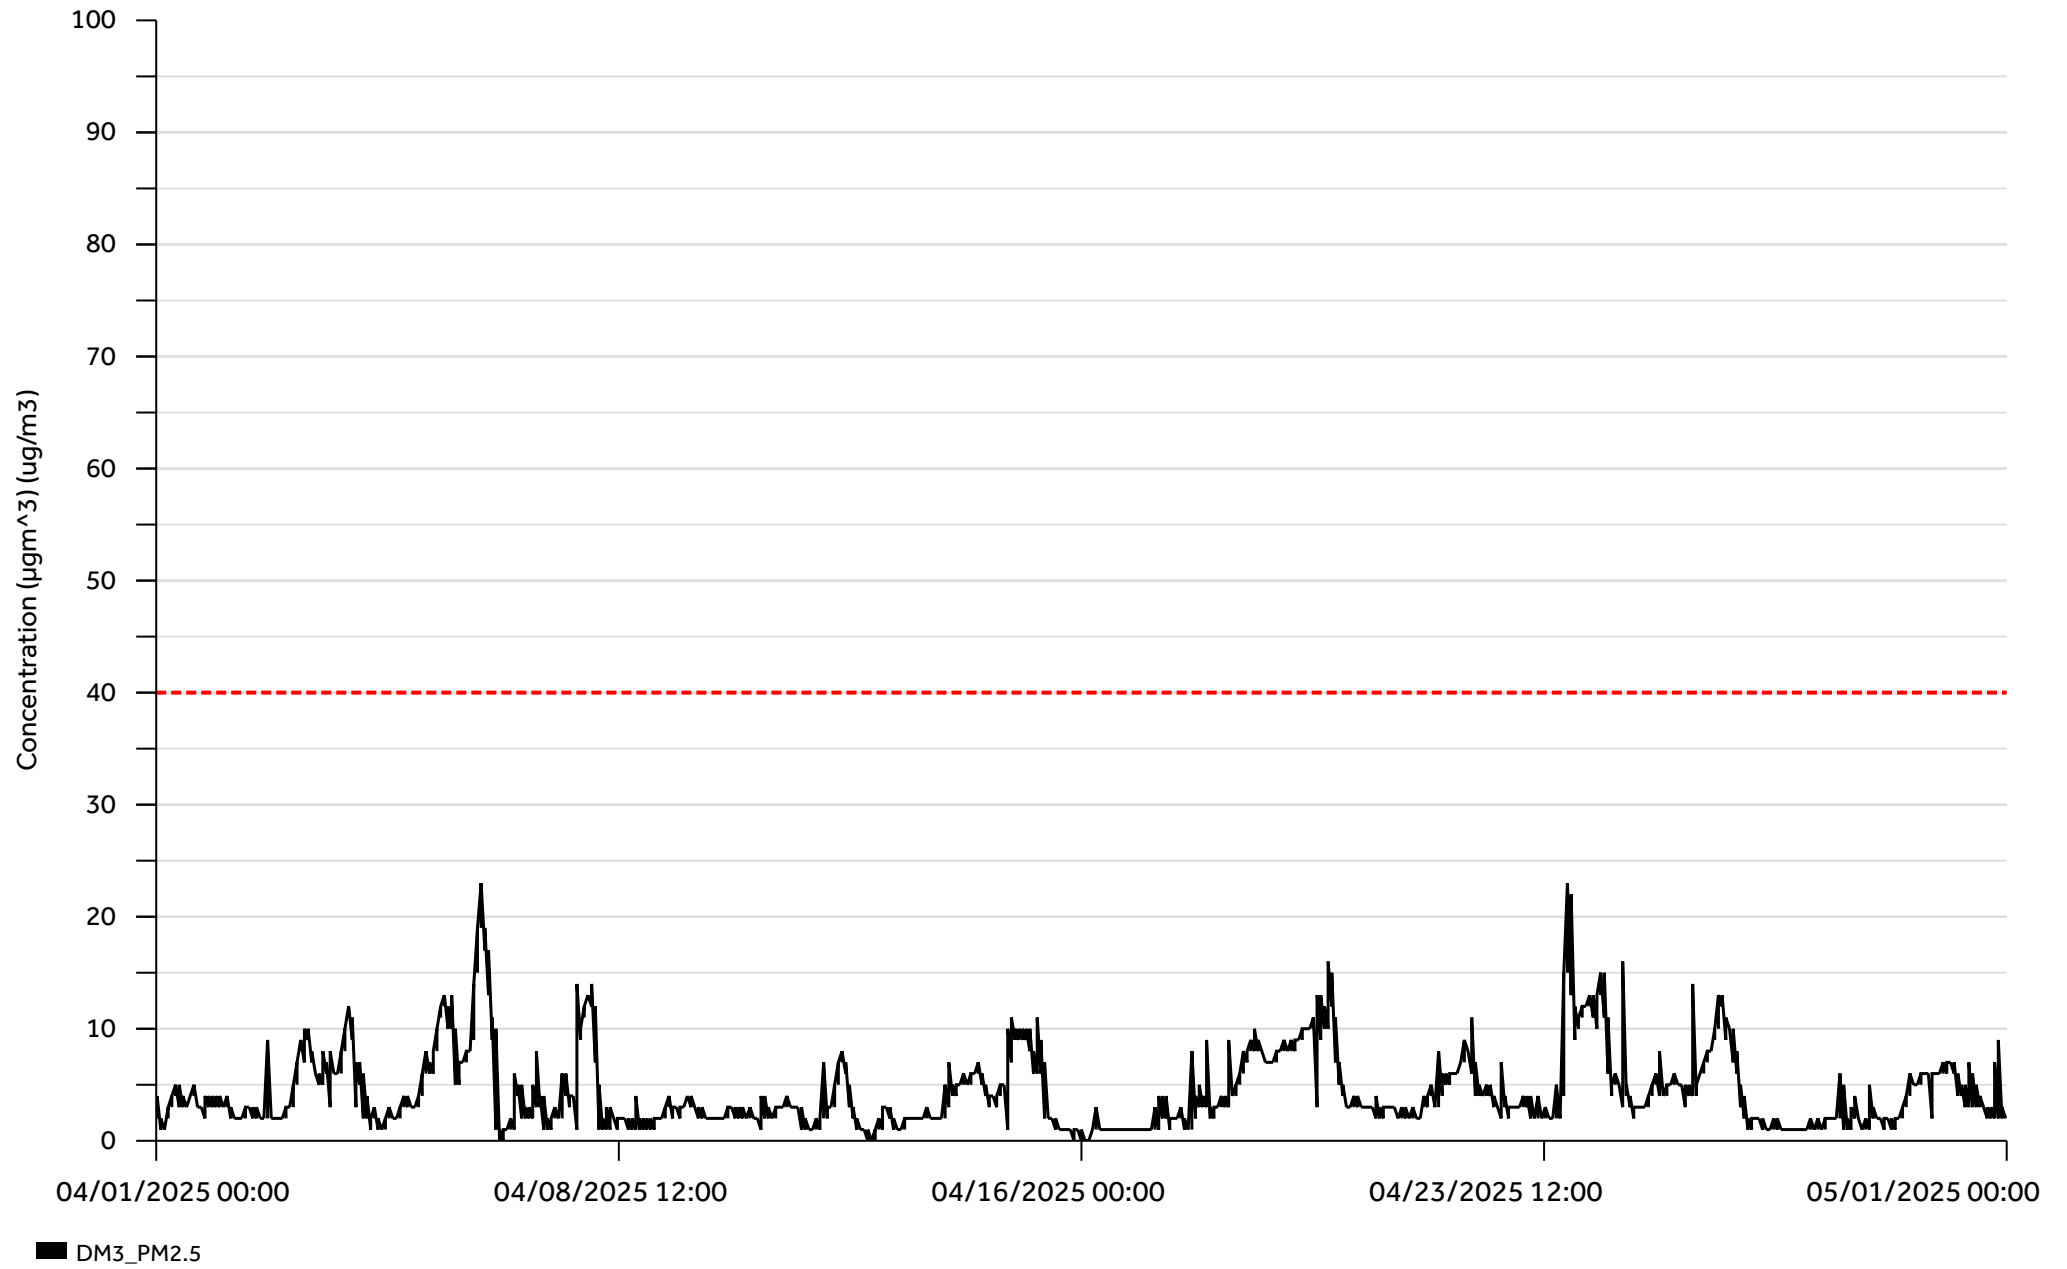
# Graph 11

| <b>Dust Monitoring Measurement</b> | <b>Monitoring Threshold</b> |
|---|---|
| Particulates (PM2.5) | 40 $\mu\text{g}/\text{m}^3$ |

DM3-PM2.5
