# Northern Bus Garage Replacement Project

Spring Community Meeting

May 9, 2023

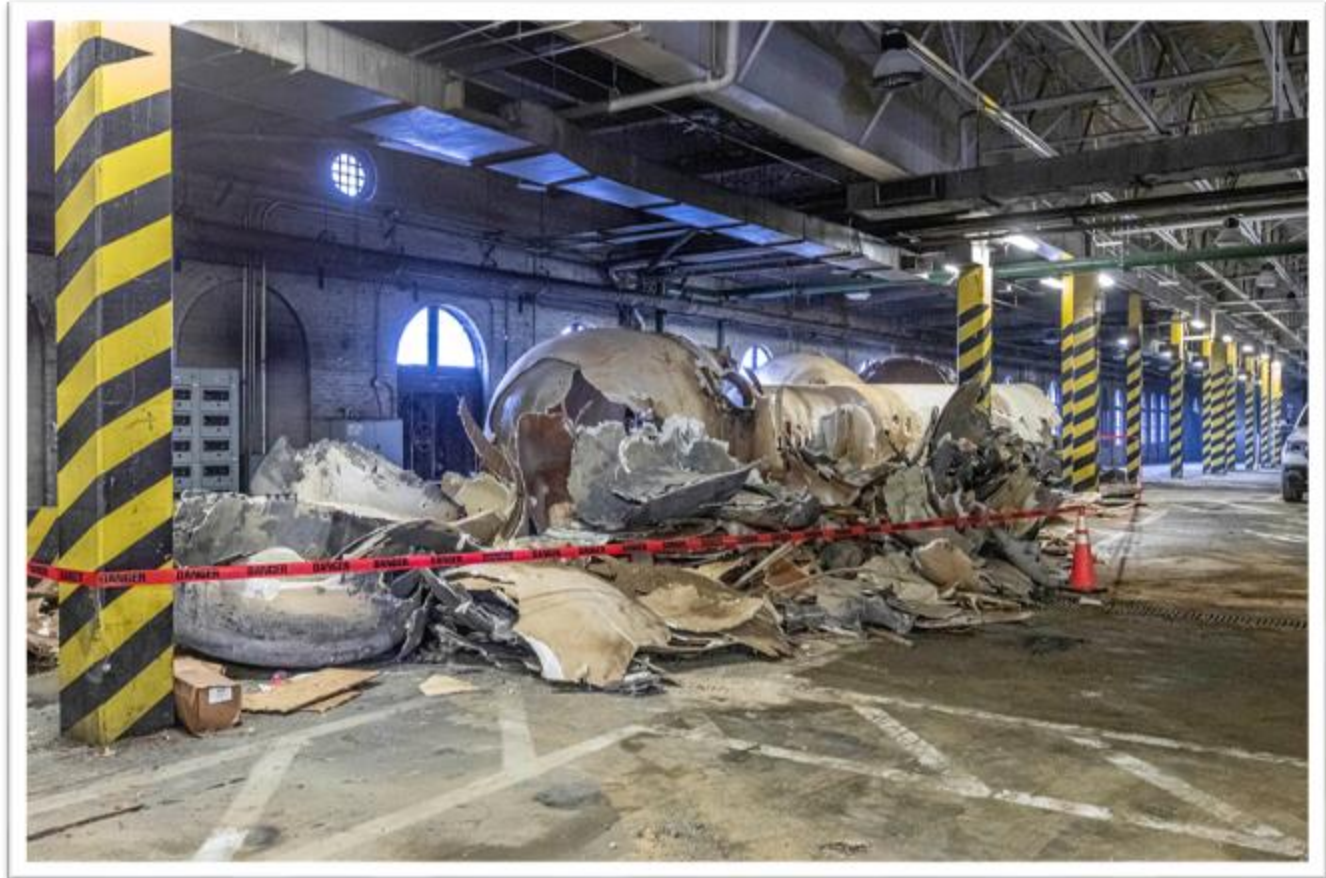
#### Q1 – Environmental Remediation

- Completed removal of underground and above ground storage tanks
- Removal of old bus maintenance and service equipment completed
- Completed regulated waste capture and removal
- Started asbestos abatement

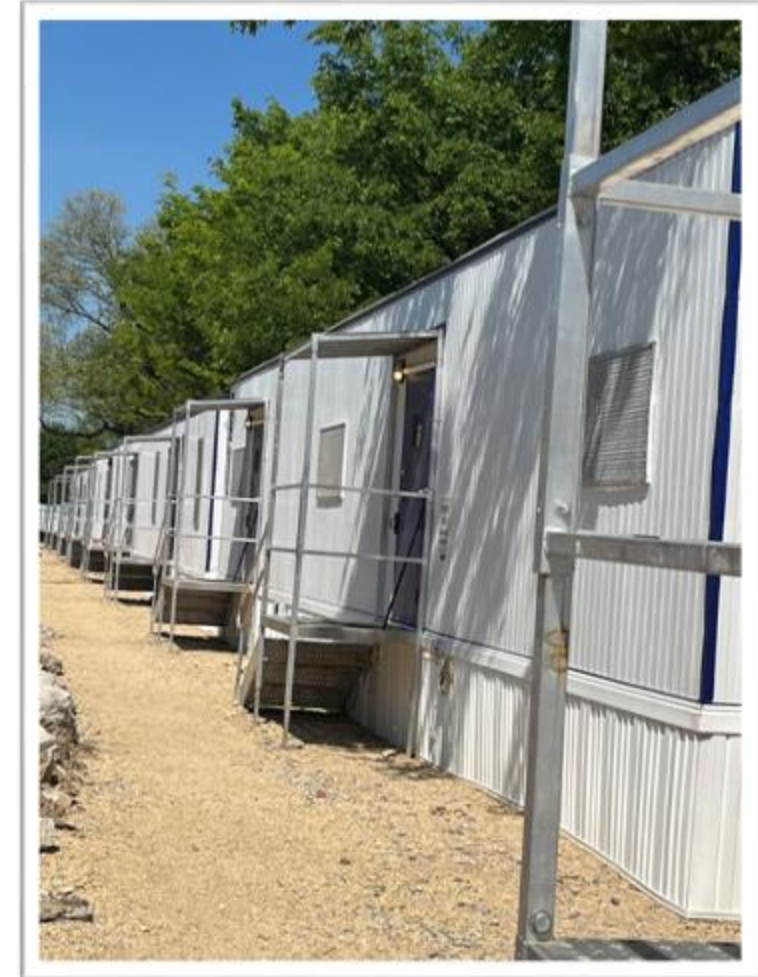
### Q1 – Completed mobilization to the site

- Set up construction fencing, site security and Maintenance of Traffic around perimeter of site
- Set up construction field trailers along Arkansas Avenue
- Completed installation of noise & vibration instrumentation equipment, reporting data monthly

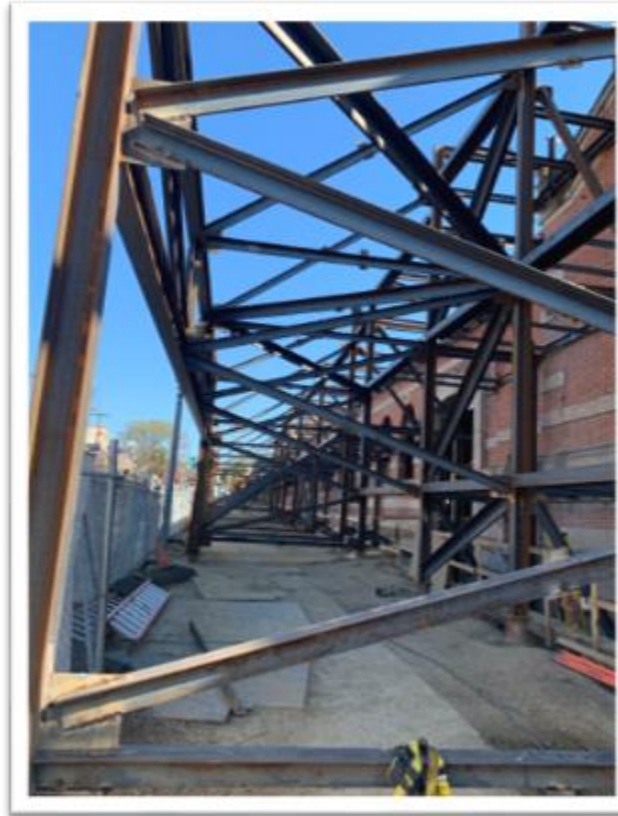
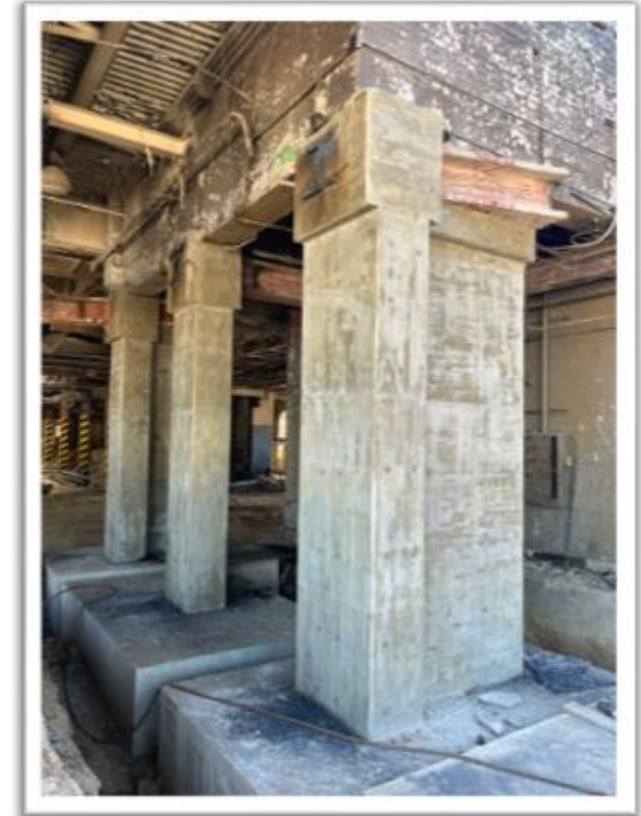
#### Q1 – Façade Bracing and Tower Re-support

- Completed deep foundations for and the installation of all façade bracing
- Completed new mini-pile foundations, concrete structures and tower jacking for tower re-support

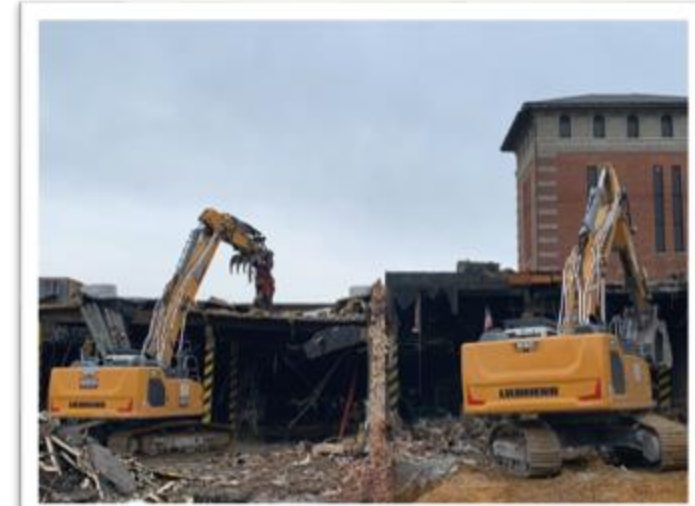
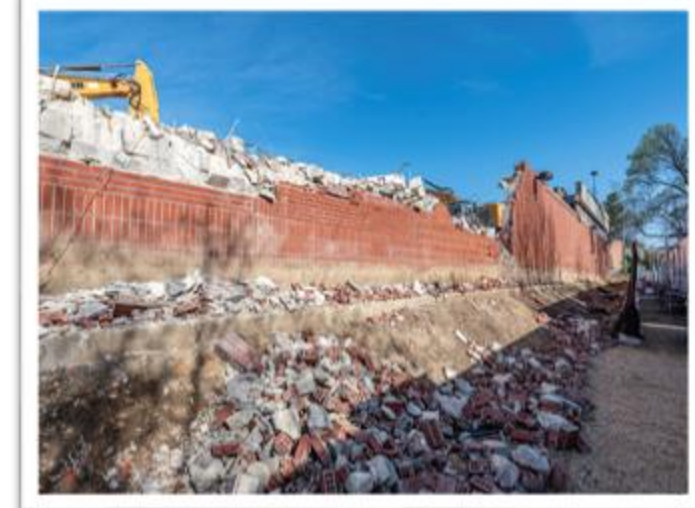
#### Q1 - Started Mass Demolition of Building

- Completed demolition of Decatur St. cover structure
- Completed utility disconnects
- Completed demolition of the former parking structure over bus storage
- Started hand separation at historic façade
- Over 98% of demolition waste is being repurposed

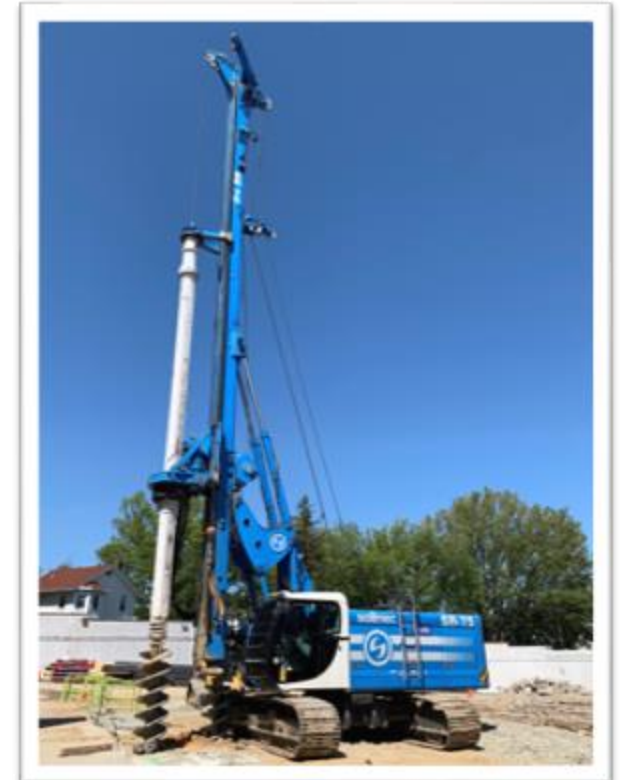
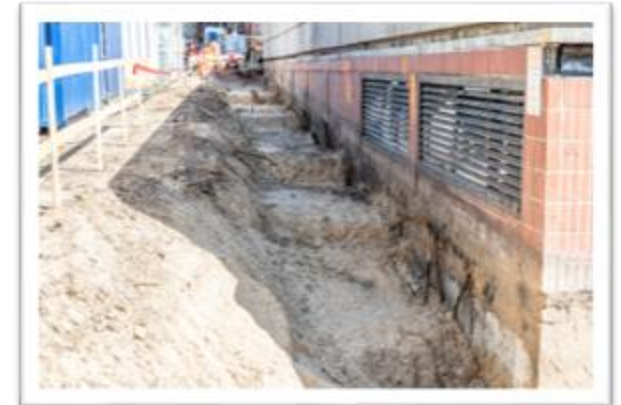
#### Q1 - Support of Excavation (SOE) and Soils Excavation

- Started Support of Excavation (SOE) pile installation east of the historic administration building
- Completed rock removal plan reviews
- Minor excavation began to support demolition

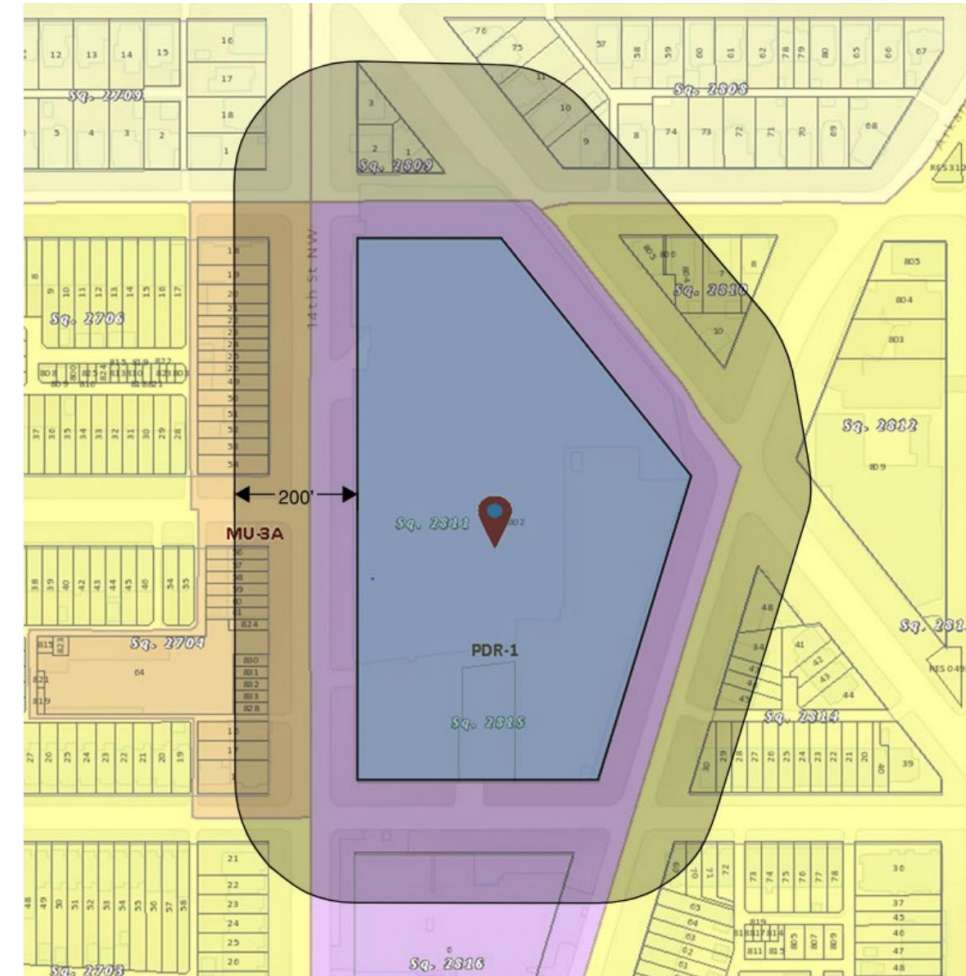
## Preconstruction Survey Update

- Map shows an overlay with the properties that fall within 200 ft of the proposed new bus garage
- For more detailed information on the preconstruction survey, please visit [https://wmata.com/initiatives/plans/northern-bus-garage/upload/Northern\\_June15\\_FINAL\\_Slides.pdf](https://wmata.com/initiatives/plans/northern-bus-garage/upload/Northern_June15_FINAL_Slides.pdf) (slides 29 – 33)

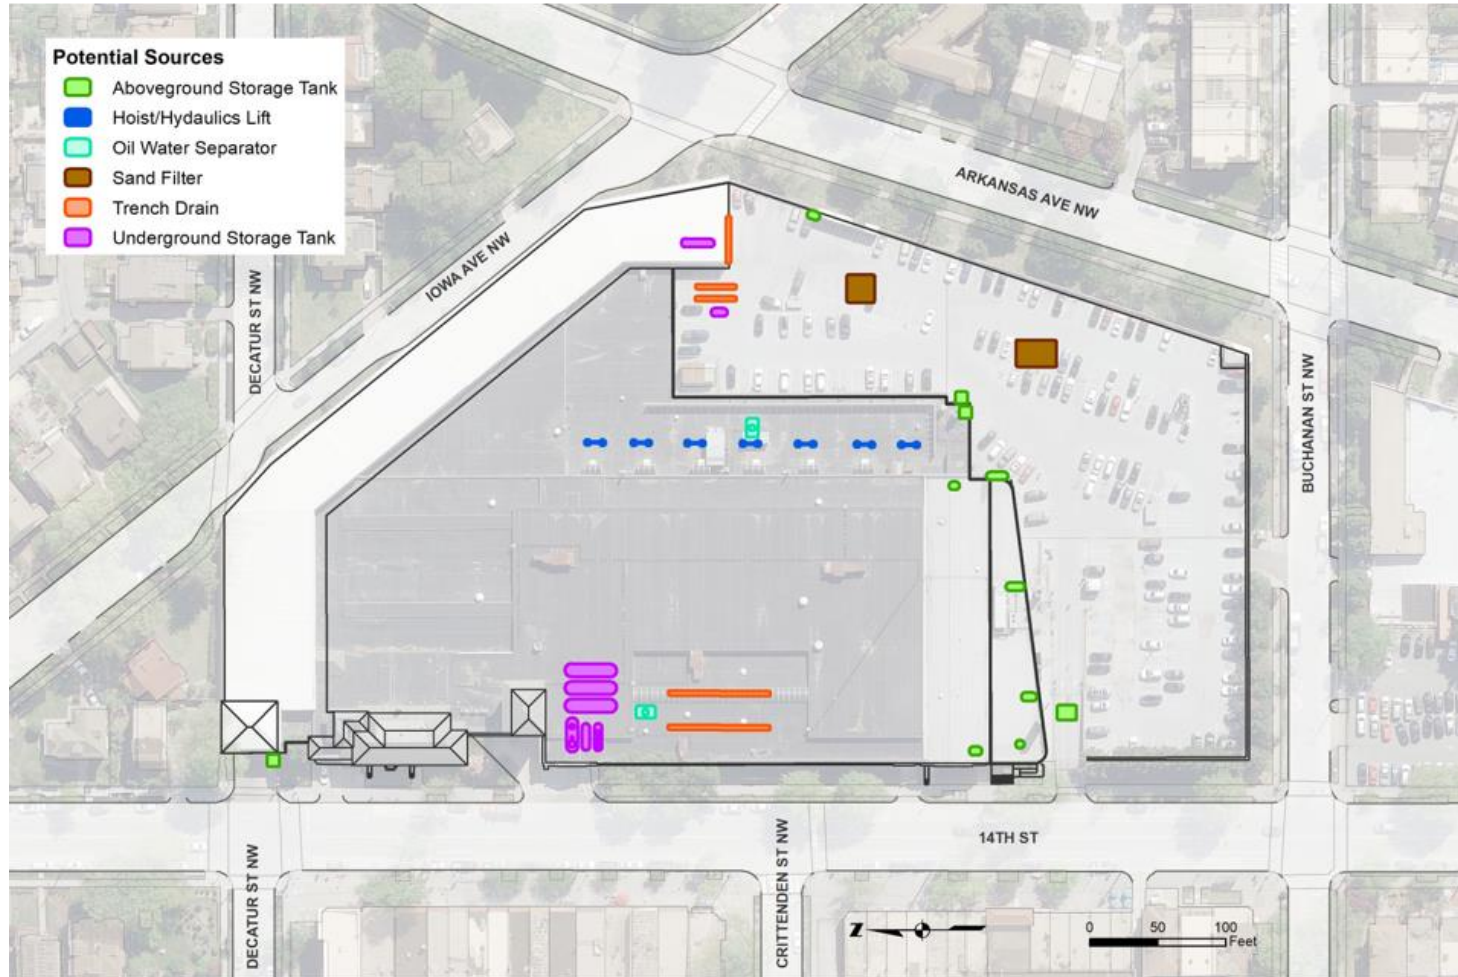
## Potential Sources

1. Underground Storage Tanks (USTs)
2. Chlorinated Solvents
3. Other materials
