# ON-STREET BUS TERMINAL STUDY

Washington Metropolitan Area Transit Authority

March 2013

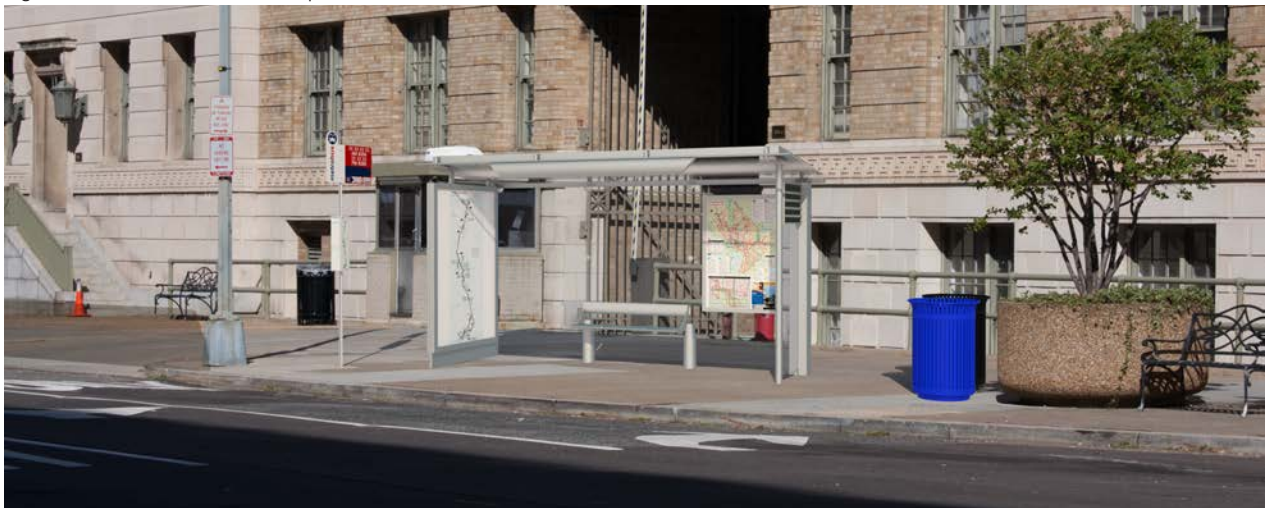
Figure ES-1: C Street SW - Proposed Shelter

In addition, the installation of a new bus shelter and additional amenities required for a basic stop is recommend at stop 1000692 (located on the 14th Street SW end of C Street SW).

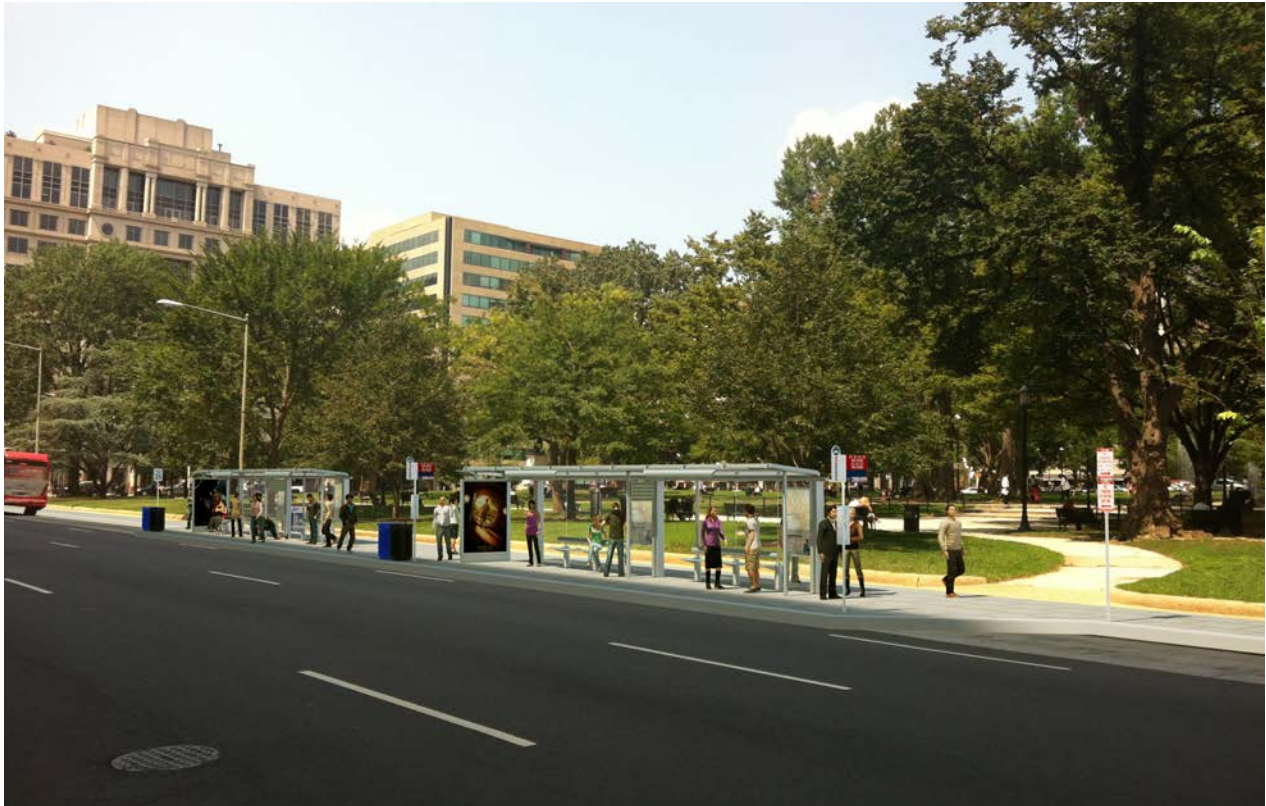
Figure ES-2: Franklin Square - Curb Extension and Shelters on I Street NW

At Franklin Square, the most extensive recommended modifications would occur along I Street NW. A mid-block curb extension on I Street NW would accommodate transit center class passenger amenities. The existing five stops along I Street NW would be consolidated into three stops (stop number 1003653, 1003661, and 1003662).

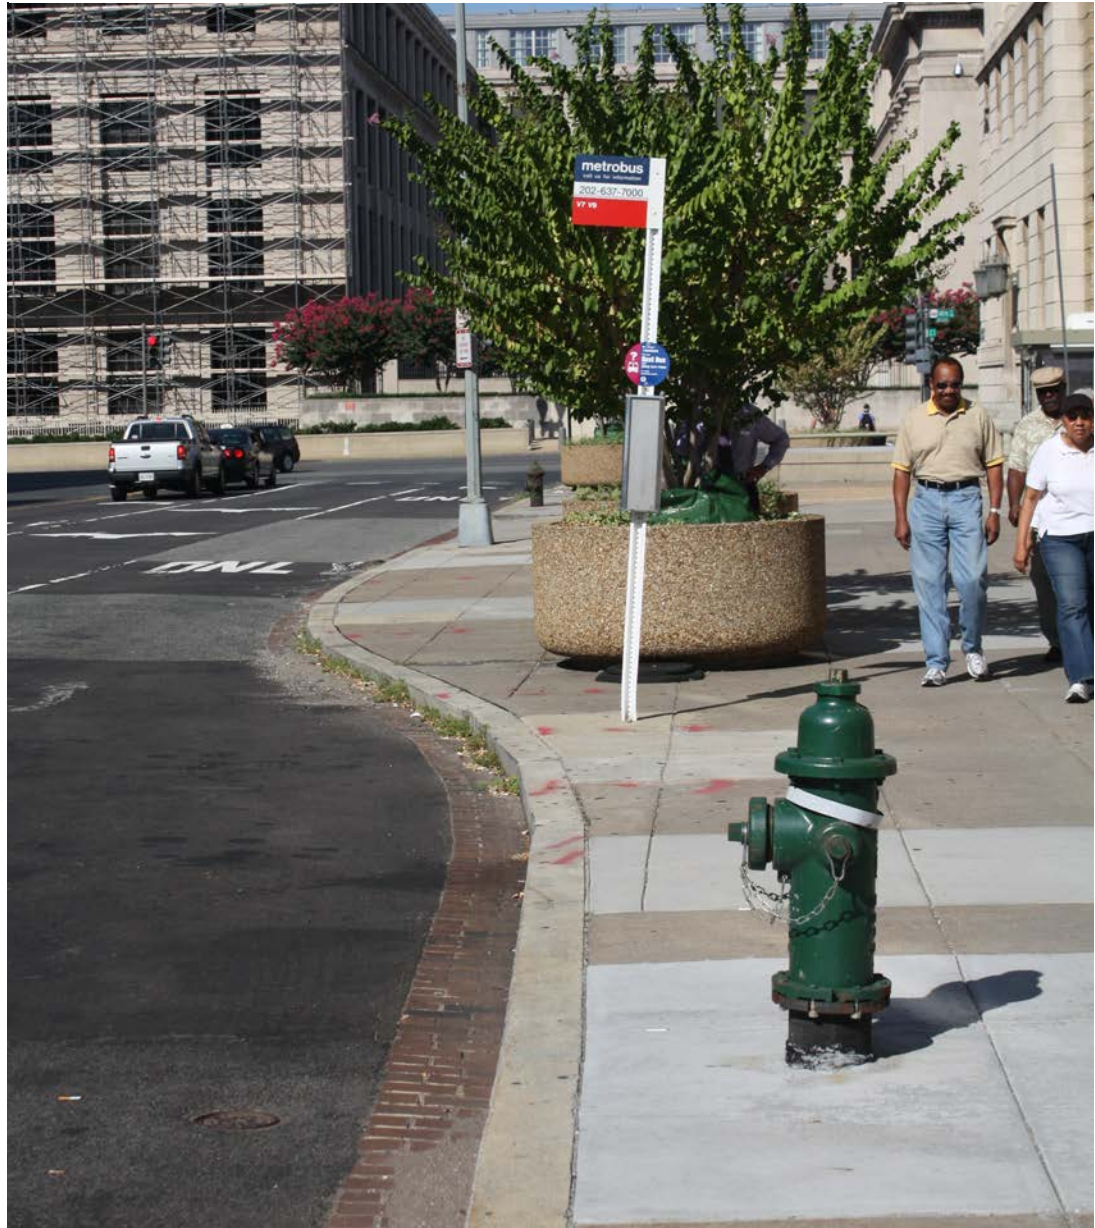
Figure 34: C Street SW Stop 1000692

Both stops at C Street SW were classified as basic stops. Although they were both classified as basic stops, stop 1000692 requires a shelter due to the higher number of daily boardings.

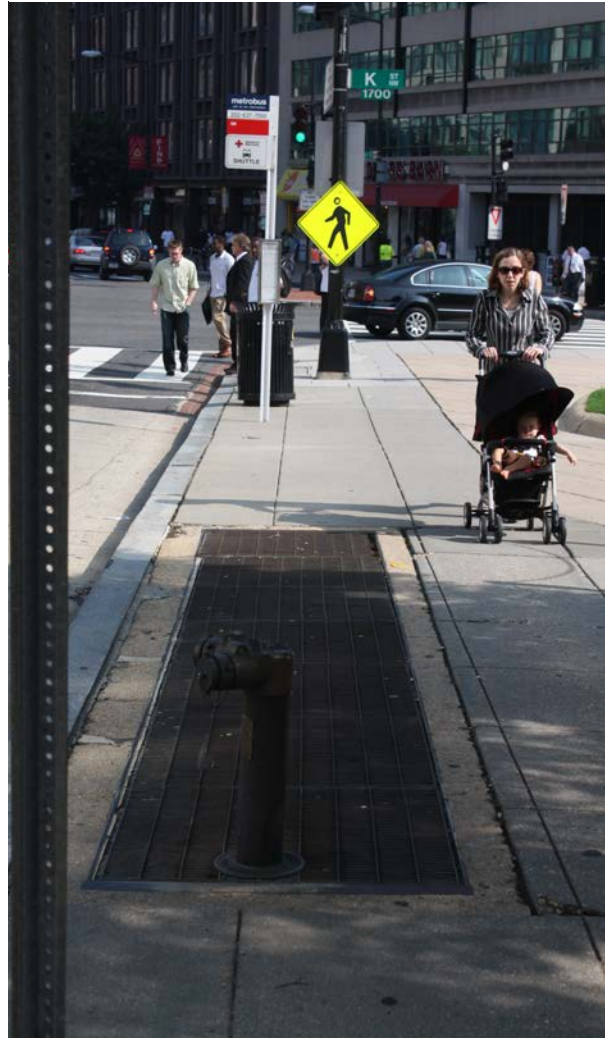
Figure 44: Metal Grates along 17th Street NW [west]

The existing infrastructure provide ADA-compliant amenities. The largest safety issues for pedestrians are the metal grates located on the sidewalks, close to the bus stops, along both I Street NW and 17th Street NW [west] (Figure 43 and Figure 44).

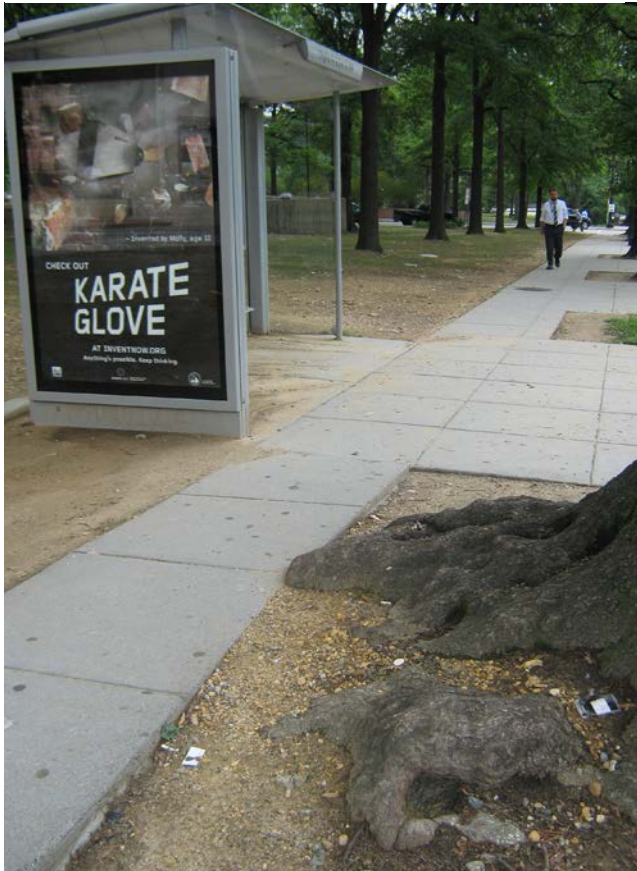
Figure 71: Sidewalk Connecting to Stop 1003537

Under existing conditions, the bus zones for stops 1000983 and 1001021 overlap with metered parking zones that, as marked, are only available during non-peak hours (Figure 70). The street signs indicate that the bus zones are utilized as parking zones from 9:30 AM to 4:00 PM (typical weekday), but the 80 route operates all day and requires access to the stops at all times. Buses were observed stopping in the adjacent through lane when parked vehicles were obstructing the curb; a potentially unsafe practice that the bus operators are forced into by the presence of the cars.

In addition, the western sidewalk approach to stop 1003537 (located on Virginia Avenue NW at E Street NW) does not provide the four feet minimum clear pathway due to an obstruction caused by a large tree root growing in the adjacent tree box. The study recommends shifting the existing shelter several feet to the north and/or to the east to allow the expansion of the existing sidewalk to meet the required four feet minimum width.
