APPENDIX 6: HISTORIC PRESERVATION REVIEW BOARD STAFF REPORTS

**HISTORIC PRESERVATION REVIEW BOARD
STAFF REPORT AND RECOMMENDATION**

Landmark/District: **Decatur Street Car Barn/Northern Bus Garage** Agenda
Address: **4701 14th Street, NW** Consent Calendar
Meeting Date: **May 28, 2020** New Construction
H.P.A. Numbers: **20-176** Alteration
 Demolition

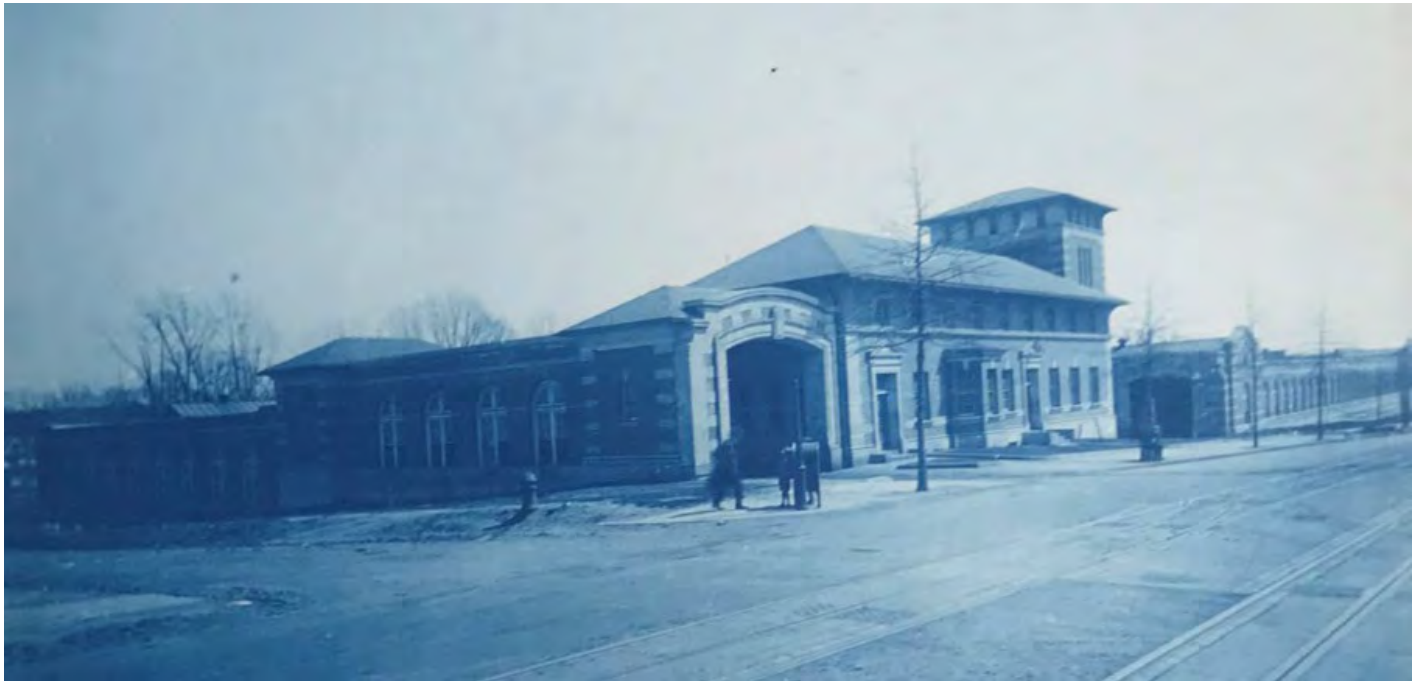
1914 Photograph of the Northern Bus Garage looking southeast (DC History Center)

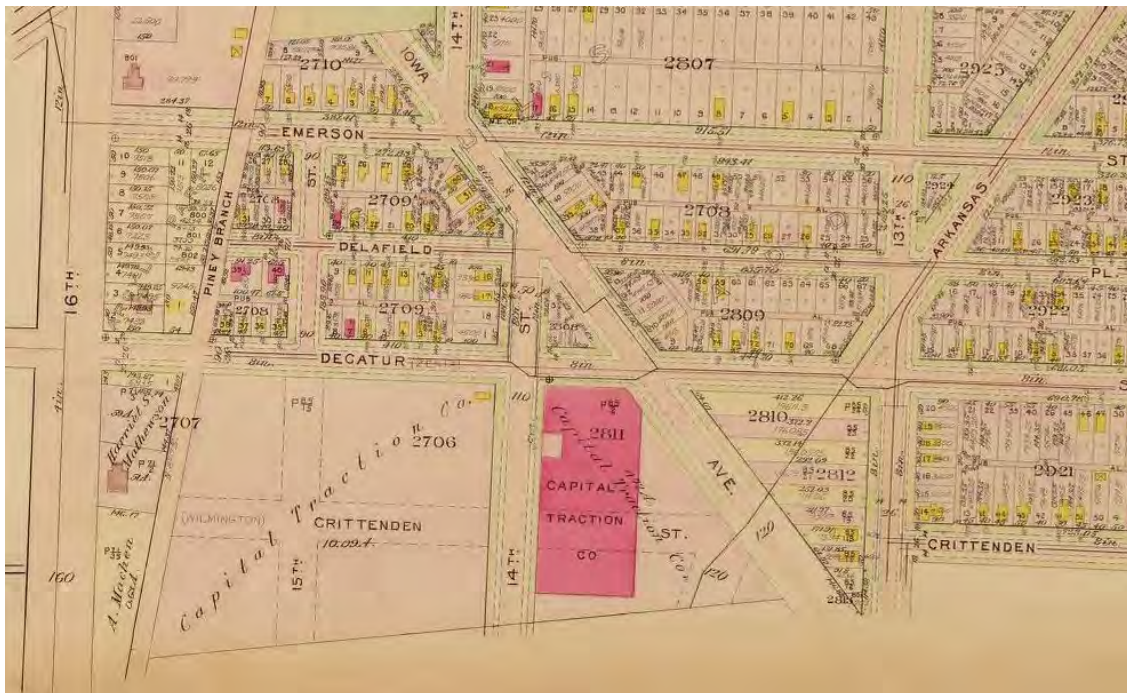
Figure 2. 1911 Baist Real Estate Map; Decatur Streetcar Barn is the pink building labeled as the Capital Traction Co. (Library of Congress)

The Northern Bus Garage site is bounded by 14th Street to the west, Decatur Street to the north, Iowa Ave to the northeast, Arkansas Ave to the southeast, and Buchanan Street to the south. The main façade of the building faces 14th Street, and therefore, the west façade is the most decorative. As originally constructed, the brick masonry car barn measured 537 feet (north-south) by 208 feet (east-west), occupying nearly half of the site on Square 2811 and a portion of Square 2815. As platted, the two squares were intended to be divided by Crittenden Street. However, because of the construction of the car barn, the road was never laid, and the squares remained joined. The 1911 Baist Real Estate Map shows the original footprint and surrounding streets of the garage. It is interesting to note the residential character of the neighborhoods to the north of the garage and that the Capital Traction Company owned the squares west of 14th Street, yet the area was not developed at the time (**Figure 2**).

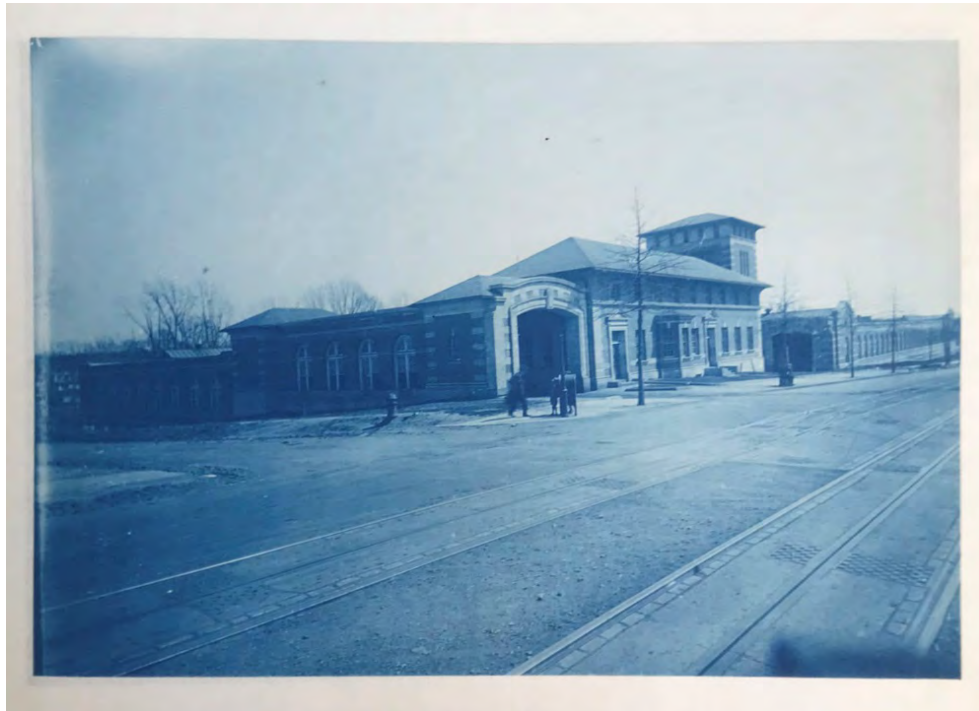
Figure 3. 1914 exterior photograph of the northwest corner of the streetcar barn showing the administrative offices, tower, and two of the three original streetcar openings. (DC History Center)

The building was designed to look like two complementary masses: a two-story structure housing the administrative offices, featuring a hipped roof with overhanging eaves, and a two-story car barn and repair shop, accentuated by a grand three-story tower with a clerestory. As designed and constructed, the garage consisted of an upper (main level) entered along 14th Street and a partially excavated lower (basement) level, accessed from the south elevation of the building. Exterior character-defining features included brick walls accented with stone belt courses, quoining, and keystones; shallow-pitched hipped roofs of the tower and administrative offices, and bracketed eaves (**Figure 3**). The garage and repair shop featured a flat roof with several large skylights and a front gable parapet. The building originally featured three streetcar entrances and exits on the west façade: two facing west and framing the

administrative offices and one facing north, immediately adjacent to the tower. Arched window openings on all elevations provided light to the garage and repair shop. The administrative offices, tower, and several projecting pavilions along the north and west elevations featured rectangular windows.

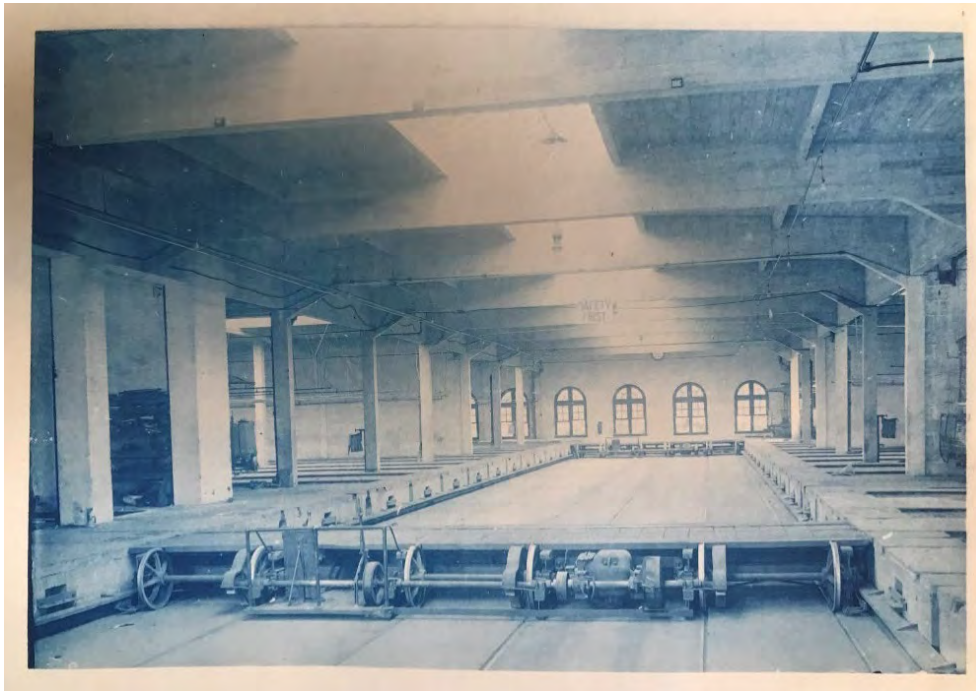
Figure 4. 1914 interior photograph of the Decatur Streetcar Barn showing the transfer table in the foreground and the skylight above (DC History Center)

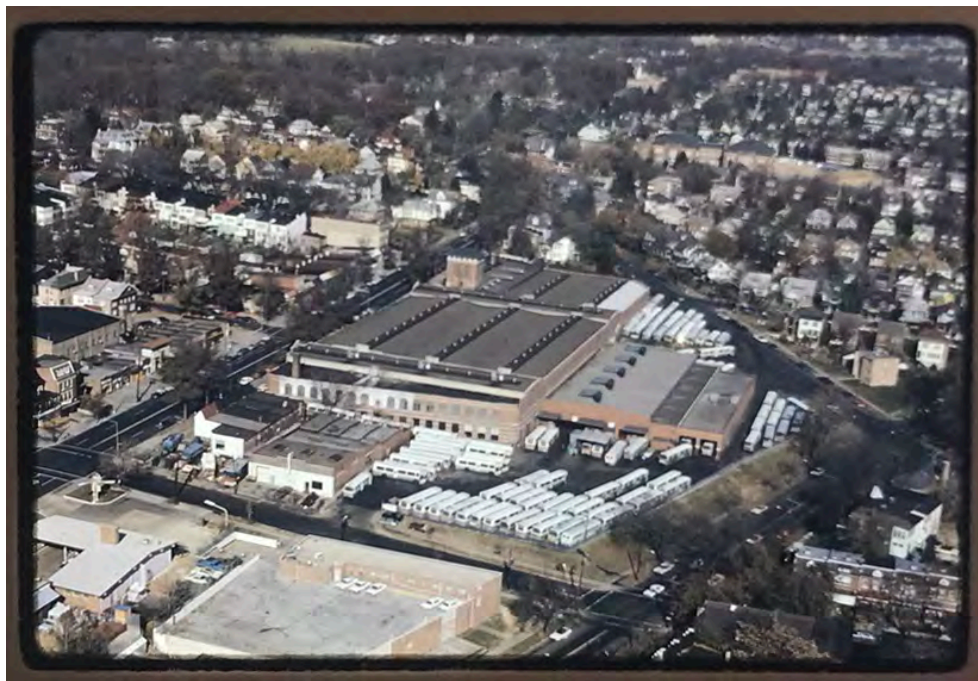
Figure 6. 1974 photograph of the bus garage looking northwest; the 1926 addition is visible on the right (WMATA Archive, George Washington University Special Collections)

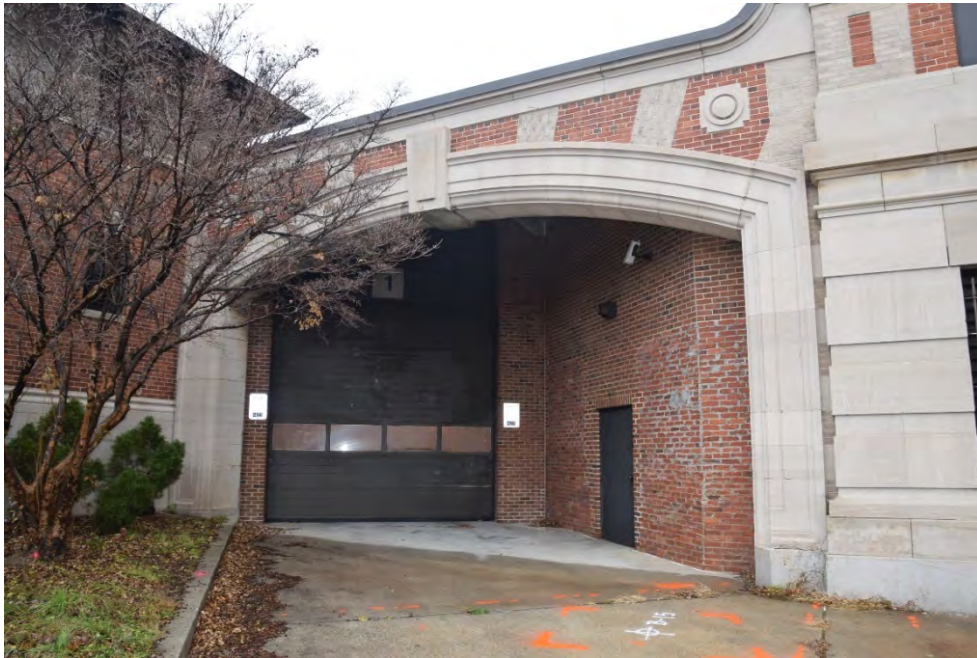
Figure 8. Angled brick wall on right constructed sometime after 1914 and prior to 1978. The other angled wall with the overhanging door was added after 1978 (BBB)

Another instance of unknown alteration occurred to the north of the tower. 1914 blueprints show that the north elevation of the tower adjacent to the streetcar opening was originally exposed, however, 1978 existing condition drawings show that an angled wall had been built at the streetcar opening, closing off the north elevation of the tower. Today, the wall is still extant, and a doorway has been inserted. (Figure 8)

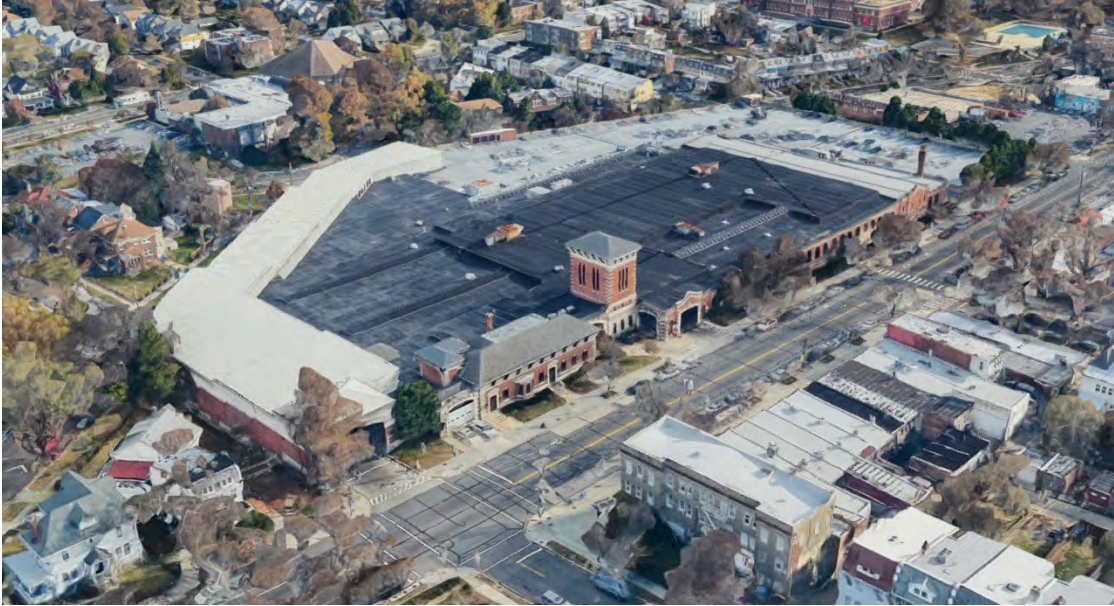
Figure 9. Contemporary aerial image of the bus garage looking southeast (Google)

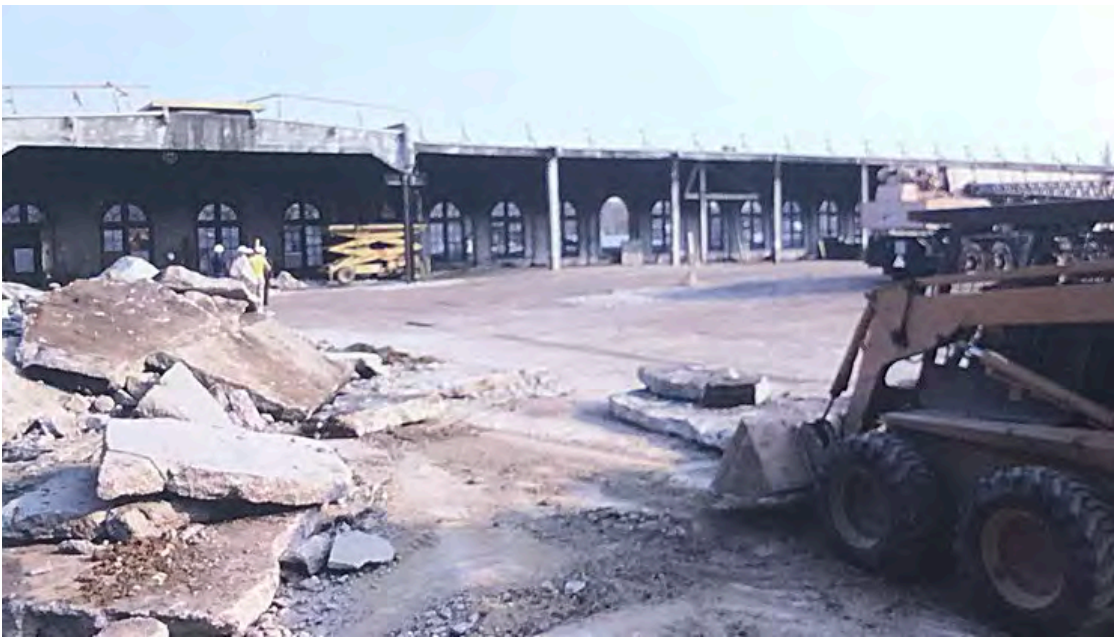
Figure 10. 1987 photograph looking east showing the extent of the demolition of ceiling and roof structure except for one bay along the perimeter of the east wall (WMATA Archive, George Washington University Special Collections)

From 1987 to 1992, the bus garage underwent a phased renovation and addition. The 1926 bus garage addition to the east of the original structure was demolished, and a one-story maintenance facility and garage with rooftop parking was constructed within the 1983 property wall, wrapping the east, south, and north elevations of the building (**Figure 9**). The majority of the original roof was demolished and rebuilt except for roofing over several bays at the northern end and a bay that remained along the full perimeter of the building (**Figures 10** and **11**). All but two of the original wood windows were replaced with aluminum windows, and several window openings were enclosed or changed to bus openings. A bus entry was inserted at the southern end of the west façade, immediately left (north) of the pedimented parapet at that end (**Figure 12**). To the right (south) of the pediment, an additional window was changed to a doorway (**Figure 13**).

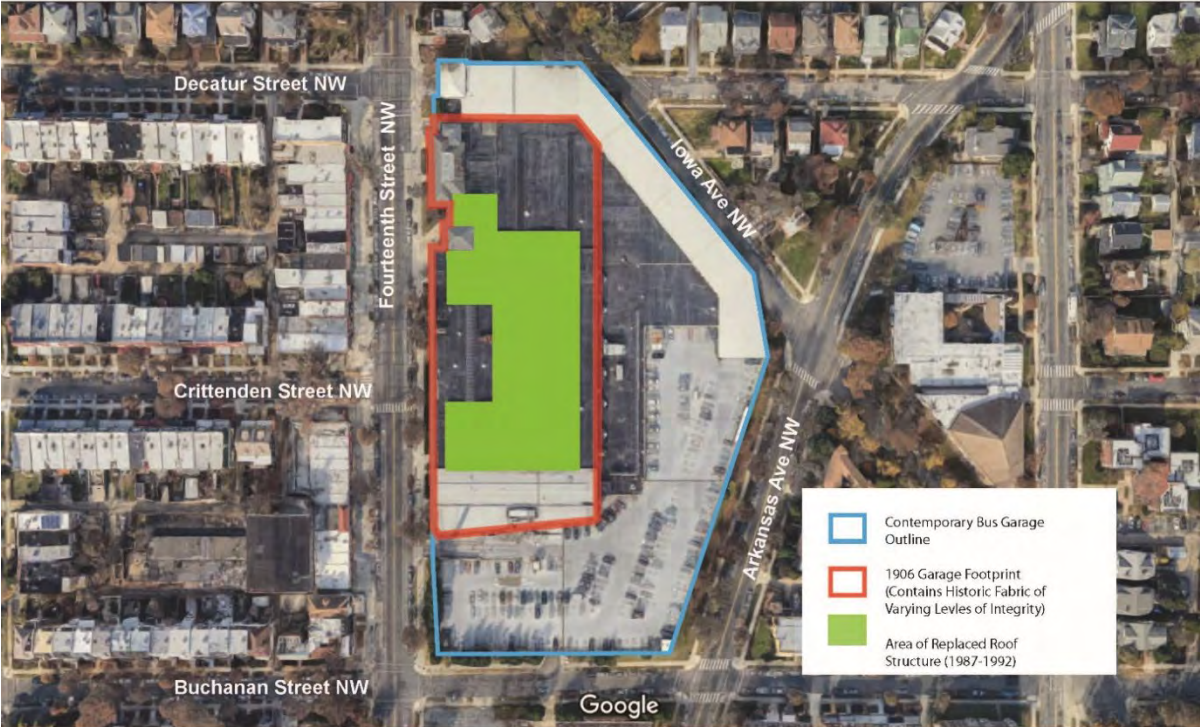
Figure 11. Original roof structure removed during the 1987-1992 renovation in green. Red outline shows the original footprint of the garage and the blue outline shows the contemporary property outline. Building outside red outline added during the 1987-1992 renovation (BBB)

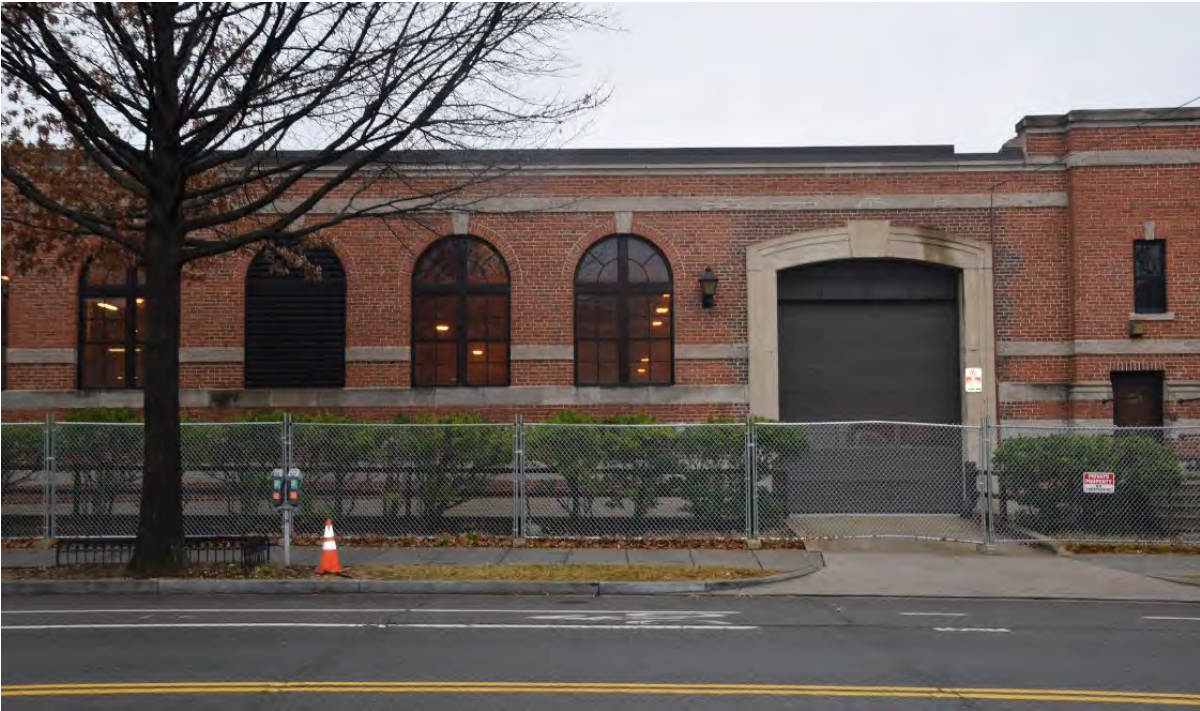
Figure 12. Bus entry at the southern end of the west façade added during the 1987-1992 renovation (BBB)

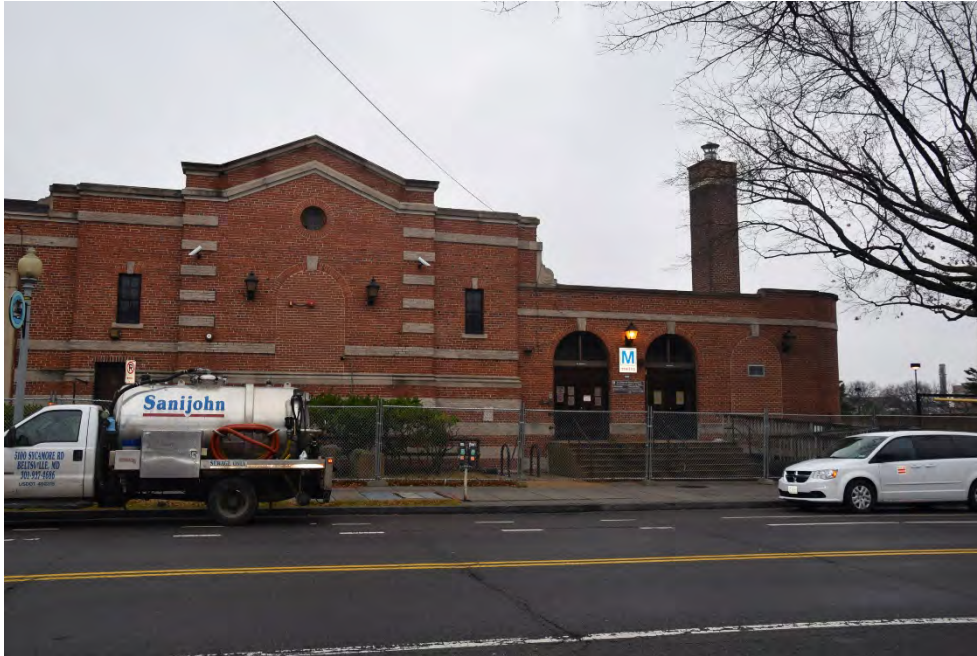
Figure 13. Two doorways to the right of the pedimented bay are non- historic. Left window opening changed to door prior to 1974 and right window changed to a door during the 1987-1992 renovation (BBB)

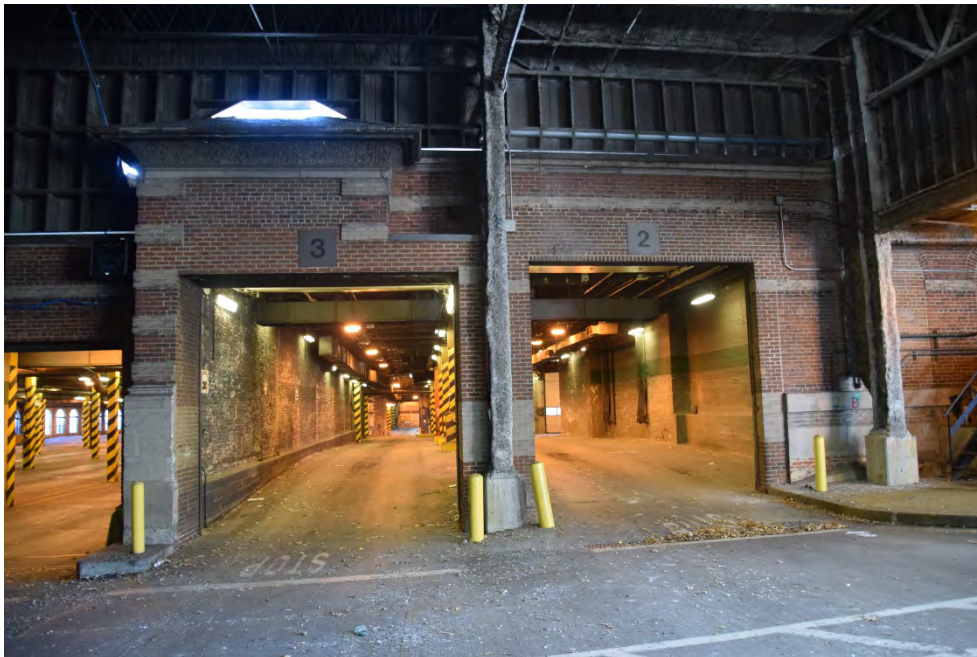
Figure 14. A truncated roof shelters the original north elevation and Decatur Street. Large bus openings punched in wall during the 1987-1992 renovation (BBB)

The north and majority of the east elevations of the building were enclosed by the addition and bus ramp. The ramp descends west to east and north to south, following the topography of the site. As a result, Decatur Street, between 14th Street and Iowa Avenue, was closed to traffic and incorporated into the bus garage. A truncated roof encloses the original north elevation of garage. The original north elevation, which featured arched window openings, was significantly altered with new bus openings, allowing buses to easily move from the garage to the bus ramp and exit at Decatur and 14th Streets (**Figure 14**). The east elevation was enveloped by the addition. The original east elevation arched window openings are still present, although many of the fanlights have been infilled with brick or

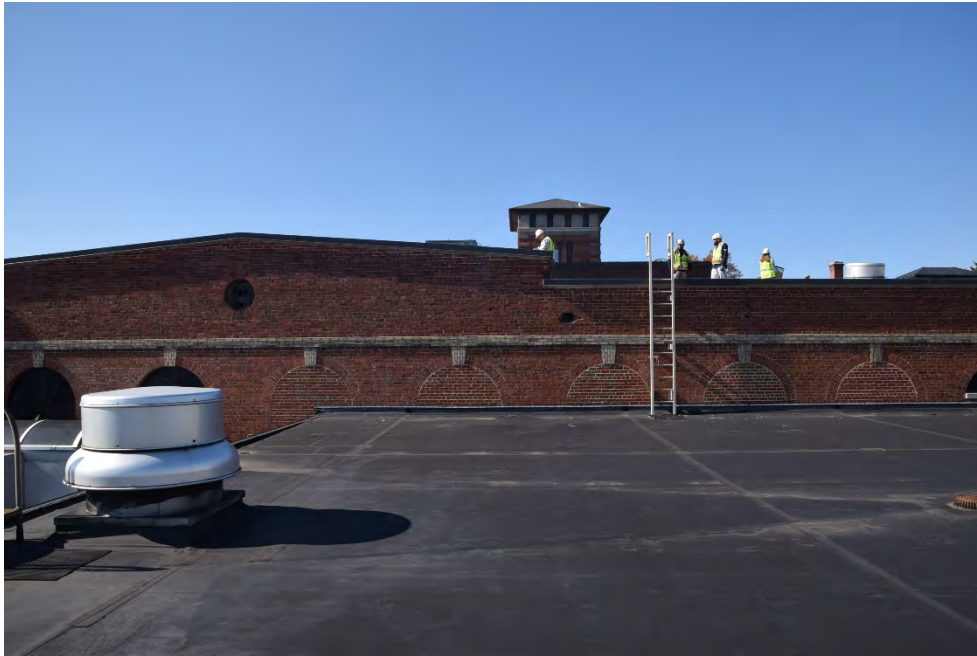
Figure 15. 1987 roof addition abuts original east elevation. Several arched windows infilled with brick (BBB)

replaced with louvers. The original east wall remains visible at the upper level interior and from the roof of the 1987 addition (**Figure 15**). The addition also made significant alterations to the south elevation of the original structure. The lower level of the south elevation was fully enclosed and many of the windows at the upper level were removed and filled with glass block.

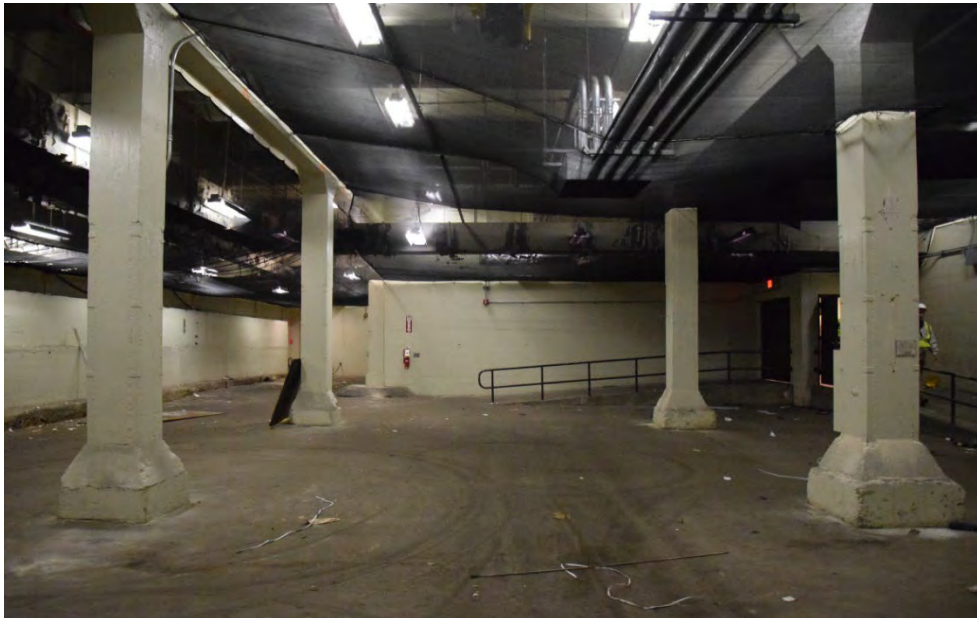
Figure 16. Lower level of the bus garage; the original columns and ceiling are present, however, the concrete floor was removed and excavated in the 1980s. The new concrete footings below the columns are visible in the photo (BBB)

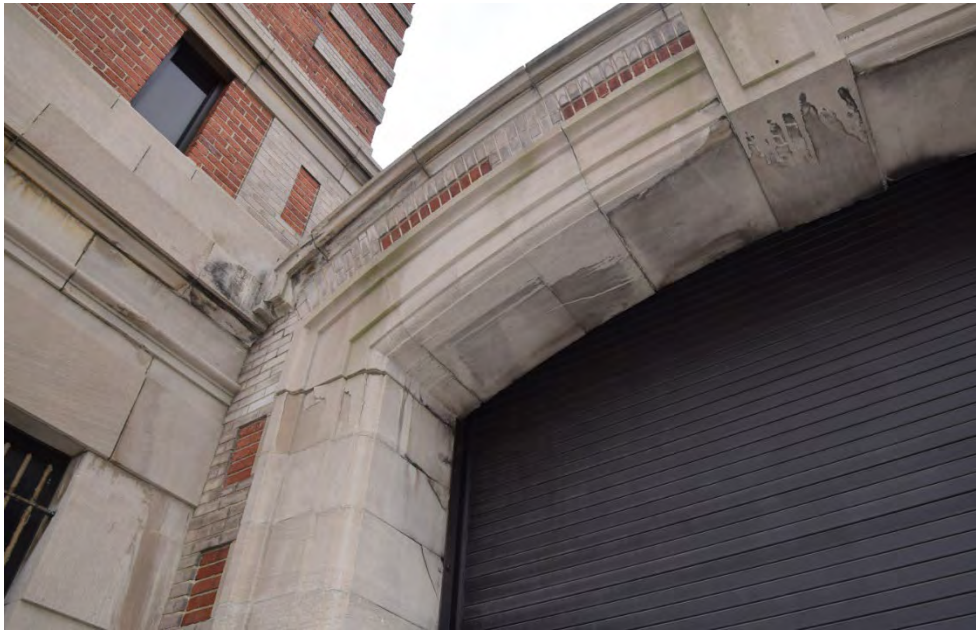
Figure 17. The north facing streetcar/bus opening adjacent to the tower exhibiting stone cracking, spalling, and masonry soiling requiring repair (BBB)

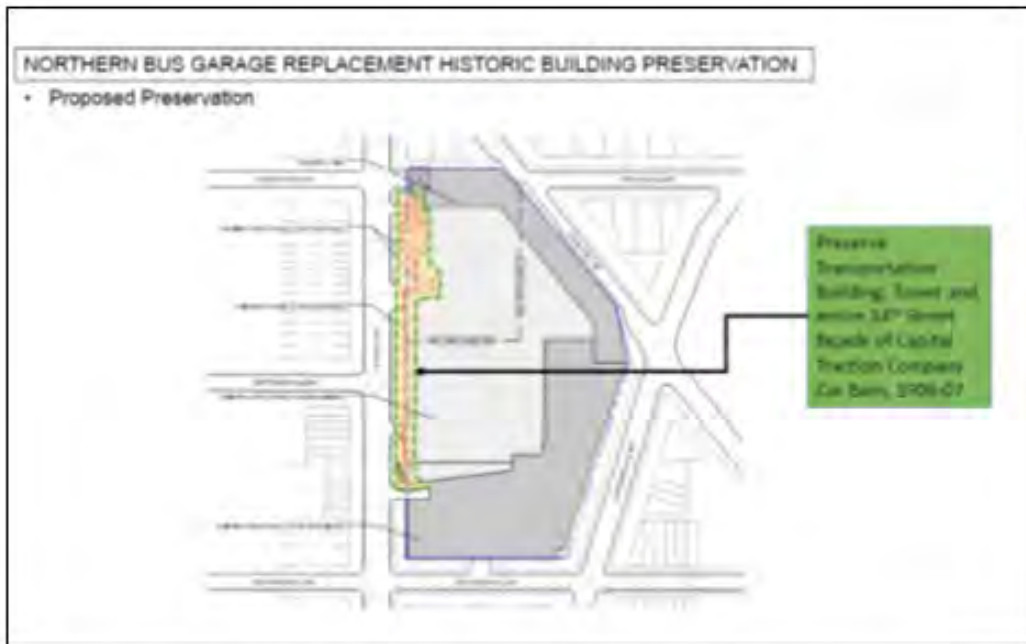
Section of façade for Preservation and Grey Areas for Demolition

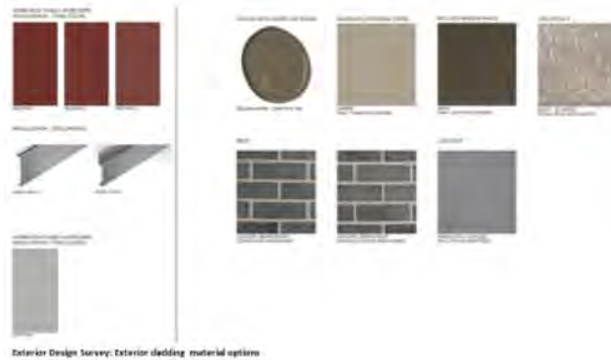
- Project scale reduced
- Large walls broken up in sections
- Exterior cladding material changed to palette compatible with historic building
- Reduction of size of building entrance southwest corner of 14th Street NW and Buchanan
- Recessed bus entry, south end on 14th Street NW
- Lower façade cornices and lightened color

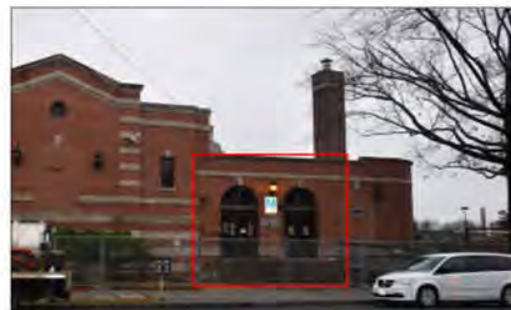
- Replacing existing façade arch windows with historically appropriate windows
- Non-historic doors replaced with windows
- Restore northwest corner of original building, exposing historic arched windows
- Reconstruction of chimney at south end
- Brick and cast stone masonry cleaning and pointing

1980s Doors to be Restored to Windows

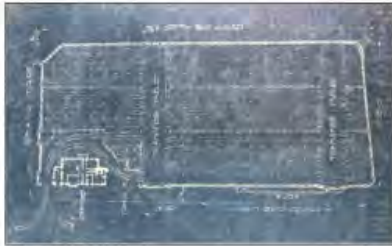
Car Barn Track Layout

- Need Consulting Party Input
 - Historic Fabric Analysis (completed)
 - Architectural lighting of 14th Street NW historic façade (proposed)
 - Pavement design/art depicting or interpreting original location of trolley tracks (proposed)

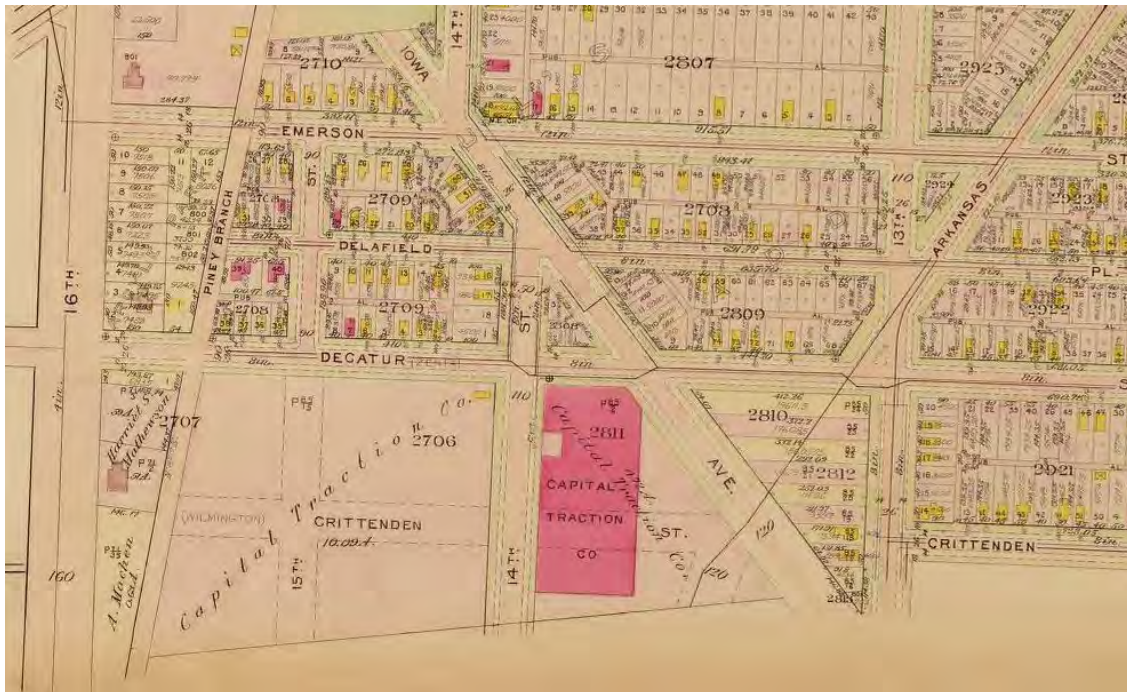
Figure 2. 1911 Baist Real Estate Map; Decatur Streetcar Barn is the pink building labeled as the Capital Traction Co. (Library of Congress)

The Northern Bus Garage site is bounded by 14th Street to the west, Decatur Street to the north, Iowa Ave to the northeast, Arkansas Ave to the southeast, and Buchanan Street to the south. The main façade of the building faces 14th Street, and therefore, the west façade is the most decorative. As originally constructed, the brick masonry car barn measured 537 feet (north-south) by 208 feet (east-west), occupying nearly half of the site on Square 2811 and a portion of Square 2815. As platted, the two squares were intended to be divided by Crittenden Street. However, because of the construction of the car barn, the road was never laid, and the squares remained joined. The 1911 Baist Real Estate Map shows the original footprint and surrounding streets of the garage. It is interesting to note the residential character of the neighborhoods to the north of the garage and that the Capital Traction Company owned the squares west of 14th Street, yet the area was not developed at the time. (See **Figure 2**)

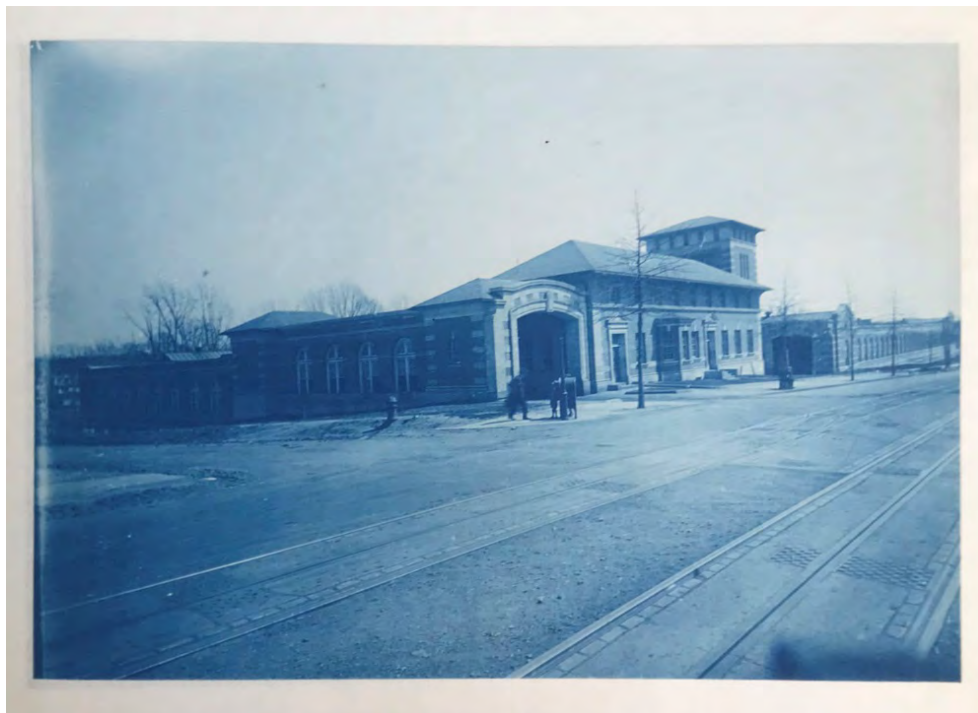
Figure 3. 1914 exterior photograph of the northwest corner of the streetcar barn showing the administrative offices, tower, and two of the three original streetcar openings. The north elevation features arched window openings and hipped roof pavilions at the center and western corner of the elevation (DC History Center)

The building was designed to look like two complementary masses: a two-story structure housing the administrative offices, featuring a hipped roof with overhanging eaves, and a two-story car barn and repair shop, characterized by a grand three-story tower with a clerestory. As designed and constructed, the garage consisted of an upper (main level) entered along 14th Street and a partially excavated lower (basement) level, accessed from the south elevation of the building. Exterior character-defining features included brick walls accented with stone belt courses, quoining, and keystones; shallow-pitched hipped roofs of the tower and administrative offices, and bracketed eaves. (See **Figure 3**) The garage and repair shop featured a flat roof with a front gable parapet and several large skylights. The building originally

featured three streetcar entrances and exits on the west façade: two facing west and framing the administrative offices and one facing north, immediately adjacent to the tower. Arched window openings on all elevations provided light to the garage and repair shop. The administrative offices, tower, and several projecting pavilions along the north and west elevations featured rectangular windows.

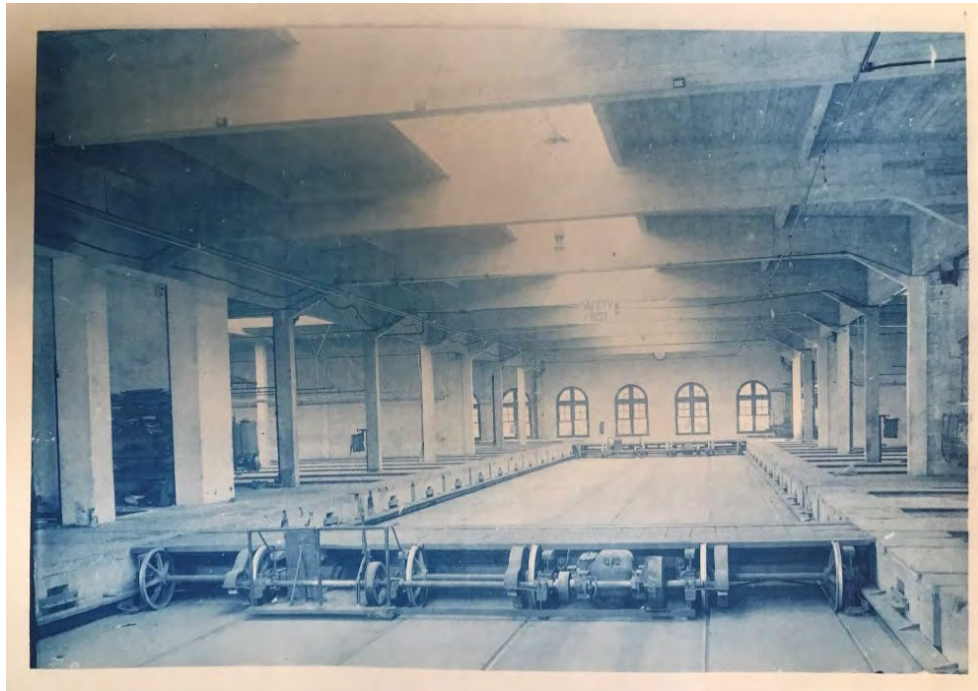
Figure 4. 1914 interior photograph of the Decatur Streetcar Barn showing the transfer table in the foreground and the skylight above (DC History Center)

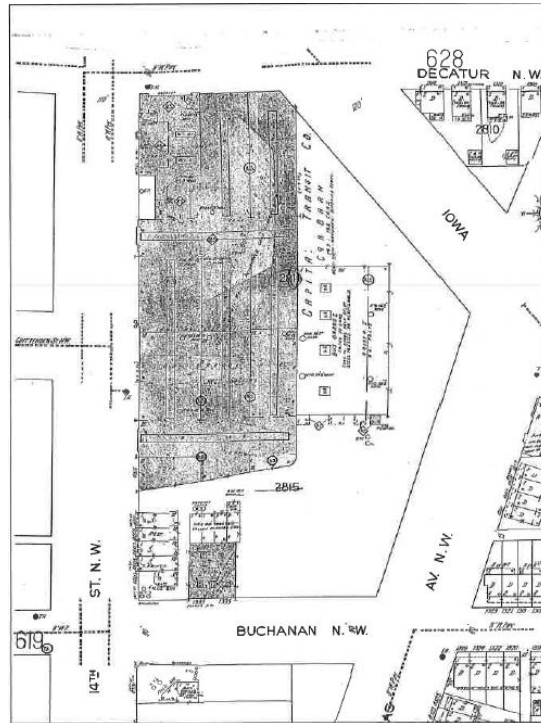
Figure 5. 1959 Sanborn map showing the garage (then owned by the Capital Transit Company) and the 1926 addition at the east side (Capital Traction Company Car Barn National Register Nomination Form)

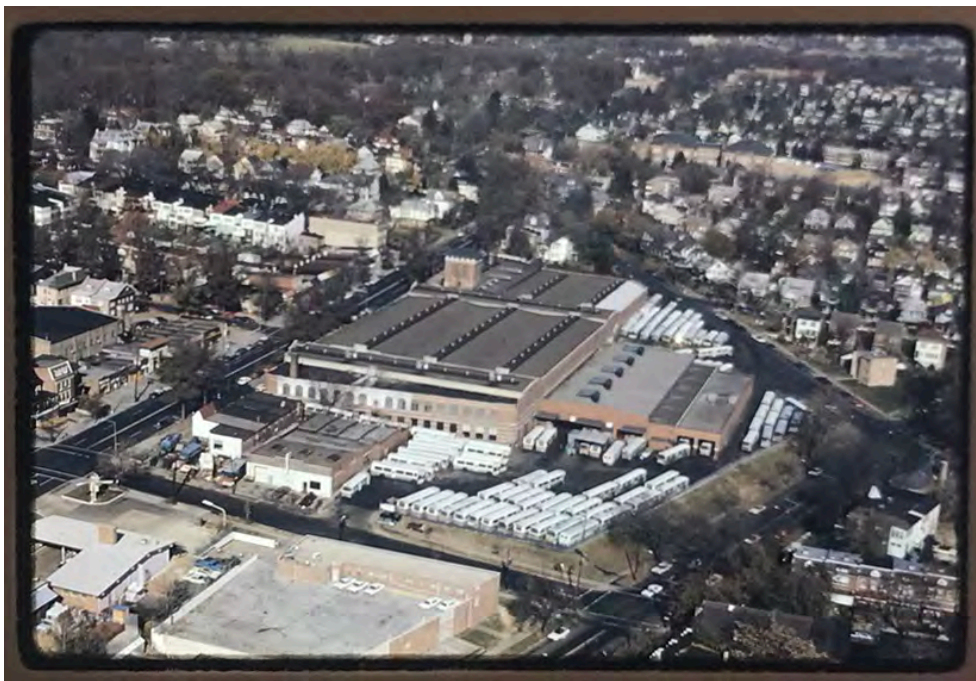
Figure 6. 1974 photograph of the bus garage looking northwest; the 1926 addition is visible on the right (WMATA Archive, George Washington University Special Collections)

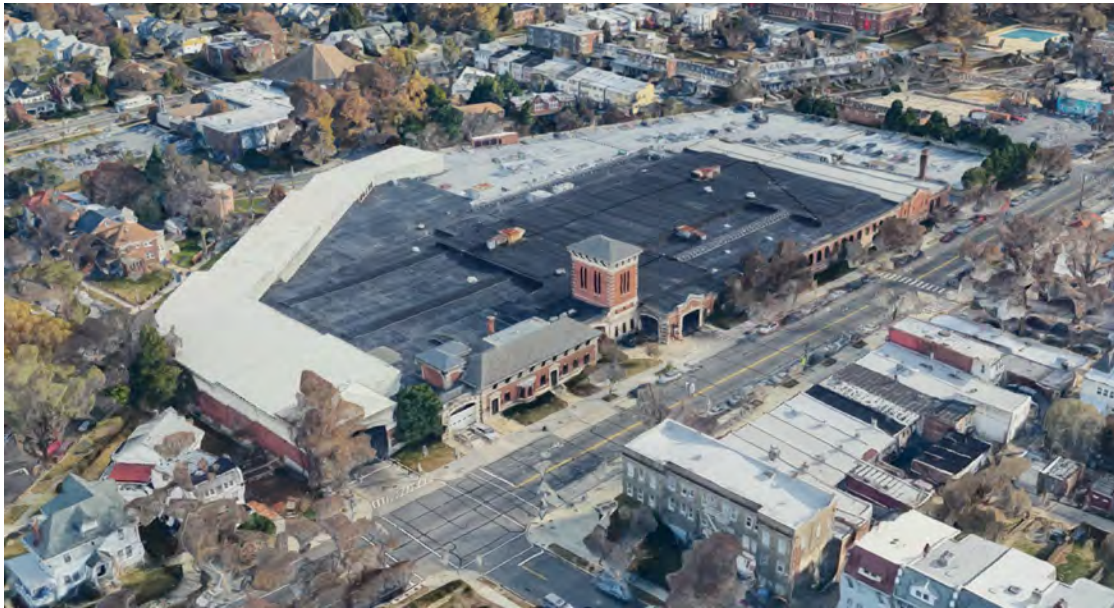
Figure 9. Contemporary aerial image of the bus garage looking southeast; the original bus garage was wrapped in the one-story 1987-1992 addition that enclosed Decatur Street to the left (north) of the administrative offices and provided WMATA with rooftop parking at the south and east (Google)

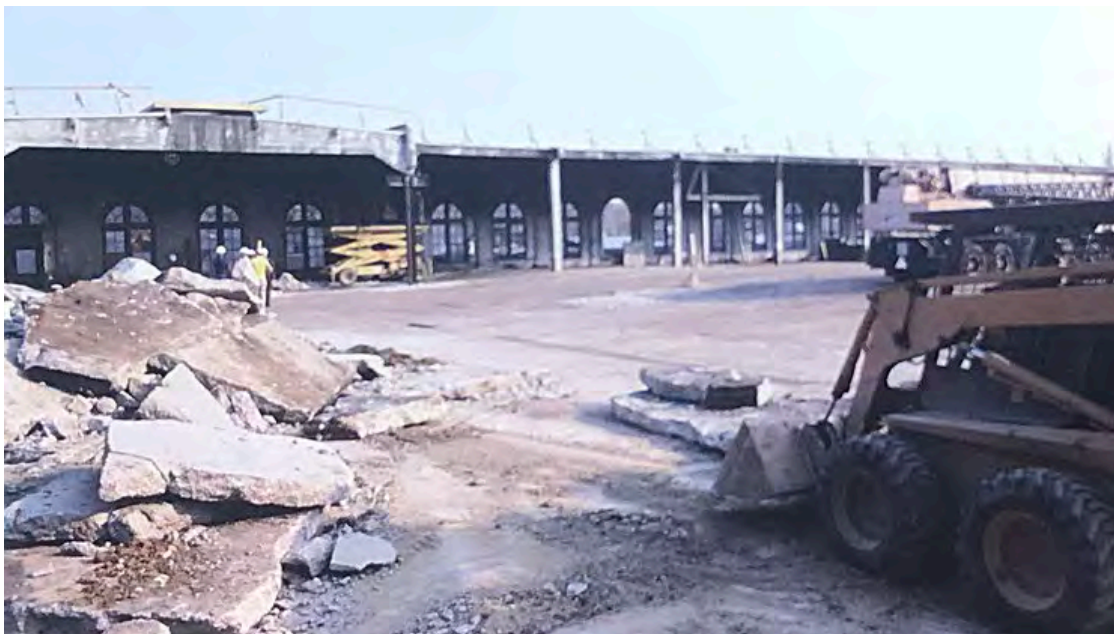
Figure 10. 1987 photograph looking east showing the extent of the demolition that occurred within the bus garage. The entire ceiling and roof structure in this area was removed except for one bay along the perimeter of the east wall (WMATA Archive, George Washington University Special Collections)

From 1987 to 1992, the bus garage underwent a phased renovation and addition. The 1926 bus garage addition to the east of the original structure was demolished, and a one-story maintenance facility and garage with rooftop parking was constructed within the 1983 property wall, wrapping the east, south, and north elevations of the building. (See **Figure 9**) The majority of the original roof was demolished and rebuilt except for roofing over several bays at the northern end and a bay that remained along the full perimeter of the building. (See **Figure 10** and **Figure 11**) All but two of the original wood windows were replaced with aluminum windows, and several window openings were enclosed or changed to bus openings. A bus entry was inserted at the southern end of the west façade, immediately left (north) of the pedimented parapet at that end. (See **Figure 12**) To the right (south) of the pediment, an additional window was changed to a doorway. (See **Figure 13**)

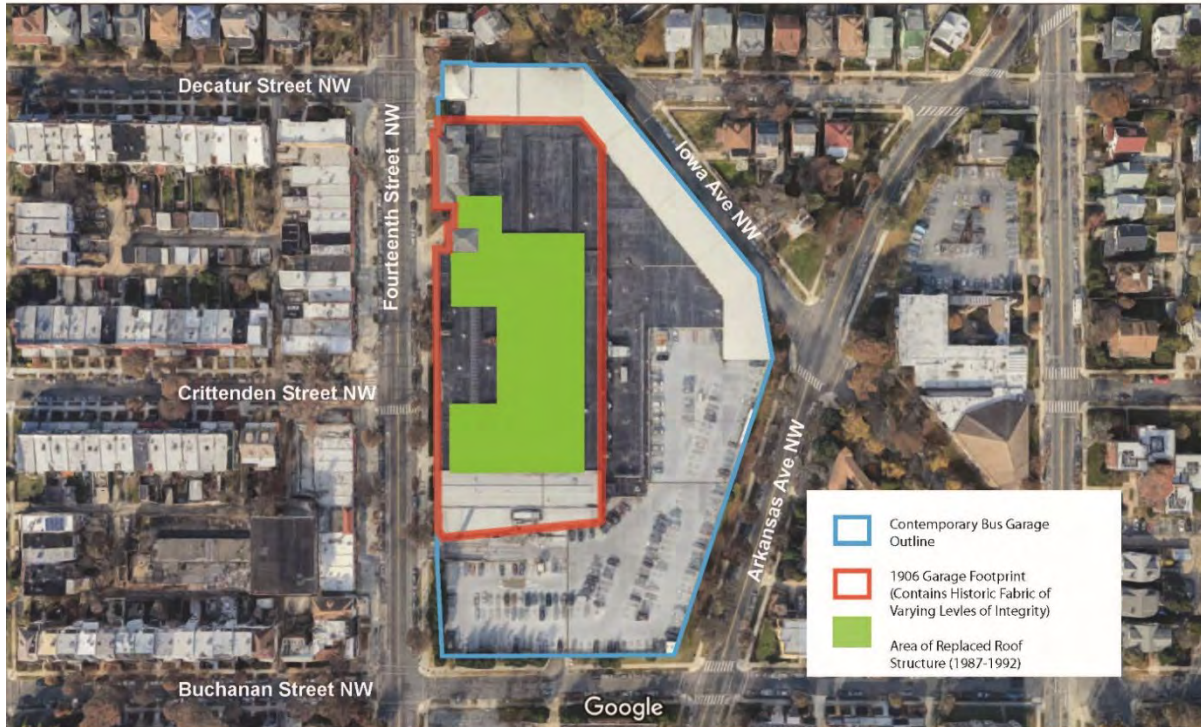
Figure 11. Diagram showing the extent of the original roof structure that was removed during the 1987-1992 renovation in green. The red outline shows the original footprint of the garage and the blue outline shows the contemporary property outline. Everything outside the red outline was added during the 1987-1992 renovation (BBB)

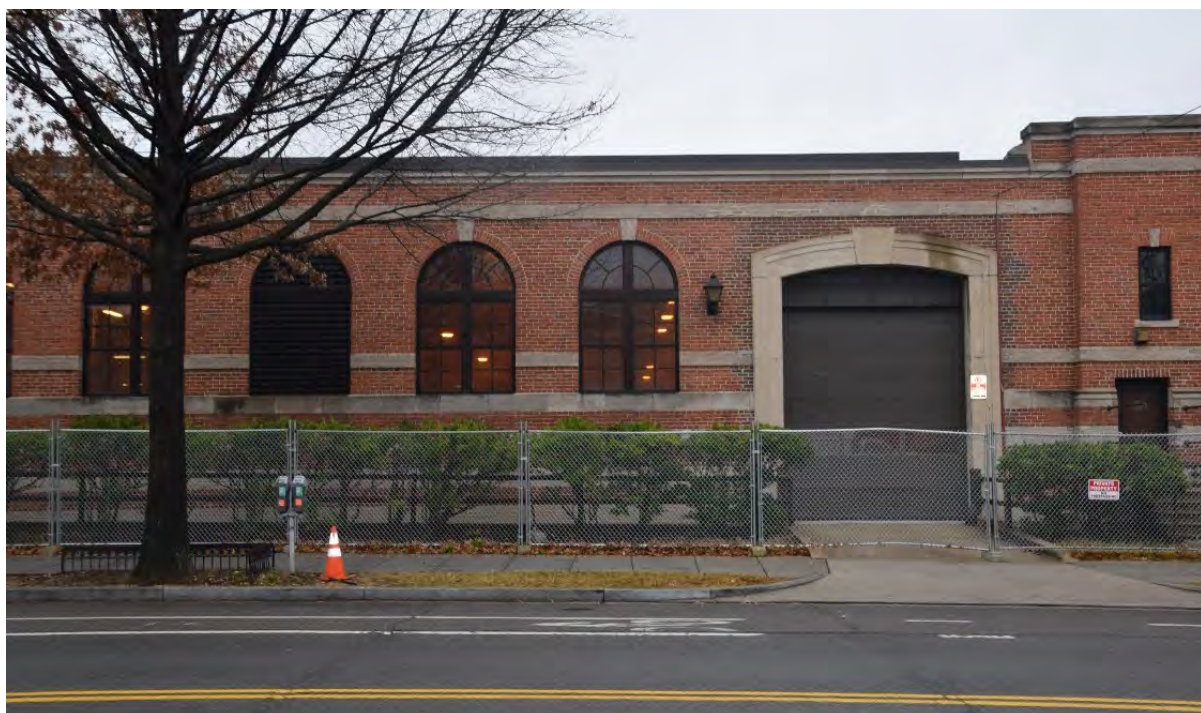
Figure 12. Bus entry at the southern end of the west façade was added during the 1987-1992 renovation (BBB)

Figure 12. Bus entry at the southern end of the west façade was added during the 1987-1992 renovation (BBB)
