APPENDIX 6: HISTORIC PRESERVATION REVIEW BOARD STAFF REPORTS

**HISTORIC PRESERVATION REVIEW BOARD
STAFF REPORT AND RECOMMENDATION**

Landmark/District: **Decatur Street Car Barn/Northern Bus Garage** Agenda
Address: **4701 14th Street, NW** Consent Calendar
Meeting Date: **May 28, 2020** New Construction
H.P.A. Numbers: **20-176** Alteration
 Demolition

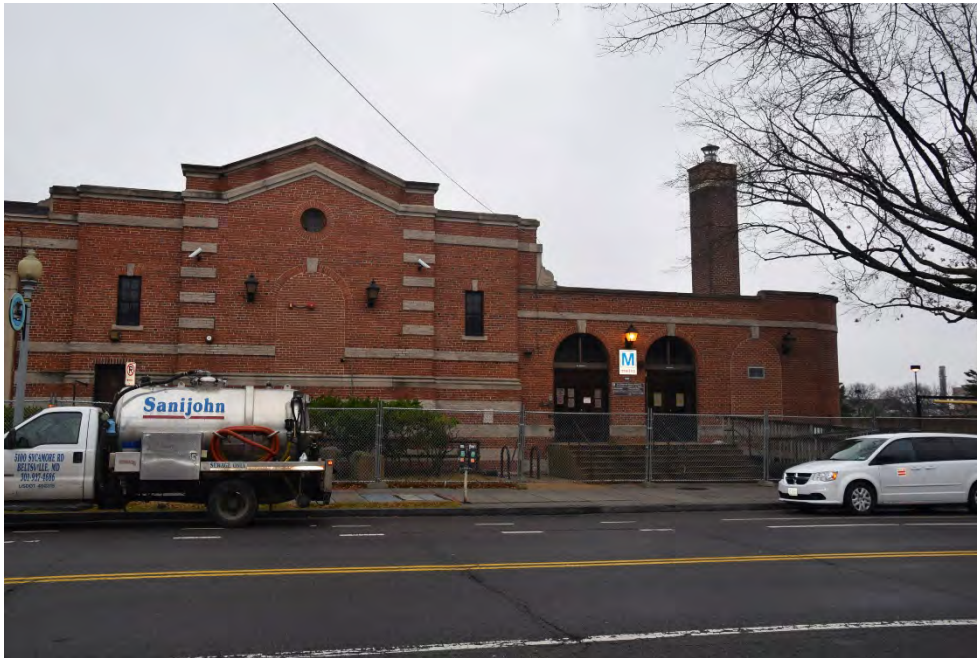
Figure 13. The two doorways to the right of the pedimented bay are not historic. The one on the left was changed from a window opening to a door prior to 1974 while the one on the right was changed during the 1987-1992 renovation (BBB)

Figure 13. The two doorways to the right of the pedimented bay are not historic. The one on the left was changed from a window opening to a door prior to 1974 while the one on the right was changed during the 1987-1992 renovation (BBB) 13

From 1987 to 1992, the bus garage underwent a phased renovation and addition. The 1926 bus garage addition to the east of the original structure was demolished, and a one-story maintenance facility and garage with rooftop parking was constructed within the 1983 property wall, wrapping the east, south, and north elevations of the building. (See **Figure 9**) The majority of the original roof was demolished and rebuilt except for roofing over several bays at the northern end and a bay that remained along the full perimeter of the building. (See **Figure 10** and **Figure 11**) All but two of the original wood windows were replaced with aluminum windows, and several window openings were enclosed or changed to bus openings. A bus entry was inserted at the southern end of the west façade, immediately left (north) of the pedimented parapet at that end. (See **Figure 12**) To the right (south) of the pediment, an additional window was changed to a doorway. (See **Figure 13**)

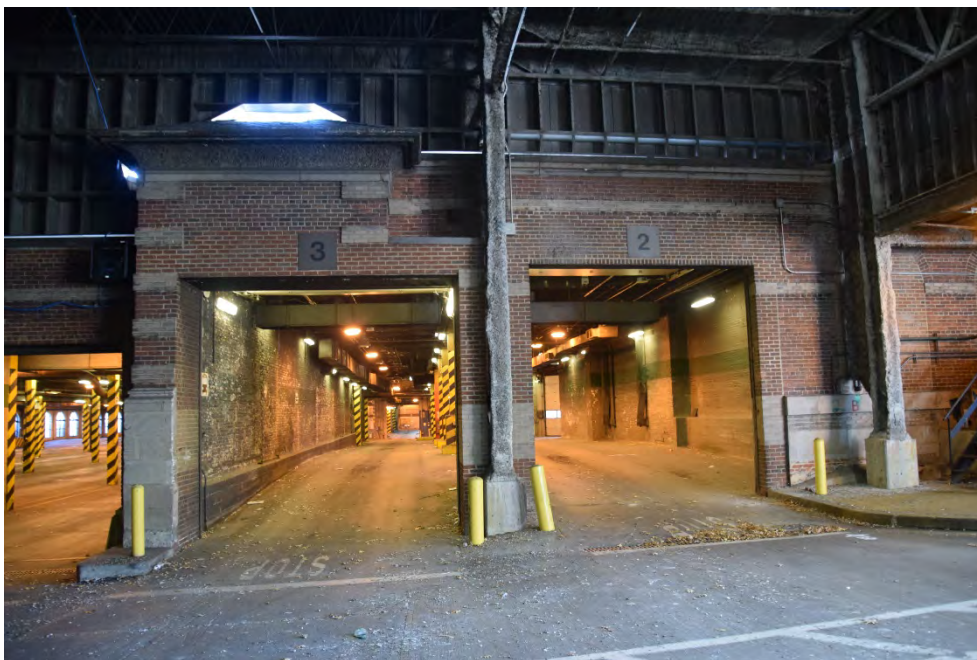
Figure 14. A truncated roof shelters the original north elevation and Decatur Street. Large openings for buses were punched in the wall during the 1987-1992 renovation (BBB)

The north and majority of the east elevations of the building were enclosed by the addition and bus ramp. The ramp descends west to east and north to south, following the topography of the site. As a result, Decatur Street, between 14th Street and Iowa Ave. was closed to traffic and was incorporated into the bus garage. A truncated roof encloses the original north elevation of garage. The original north elevation, which featured arched window openings was significantly altered with new bus openings, allowing buses to easily move from the garage to the bus ramp and exit at Decatur and 14th Streets. (See **Figure 14**) The east elevation was enveloped by the addition. The original arched window openings are

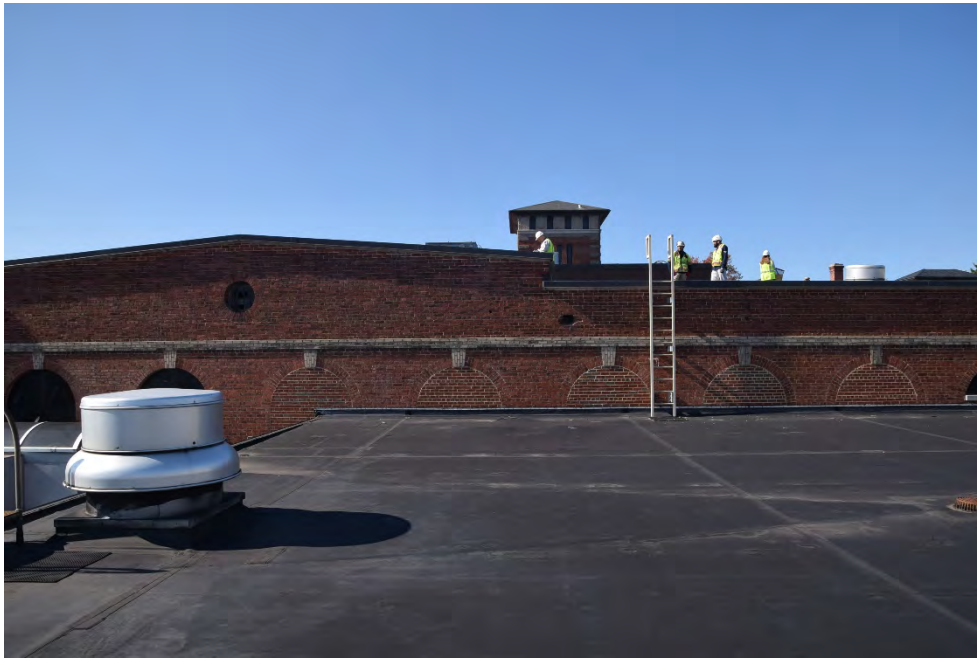
Figure 15. Roof of the 1987 addition abuts the original east elevation. Several of the arched windows have been infilled with brick (BBB)

still present, although many of the fanlights have been infilled with brick or replaced with louvers. The original east wall remains visible at the upper level interior and from the roof of the 1987 addition. (See **Figure 15**) The addition also had significant effects to the south elevation of the original structure. The lower level of the south elevation was fully enclosed and many of the windows at the upper level were removed and filled with glass block.

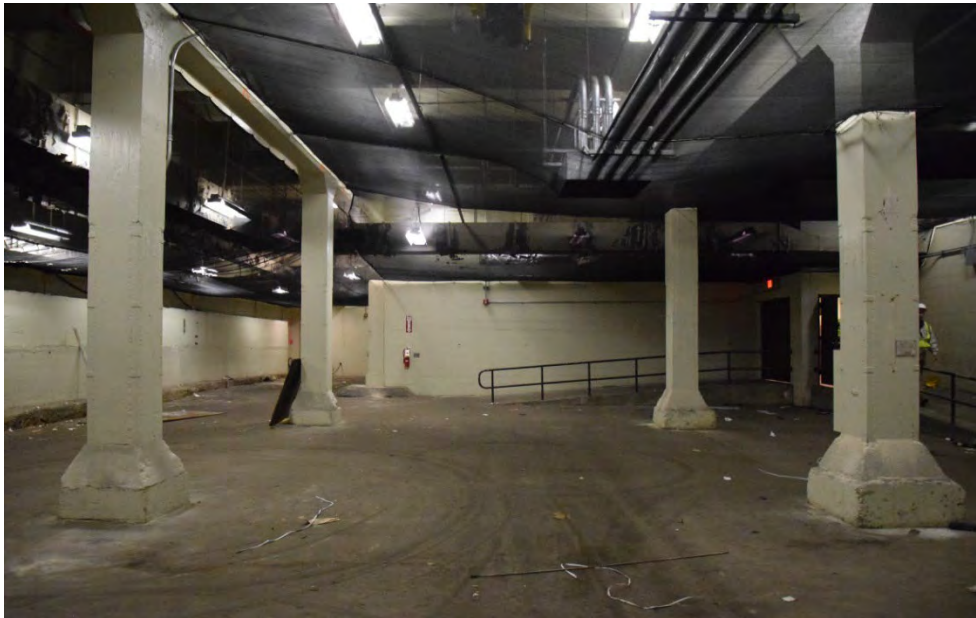
Figure 16. Lower level of the bus garage; the original columns and ceiling are present, however, the concrete floor was removed and excavated in the 1980s. The new concrete footings below the columns are visible in the photo (BBB)

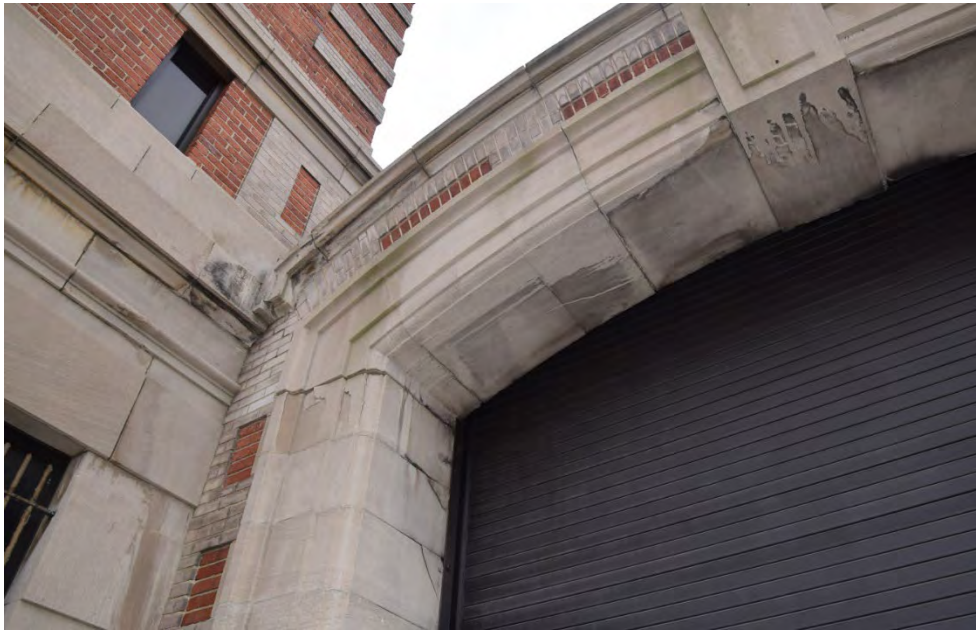
Figure 17. The north facing streetcar/bus opening adjacent to the tower exhibits stone cracking, spalling, and masonry soiling which require repair (BBB)

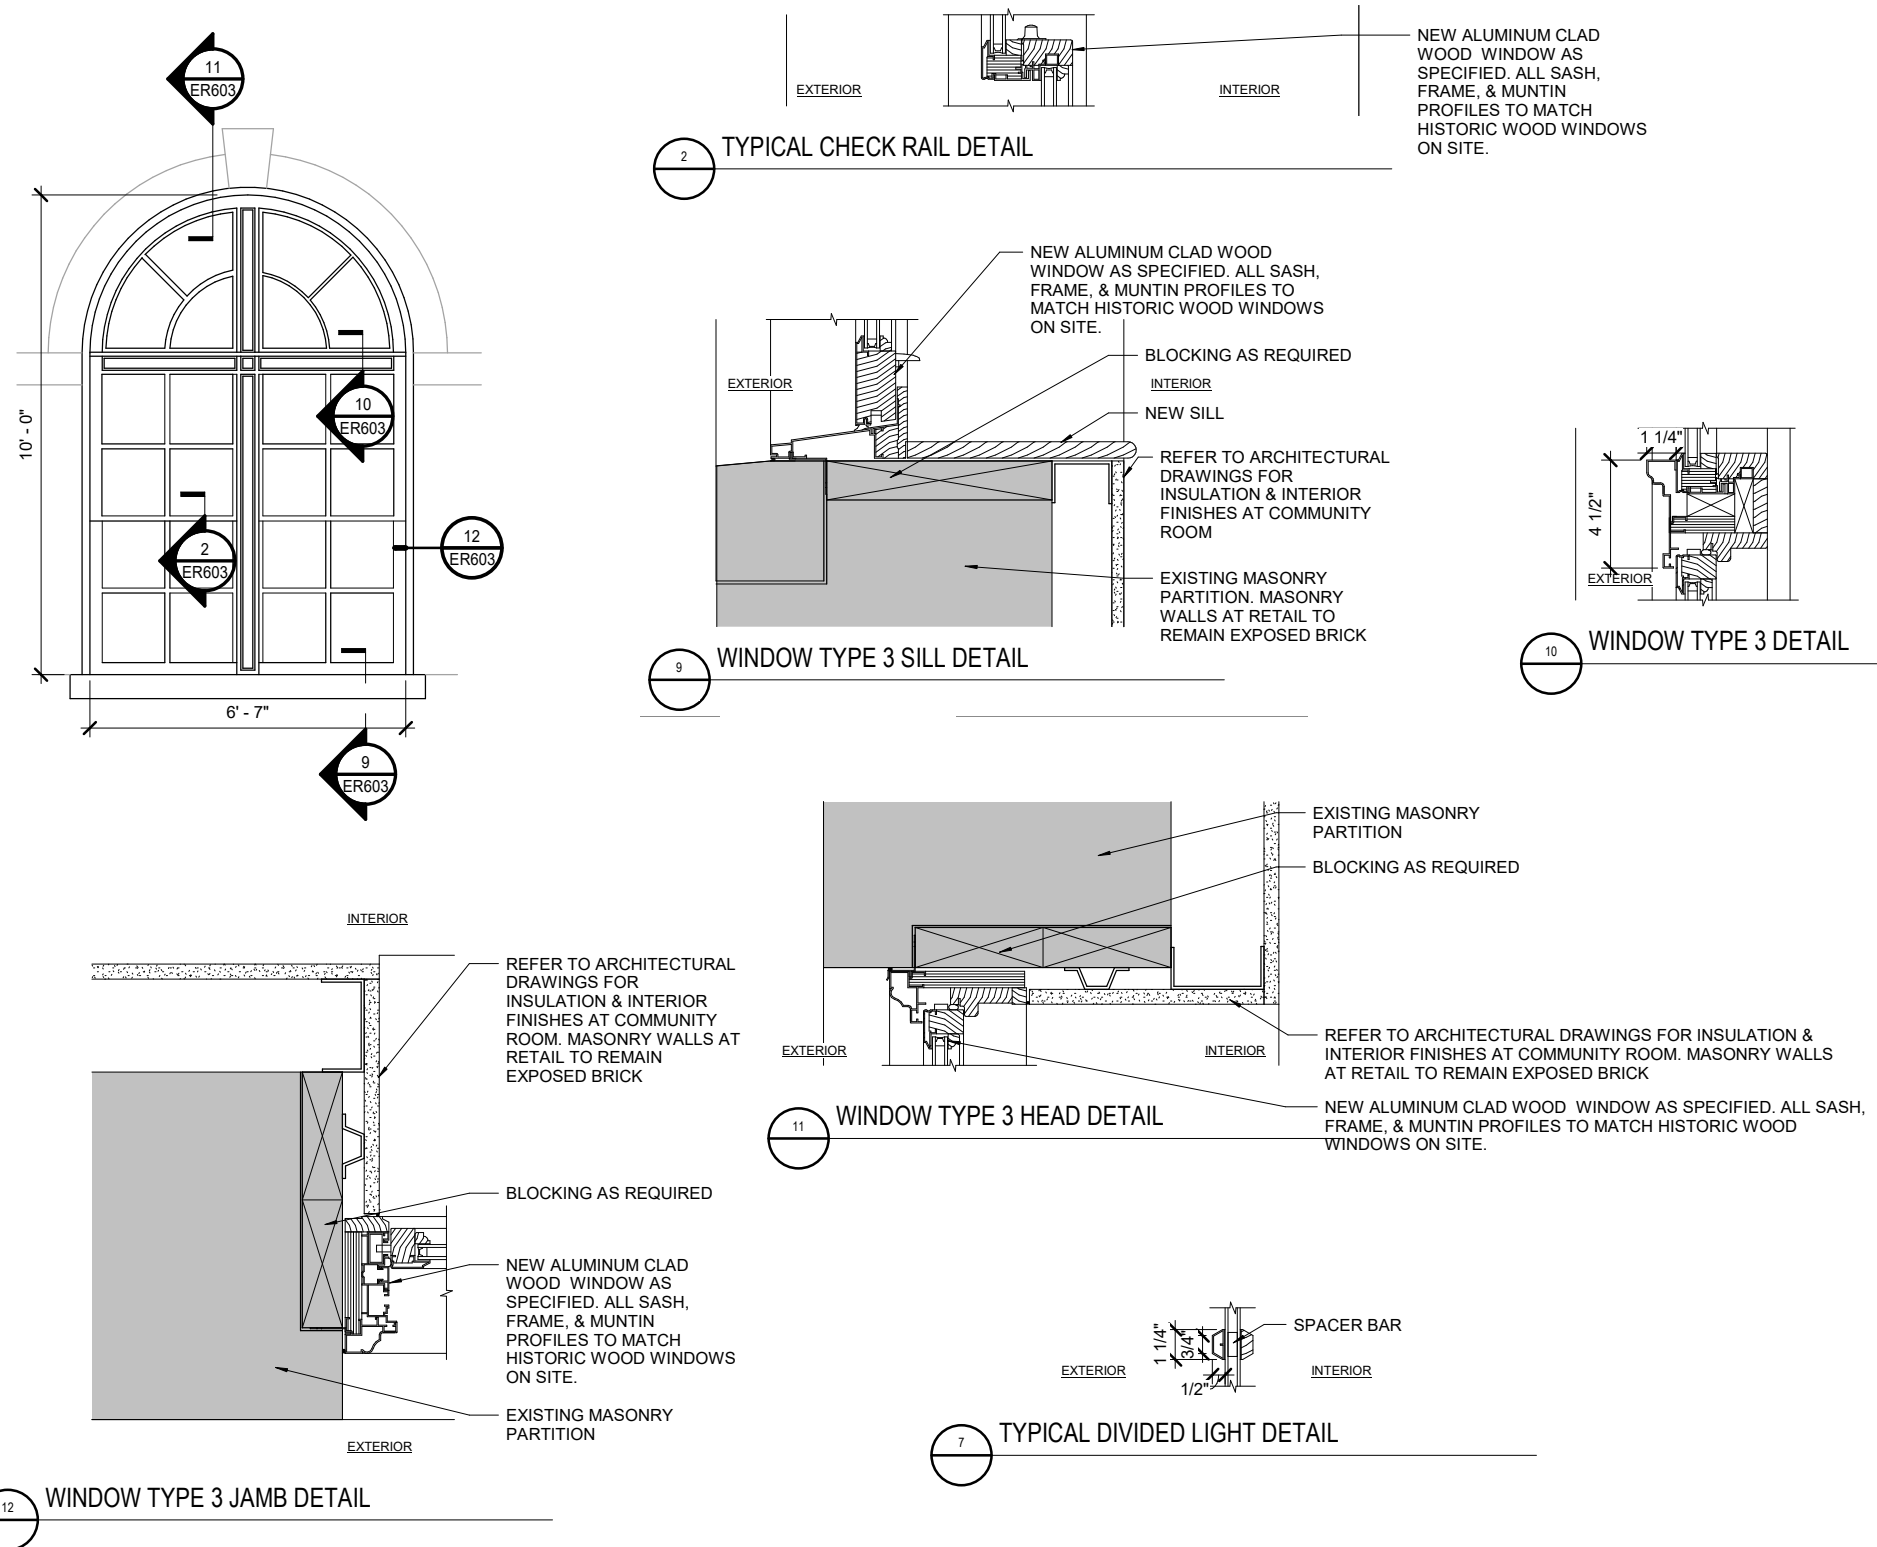
Remaining Original Window

All sash, frame, and muntin profiles to match the only remaining original window on site.

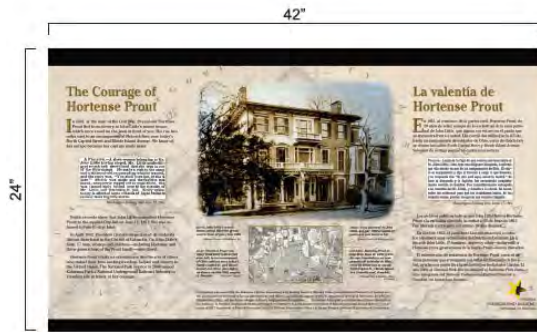
QTY: 1 (24"x42") EXTERIOR GRAPHIC FOR PEDESTAL
 SCALE: 3/4"=1'-0"
 MATERIAL: EXTERIOR GRADE CHPL GRAPHIC FOR
 SURFACE MOUNT ON PEDESTAL

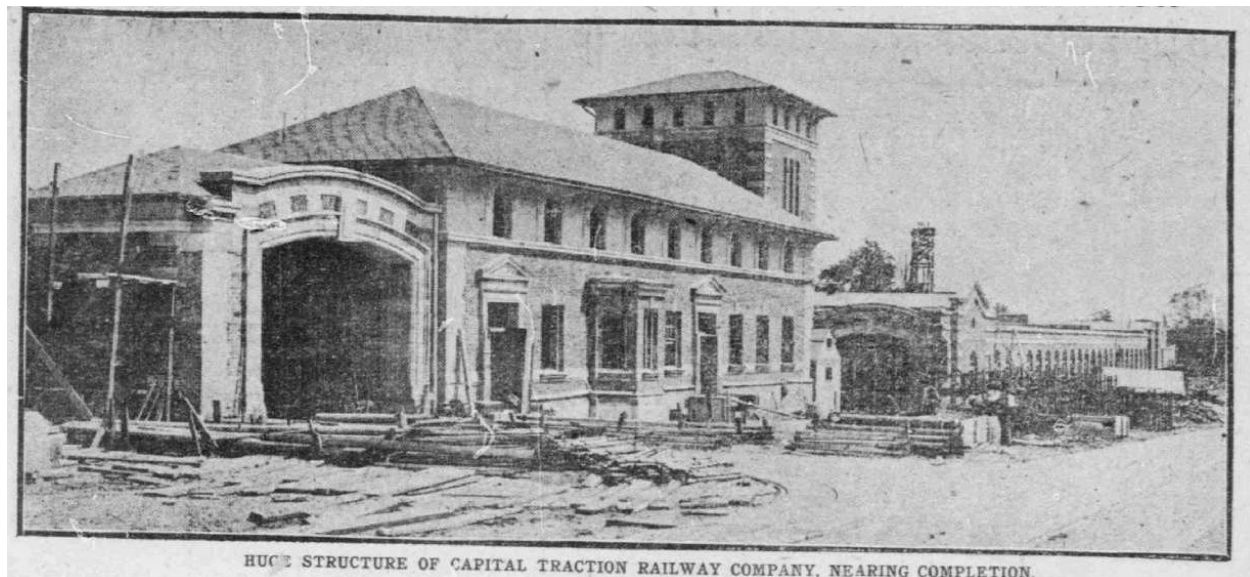
Figure 1. 1906 photograph of the car barn and administrative offices during construction (Washington Times)

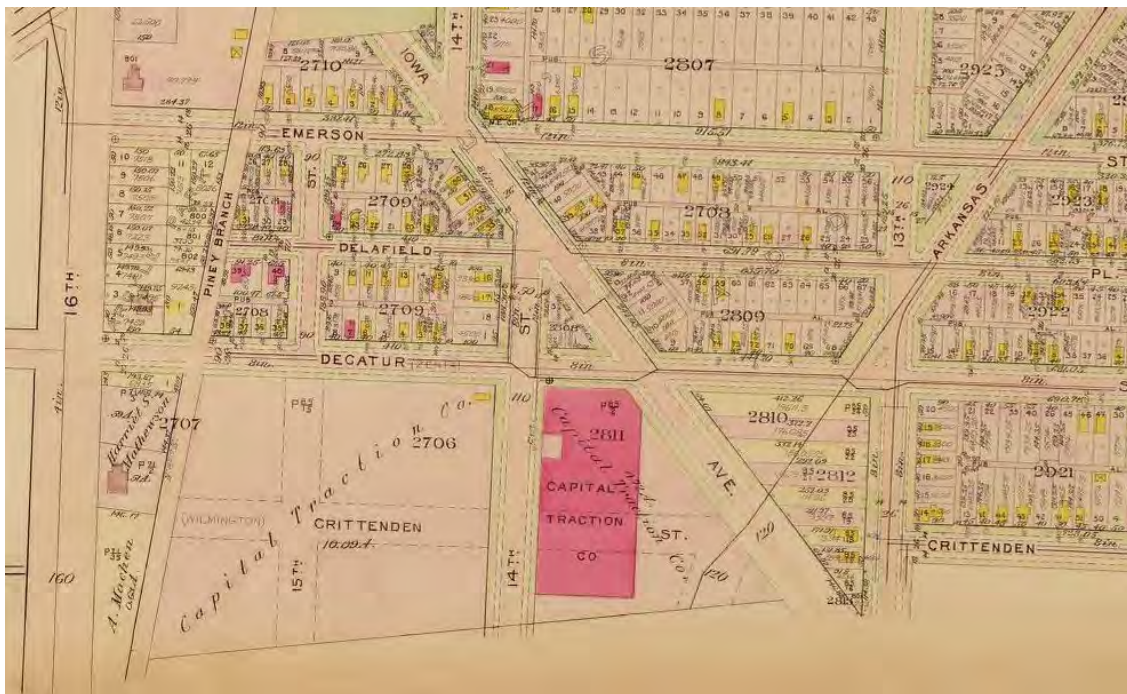
Figure 2. 1911 Baist Real Estate Map; Decatur Streetcar Barn is the pink building labeled as the Capital Traction Co. (Library of Congress)

The Northern Bus Garage site is bounded by 14th Street to the west, Decatur Street to the north, Iowa Ave to the northeast, Arkansas Ave to the southeast, and Buchanan Street to the south. The main façade of the building faces 14th Street, and therefore, the west façade is the most decorative. As originally constructed, the brick masonry car barn measured 537 feet (north-south) by 208 feet (east-west), occupying nearly half of the site on Square 2811 and a portion of Square 2815. As platted, the two squares were intended to be divided by Crittenden Street. However, because of the construction of the car barn, the road was never laid, and the squares remained joined. The 1911 Baist Real Estate Map shows the original footprint and surrounding streets of the garage. It is interesting to note the residential character of the neighborhoods to the north of the garage and that the Capital Traction Company owned the squares west of 14th Street, yet the area was not developed at the time. (See **Figure 2**)

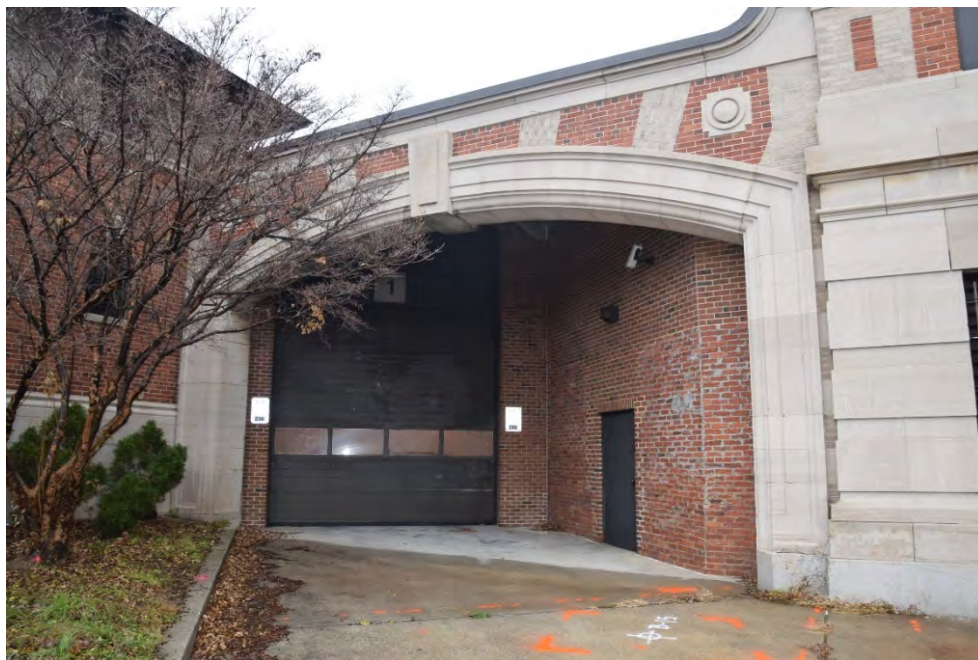
Figure 8. Angled brick wall on right constructed sometime after 1914 and prior to 1978. The wall created an additional interior room and enclosed the north elevation of the tower at that level. The other angled wall with the overhanging door was added after 1978 (BBB)

Another instance of unknown alteration occurred to the north of the tower. 1914 blueprints show that the north elevation of the tower adjacent to the streetcar opening was originally exposed, however, 1978 existing condition drawings show that an angled wall had been built at the streetcar opening, closing off the north elevation of the tower. Today, the wall is still extant, and a doorway has been inserted. (See **Figure 8**)

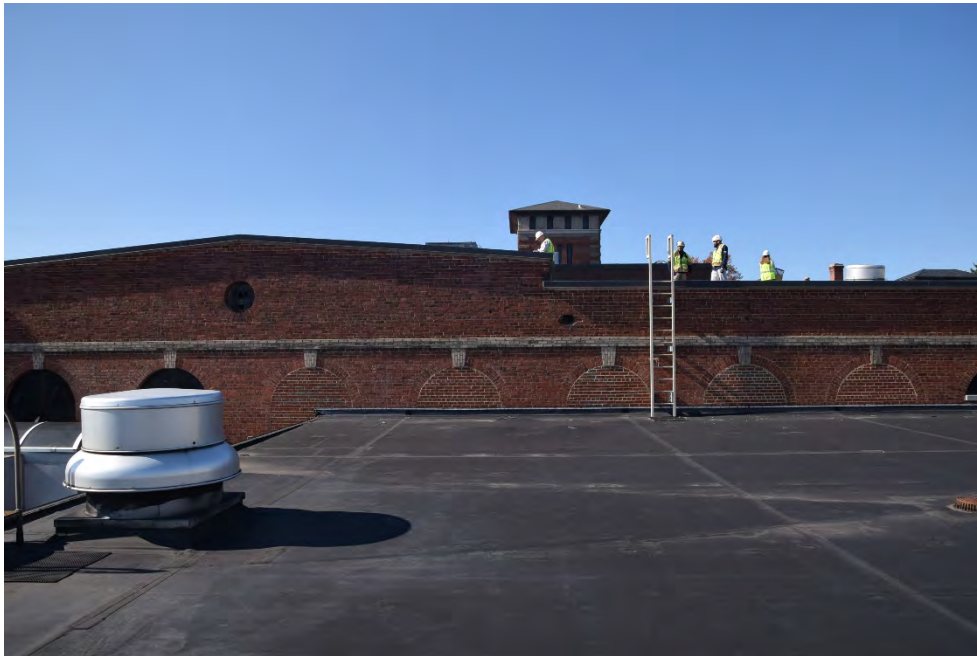
Figure 15. Roof of the 1987 addition abuts the original east elevation. Several of the arched windows have been infilled with brick (BBB)

still present, although many of the fanlights have been infilled with brick or replaced with louvers. The original east wall remains visible at the upper level interior and from the roof of the 1987 addition. (See **Figure 15**) The addition also had significant effects to the south elevation of the original structure. The lower level of the south elevation was fully enclosed and many of the windows at the upper level were removed and filled with glass block.

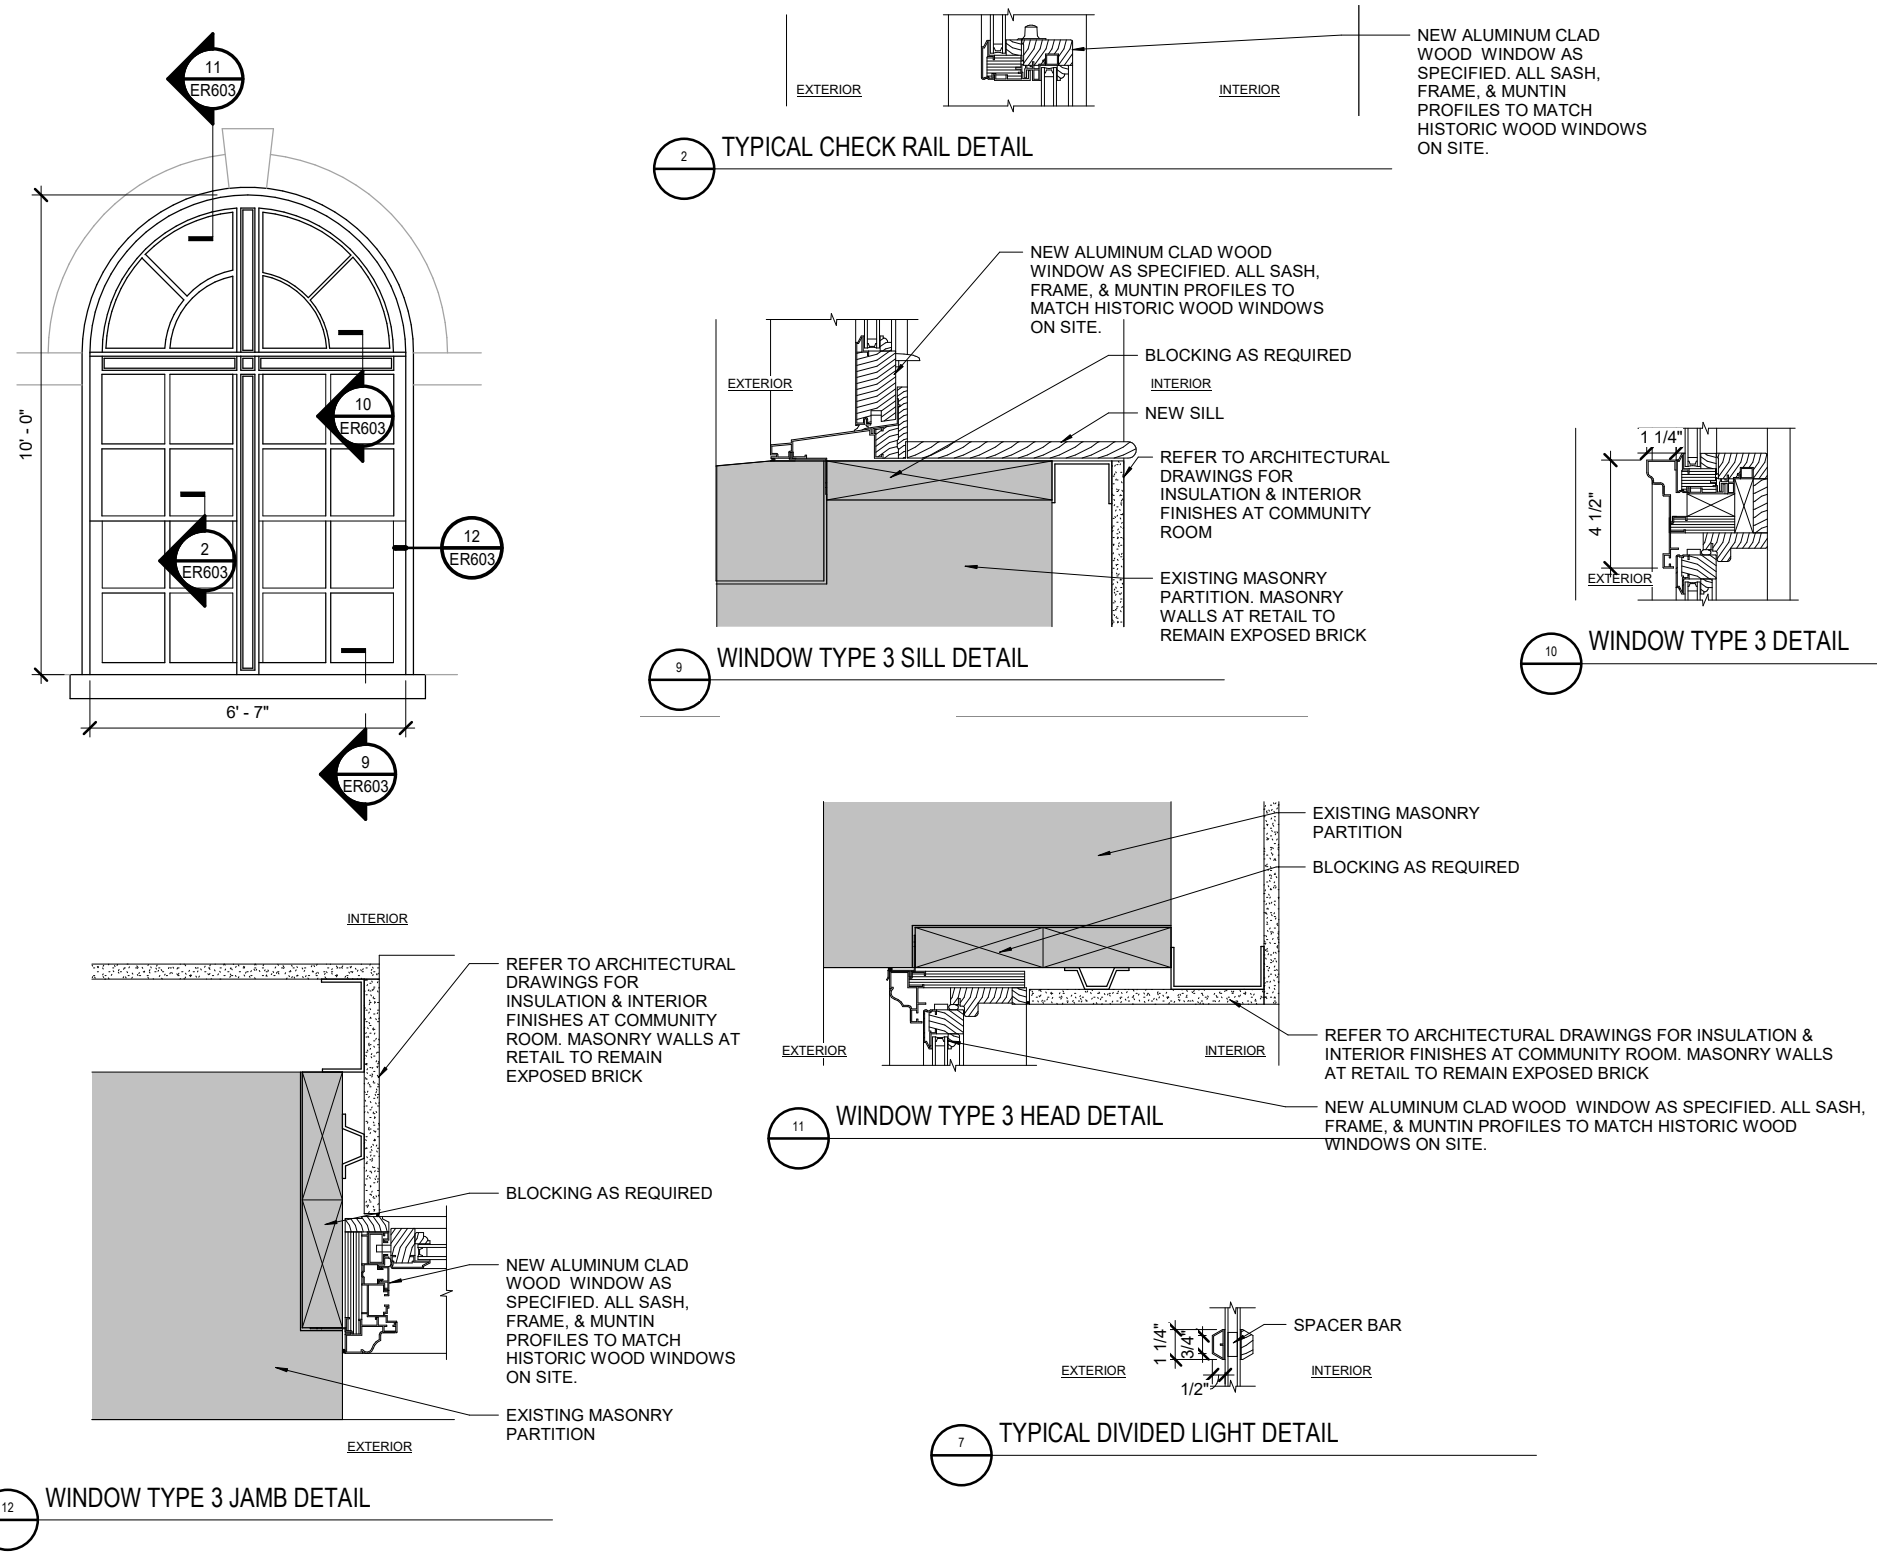
All sash, frame, and muntin profiles to match the only remaining original window on site.

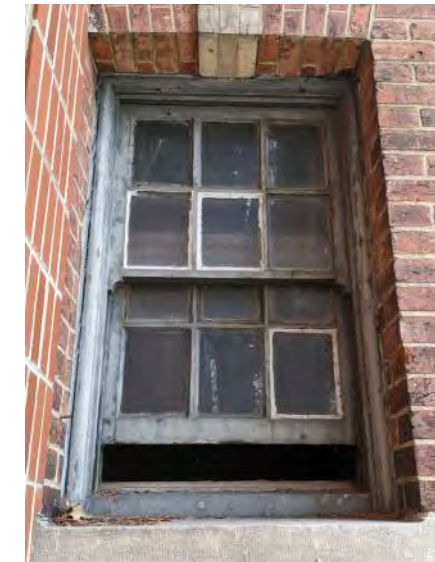
Window Type 3

Remaining Original Window

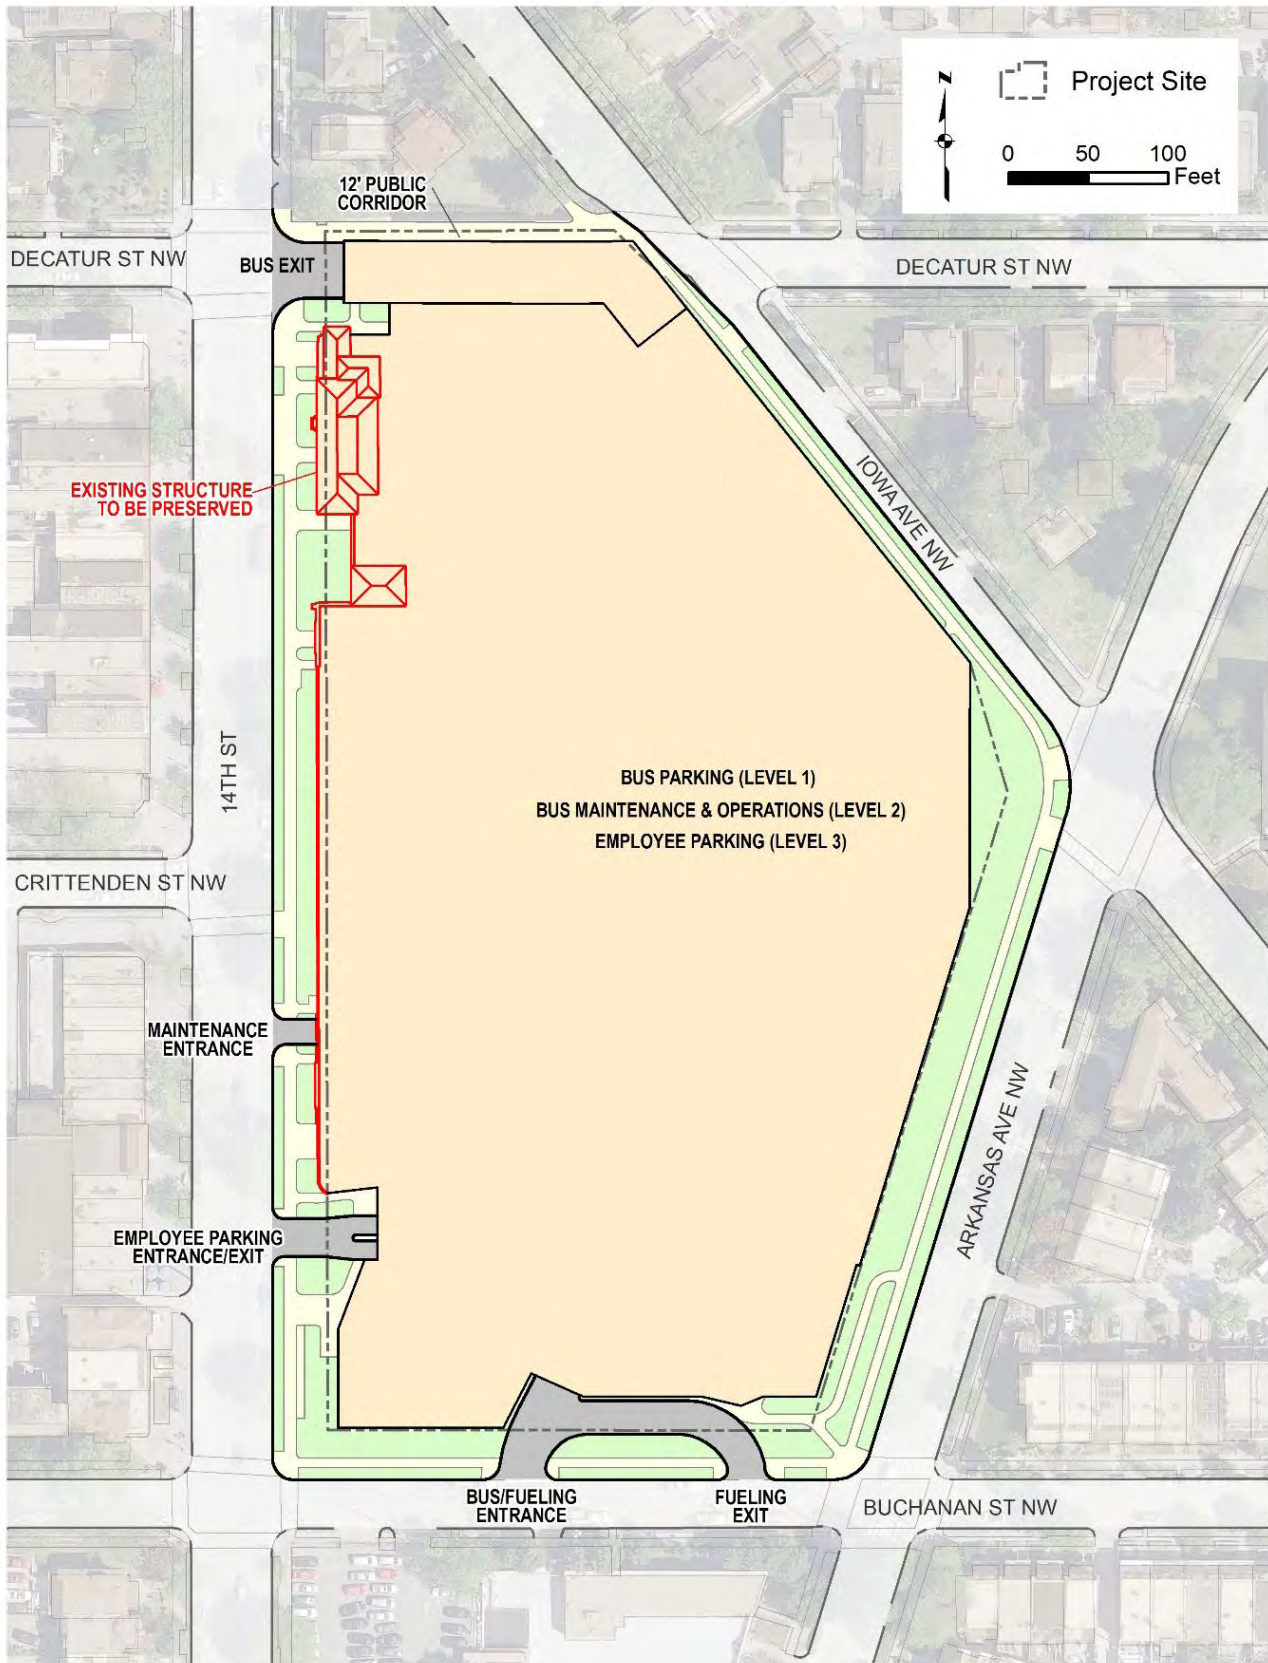
Figure 1-1: Detailed Project Concept (Proposed Conditions)

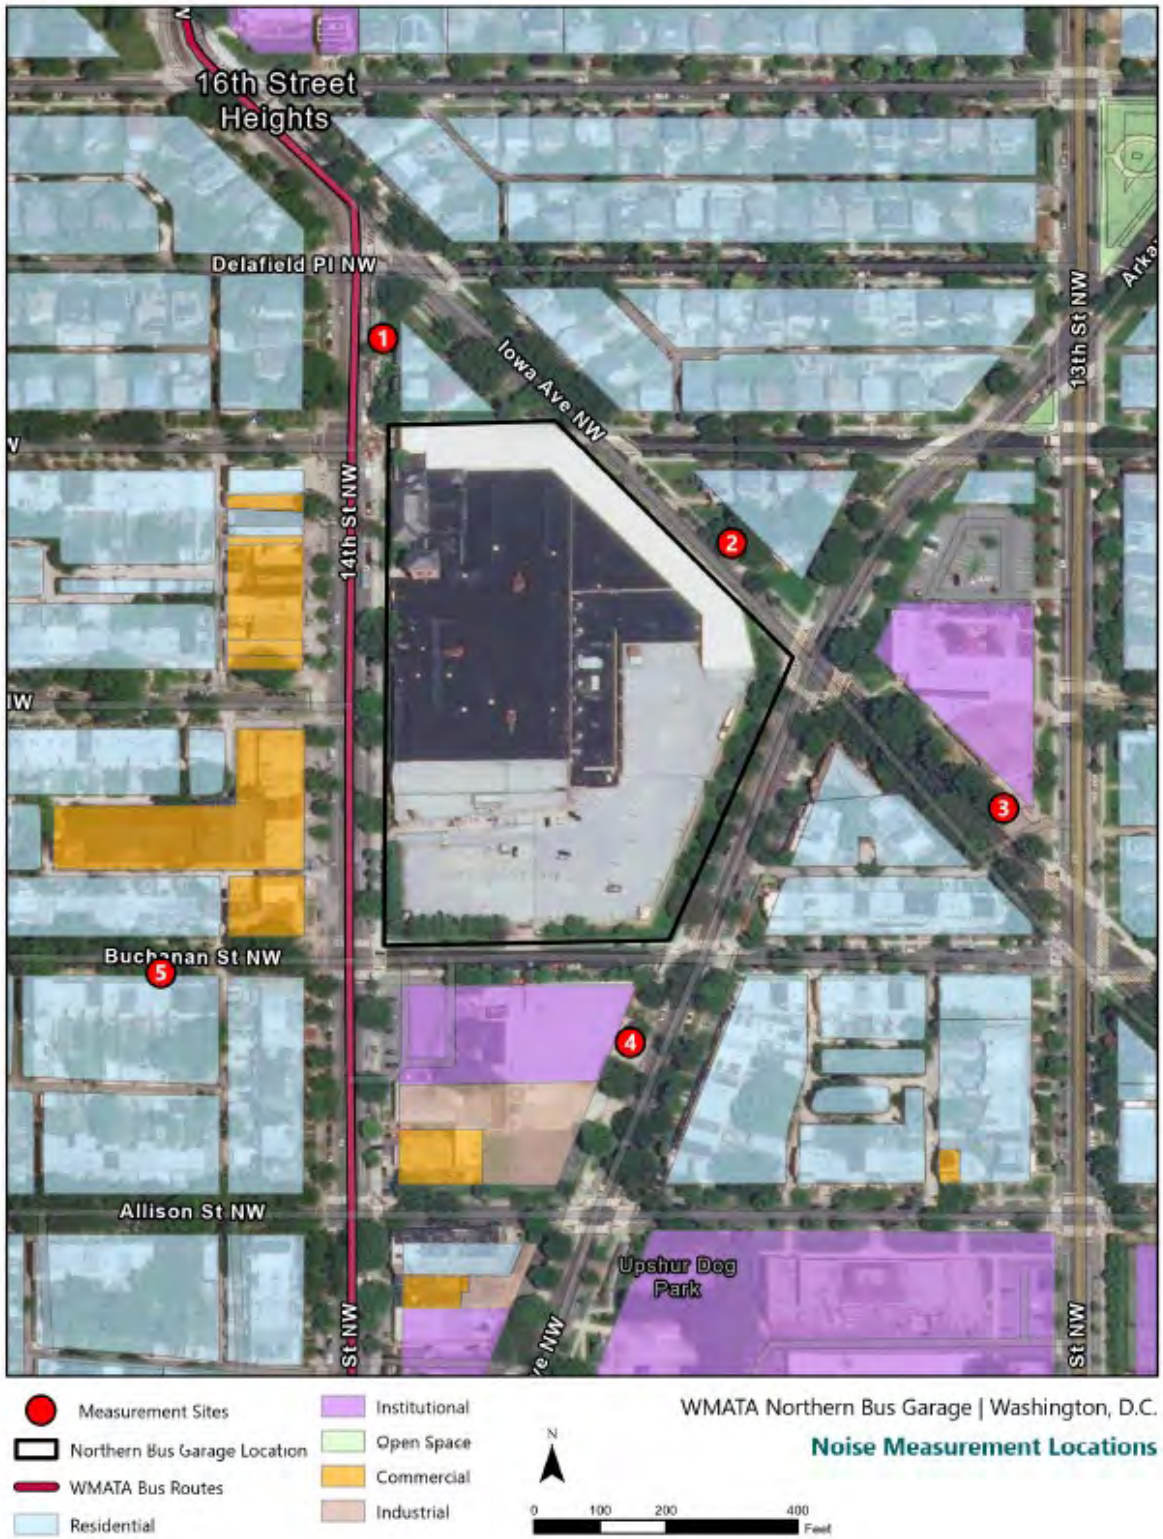
Figure 2-1 Noise Measurement Locations

Ambient sound measurements were conducted for one hour in duration each on December 2, 2021 and December 3, 2021 at five locations (Sites M1 to M5) representative of sensitive land use in the study area as shown in **Figure 2-1**. Measurement locations were selected based on their proximity to previously existing and proposed noise sources at the facility as well as the need to be representative of the various noise-sensitive land uses within the study area. The measurements were conducted with a Larson Davis model LxT which meets Type 1 accuracy according to the American National Standards Institute. The meter was calibrated in the field and by a laboratory traceable to the National Institute of Standards and Technology. Measurements were conducted for one hour during the midday period at each location. Observations were made of the predominant sources of sound and atmospheric conditions including temperature, wind speed, wind direction, and precipitation. Traffic counts were conducted by vehicle type and speed at all locations.

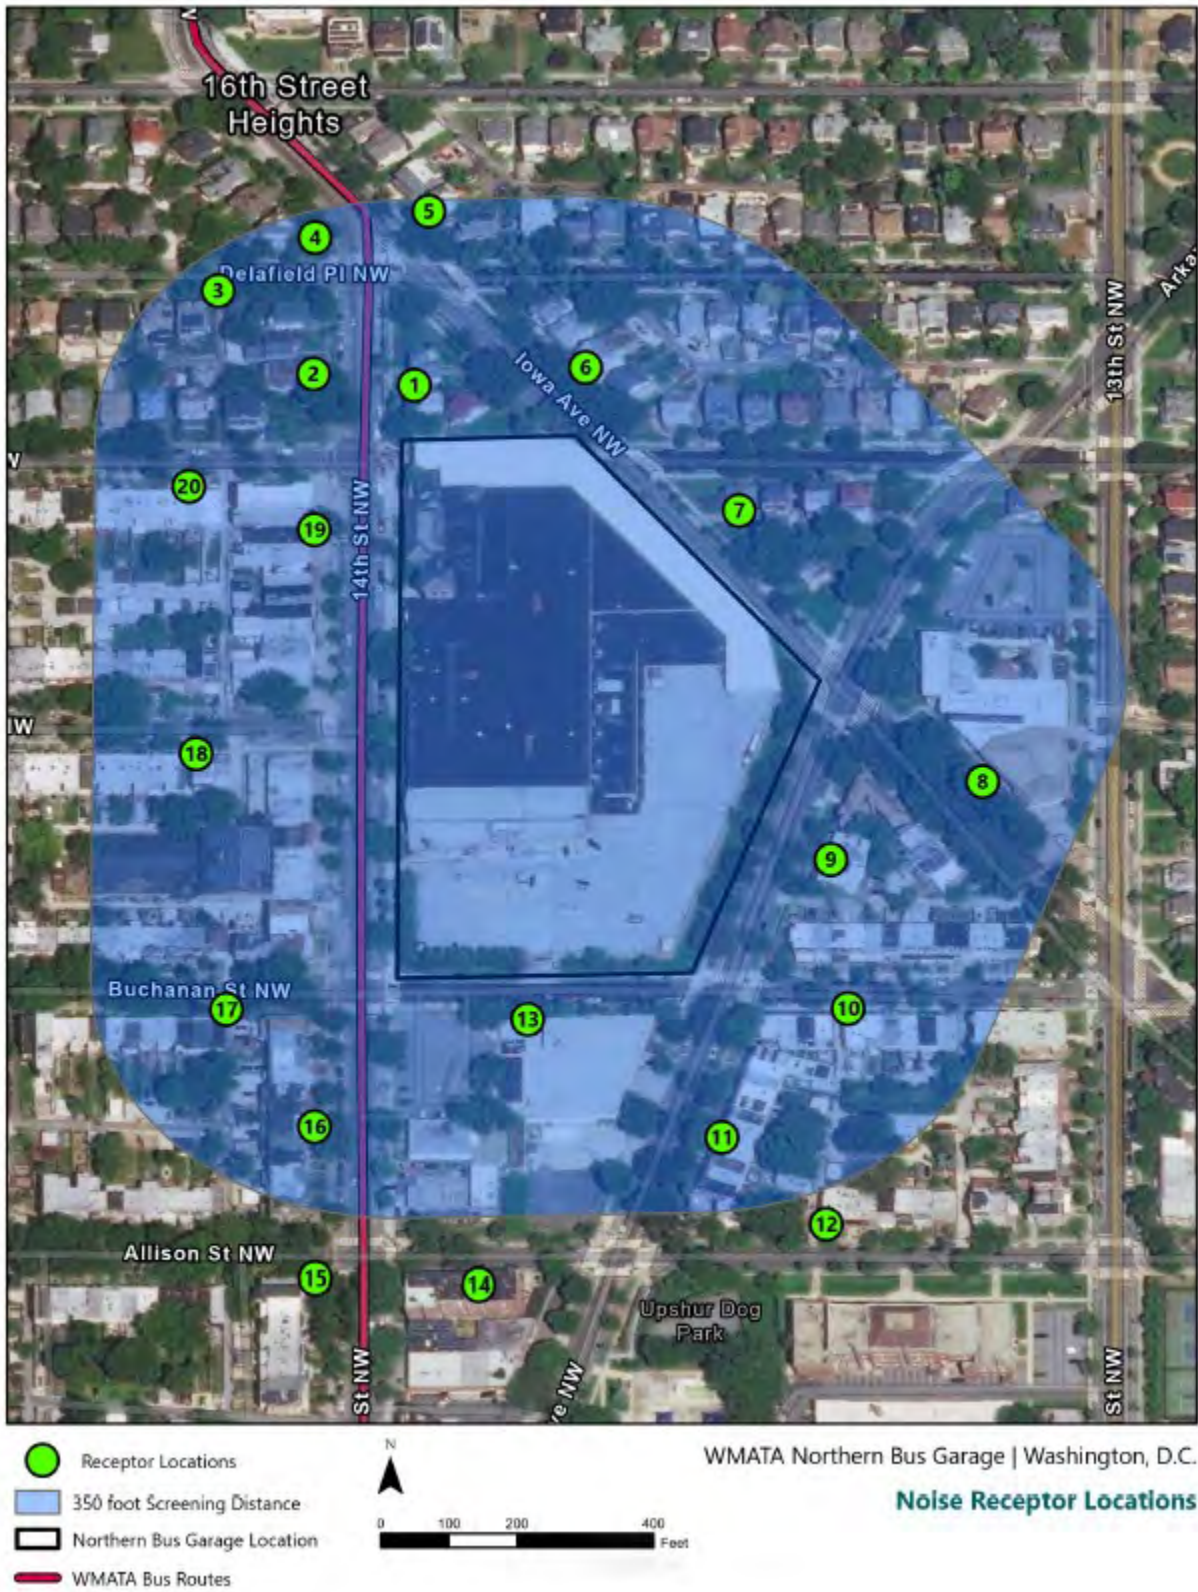
Figure 2-2 Noise Receptor Locations

Table 2-2 and **Figure 2-2** present the results of the noise impact assessment conducted at 20 nearby noise-sensitive receptors. Noise receptors were selected based on land use, bus access points to the facility, bus routes, and proximity to bus facility noise sources within the 350-foot screening distance. Measured noise levels were applied to receptor locations based on land use, their proximity to similar existing noise sources, setback distances from existing noise sources, and the proximity of the measurement location to the receptor location. The table includes the land use category, address, the measurement location applied to each receptor, 2021 ambient noise level measured in the field, the noise level based on the bus operations in June 2018, the future condition (2026) noise level, the moderate and severe impact criteria based on the 2018 noise level, increase in noise level, and impact determination.
