## Northern Bus Garage

### Noise, Vibration, and Dust Monitoring Report (February 2024)

Noise, Vibration, and Dust levels were monitored as part of the reconstruction of Northern Bus Garage, 4615 14<sup>th</sup> Street, NW, Washington, DC, for the month of February 2024.

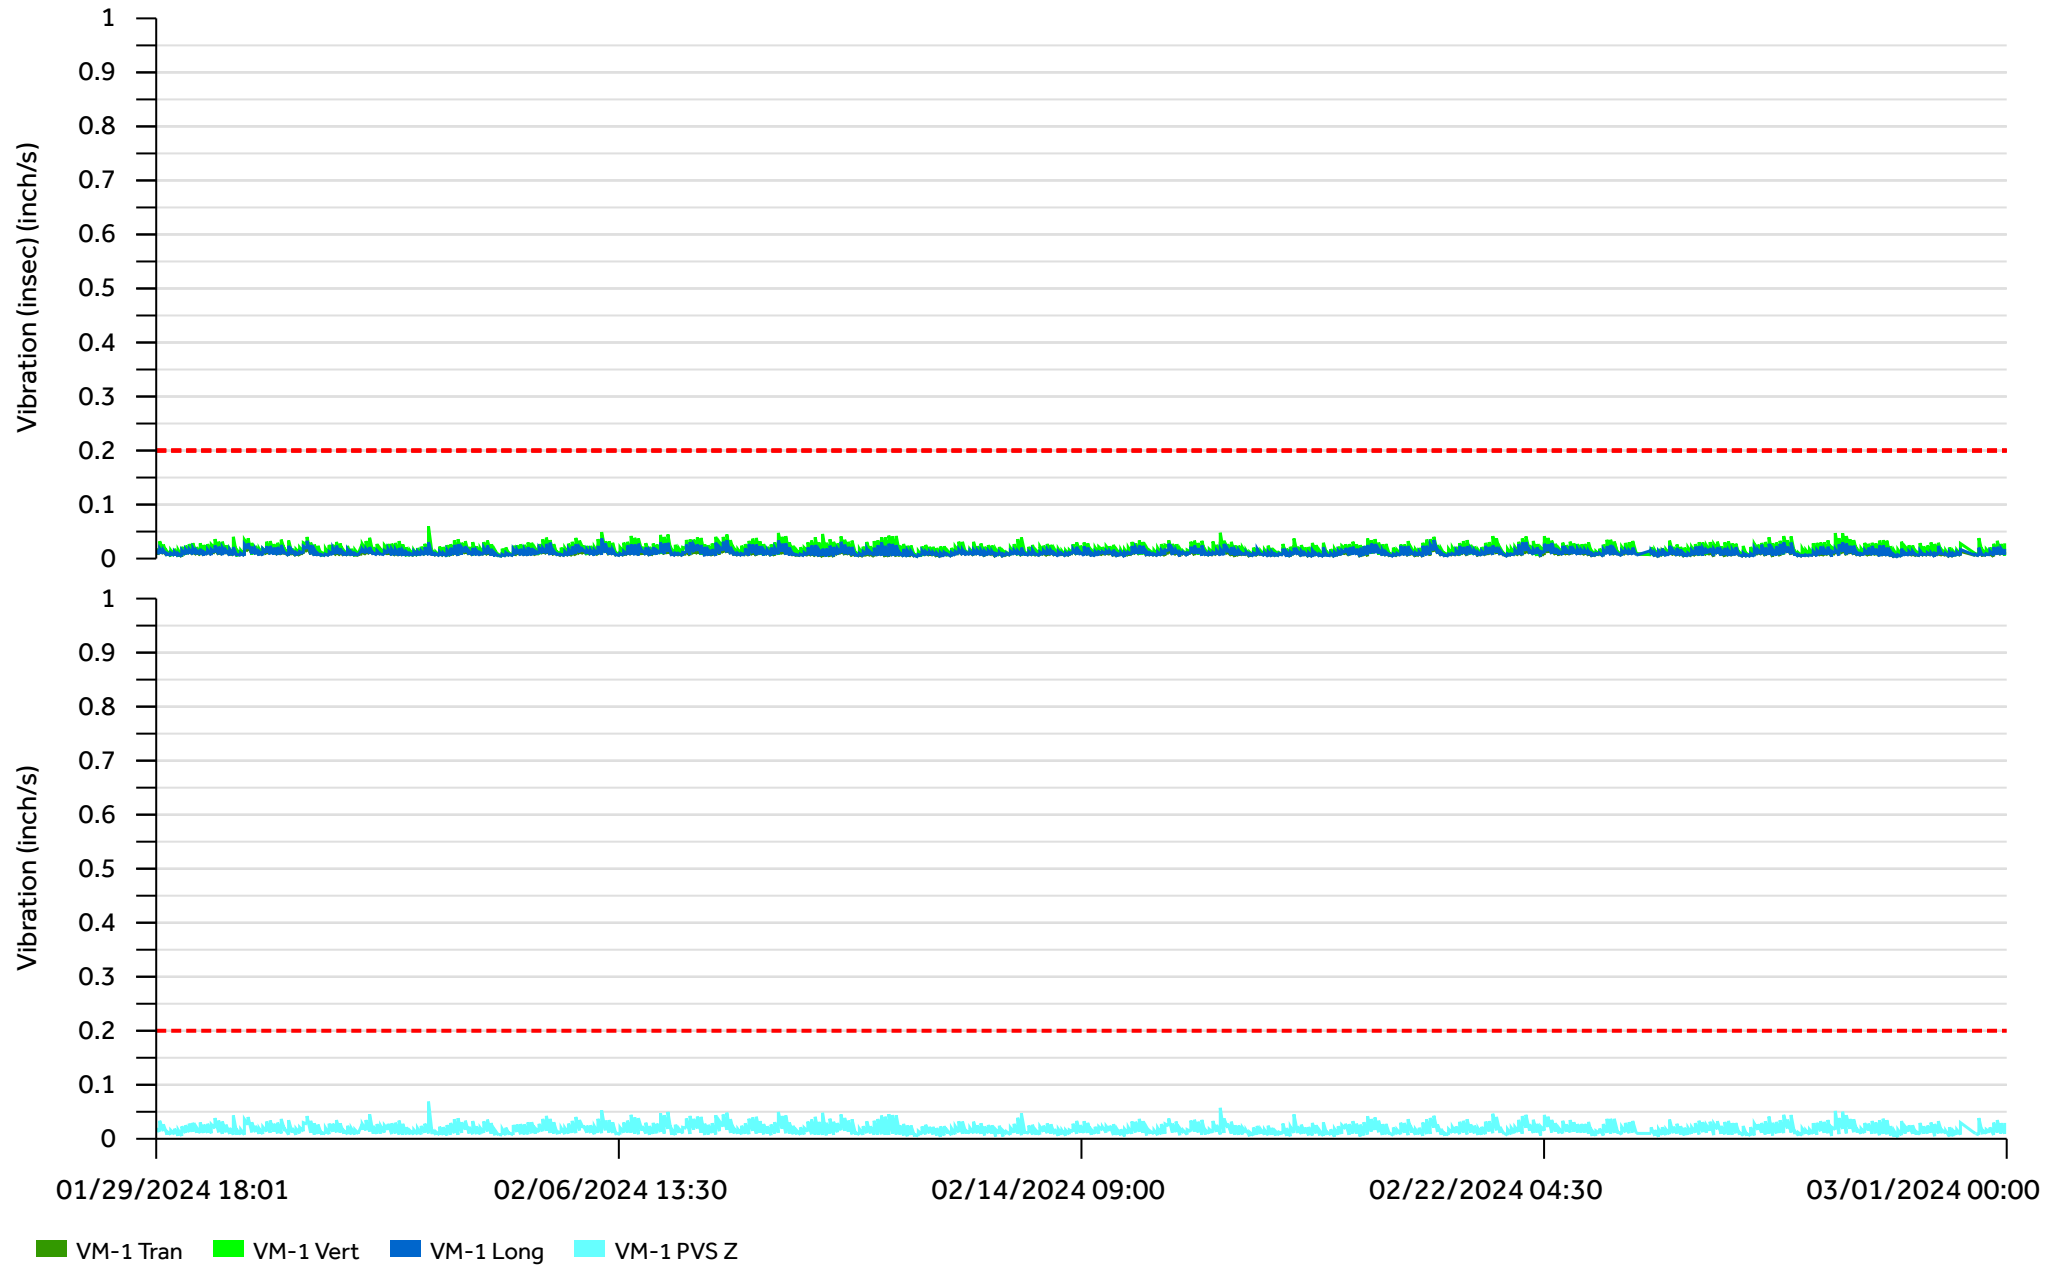
Graph 1:  
VM-1- Vibration Monitor

<b>Instrument Type</b>	<b>Monitoring Threshold</b>
Vibration Monitor (VM-1)	0.2 in/sec
Vibration Monitor (VM-2)	0.2 in/sec
Vibration Monitor (VM-3)	2.0 in/sec
Vibration Monitor (VM-4)	2.0 in/sec
Vibration Monitor (VM-5)	2.0 in/sec

There were no vibration exceedances in the month of February 2024.

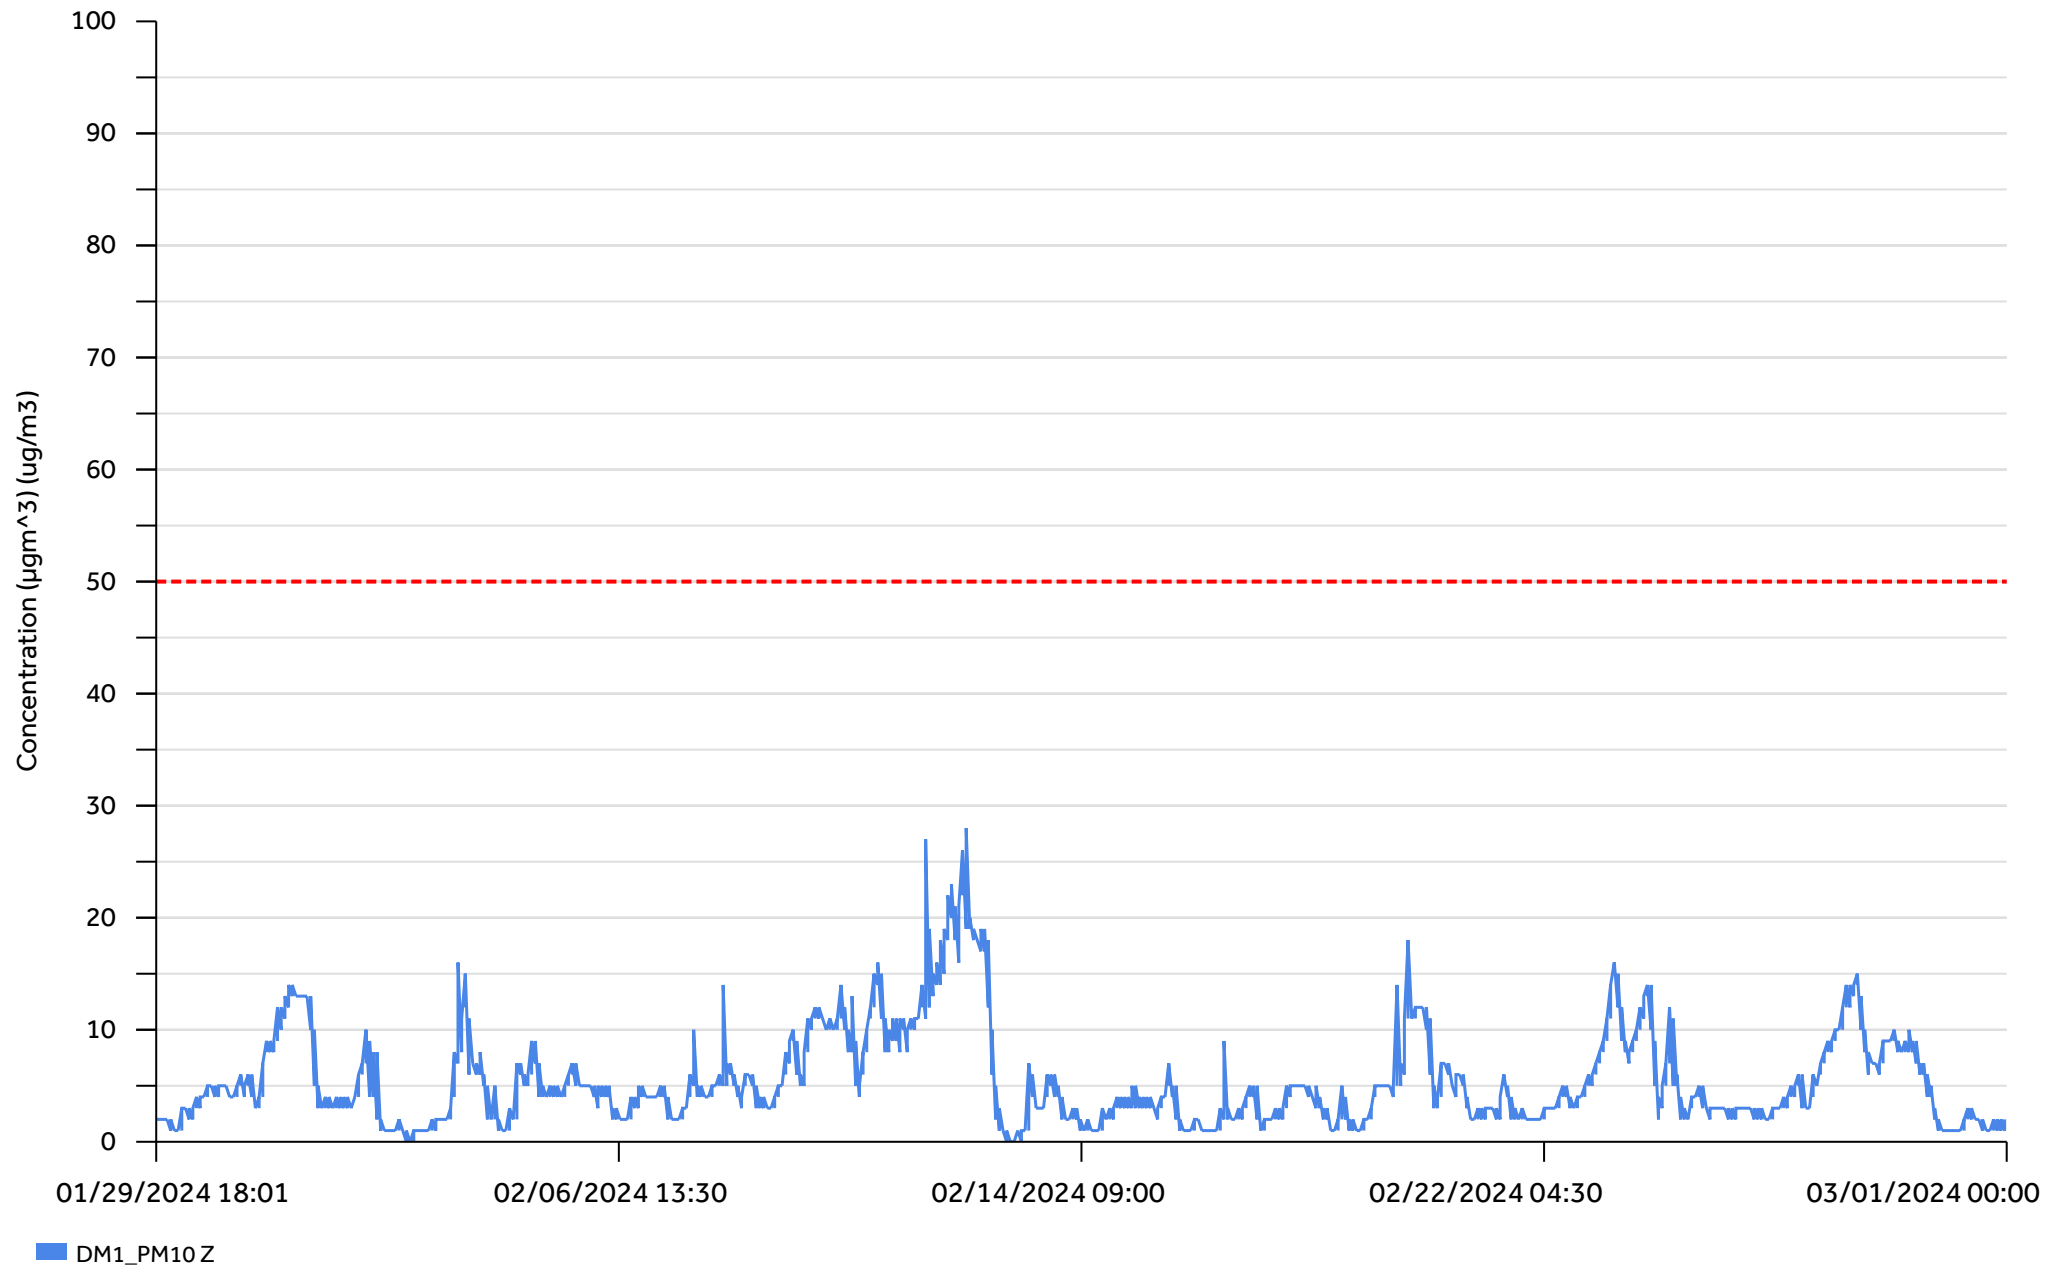
Graph 6:  
DM1 - PM10

<b>Dust Monitoring Measurement</b>	<b>Monitoring Threshold</b>
Particulates (PM2.5)	40 µg/m <sup>3</sup>
Particulates (PM10)	50 µg/m <sup>3</sup>

There were no dust monitoring exceedances in the month of February 2024.
