Monitoring Report

WMATA Bus Garage Monthly Report

July 2023

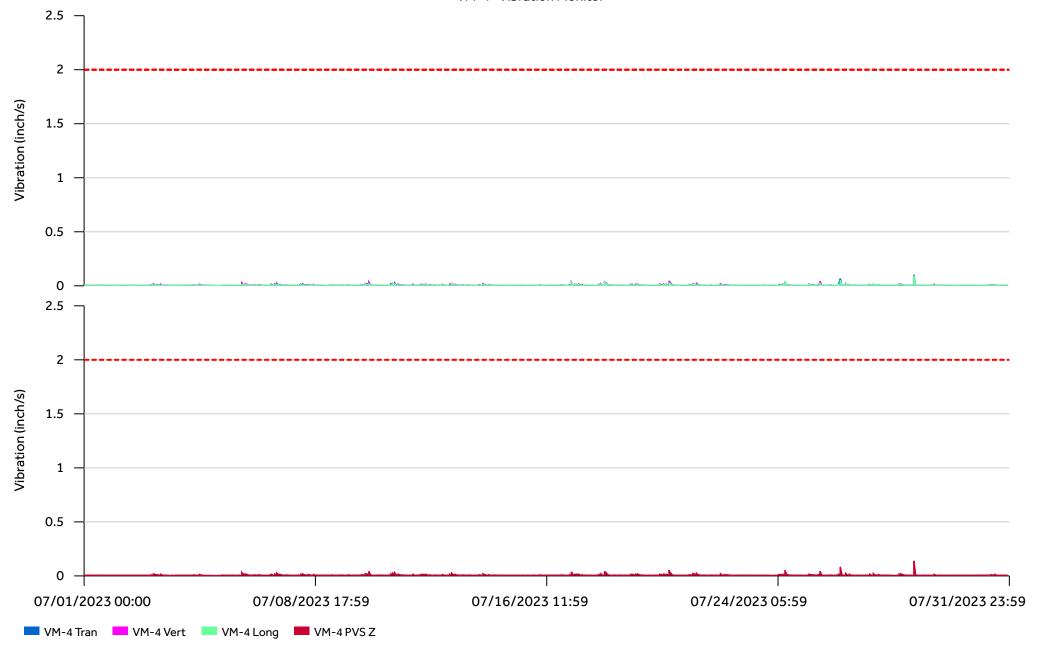
VM Sensor 1

VM1 – 7/28 2005h. 0.59 in/sec on the Transverse channel. Appears to be electrical not physical vibration.

The 0.59 in/sec event does not appear to be caused by physical vibration, but rather electrical noise. While not an exceedance, VM4 and VM5 also recorded measurements of 0.1 and 0.32 in/sec at the same time as the 7/28 2005h recording at VM1. These also appear to be electrical in nature. The single event that triggered all three units may have been a lightning strike or other electrical anomaly at the site.

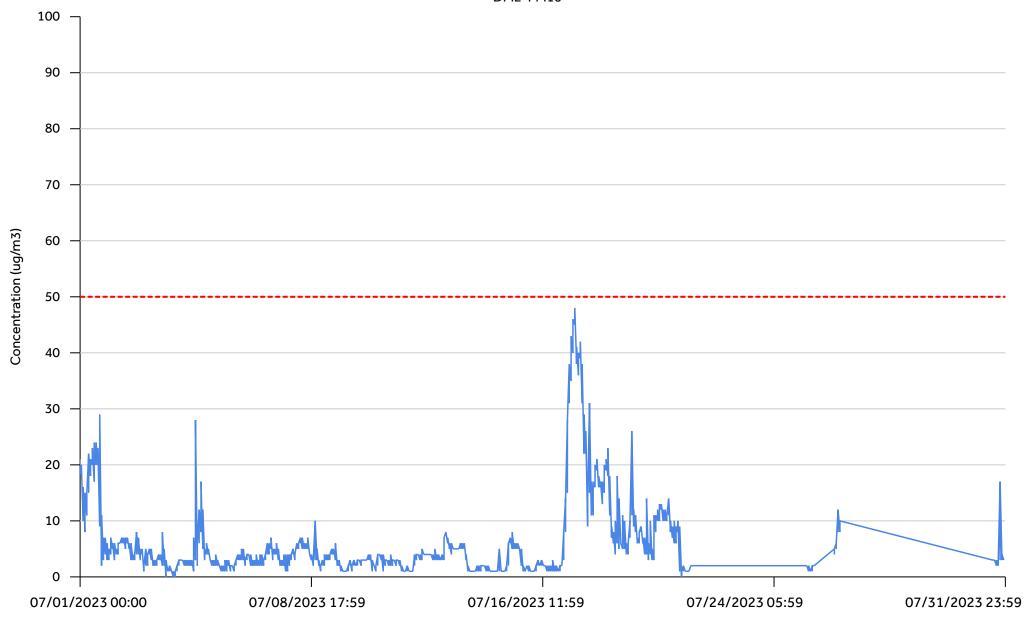
■ DM2_PM10 Z

DM2 -7/17 1116-1930h, 48 μ g/m^3.

A review of the data reveals threshold exceedances from regional poor air quality events on July 4th and 17th as found on www.CleanAirPartners.net. DM2 experienced power failure during most of the July 21 through 31 period. DM3 also experienced power failure from July 14 through 19 and from July 20 through 22. These units require a lot of power and DM3 has now been moved to hard wired power from solar to ensure higher reliability. In addition, new modems are being sourced that will allow us to measure incoming voltage and send alarms if it drops below a prescribed threshold.

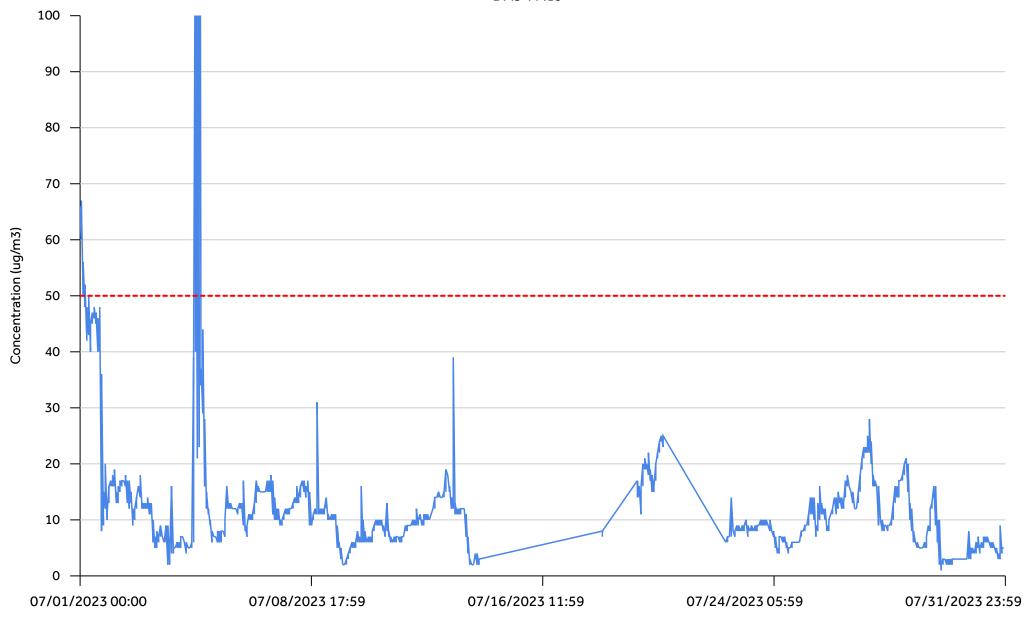
■ DM3_PM10 Z

DM3 – 7/4 2126h, 130 μg/m³. DM3 – 7/5 0026h, 250 μg/m³.
