# Northern Bus Garage

## Noise, Vibration, and Dust Monitoring Report (July 2024)

Noise, Vibration, and Dust levels were monitored as part of the reconstruction of Northern Bus Garage, 4615 14<sup>th</sup> Street, NW, Washington, DC, for the month of July 2024.

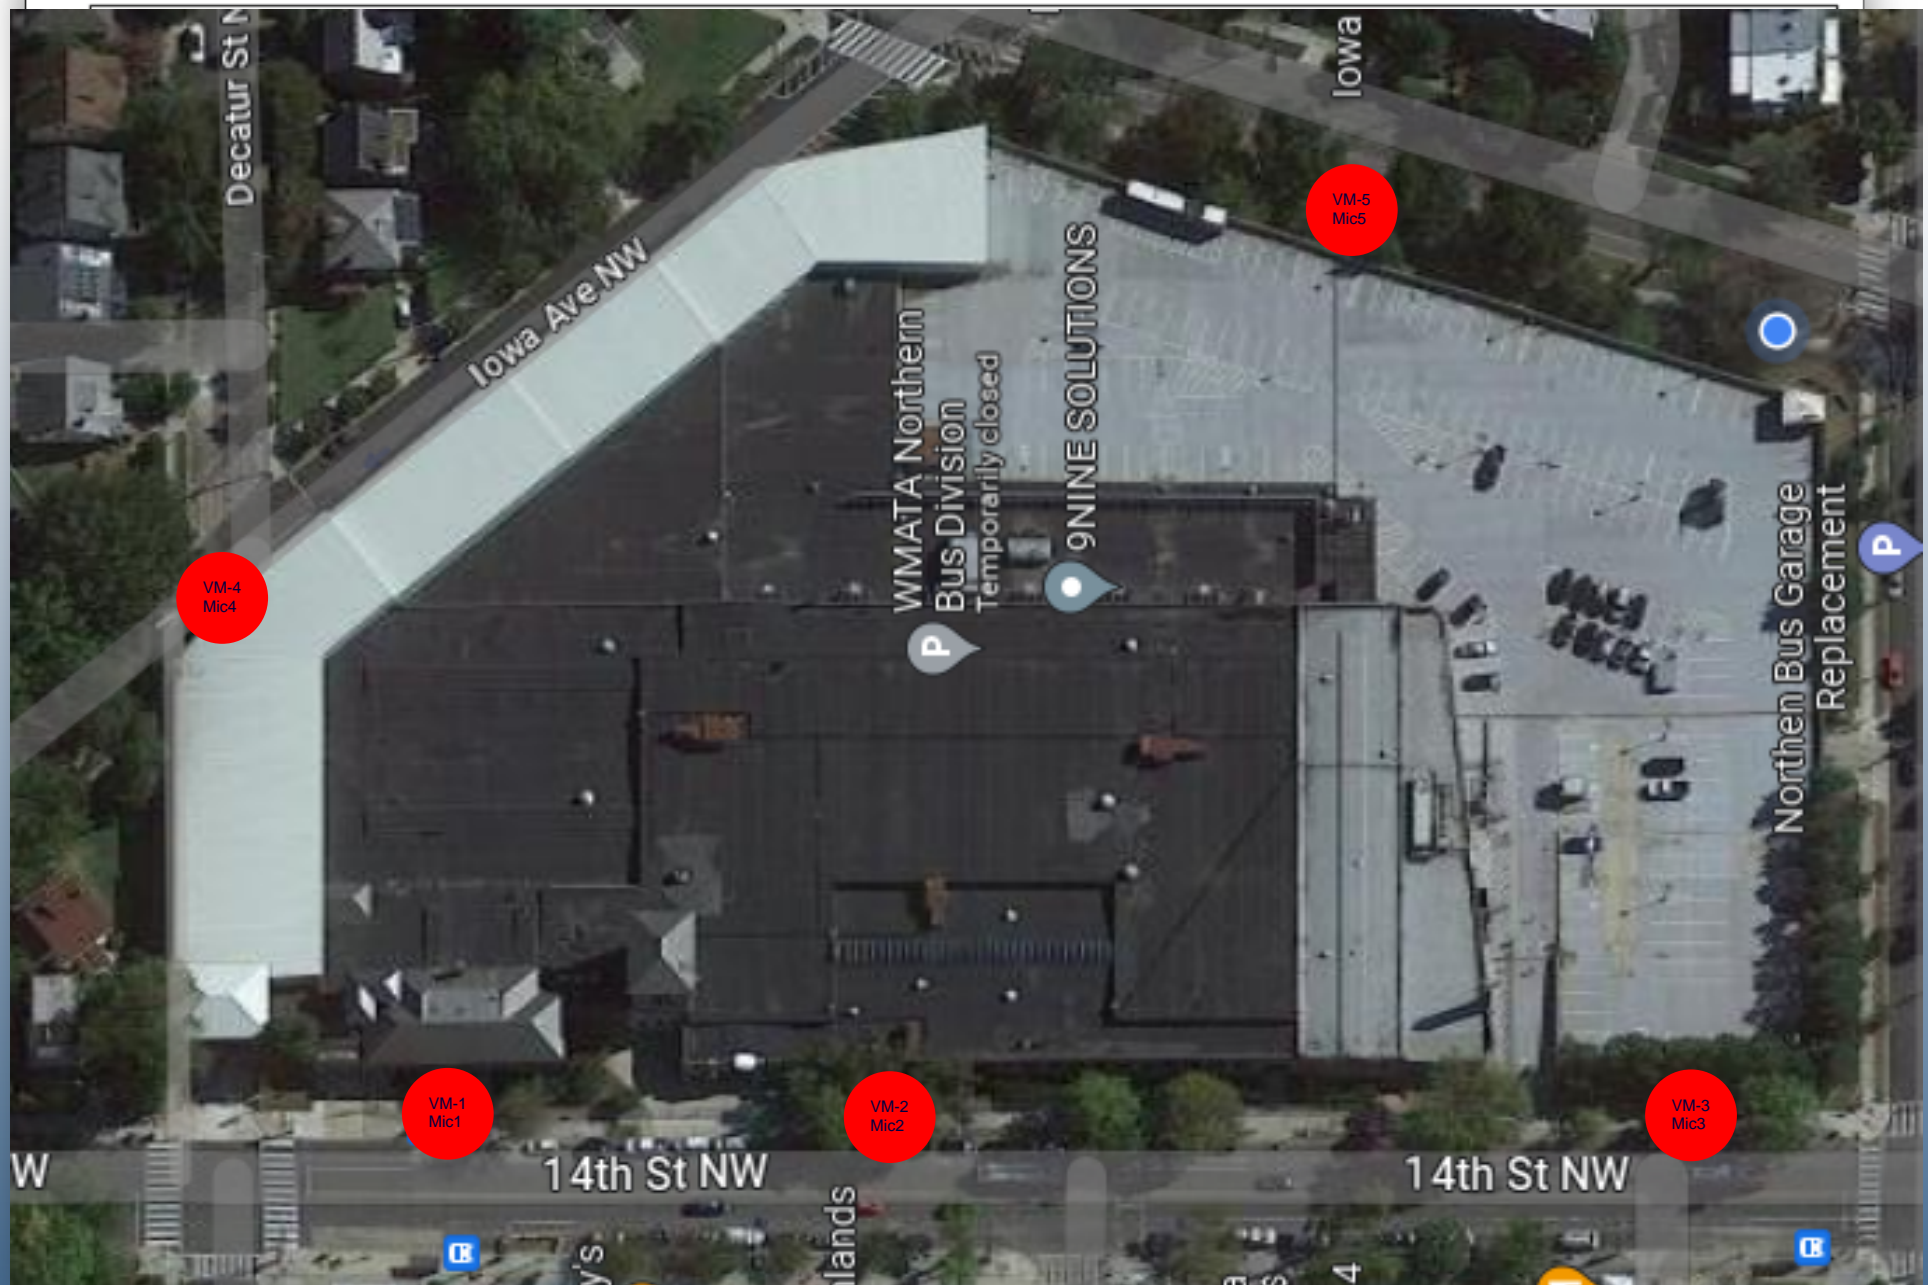
# Figure 1: Vibration and Noise Monitor Location Plan

Five noise monitors are positioned around the perimeter of the project site. (See Figure 1) Under DC regulations, the regulatory standard is 80 dBA, measured 25 ft from the property line (20 DCMR 2802.1). Because the noise monitoring devices are placed on the property line (rather than a 25 ft offset), the monitoring threshold for site activities is adjusted to 85 dBA (assuming the noise level will dissipate). Noise levels and vibration levels were measured automatically with Micromate and Geophone Instrument.

Five vibration monitors are positioned around the perimeter of the project site. (See Figure 1) Vibration thresholds are based the WMATA Design Criteria. Monitors VM-1 and VM-2 are set at a lower vibration threshold due to their proximity to the historic façade, which is more sensitive to any movement. Noise levels and vibration levels were measured automatically with Micromate and Geophone Instrument.

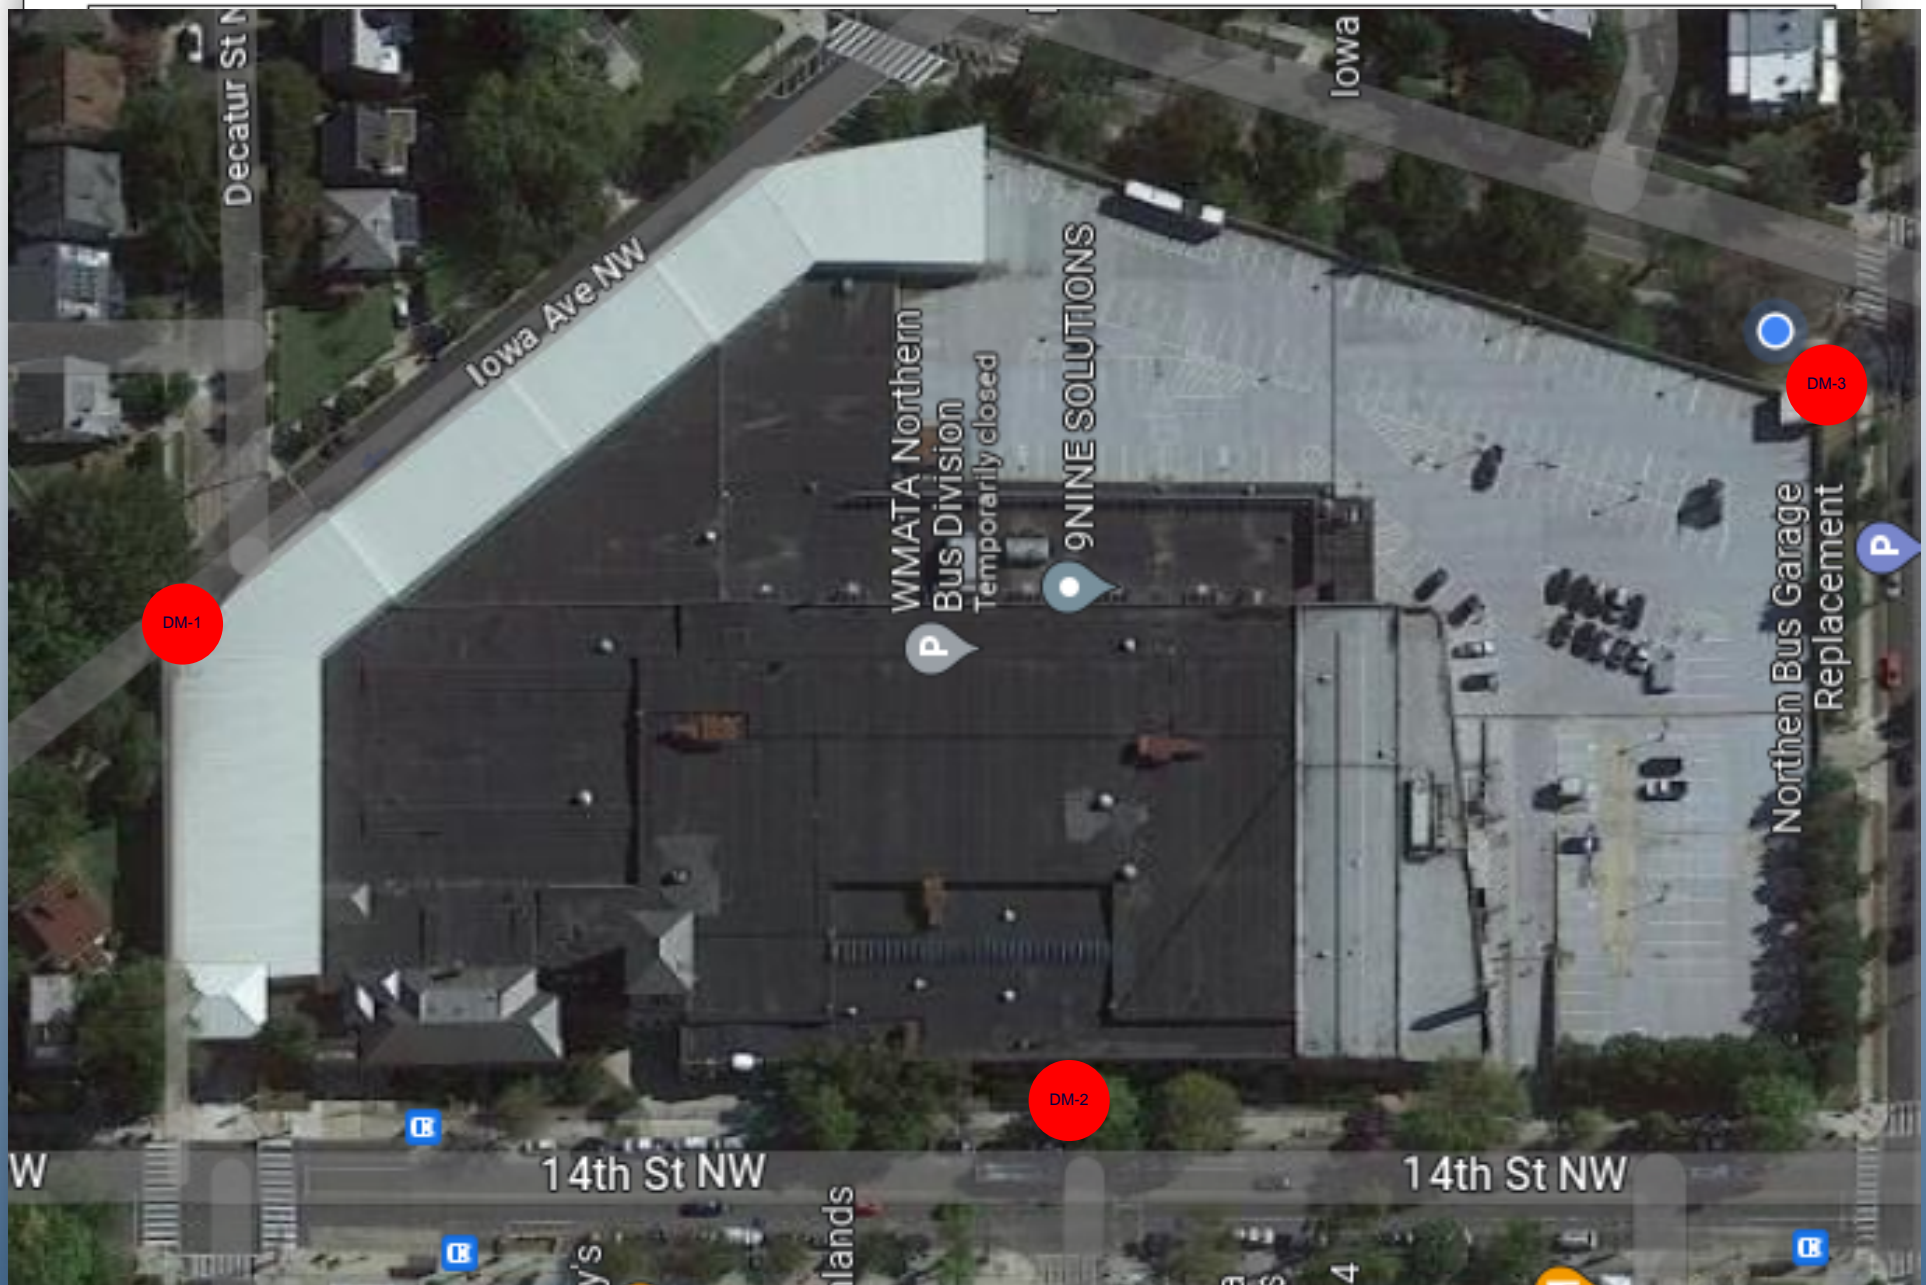
# Figure 2: Dust Monitor Location Plan

Three dust monitors are positioned at the project site. (See Figure 2) EPA regulatory thresholds are based on a 24-hour monitoring period; the project has adopted thresholds to monitor site levels and provide an indication of when EPA standards might be exceeded. (See Table 3) Dust measurements were monitored using Aeroqual Dust Sentry Pro.

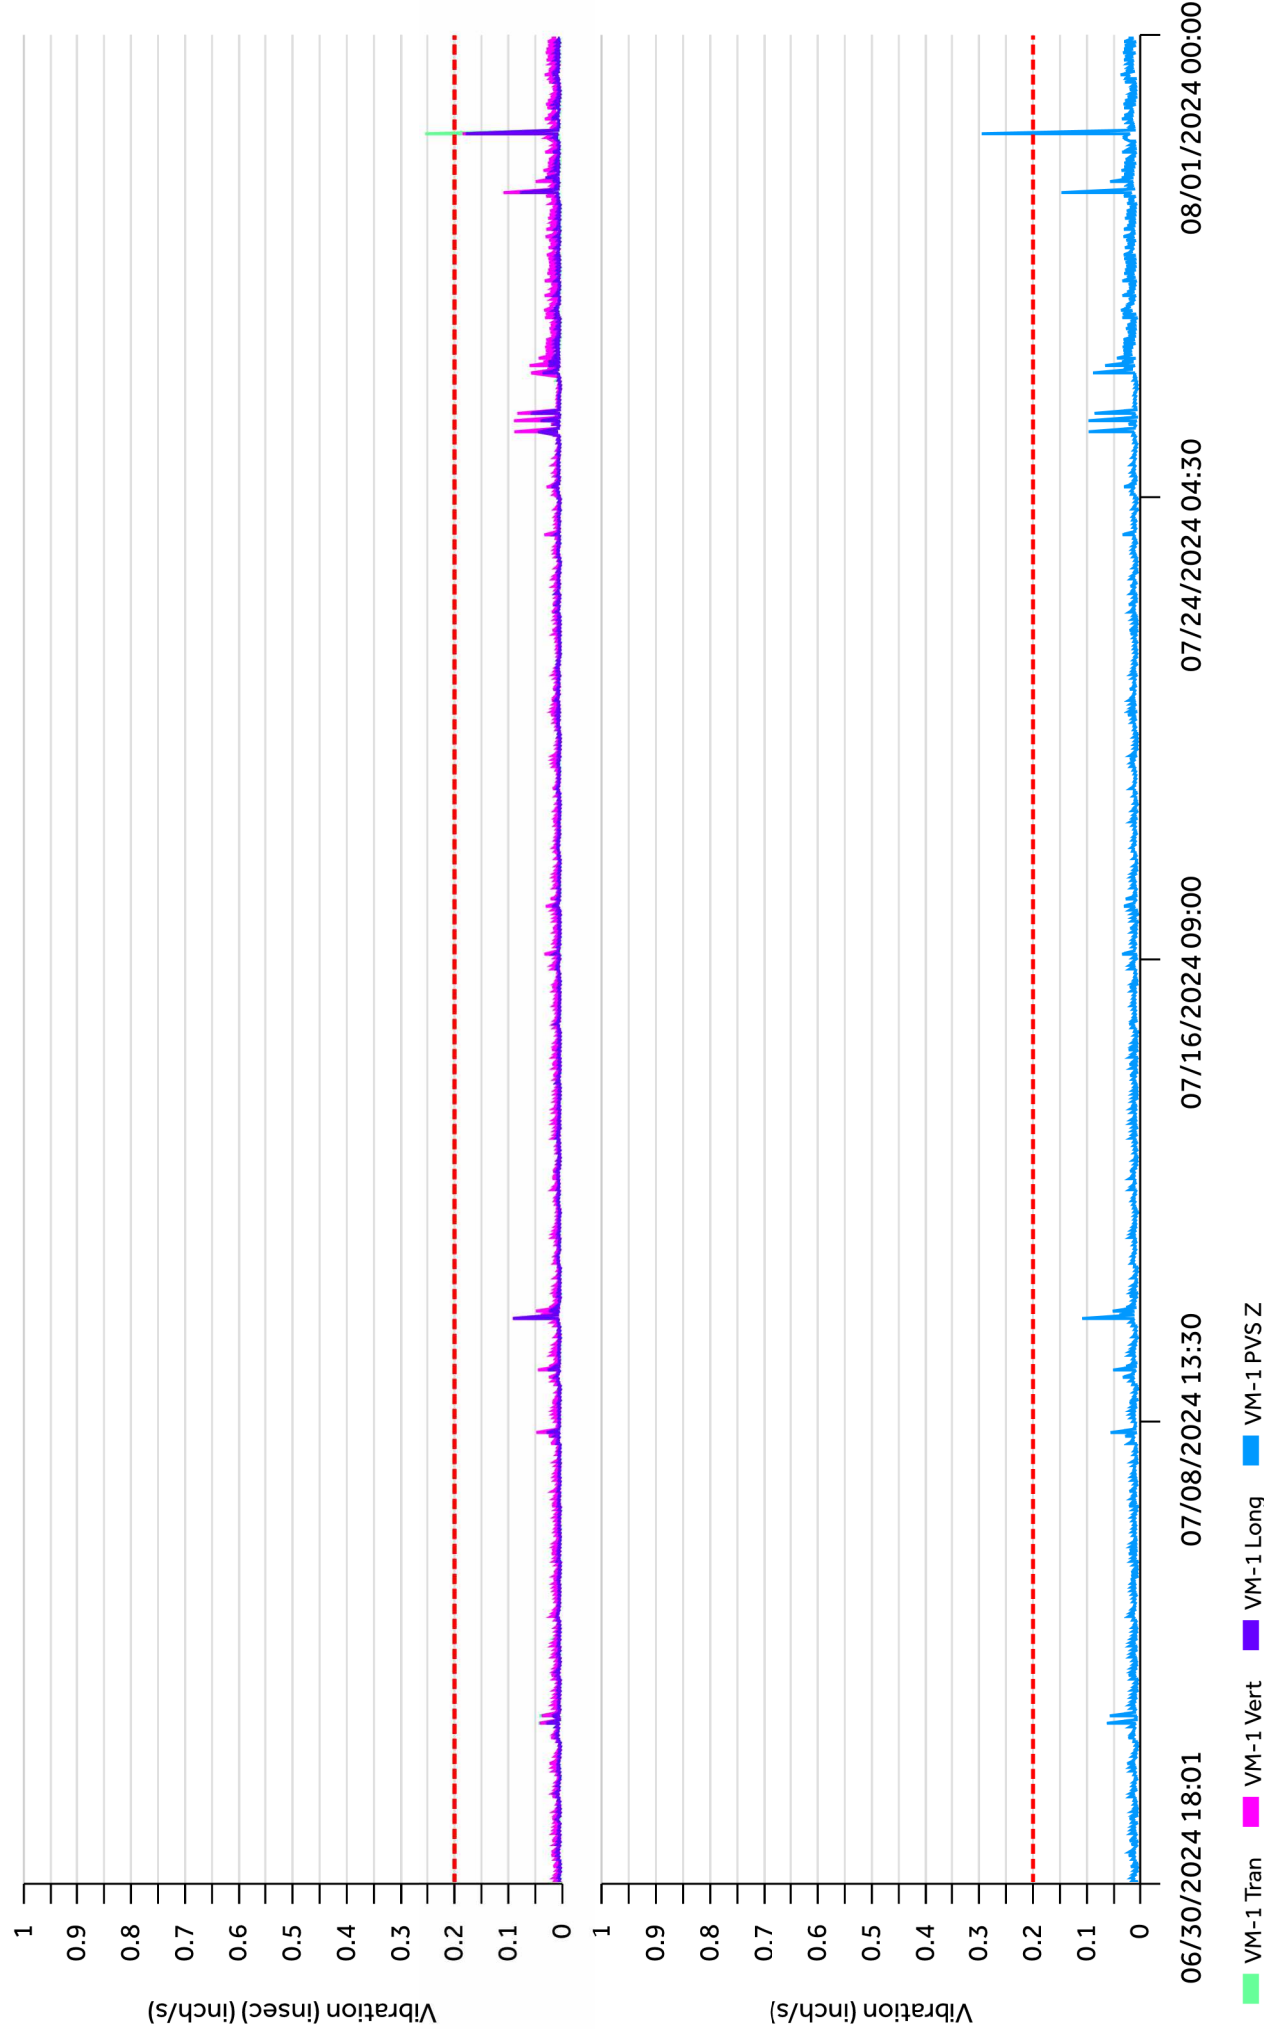
Graph 1  
VM-1 - Vibration Monitor

- VM1 exhibited a vibration exceedance of 0.25 in/sec on July 30 at 08:06. Clark notes that a subcontractor was saw cutting for a utility line near the monitoring unit at that time.
- VM2 exhibited a vibration exceedance of 0.31 in/sec on July 10 at 07:17. Clark noted that the instrument was bumped by a subcontractor employee.
- VM2 exhibited a vibration exceedance of 0.41 in/sec on July 24 at 07:11. Clark noted that the instrument was bumped by a subcontractor employee.
- VM2 exhibited a vibration exceedance of 0.20 in/sec on July 29 at 09:54. Clark notes that a subcontractor was saw cutting for a utility line near the monitoring unit at that time.
- VM2 exhibited a vibration exceedance of 0.21 in/sec on July 31 at 07:08. Clark notes that a subcontractor was saw cutting and excavating for a utility line near the monitoring unit at that time

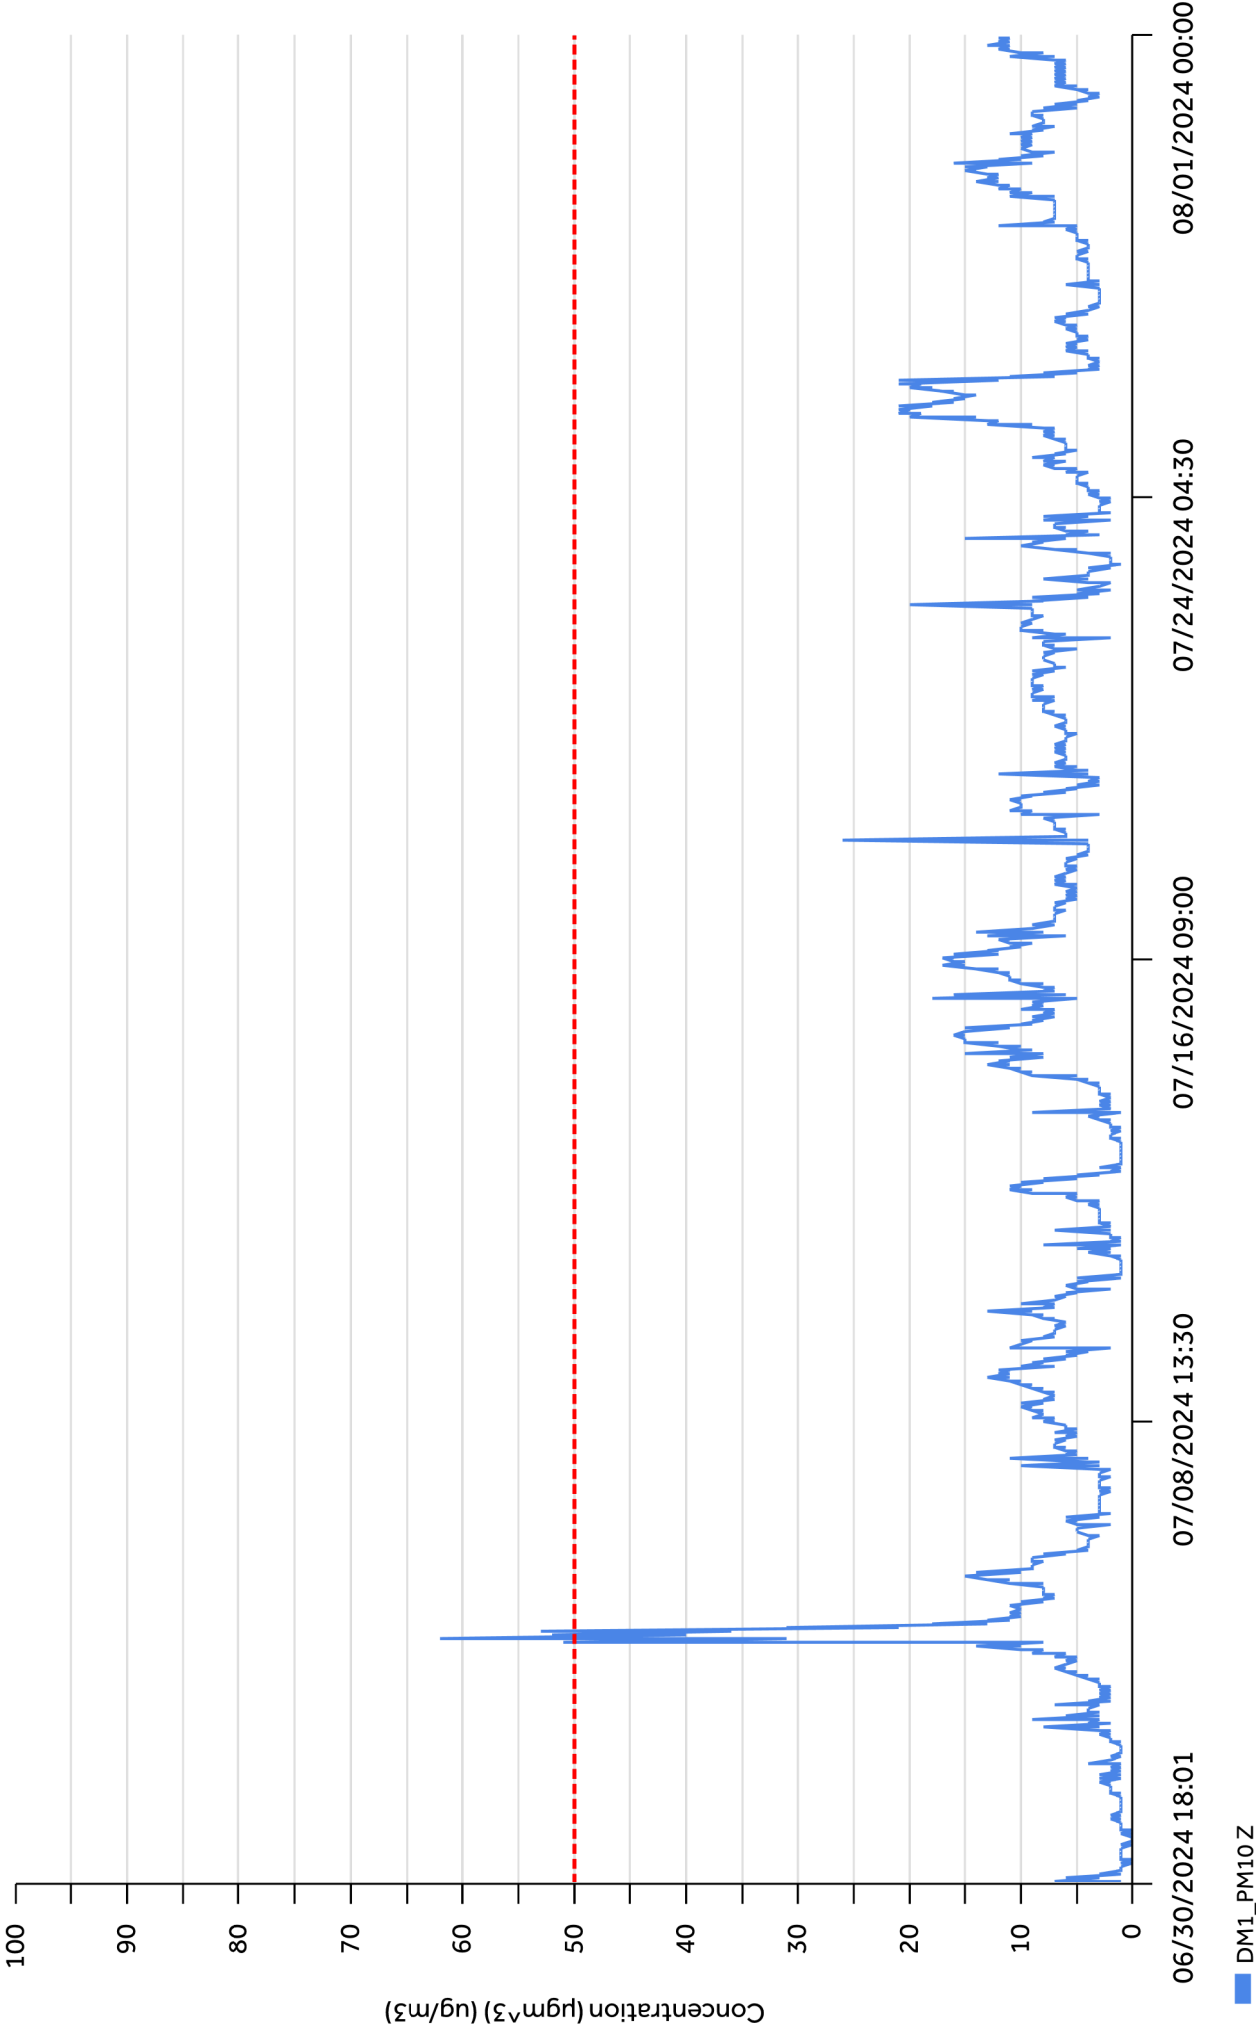
Graph 6

- DM1 – Exceedance of the PM2.5 limit on 7/4 from about 21:00 to 01:30 with readings up to 62  $\mu\text{g}/\text{m}^3$ .
- DM1 – Exceedance of the PM10 limit on 7/4 from about 20:00 to 01:00 with readings up to 62  $\mu\text{g}/\text{m}^3$ .
- DM2 – Exceedance of the PM2.5 limit on 7/4 from about 22:30 to 01:00 with readings up to 42  $\mu\text{g}/\text{m}^3$

DM1 - PM10

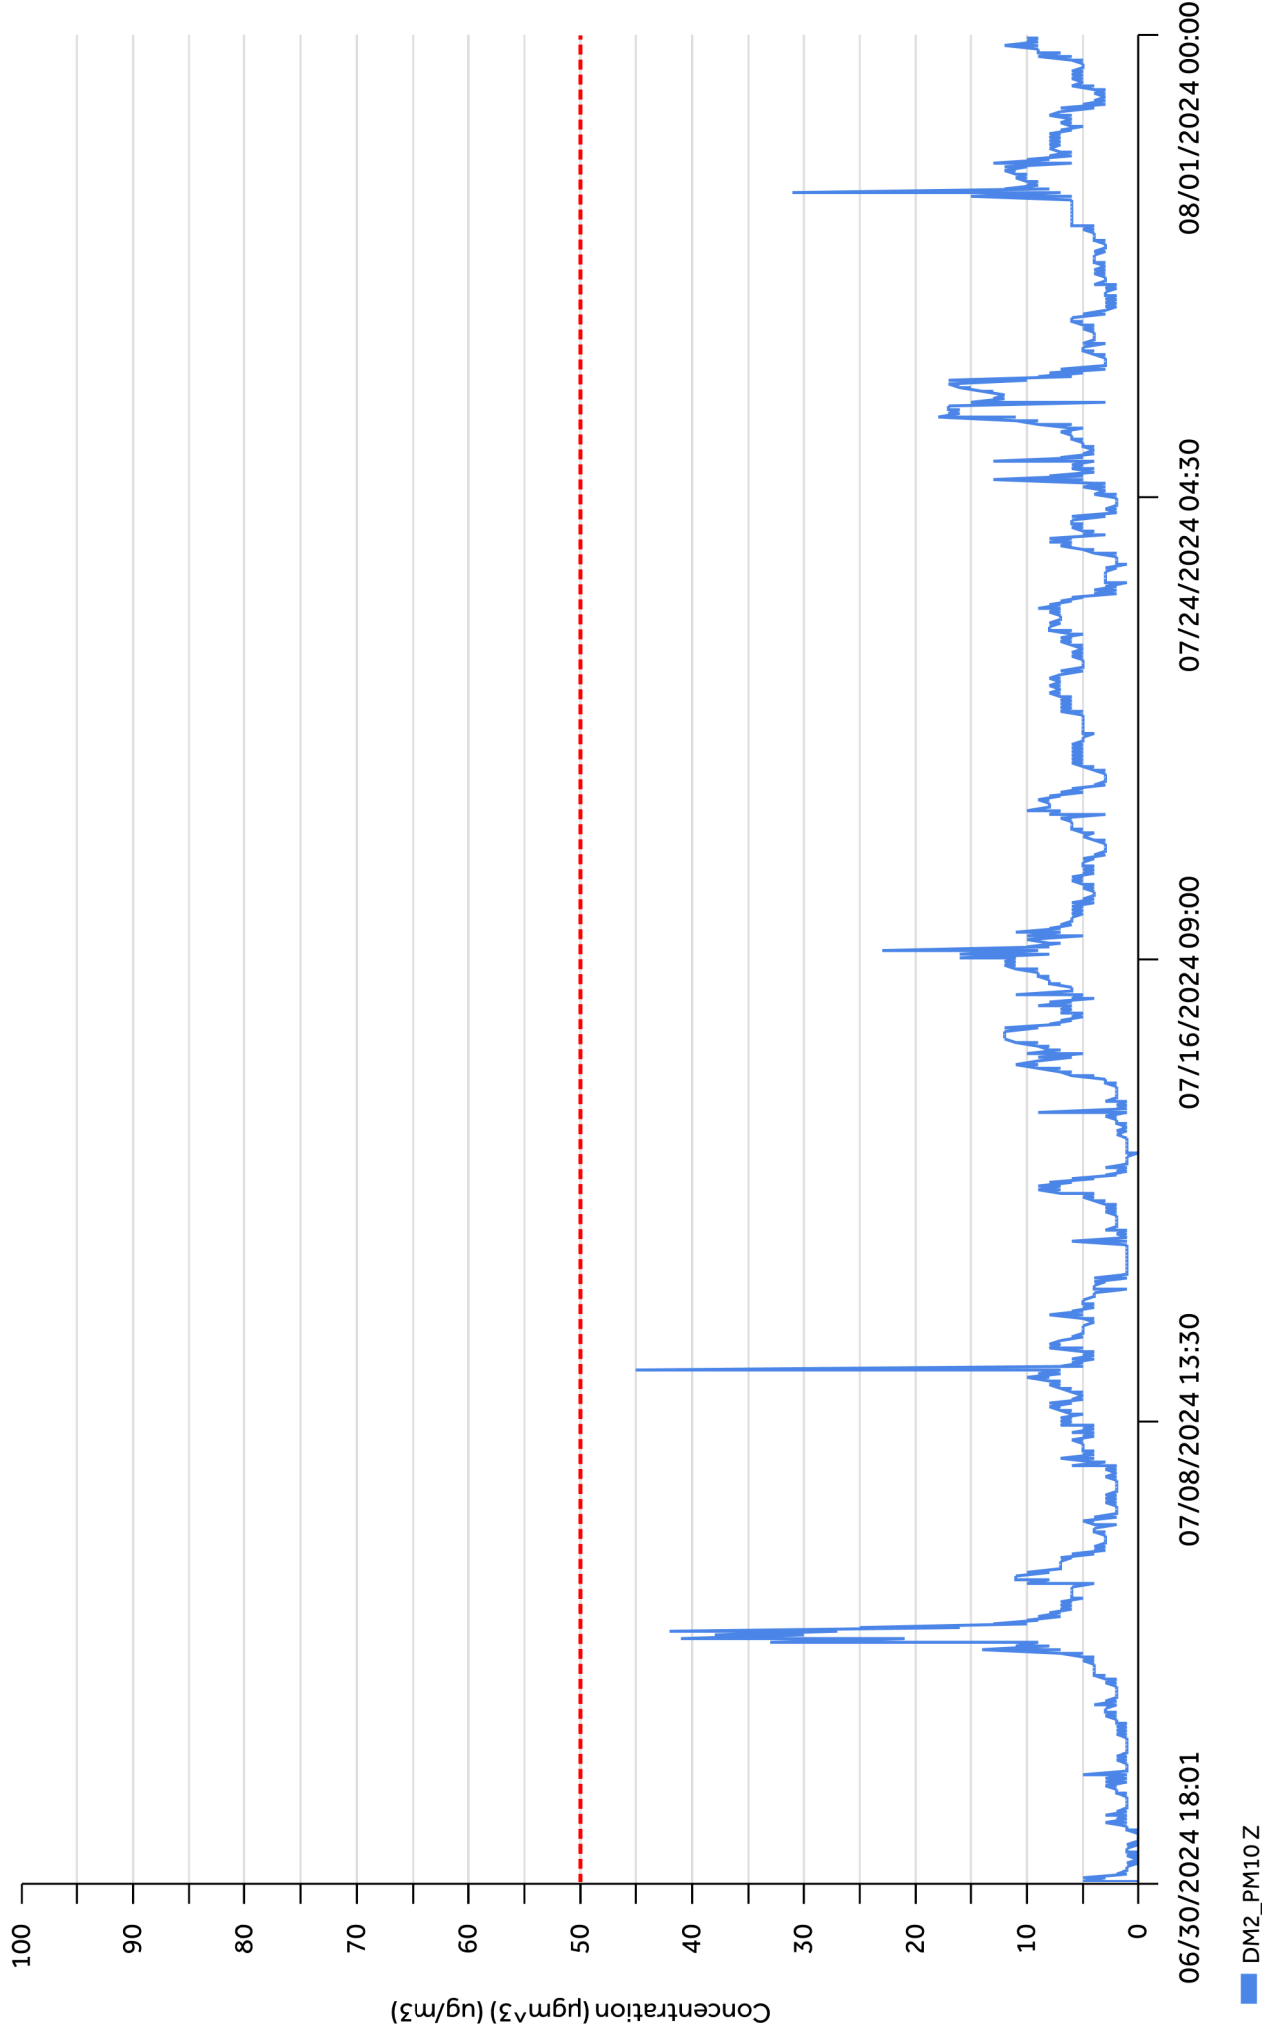
Graph 7

DM2-PM10

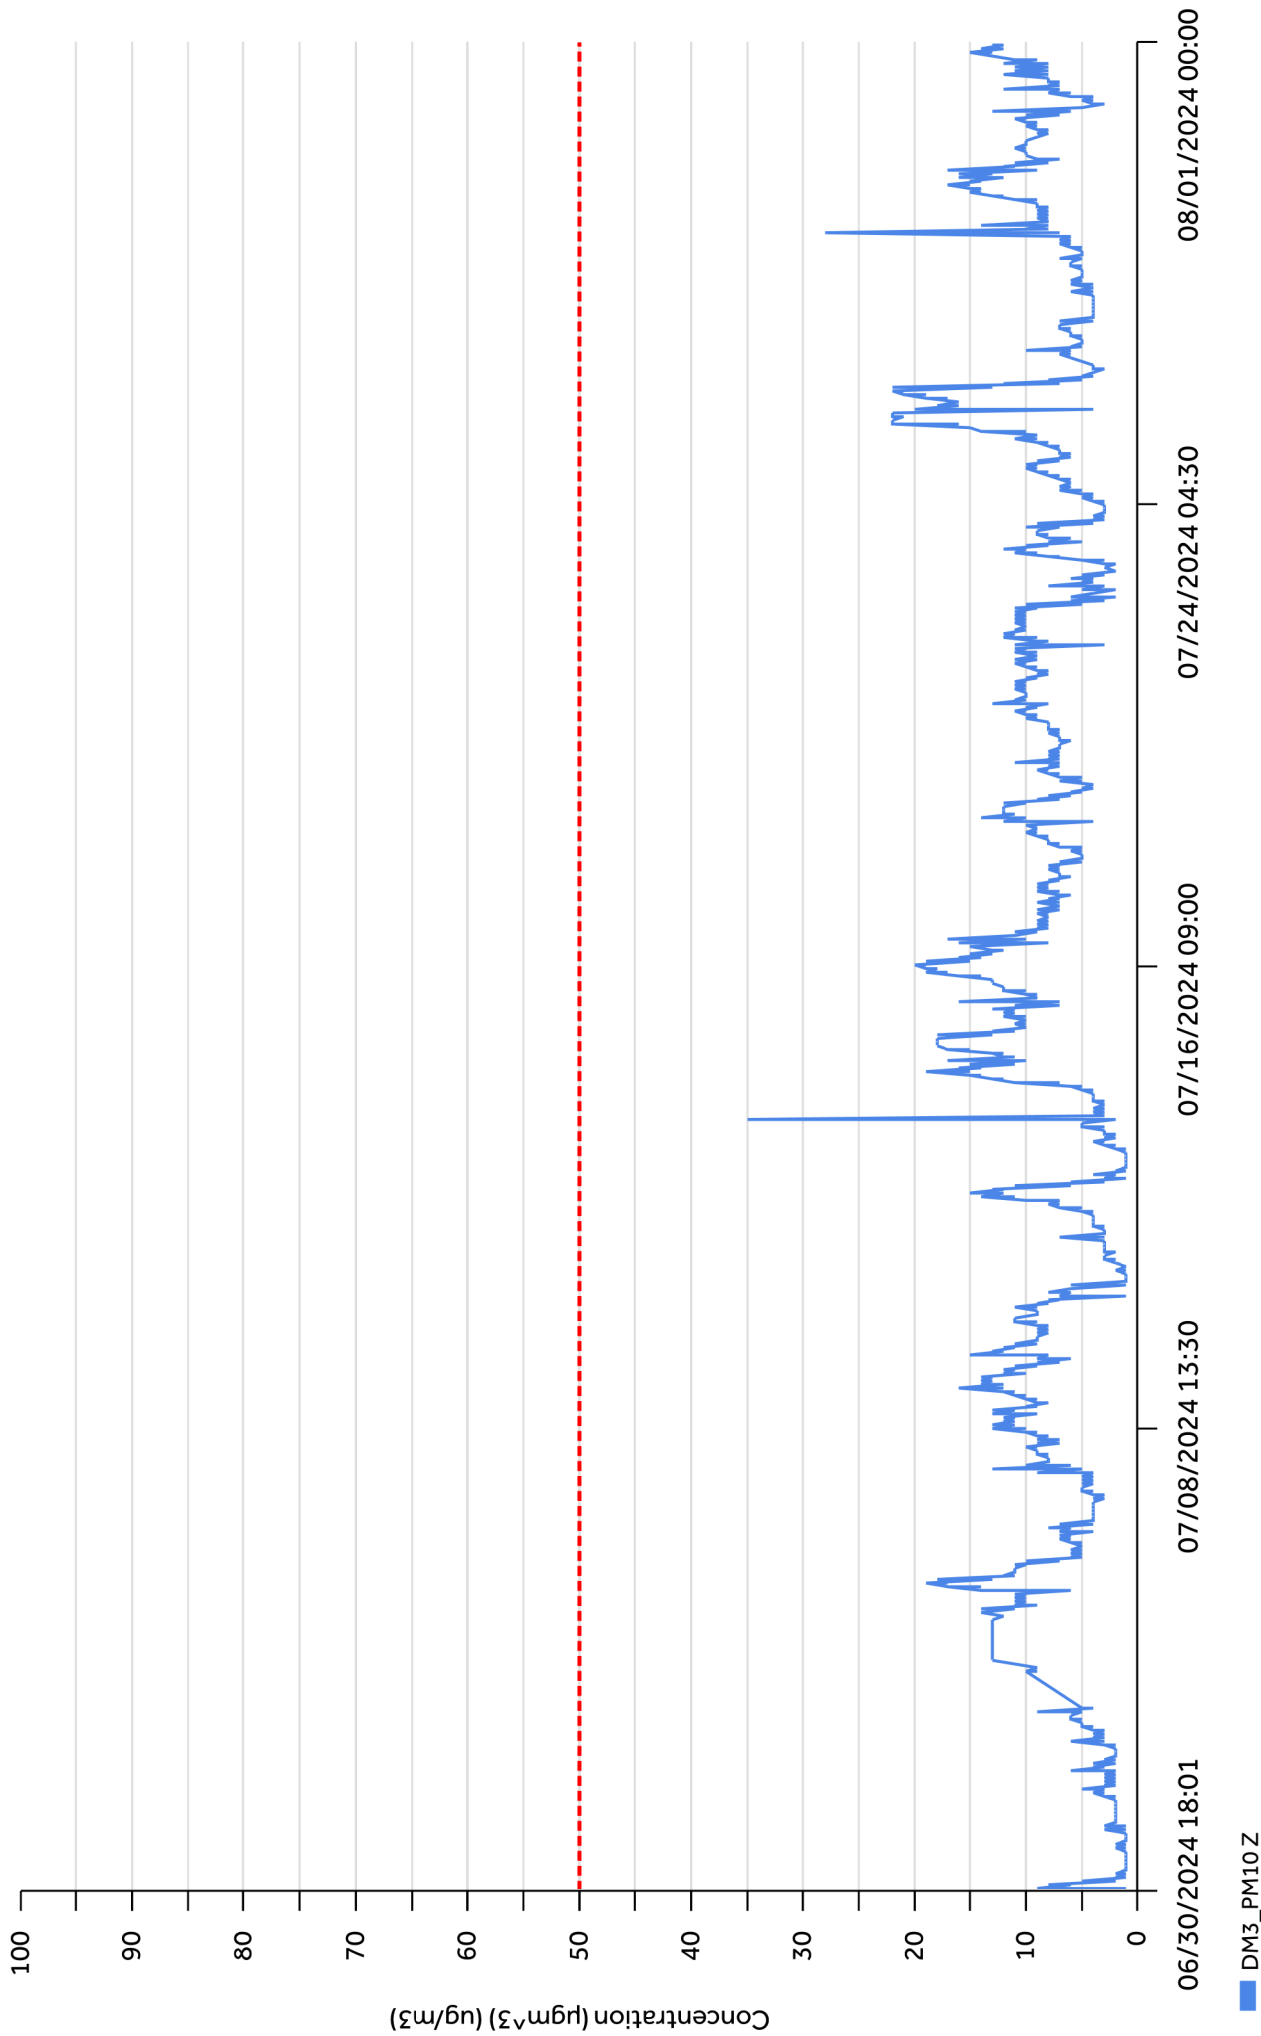
Graph 8

DM3 did experience power interruptions from 7/3 20:30 to 7/4 11:20 and again from 7/4 15:50 to 7/5 09:15.

DM3-PM10

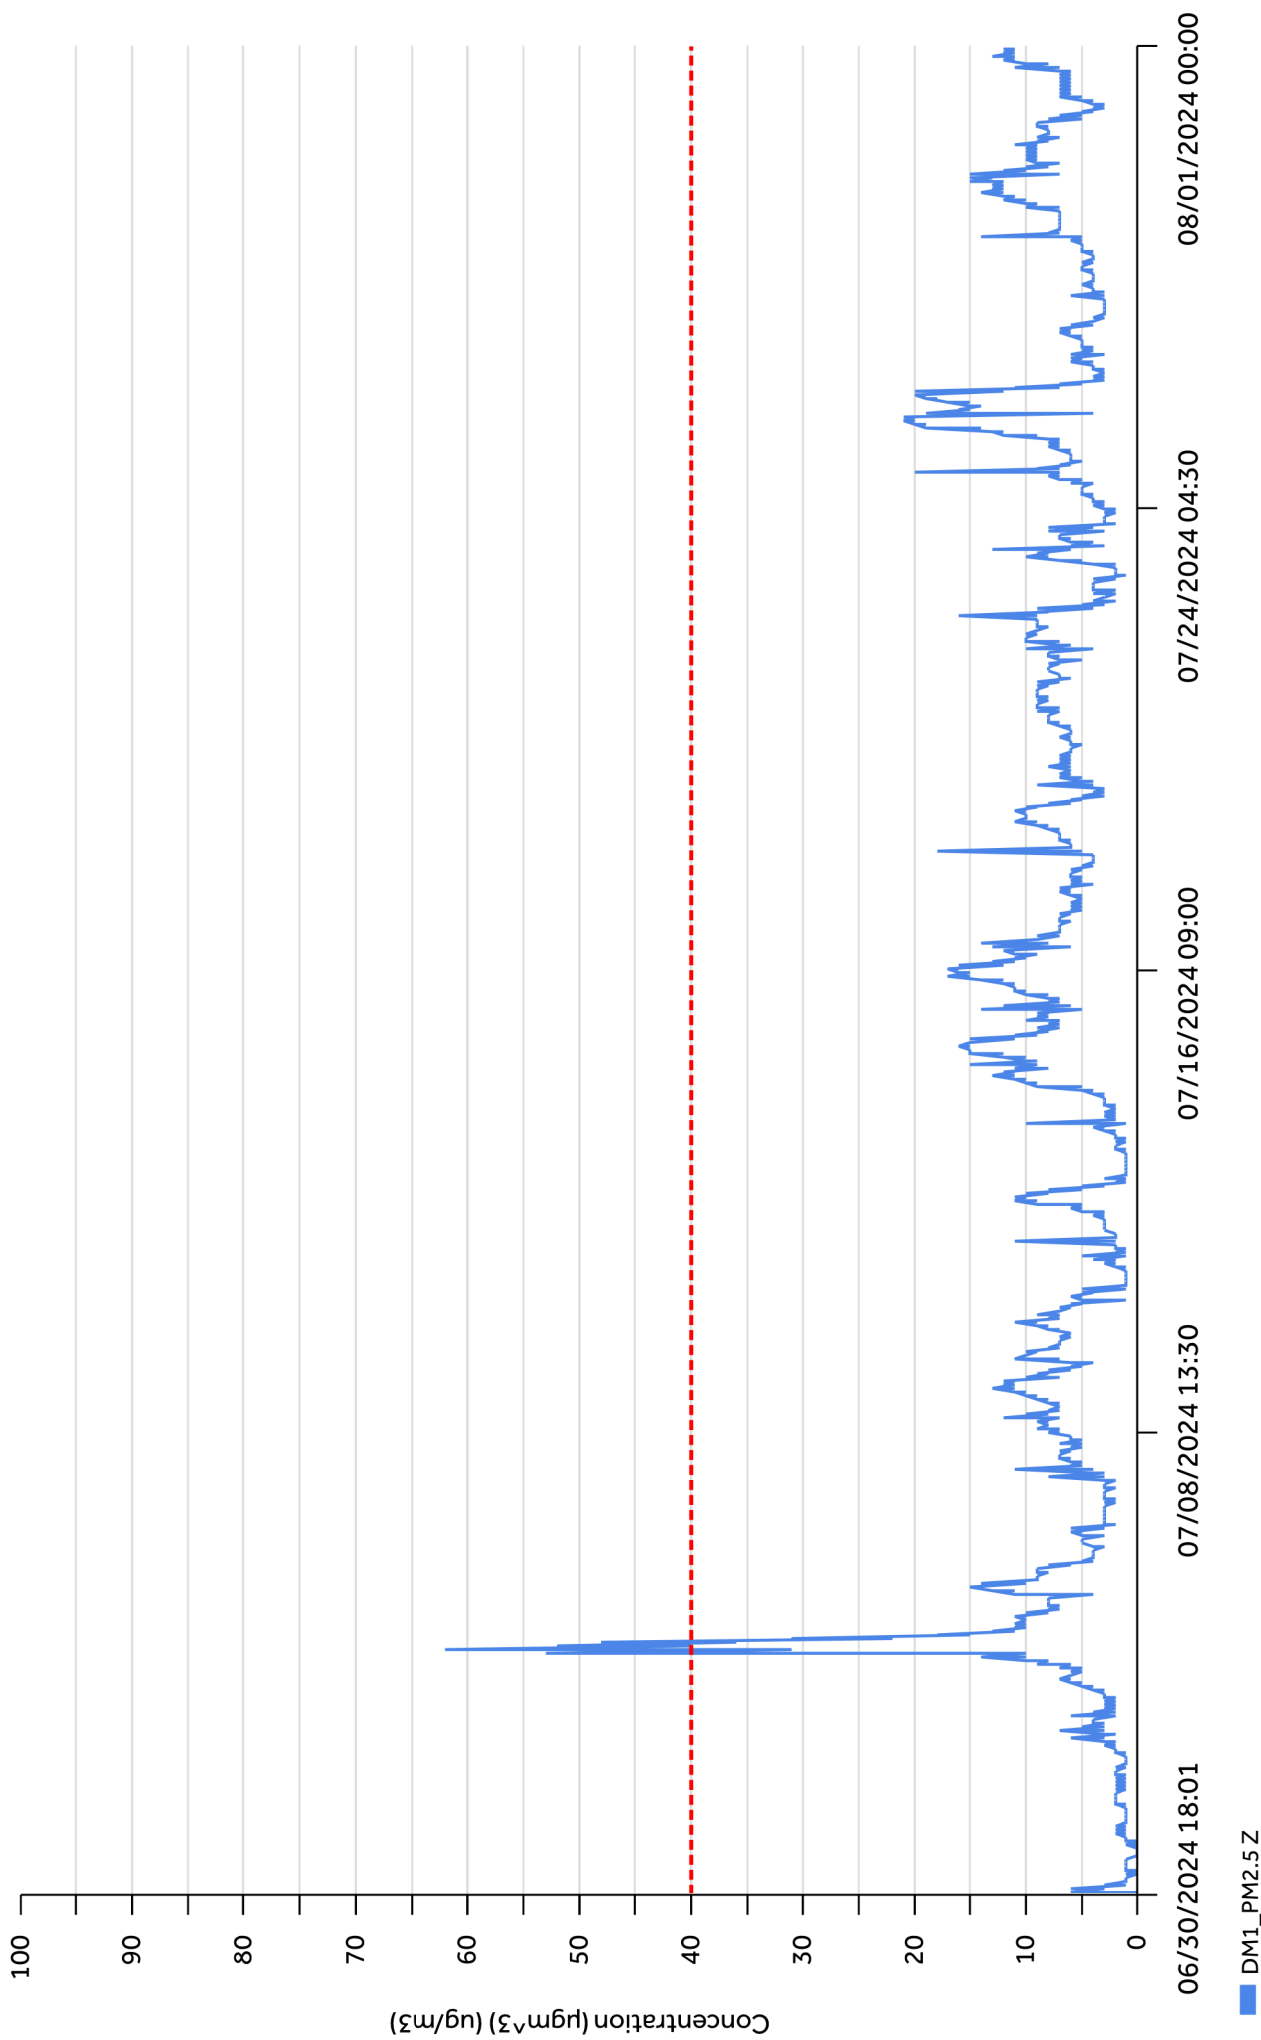
Graph 9

DM1-PM2.5
