Northern Bus Garage Replacement Project

Spring Community Meeting

May 9, 2023

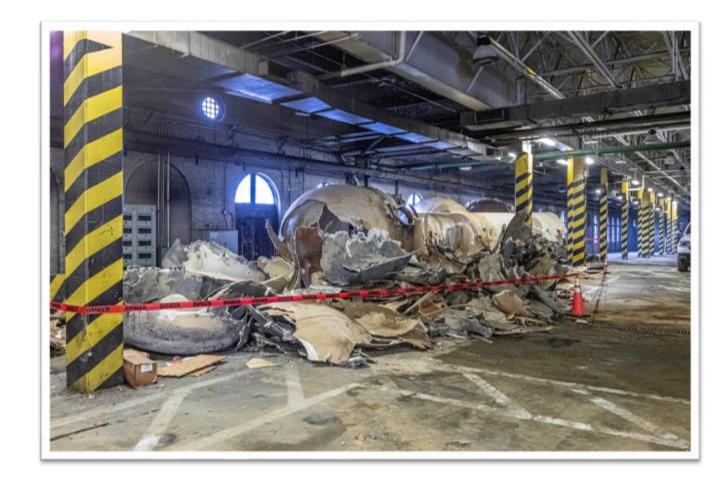
Construction

Q1 – Environmental Remediation

- Completed removal of underground and above ground storage tanks
- Removal of old bus maintenance and service equipment completed
- Completed regulated waste capture and removal
- Started asbestos abatement

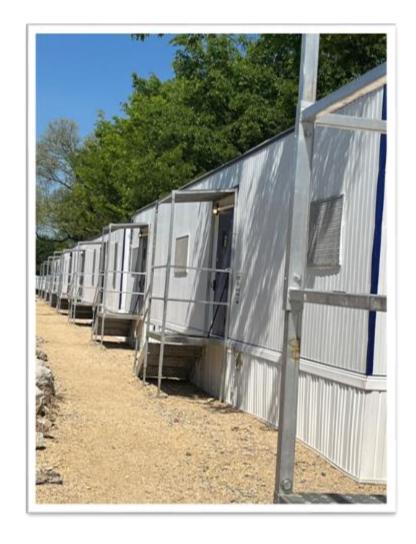
Construction

Q1 – Completed mobilization to the site

- Set up construction fencing, site security and Maintenance of Traffic around perimeter of site
- Set up construction field trailers along Arkansas Avenue
- Completed installation of noise & vibration instrumentation equipment, reporting data monthly

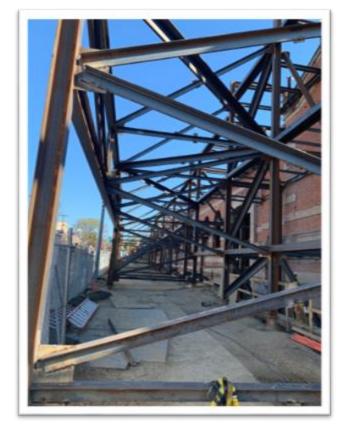
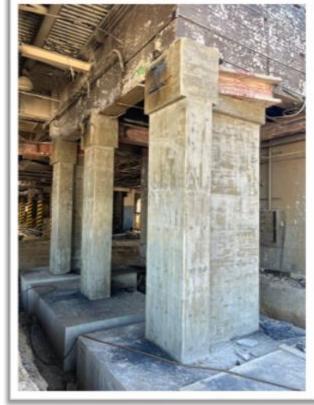
Construction

Q1 – Façade Bracing and Tower Re-support

- Completed deep foundations for and the installation of all façade bracing
- Completed new mini-pile foundations, concrete structures and tower jacking for tower resupport

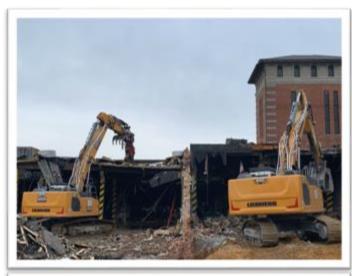
Construction

Q1 - Started Mass Demolition of Building

- Completed demolition of Decatur St. cover structure
- Completed utility disconnects
- Completed demolition of the former parking structure over bus storage
- Started hand separation at historic façade
- Over 98% of demolition waste is being repurposed

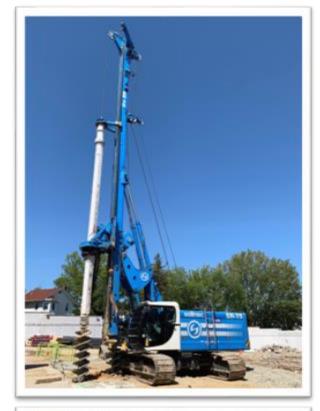
Construction

Q1 - Support of Excavation (SOE) and Soils Excavation

- Started Support of Excavation (SOE) pile installation east of the historic administration building
- Completed rock removal plan reviews
- Minor excavation began to support demolition

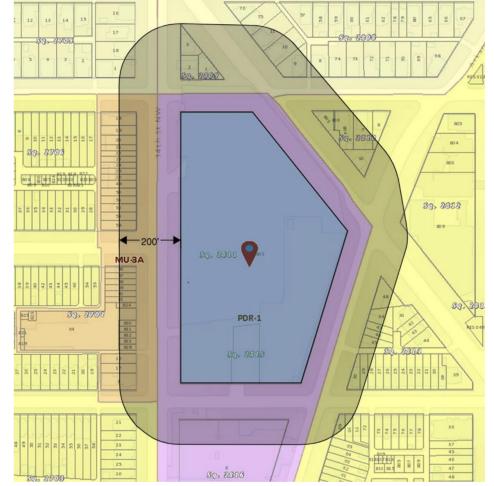
Preconstruction Survey Update

- Map shows an overlay with the properties that fall within 200 ft of the proposed new bus garage
- For more detailed information on the preconstruction survey, please visit https://wmata.com/initiatives/plans/northern-bus-garage/upload/Northern_June15_FlNAL_Slides.pdf (slides 29 33)

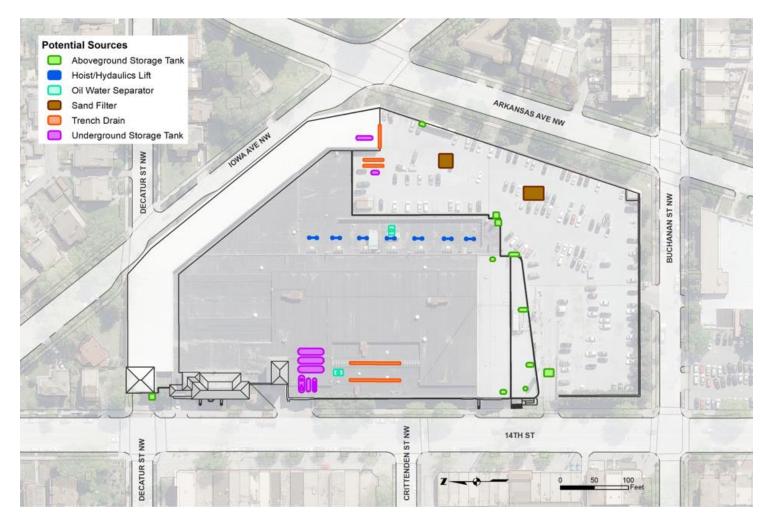
Potential Sources

- 1. Underground Storage Tanks (USTs)
- 2. Chlorinated Solvents
- 3. Other materials

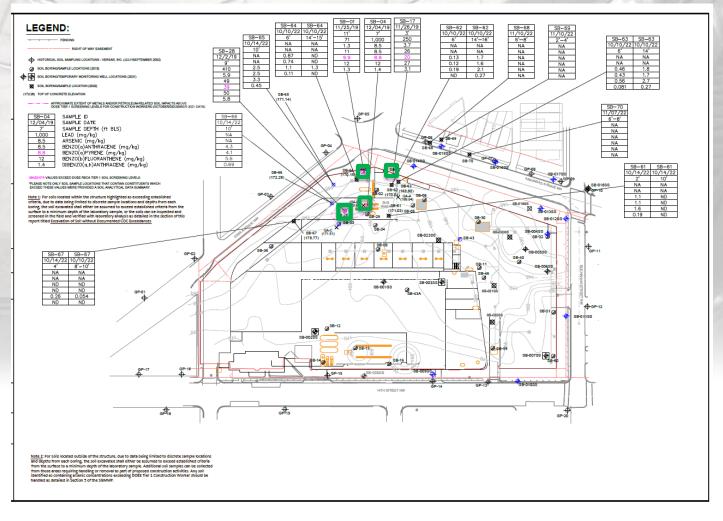
Soil Results (Fall 2022)

Petroleum

Chlorinated Solvents

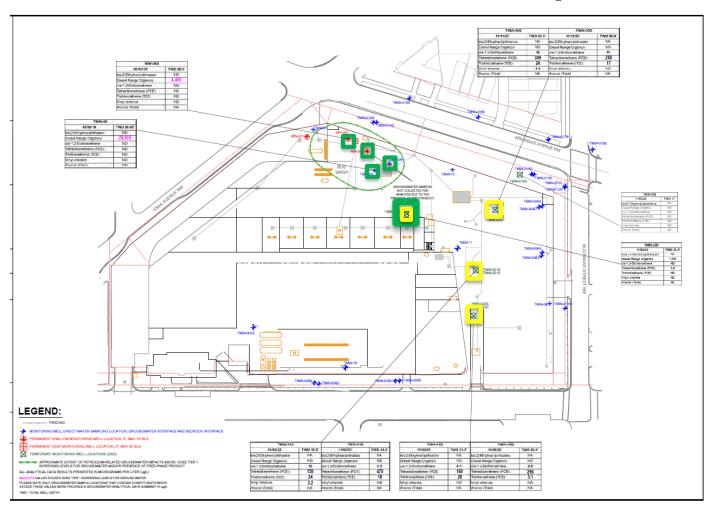
Groundwater Results (Fall 2022)

Petroleum

Chlorinated Solvents
