A PEER REVIEW

Washington Metropolitan Area Transit Authority

JULY 2016

**REPORT
OF THE
NORTH AMERICAN TRANSIT SERVICES ASSOCIATION
PEER REVIEW PANEL
ON THE
THIRD RAIL POWER & INFRASTRUCTURE
PROVIDED AT
WASHINGTON METROPOLITAN AREA TRANSIT
AUTHORITY**

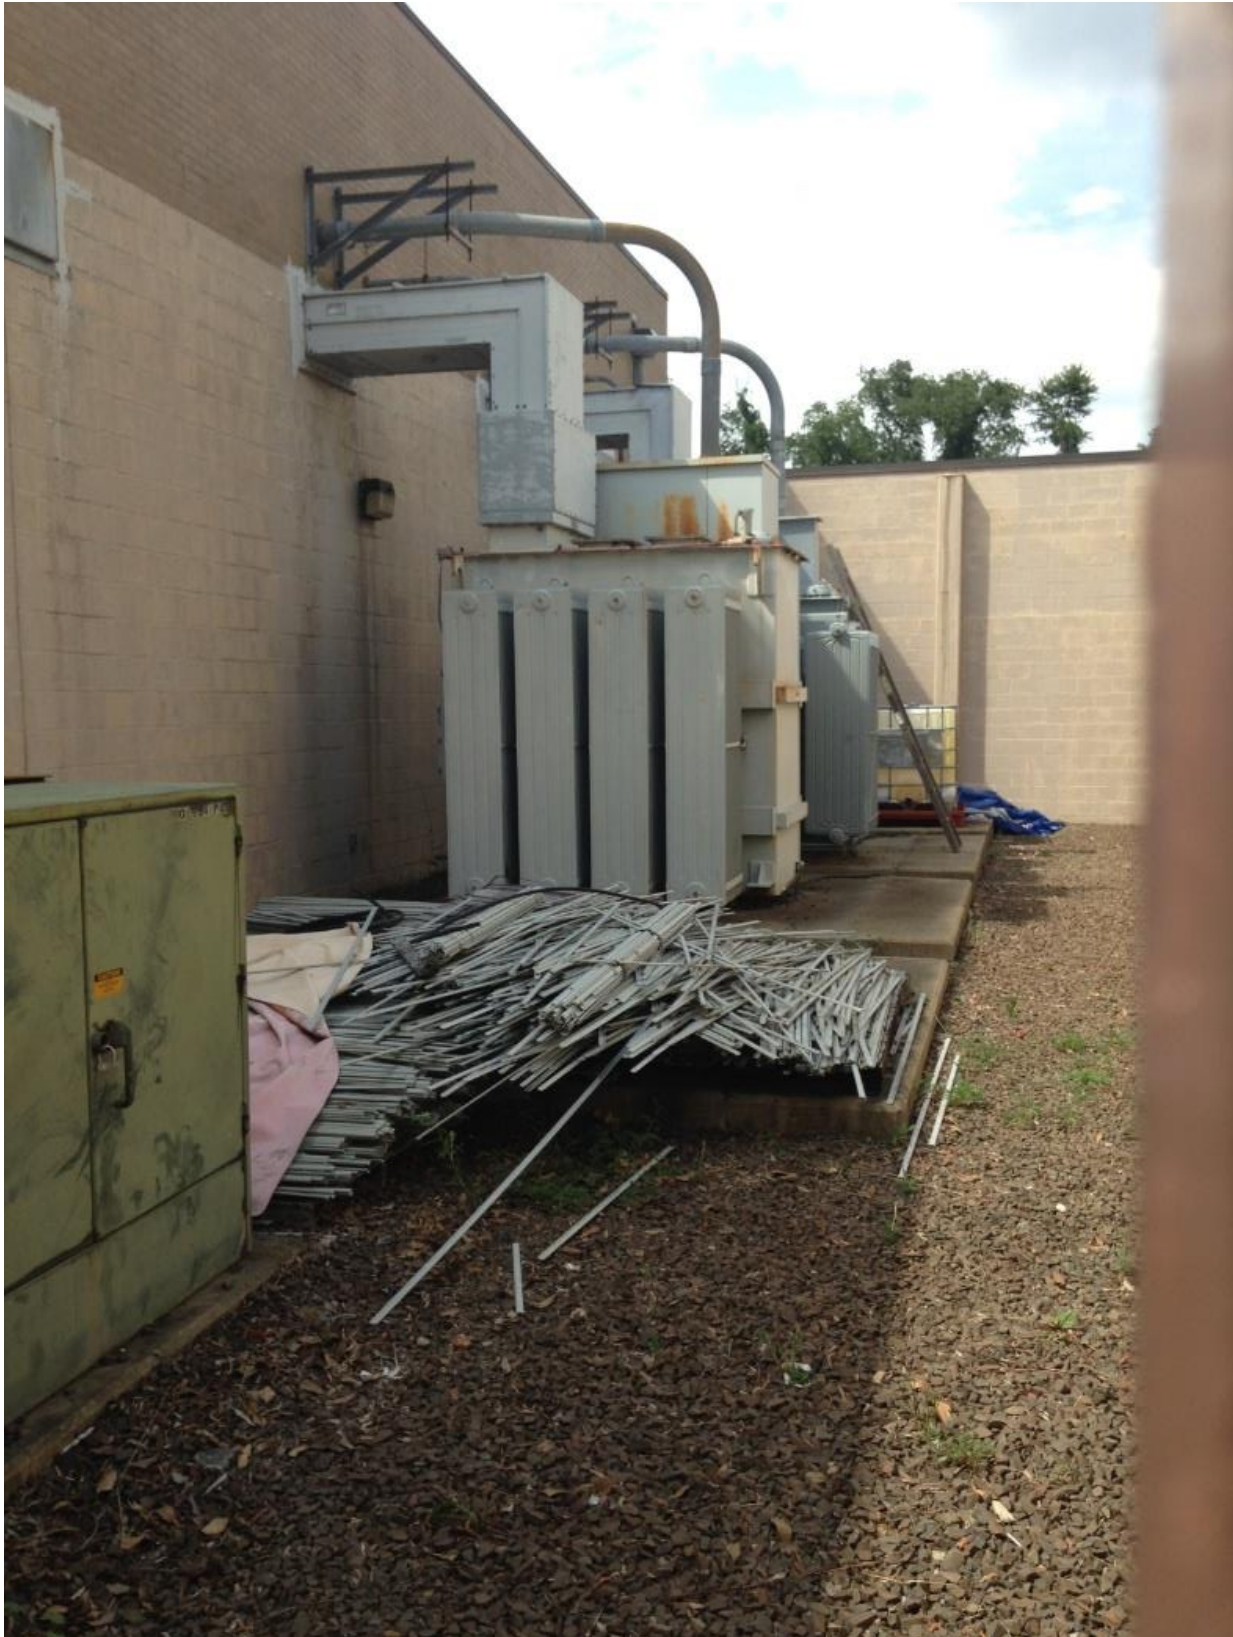
Photo 1: Traction Power Substations Housekeeping

A site visit to one of the traction power substations found debris was staged with tape material stored outside the room next to a transformer currently out of service. Breakers on floor were racked out for line-up out of service. Breakers removed for extended periods are preventative maintenance checked prior to being put back in service. (See Photo 1)

- i) Housekeeping of traction power substations (TPSS) needs to be improved.
- ii) Ensure that substation equipment is free from dust.
- iii) Remove any unnecessary debris/equipment not relevant to DC Traction power substation.
- iv) Properly protect circuit breakers that are racked out of the switchgear.
Dust, dirt and debris on the breaker could potentially lead to equipment failures and arcing within switchgear.
- v) The use of plastic sheeting to protect the gear from roof leaks should be discouraged.
- vi) Building infrastructure should also be included in preventative maintenance cycles.
- vii) WMATA to verify that TPSS preventative maintenance procedures being performed meets industry standards and best practices.

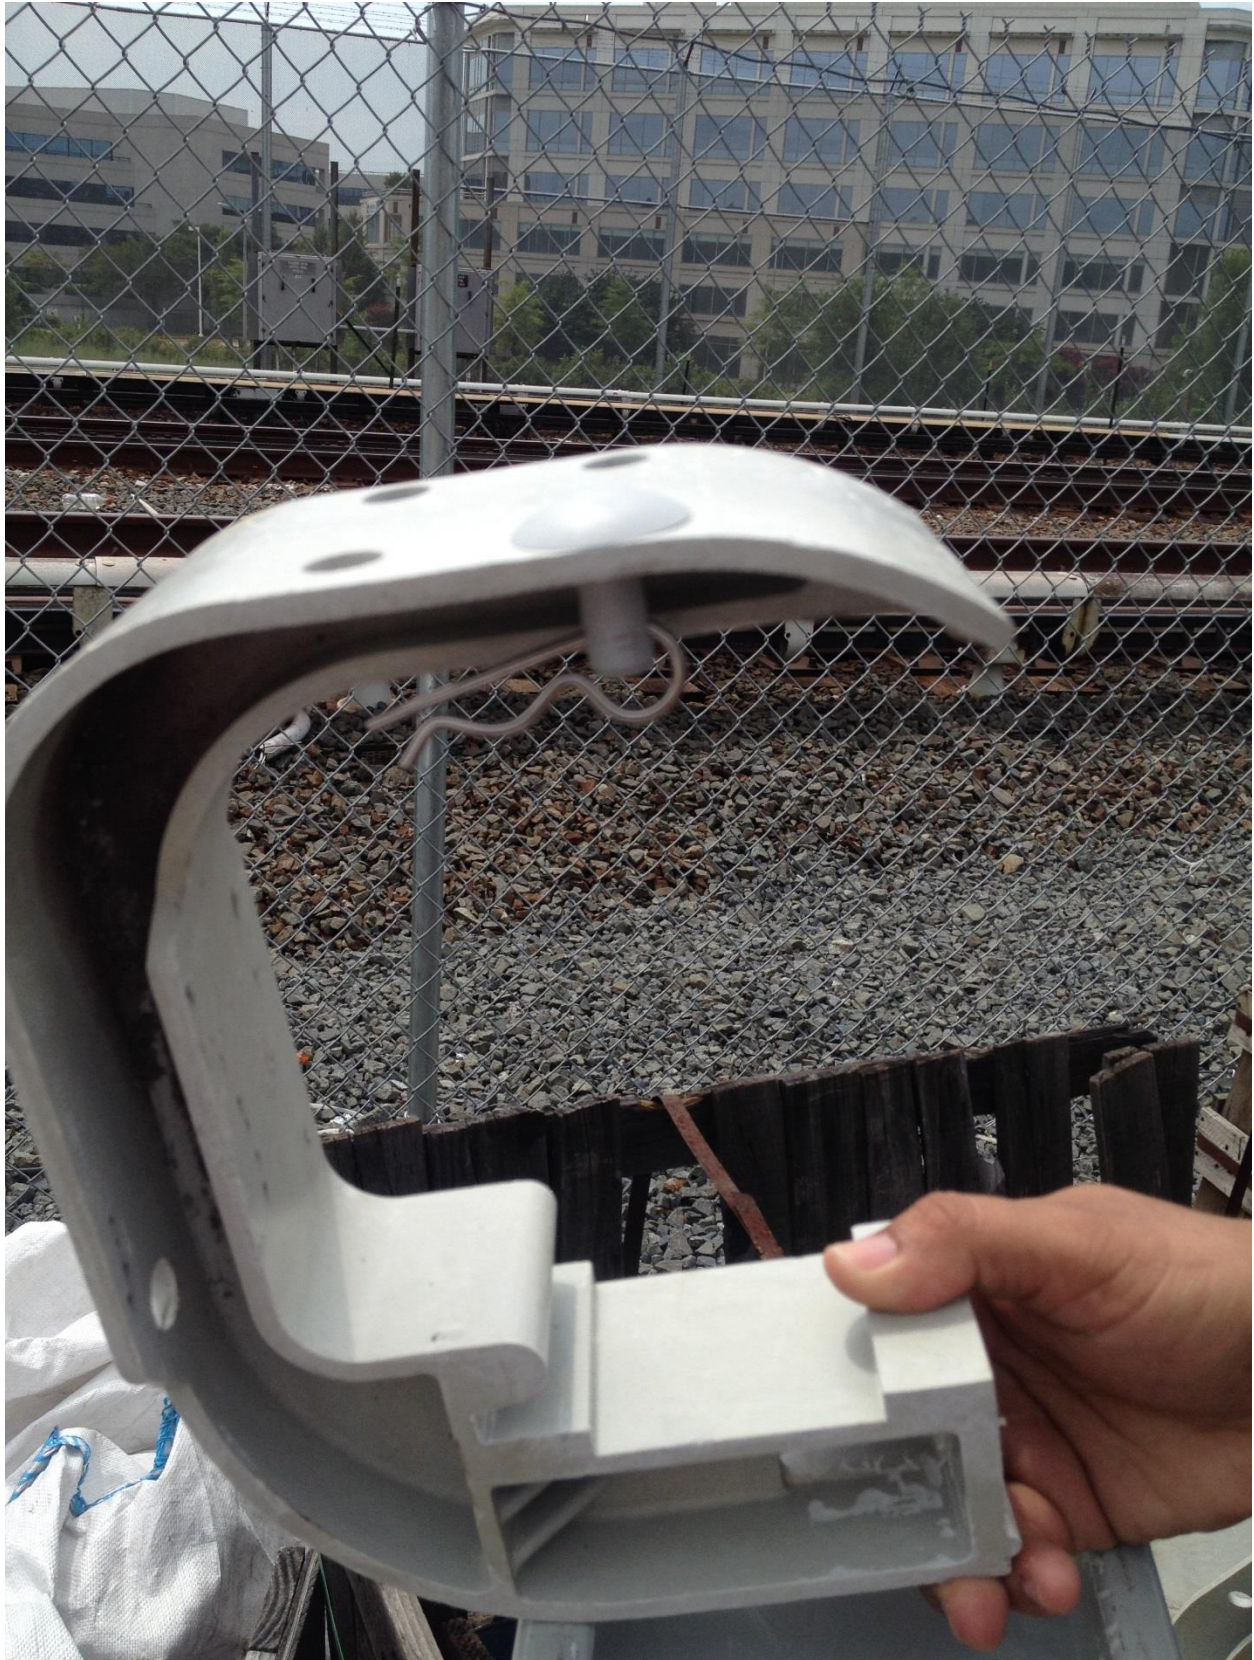
Photo 2: Third Rail Cover Board Securement Assembly

The team's visual observations of sample cover board assemblies with regards to securement are considered adequate. The method of securing these cover boards is with a mushroom type button threaded from the top of the cover board and fastened with a cotter pin under the board. While this method is considered adequate, it does pose difficulties when carrying out inspections to verify that the cotter pin is in place and secure. Some agencies have the mushroom button threaded from under the board and secured with a nut on top. (See Photo 2 for traction power cover board securement assembly). We also found several areas where cover boards were missing.

- a) Verify that all traction power third rail cover boards are made of low smoke zero halogen materials in accordance with NFPA³ 130.
- b) Identify the causal factors why several cover boards are failing and have a plan to address issues.
- c) Research alternative means of securement of cover boards in order to facilitate inspection of the securement method.

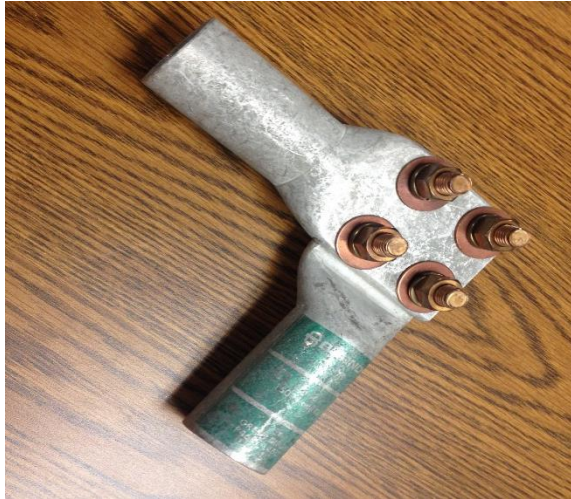
Photo 3: Orange Boot

WMATA has used the 'Orange Boot' design for connecting the feeder from the traction power substation and the jumper cables to the web of the third rail. This design has been used extensively for many years. (See Photo 3 for picture of the boot).

- a) Orange Boot
 - i) Re-evaluate the use of the orange boot design and consider alternative third rail termination points.
 - ii) Consider using multiple smaller conductors to connect feeder and jumper cables to the web of the contact rail which may allow for greater flexibility and less stress on the point of connection.
 - iii) Consider the use of a bolted ERICO exothermic connection (Type QV/LS) or similar due to the lack of track side disconnect switches.

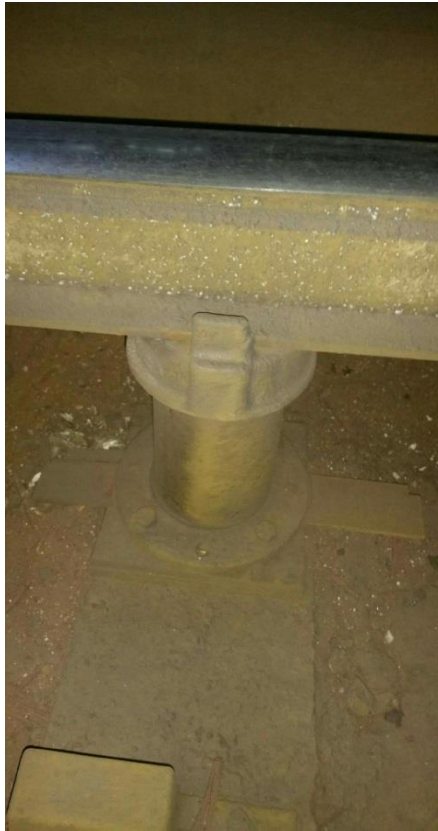
Photo 4: Cleaning of Third Rail Insulators

Third rail insulators were found to be excessively contaminated in the yard and on open deck areas. Soiled insulators result in a higher likelihood of arcing and a point of failure. (See Photo 4 for a cleaning method employed by one transit agency).

Example of how one transit agency cleans their third rail insulators with traction power switched ON.

Dirty insulator

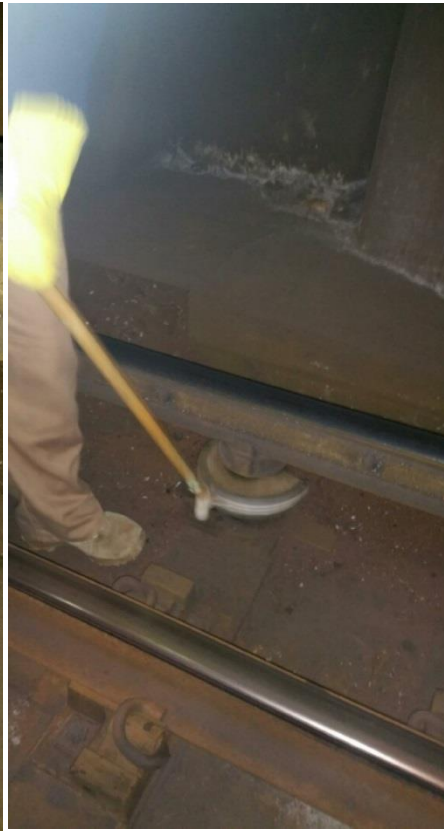
Brushing insulator

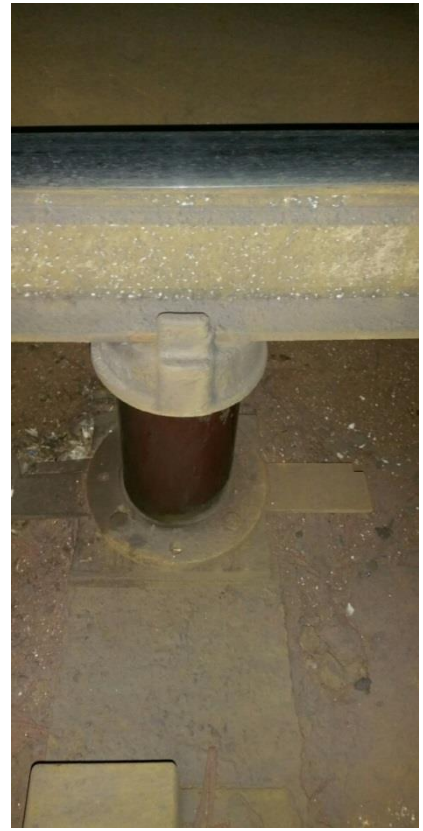
Insulator cleaned and dried

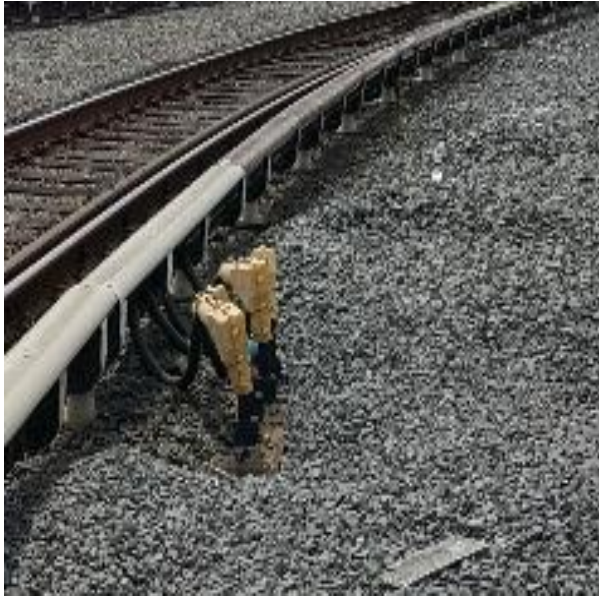
Photo 5: Photos taken at Alexandria Yard Facility from the Parking Lot

Yard curve with cover board and boots showing wear/age possibly UV issue.

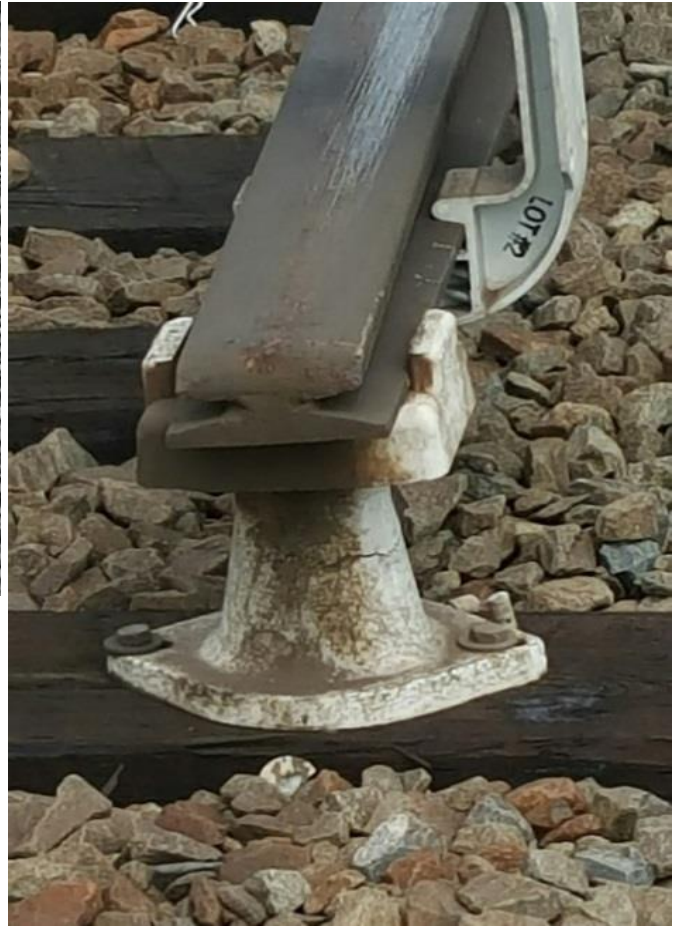
Third rail end with cracked insulator – possibly load imbalance due to curve.

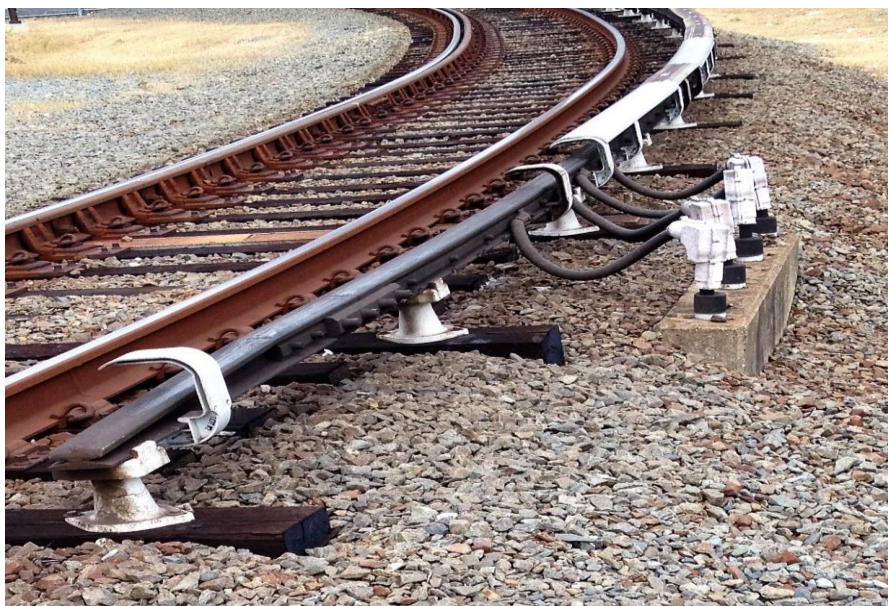
Shows missing cover board and connection.

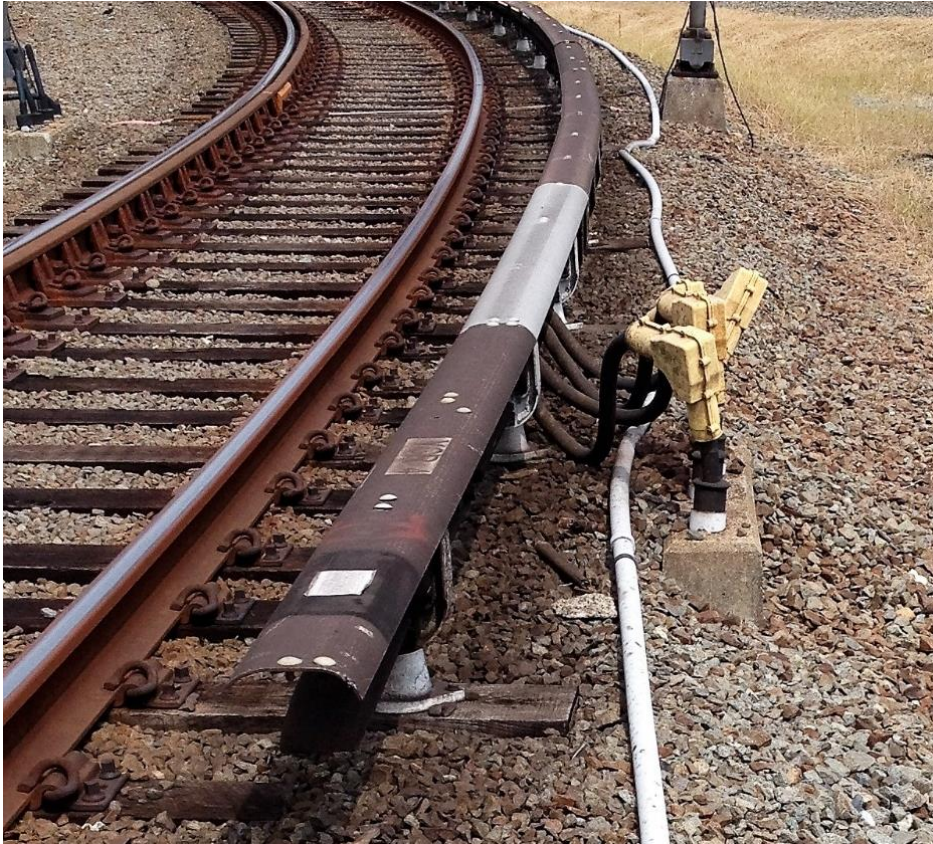
Photo 5 continued: Photos taken at Alexandria Yard Facility from the
Parking Lot

Shows boots and
how they leave
duct. Some
droop-weight can
cause weakening
over time due to
heat.

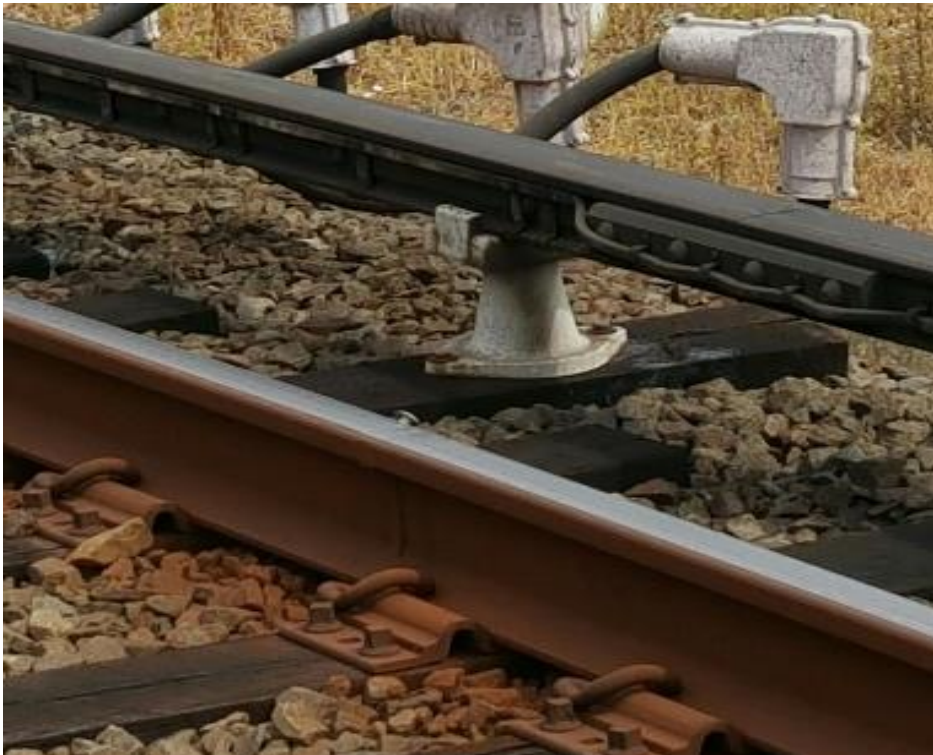
Third rail
heat and joint
bars.

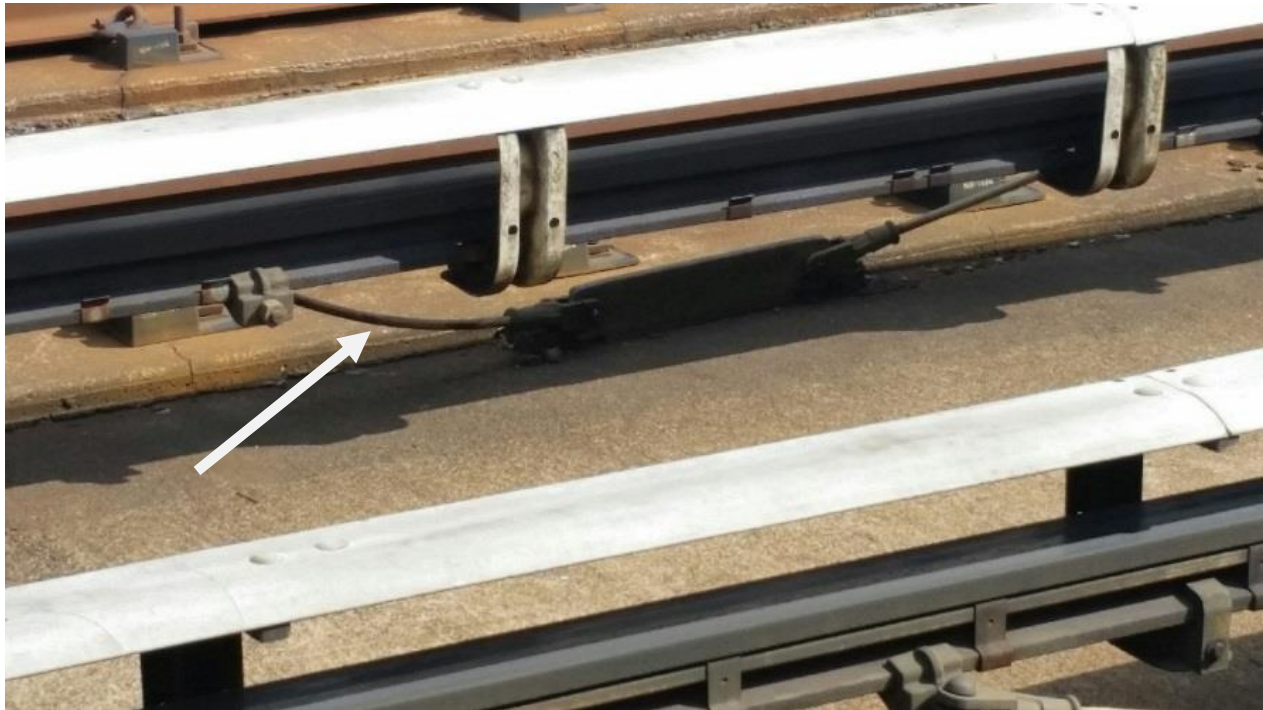
Photo 6: Photos taken from Alexandria Station Platform

Contact rail anchor improper installation, anchor is bowing due to improper placement of connection on third rail.

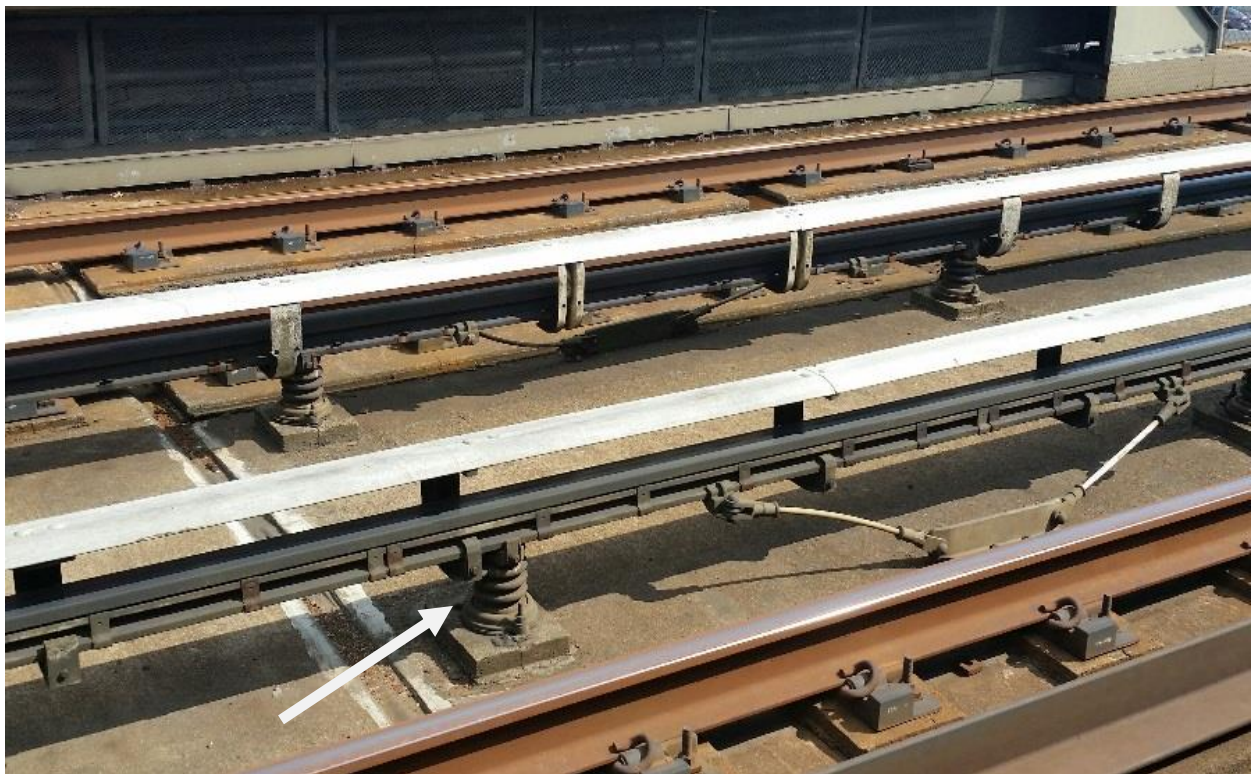
Dirty insulator.

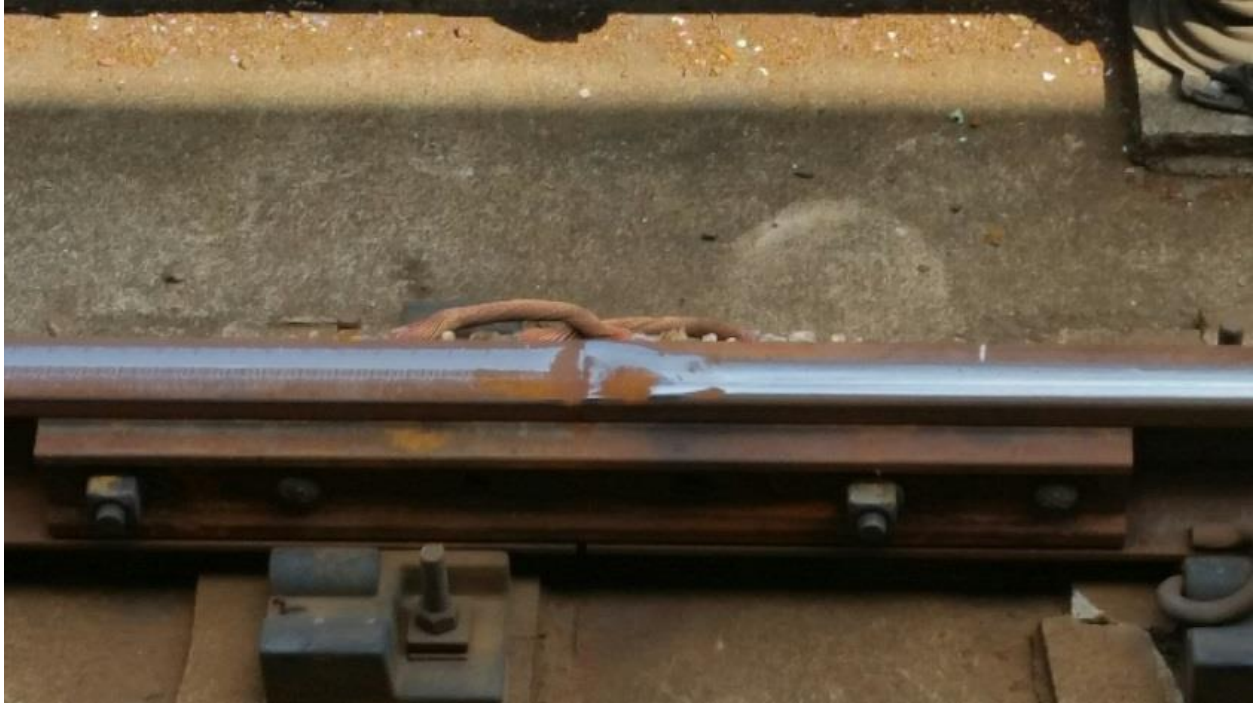
Photo 6 continued: Photos from Alexandria Station Platform

Running Rail Joint "C" bond, appears to be in good condition.

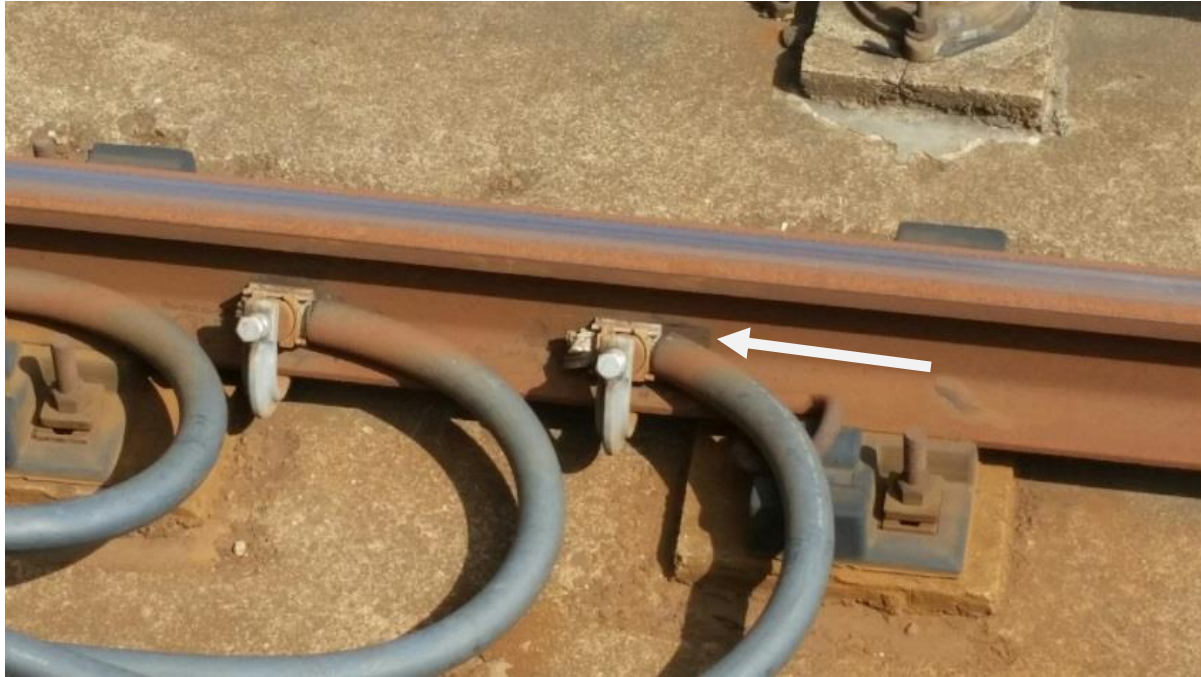
Photo 6 continued: Photos from Alexandria Station Platform

Signal cable clamped to rail, appears to have been in place for extended period of time. One clamp shows movement on rail.

Re-evaluate the suitability of clamps for use in any cable termination. The peer review team noted that clamps could become loose over time and continuity could be lost due to corrosion. The Polidori Clamps used to attach the ATC (Automatic Train Control) cables to the running rail should only be used for short term correction of deficiencies, until time is available to install a permanent bond to the rail. The loosening of the clamp and corrosion of the connection contribute to stray current corrosion and negatively impact traction return and track/signal circuits.

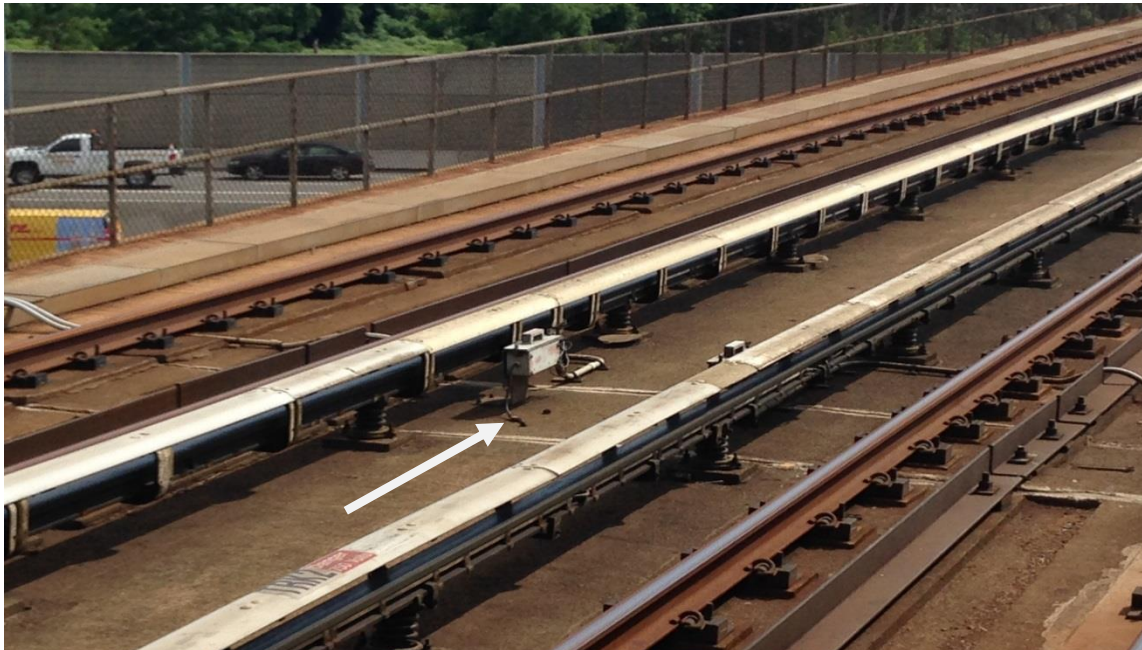
Photo 7: Cable Connection Issues

The third rail connection to the heater control panel is off the rail.

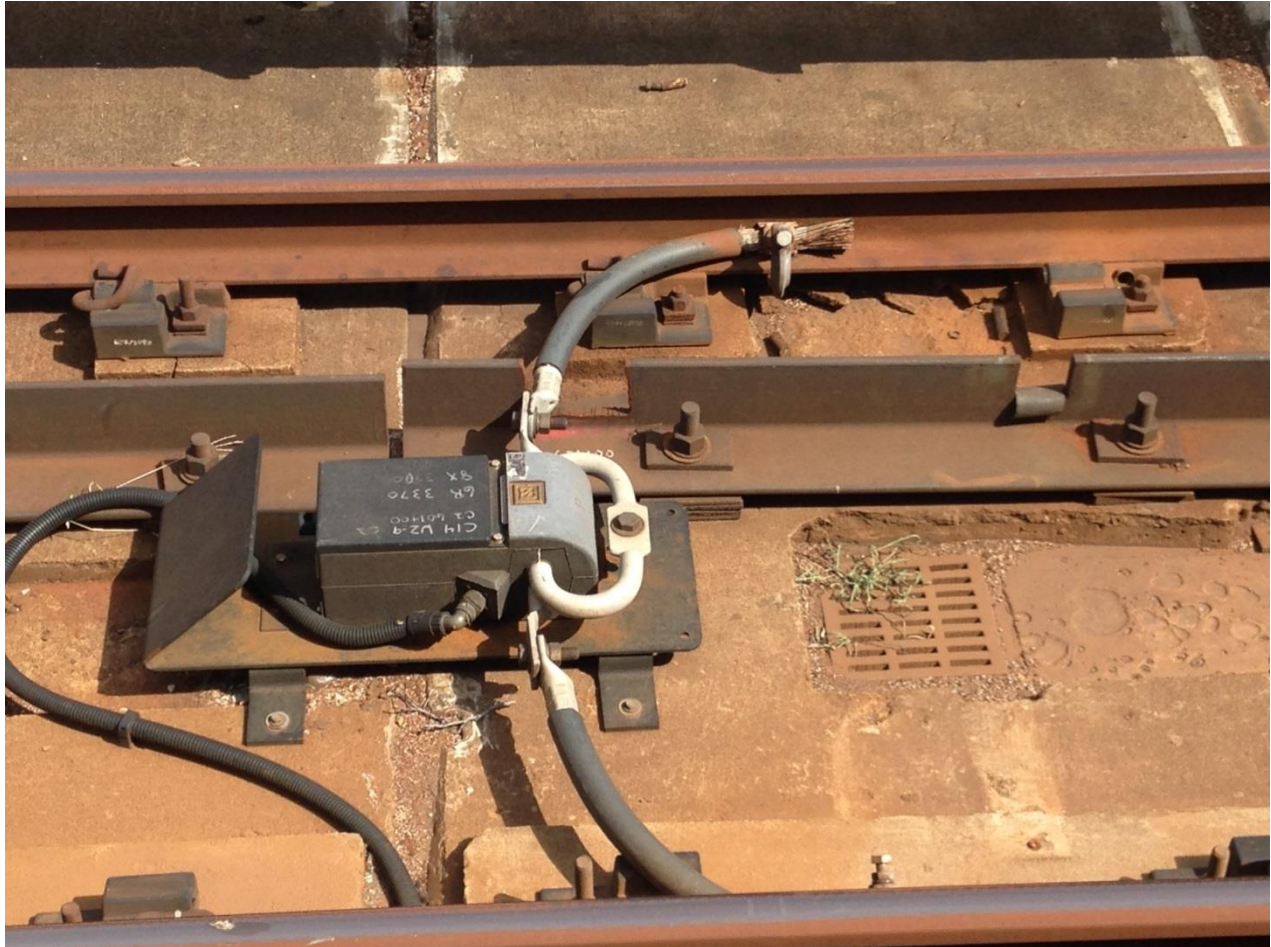
Photo 7 continued Cable Connection Issues

The impedance bond cable, which appears to have been short to begin with, was moved forward in the Polidori Clamp making it even shorter thereby further limiting the cable to move with the thermal expansion joint.
