Update on January 15, 2018 Derailment

Washington Metropolitan Area Transit Authority

Derailment: January 15, 2018

Farragut North Station

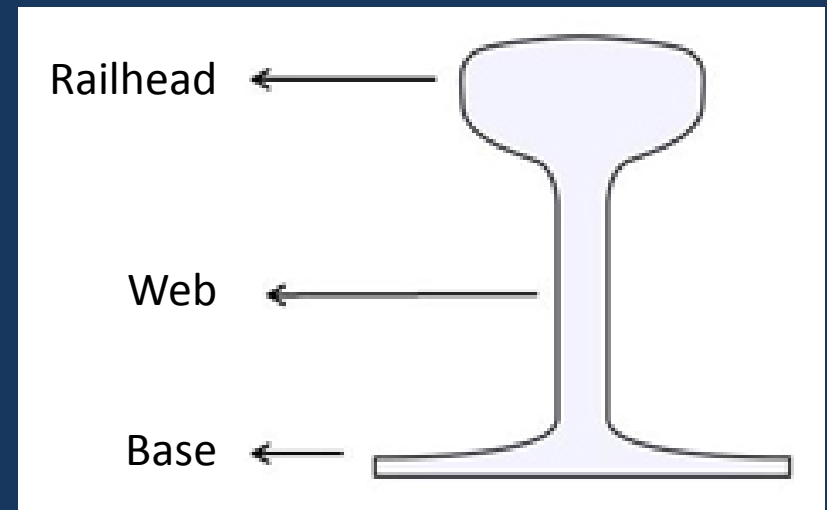
Common Causes of Rail Defects

- Base of Rail Corrosion
- Rail Surface Defects
- Rail Wear
- Fastener Deterioration/Poor Support
- Track Geometry Conditions
- Weather (Temperature)
