Collector Shoe Assemblies Update

Washington Metropolitan Area Transit Authority

Safety & Operations Committee
March 7, 2024

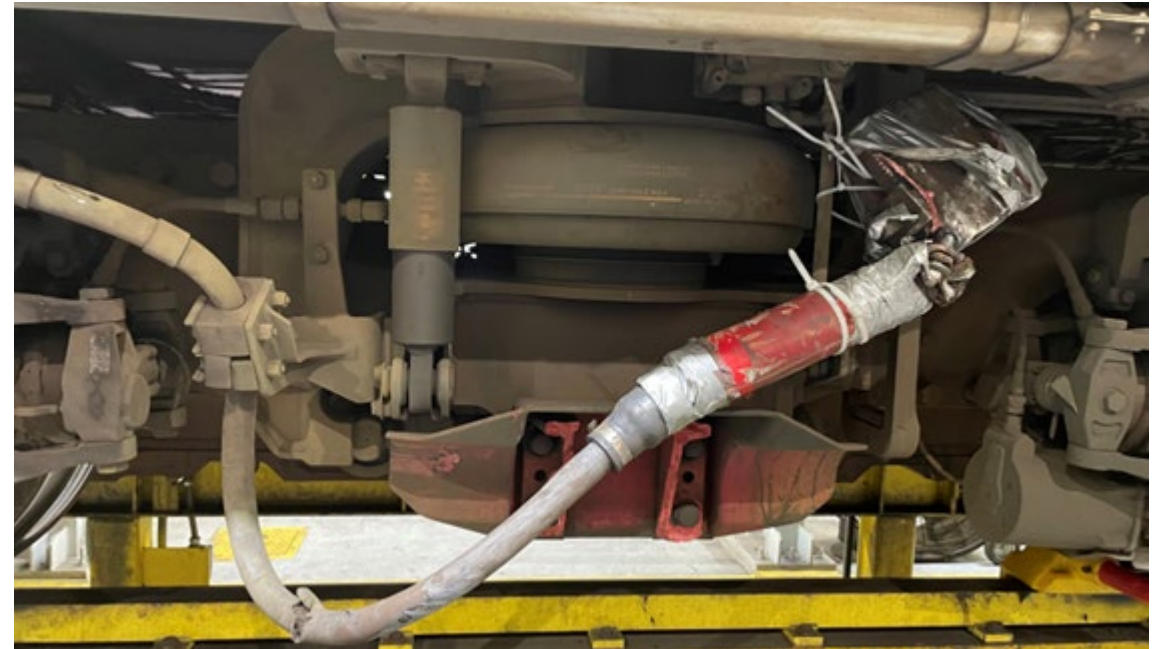
Eastern Market Incident on Feb.15, 2024

- Collector shoe assembly (draws electric power to the train by contacting third rail) dislodged
- Dragged and grounded causing second collector shoe on same railcar to fail in station limits
- Resulted in smoke and fire
- Rail Operations and Metro Transit Police personnel immediately evacuated the train and station

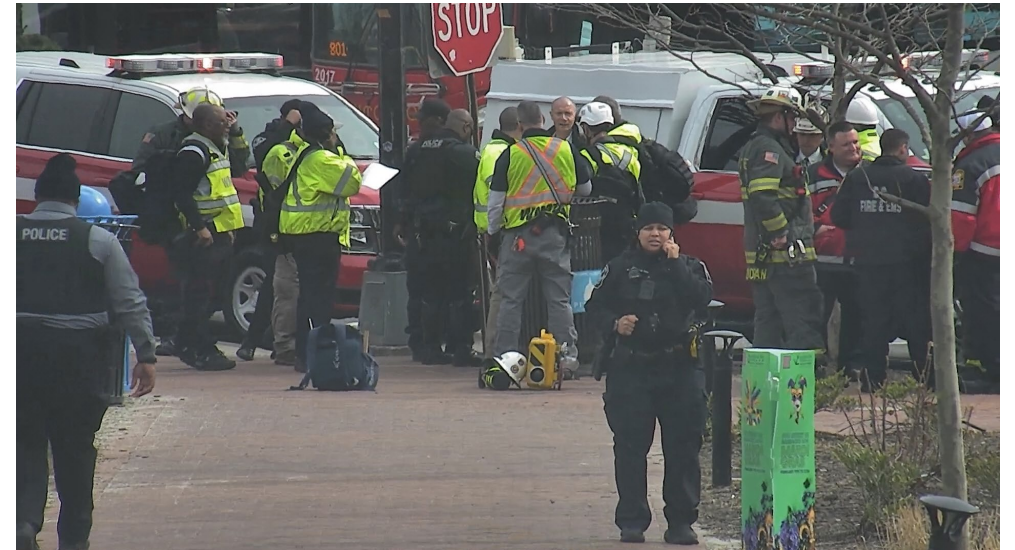
- Multi-agency after-action review conducted on February 23
- Unified incident command established between DC Fire, Metro Transit Police, and Metropolitan Police departments
- Incident command coordinated well with the Metro Integrated Command and Communications Center
- Rapid evacuation of customers from the train and station
- Fans were activated as per procedure
- Opportunities to improve:
 - Radio communications
 - Continued maturation of Incident Management Framework
 - Enhanced ventilation fan training for fire departments

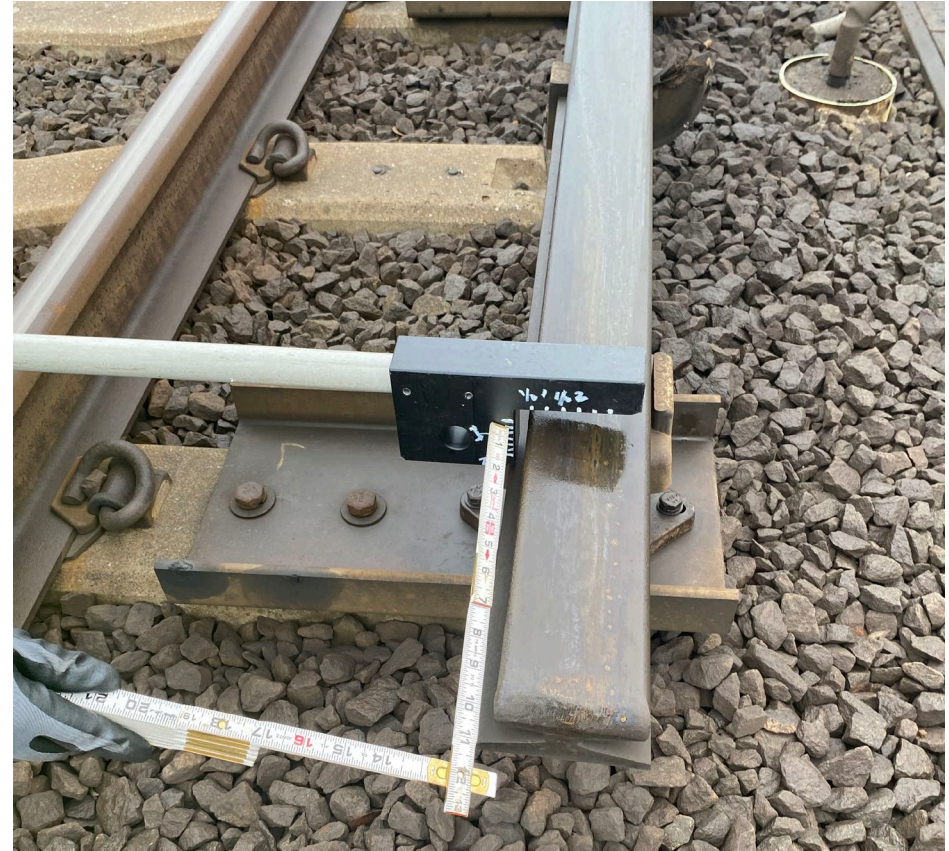
- Debris fire
- Collector shoes found on tracks
- Track height anomalies

- Clean track bed to remove trash
- Look for missing collector shoes during daily inspection
- Measure and correct track heights
