Union Station – Train Separation Event October 9, 2020

Preliminary Investigation
Briefing
October 22, 2020

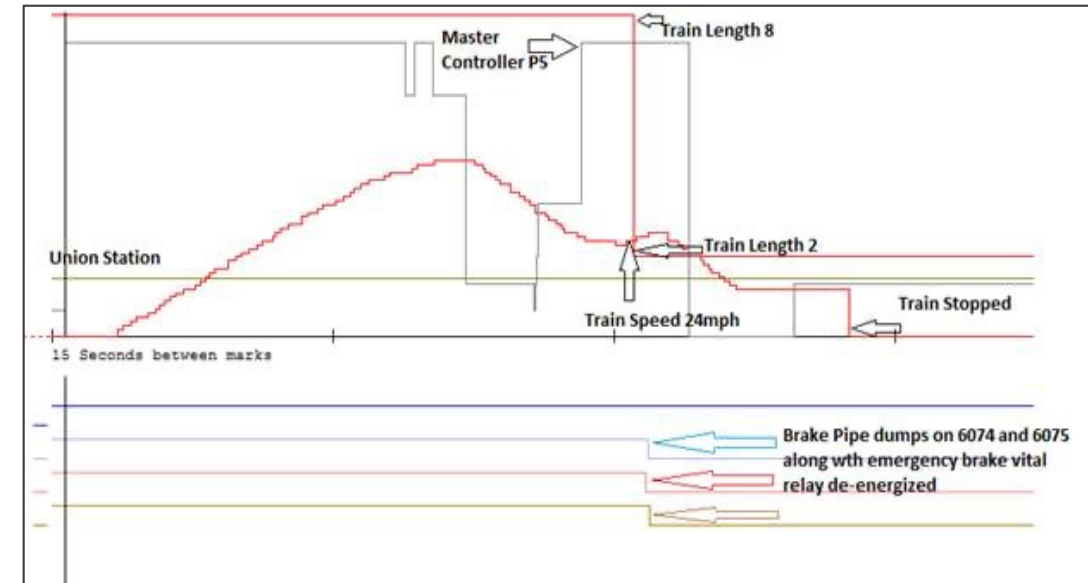
Event Recorder (ER) Data Graph/Sequence of Events

- Data does not show any abnormalities with train operations that could result in this incident
