**Dulles Metro Silver Line Concrete Panel Assessment  
Innovation Center Station Precast Inspections**  
Herndon, Virginia

**DeSimone Consulting Engineers**

Report Issued: August 24, 2020

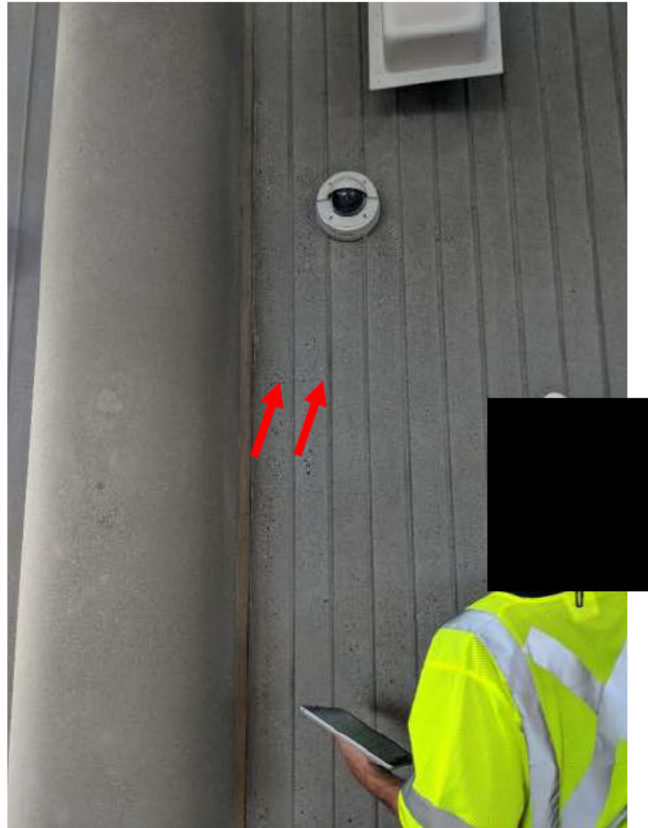
Figure 21: Exterior face of Panel 107. Source: DeSimone.

Figure 17: Crack at exterior face of Panel 107. Source: DeSimone.

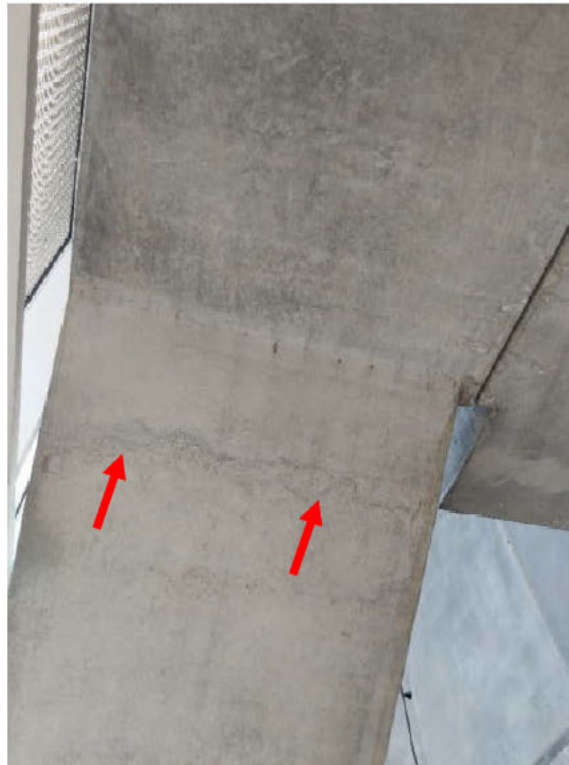
Figure 22: Underside of Panel ST-4. Source: DeSimone.

Figure 18: Crack at underside of Panel ST-4. Source: DeSimone.

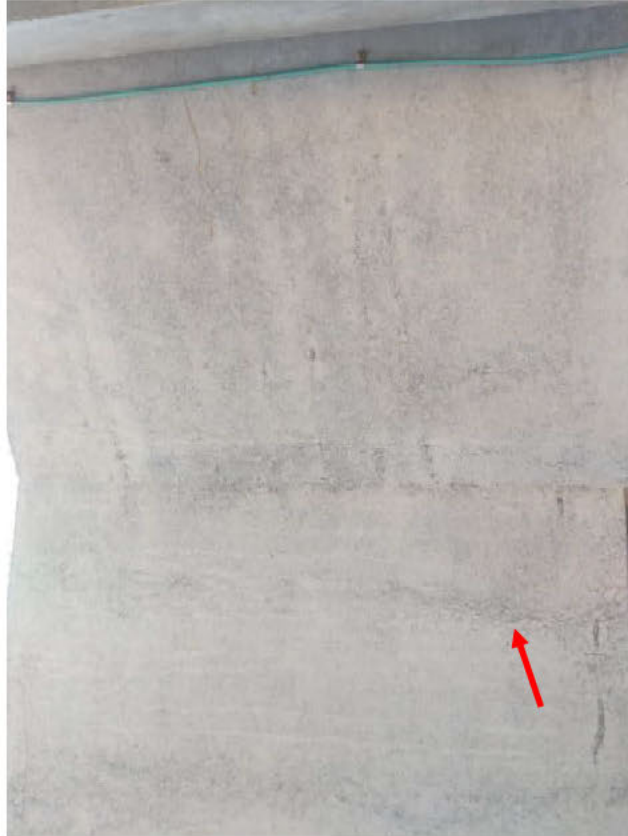
Figure 23: Underside of Panel ST-2. Source: DeSimone.

Figure 19: Crack at underside of Panel ST-2. Source: DeSimone.

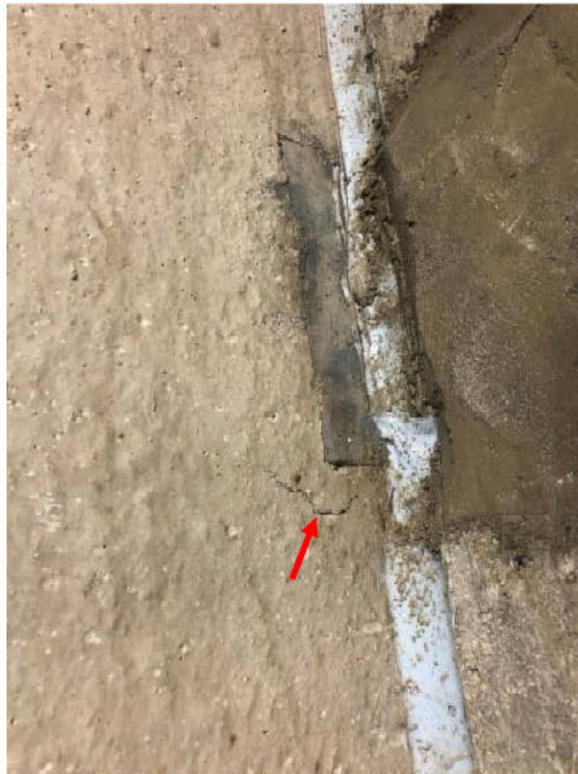
Figure 24: Interior face of Panel 1404. Source: DeSimone.

Figure 20: Crack at Interior face of Panel 1404. Source: DeSimone.

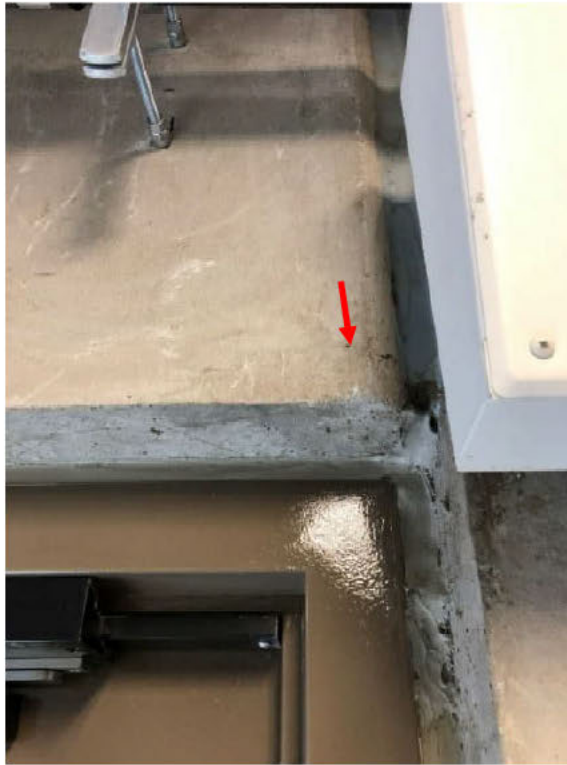
Figure 25: Interior face of Panel 1404. Source: DeSimone.

Figure 21: Crack at separate region of interior face of Panel 1404. Source: DeSimone.

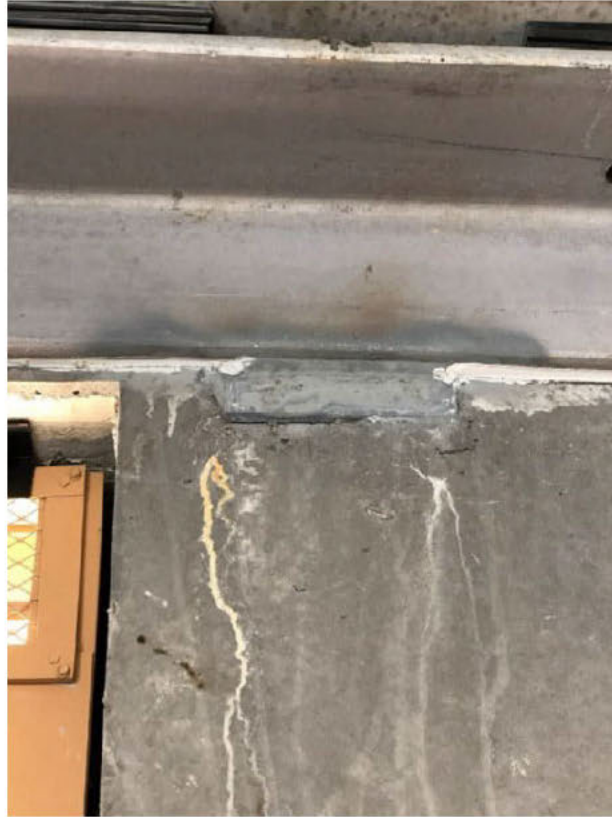
Figure 29: Interior face of Panel 1901. Source: DeSimone.

Figure 27: Chipped concrete at interior face of Panel 1901. Source: DeSimone.

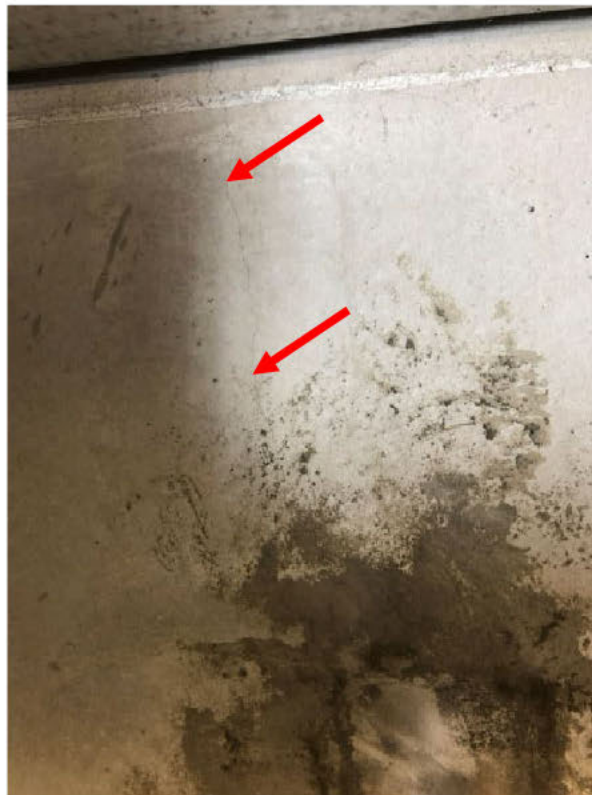
Figure 30: Interior face of Panel 1904. Source: DeSimone.

Figure 28: Crack at Interior face of Panel 1904. Source: DeSimone.

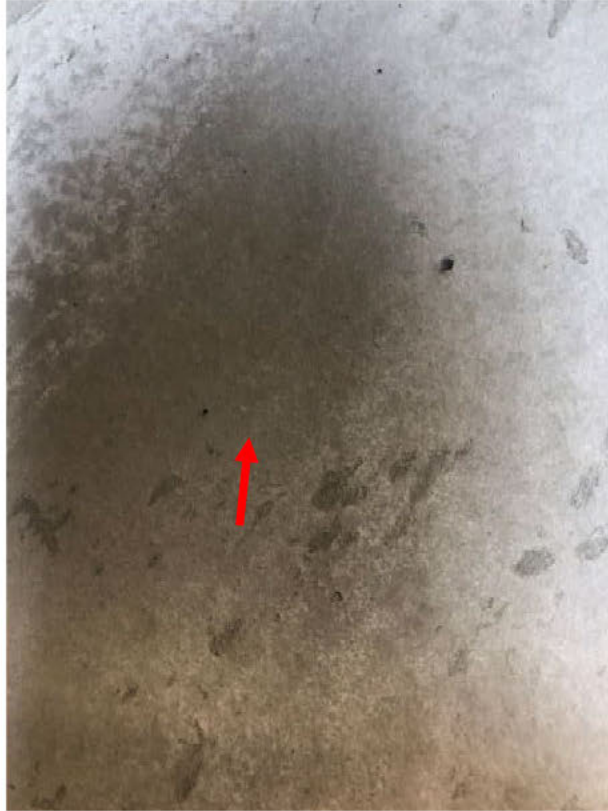
Figure 31: Interior face of Panel 1904. Source: DeSimone.

Figure 29: Crack at interior face of Panel 1904. Source: DeSimone.

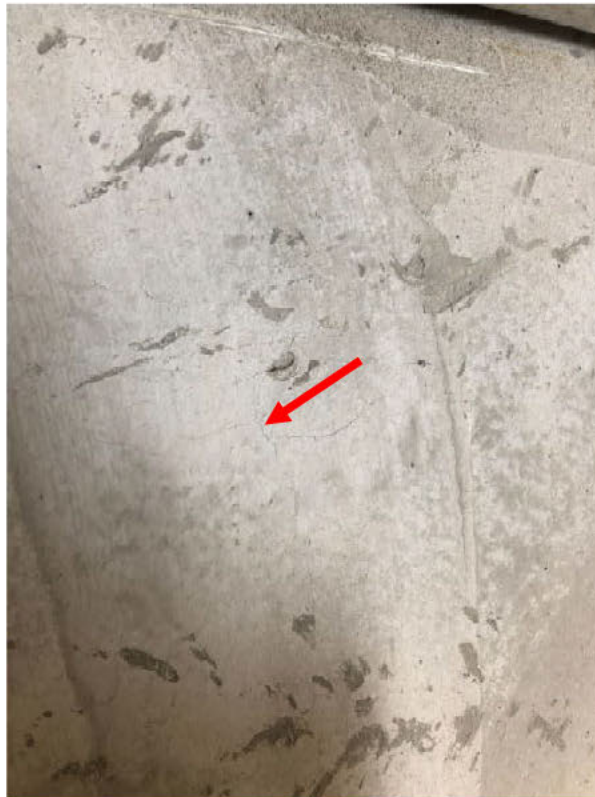
Figure 32: Interior face of Panel 1904. Source: DeSimone.

Figure 30: Crack at interior face of Panel 1904. Source: DeSimone.

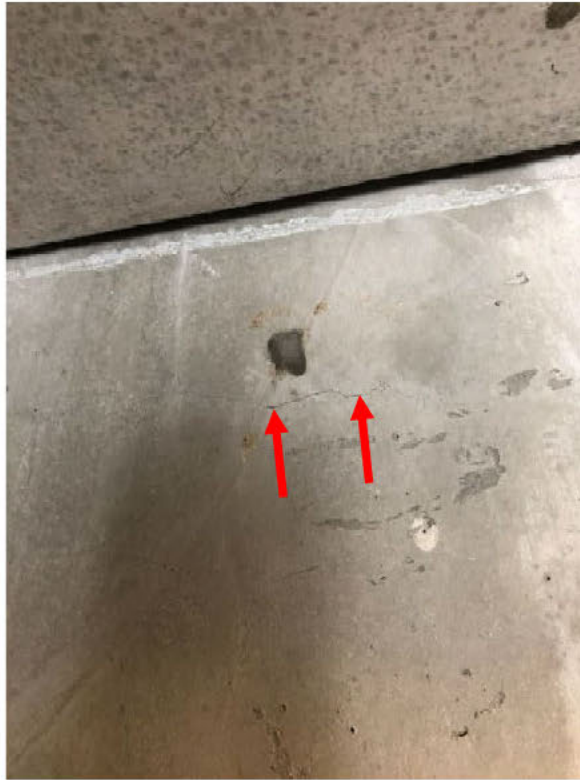
Figure 33: Interior face of Panel 1904. Source: DeSimone.

Figure 31: Crack at interior face of Panel 1904. Source: DeSimone.

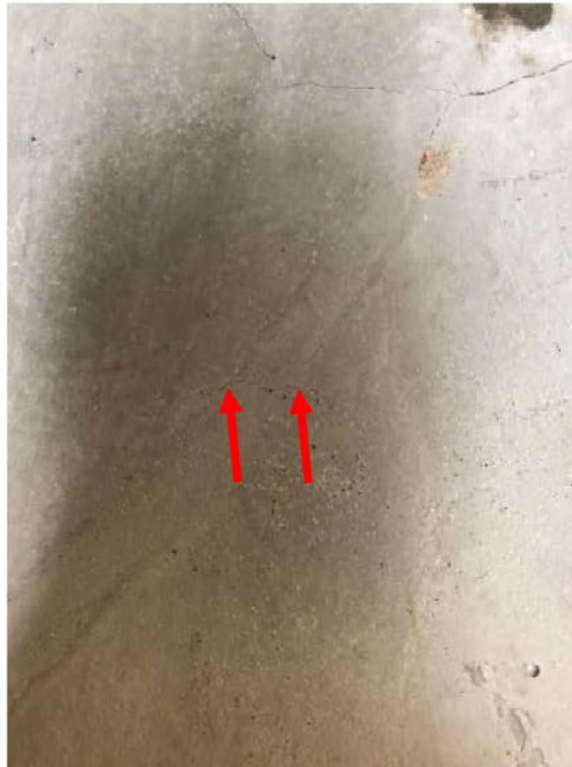
Figure 34: Interior face of Panel 1904. Source: DeSimone.

Figure 32: Crack at Interior face of Panel 1904. Source: DeSimone.

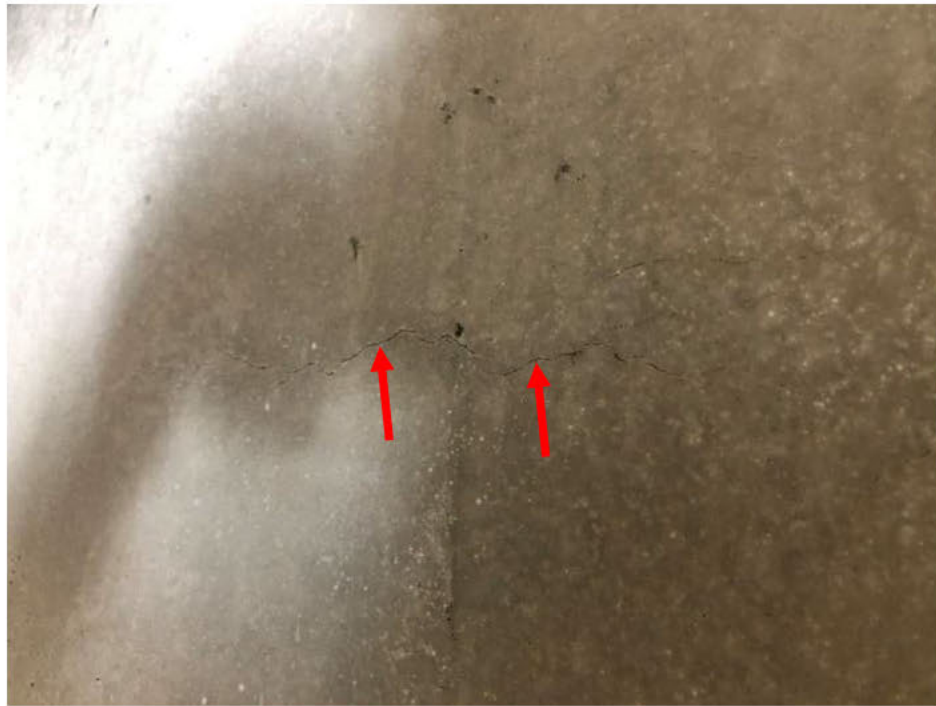
Figure 35: Interior face of Panel 1904. Source: DeSimone.

Figure 33: Crack at interior face of Panel 1904. Source: DeSimone.

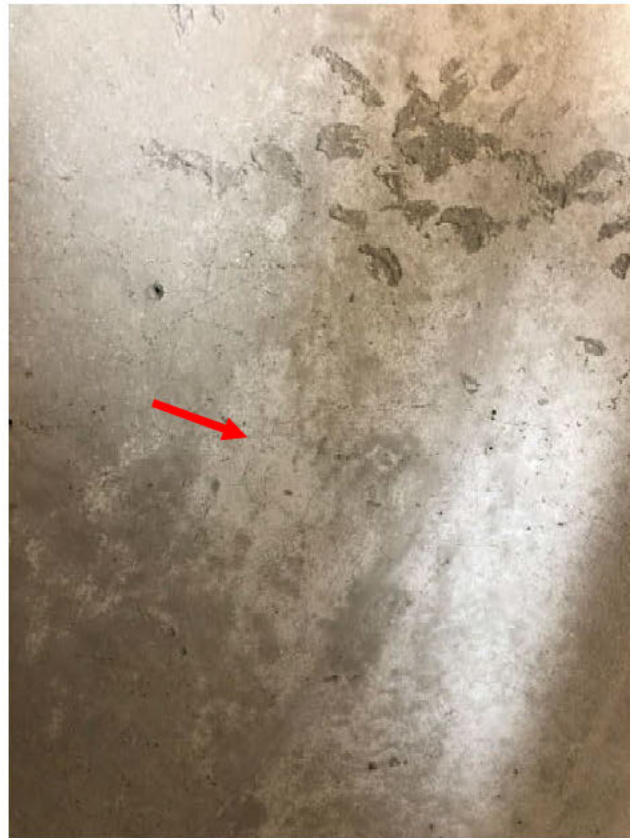
Figure 36: Interior face of Panel 1904. Source: DeSimone.

Figure 34: Crack at interior face of Panel 1904. Source: DeSimone.

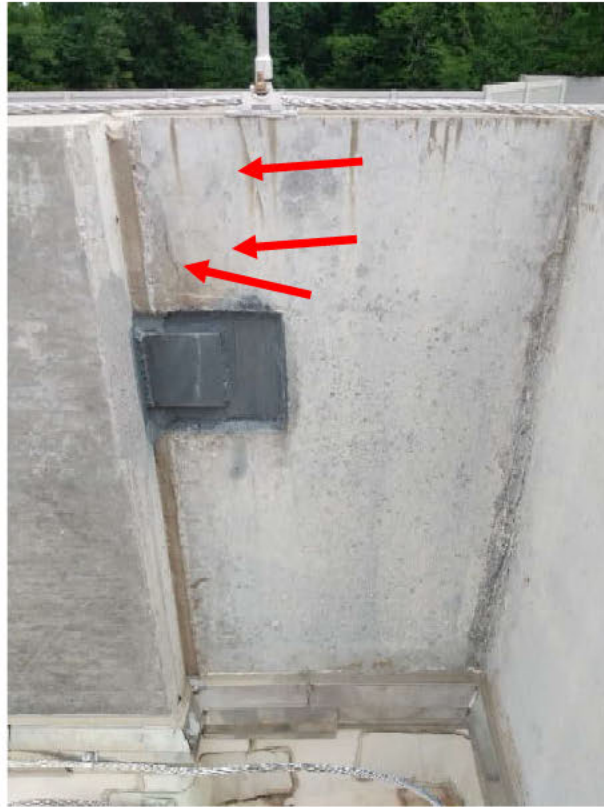
Figure 37: Interior face of Panel WP-1328-RI. Source: DeSimone.

Figure 35: Spider cracks at interior of Panel WP-1328-RI. Source: DeSimone.

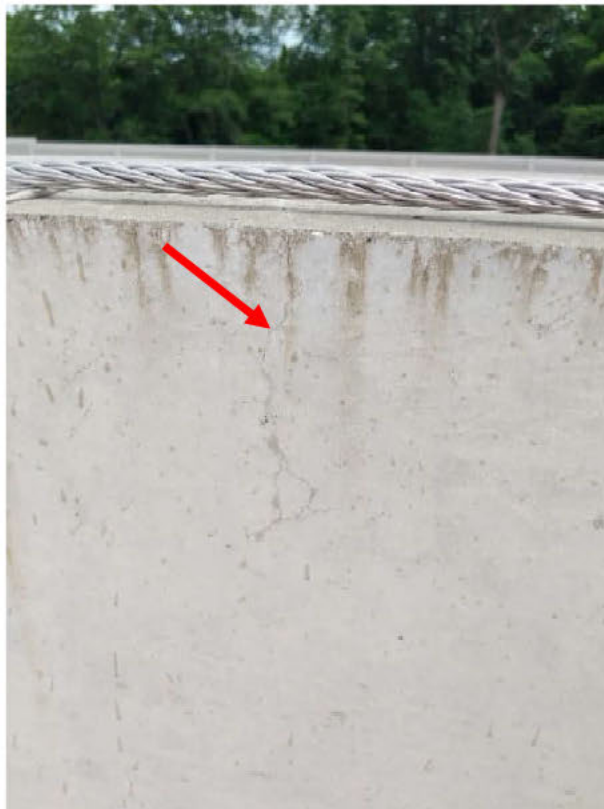
Figure 38: Interior face of Panel WP-1328-RI. Source: DeSimone.

Figure 36: Crack at Interior face of Panel WP-1328-R!. Source: DeSimone.

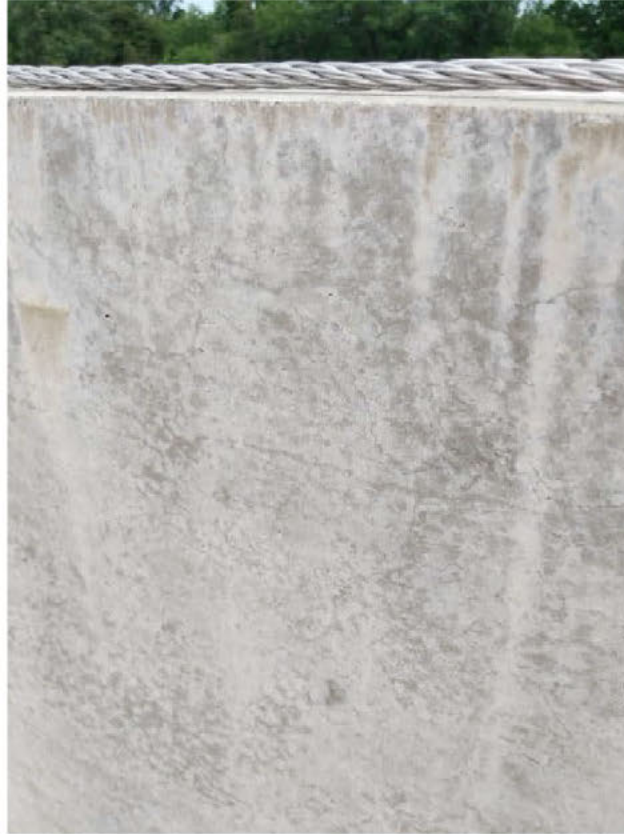
Figure 39: Interior face of Panel WP-1321-RI. Source: DeSimone.

Figure 37: Spider cracks at interior of Panel WP-1321-RI. Source: DeSimone.

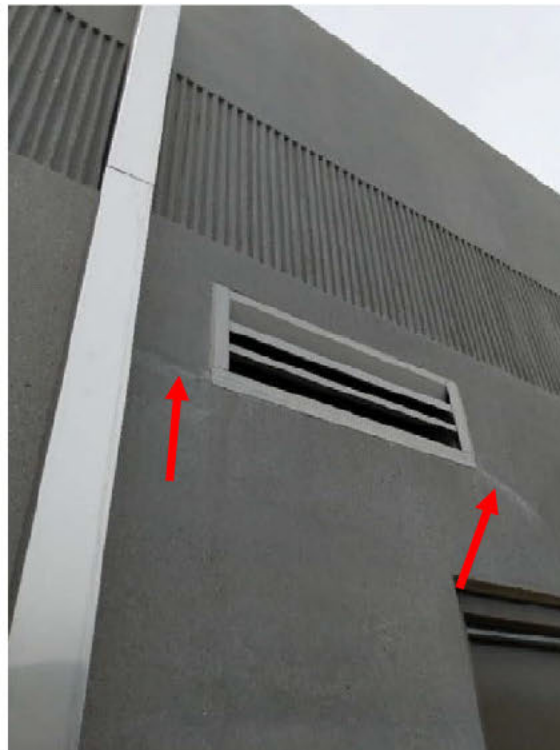
Figure 40: Exterior face of Panel WP-1307-RI. Source: DeSimone.

Figure 38: Previously repaired cracks at exterior face of Panel WP-1307-RI. Source: DeSimone.

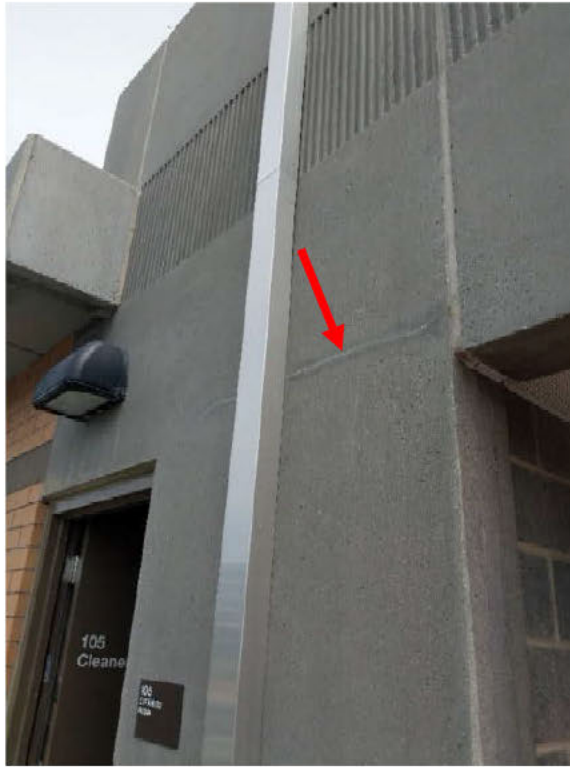
Figure 41: Exterior face of Panel WP-1313. Source: DeSimone.

Figure 39: Previously repaired crack at exterior face of Panel WP-1313. Source: DeSimone.

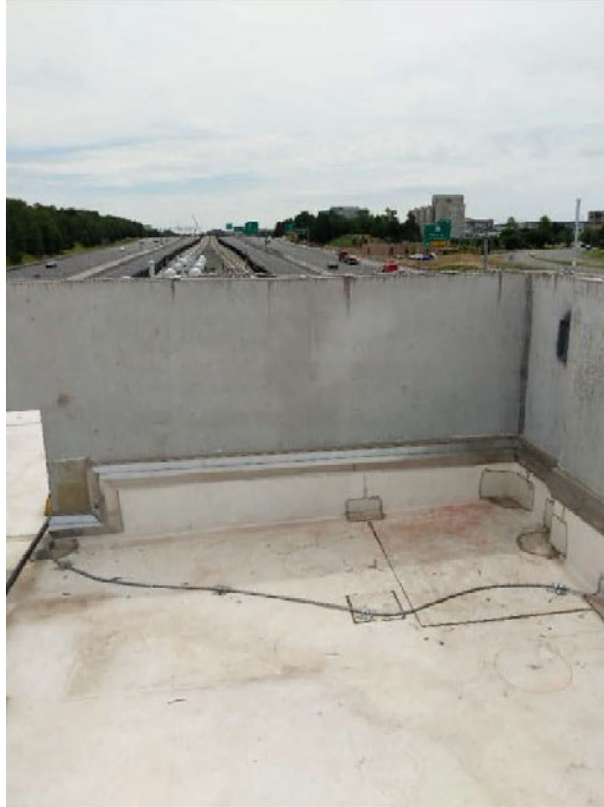
Figure 45: Interior face of Panel WP-1329. Source: DeSimone.

Figure 43: Spider cracks at interior face of Panel WP-1329. Source: DeSimone.

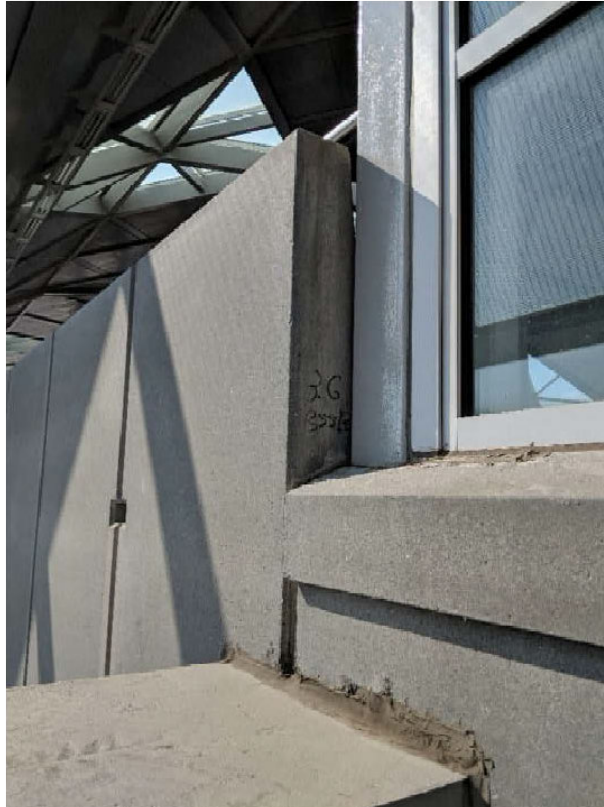
Figure 46: Exterior face of Panel WP-1206. Source: DeSimone.

Figure 44: Chipped concrete at exterior face of Panel WP-1206. Source: DeSimone.

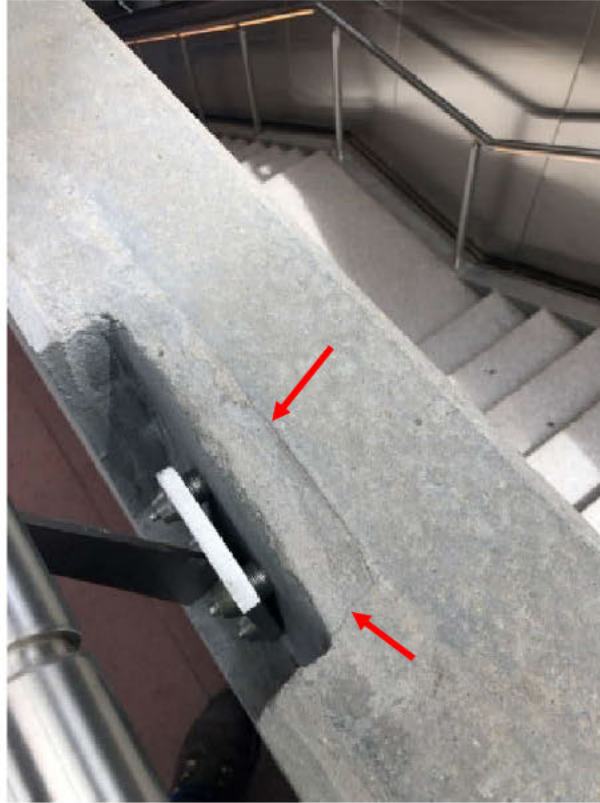
Figure 47: Top face of Panel WP-1235. Source: DeSimone.

Figure 45: Crack at top face of Panel WP-1235. Source: DeSimone

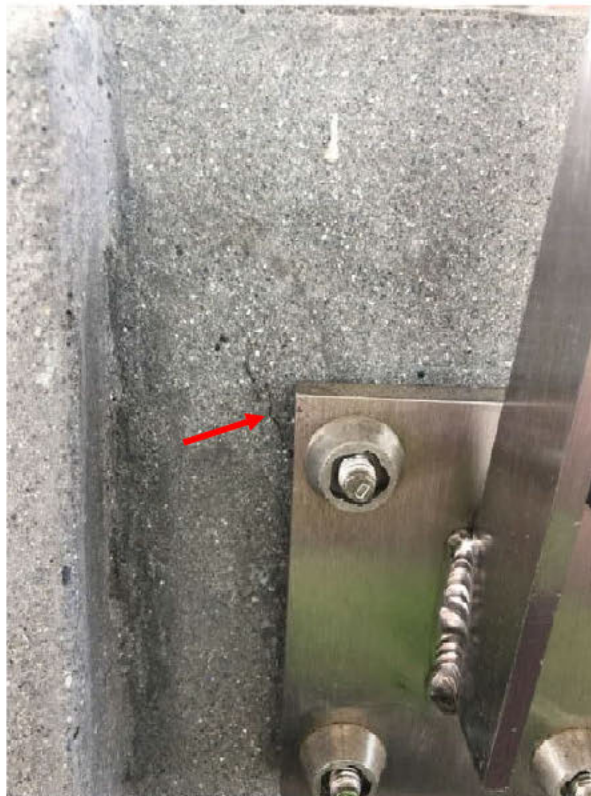
Figure 48: Interior of Panel WP-1233. Source: DeSimone

Figure 46: Crack at interior face of Panel WP-1233. Source: DeSimone.

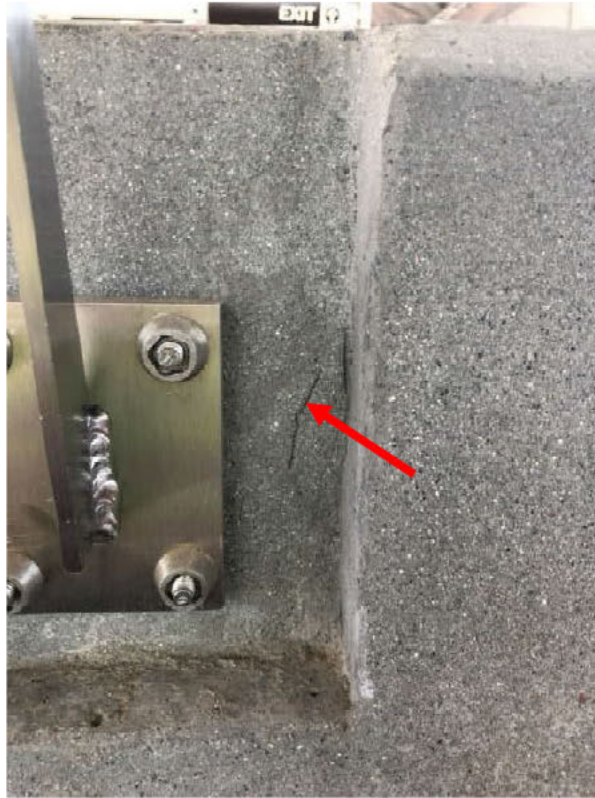
Figure 49: Interior face of Panel WP-1233. Source: DeSimone.

Figure 47: Crack at interior face of Panel WP-1233. Source: DeSimone.

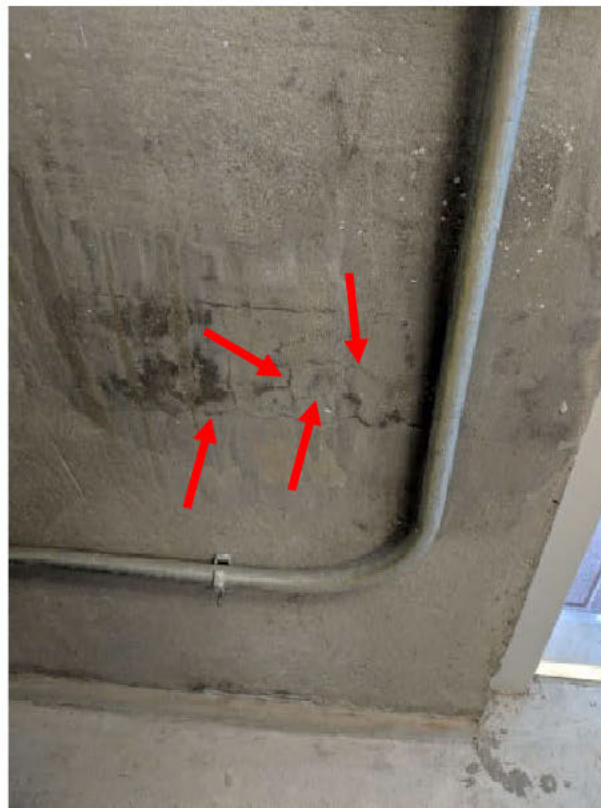
Figure 50: Interior of Panel WP-1239. Source: DeSimone.

Figure 48: Spider cracks at interior face of Panel WP-1239. Source: DeSimone.

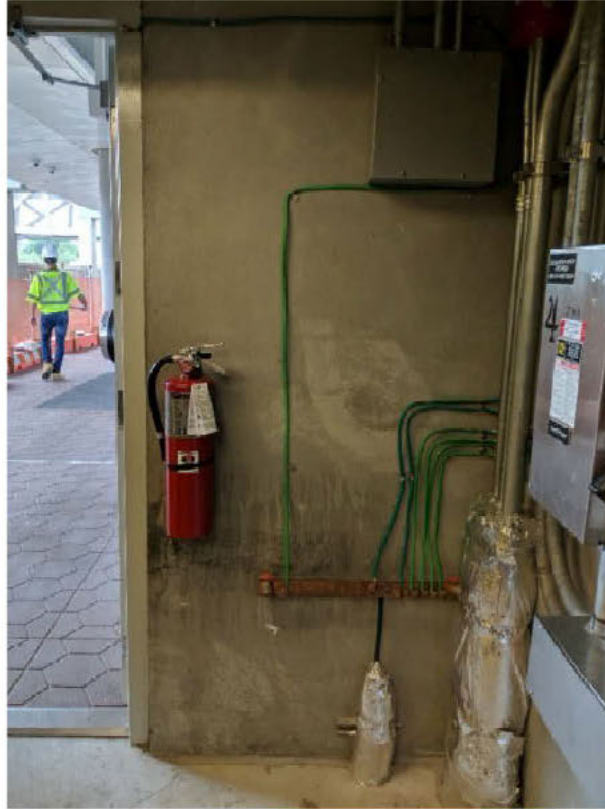
Figure 51: Interior face of Panel WP-1239. Source: DeSimone.

Figure 49: Spider cracks at interior face of Panel WP-1239. Source: DeSimone.

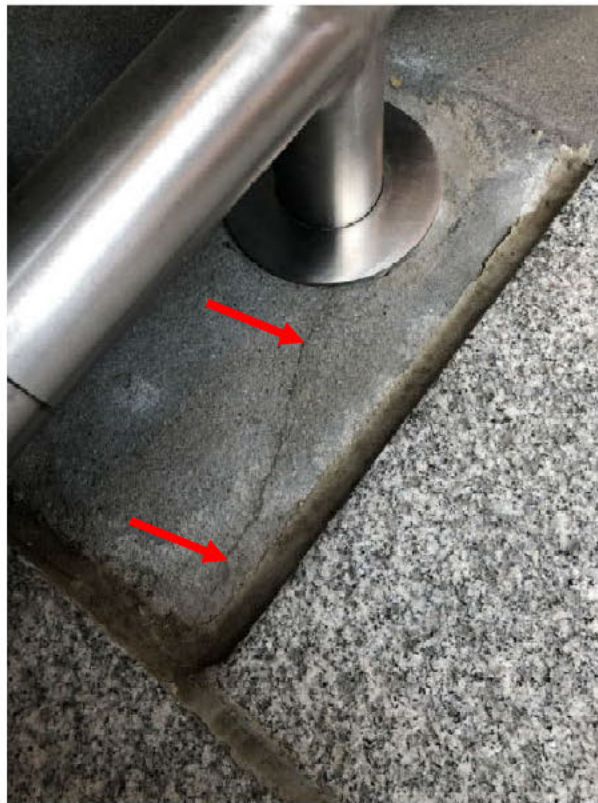
Figure 52: Top face of Panel ST-1264 at top of stair. Source: DeSimone.
