Invitation For Bid

Electrical and Data Cable Installation

Project Name: 15-NEPP-01 In-Floor Duct Inspections
Task: Mezzanine Inspection Reports
Date of Inspection: August 22, 2014
Mezzanine Inspected: A01 - Metro Center East
Report Includes:
- Mezzanine Inspection Checklist
- Field Photos
- Existing AFC Installation Plan with field notes

Mezzanine Inspection Report (Scoping)

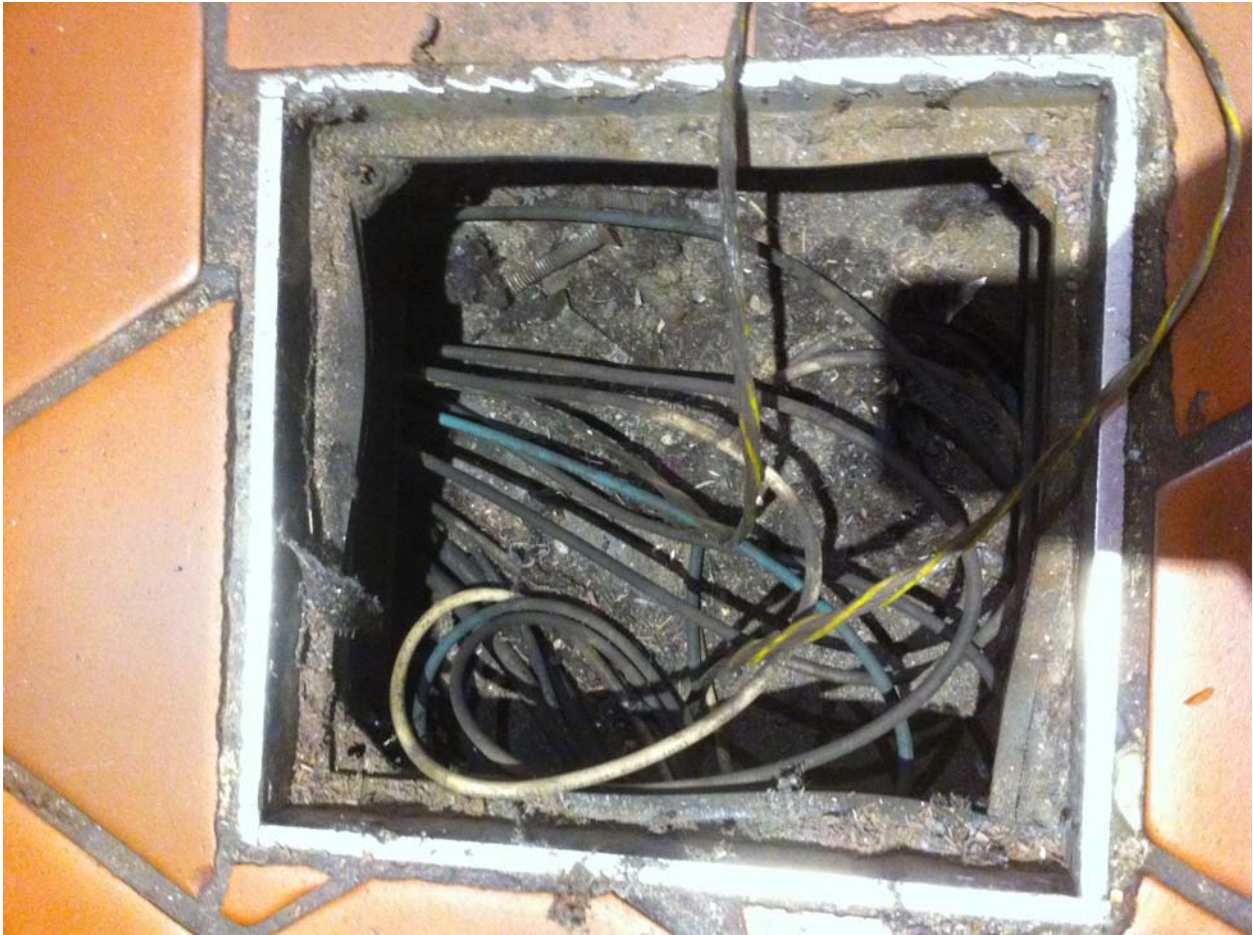
Metro Center East Photo #3 – Close-up of Hand Hole #3 to access power duct from Kiosk to AFC Panel
– 12 wires counted, therefore duct is not at capacity.

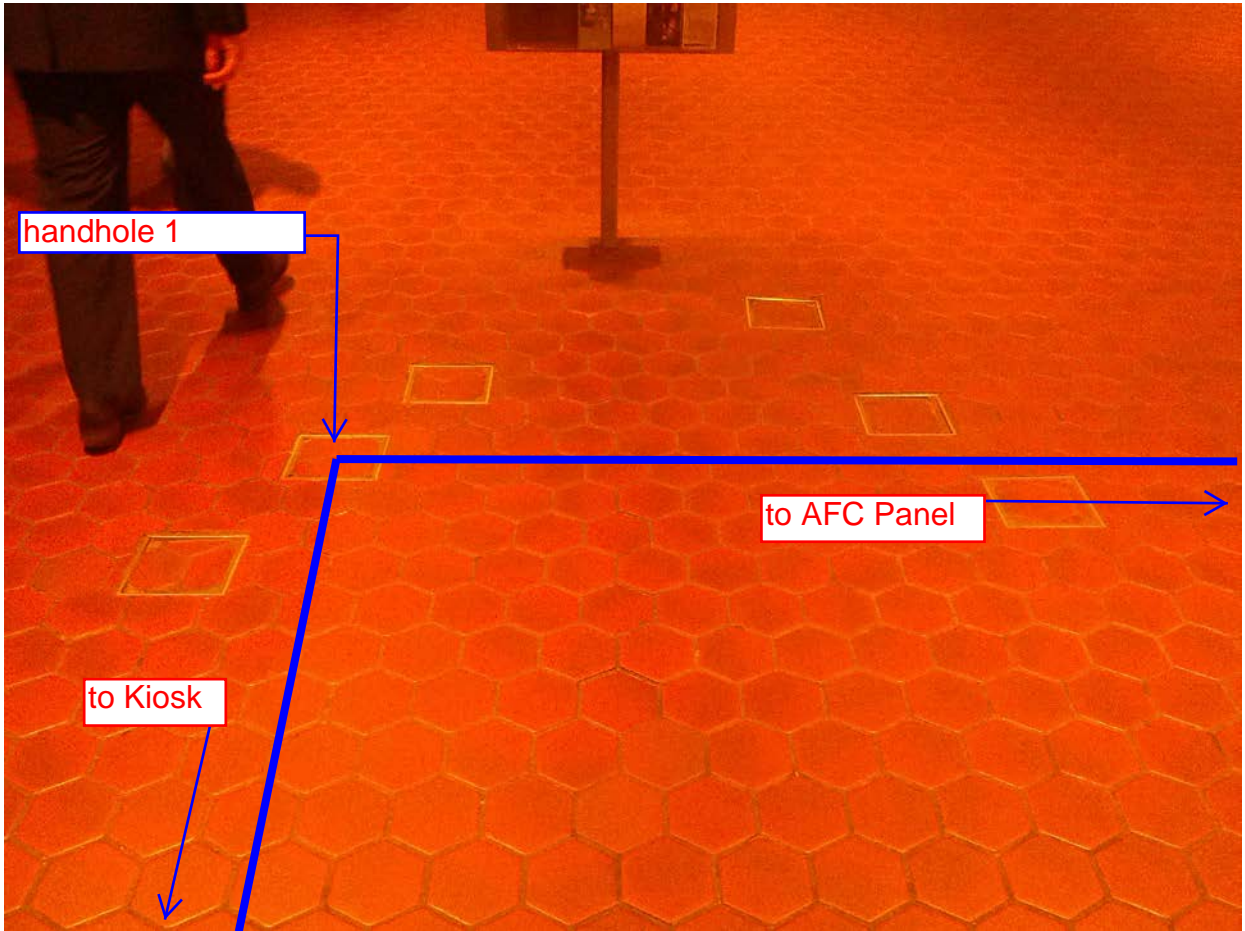
Photo #1 – A01 Metro Center West: Mezzanine level handholes

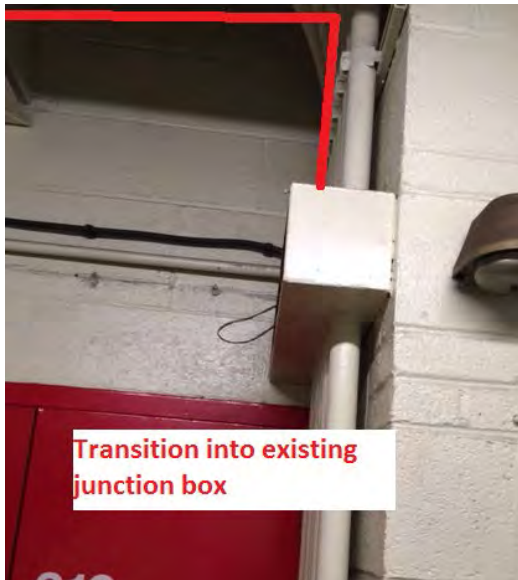
Farragut North NW Photo # 10 – Proposed conduit transition into existing junction box

A proposed overhead conduit path from the Kiosk to the junction box has been identified (see photos 6-10 below) since the existing conduit from the Kiosk to the junction box is deemed to be unusable. There is no room for installation of new in-floor duct based on the location of the existing manhole and the existing ducts. It is recommended to install overhead conduit from the kiosk along the recessed channel along the ceiling of the mezzanine and transition into the existing junction box located in the service hallway. There is already an existing core drill hole, so a core drill may not be required.

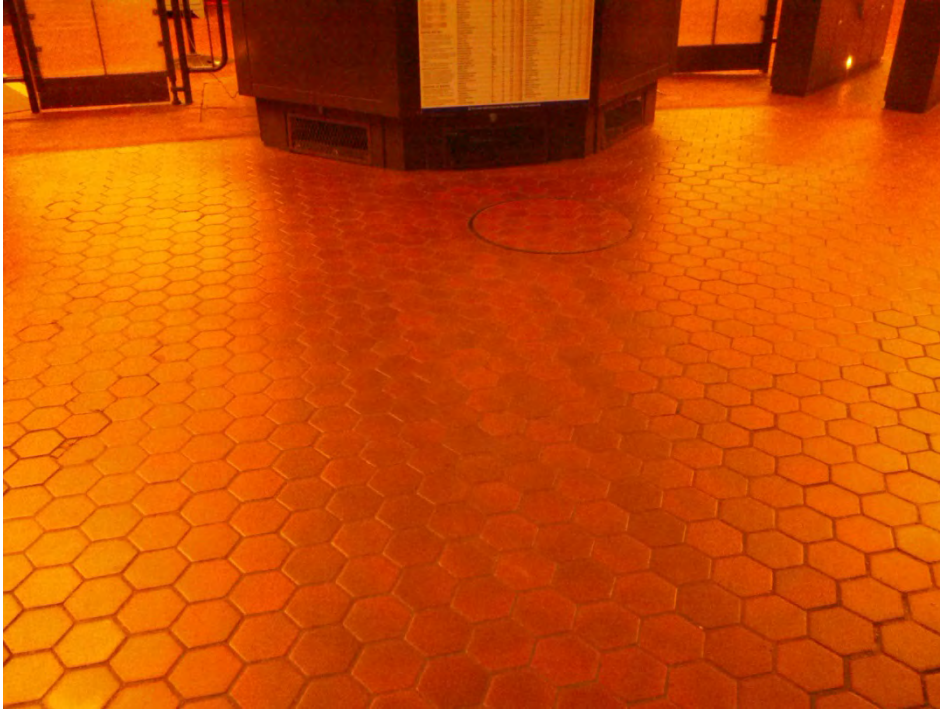
Photo #1: Kiosk on mezzanine floor

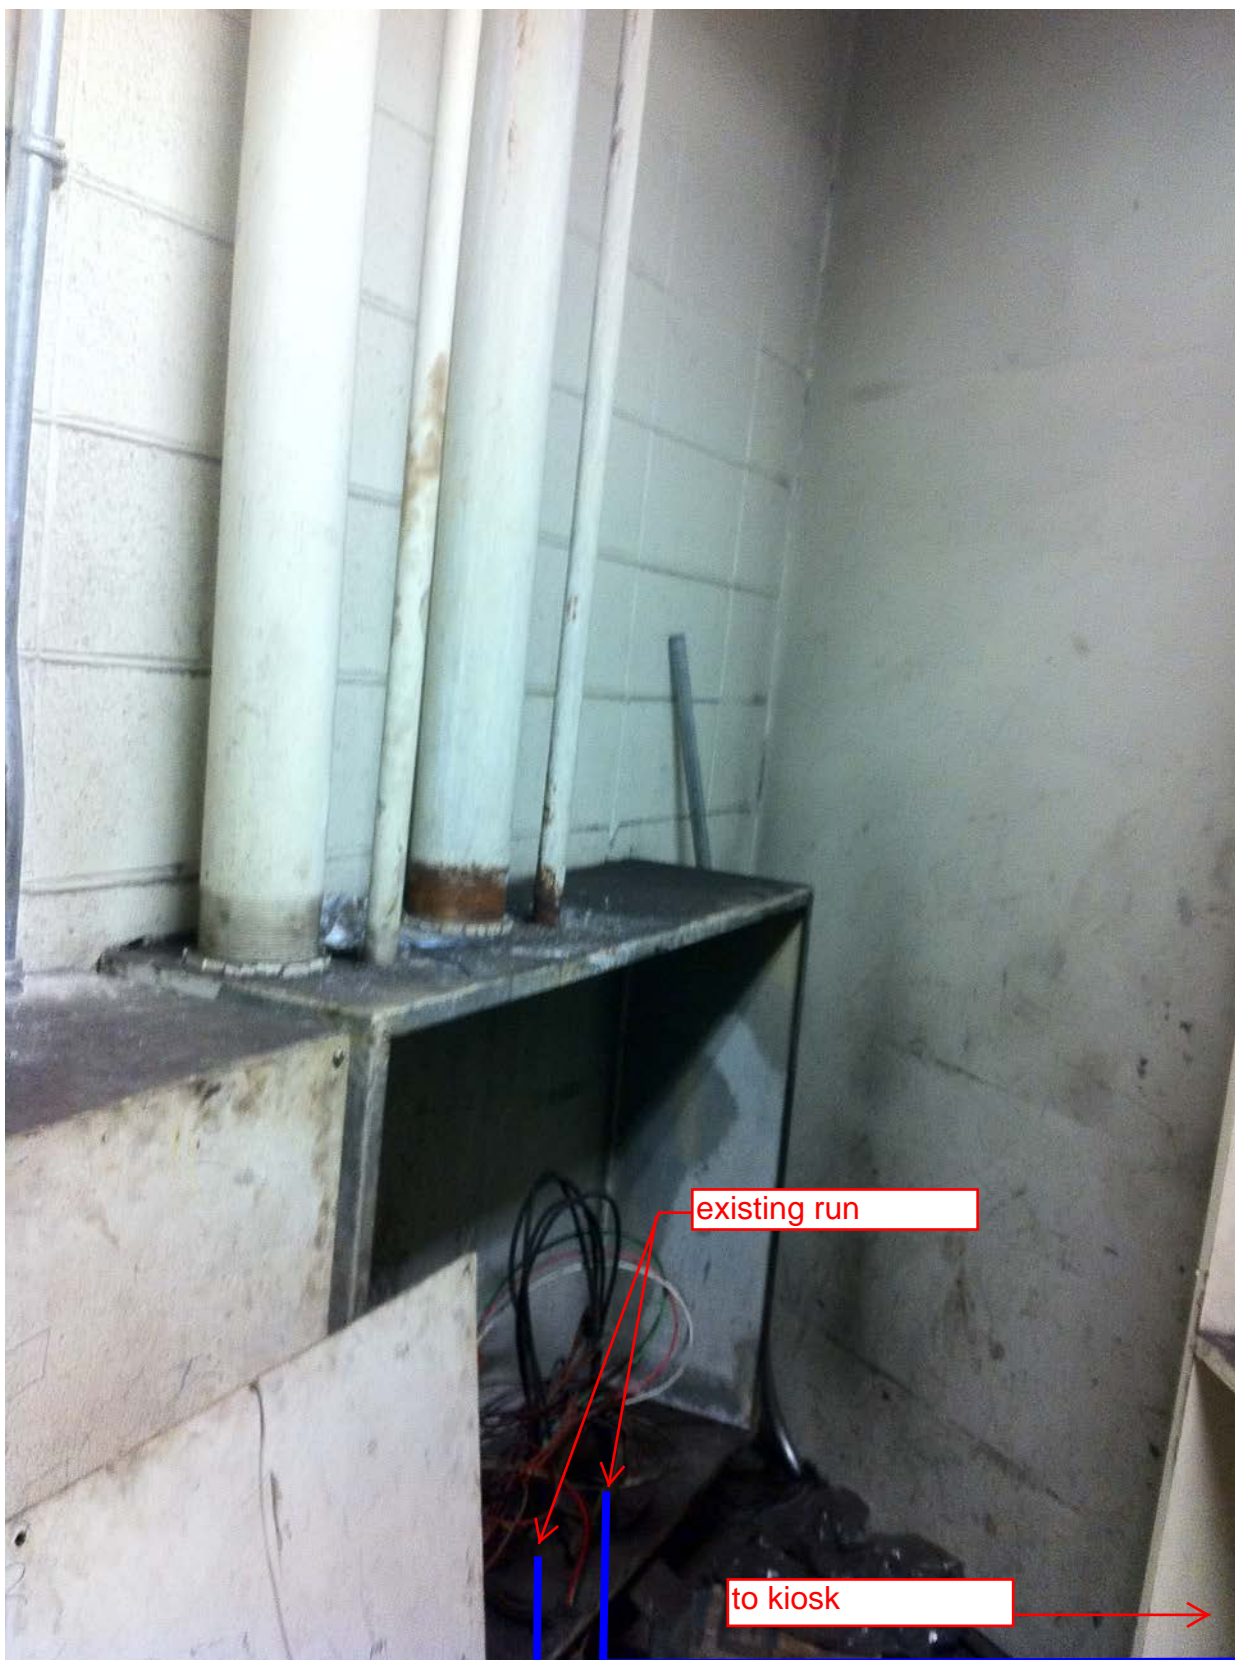
Photo #1 – A03 Dupont Circle South: Shared pull box in Verizon room #203

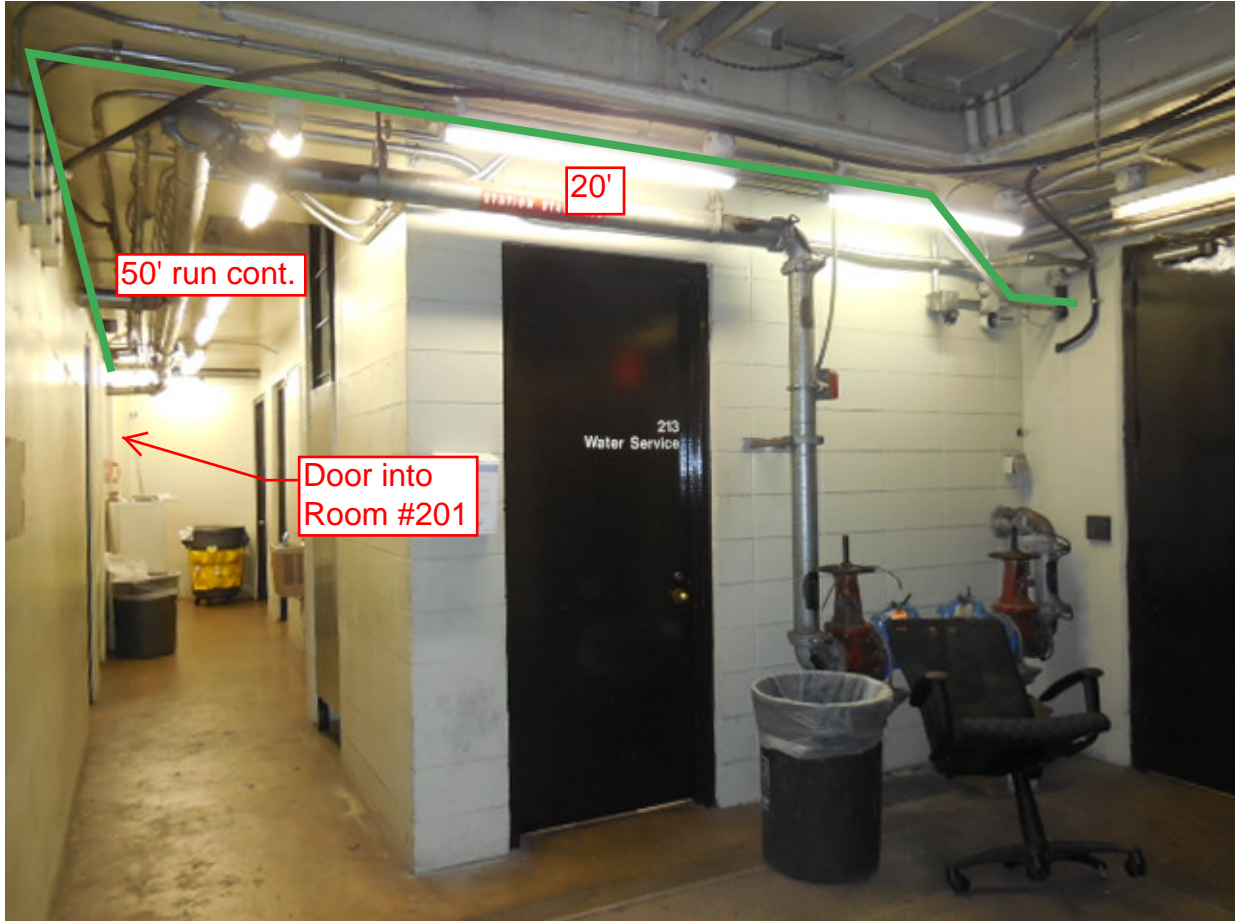
Photo #7 – A03 Dupont Circle South: Proposed conduit run continuing down hallway of room #201 and towards room #215

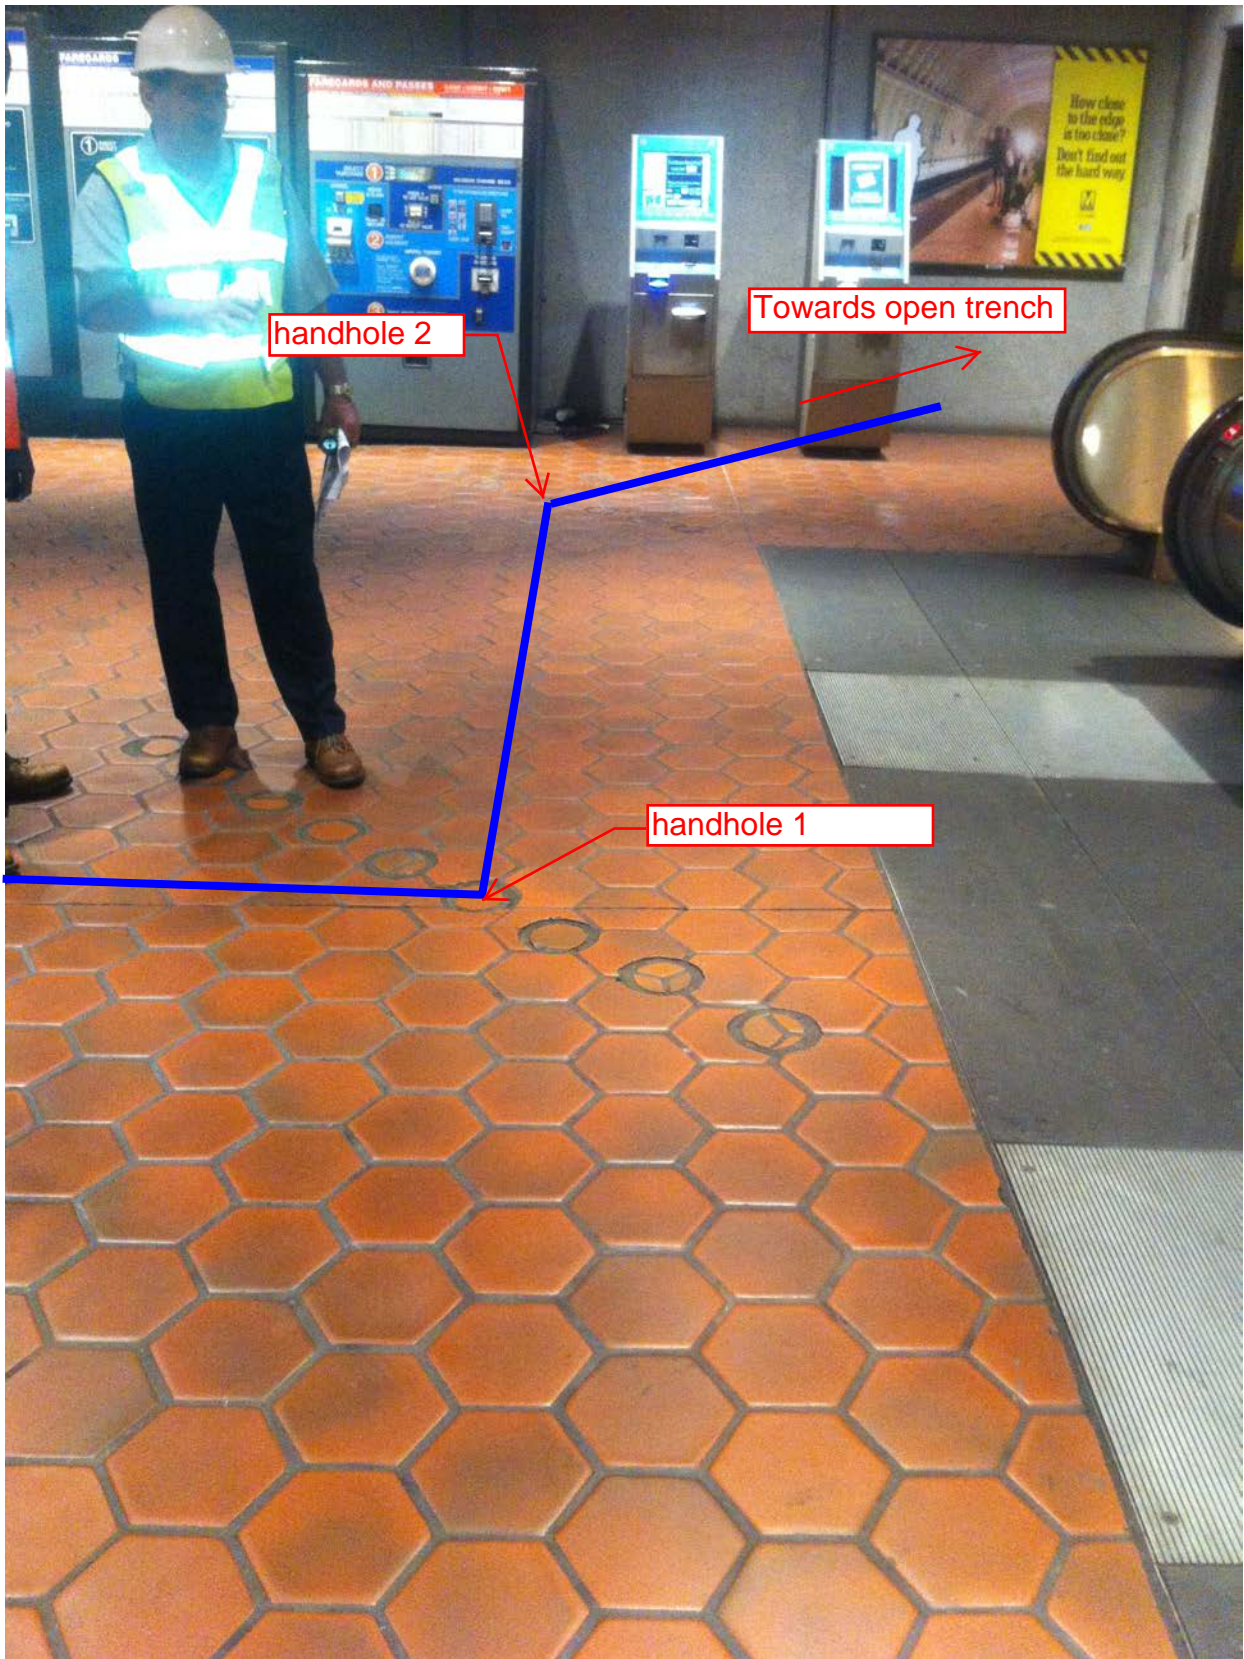
Photo #2 – A05 Cleveland Park: Handhole 1 and Handhole 2

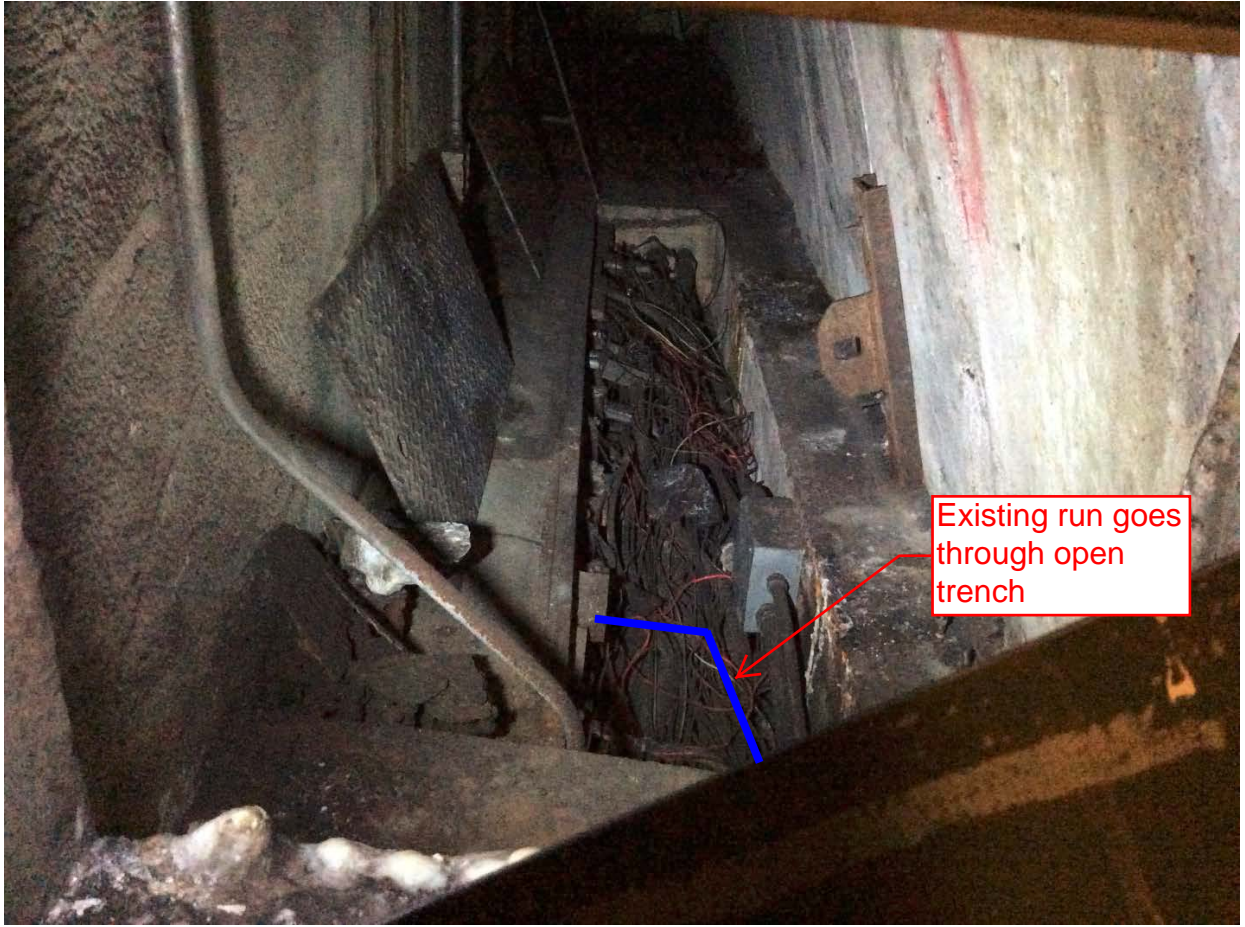
Photo #3 – A05 Cleveland Park: Existing power run in open trench

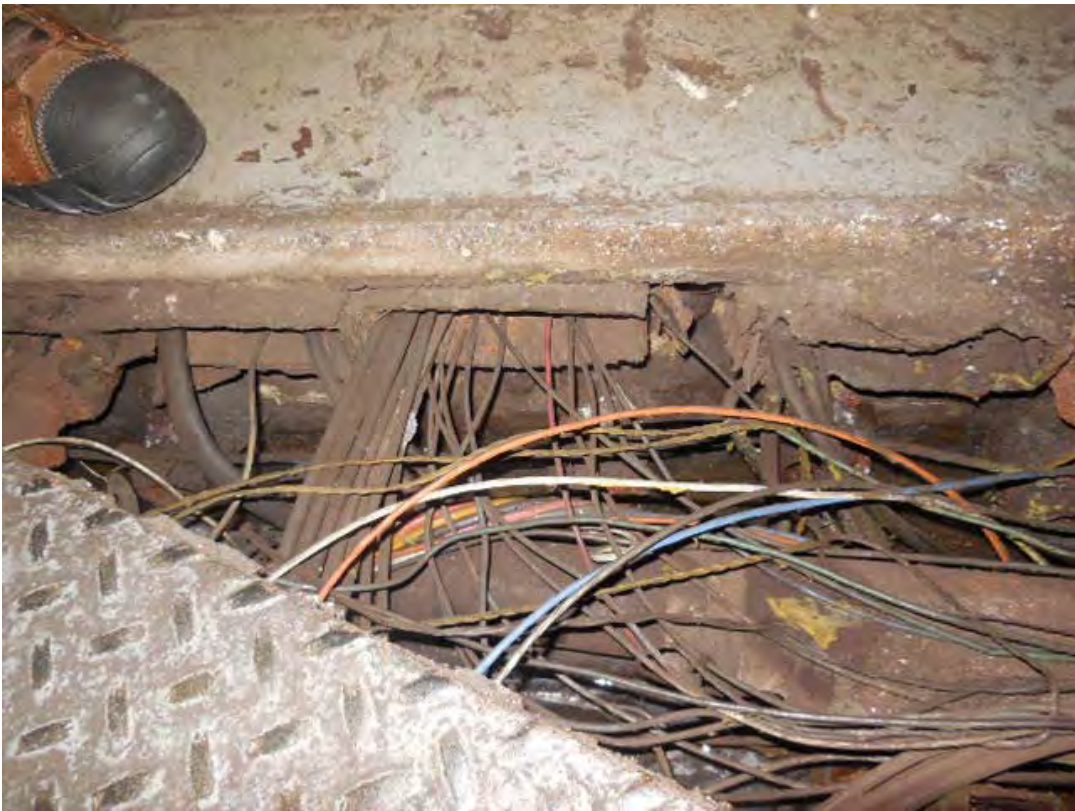
Photo #3 – Ducts from Handhole 2 entering Trench 1 in Room # 200

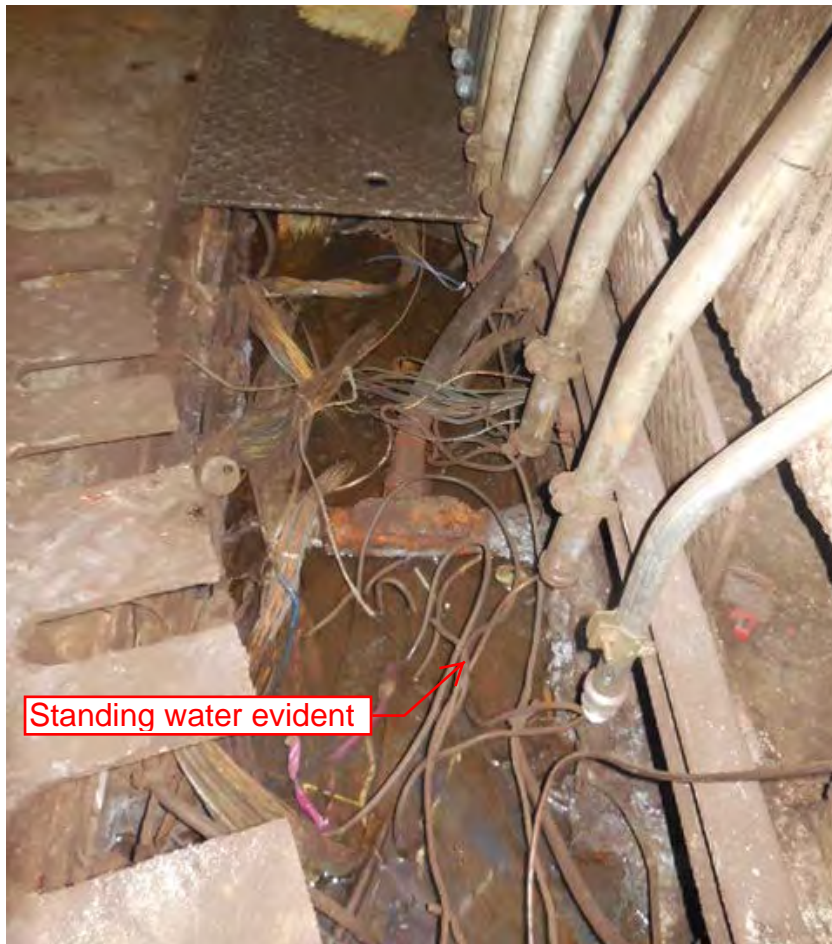
Photo #4 –Trench 1 in Room # 200 with overhead conduit transition, standing water evident.

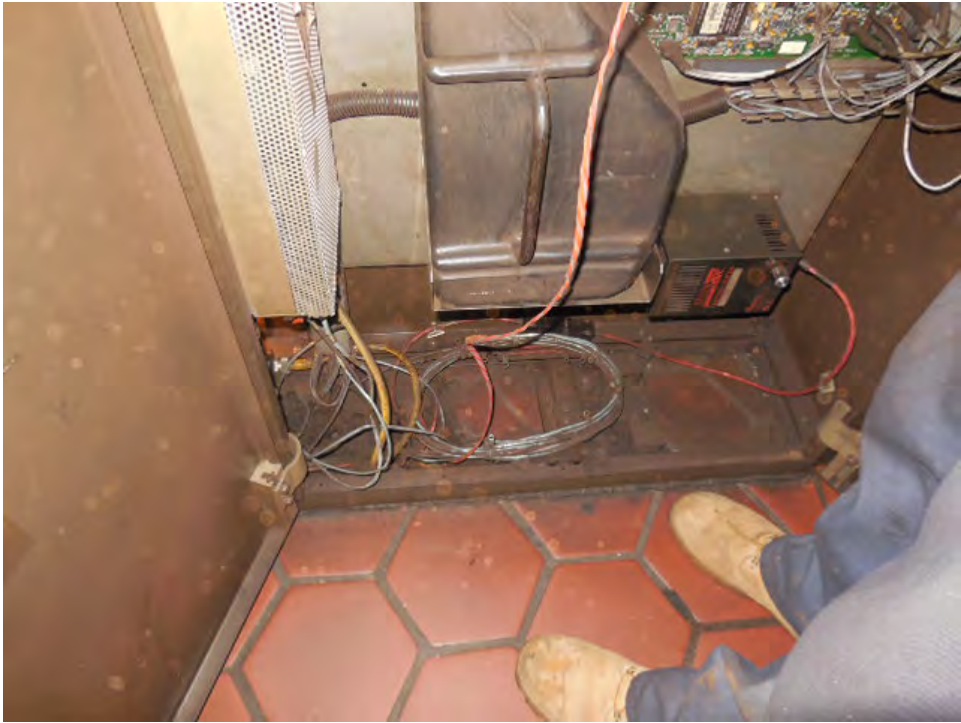
Photo #3: A08 Friendship Heights – Pull string installed in faregate array duct

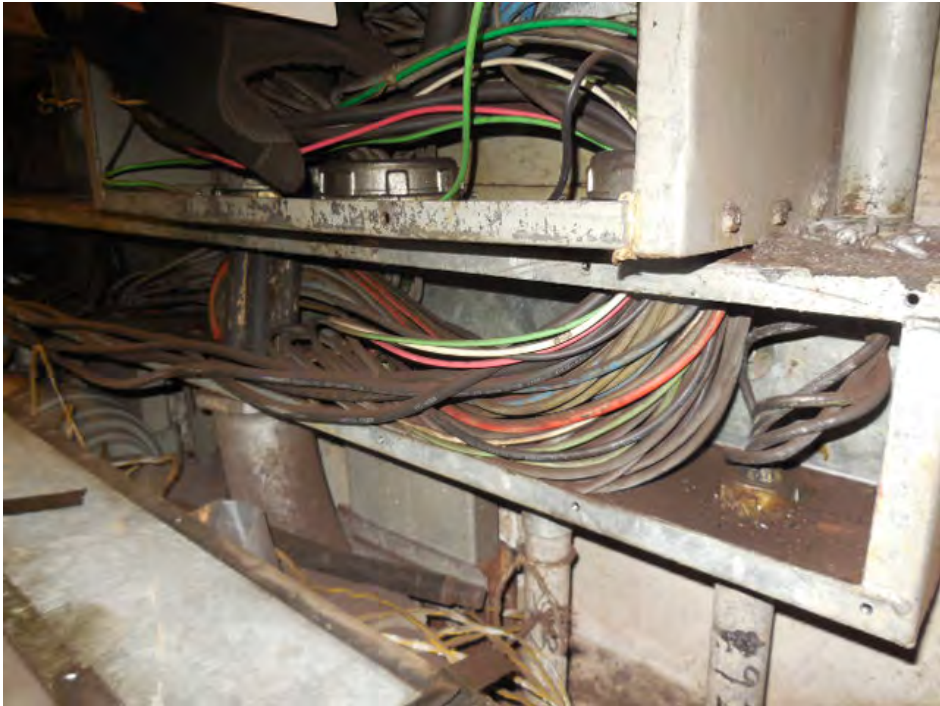
Photo #7: A08 Friendship Heights – Cable trough below AFC Panel. Power ducts from kiosk feed into bottom of trough

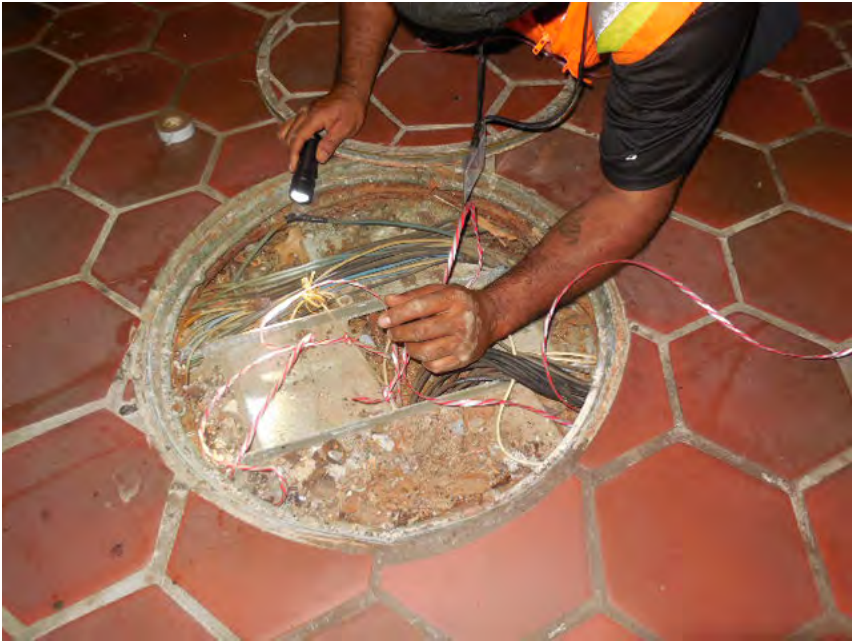
Photo #5: A13 Twinbrook – Pull string installation to mezzanine handhole

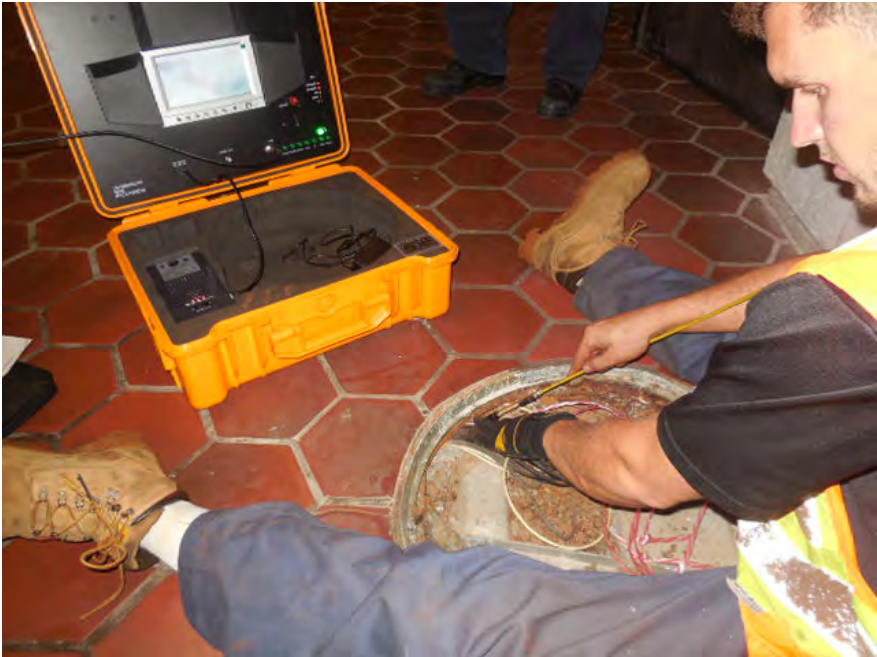
Photo #6: A13 Twinbrook – Video-scoping between kiosk and mezzanine handhole

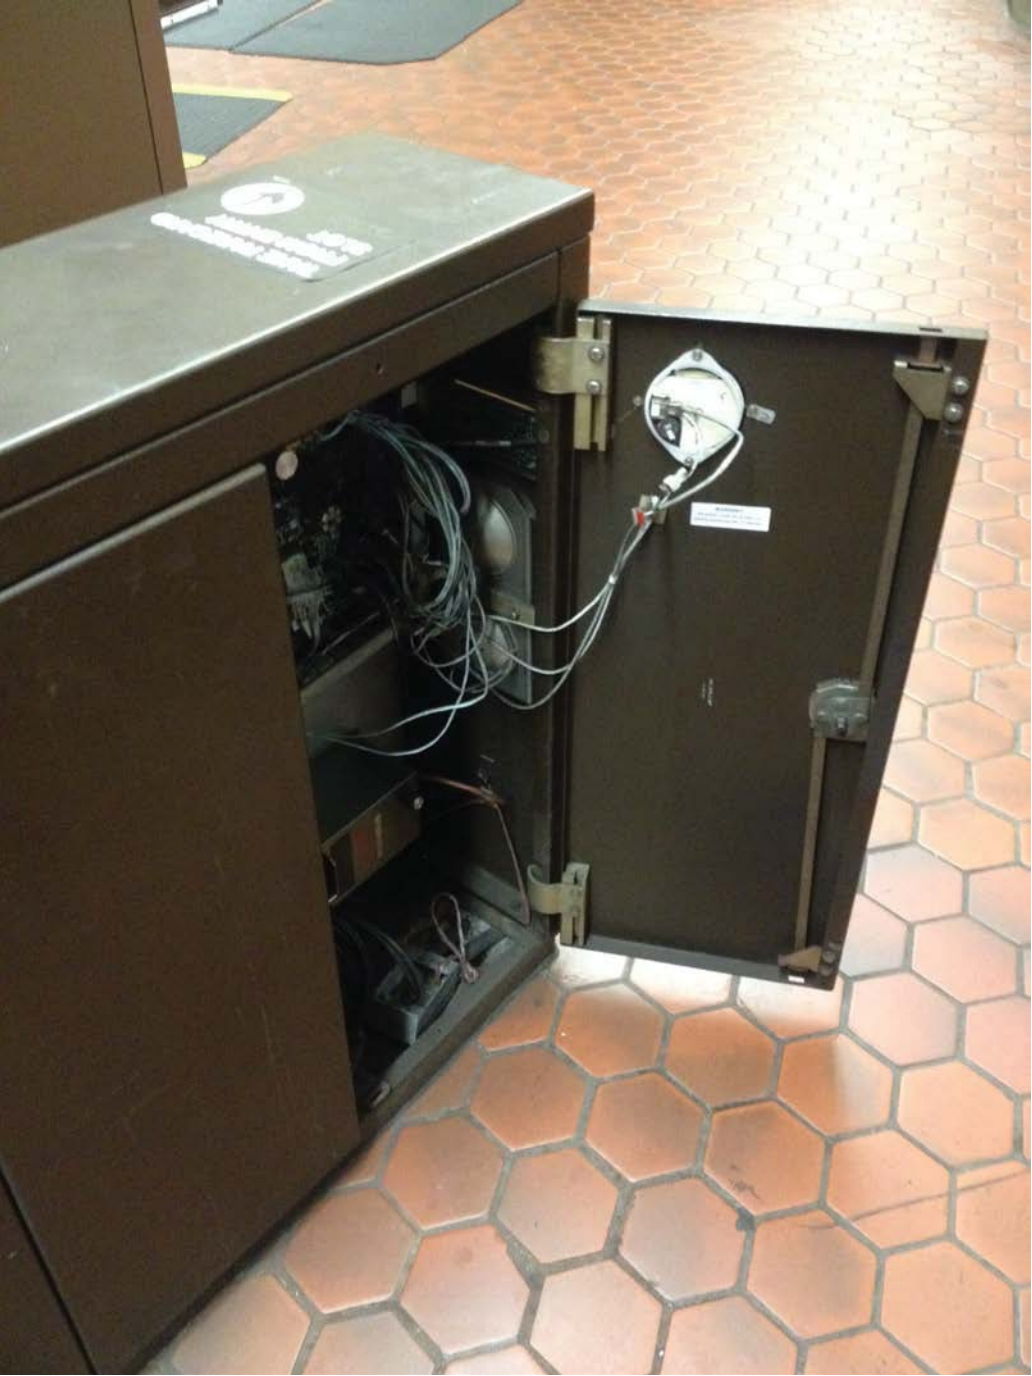
Photo #1: B02 Judiciary Square (East) – Faregate with new comm. duct and cable installed

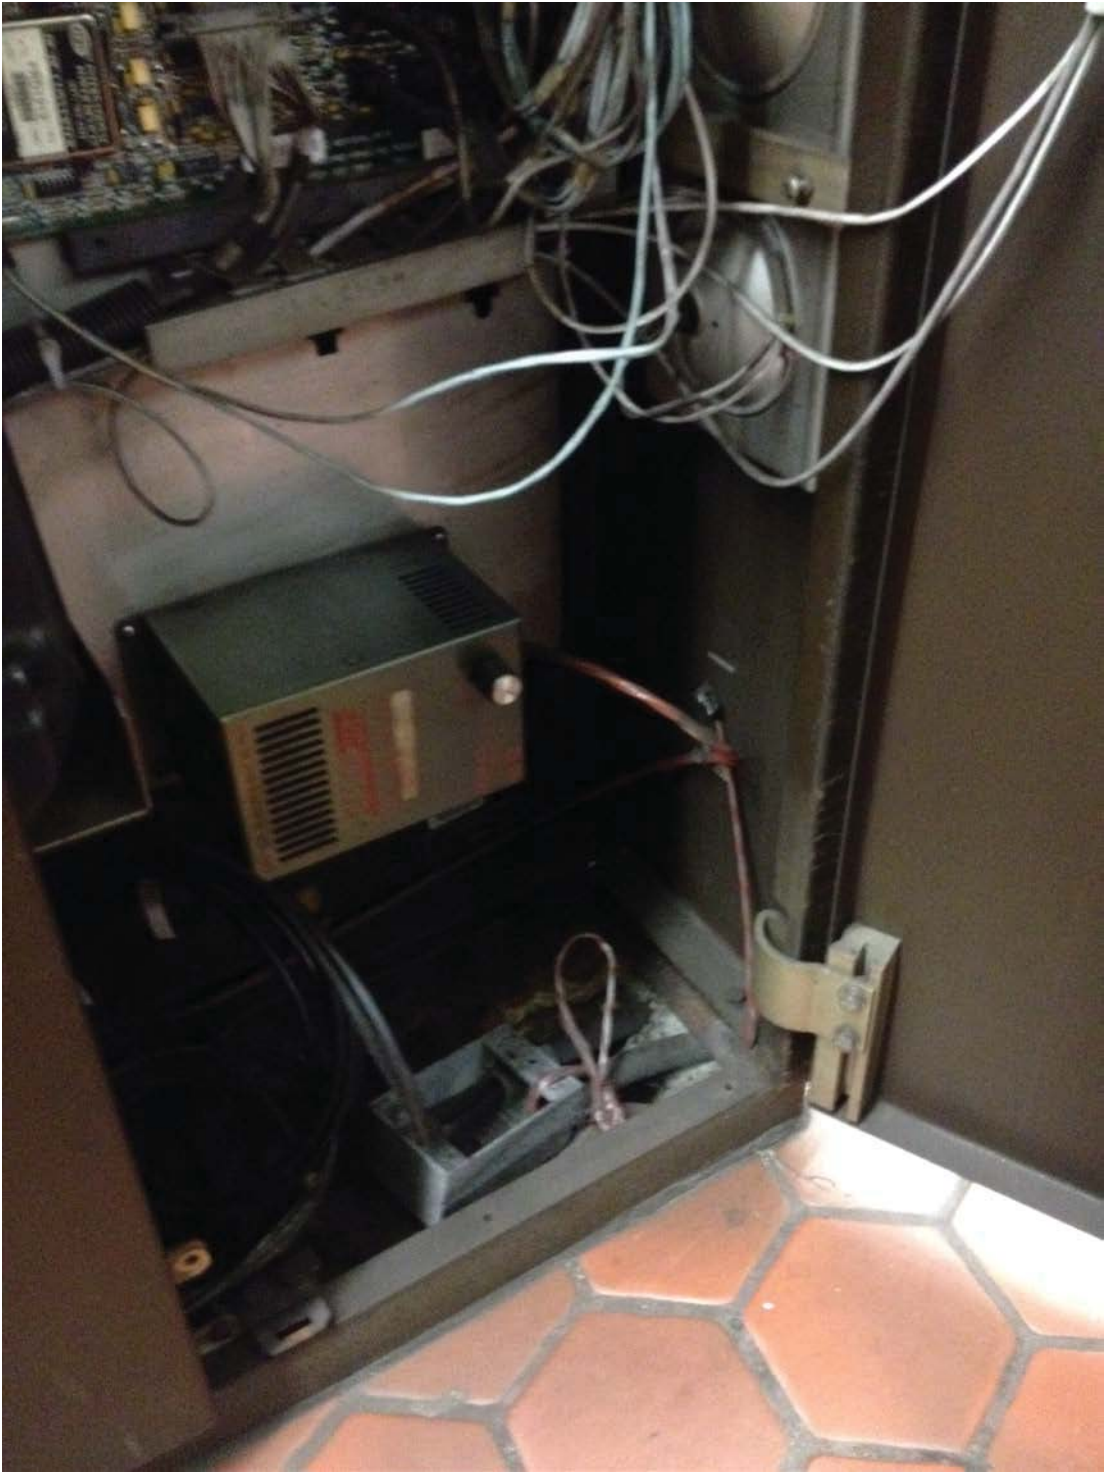
Photo #2: B02 Judiciary Square (East) – Faregate with new comm. duct and cable installed

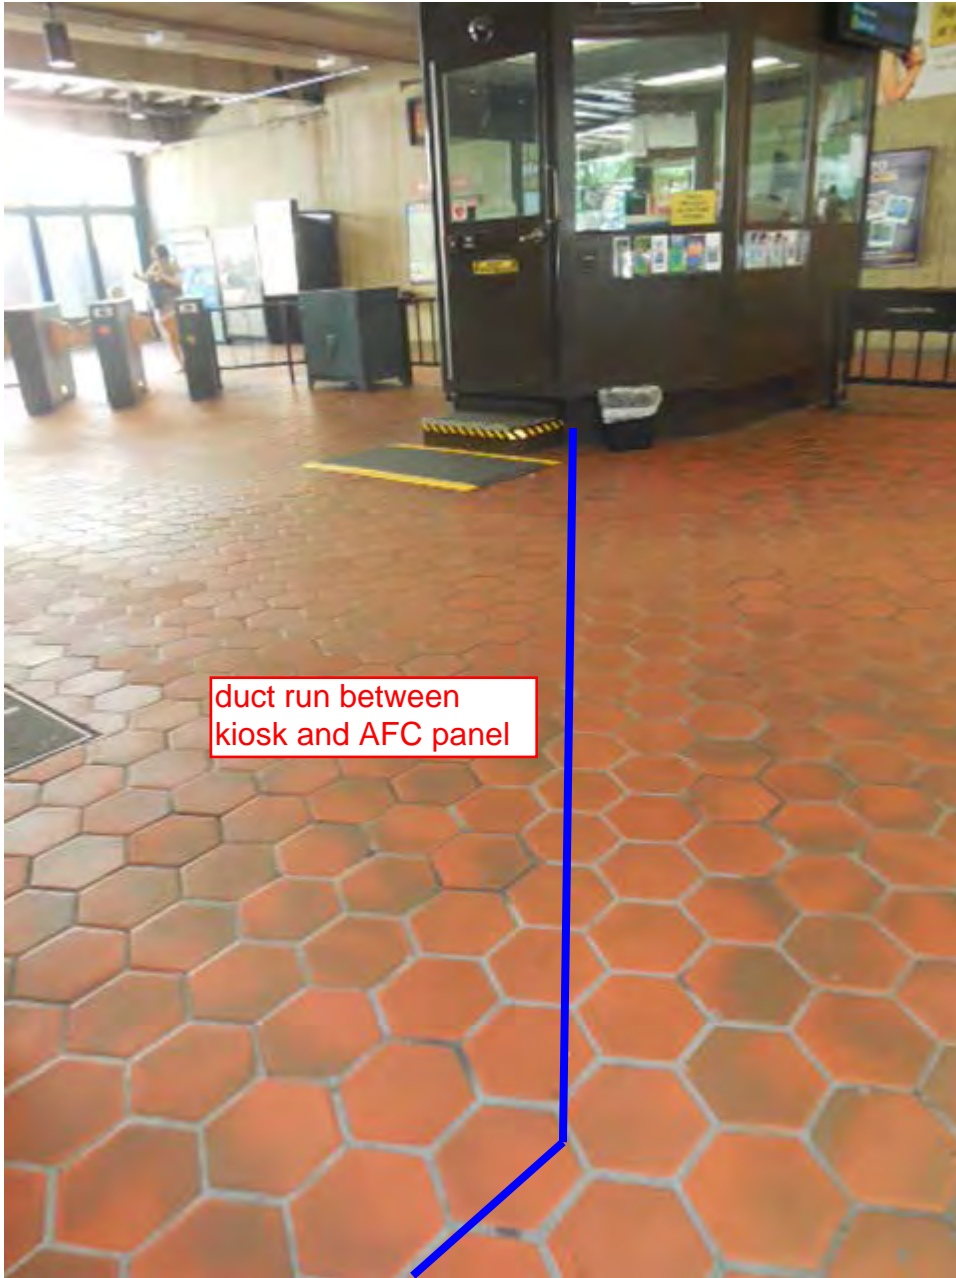
Photo #1 – B08 Silver Spring North: Kiosk on Mezzanine level

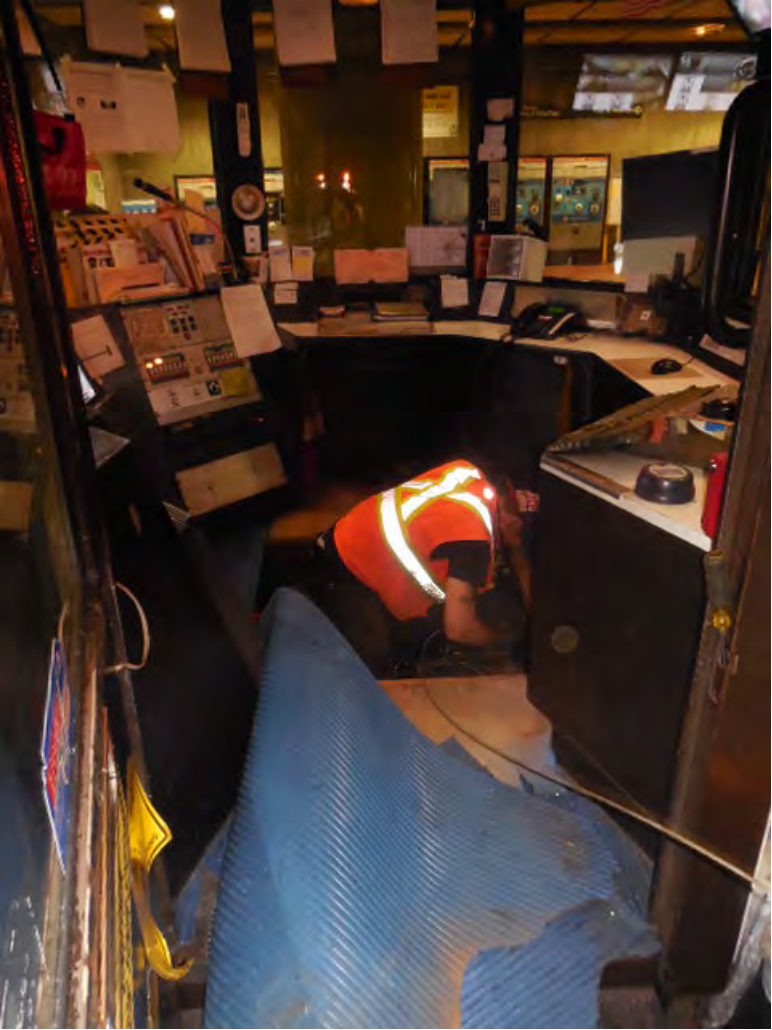
Photo #3: B10 Wheaton: Pushing in fish tape for the faregate array ducts

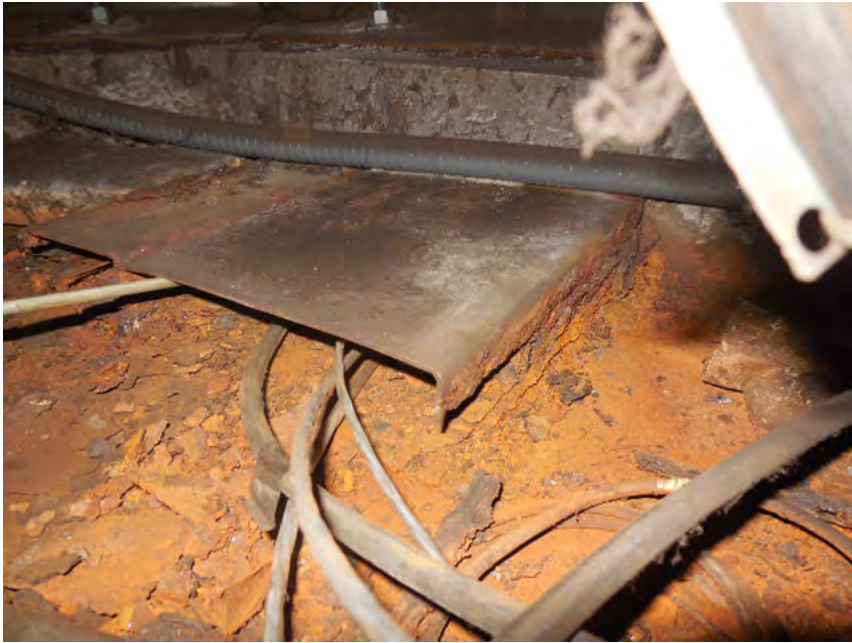
Photo #6: B10 Wheaton: Corroded communications duct opening in kiosk

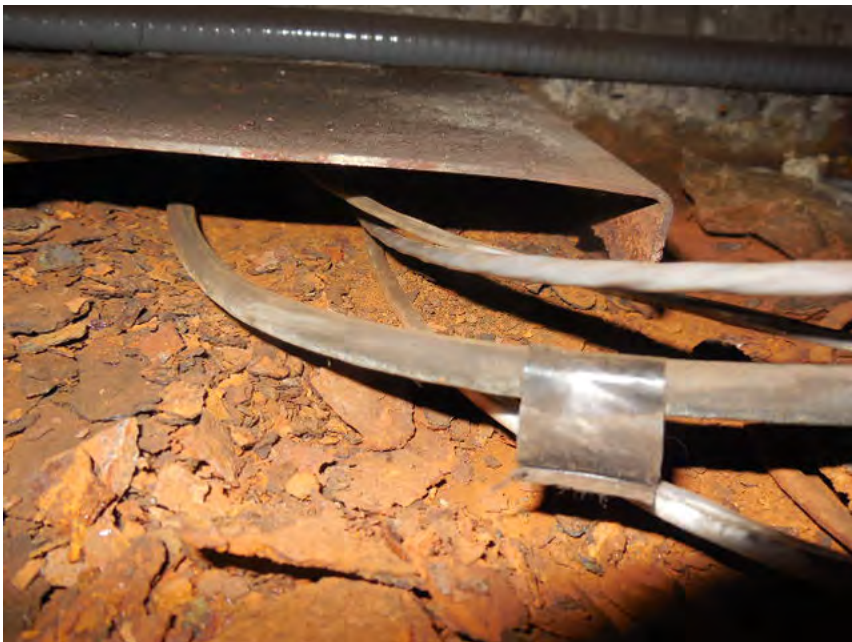
Photo #7: B10 Wheaton: Corroded communications duct opening in kiosk

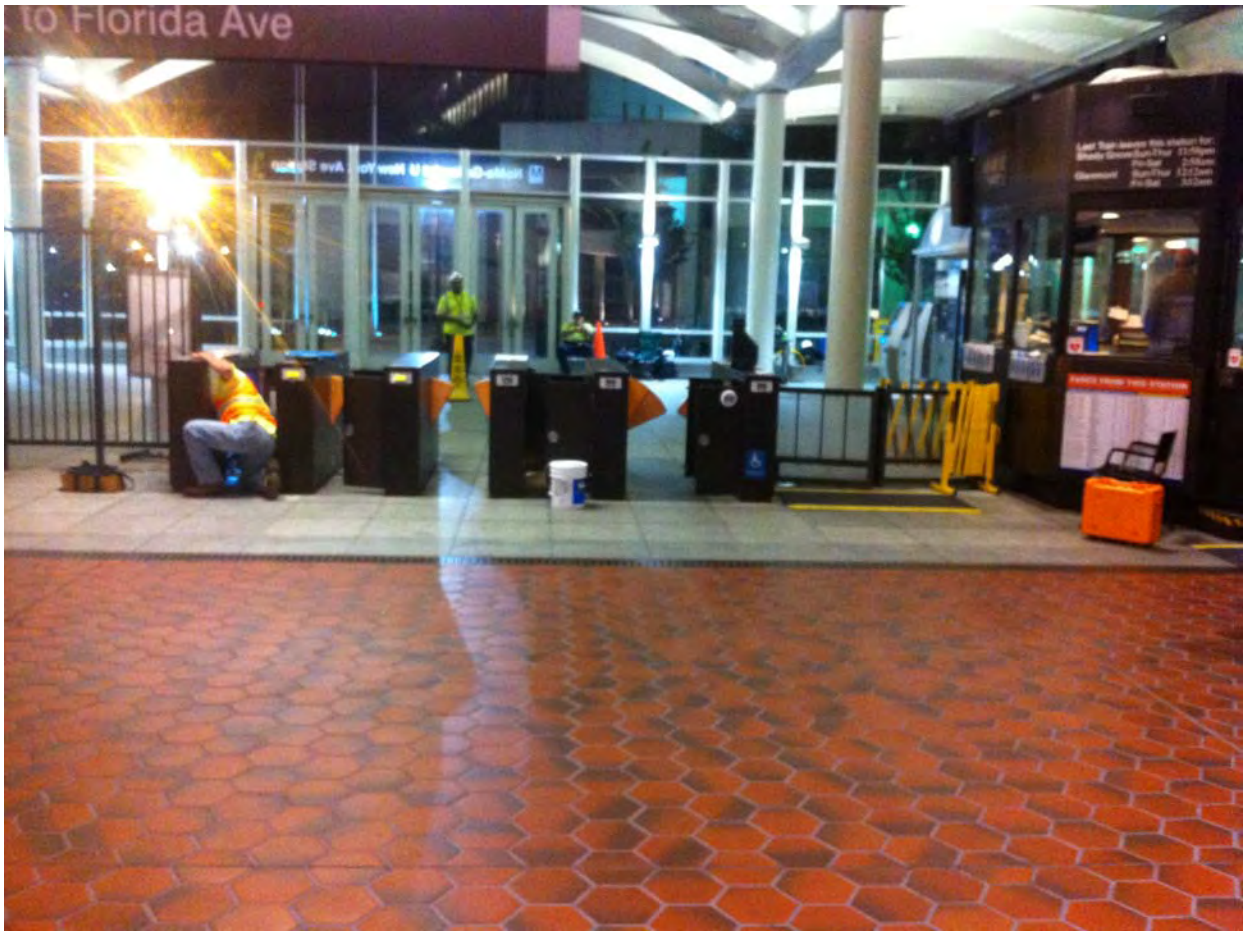
Photo #1 – Kiosk and Faregates on Mezzanine Floor

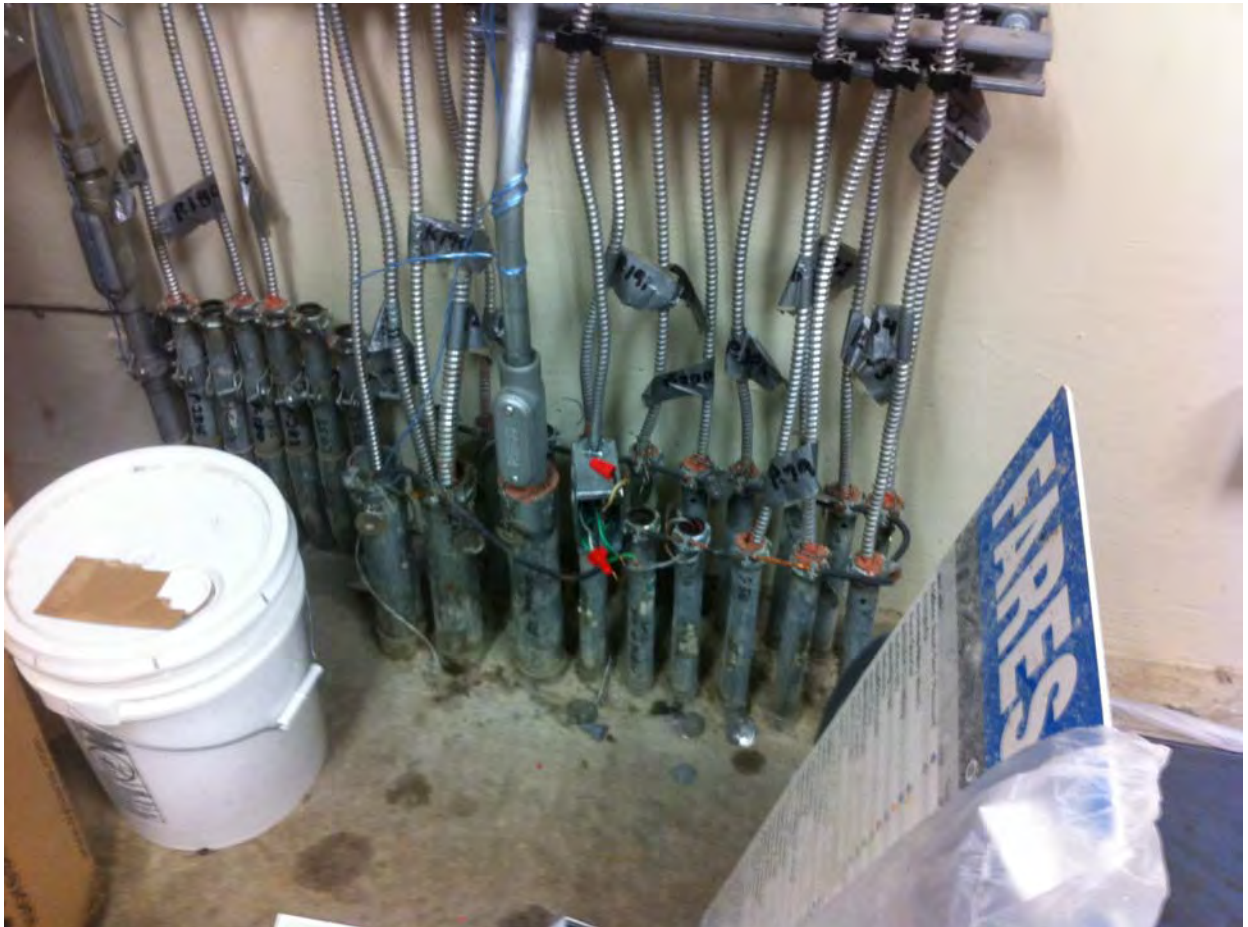
Photo #2 – Power Conduit transition to Armored Flex Cables leading to AFC Panel (Electrical Room 110)
