Invitation For Bid

Electrical and Data Cable Installation

Project Name: 15-NEPP-01 In-Floor Duct Inspections
Task: Mezzanine Inspection Reports
Date of Inspection: August 22, 2014
Mezzanine Inspected: A01 - Metro Center East
Report Includes:
- Mezzanine Inspection Checklist
- Field Photos
- Existing AFC Installation Plan with field notes

Mezzanine Inspection Report (Scoping)

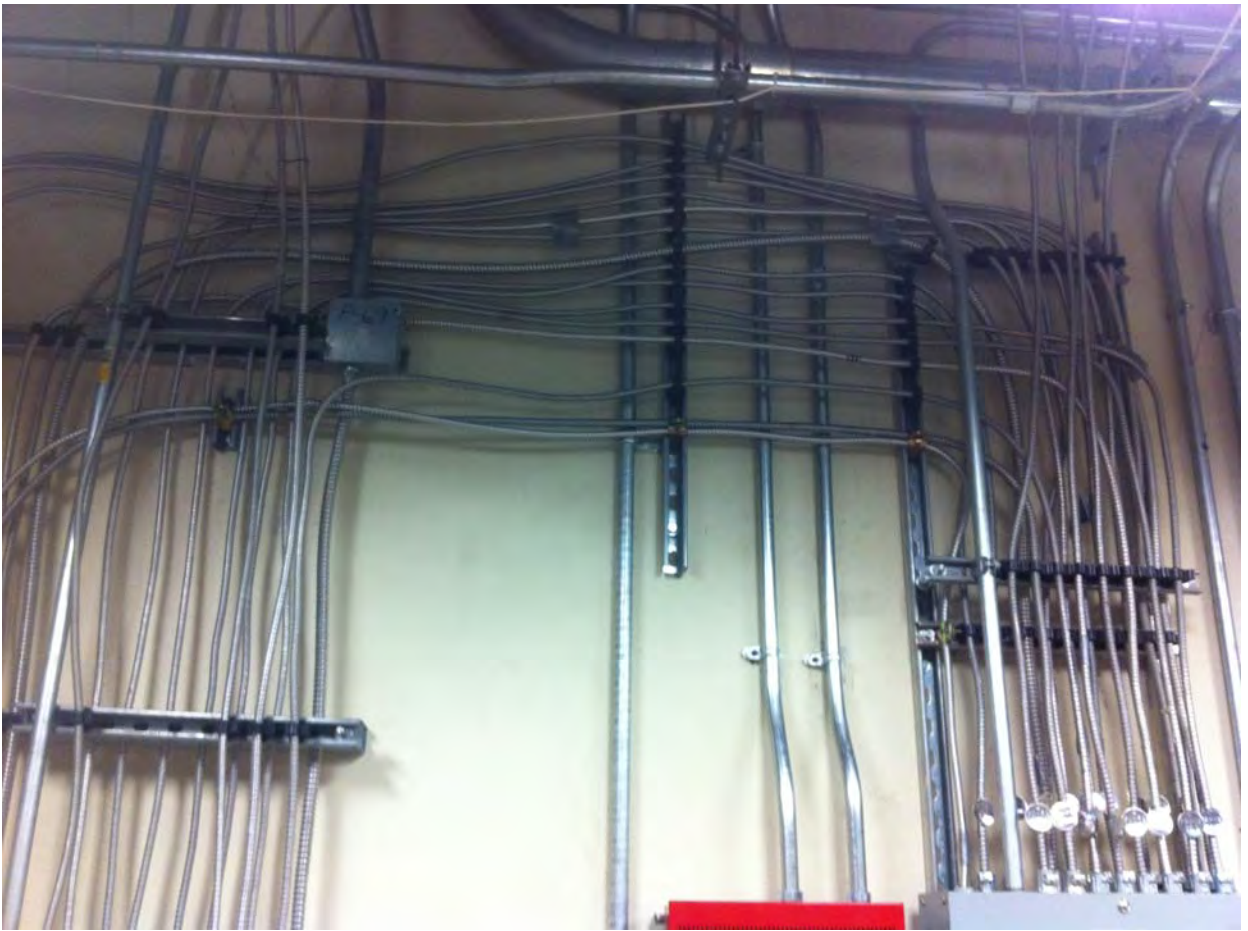
Photo #3 –Armored Flex Cables leading to AFC Panel (Electrical Room 110)

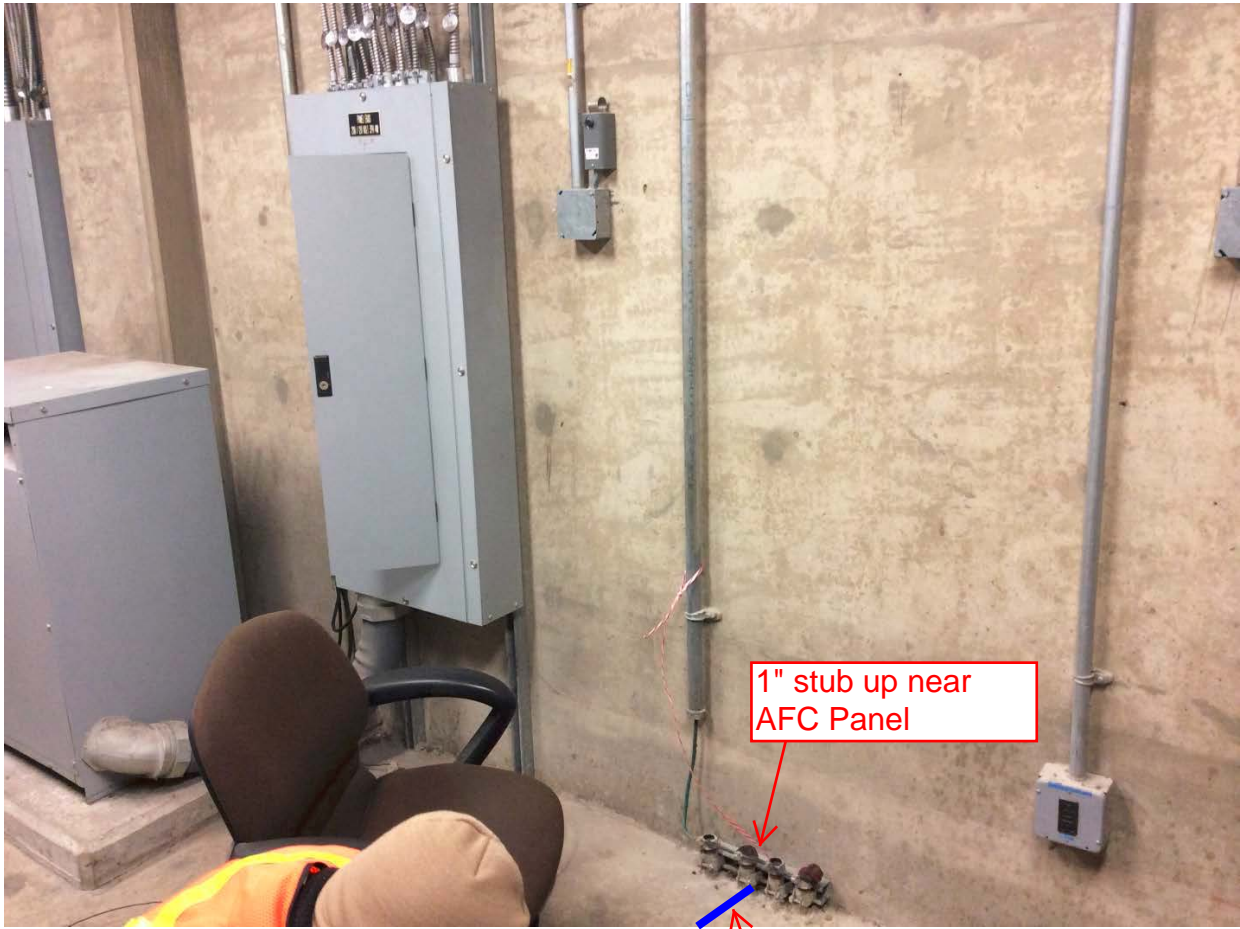
Photo #3 – B35 New York Ave South: AFC Panel near 1 inch stub up

1" conduit towards
proposed
connection to 4"
stub up

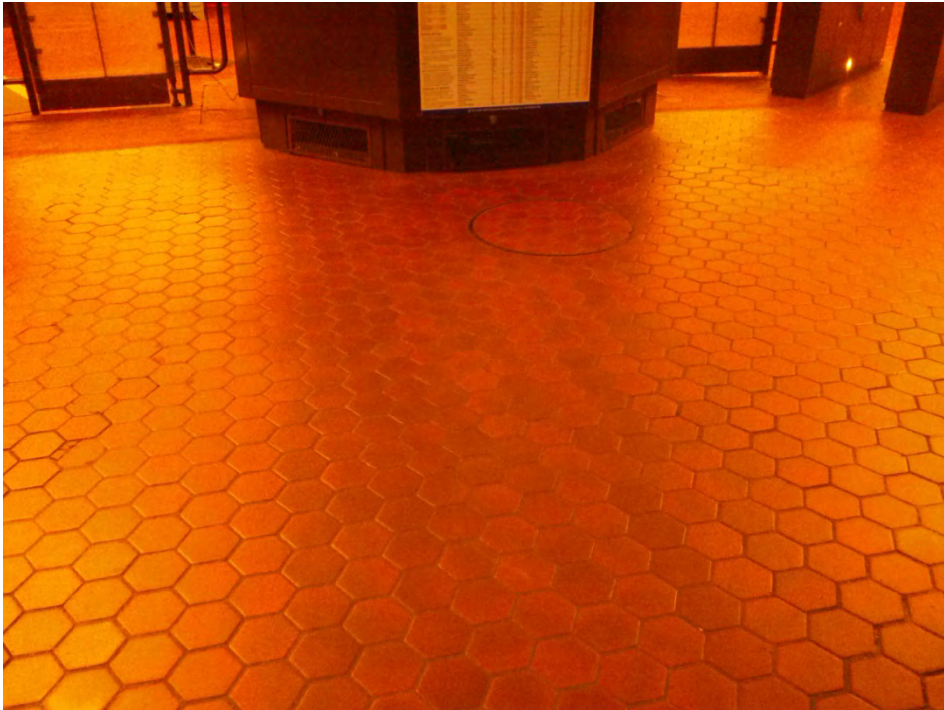
Photo #1: Kiosk on mezzanine floor

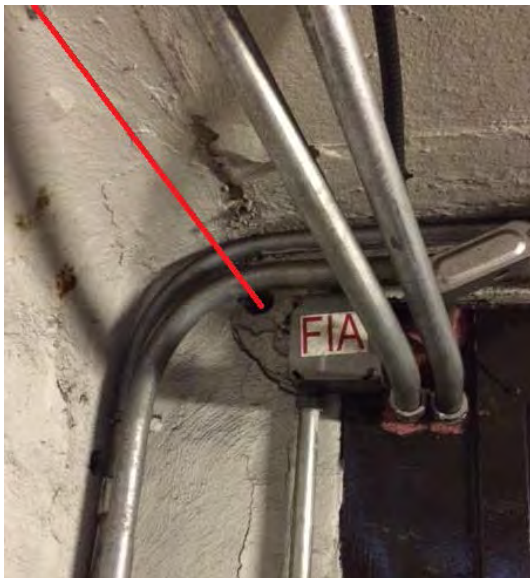
Farragut North NW Photo # 9 – Proposed conduit run through existing core drill

A proposed overhead conduit path from the Kiosk to the junction box has been identified (see photos 6-10 below) since the existing conduit from the Kiosk to the junction box is deemed to be unusable. There is no room for installation of new in-floor duct based on the location of the existing manhole and the existing ducts. It is recommended to install overhead conduit from the kiosk along the recessed channel along the ceiling of the mezzanine and transition into the existing junction box located in the service hallway. There is already an existing core drill hole, so a core drill may not be required.

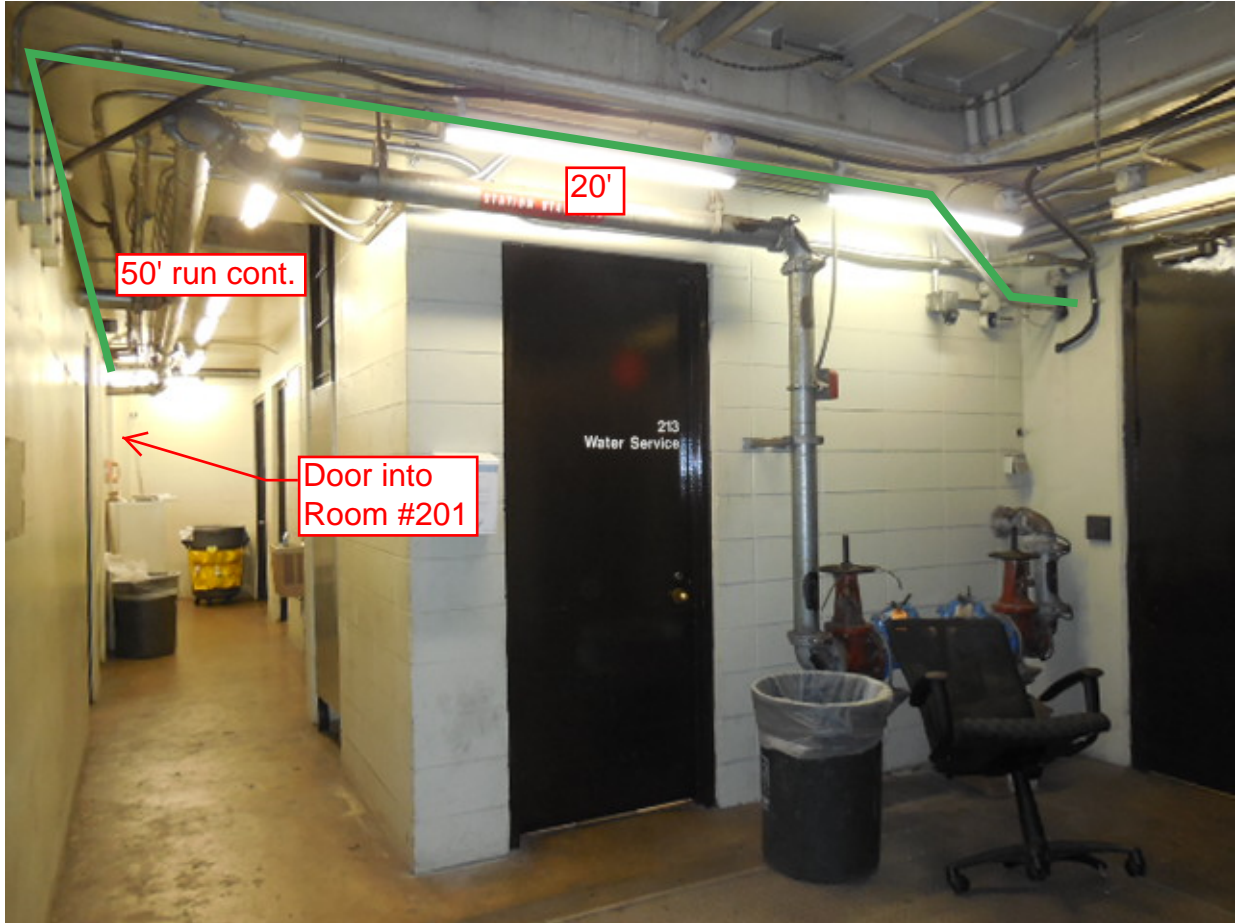
Photo #7 – A03 Dupont Circle South: Proposed conduit run continuing down hallway of room #201 and towards room #215

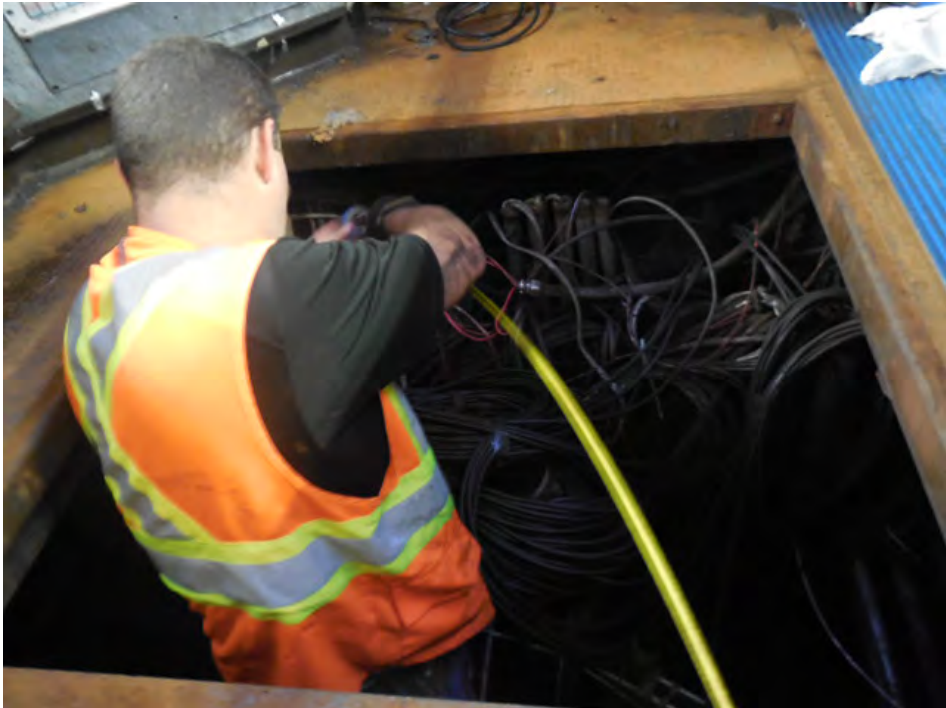
Photo #4: A08 Friendship Heights – Installing pull string between kiosk and AFC panel

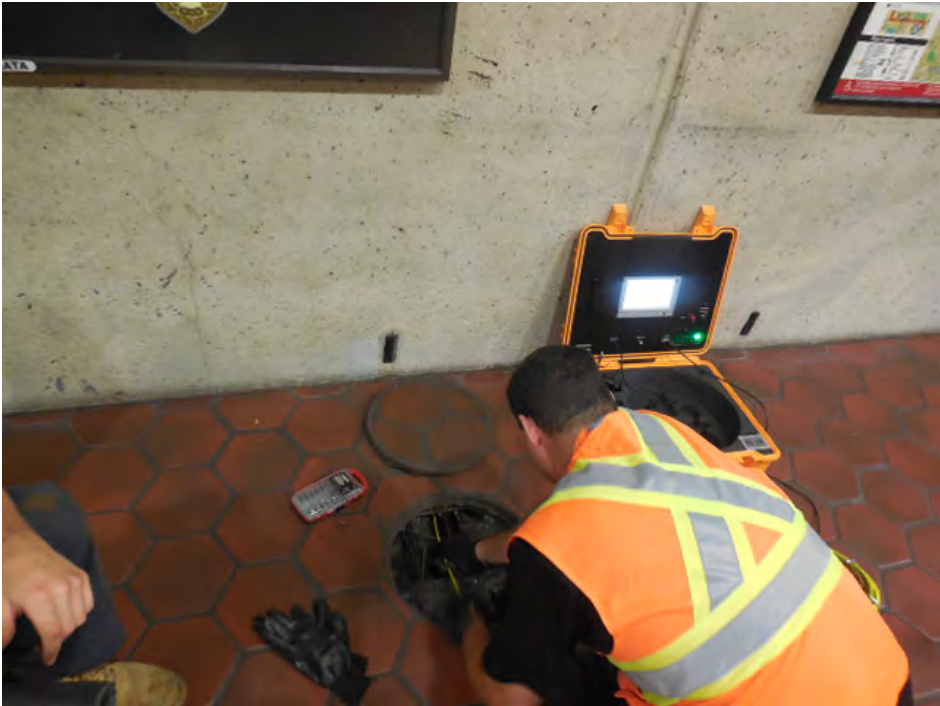
Photo #6: A08 Friendship Heights – Video-scoping the power ducts between kiosk and AFC panel

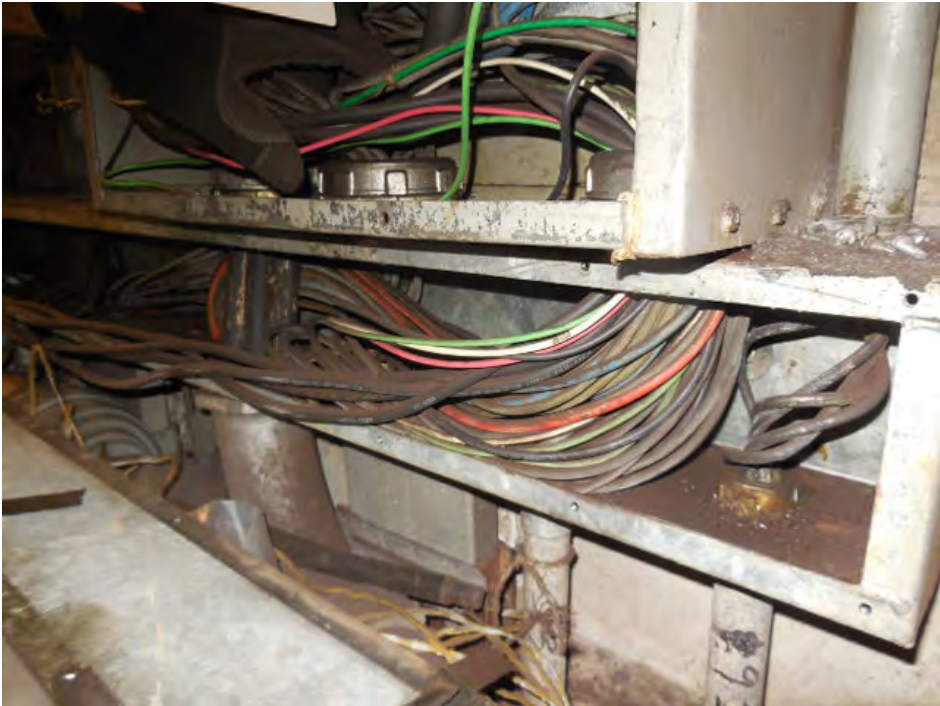
Photo #7: A08 Friendship Heights – Cable trough below AFC Panel. Power ducts from kiosk feed into bottom of trough

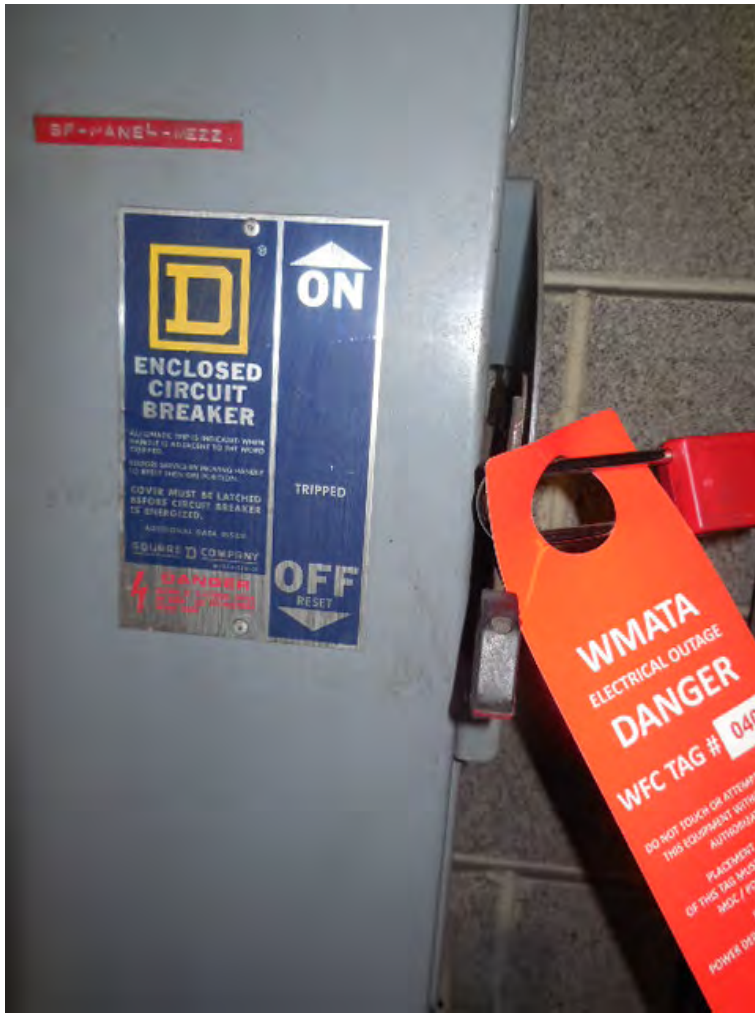
Photo #1: A12 White Flint – Lock-out tag-out of AFC Panel source breaker

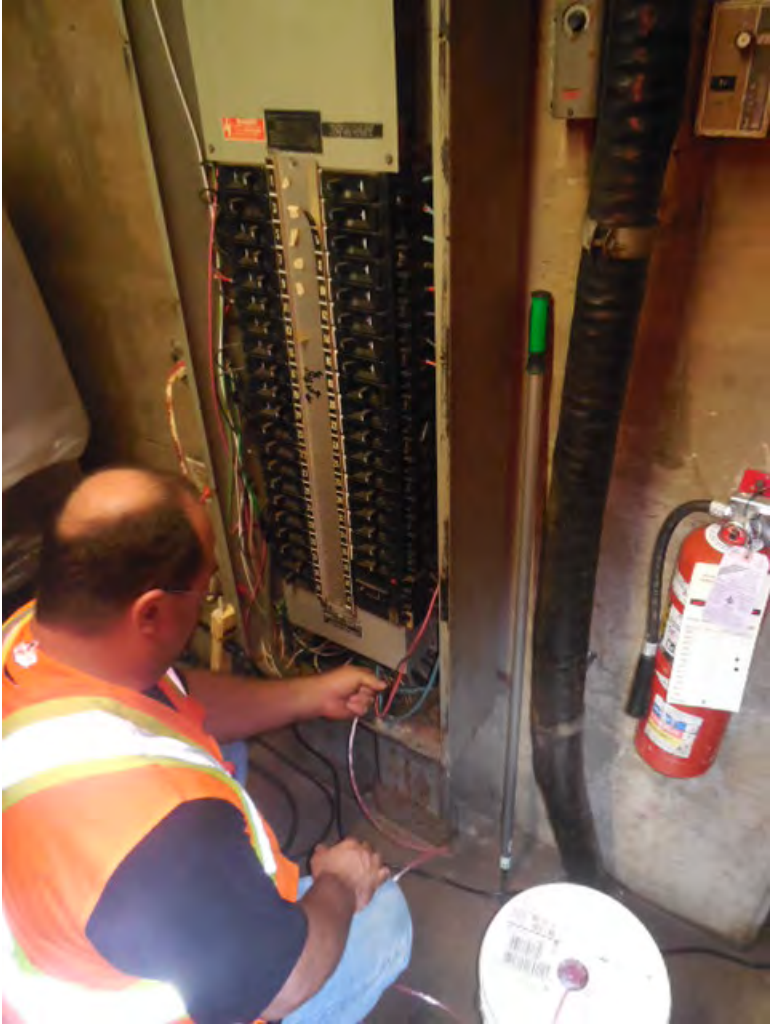
Photo #6: A12 White Flint – Pull string installation in AFC panel from kiosk

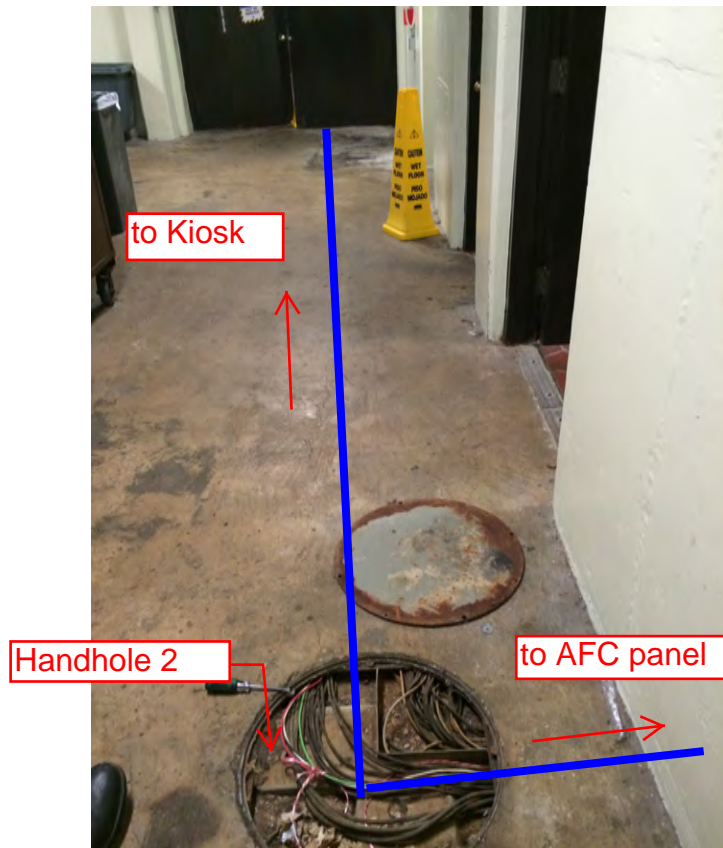
Rockville Photo #2 – Duct route between Kiosk and Electrical Room

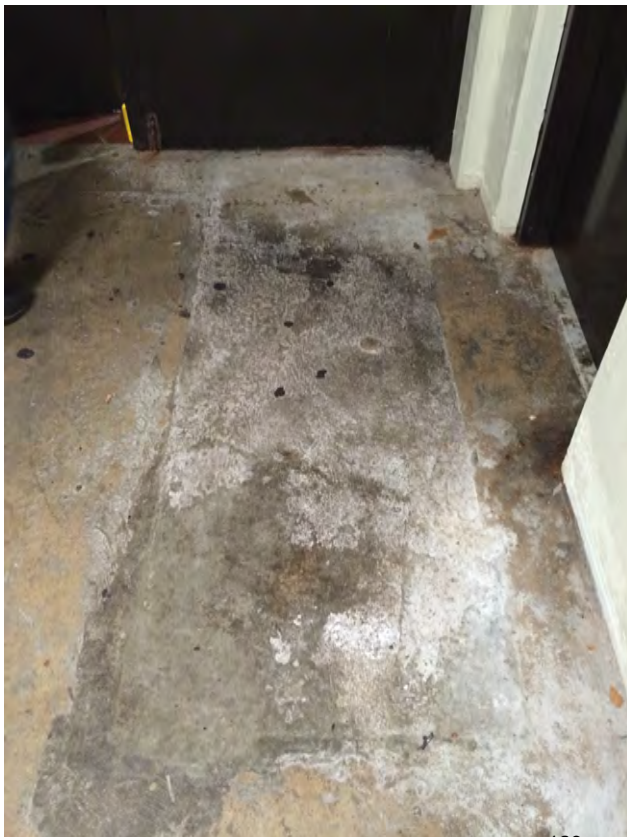
Rockville Photo #3 – Concrete repair to floor in back hallway outside Room C113

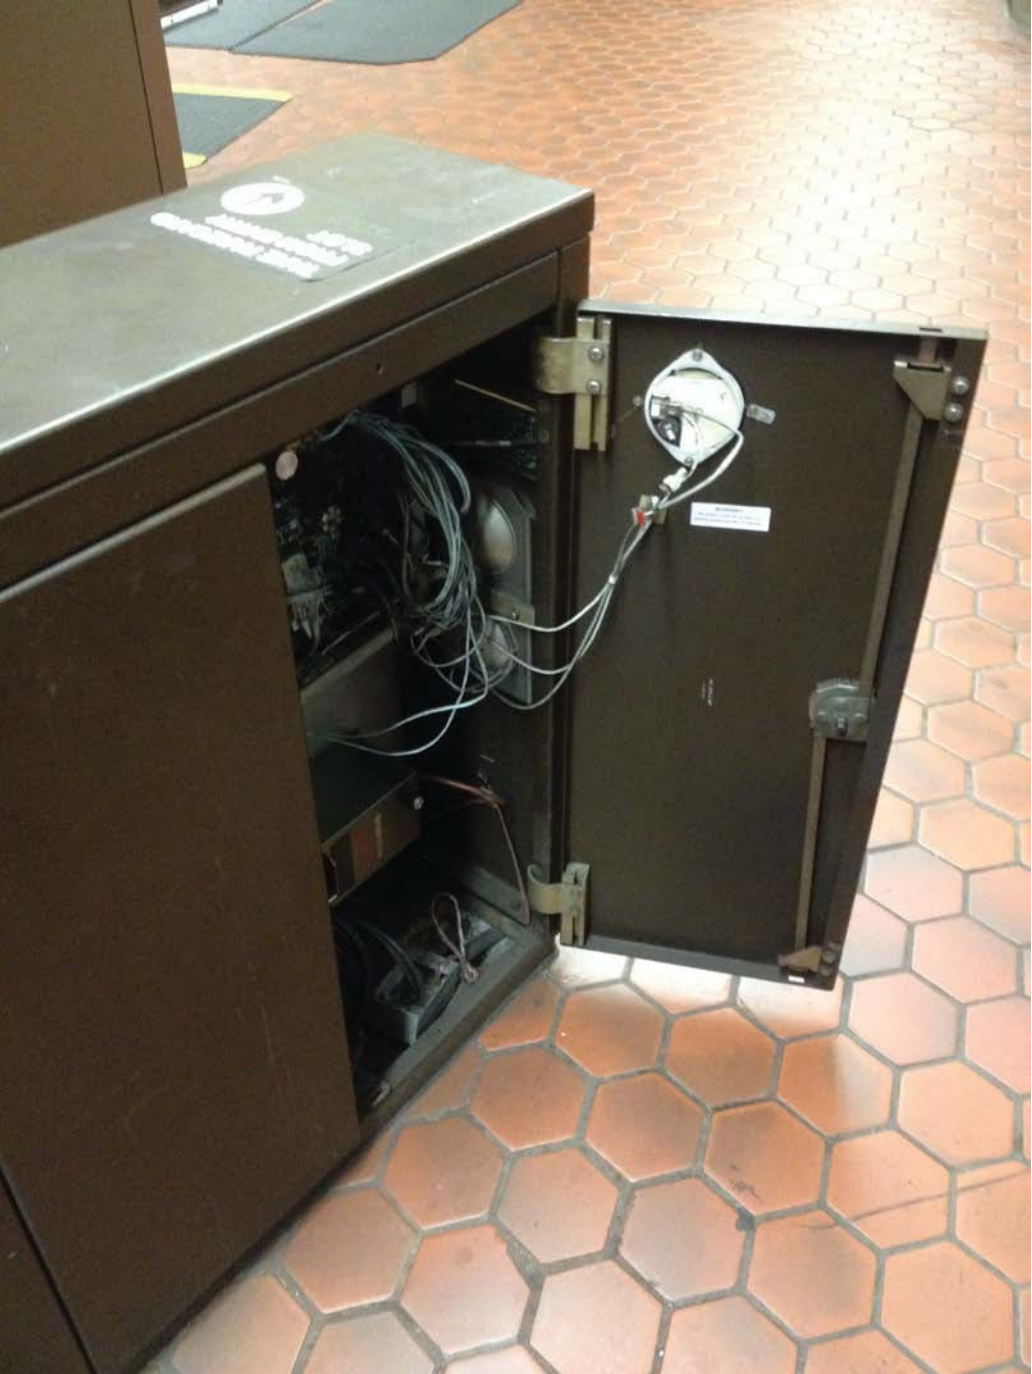
Photo #1: B02 Judiciary Square (East) – Faregate with new comm. duct and cable installed

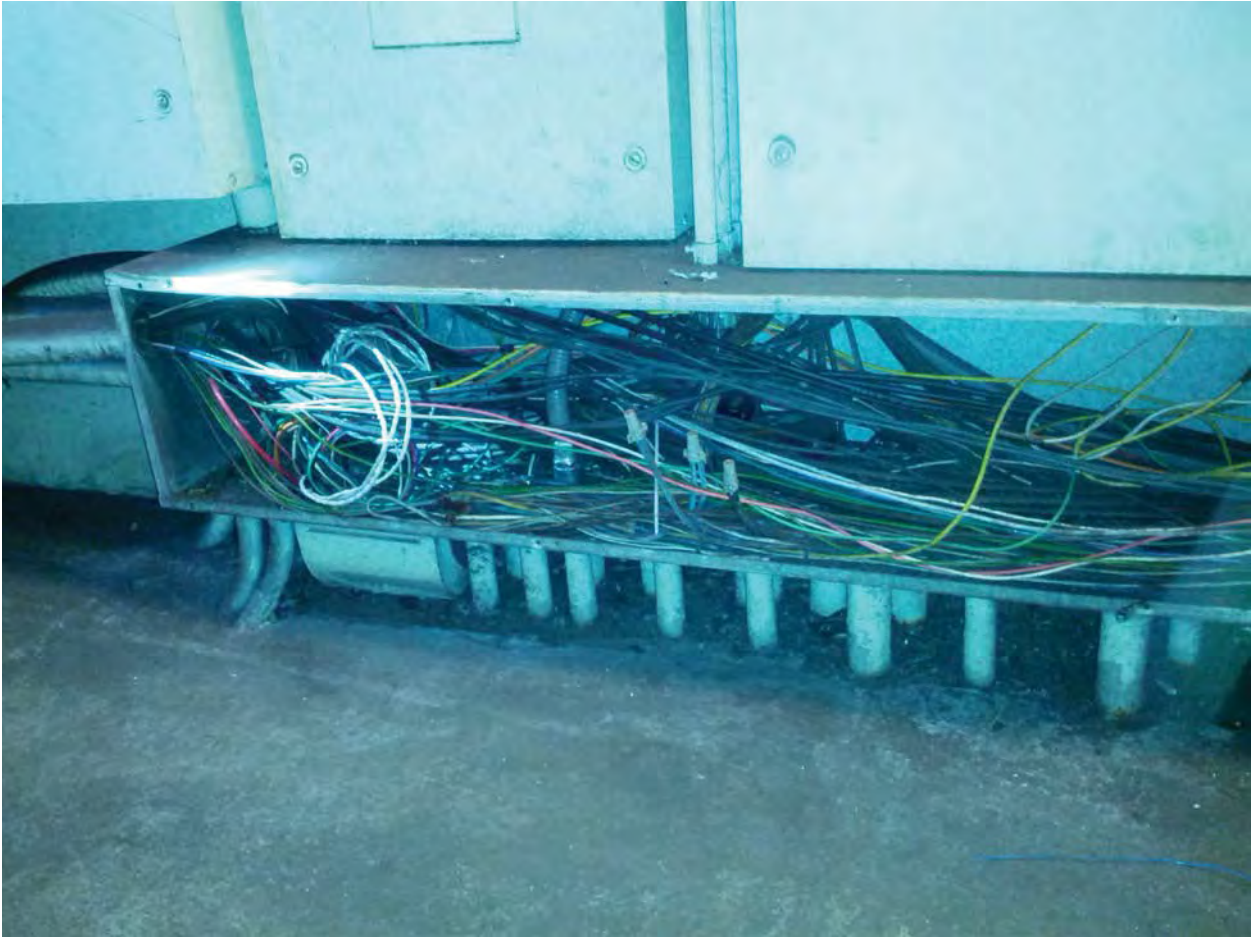
Photo #4: B02 Judiciary Square (East) – Shared cable trough in room 206. Power duct enters trough from the bottom at left.

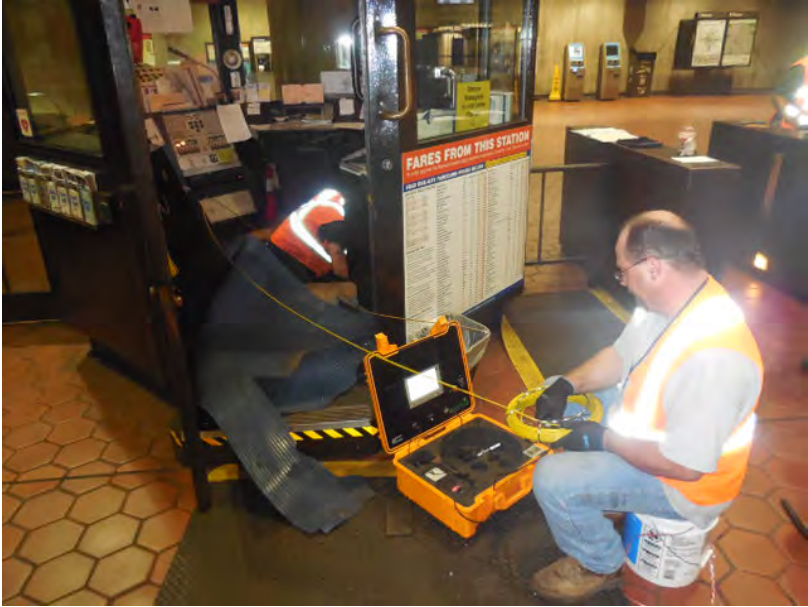
Photo #4: B10 Wheaton: Attempting to video-scope the faregate array ducts

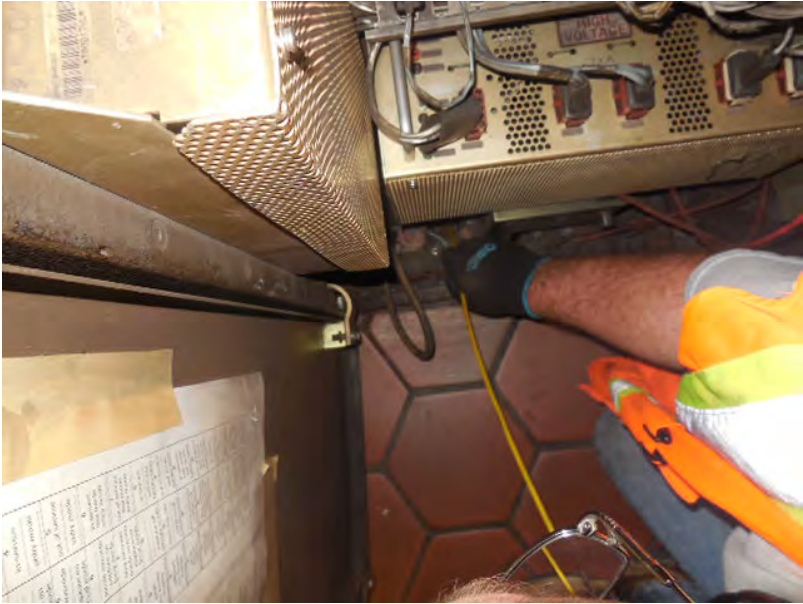
Photo #5: B10 Wheaton: Attempting to rod the faregate array ducts

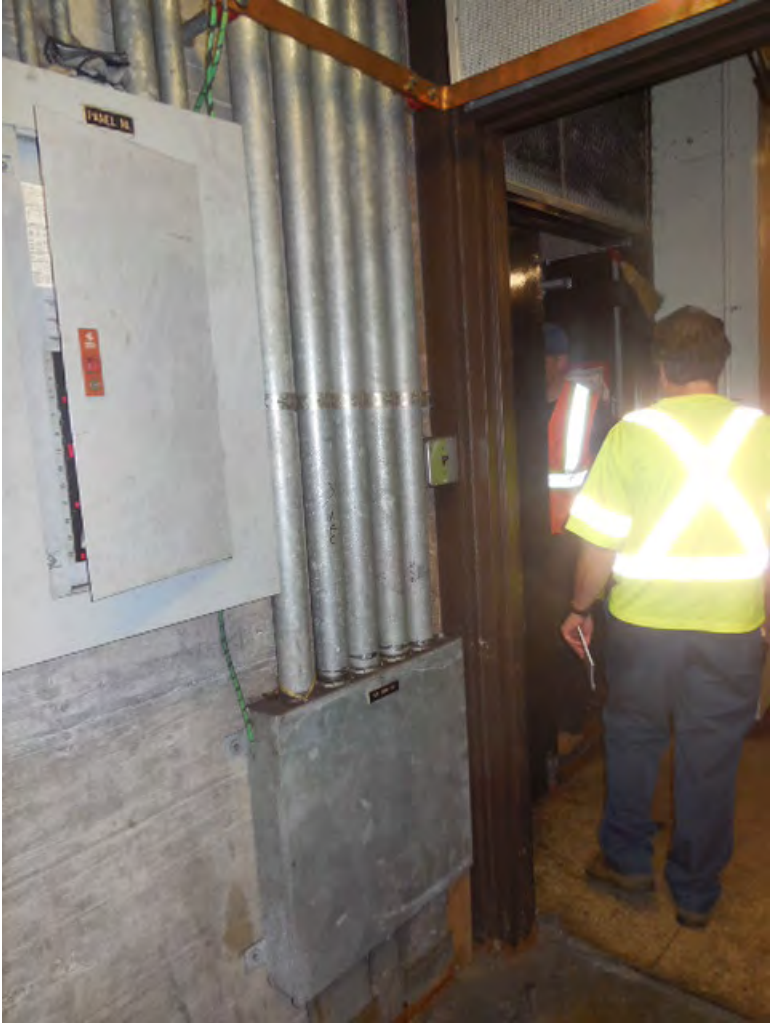
Photo #9: B10 Wheaton: Junction box near the AFC panel
