Northern Bus Garage

Noise, Vibration, and Dust Monitoring Report (December 2023)

WMATA Bus Garage Monthly Report

December 2023

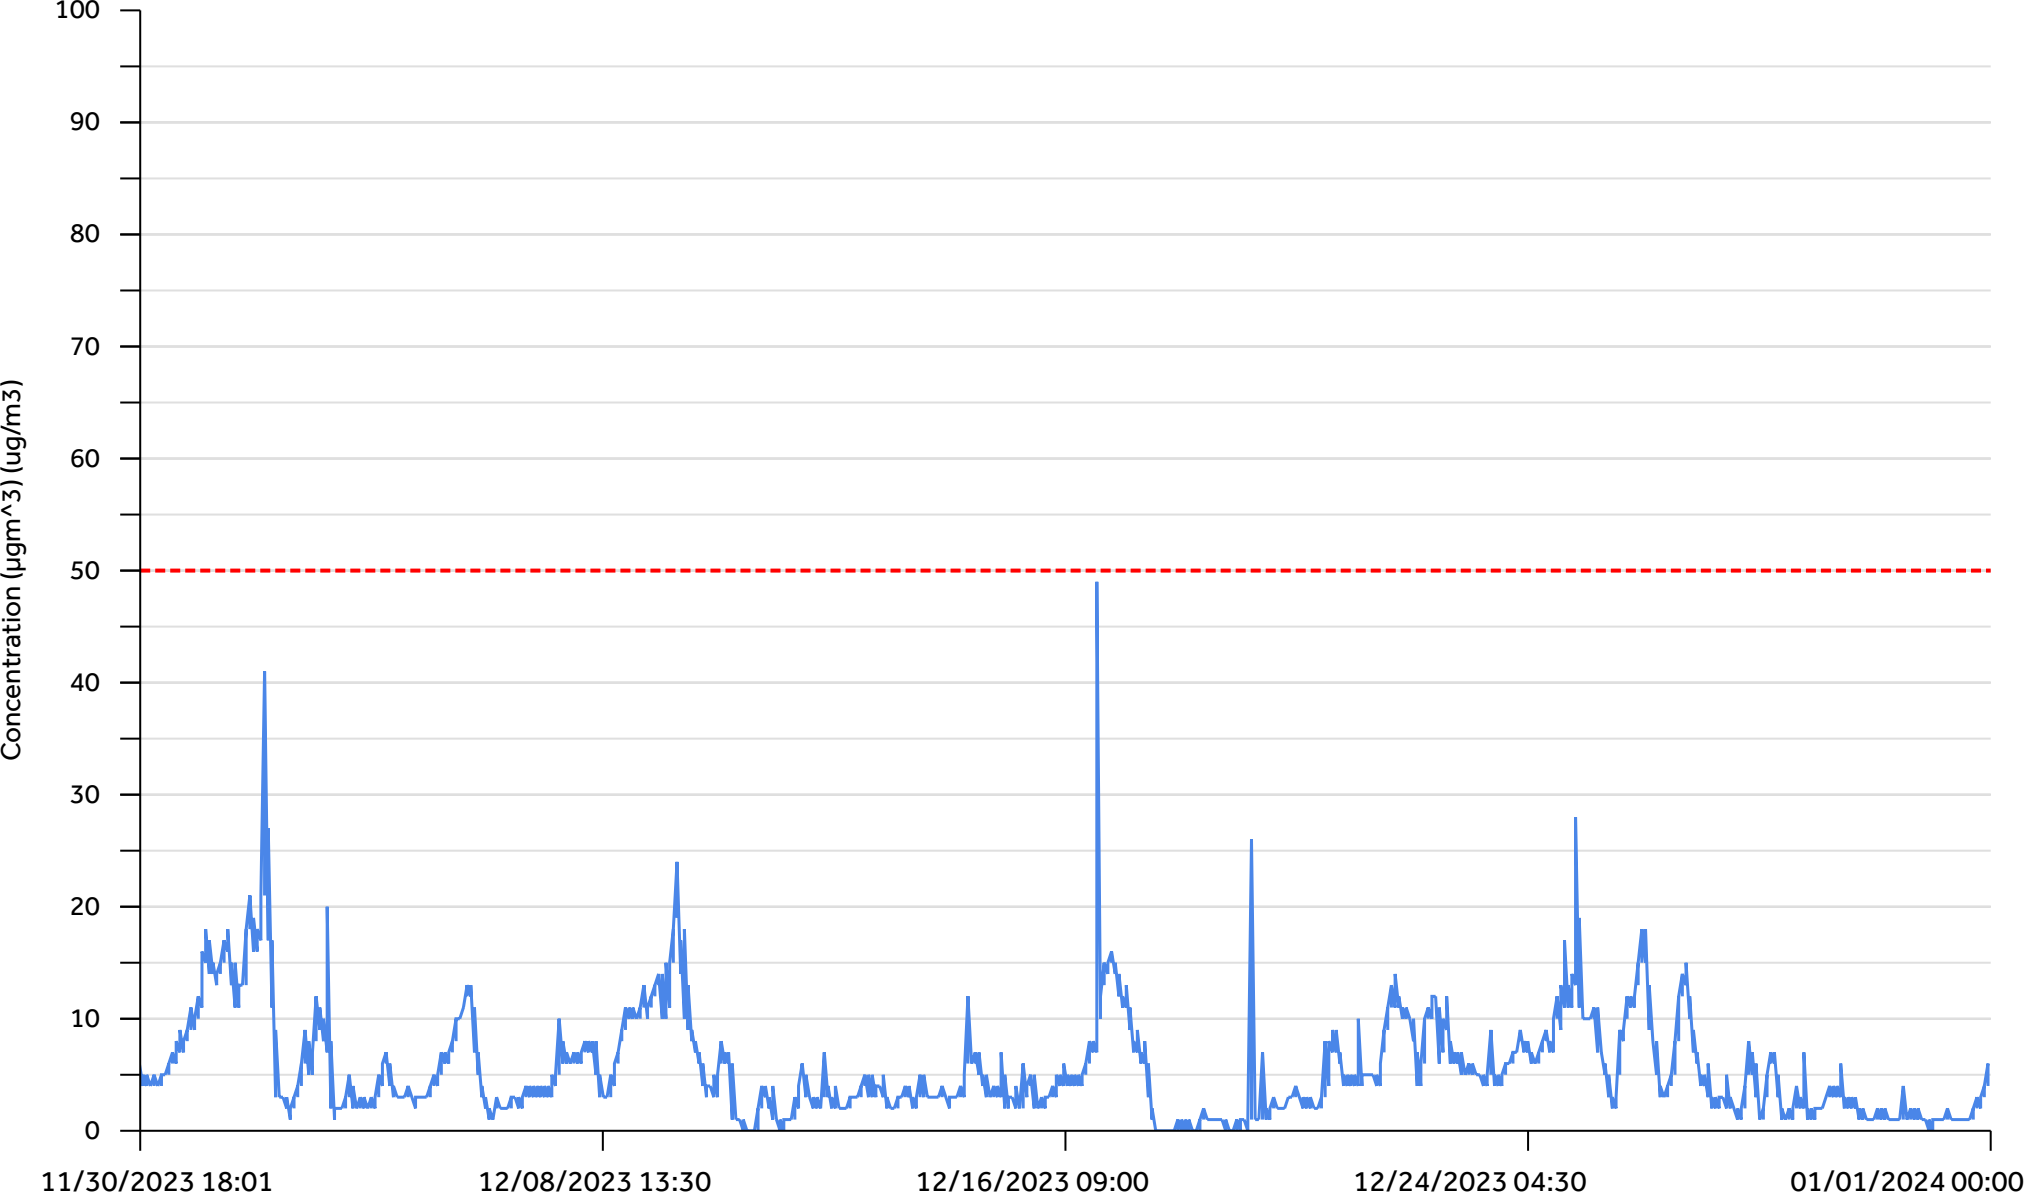
Graph 7:
DM2-PM10

Higher winds in the evening of December 2 caused exceedances from 9:36pm to 9:47 pm. DM2 recorded a PM2.5 of 41. DM3 recorded a PM2.5 of 51 and a PM10 of 53. More winds on the evening of December 16 caused an exceedance at 11:12 pm. DM1 recorded a PM2.5 of 65 and a PM10 of 89.
