Northern Bus Garage

Noise, Vibration, and Dust Monitoring Report (July 2025)

Noise, Vibration, and Dust levels were monitored as part of the reconstruction of Northern Bus Garage, 4615 14th Street, NW, Washington, DC, for the month of July 2025.

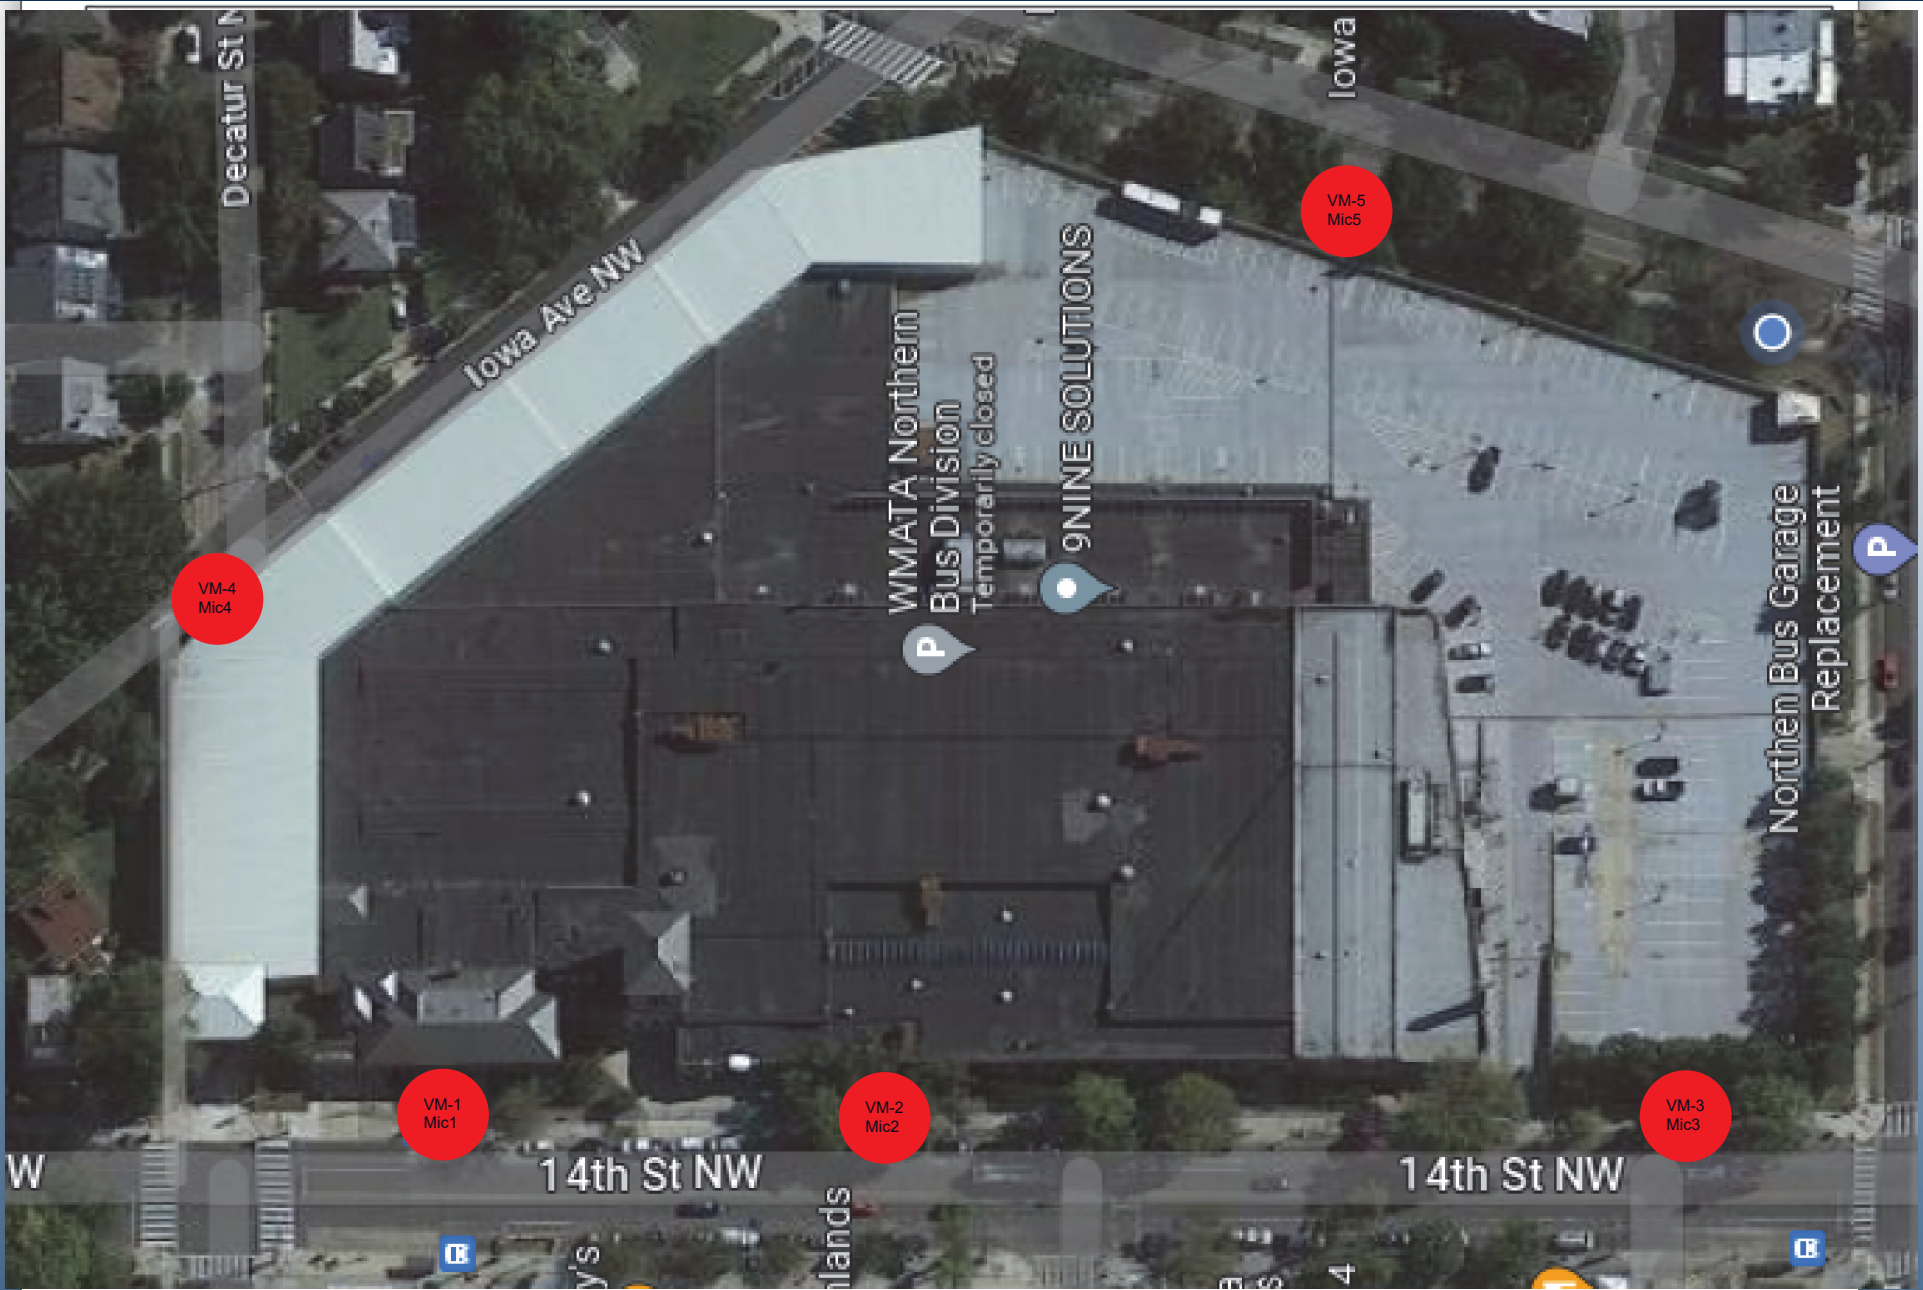
Figure 1: Vibration and Noise Monitor Location Plan

Five noise monitors are positioned around the perimeter of the project site. (See Figure 1) Under DC regulations, the regulatory standard is 80 dBA, measured 25 ft from the property line (20 DCMR 2802.1). Because the noise monitoring devices are placed on the property line (rather than a 25 ft offset), the monitoring threshold for site activities is adjusted to 85 dBA (assuming the noise level will dissipate). Noise levels and vibration levels were measured automatically with Micromate and Geophone Instrument.

Five vibration monitors are positioned around the perimeter of the project site. (See Figure 1) Vibration thresholds are based the WMATA Design Criteria. Monitors VM-1 and VM-2 are set at a lower vibration threshold due to their proximity to the historic façade, which is more sensitive to any movement. Noise levels and vibration levels were measured automatically with Micromate and Geophone Instrument.

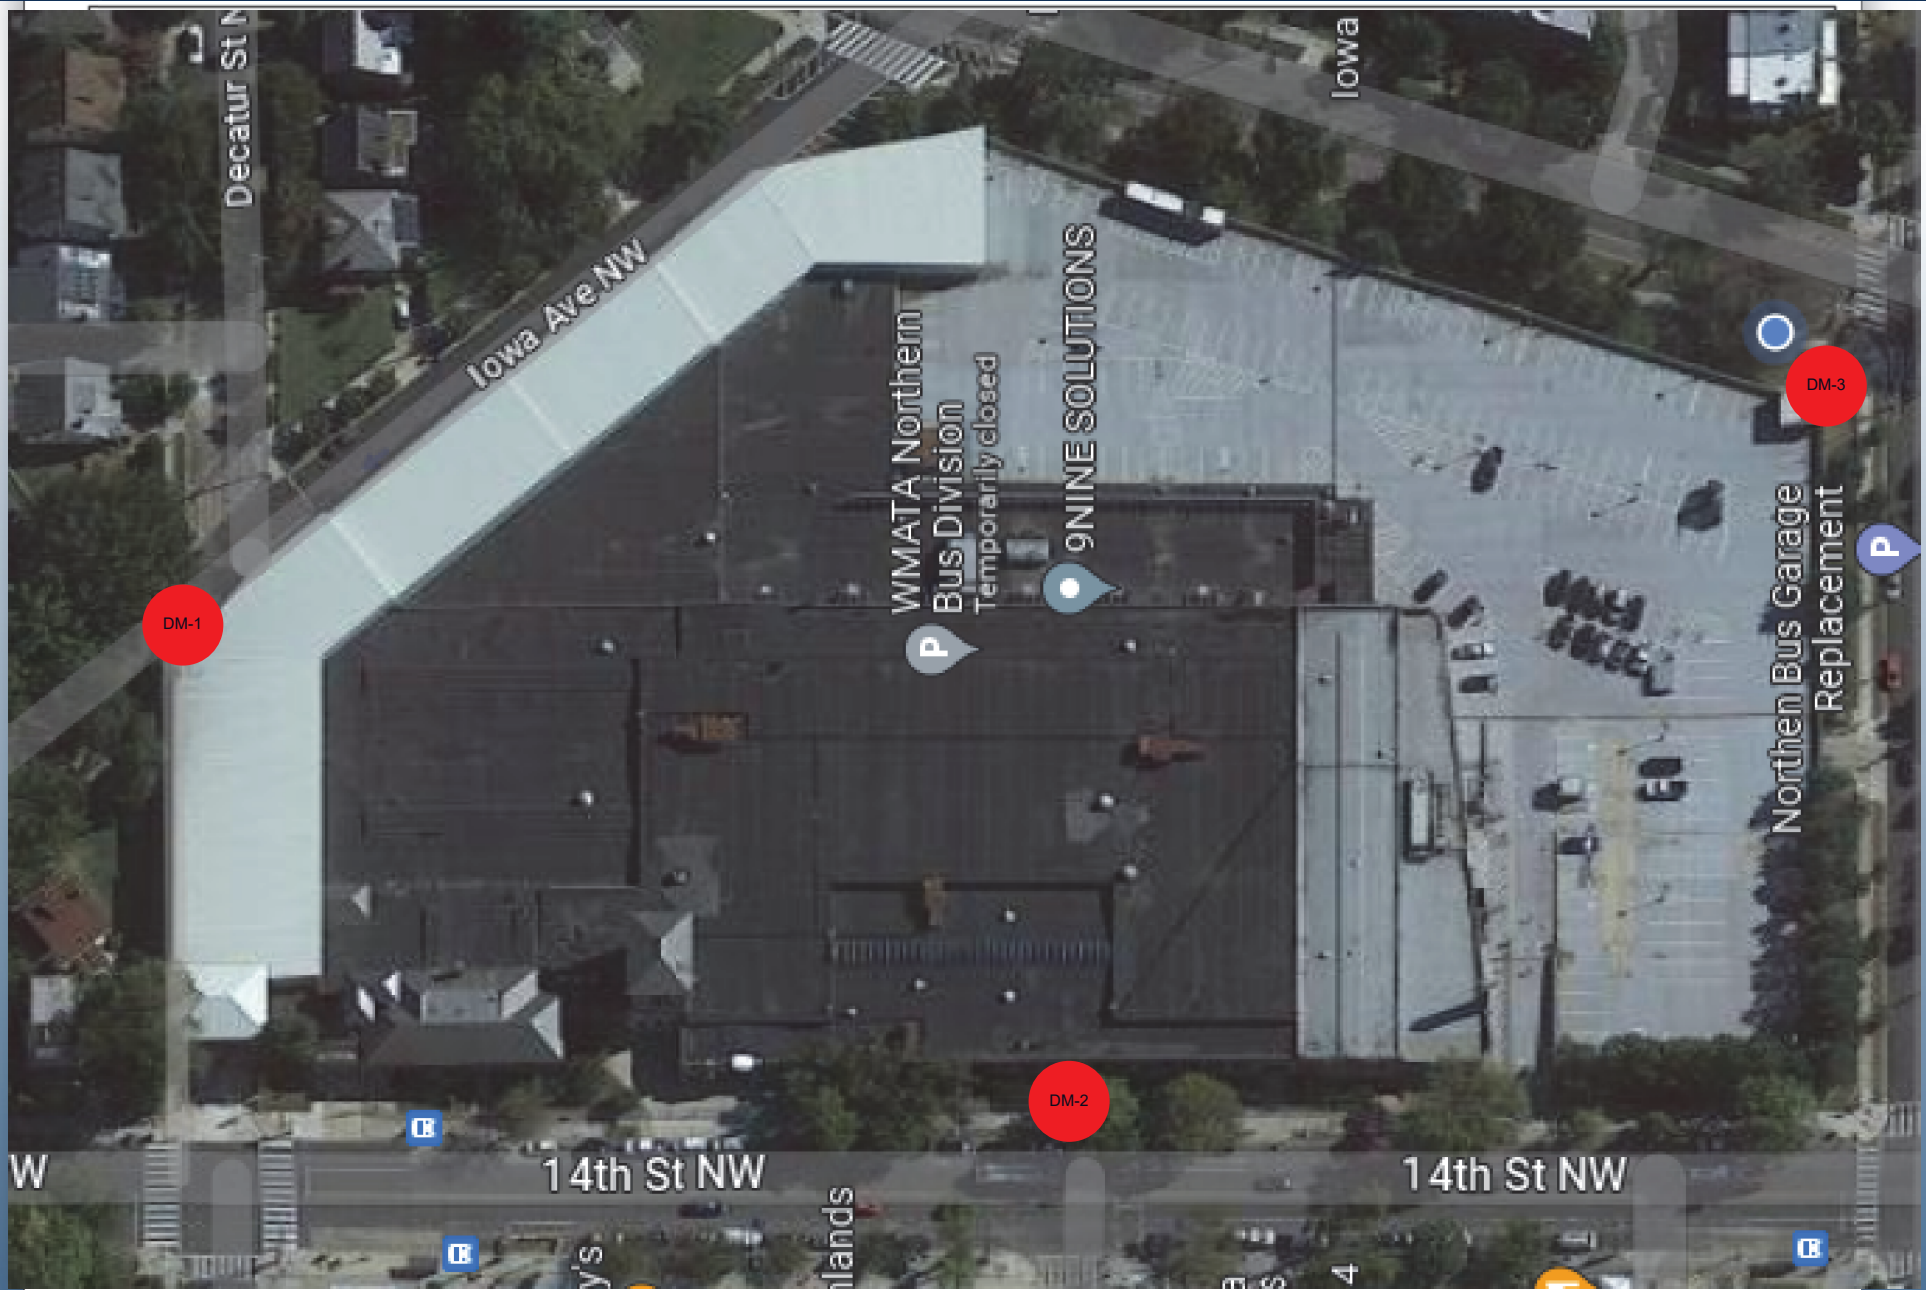
Figure 2: Dust Monitor Location Plan

Three dust monitors are positioned at the project site. (See Figure 2) EPA regulatory thresholds are based on a 24-hour monitoring period; the project has adopted thresholds to monitor site levels and provide an indication of when EPA standards might be exceeded. (See Table 3) Dust measurements were monitored using Aeroqual Dust Sentry Pro.
