Monitoring Report

WMATA Bus Garage Monthly Report

**July 2023**

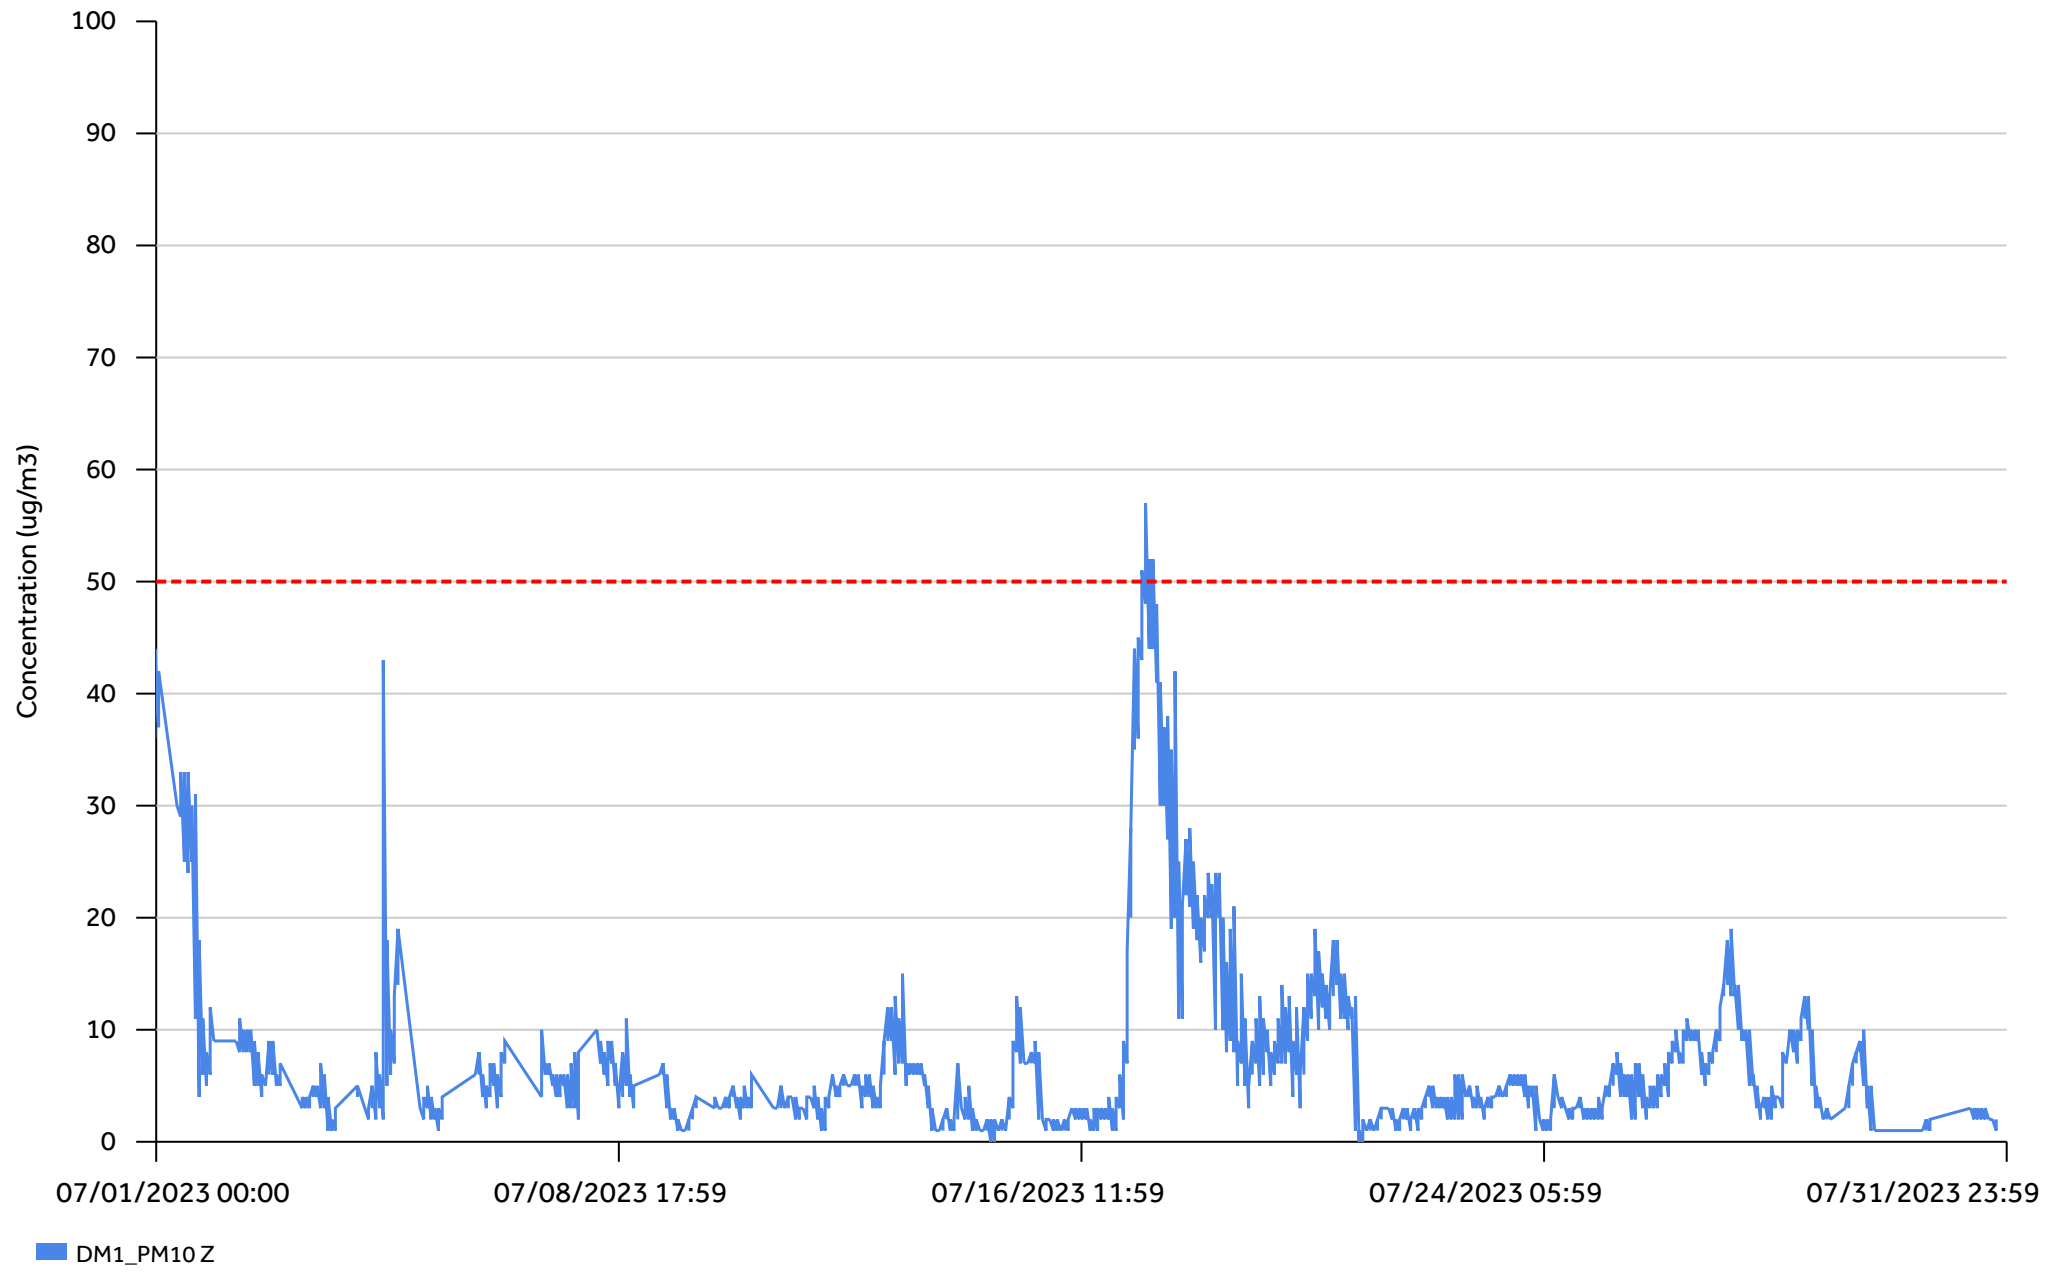
DM1 - PM10

DM1 – 7/4 2036h, 43  $\mu\text{g}/\text{m}^3$ .

DM1 – 7/17 1432h. 57  $\mu\text{g}/\text{m}^3$ .

A review of the data reveals threshold exceedances from regional poor air quality events on July 4th and 17th as found on [www.CleanAirPartners.net](http://www.CleanAirPartners.net). DM2 experienced power failure during most of the July 21 through 31 period. DM3 also experienced power failure from July 14 through 19 and from July 20 through 22. These units require a lot of power and DM3 has now been moved to mains power to ensure reliability. New modems are being sourced now that will allow us to measure incoming voltage and set alarms if it drops below a certain threshold.

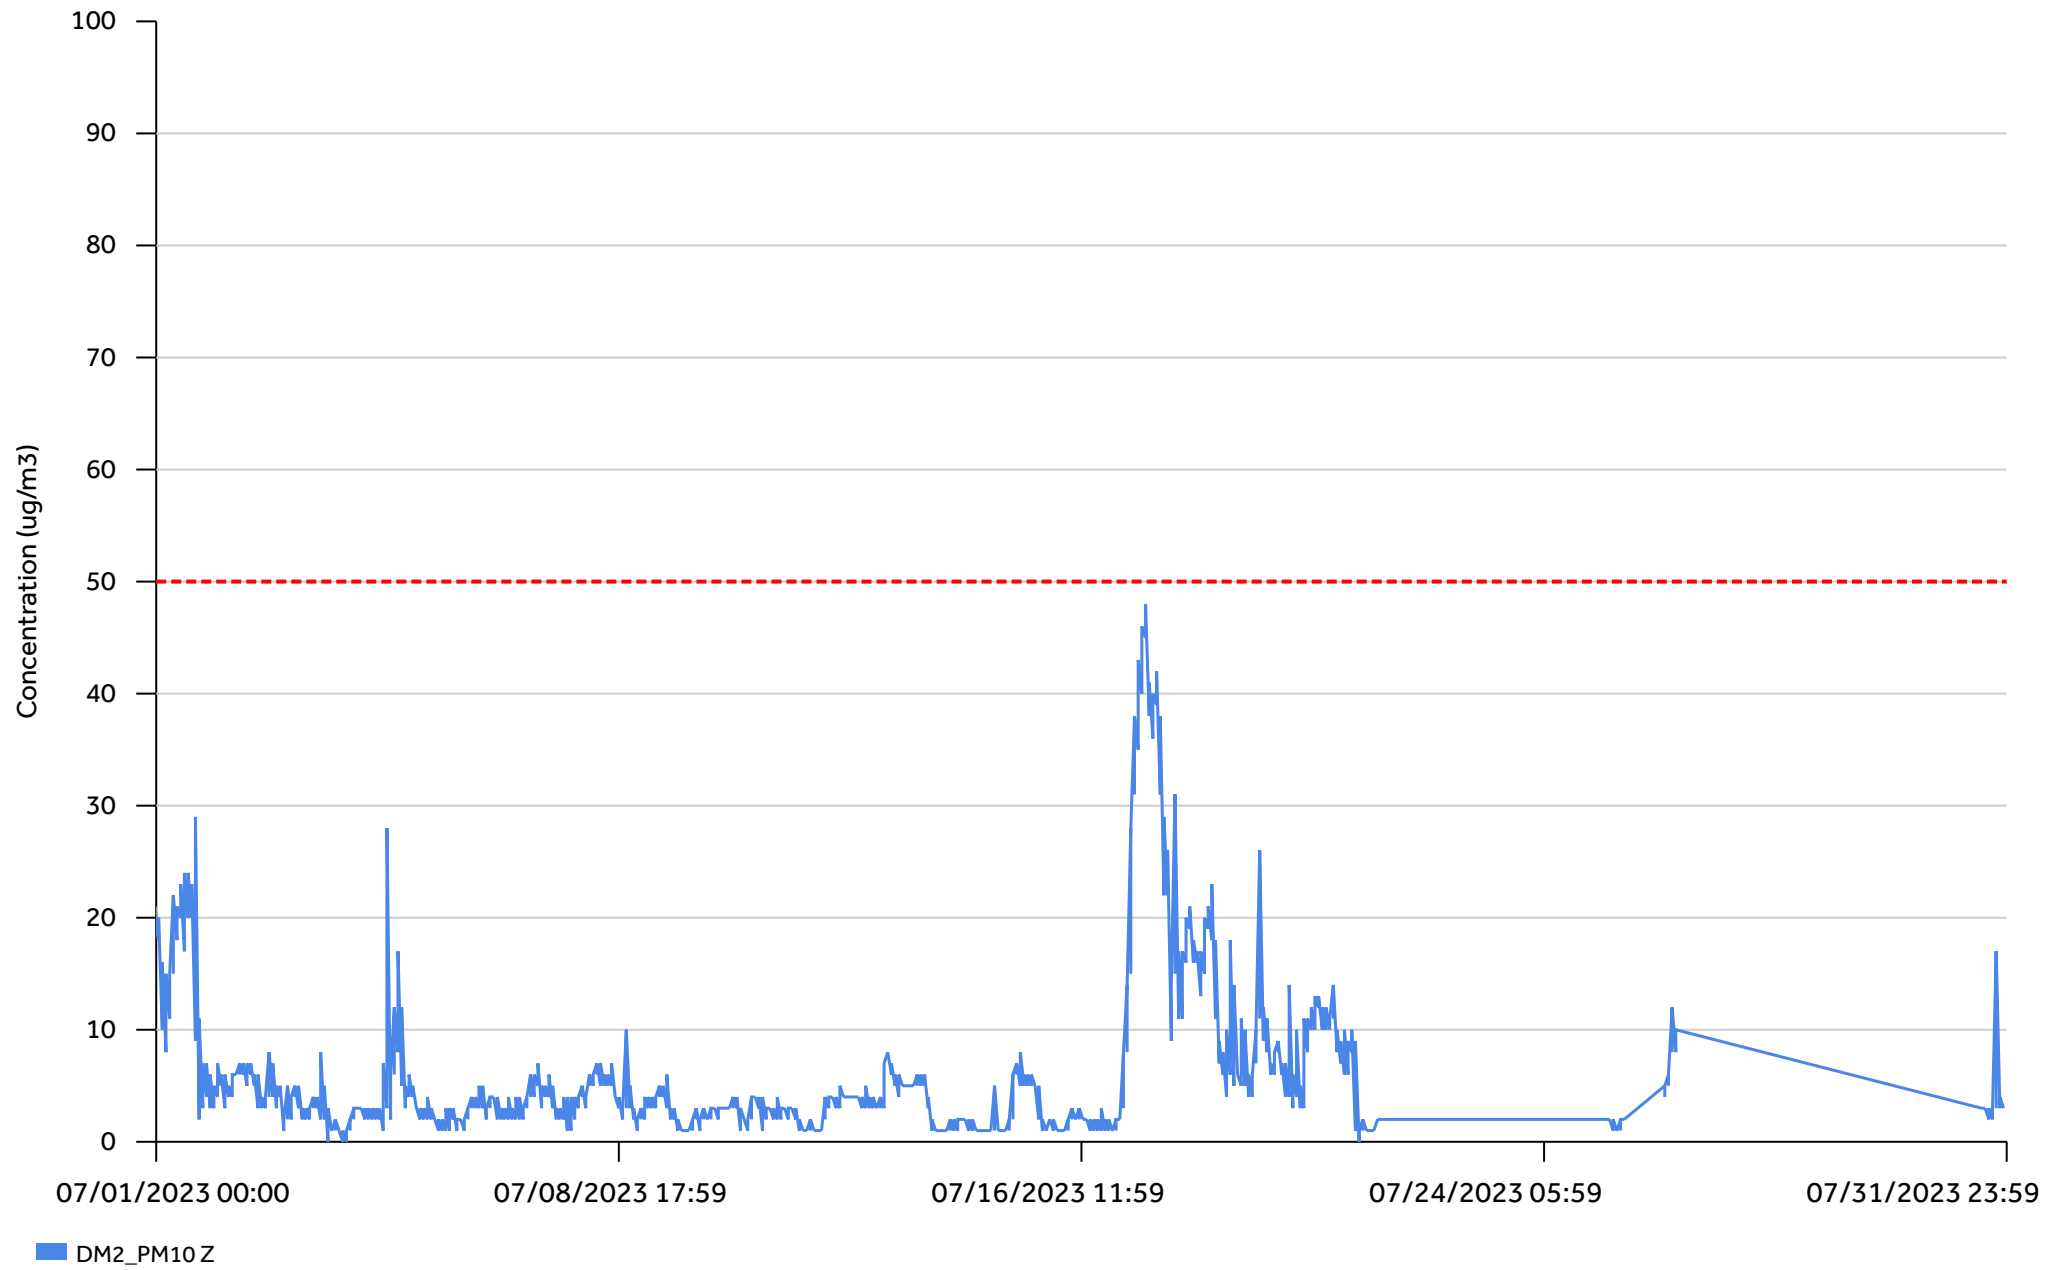
DM2-PM10

DM2 – 7/17 1116-1930h, 48  $\mu\text{g}/\text{m}^3$ .

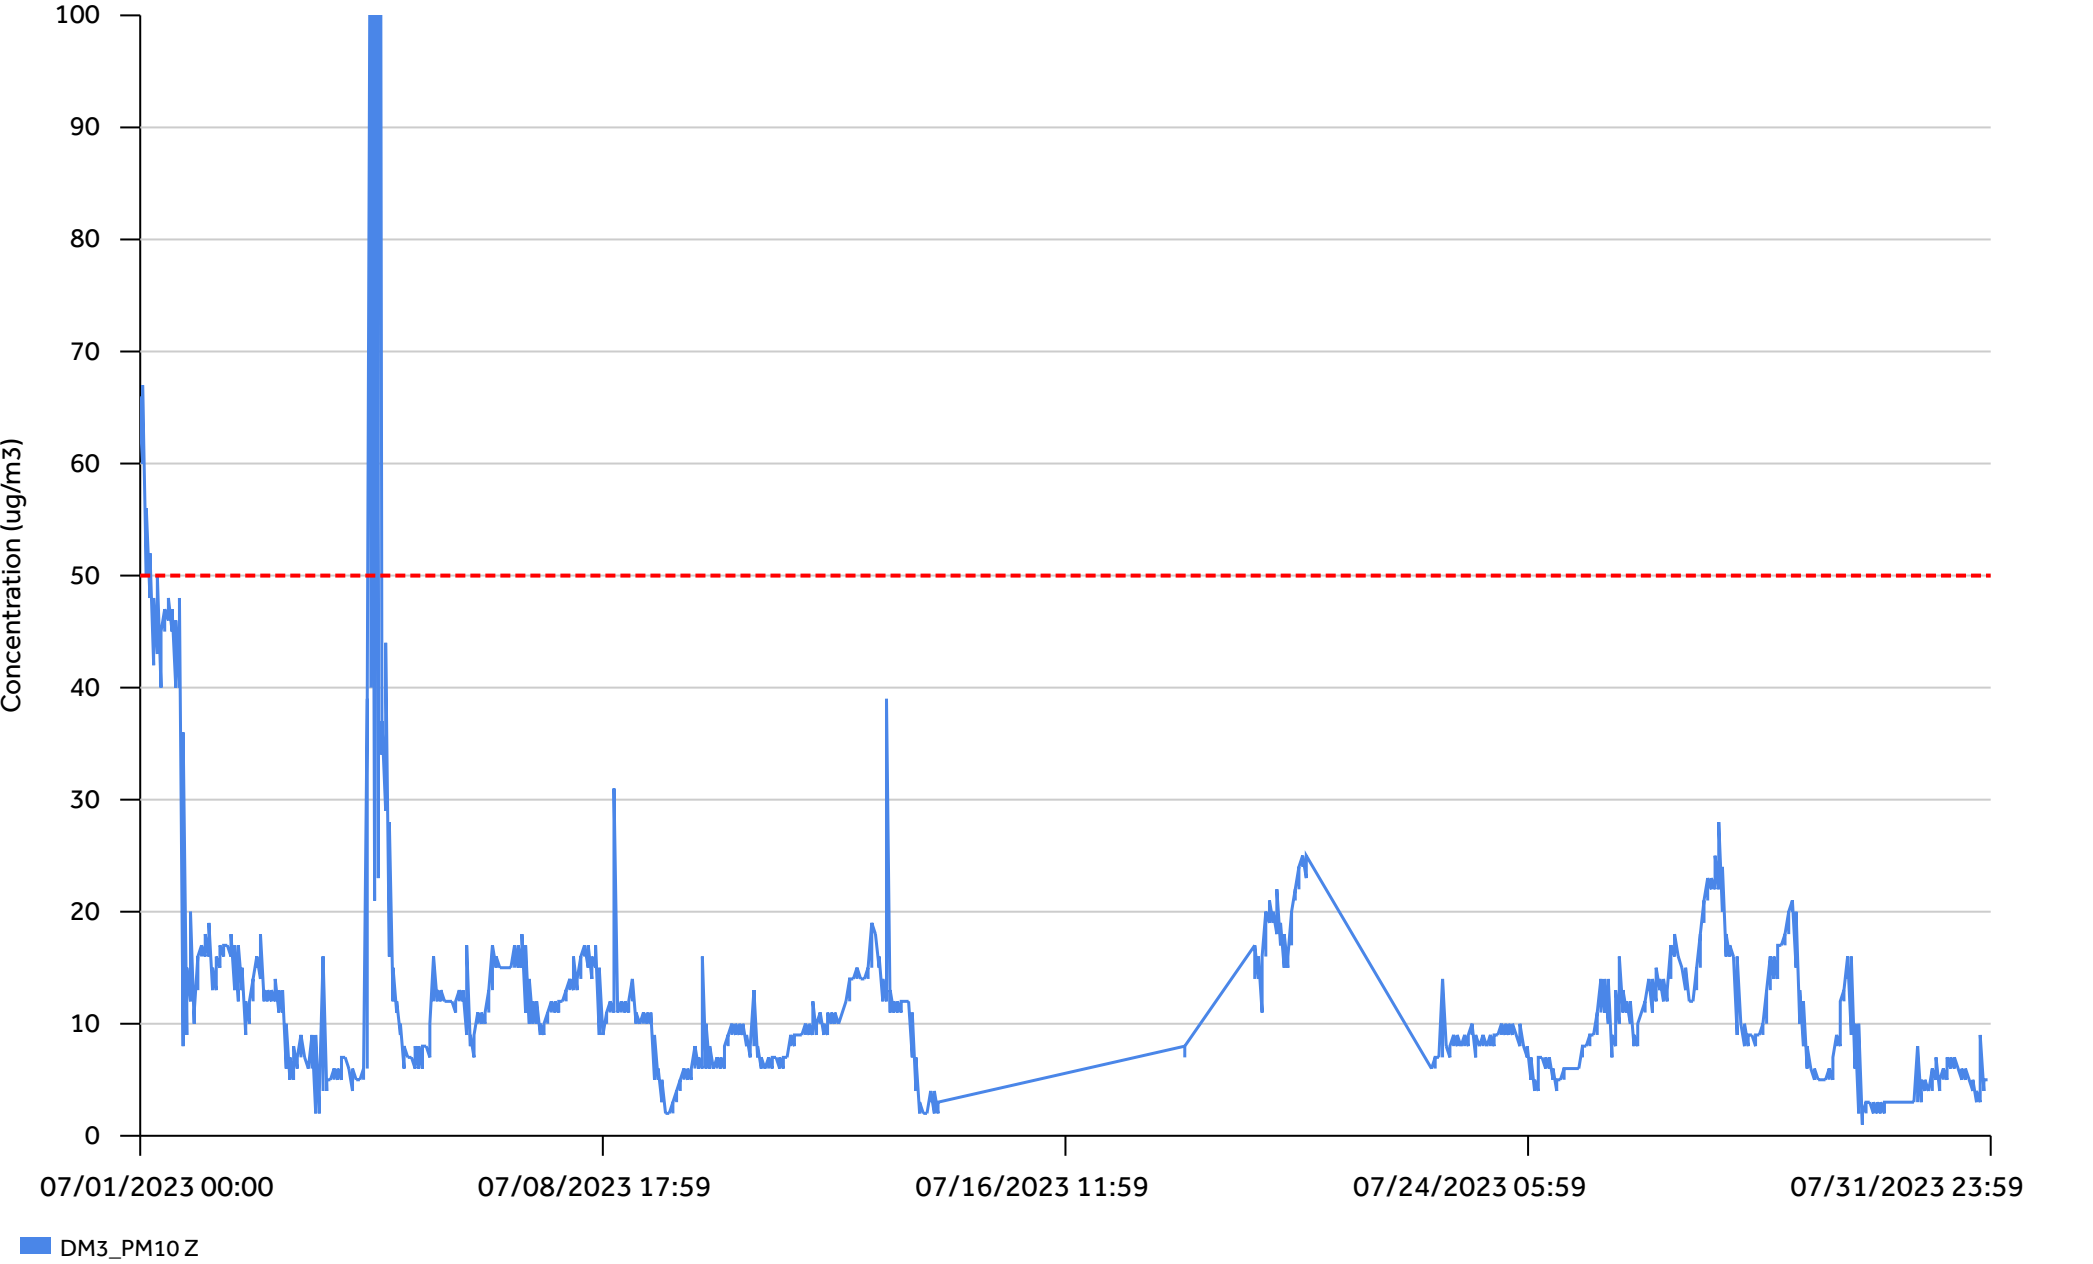
DM3-PM10

DM3 – 7/4 2126h, 130  $\mu\text{g}/\text{m}^3$ .

DM3 – 7/5 0026h, 250  $\mu\text{g}/\text{m}^3$ .
