# ASSET (BUS SHELTER) IMPROVEMENT EVALUATION STUDY

**Final Report**

**June 2013**

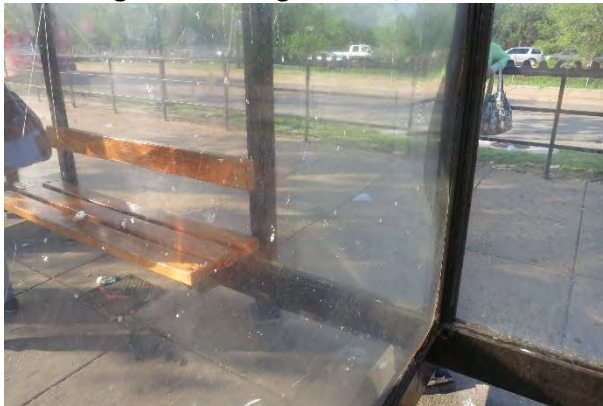
Overall, shelter conditions at the station are above average, with a station condition score of 3.2. **Table 2** summarizes conditions for each individual shelter. The shelters as a whole scored the lowest in panels and dome tops. Shelters B, C, D, E, F, H, J, L and M all had damaged panels with smearing, glossing, and

**Figure 8: Damaged Panel, Shelter B**

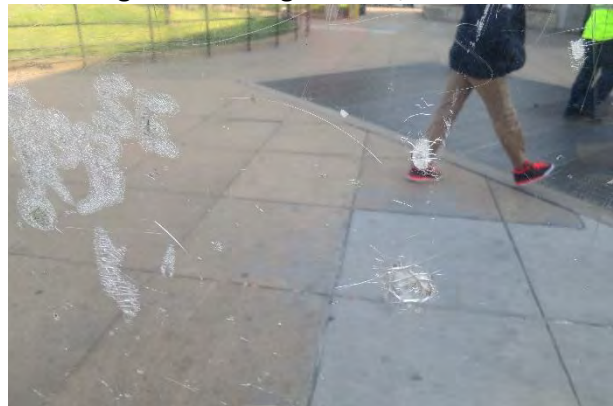
**Figure 9: Damaged Panel, Shelter H**

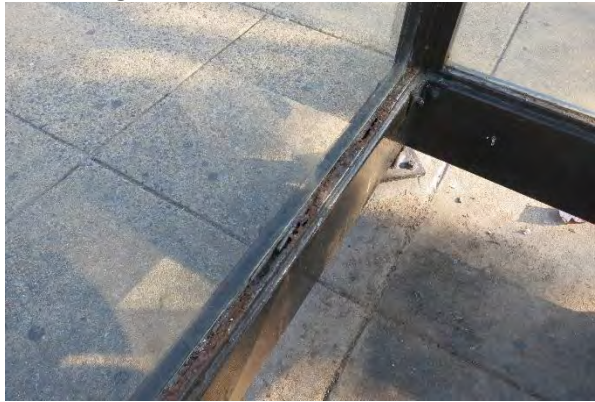
cracking. Shelters C and L also had some cracking damage to their dome tops. Benches and pads at the station were in above average shape, and frames had minimal rust with the exception of shelters B, C, K, and L.

Figure 10: Rusted Frame, Shelter K

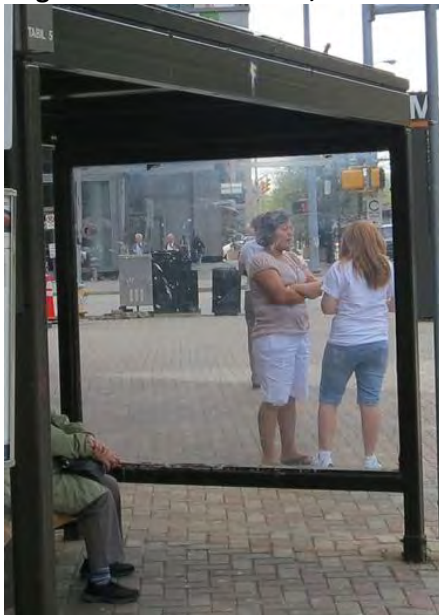
Overall, shelter conditions at the station are slightly below average, with a station condition score of 2.8. **Table 3** summarizes conditions for each individual shelter. The shelters, as a whole, scored the lowest in panel and dome top condition, with damage to each of these elements present at several shelters. Shelters D and E are in the worst condition, with D missing a panel and E showing above average rust, damaged panels, and a damaged dome top.

**Figure 16: Rusty Frame, Shelter E**

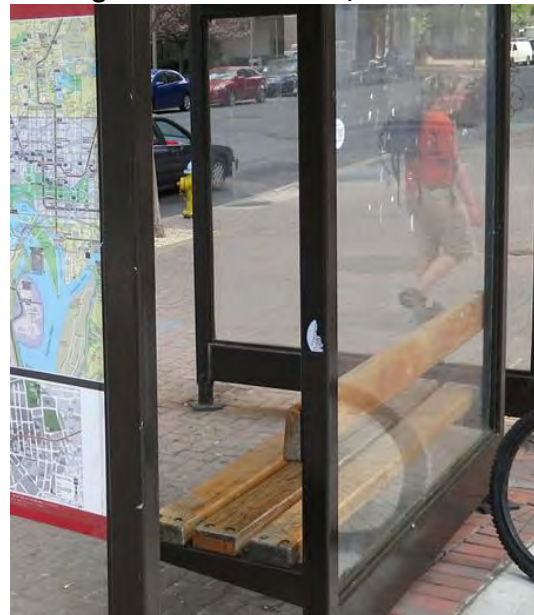
Rust on the frames was common among all the shelters at this station with the exception of G, which had the best overall frame condition. Benches at E and H were worn and heavily scratched, while benches at other shelters were in average condition. Pads at the station were in above average condition overall. **Figures 14 through 17** illustrate the different shelter conditions at the station, while **Figure 18** summarizes each shelter's overall condition score.

**Figure 17: Worn Bench, Shelter H**

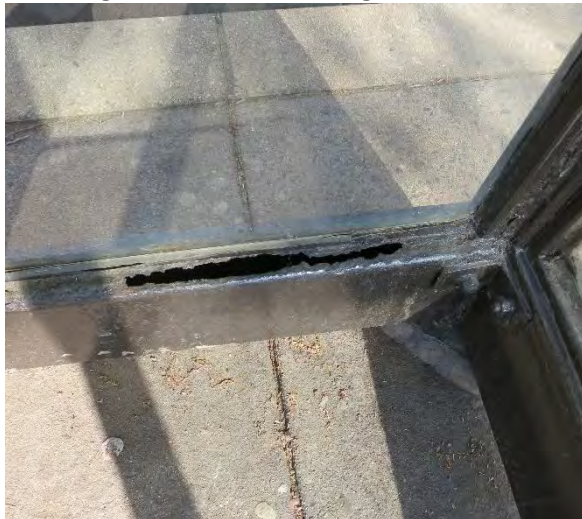
Overall, shelter conditions at the station are average, with a station condition score of 3.0. **Table 4** summarizes conditions for each individual shelter. The shelters, as a whole, scored the lowest in pad and frame condition. Shelters B, C, and D all have significant rust on their frames, while A, D, and E all had significant cracking in their pads. Shelter E also had a damaged panel. Dome tops were generally in average condition, while benches were in slightly above average condition.

**Figure 20: Frame Damage, Shelter B**

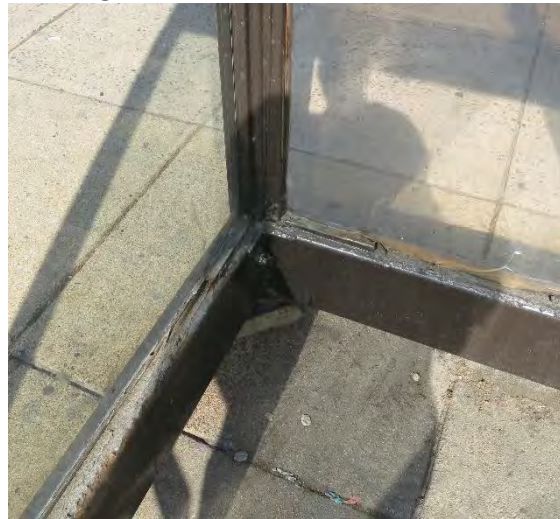
**Figure 21: Rusty Frame, Shelter C**

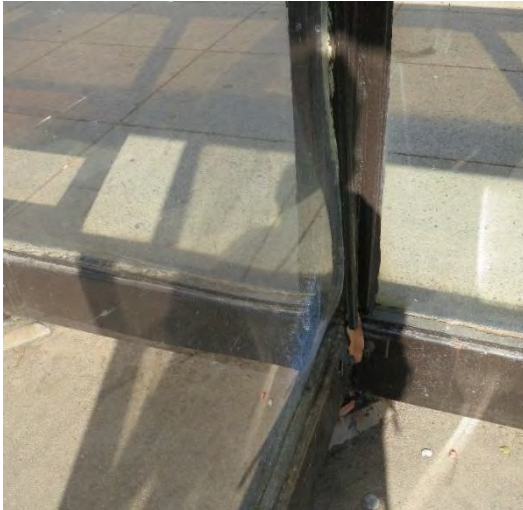
**Figure 22: Damaged Panel, Shelter E**

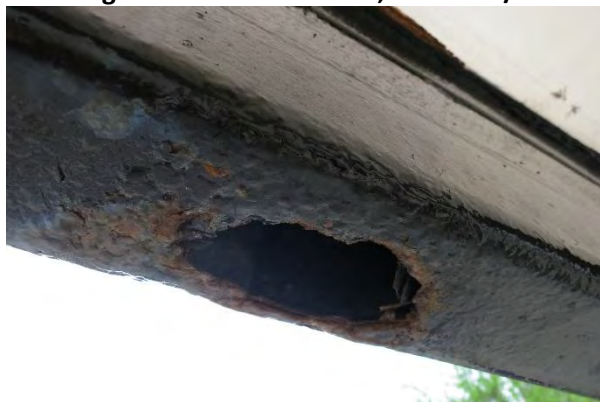
Overall, shelter conditions at the Brookland station are poor, with an overall station condition score of 1.9. **Table 5** summarizes conditions for each individual shelter. The shelters, as a whole, scored the lowest in frame and bench condition, though panel and dome top condition were also below average. Shelter A is in particularly bad condition, with an overall condition score of 1. Shelter A had significant rust on its frame, missing panels, a missing dome top and worn/split benches. Shelters B, C, and D/J also had significant rust on their frames, while shelters E/H and F/G also had missing dome tops. Shelter D/J also had a hole in its frame.

**Figure 27: Hole in Frame, Shelter D/J**

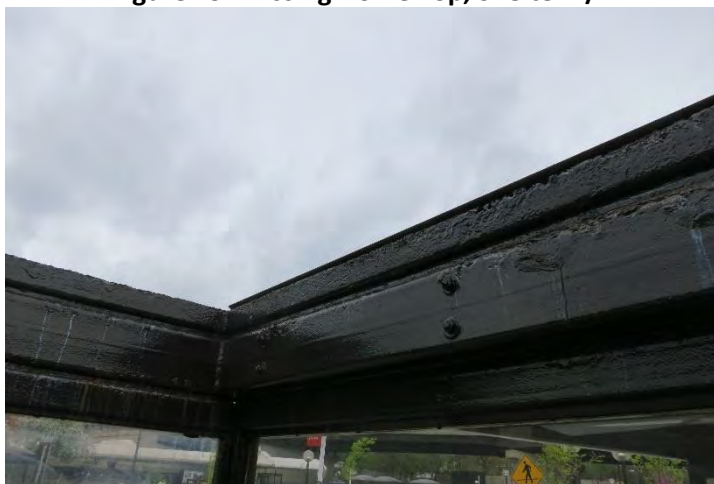
**Figure 29: Missing Dome Top, Shelter E/H**

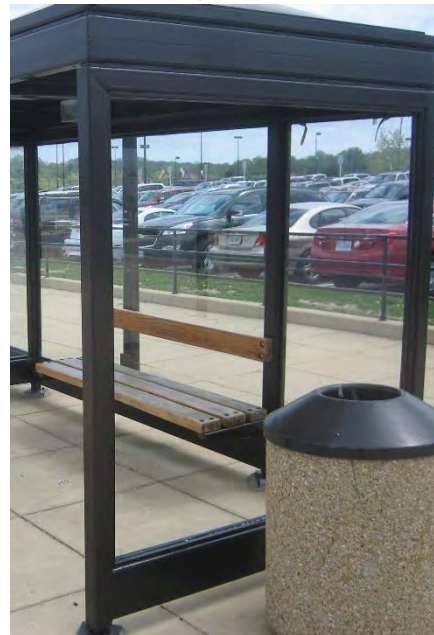
Figure 33: Missing Panel & Worn Bench, Shelter B

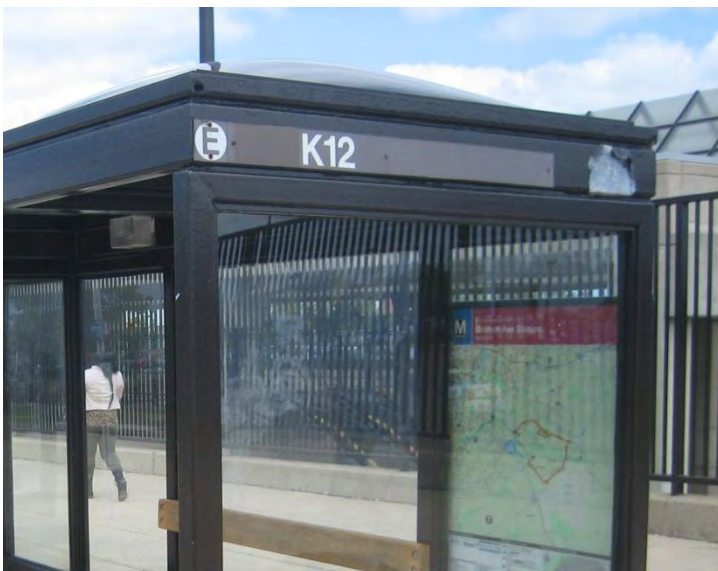
**Figure 34: Peeling Paint, Shelter E**

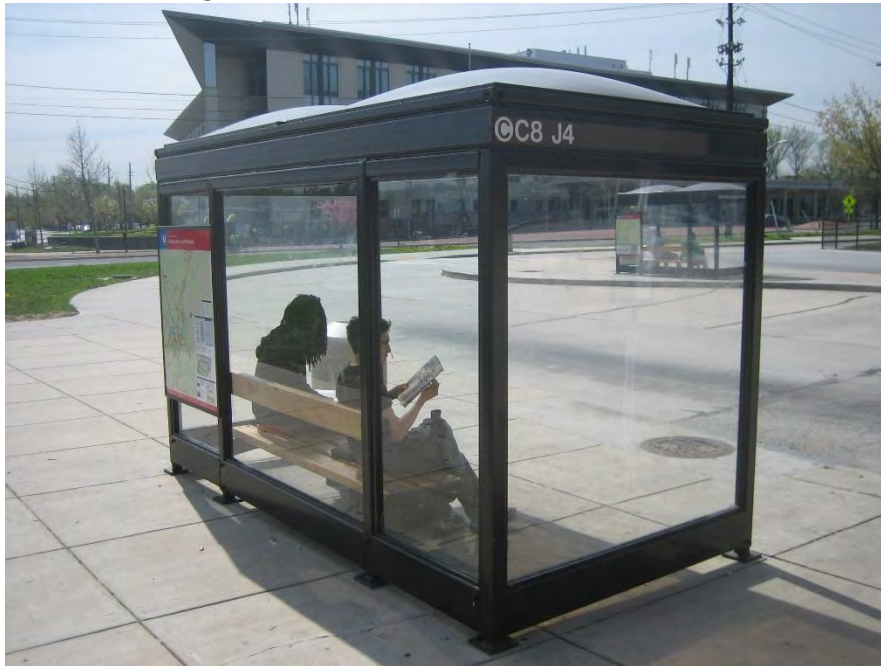
**Figure 44: Good Overall Condition, Shelter C**

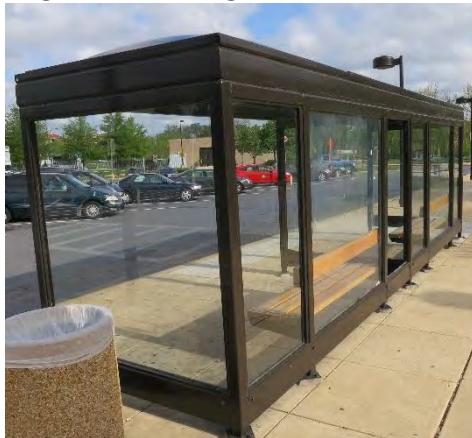
**Figure 51: Missing Panel, Kiss & Ride**

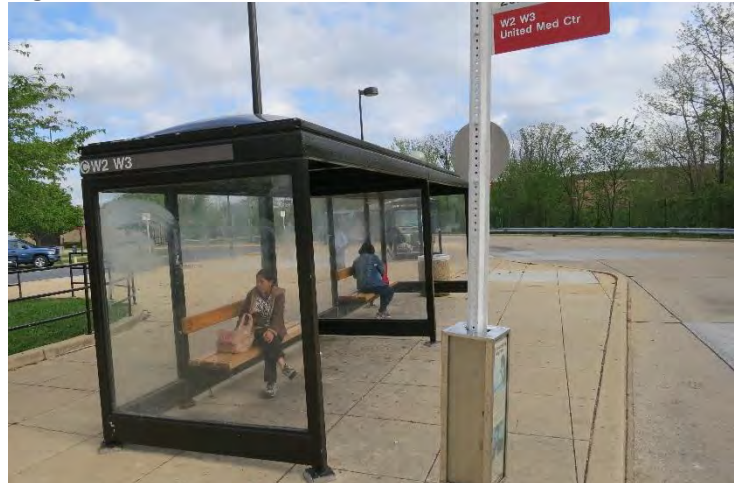
**Figure 52: Smeared Panel, Good Frame Condition, Shelter C**

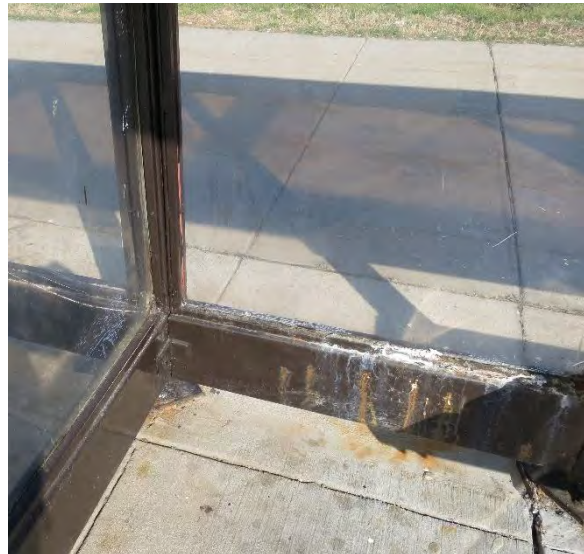
**Figure 56: Frame Rust, Shelter C**

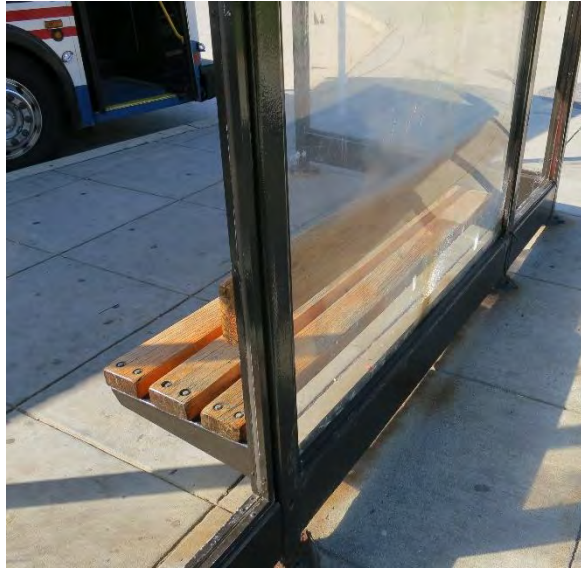
**Figure 57: Missing Panel and Frame Rust, Shelter D**

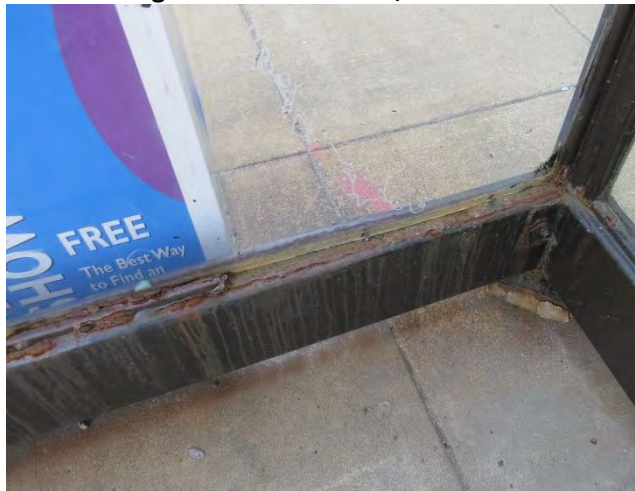
**Figure 66: Frame Rust, Shelter F**

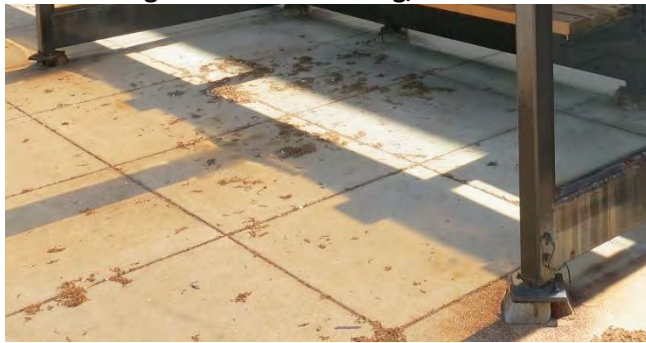
**Figure 68: Pad Cracking, Shelter D**

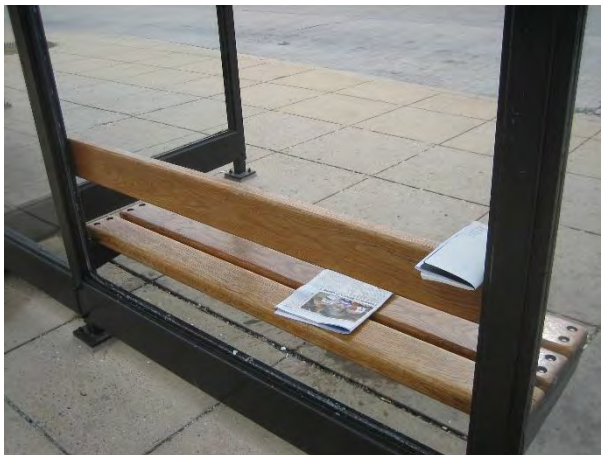
**Figure 84: Missing Panel, Shelter B**

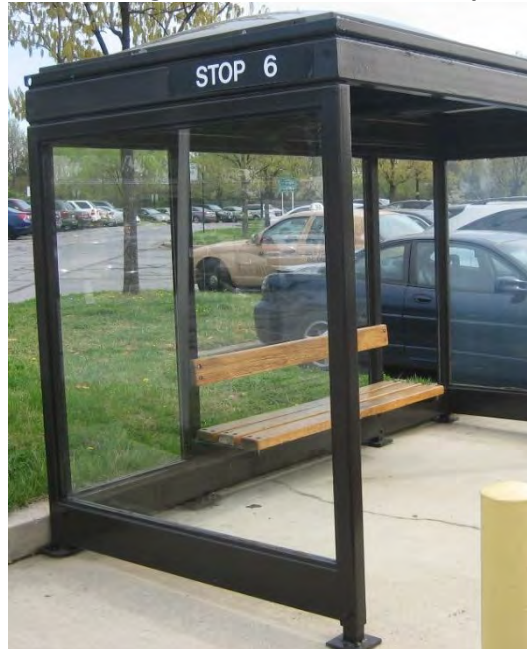
**Figure 86: Missing Panel, Park-and-Ride Stop 6 Shelter**

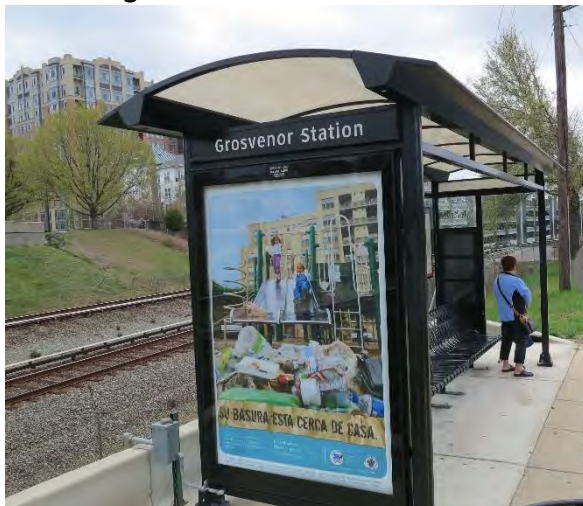
**Figure 89: J5 Shelter on MD-355**

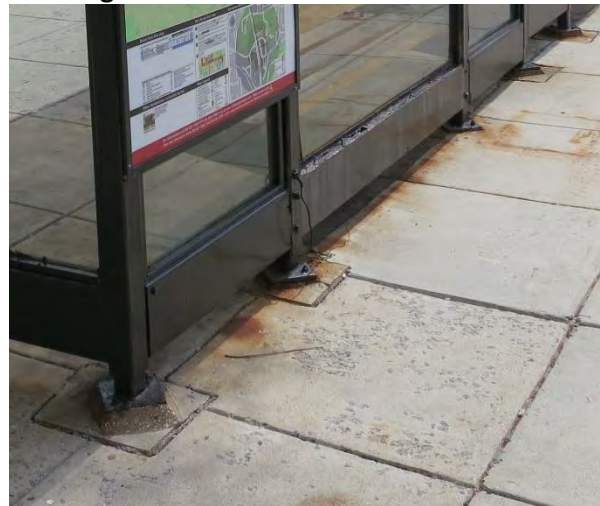
Rust on the frames was present on shelters E and F though it was not excessive. All of the shelters (with the exception of the J5 shelter on MD-355) had evidence of previous rusting with stains on the concrete pads below them. Painting of the frames has likely taken place within the past few years. **Figures 89 through 91** illustrate the different shelter conditions at the station, while figure 92 summarizes each shelter's overall condition score.

**Figure 90: Rust on Frame of Shelter E**

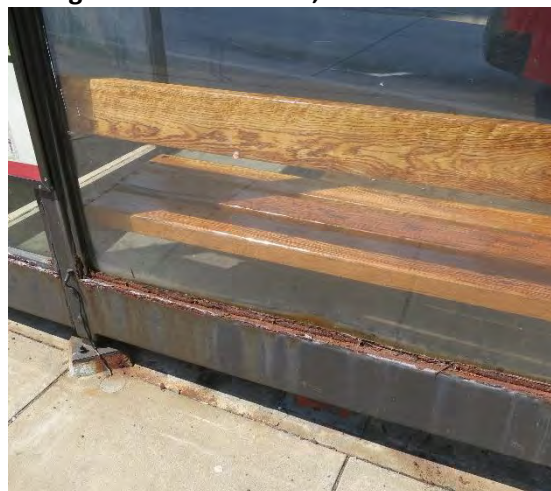
**Figure 97: Frame Rust, Shelter D North**

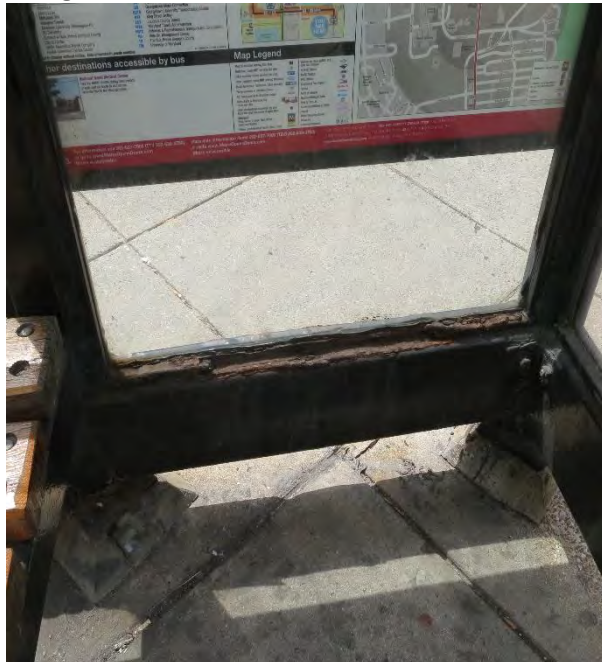
Overall, shelter conditions at the station are below average, with a station condition score of 2.7. **Table 19** summarizes conditions for each individual shelter. The shelters as a whole scored the poorest in frame condition and bench condition. Shelters C, D and F are in the worst condition, with overall condition ratings of 2. Shelter D is in particularly bad condition, with holes in its frame.

**Figure 106: Poor Frame Condition, Shelter D**

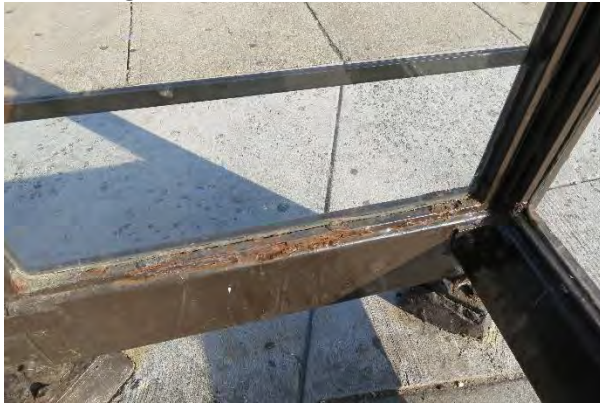
**Figure 114: Frame Rust, Shelter B**

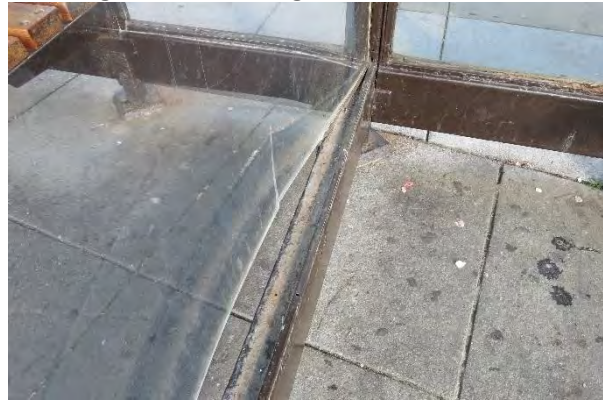
**Figure 115: Damaged Panel, Shelter D**

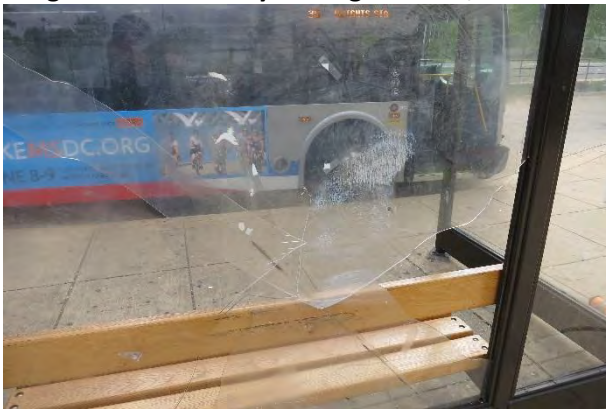
**Figure 118: Severely Damaged Panel, Shelter F**

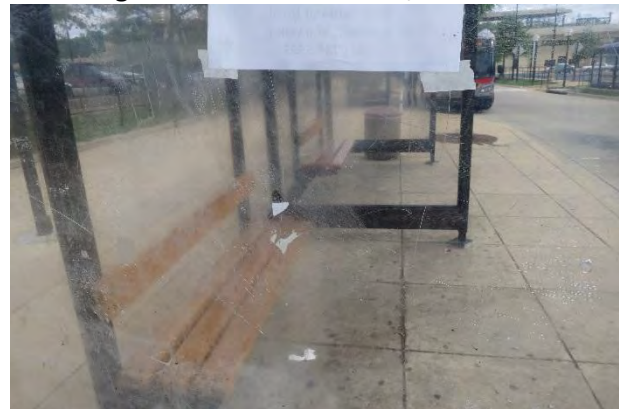
**Figure 119: Cracked Panel, Shelter G**

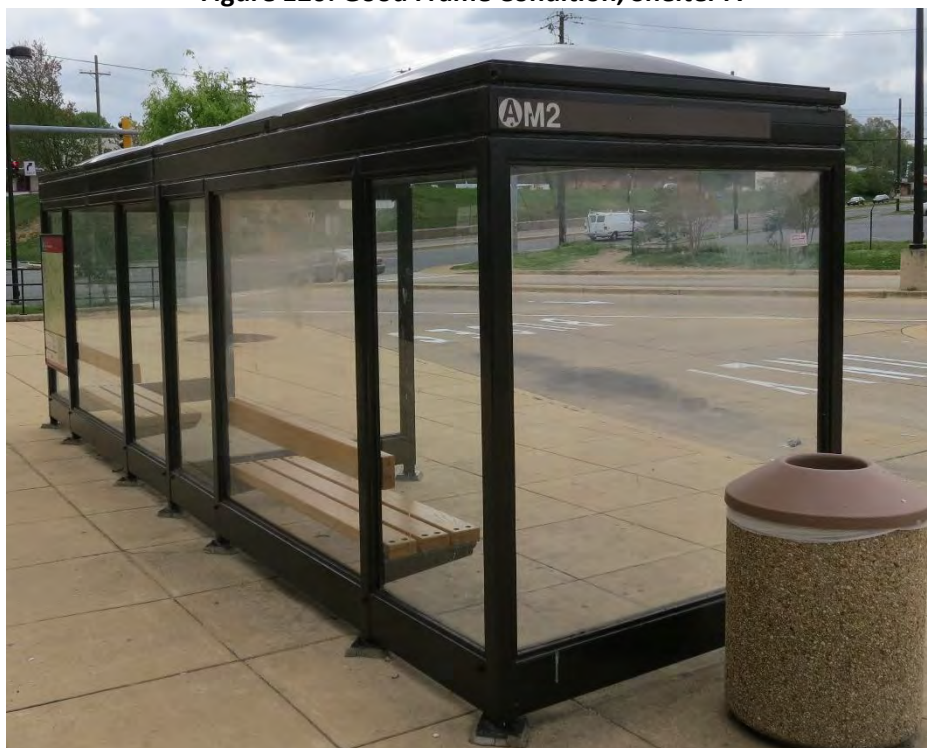
**Figure 120: Good Frame Condition, Shelter A**

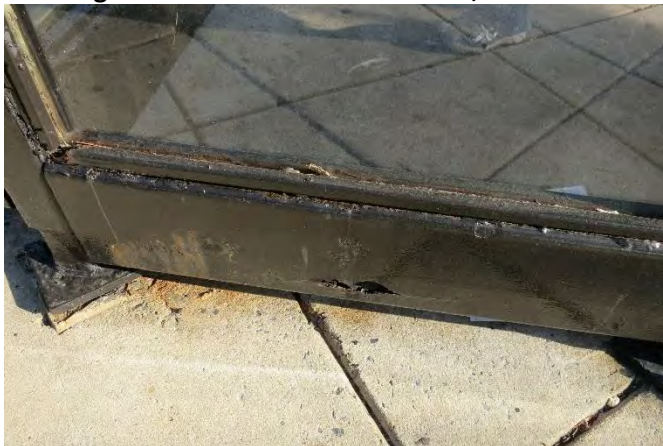
Overall, shelter conditions at the station are average, with a station condition score of 3.0. **Table 22** summarizes conditions for each individual shelter. The shelters as a whole scored the lowest in panel and frame condition, while bench condition and pad condition were both above average. Shelters A and G both had holes in their frames and shelters B and C both showed significant rust on their frames. Shelters A, F, G and the taxi shelter all had damaged panels, with the taxi shelter also having a cracked dome top. Shelter D also had a cracked dome top.

**Figure 123: Rust & Hole in Frame, Shelter G**

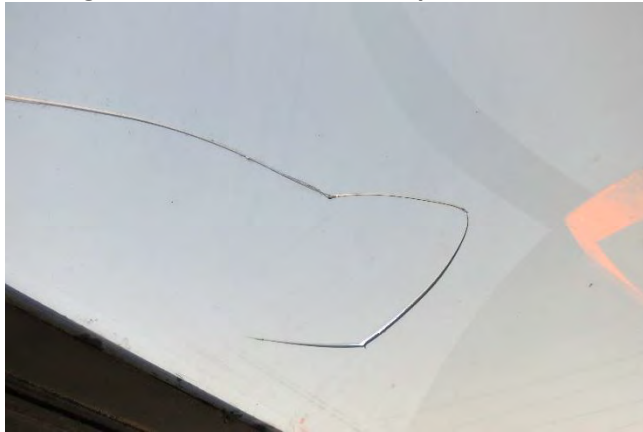
**Figure 125: Cracked Dome Top, Taxi Shelter**

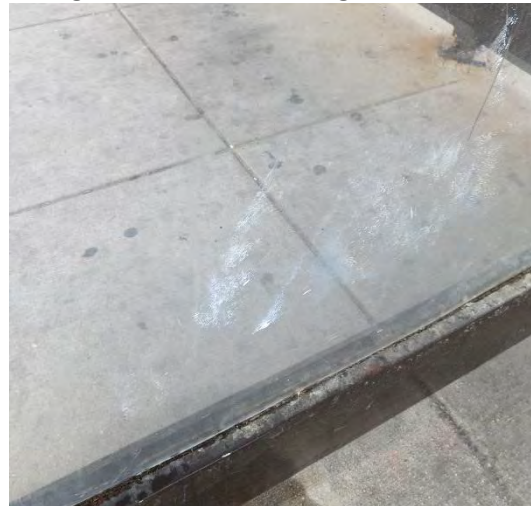
**Figure 126: Panel Damage, Shelter A**

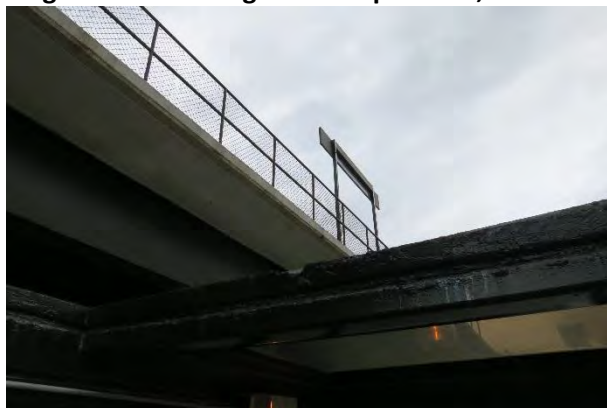
**Figure 131: Missing Dome Top & Rust, Shelter C**

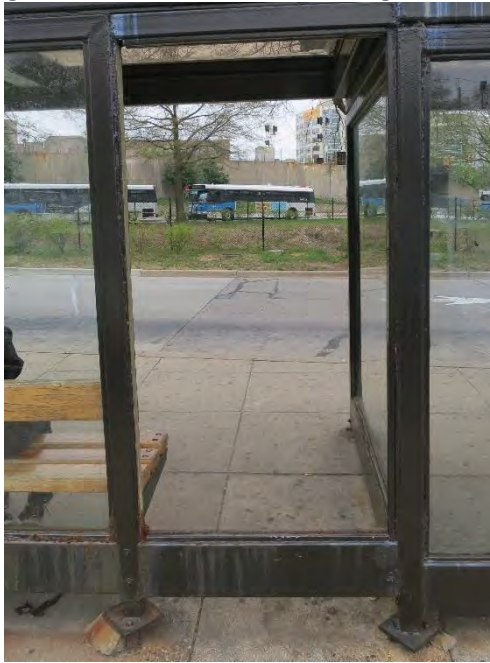
Overall, shelter condition at the Rockville station is slightly below average, with a station condition score of 2.9. **Table 24** summarizes conditions for each individual shelter. The shelters as a whole scored the poorest in panel condition and pad condition. Shelter C East is in particularly bad condition, with a missing panel on its rear side and poor pad condition. This shelter received an overall rating of 2, while the rest of the shelters at the station received an overall rating of 3. The Kiss-and-Ride shelter on the west side of the station also received a poor panel rating due to a missing panel on its north side.

**Figure 137: Shelter C East Missing Panel**

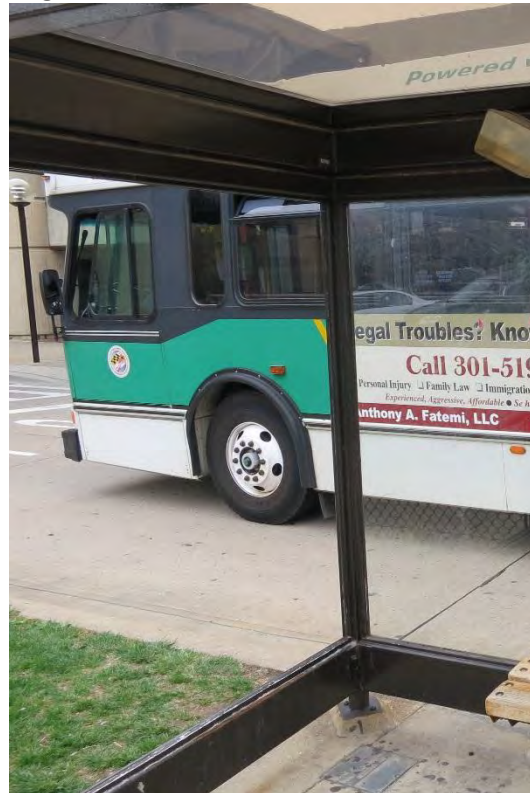
**Figure 138: Shelter B West Rust on Frame**

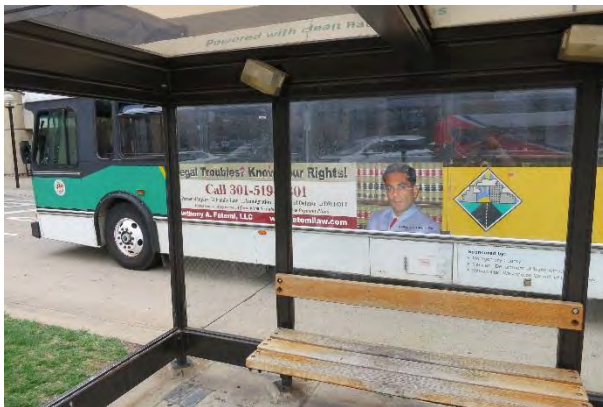
**Figure 139: Kiss-and-Ride Shelter Missing Panel**

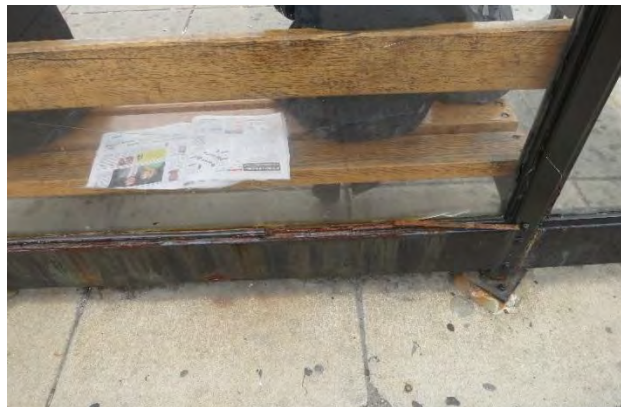
**Figure 140: Shelter C East Poor Pad Condition**

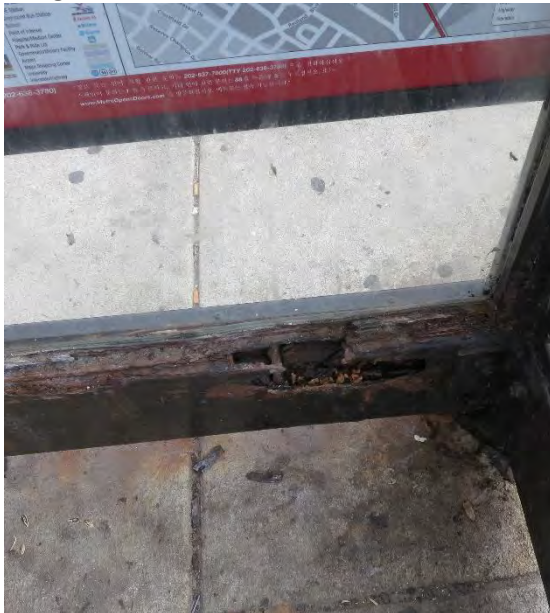
Overall, shelter conditions at the Shady Grove station are average, with a station condition score of 3.1. **Table 25** summarizes conditions for each individual shelter. The shelters as a whole scored the poorest in frame condition and panel condition, with persistent rust and missing or damaged panels on several shelters. Shelters C West, A East and C East are in particularly bad condition, all receiving overall scores of 2. C West and C East both have holes in their frames, while A East has extensive rust and cracked/smear panels.

Figure 143: Shelter C West Hole in Frame

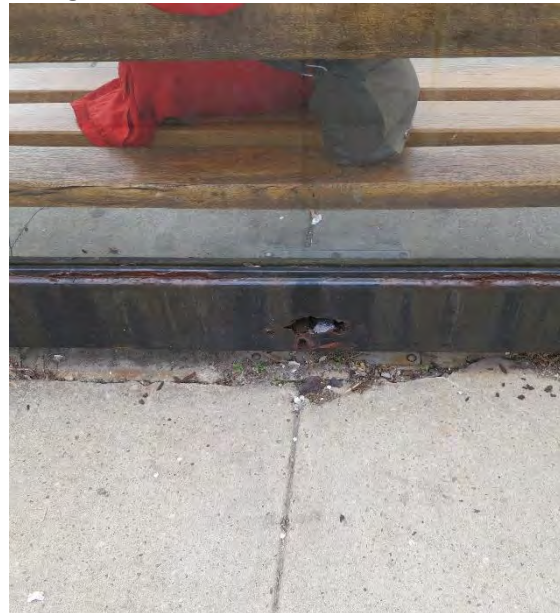
Figure 144: Shelter C East Hole in Frame

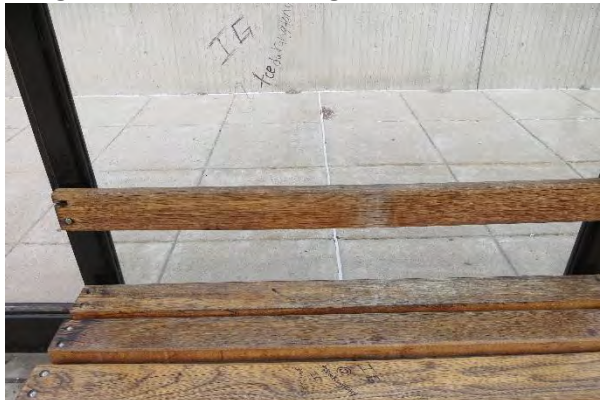
Overall, shelter conditions at the station are above average, with a station condition score of 3.4. **Table 26** summarizes conditions for each individual shelter. The shelters as a whole scored the lowest in bench condition, with shelters E, H, J, K, L and P having worn benches. Panel conditions were average with some fading and smearing and also damaged panels at shelters B, C and M and a missing panel at shelter H. Frames were in good condition overall, with rust present only on shelters K, L and M. Dome tops and pads were in above average condition overall.

**Figure 148: Worn/Damaged Bench, Shelter K**

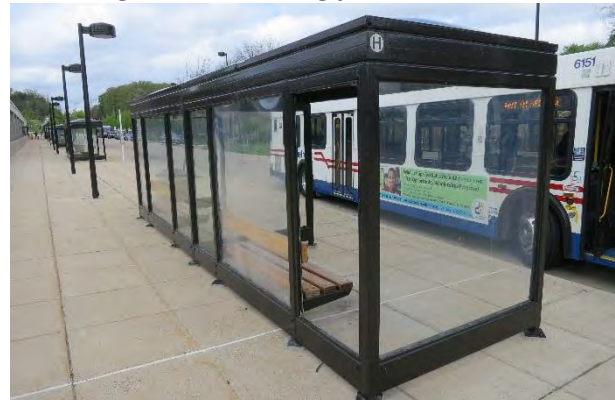
**Figure 149: Missing panel, Shelter H**

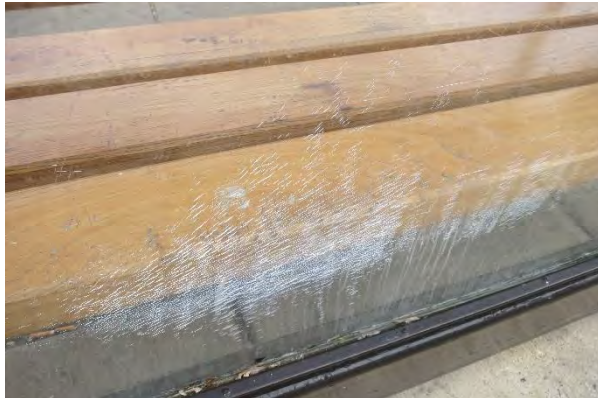
**Figure 150: Damaged Panel, Shelter C**

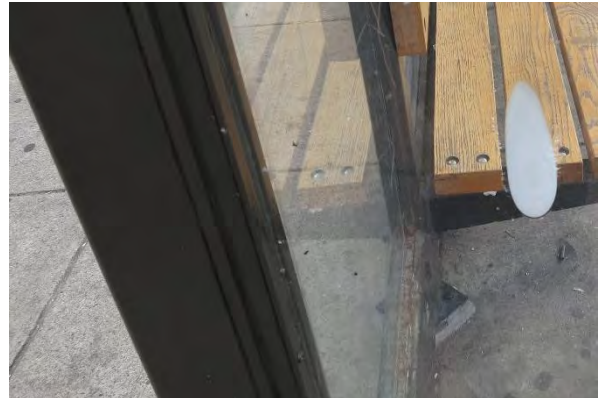
**Figure 151: Frame Rust, Damaged Panel, Shelter M**

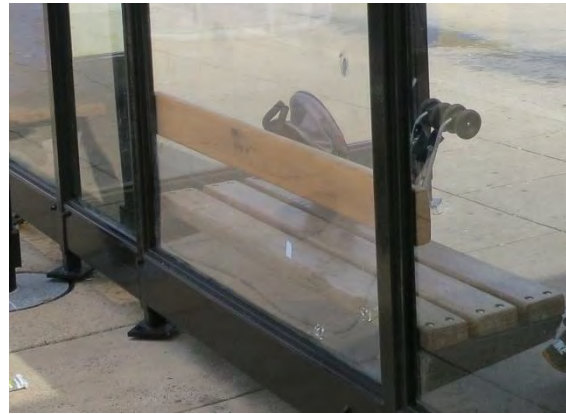
**Figure 156: Worn Bench, Cracked Panel, Shelter L**

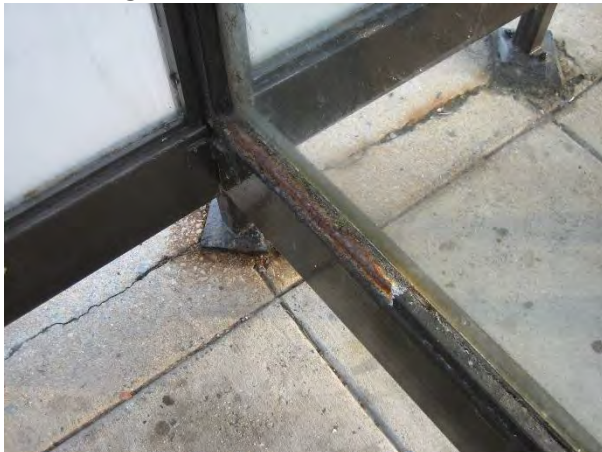
Overall, shelter conditions at the station are slightly below average, with a station condition score of 2.9. Table 28 summarizes conditions for each individual shelter. The shelters as a whole scored the lowest in frame and dome top conditions. Rust was common on all the shelter frames and was particularly bad on shelters B and D. Dome tops were generally worn and faded, with shelters G and H also having some damage to them. Panel conditions were slightly below average with fading, smearing or scratching on all the shelters except A and J. Shelters C, H and the Kiss-and-Ride shelter also had cracks in their panels. Pad conditions were average, with shelters A, B, C, D, H and J showing moderate cracking. Bench conditions were slightly above average, with shelters A, C, D, E, F, J and the Kiss-and-Ride shelter showing some wear.

**Figure 159: Frame Rust, Shelter B**

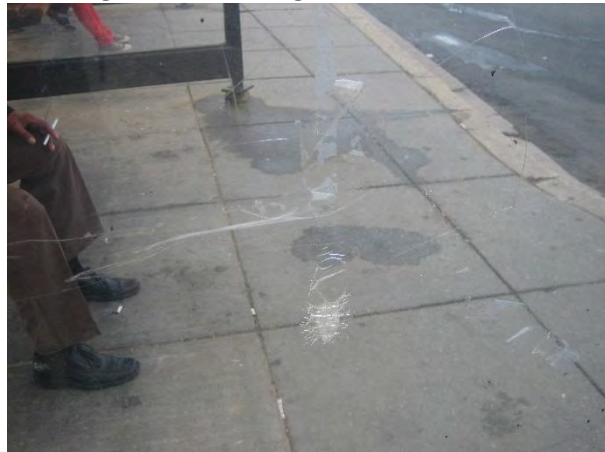
**Figure 160: Damaged Panel, Shelter H**

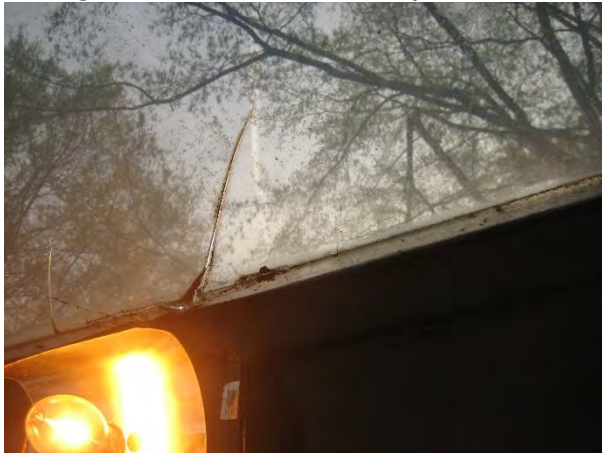
**Figure 161: Cracked Dome Top, Shelter G**

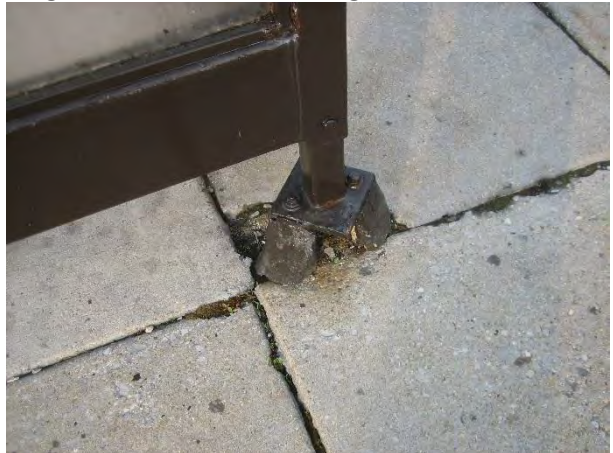
**Figure 162: Cracked Footing and Pad, Shelter B**

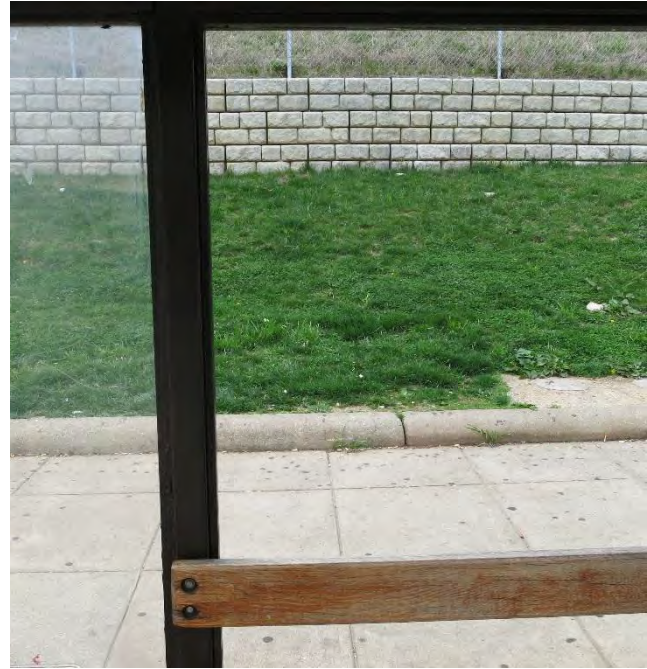
**Figure 166: Shelter A East Missing Panel**

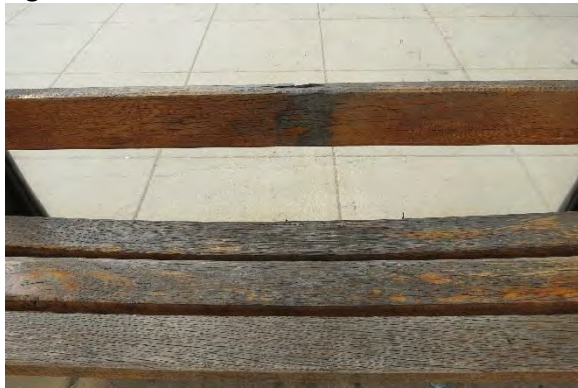
**Figure 167: Shelter F East Poor Bench Condition**

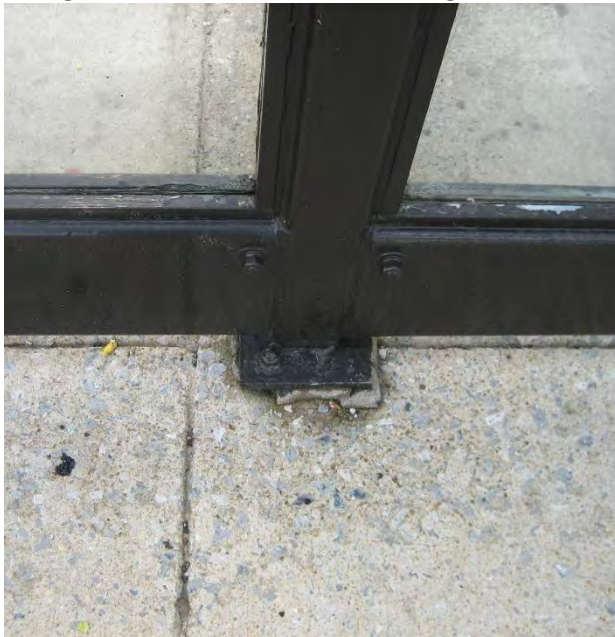
**Figure 184: Cracked Pad & Footing, Shelter C**

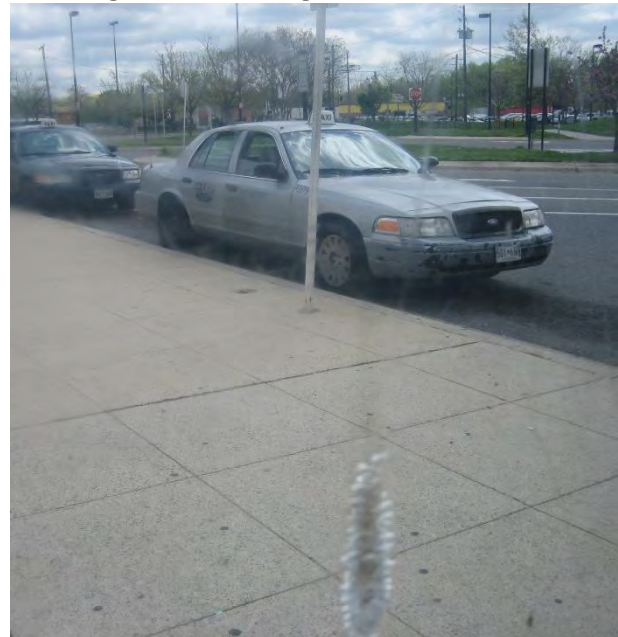
**Figure 185: Damaged Panel, Shelter F**

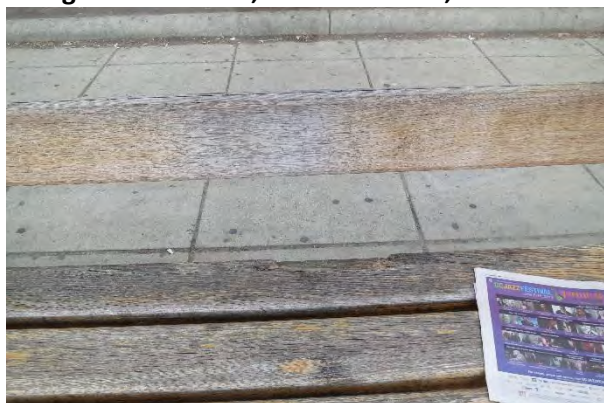
**Figure 191: Worn, Cracked Bench, Shelter B**

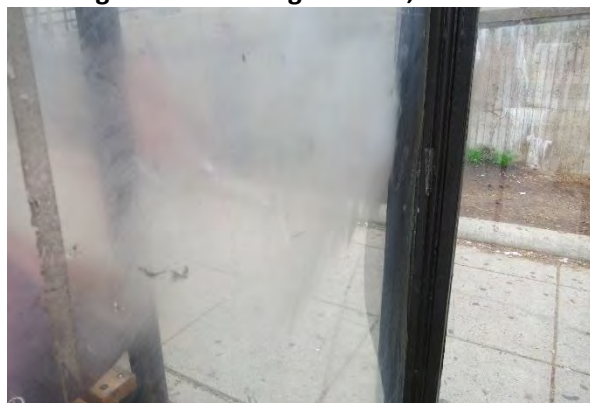
**Figure 192: Damaged Panel, Shelter D**

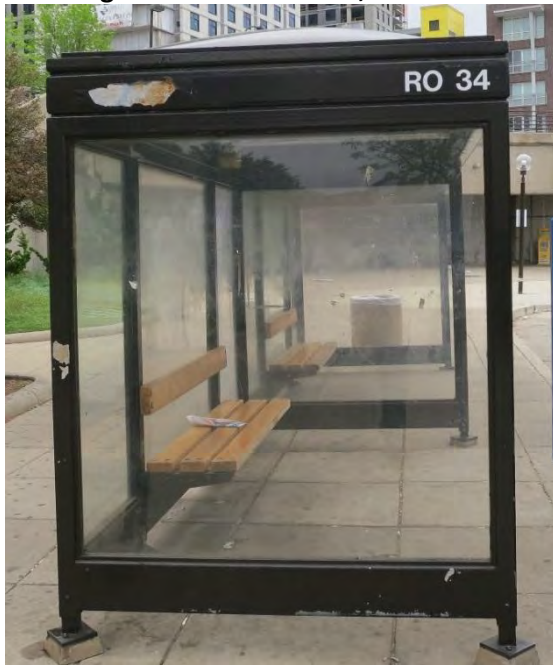
**Figure 193: Frame Rust, Shelter F**

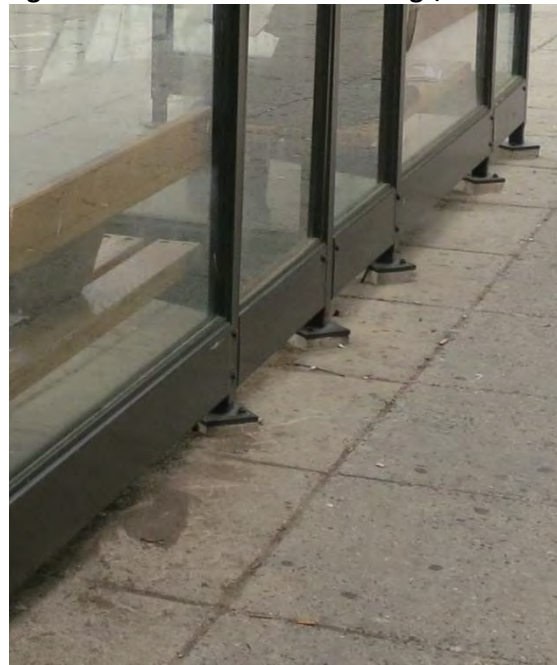
**Figure 194: Cracked Pad & Footings, Shelter G**

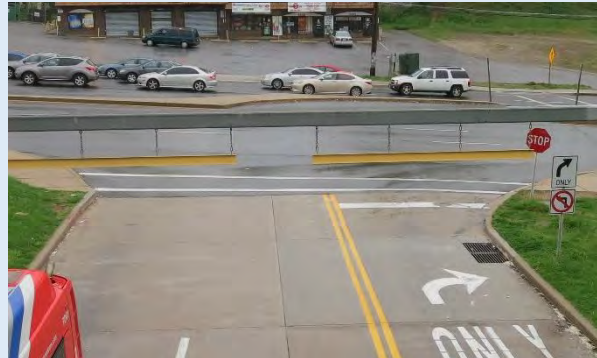
**Crosswalk Traversing Central Ave Entrance Driveway**

**Replace left-turn/thru pavement marking with left-turn/right-turn pavement marking in the southbound left lane of the driveway at Kiss-and-Ride/Busway/Addison Road entrance driveway intersection.**

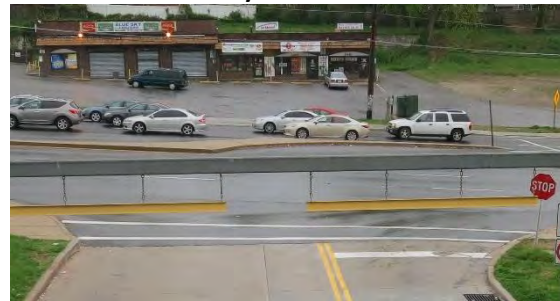
**Left-Turn Bay on Central Avenue**

**Fencing along the left-turn bay on Central Avenue at the station entrance driveway**

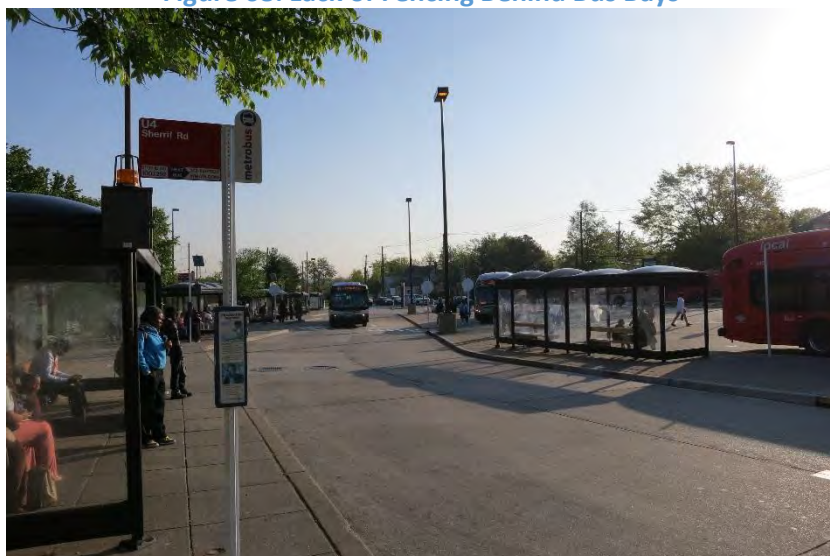
Figure 68: Lack of Fencing Behind Bus Bays

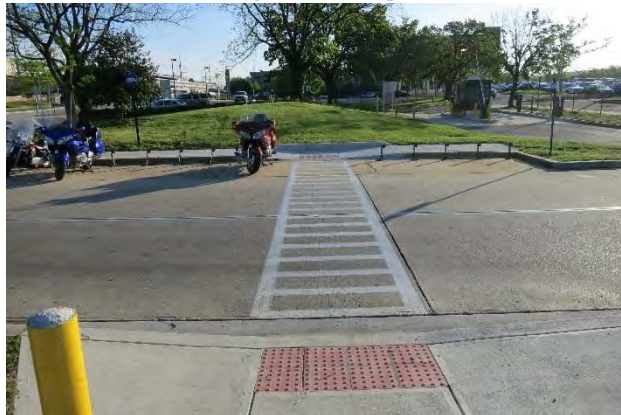
**Figure 103: Egress Driveway Crosswalk at Motorcycle Parking Area**

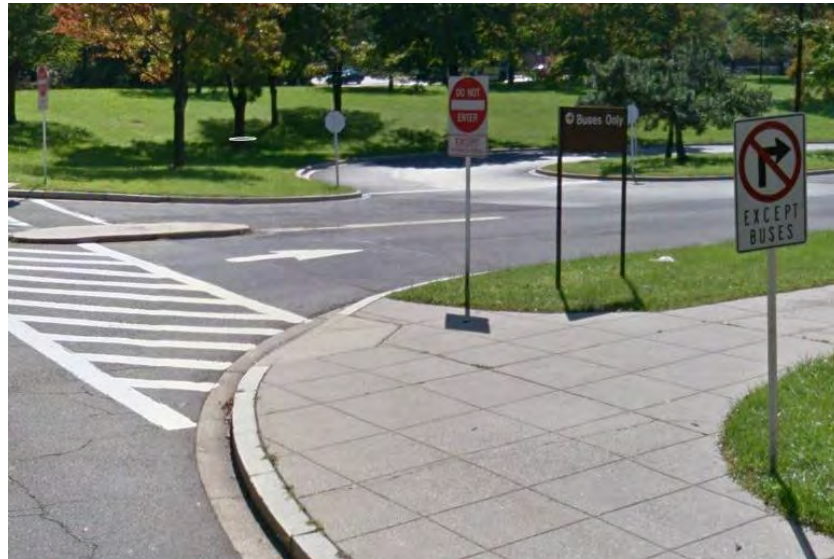
**Figure 118: Eastern Avenue Southbound Signage at Busway**

no signage on Eastern Avenue in the northbound direction indicating the busway, however. **Figure 118** illustrates signage at this intersection.
