Northern Bus Garage

Noise, Vibration, and Dust Monitoring Report (December 2024)

Noise, Vibration, and Dust levels were monitored as part of the reconstruction of Northern Bus Garage, 4615 14th Street, NW, Washington, DC, for the month of December 2024.

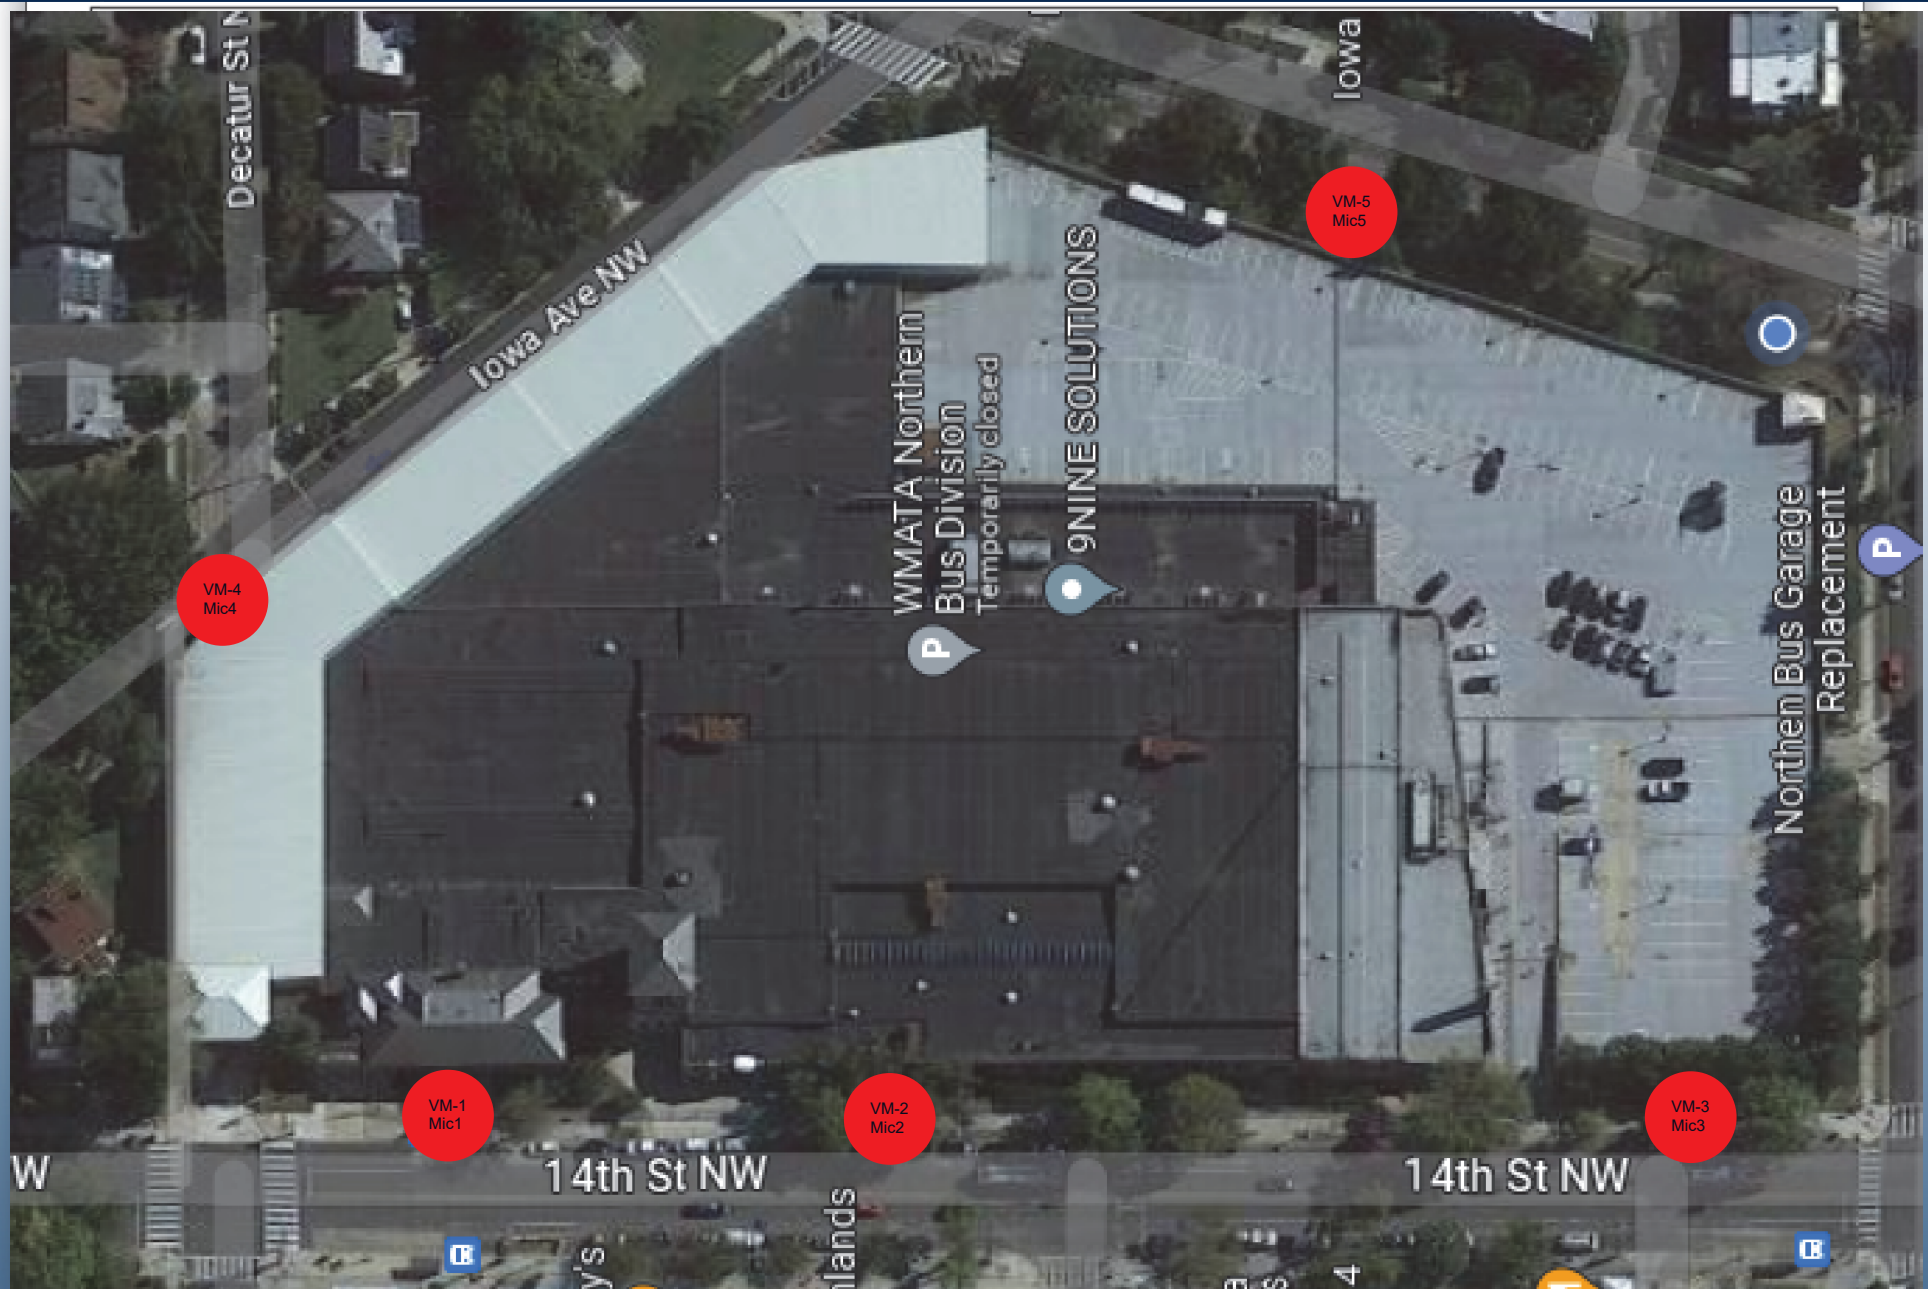
Figure 1: Vibration and Noise Monitor Location Plan

Five noise monitors are positioned around the perimeter of the project site. (See Figure 1) Under DC regulations, the regulatory standard is 80 dBA, measured 25 ft from the property line (20 DCMR 2802.1). Because the noise monitoring devices are placed on the property line (rather than a 25 ft offset), the monitoring threshold for site activities is adjusted to 85 dBA (assuming the noise level will dissipate). Noise levels and vibration levels were measured automatically with Micromate and Geophone Instrument.

Five vibration monitors are positioned around the perimeter of the project site. (See Figure 1) Vibration thresholds are based the WMATA Design Criteria. Monitors VM-1 and VM-2 are set at a lower vibration threshold due to their proximity to the historic façade, which is more sensitive to any movement. Noise levels and vibration levels were measured automatically with Micromate and Geophone Instrument.

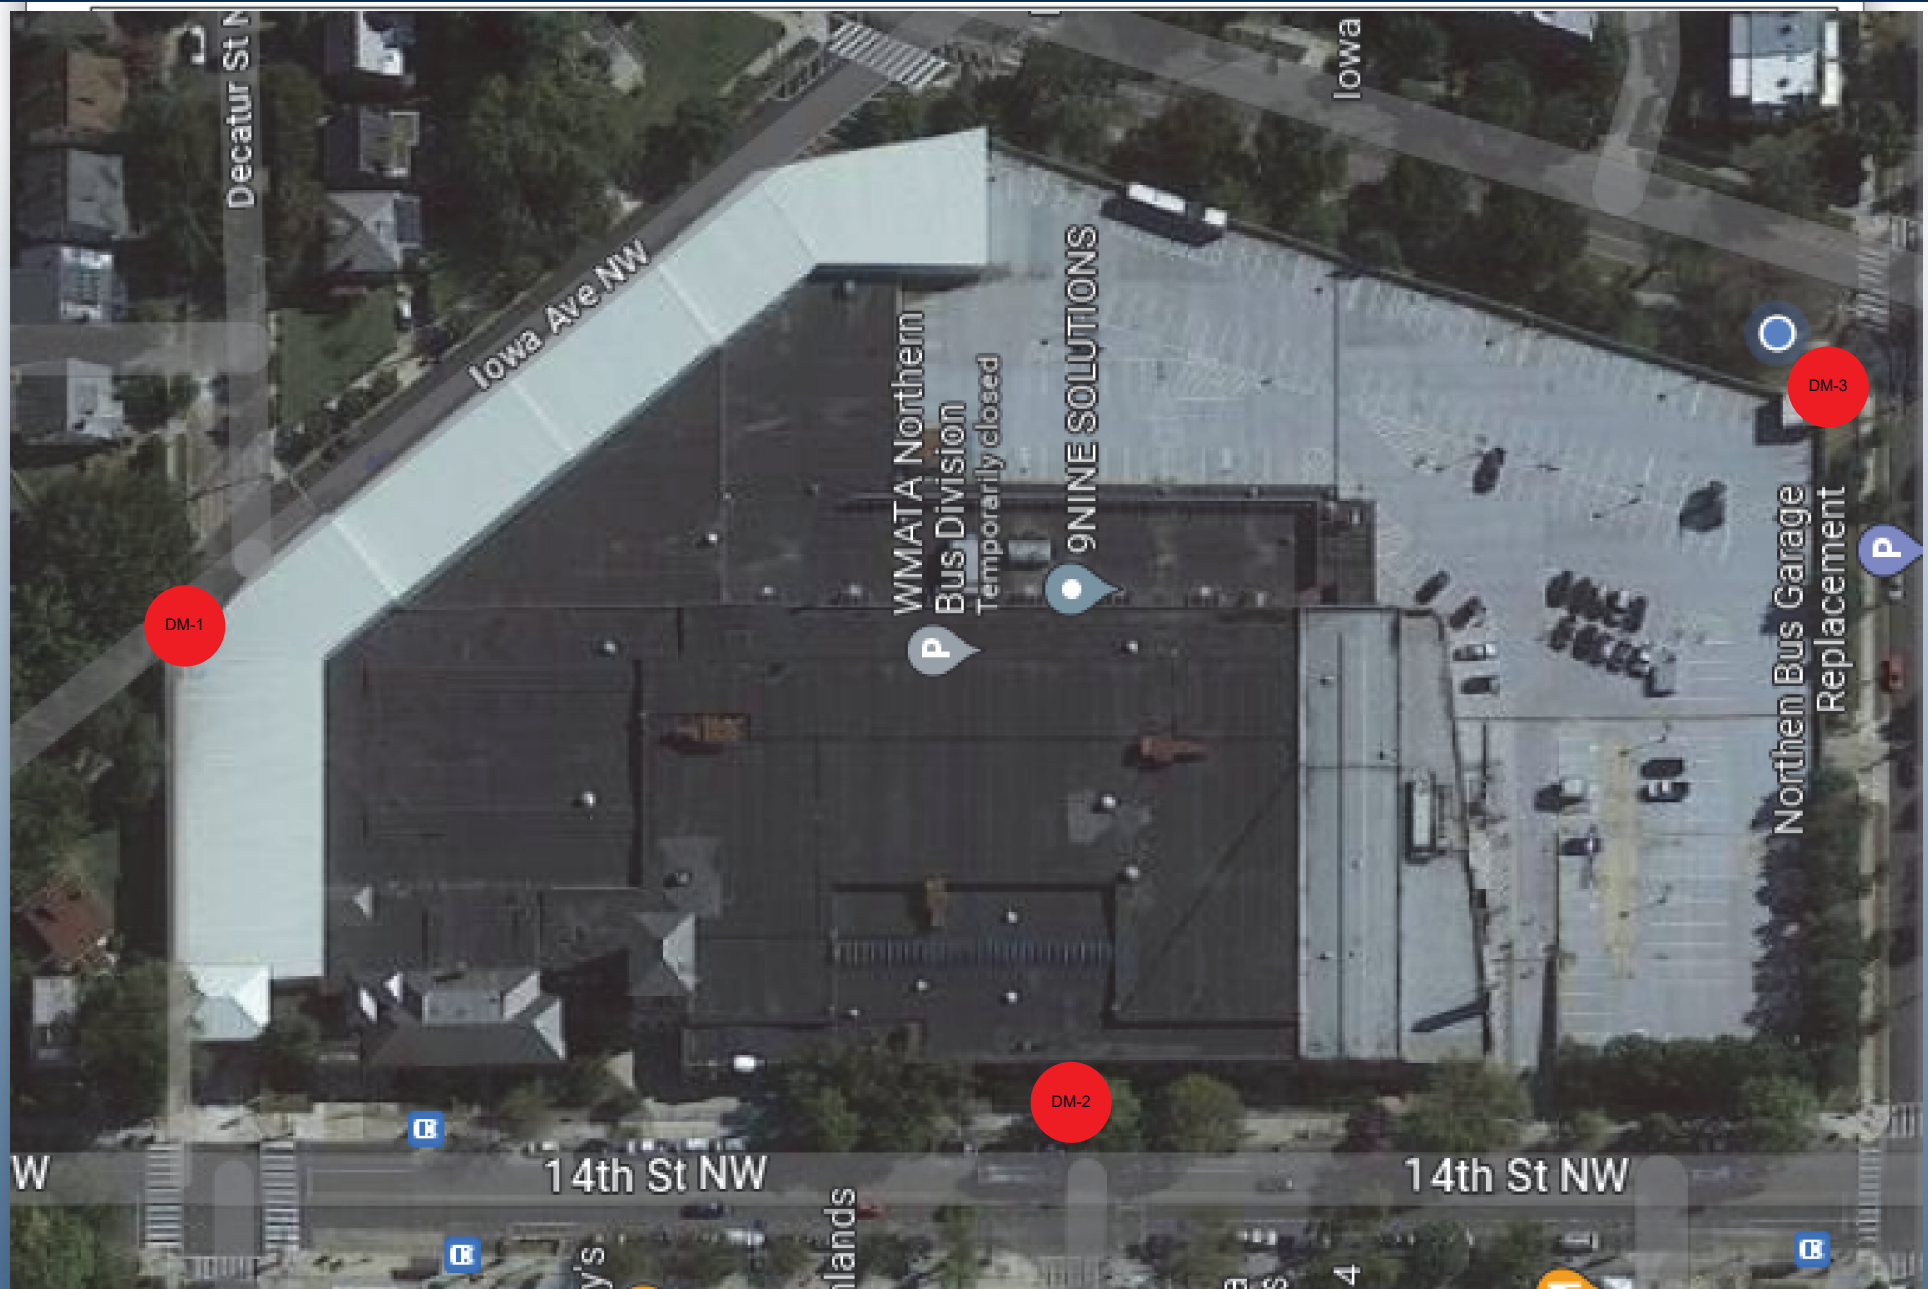
Figure 2: Dust Monitor Location Plan

Three dust monitors are positioned at the project site. (See Figure 2) EPA regulatory thresholds are based on a 24-hour monitoring period; the project has adopted thresholds to monitor site levels and provide an indication of when EPA standards might be exceeded. (See Table 3) Dust measurements were monitored using Aeroqual Dust Sentry Pro.
