## Northern Bus Garage Noise, Vibration, and Dust Monitoring Report (August 2024)

Noise, Vibration, and Dust levels were monitored as part of the reconstruction of Northern Bus Garage, 4615 14<sup>th</sup> Street, NW, Washington, DC, for the month of August 2024.

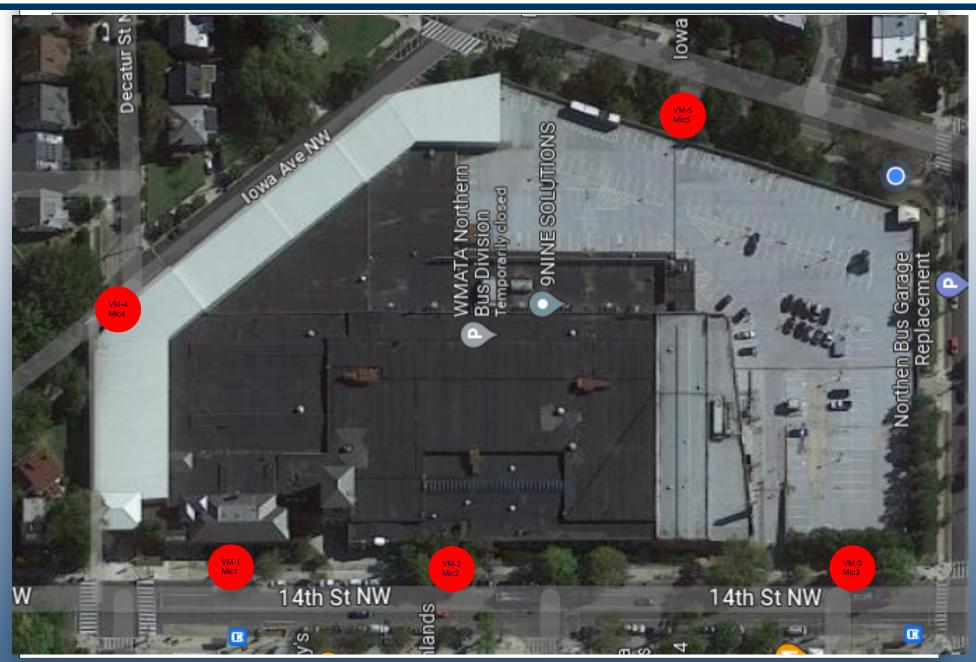
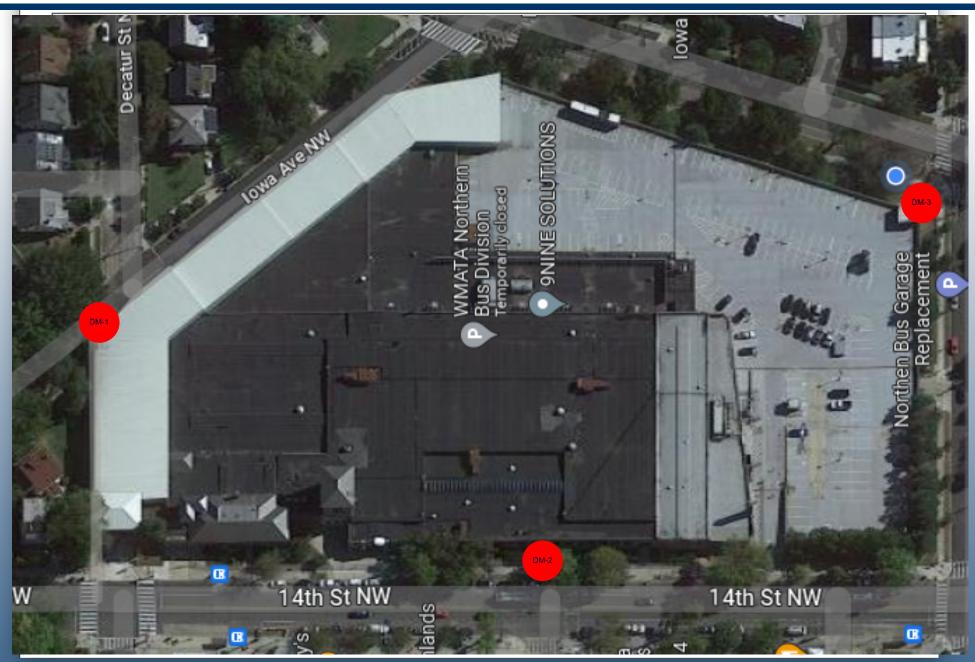
Figure 1: Vibration and Noise Monitor Location Plan

Five vibration monitors are positioned around the perimeter of the project site. (See Figure 1) Vibration thresholds are based the WMATA Design Criteria. Monitors VM-1 and VM-2 are set at a lower vibration threshold due to their proximity to the historic façade, which is more sensitive to any movement. Noise levels and vibration levels were measured automatically with Micromate and Geophone Instrument.
