Northern Bus Garage

Noise, Vibration, and Dust Monitoring Report (January 2024)

WMATA Bus Garage Monthly Report

January 2024

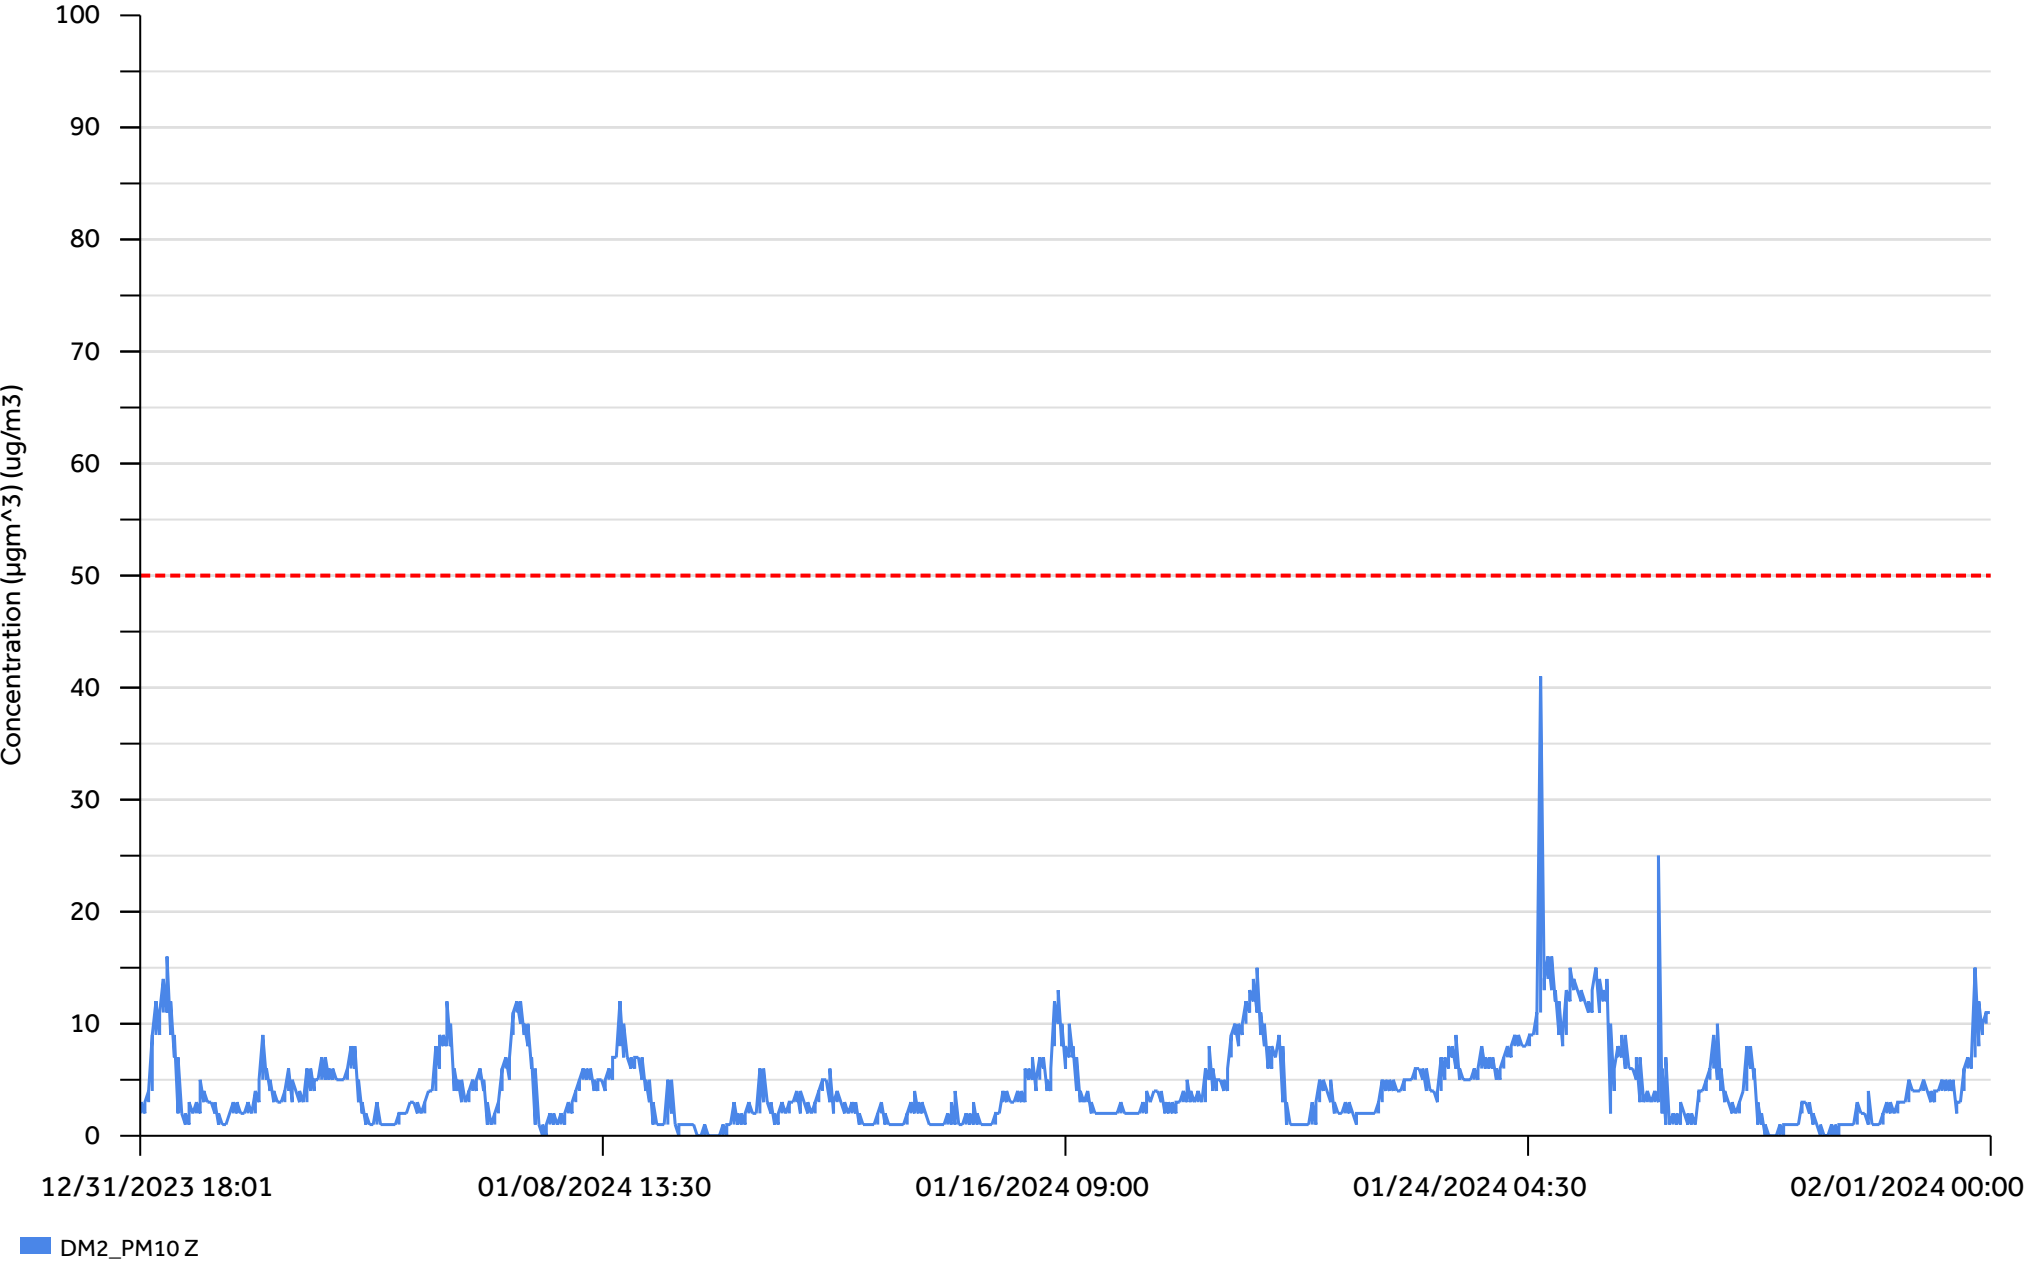
DM2-PM10

DM1 began experiencing power interruptions on January 1, 2024. The solar panel was relocated and replaced with a larger one on January 4. DM1 lost power again on January 18 and the battery was exchanged on the 19th. All three of the units have been fitted with hardware that allows tracking and alarming upon low voltage. It is not possible to plug the DM1 unit into mains power and the structure wall left in place shades the solar panel much of the day. Continued battery swaps will be the interim solution until site
