Northern Bus Garage

Noise, Vibration, and Dust Monitoring Report (December 2023)

WMATA Bus Garage Monthly Report

December 2023

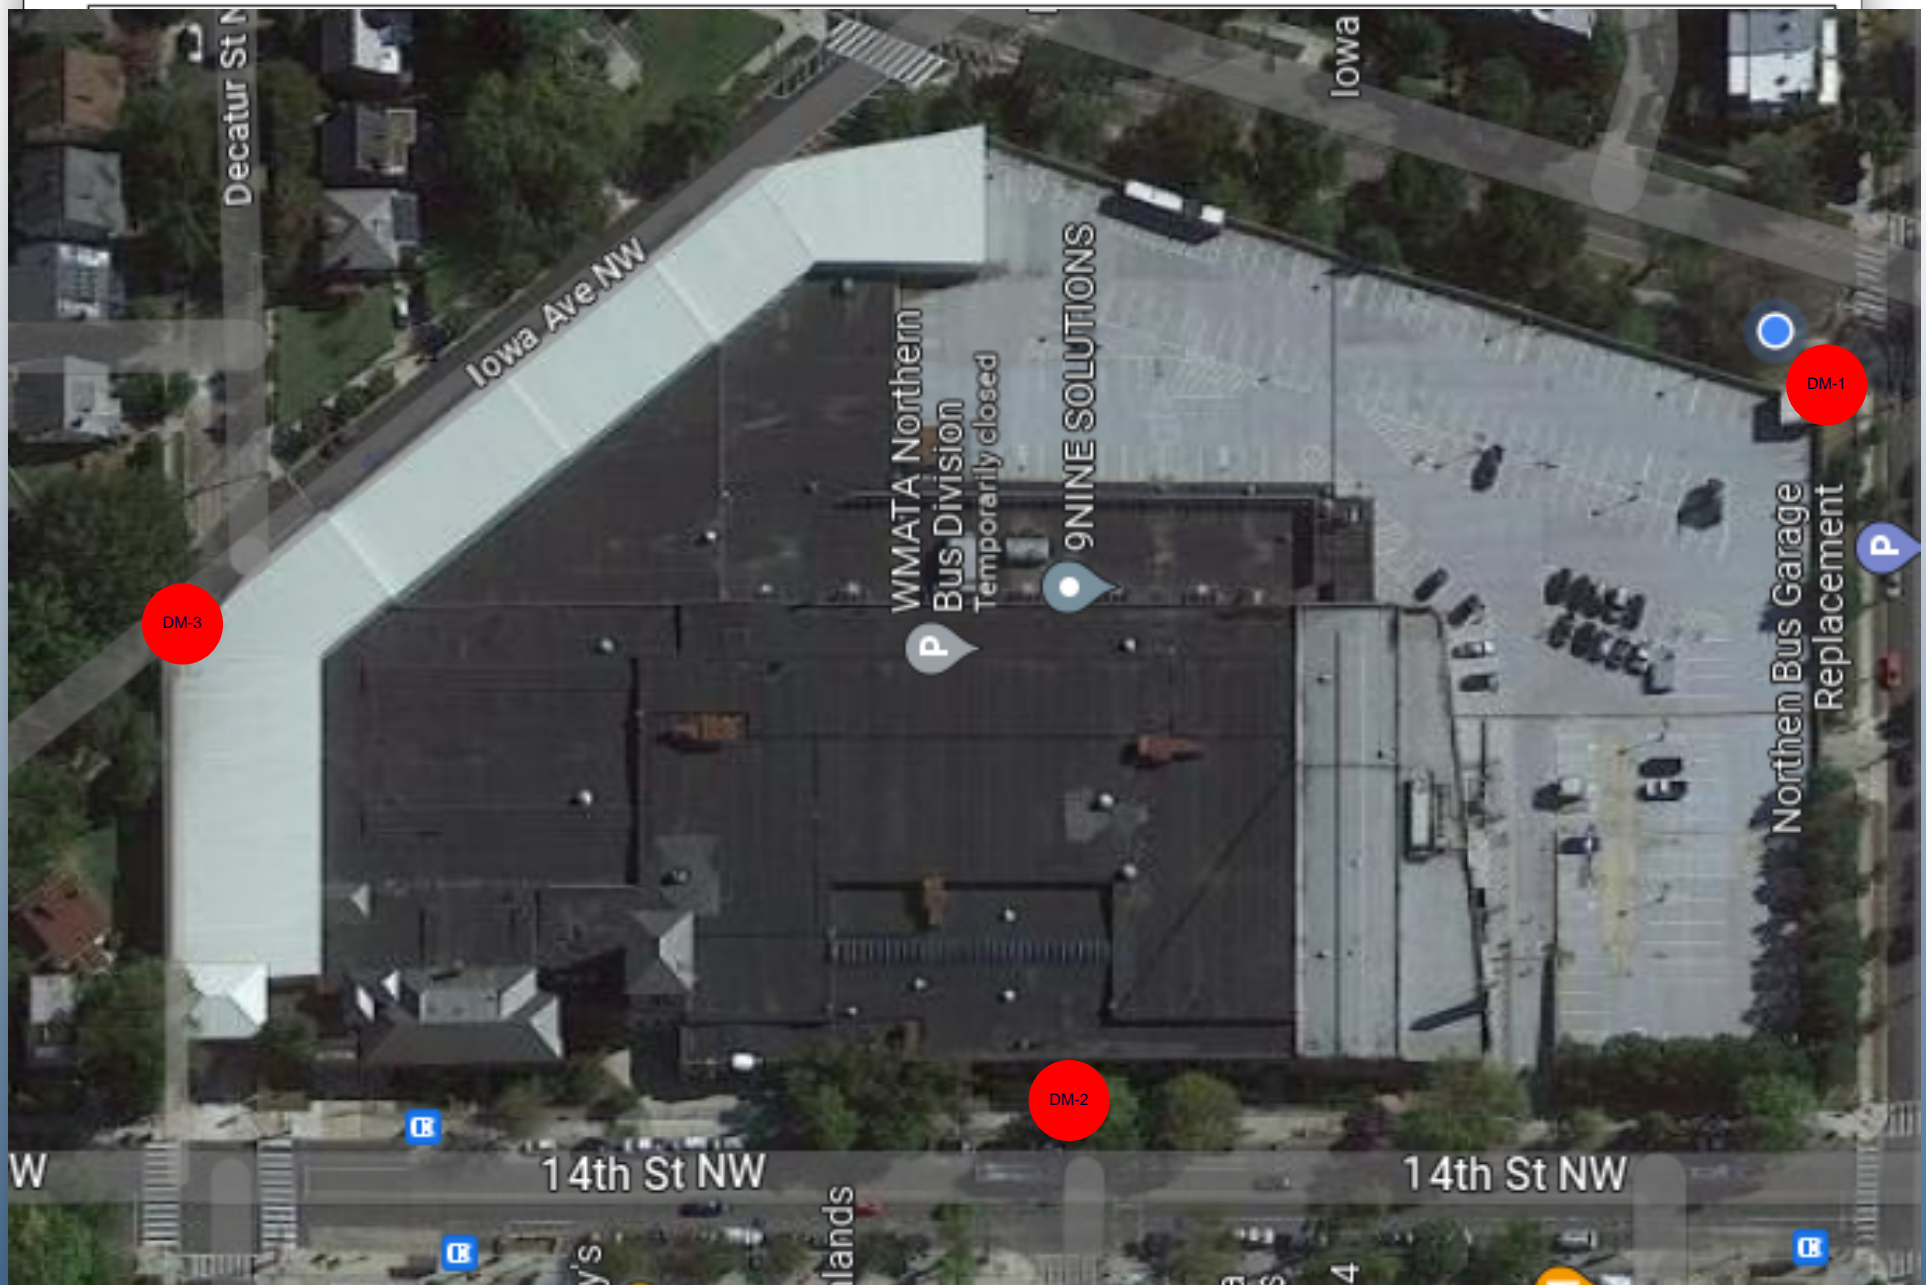
Figure 2: Dust Monitor Location Plan

Three dust monitors are positioned at the project site. (See Figure 2) EPA regulatory thresholds are based on a 24-hour monitoring period; the project has adopted thresholds to monitor site levels and provide an indication of when EPA standards might be exceeded. (See Table 3) Dust measurements were monitored using Aeroqual Dust Sentry Pro.

Higher winds in the evening of December 2 caused exceedances from 9:36pm to 9:47 pm. DM2 recorded a PM2.5 of 41. DM3 recorded a PM2.5 of 51 and a PM10 of 53. More winds on the evening of December 16 caused an exceedance at 11:12 pm. DM1 recorded a PM2.5 of 65 and a PM10 of 89.
