Monitoring Report

WMATA Bus Garage Monthly Report

July 2023

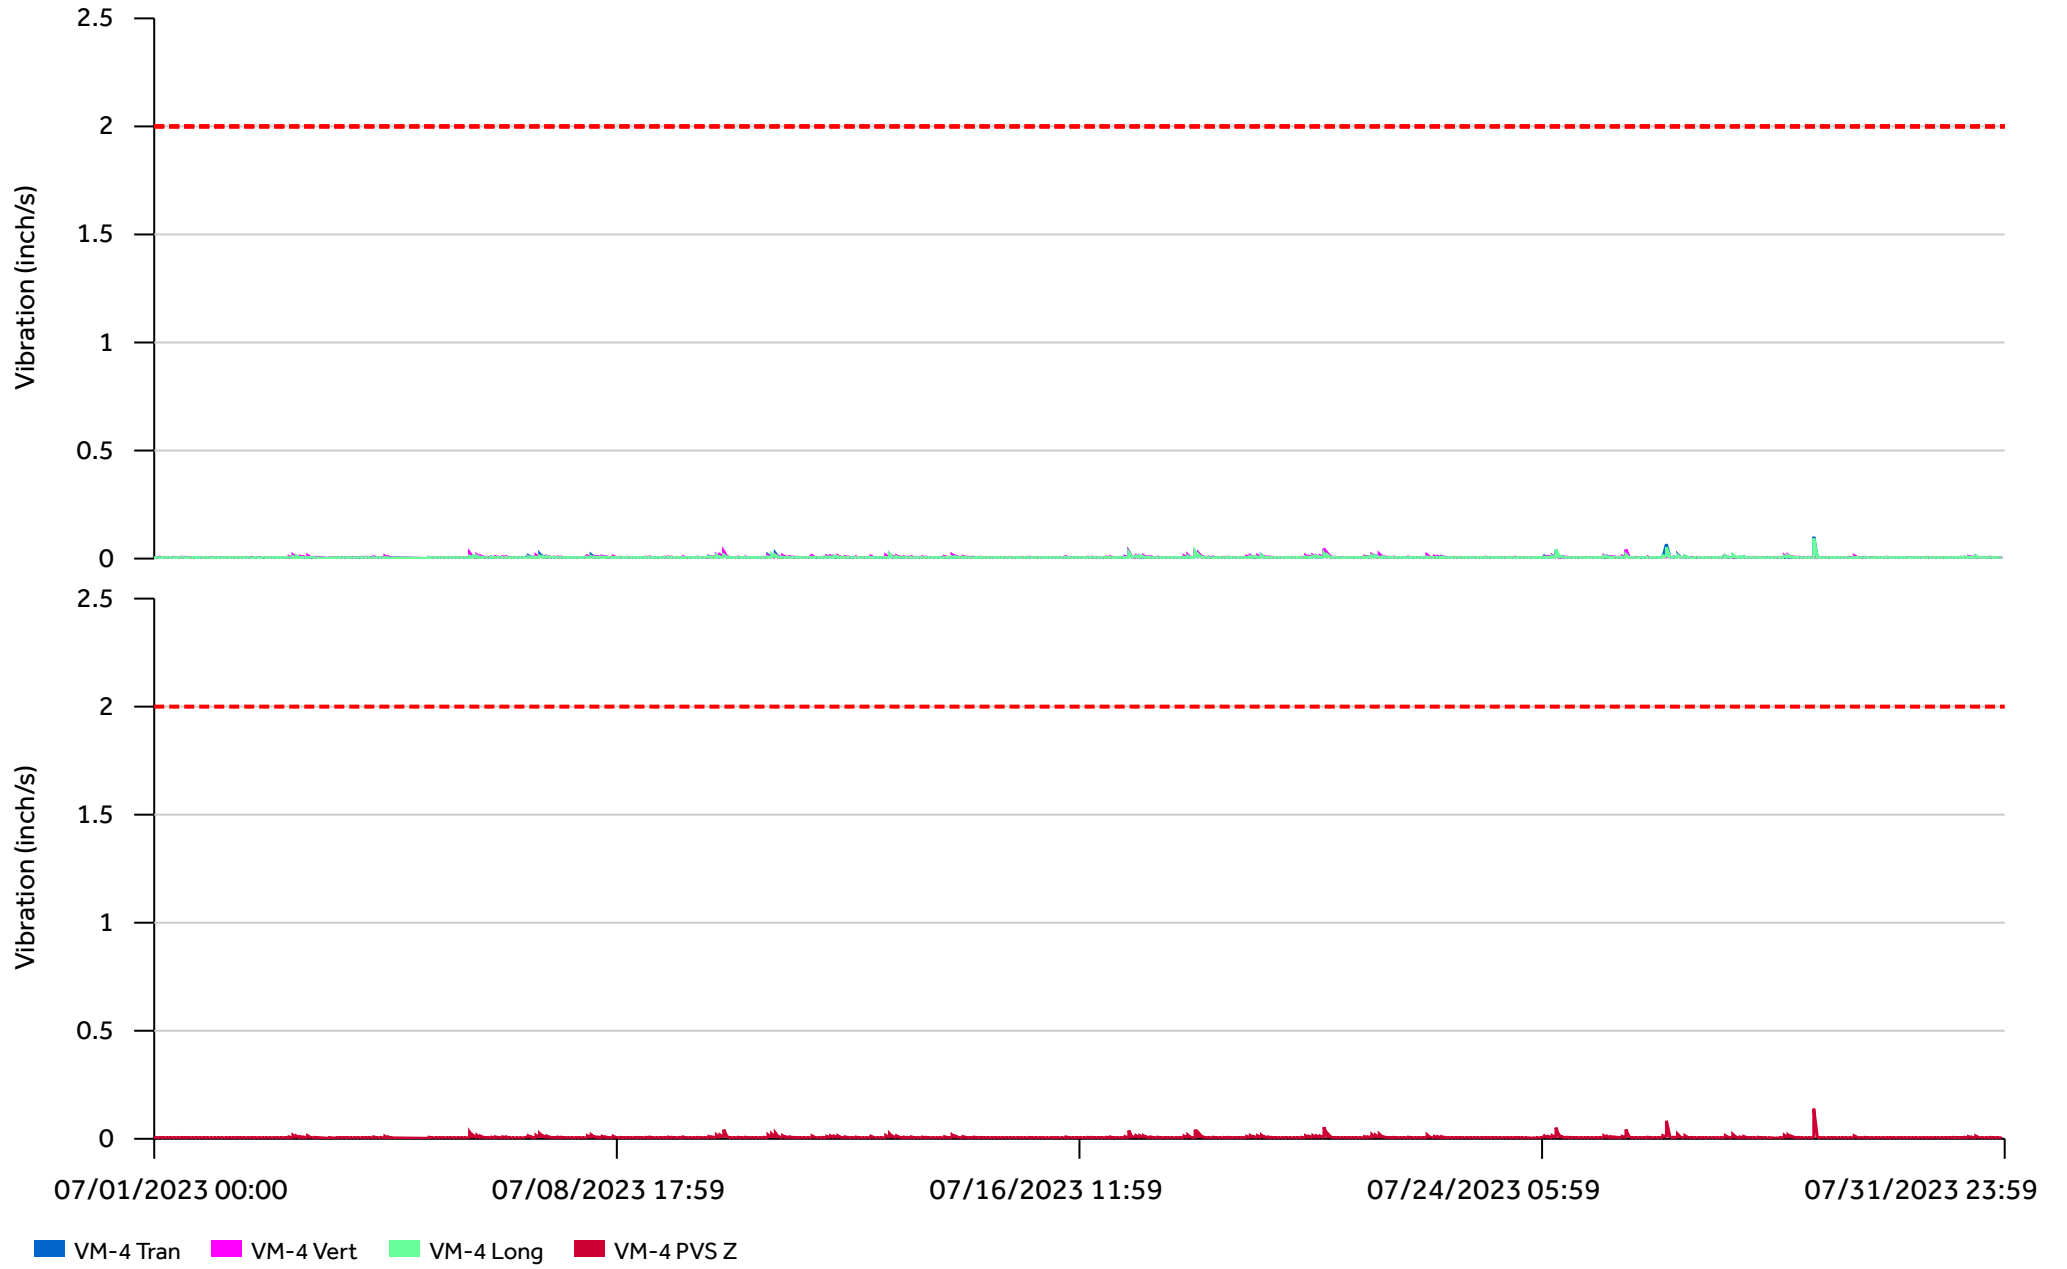
VM-4- Vibration Monitor

The 0.59 in/sec event does not appear to be caused by physical vibration, but rather electrical noise. While not an exceedance, VM4 and VM5 also recorded measurements of 0.1 and 0.32 in/sec at the same time as the 7/28 2005h recording at VM1. These also appear to be electrical in nature. The single event that triggered all three units may have been a lightning strike or other electrical anomaly at the site. VM2 had the appearance of vibration exceedances in the first half of the month. Upon further review during the compiling of this report it was discovered that the VM2 geophone was malfunctioning at the time. The unit was exchanged on July 12 and the new unit is operating normally.

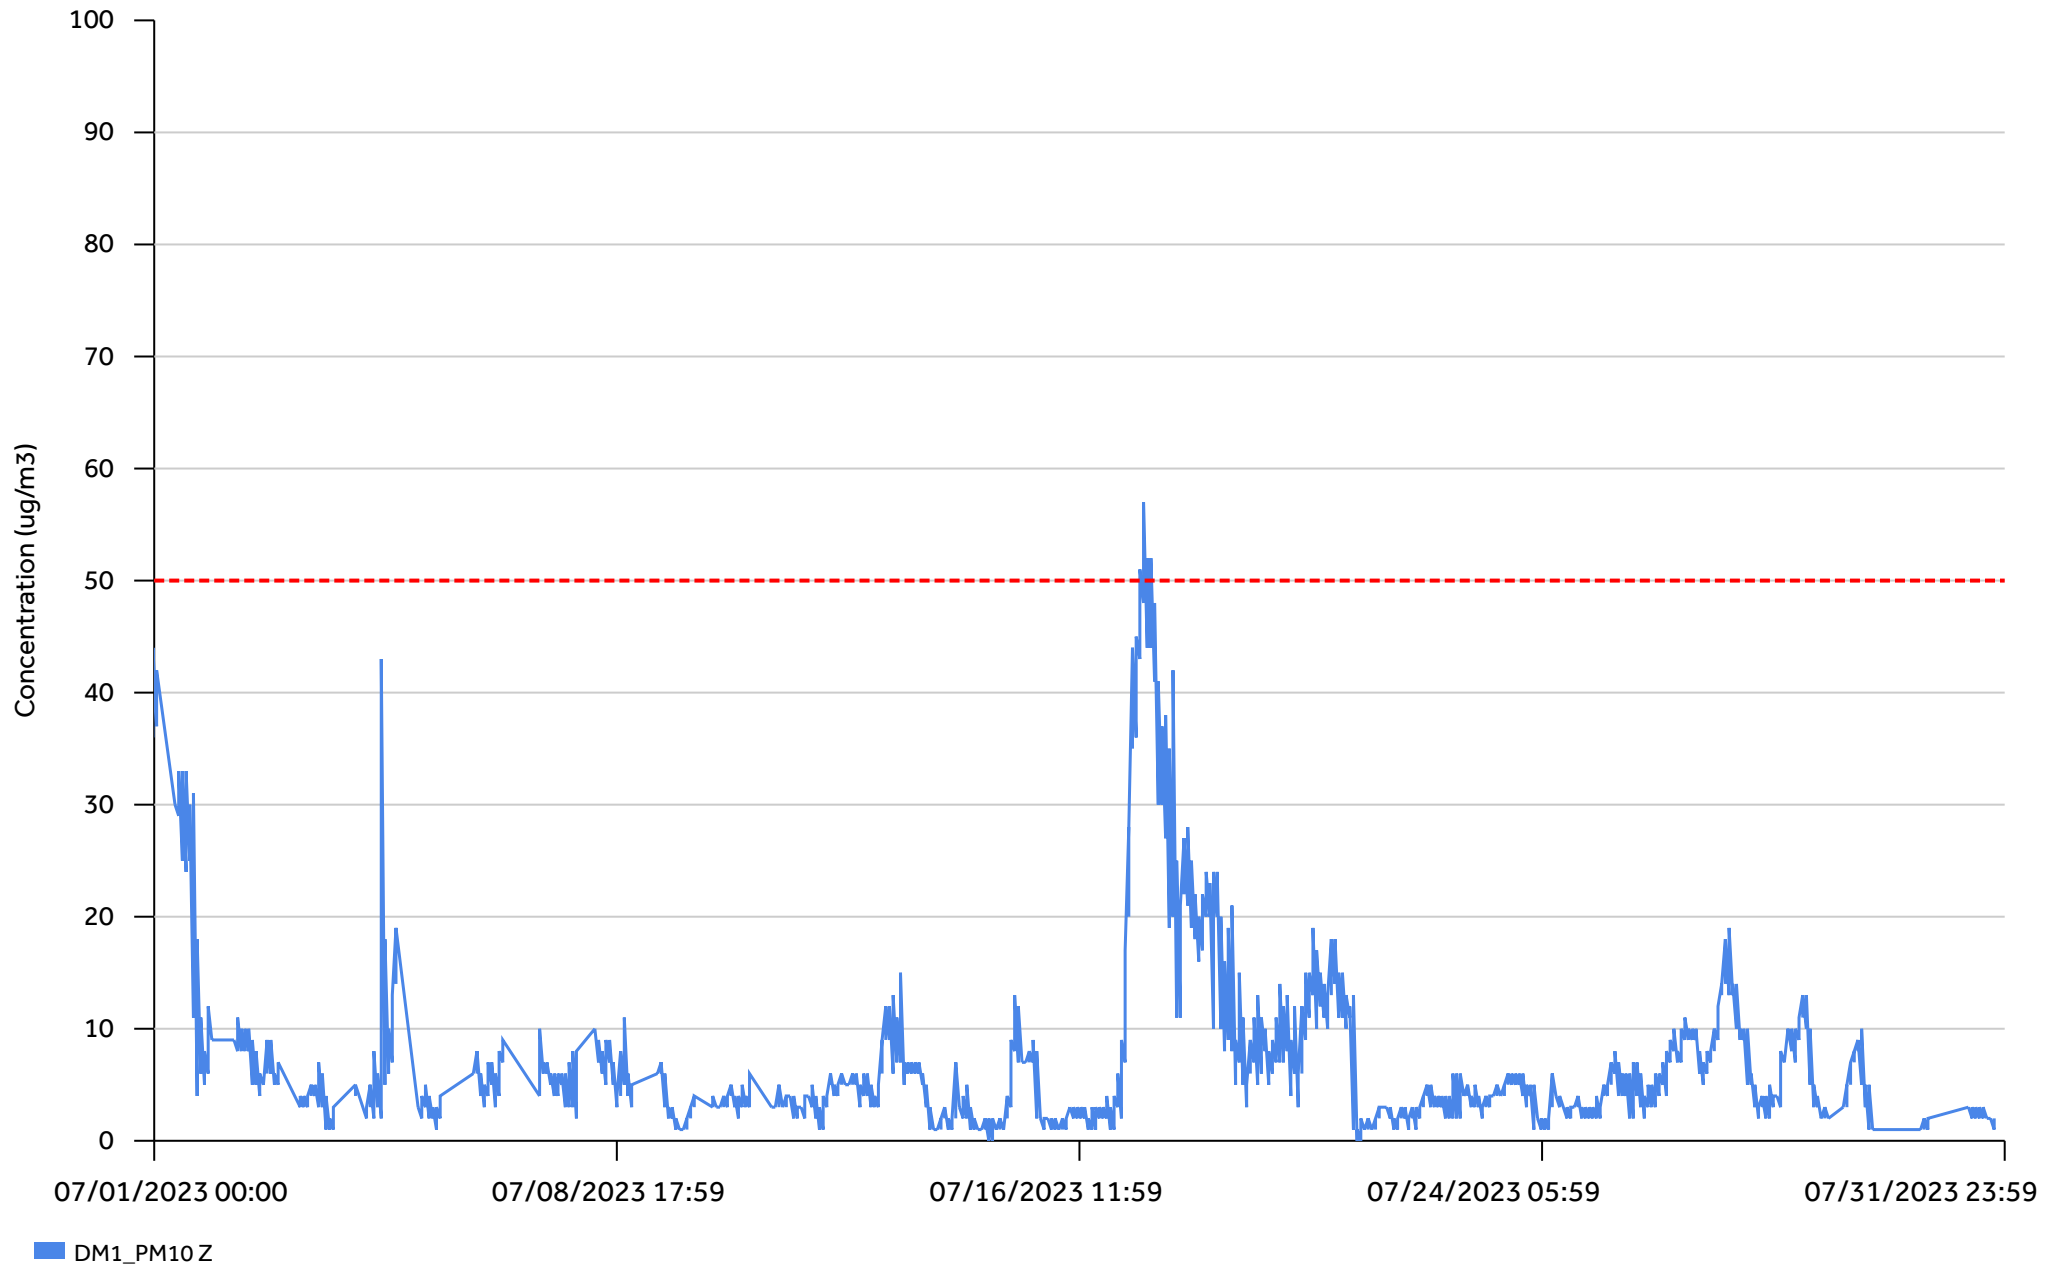
DM1 - PM10

DM1 – 7/4 2036h, 43 $\mu\text{g}/\text{m}^3$.

DM1 – 7/17 1432h. 57 $\mu\text{g}/\text{m}^3$.

A review of the data reveals threshold exceedances from regional poor air quality events on July 4th and 17th as found on www.CleanAirPartners.net. DM2 experienced power failure during most of the July 21 through 31 period. DM3 also experienced power failure from July 14 through 19 and from July 20 through 22. These units require a lot of power and DM3 has now been moved to mains power to ensure reliability. New modems are being sourced now that will allow us to measure incoming voltage and set alarms if it drops below a certain threshold.

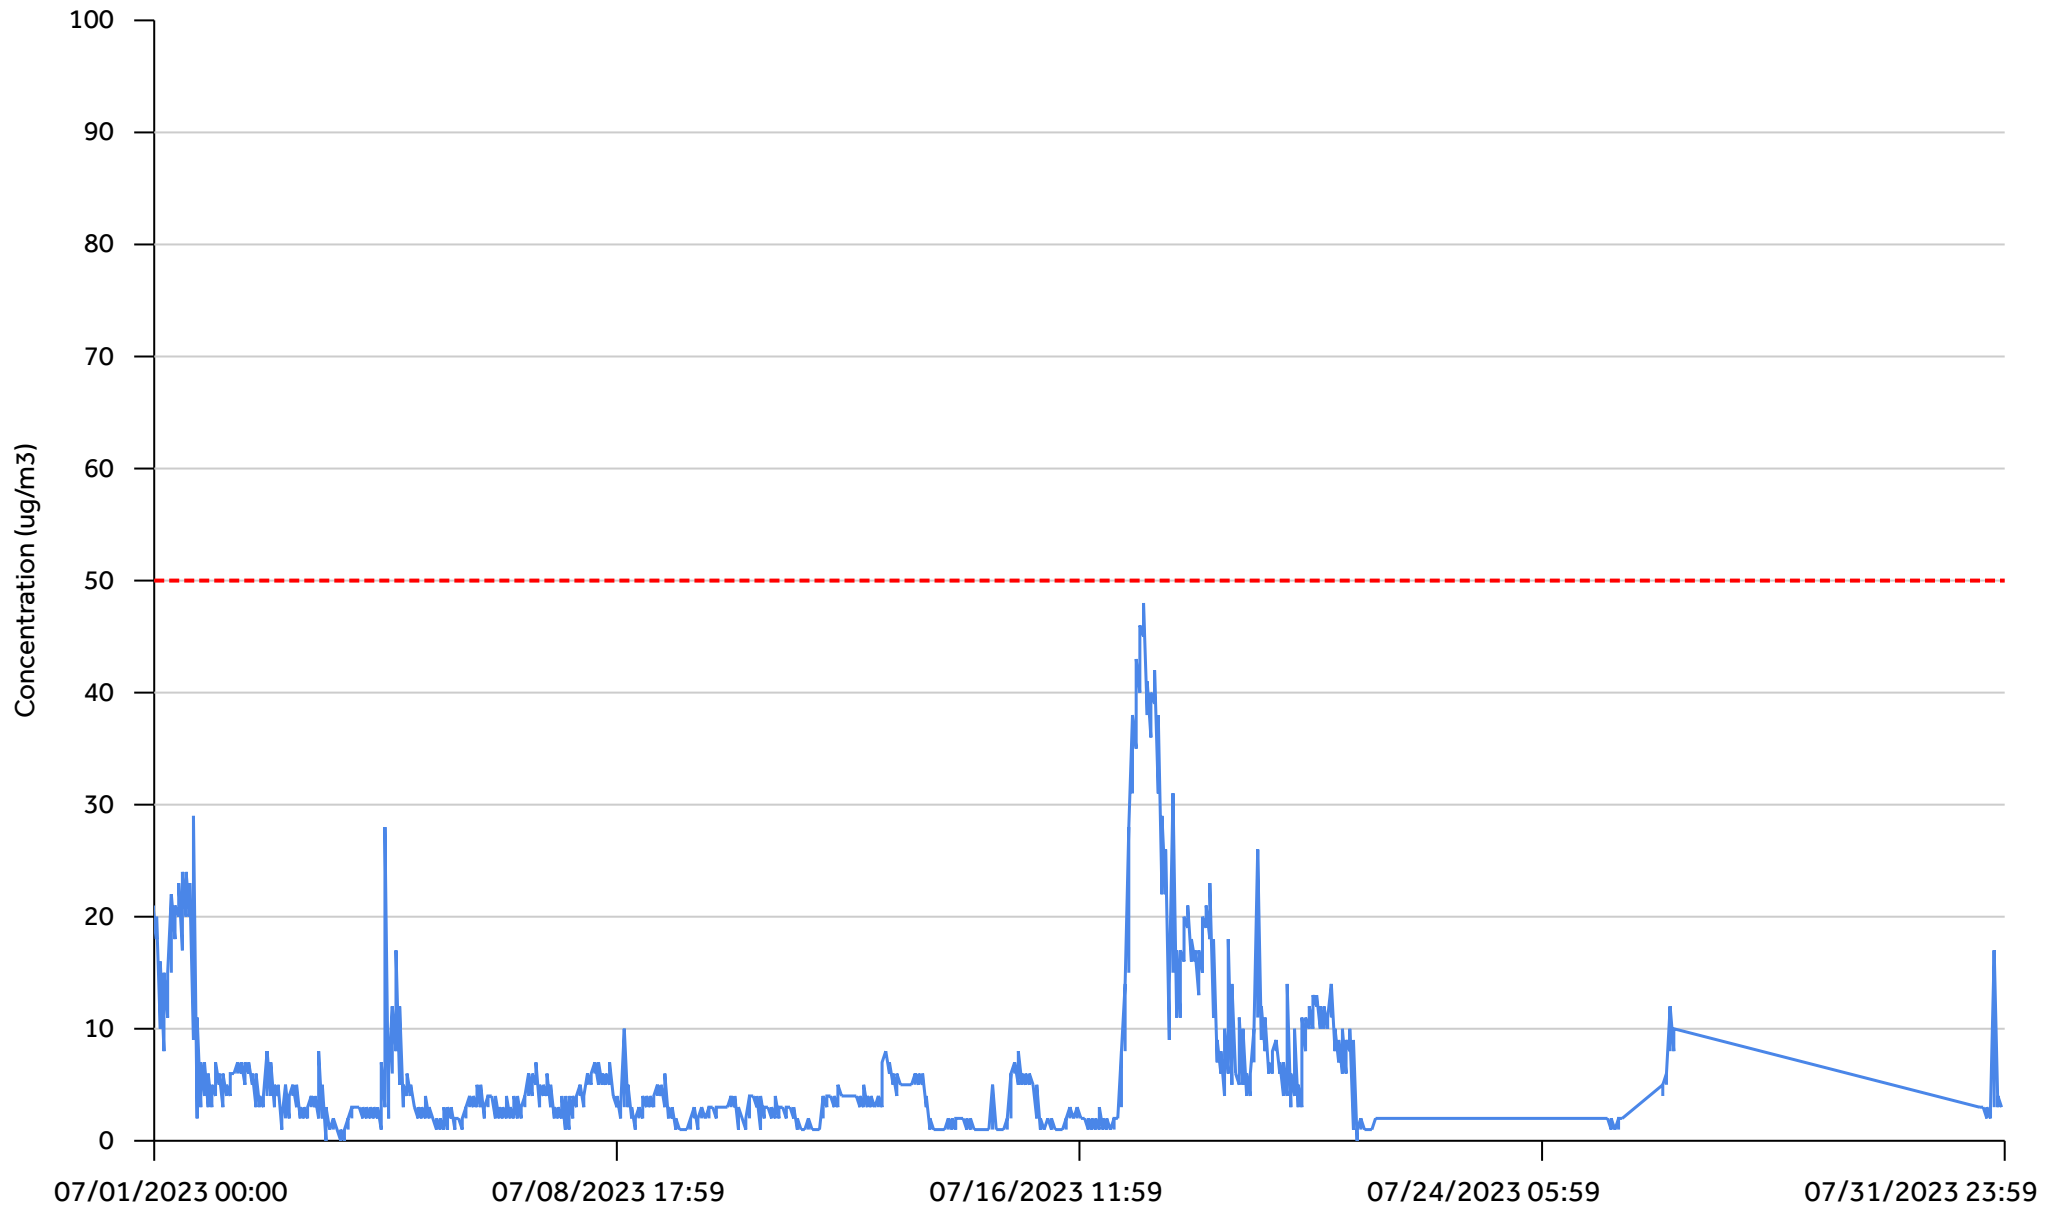
DM2-PM10

DM2 – 7/17 1116-1930h, 48 $\mu\text{g}/\text{m}^3$.

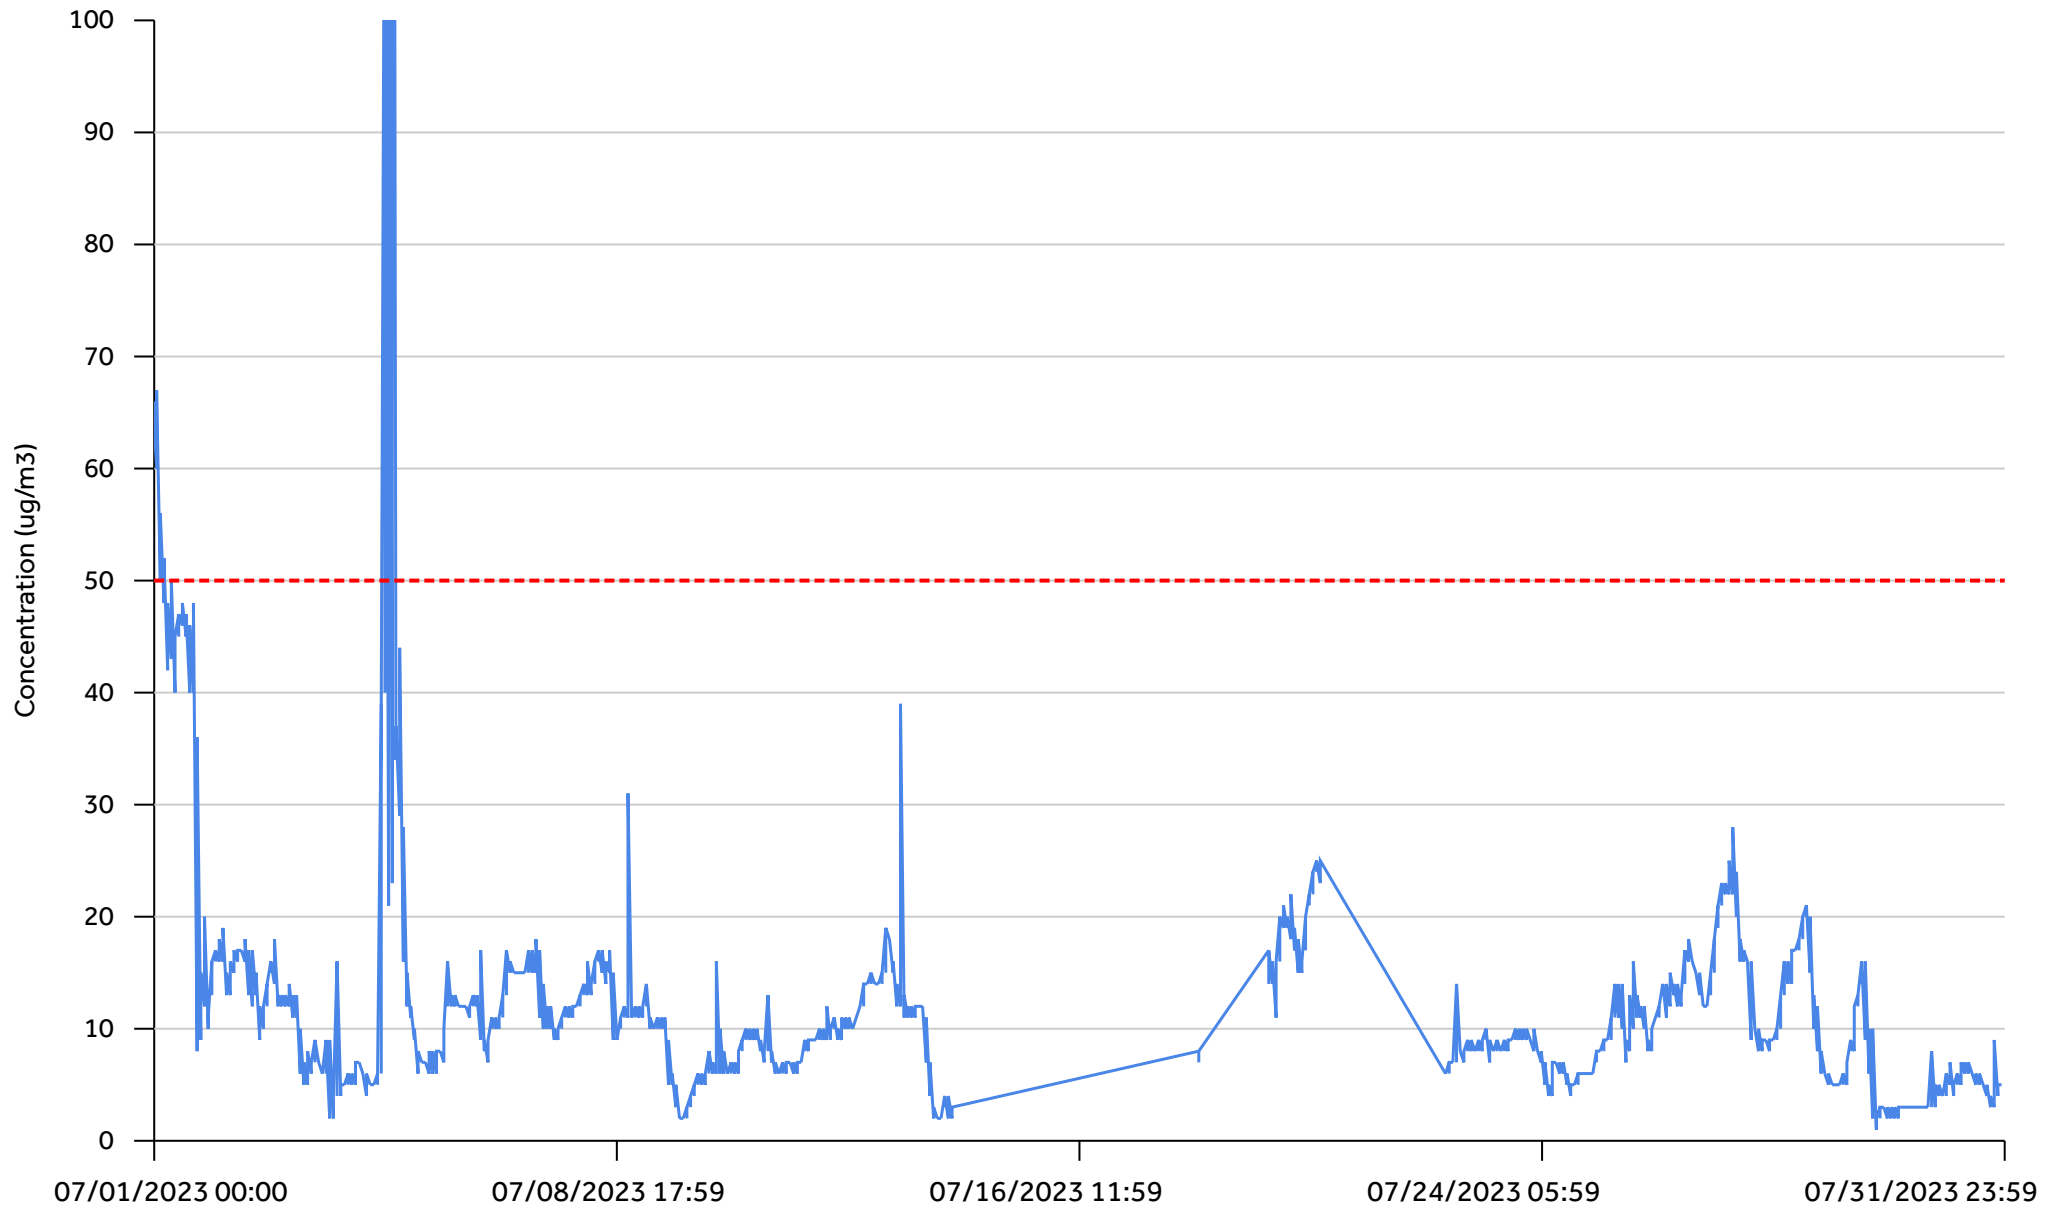
DM3-PM10

DM3 – 7/4 2126h, 130 $\mu\text{g}/\text{m}^3$.

DM3 – 7/5 0026h, 250 $\mu\text{g}/\text{m}^3$.
