Northern Bus Garage

Noise, Vibration, and Dust Monitoring Report (November 2023)

WMATA Bus Garage Monthly Report

November 2023

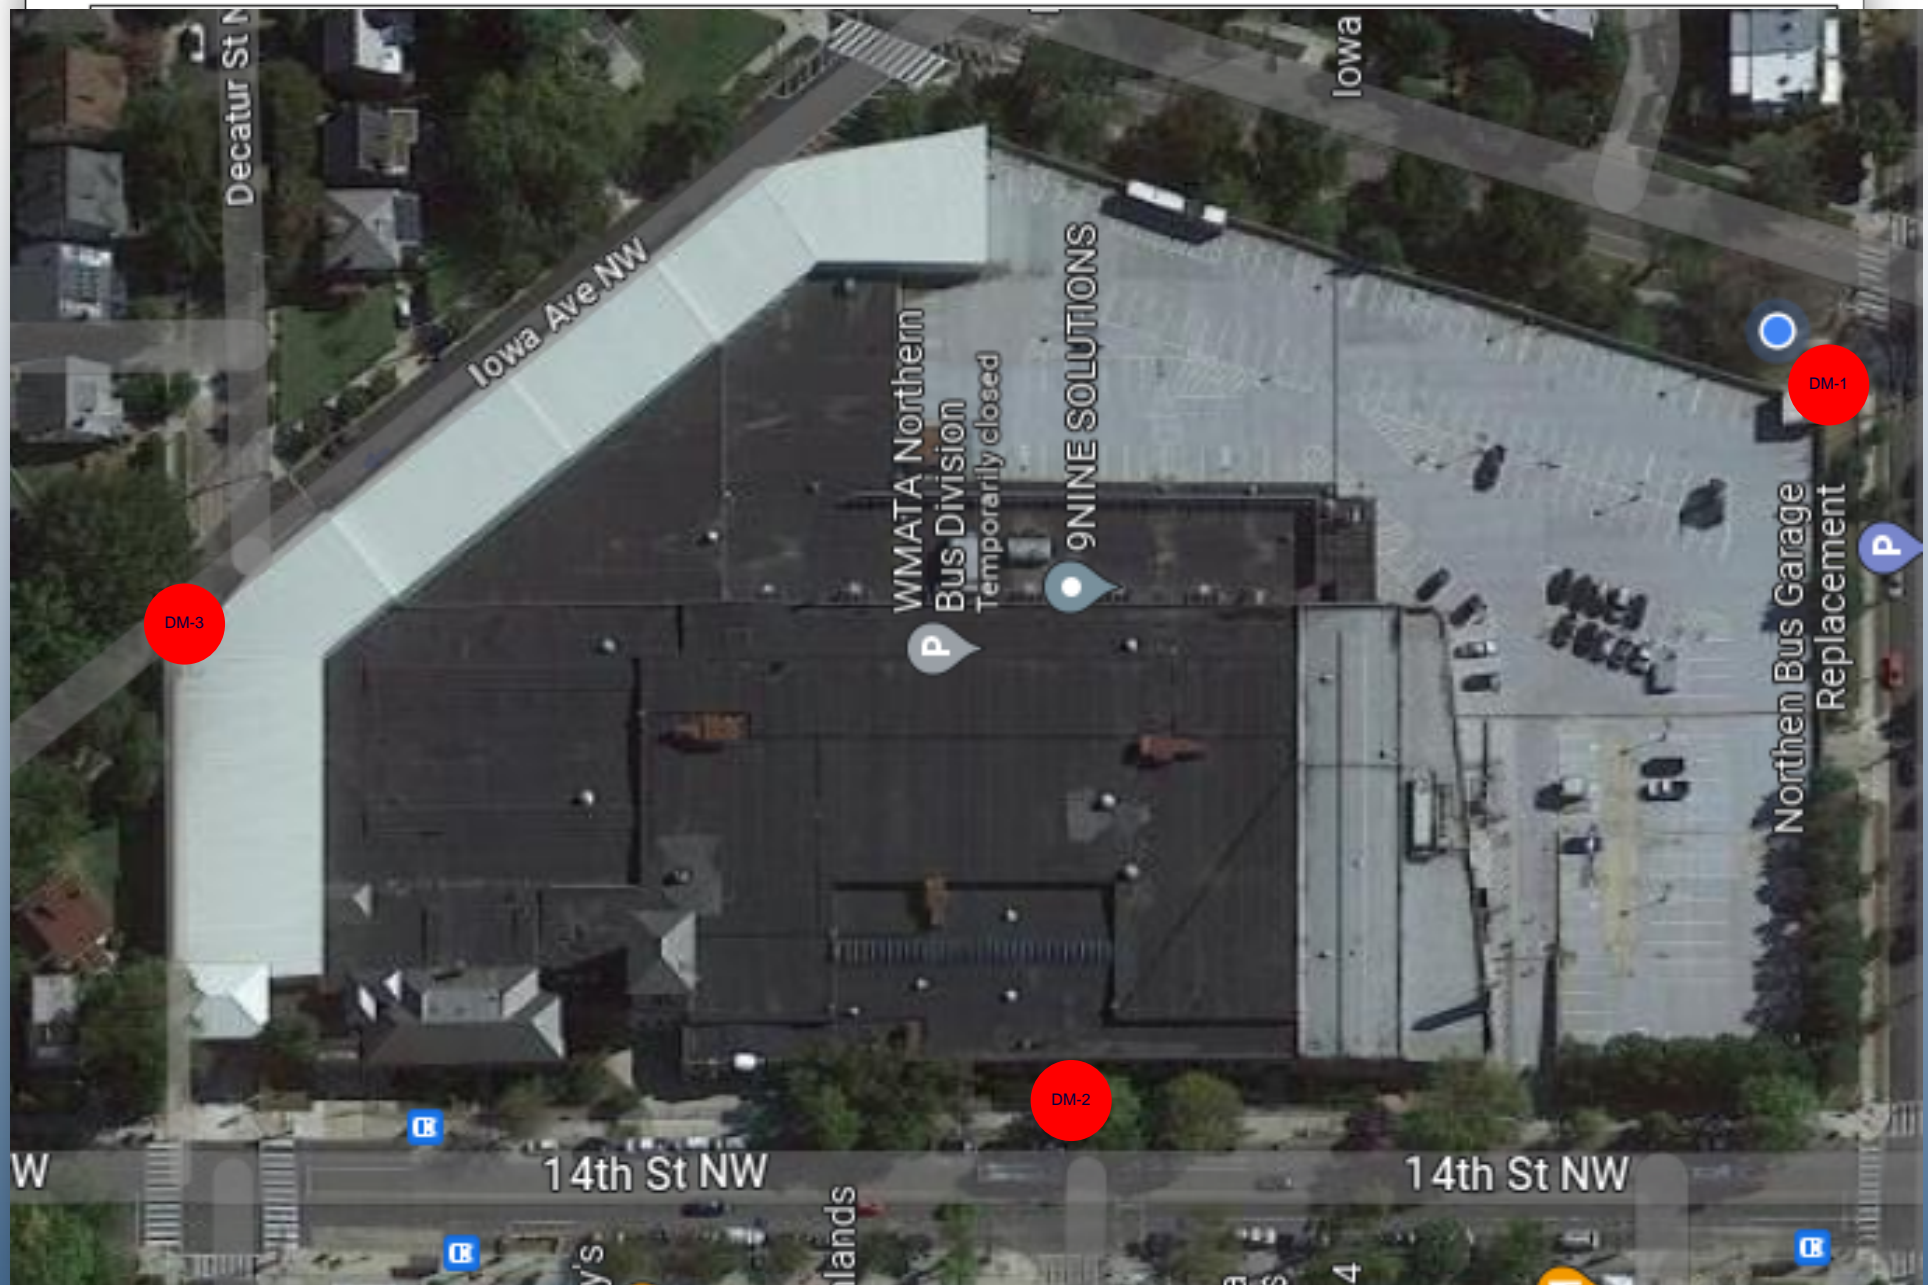
Figure 2: Dust Monitor Location Plan

Three dust monitors are positioned at the project site. (See Figure 2) EPA regulatory thresholds are based on a 24-hour monitoring period; the project has adopted thresholds to monitor site levels and provide an indication of when EPA standards might be exceeded. (See Table 3) Dust measurements were monitored using Aeroqual Dust Sentry Pro.

DM1 began experiencing power interruptions until the battery was exchanged on November 10. Two of the units have been fitted with hardware that allows tracking and alarming upon low voltage. Due to site restrictions, DM1 cannot be plugged into main power so continued battery swaps will be the interim solution until site conditions change.
