Washington Metropolitan Area Transit Authority Board Action/Information Summary

Briefing on Red Signal Overruns

Update on Red Signal Violations

Investigation and Analysis of WMATA 2014 Red Signal Violation Incidents

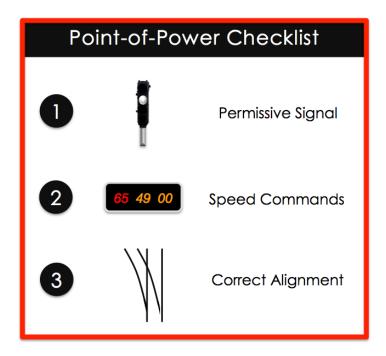
Figure No. 7

Recommended Placement of the Point-of-Power Checklist

Therefore the purpose of the "Point-of-Power Checklist", and the attention performance training recommended for train operators is intended to prevent <u>all</u> instances of attention-related errors, not just the ones that happen to result in a red signal violation. For this reason and the fact that the combination train operators' of rushing combined with their automatic habitual behavior of going to a point-of-power automatically without full conscious awareness of their speed commands, signal indication or switch position was a contributing factor in nine (9) of the eleven (11) red signal violation incidents that occurred in 2014 it is strongly recommended that WMATA leadership consider the immediate and mandatory use of the Point-of-Power Checklist by its train operators. An example of the Point-of-Power Checklist and its suggested placement on the control panel in the cab of its motive power are shown in Figure No. 2 and Figure No. 3. Atticus is happy to discuss the specific procedures it has developed and field tested for execution by WMATA train operators should WMATA leadership decide to proceed with this recommendation.
