Washington Metropolitan Area Transit Authority
Board Action/Information Summary

Metrorail Incident Near Farragut North

MetroRail Incident near Farragut North Metro Station

Safety Committee
September 22, 2016

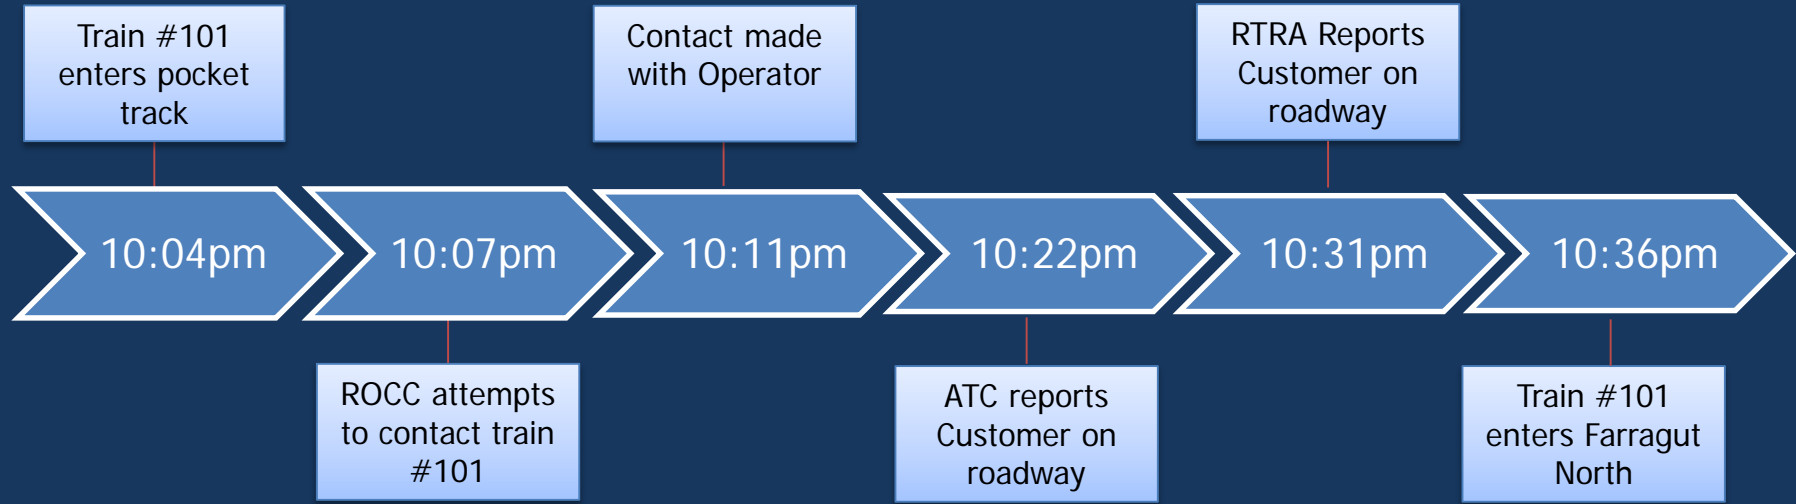
Timeline of Events

Time Between Train Entering Pocket Track and Self Evacuation = **18 Minutes**

Total Incident Time = **32 Minutes**
