ASSET (BUS SHELTER) IMPROVEMENT EVALUATION STUDY

Final Report

June 2013

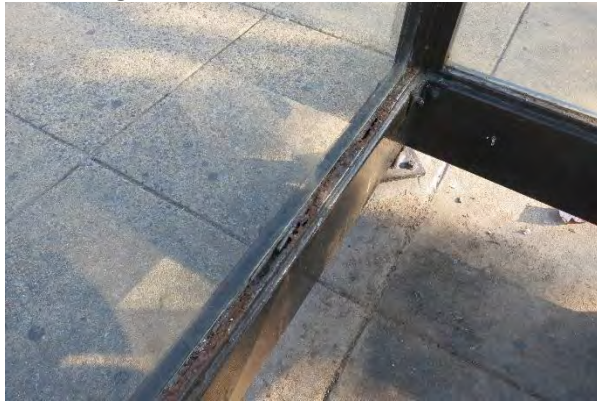
Figure 10: Rusted Frame, Shelter K

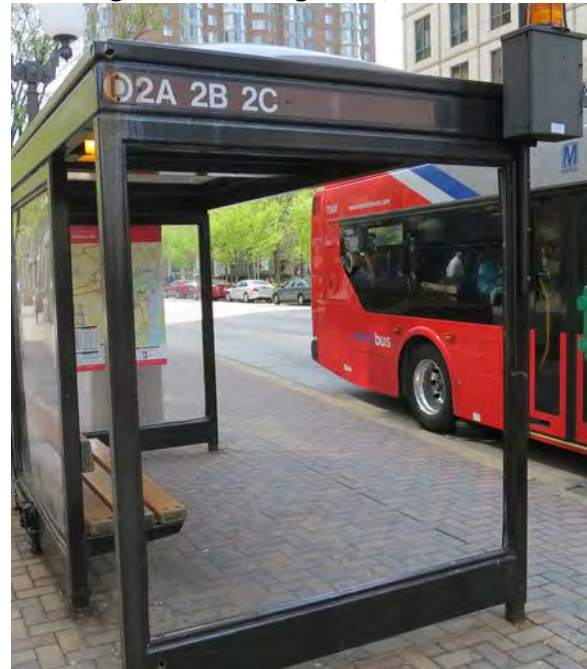
Overall, shelter conditions at the station are slightly below average, with a station condition score of 2.8. **Table 3** summarizes conditions for each individual shelter. The shelters, as a whole, scored the lowest in panel and dome top condition, with damage to each of these elements present at several shelters. Shelters D and E are in the worst condition, with D missing a panel and E showing above average rust, damaged panels, and a damaged dome top.

Figure 15: Missing Panel, Shelter D

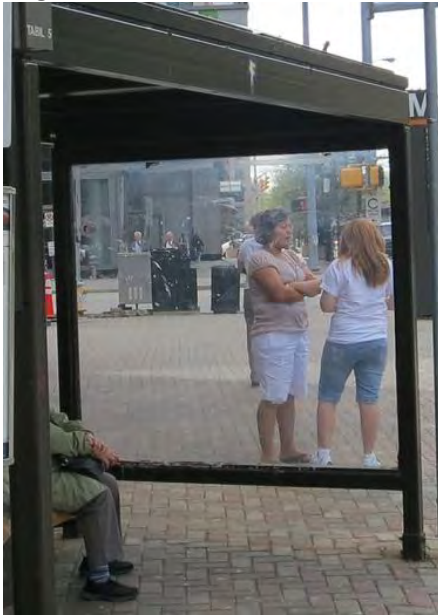
Figure 16: Rusted Frame, Shelter E

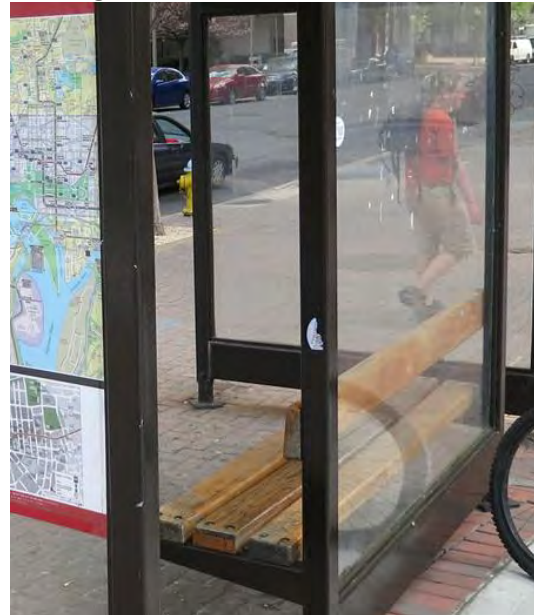
Rust on the frames was common among all the shelters at this station with the exception of G, which had the best overall frame condition. Benches at E and H were worn and heavily scratched, while benches at other shelters were in average condition. Pads at the station were in above average condition overall. **Figures 14 through 17** illustrate the different shelter conditions at the station, while **Figure 18** summarizes each shelter's overall condition score.

Figure 17: Worn Bench, Shelter H

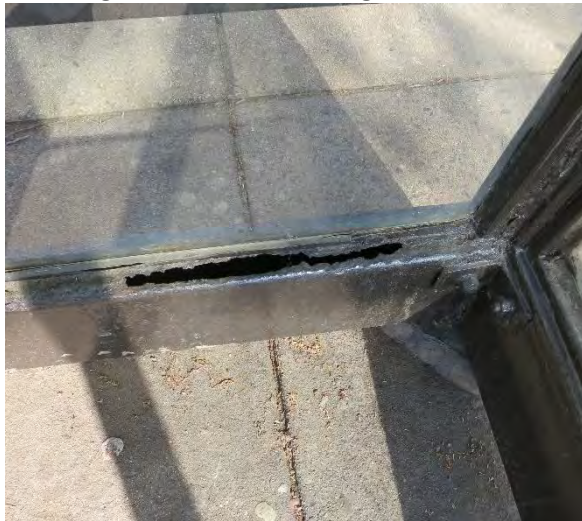
Overall, shelter conditions at the station are average, with a station condition score of 3.0. **Table 4** summarizes conditions for each individual shelter. The shelters, as a whole, scored the lowest in pad and frame condition. Shelters B, C, and D all have significant rust on their frames, while A, D, and E all had significant cracking in their pads. Shelter E also had a damaged panel. Dome tops were generally in average condition, while benches were in slightly above average condition.

Figure 20: Frame Damage, Shelter B

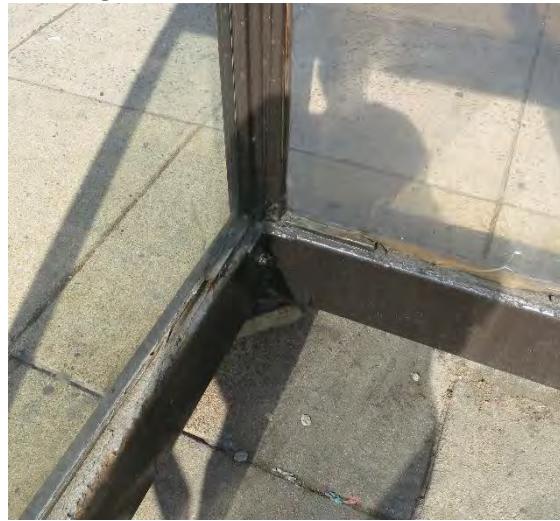
Figure 21: Rusted Frame, Shelter C

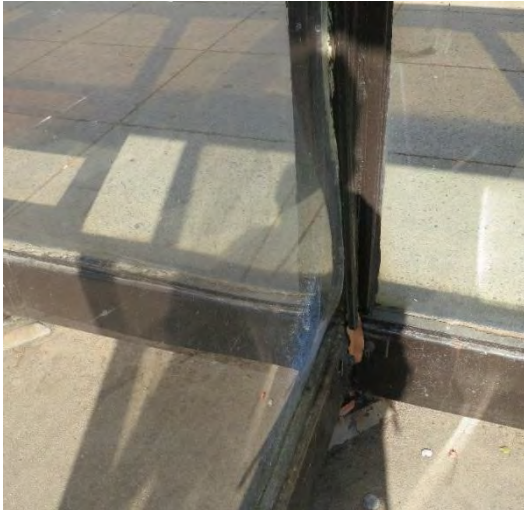
Figure 22: Damaged Panel, Shelter E

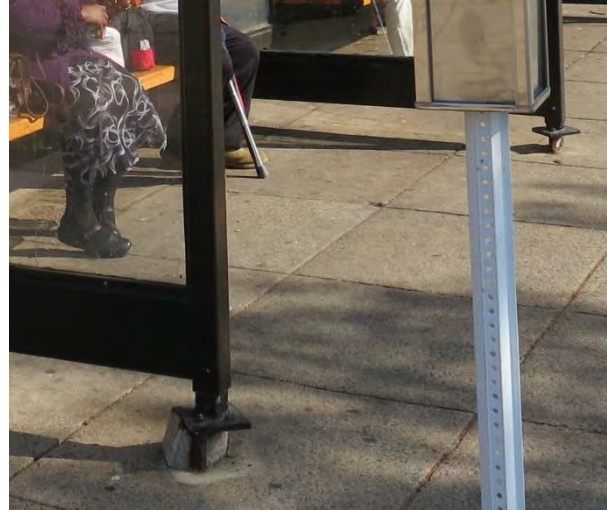
Figure 23: Cracked Pads/Footings, Shelter B

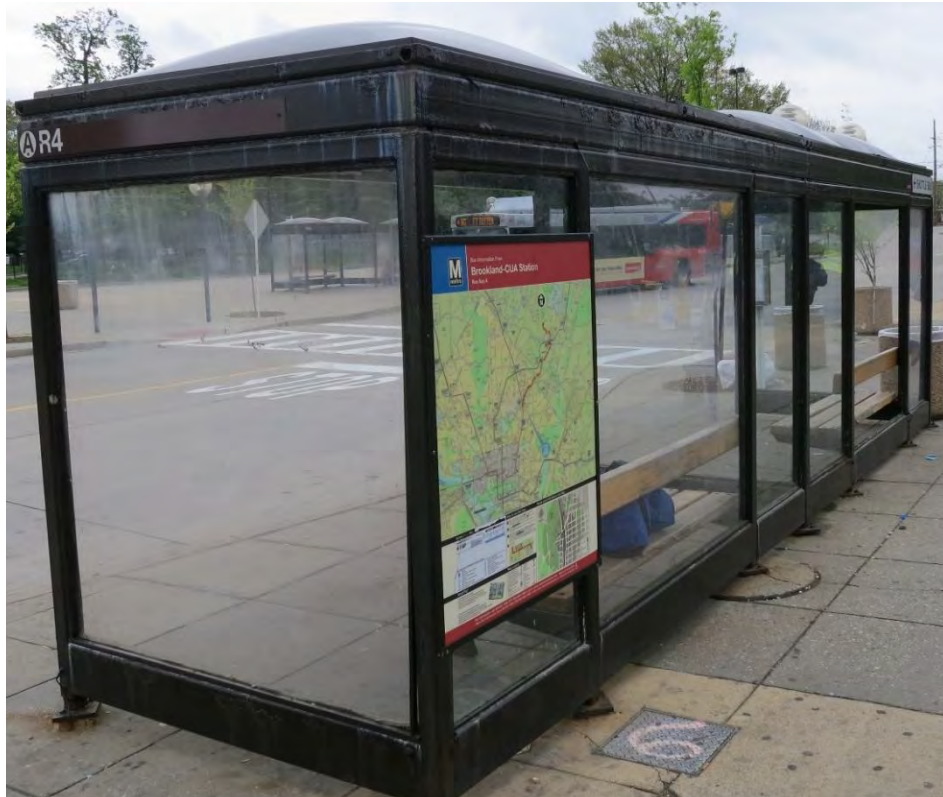
Overall, shelter conditions at the Brookland station are poor, with an overall station condition score of 1.9. **Table 5** summarizes conditions for each individual shelter. The shelters, as a whole, scored the lowest in frame and bench condition, though panel and dome top condition were also below average. Shelter A is in particularly bad condition, with an overall condition score of 1. Shelter A had significant rust on its frame, missing panels, a missing dome top and worn/split benches. Shelters B, C, and D/J also had significant rust on their frames, while shelters E/H and F/G also had missing dome tops. Shelter D/J also had a hole in its frame.

Figure 26: Poor Condition of Shelter A, Missing Panels, Missing Dome Top and Rust

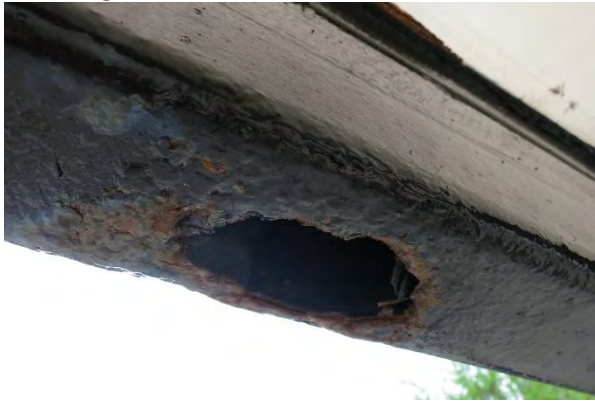
Figure 27: Hole in Frame, Shelter D/J

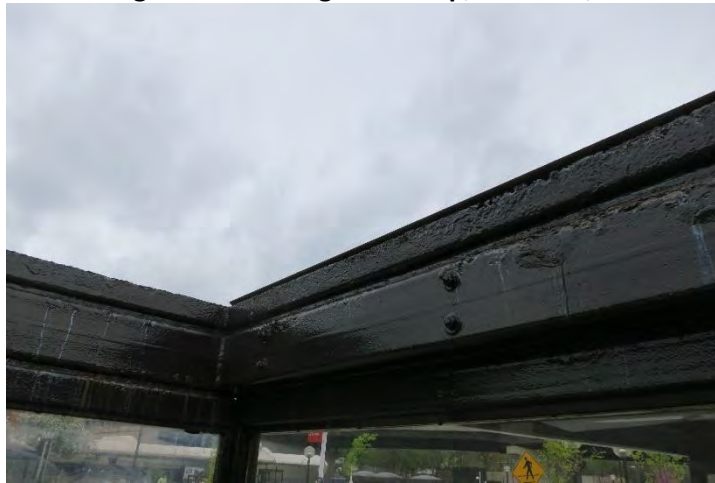
Figure 29: Missing Dome Top, Shelter E/H

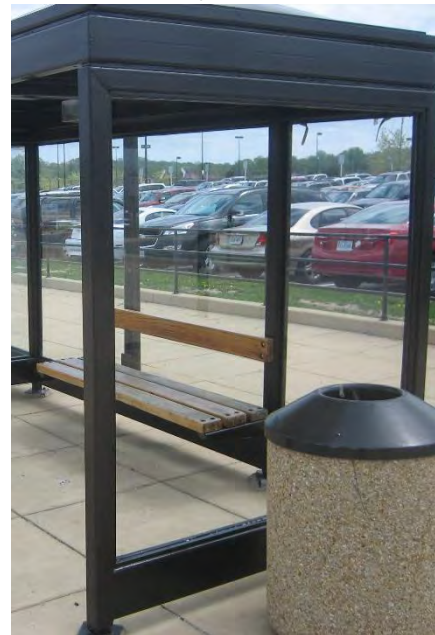
Figure 33: Missing Panel & Worn Bench, Shelter B

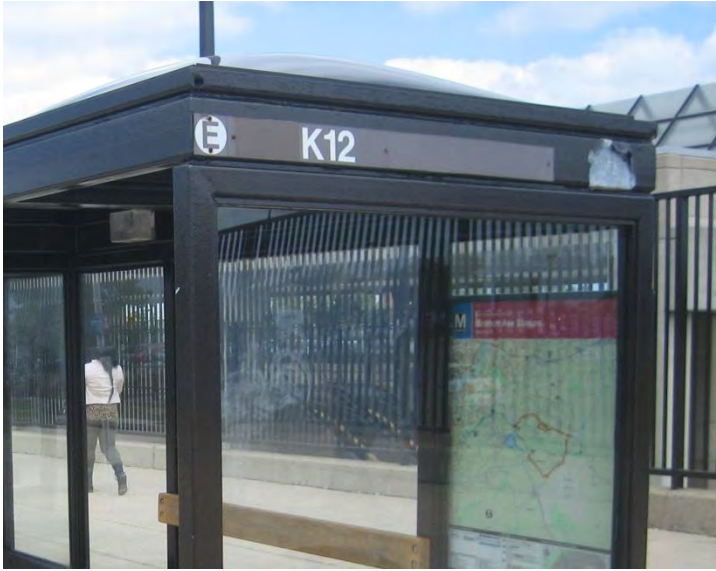
Figure 34: Peeling Paint, Shelter E

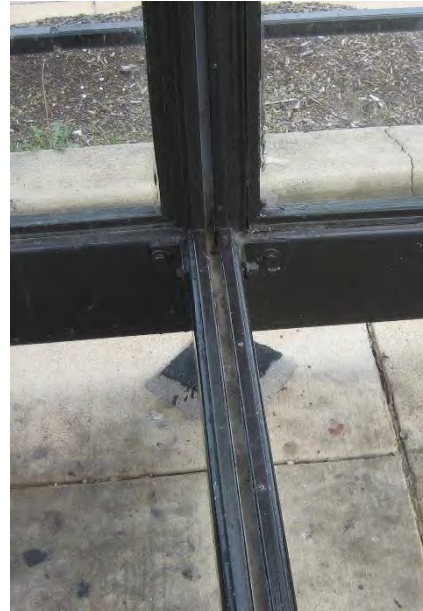
Figure 35: One of Two Missing Panels, East Kiss & Ride

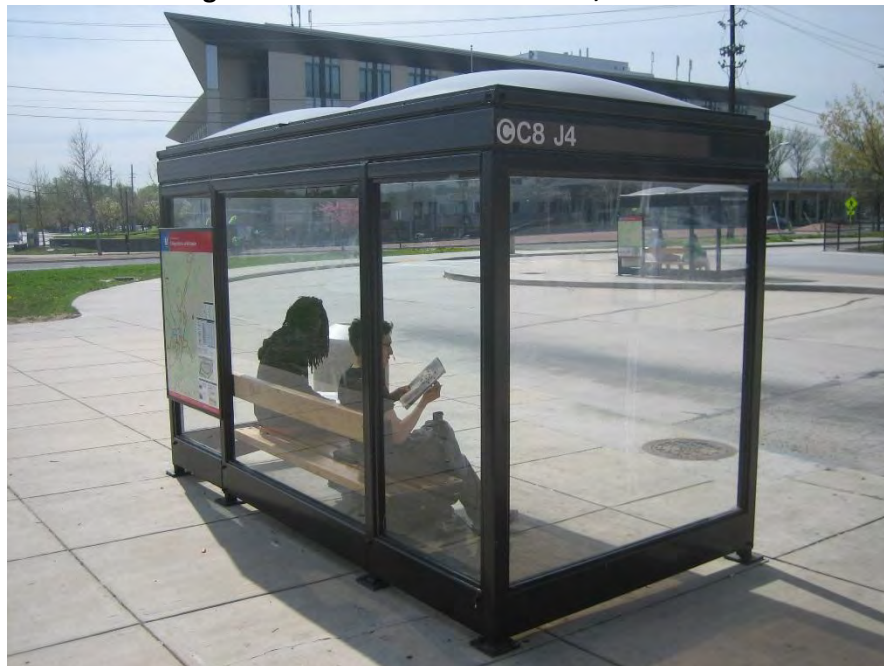
Figure 44: Good Overall Condition, Shelter C

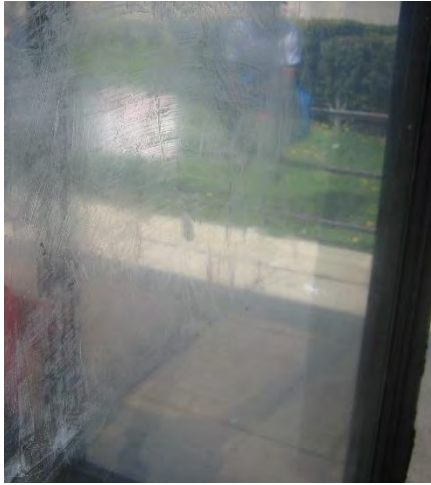
Figure 45: Smeard/Scratched Panel, Shelter E

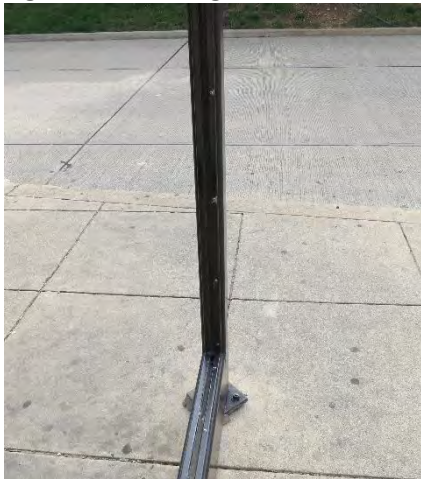
Figure 49: Missing Panel, Shelter D

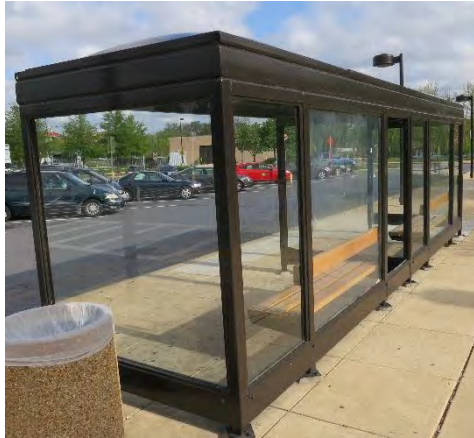
Figure 51: Missing Panel, Kiss & Ride

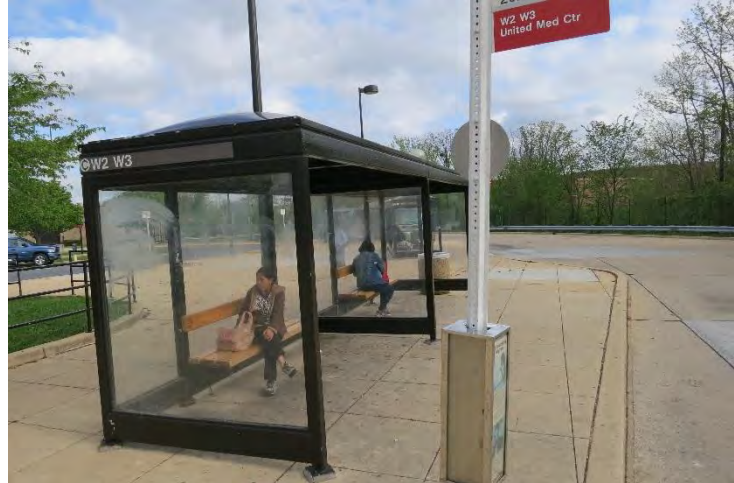
Figure 52: Smeared Panel, Good Frame Condition, Shelter C

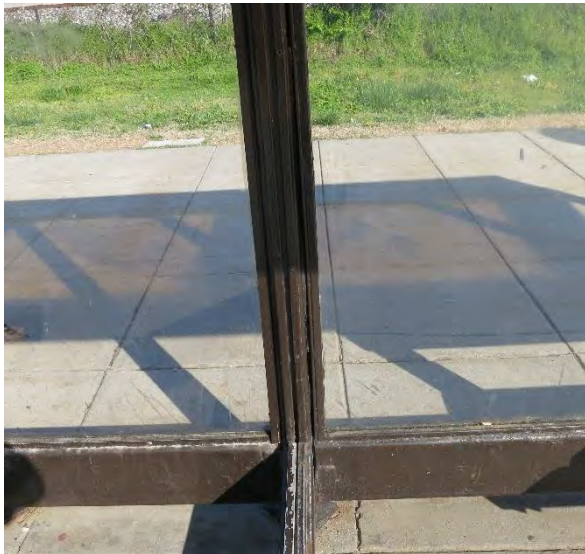
Figure 55: Missing Panel, Shelter B

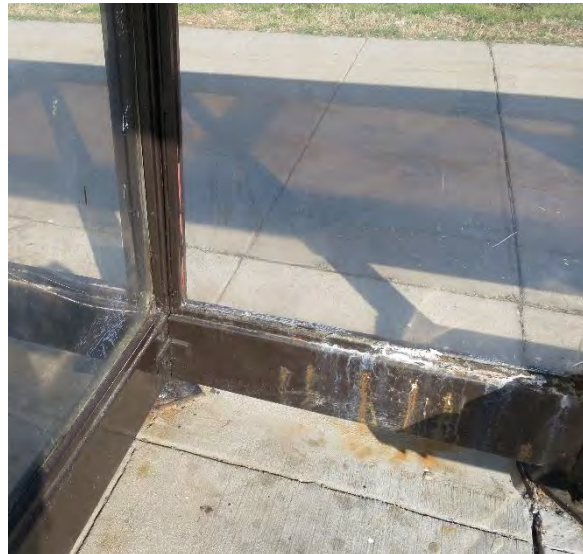
Figure 56: Frame Rust, Shelter C

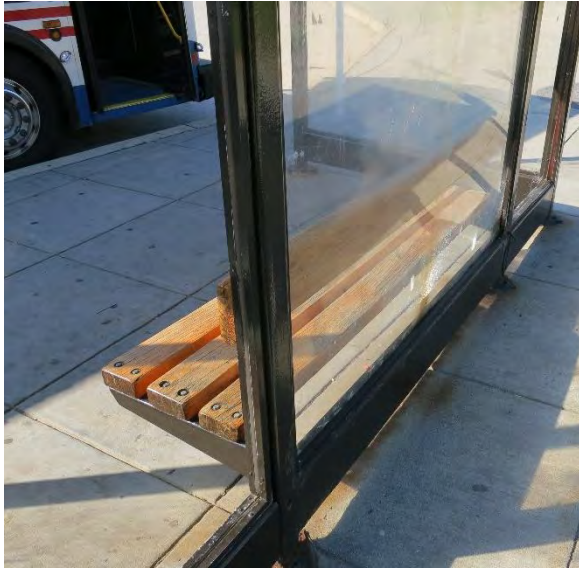
Figure 57: Missing Panel and Frame Rust, Shelter D

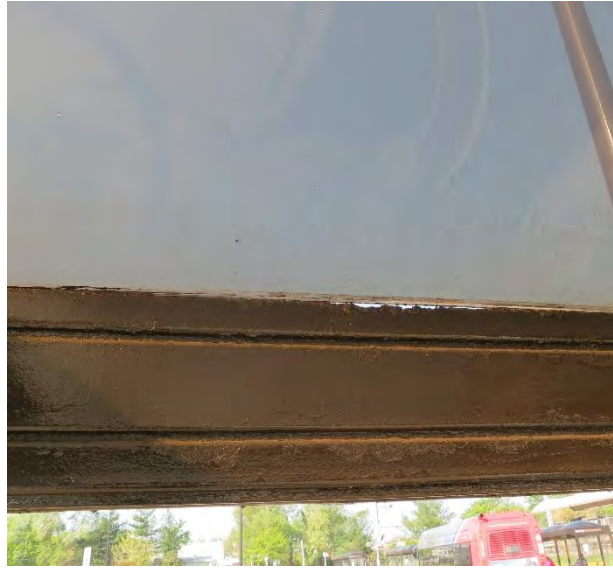
Figure 58: Frame Rust and Separated Dome Top, Kiss & Ride Shelter

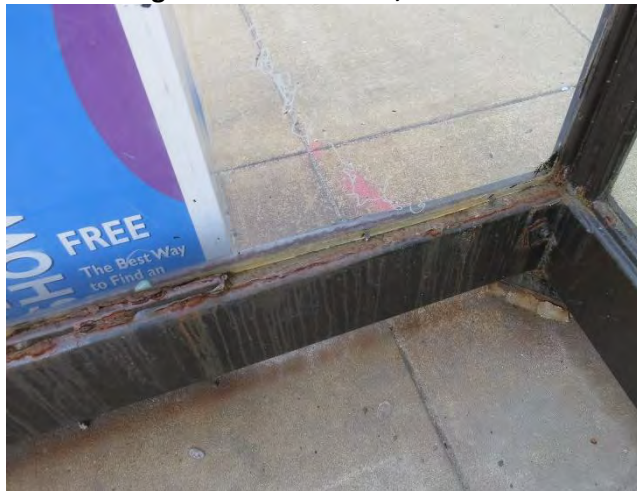
Figure 66: Frame Rust, Shelter F

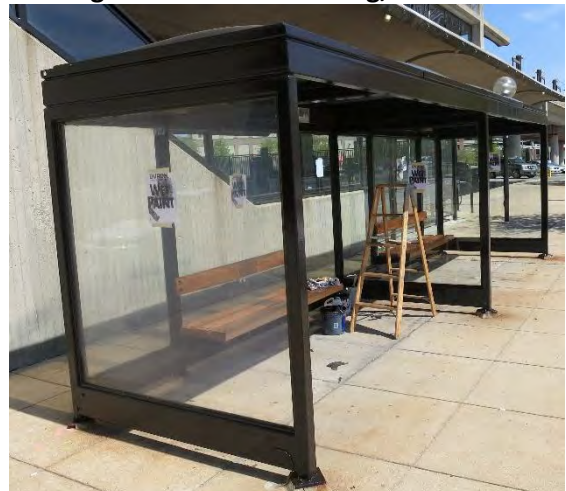
Figure 67: Frame Painting, Shelter A

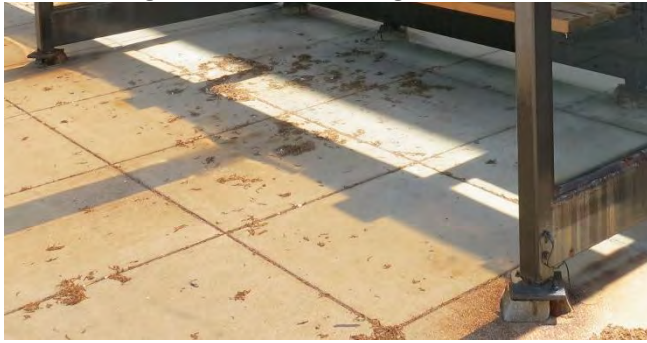
Figure 68: Pad Cracking, Shelter D

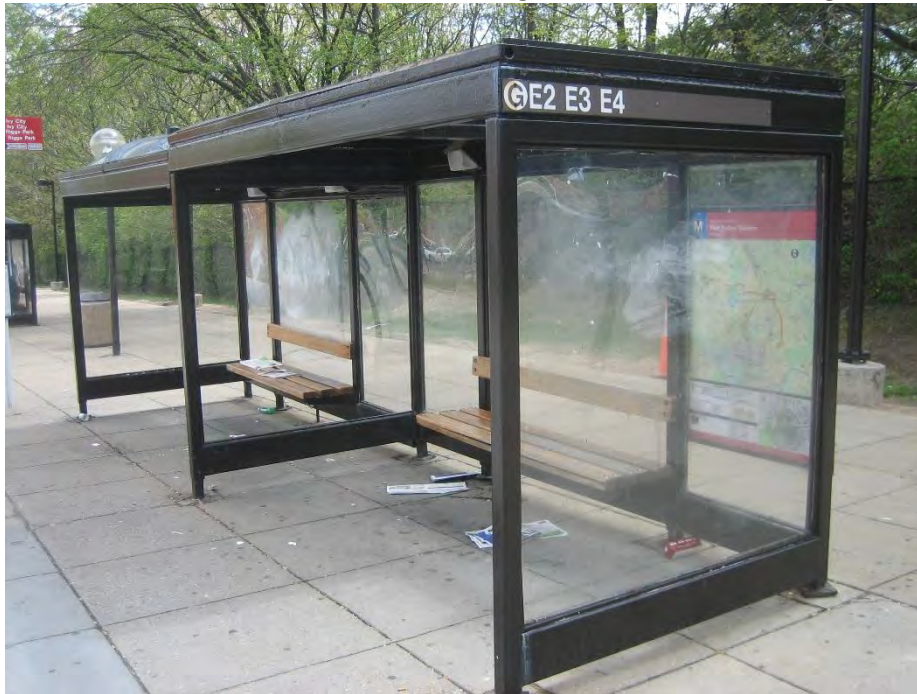
Figure 72: Poor Condition of Shelter G, Missing Panels, Rust and Missing Dome Top

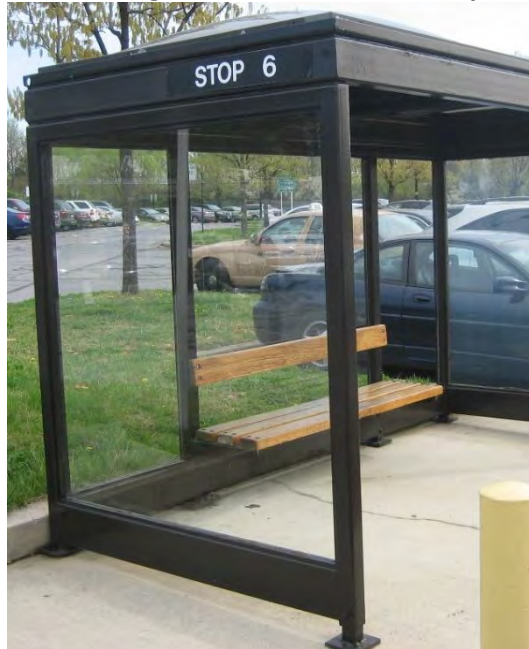
Figure 86: Missing Panel, Park-and-Ride Stop 6 Shelter

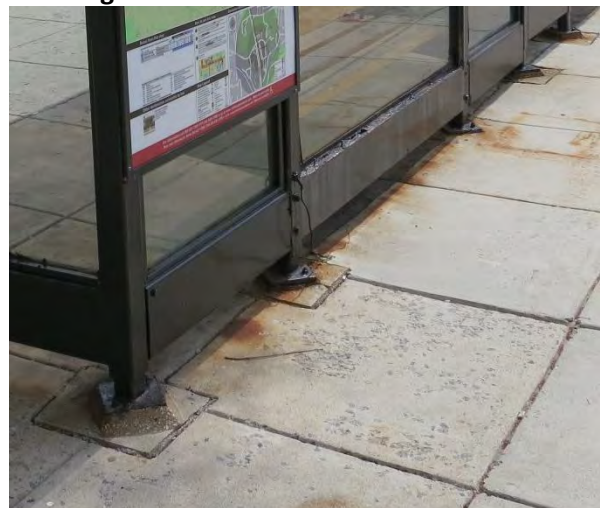
Figure 91: Overall Above Average Condition, Shelter D

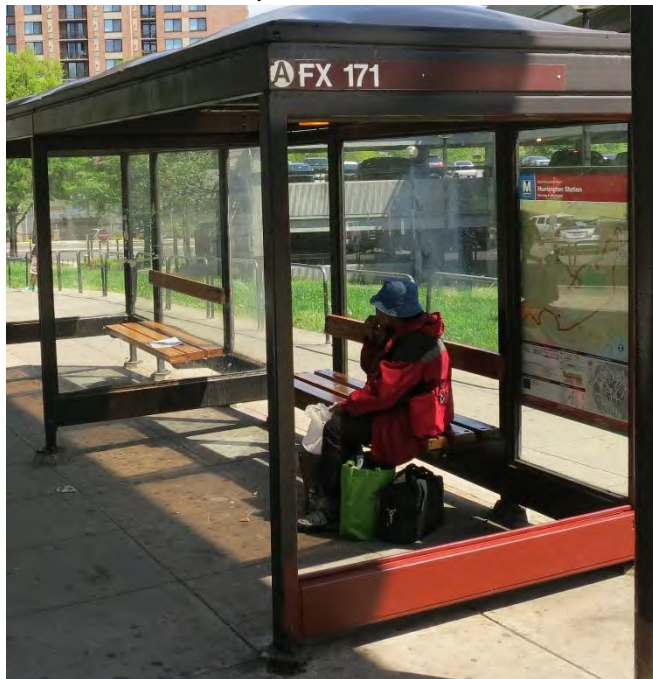
Overall, shelter conditions at the station are slightly below average, with a station condition score of 2.8. **Table 17** summarizes conditions for each individual shelter. The shelters as a whole scored the lowest in frame condition and pad condition, with significant frame rust and pad cracking present. Shelters A North and C South were in the worst condition, both receiving an overall condition score of 2. Both of these shelters had significant rust, damaged panels and a cracked pad, with A North missing a panel as well. C North had rusted to the point of having holes in its frame. All of the shelters at the station had fairly significant frame rust while every shelter except the Kiss-and-Ride shelter and shelter D South had some panel fading, smearing, or other damage.

Figure 94: Missing Panel, Cracked Pad and Frame Rust, Shelter A North

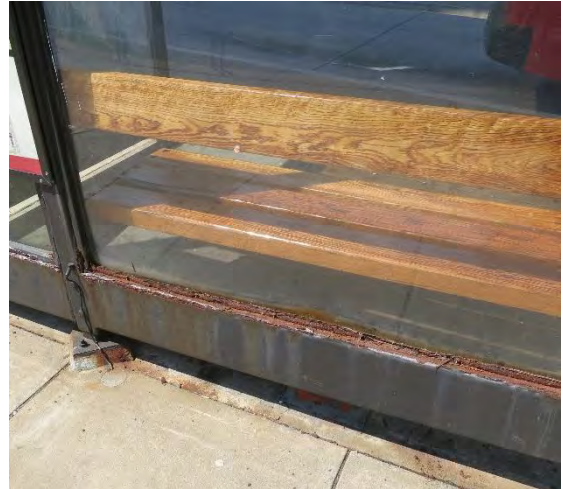
Figure 97: Frame Rust, Shelter D North

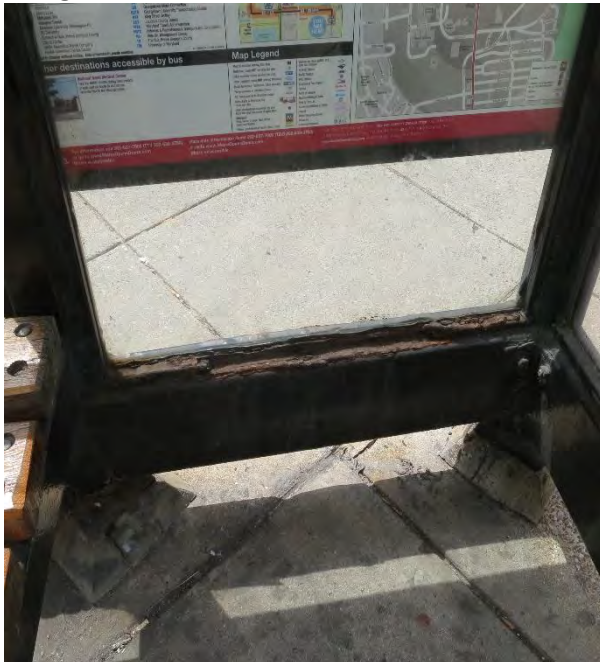
Overall, shelter conditions at the station are below average, with a station condition score of 2.7. **Table 19** summarizes conditions for each individual shelter. The shelters as a whole scored the poorest in frame condition and bench condition. Shelters C, D and F are in the worst condition, with overall condition ratings of 2. Shelter D is in particularly bad condition, with holes in its frame.

Figure 106: Poor Frame Condition, Shelter D

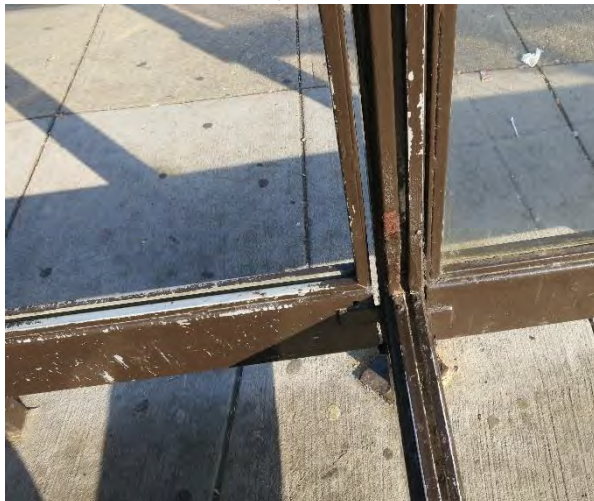
Figure 112: Missing Panel, Scratched/Rusted Frame, Shelter C

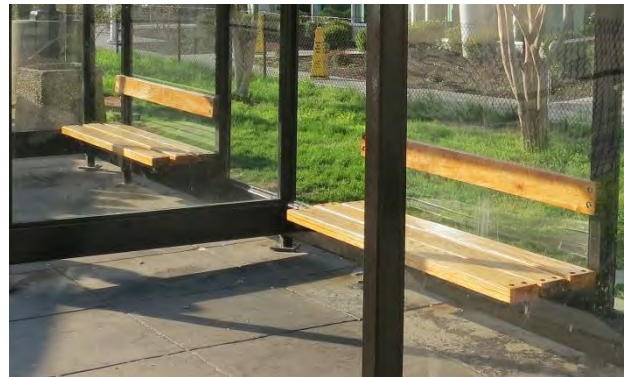
Figure 113: Worn Benches, Shelter G

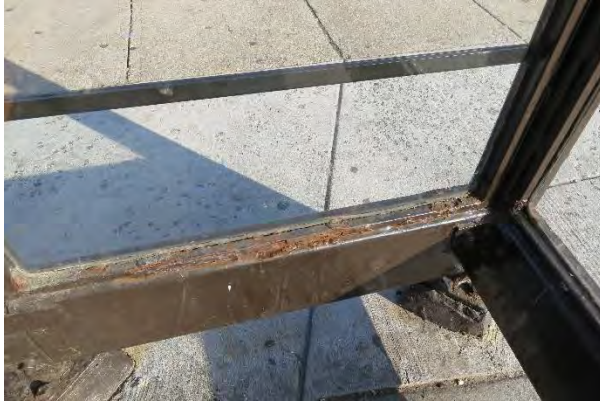
Figure 114: Frame Rust, Shelter B

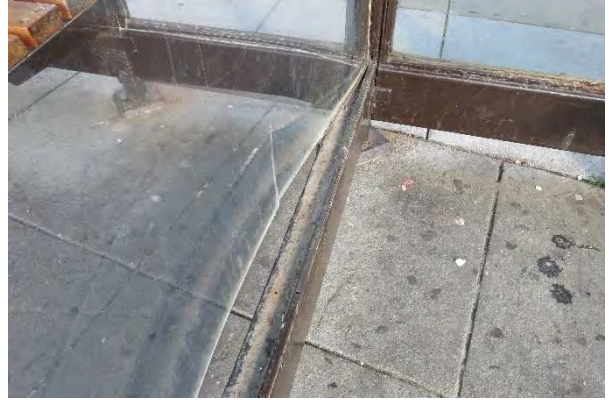
Figure 115: Damaged Panel, Shelter D

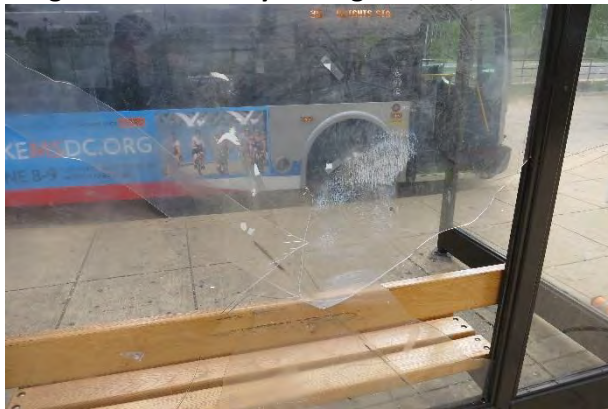
condition, with shelter F having a severely damaged panel and shelters G and H and the south Kiss-and-Ride shelter having moderately damaged panels. Frame condition overall was above average, with little rust present on any of the shelters. Bench condition, dome top condition and pad condition were all above average as well.

Figure 118: Severely Damaged Panel, Shelter F

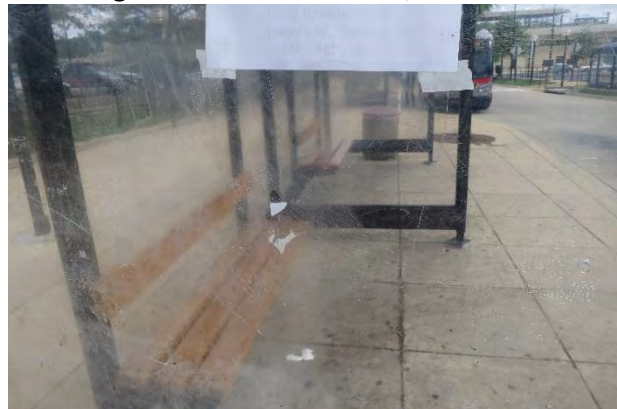
Figure 119: Cracked Panel, Shelter G

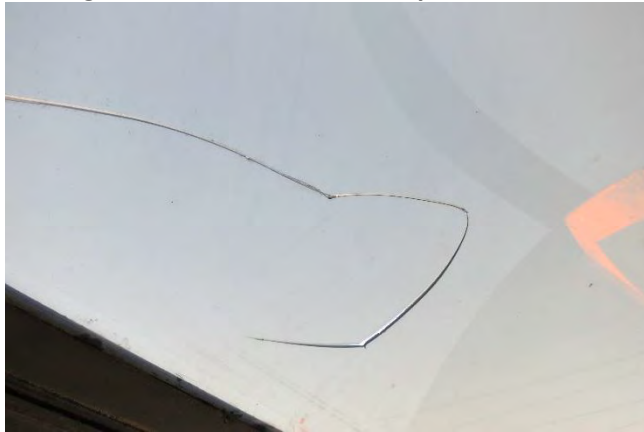
Overall, shelter conditions at the station are average, with a station condition score of 3.0. **Table 22** summarizes conditions for each individual shelter. The shelters as a whole scored the lowest in panel and frame condition, while bench condition and pad condition were both above average. Shelters A and G both had holes in their frames and shelters B and C both showed significant rust on their frames. Shelters A, F, G and the taxi shelter all had damaged panels, with the taxi shelter also having a cracked dome top. Shelter D also had a cracked dome top.

Figure 125: Cracked Dome Top, Taxi Shelter

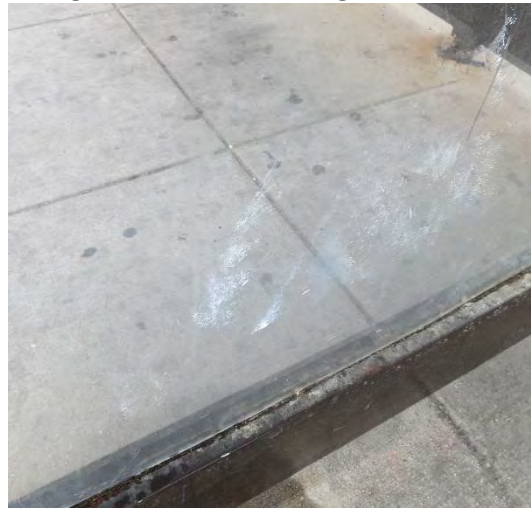
Figure 126: Panel Damage, Shelter A

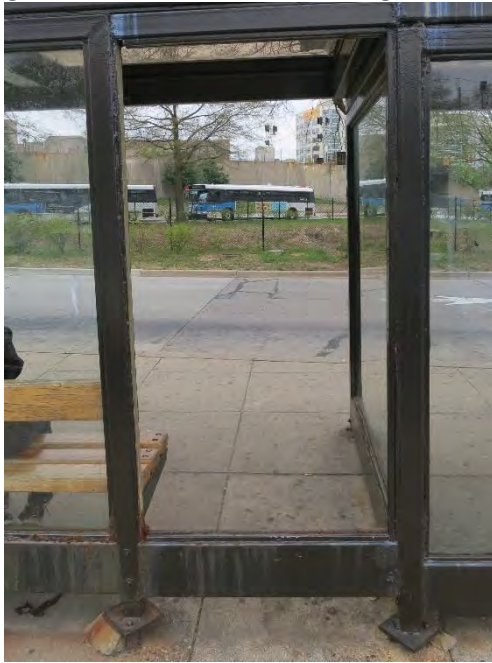
Overall, shelter condition at the Rockville station is slightly below average, with a station condition score of 2.9. **Table 24** summarizes conditions for each individual shelter. The shelters as a whole scored the poorest in panel condition and pad condition. Shelter C East is in particularly bad condition, with a missing panel on its rear side and poor pad condition. This shelter received an overall rating of 2, while the rest of the shelters at the station received an overall rating of 3. The Kiss-and-Ride shelter on the west side of the station also received a poor panel rating due to a missing panel on its north side.

Figure 137: Shelter C East Missing Panel

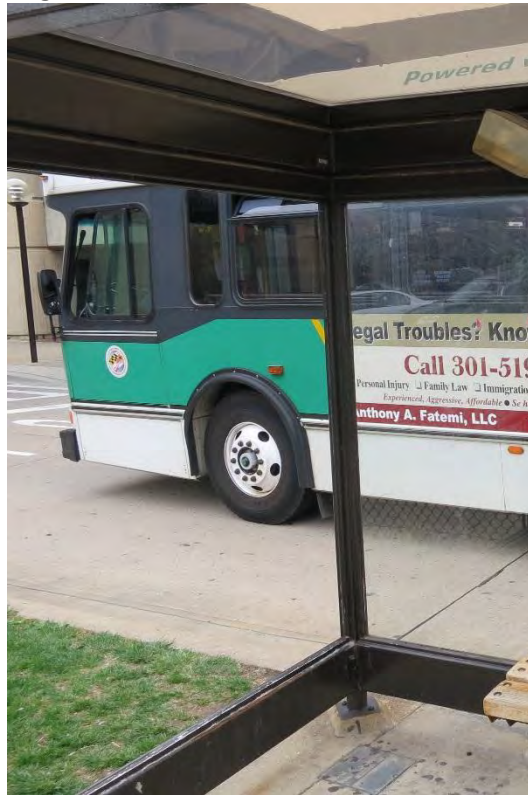
Figure 138: Shelter B West Rust on Frame

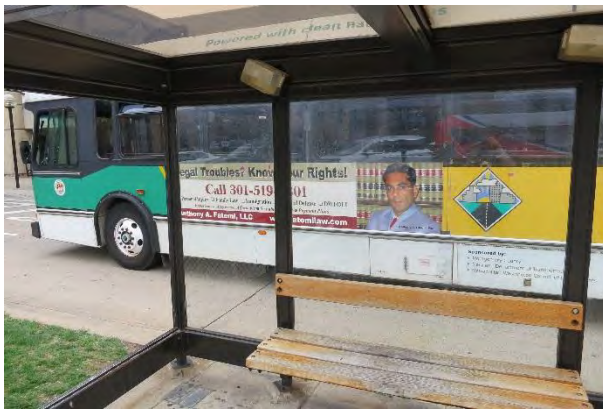
Figure 139: Kiss-and-Ride Shelter Missing Panel

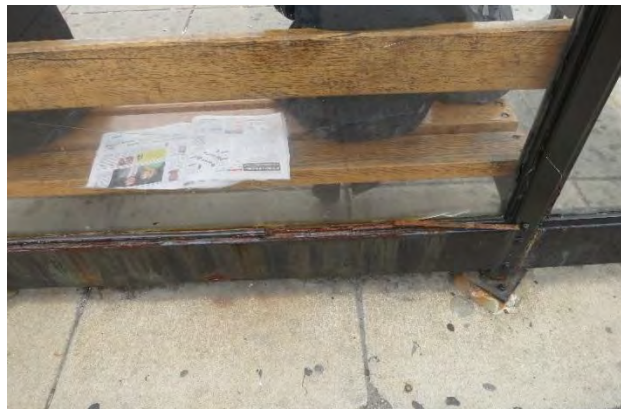
Figure 140: Shelter C East Poor Pad Condition

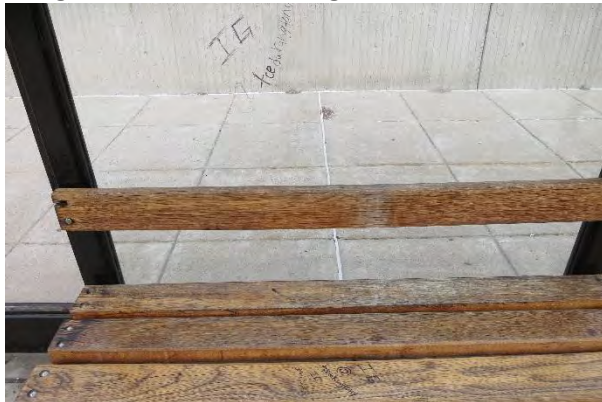
Figure 148: Worn/Damaged Bench, Shelter K

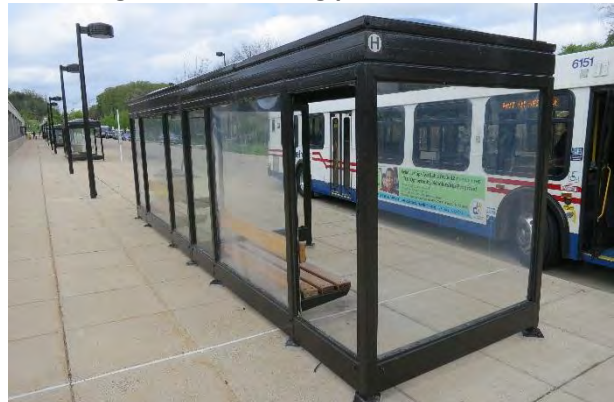
Figure 149: Missing panel, Shelter H

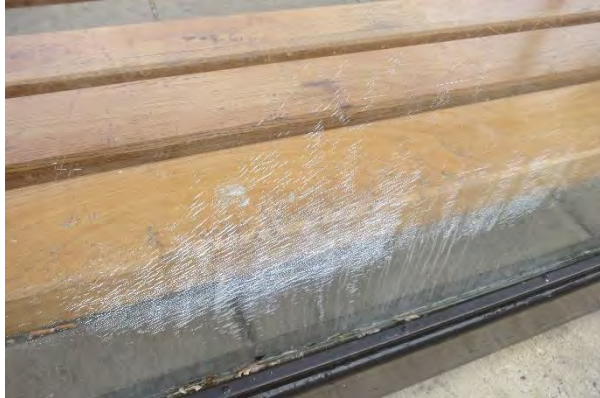
Figure 150: Damaged Panel, Shelter C

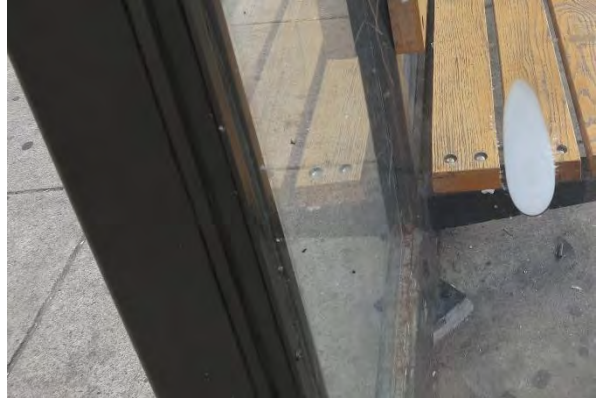
Figure 151: Frame Rust, Damaged Panel, Shelter M

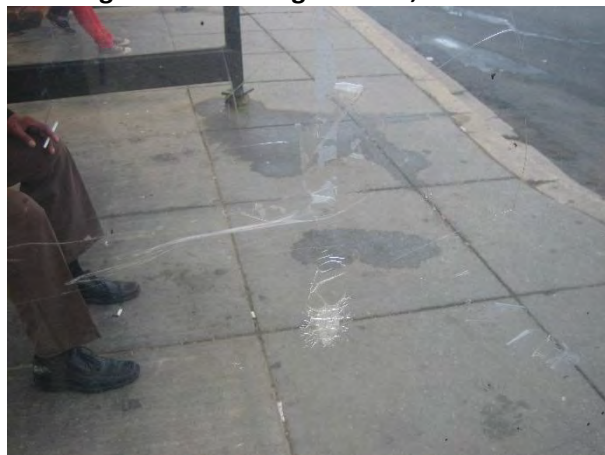
Figure 160: Damaged Panel, Shelter H

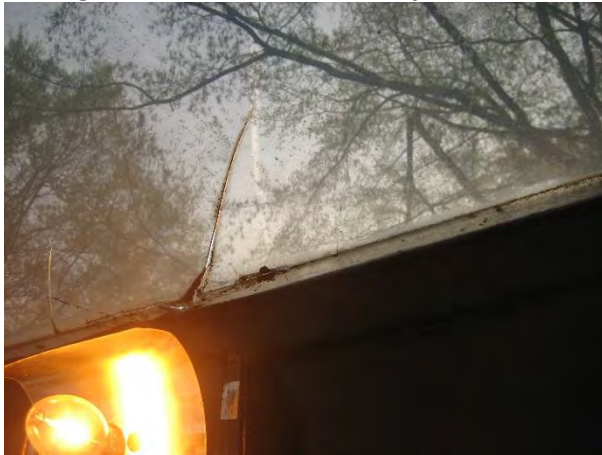
Figure 161: Cracked Dome Top, Shelter G

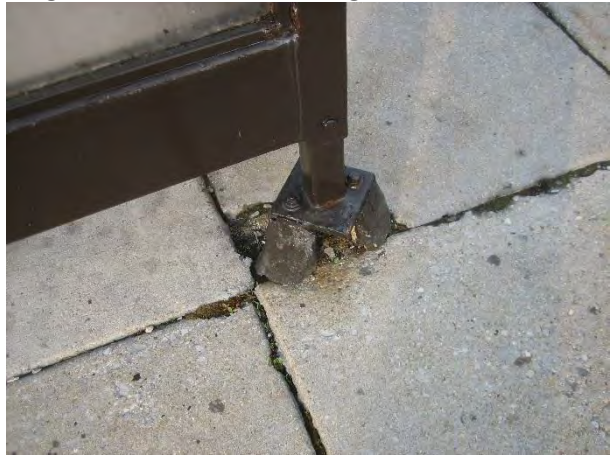
Figure 162: Cracked Footing and Pad, Shelter B

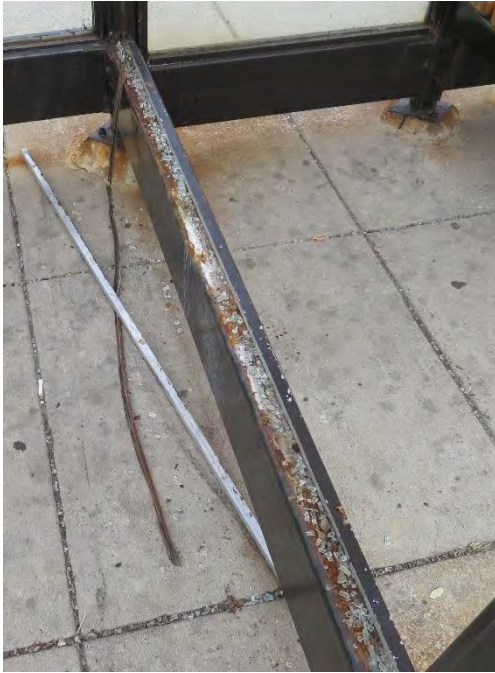
Figure 165: Shelter B West Missing Panel

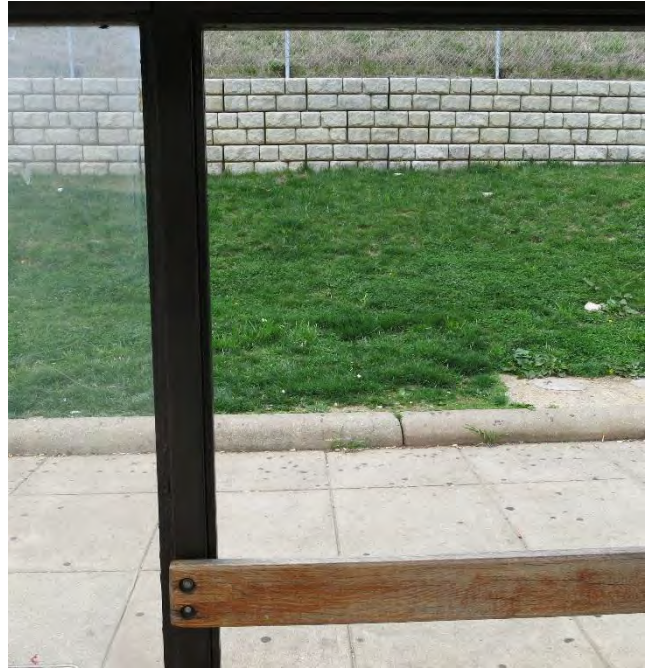
Figure 166: Shelter A East Missing Panel

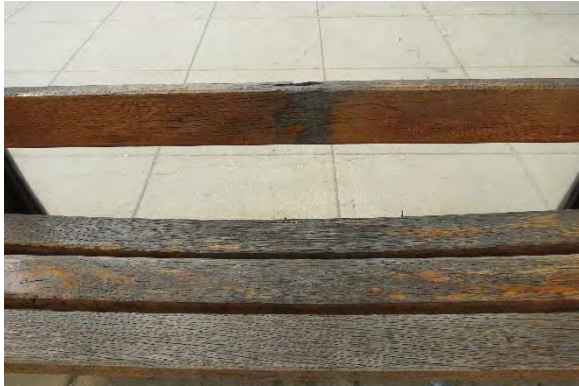
Figure 167: Shelter F East Poor Bench Condition

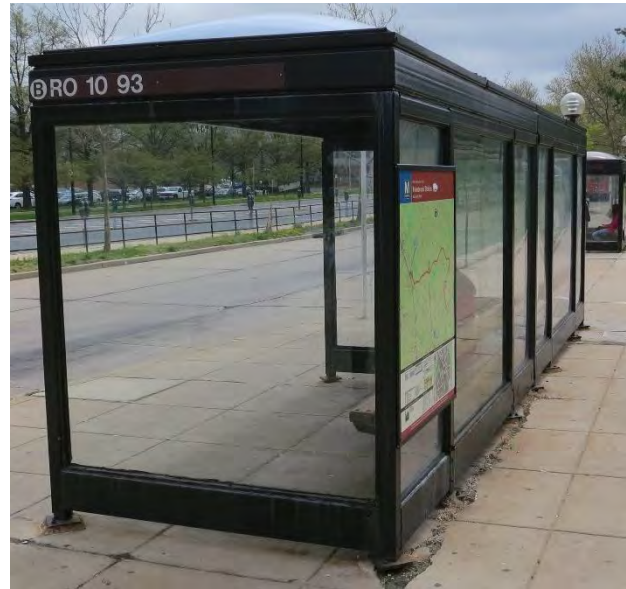
Figure 168: Shelter B East Poor Pad Condition

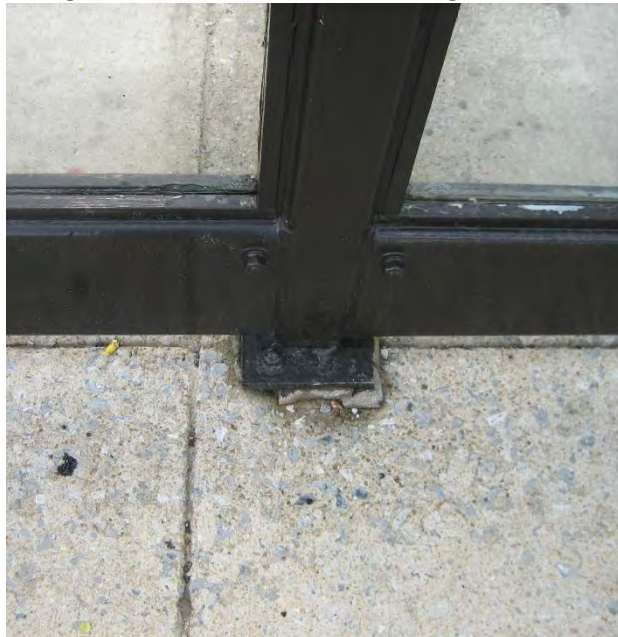
Overall, shelter conditions at the station are above average, with a station condition score of 3.8. **Table 32** summarizes conditions for each individual shelter. The shelters, as a whole, scored the lowest in bench condition and panel condition. All of the benches at the station showed some kind of wear, while panels at shelters F and E had damage. Faded and scratched panels were also present at shelter G. Frames at the station were in good condition, with little-to-no rust present. Dome tops were also in good condition. Pad conditions were overall above average, with some cracking and settling noted at shelters C, E and F.

Figure 184: Cracked Pad & Footing, Shelter C

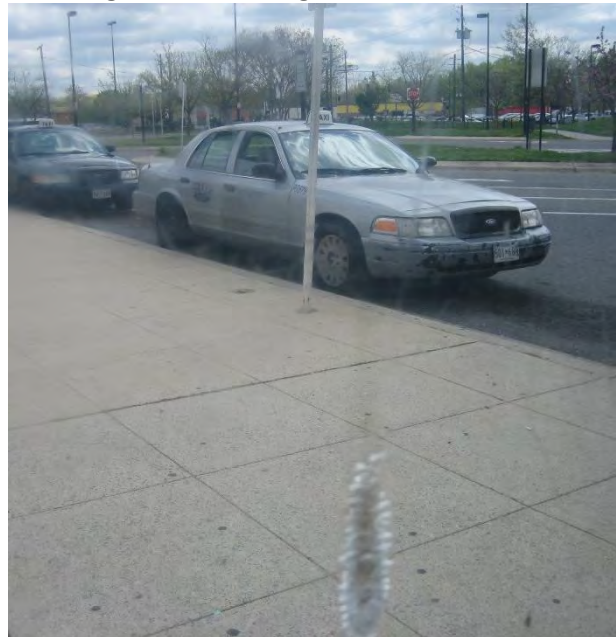
Figure 185: Damaged Panel, Shelter F

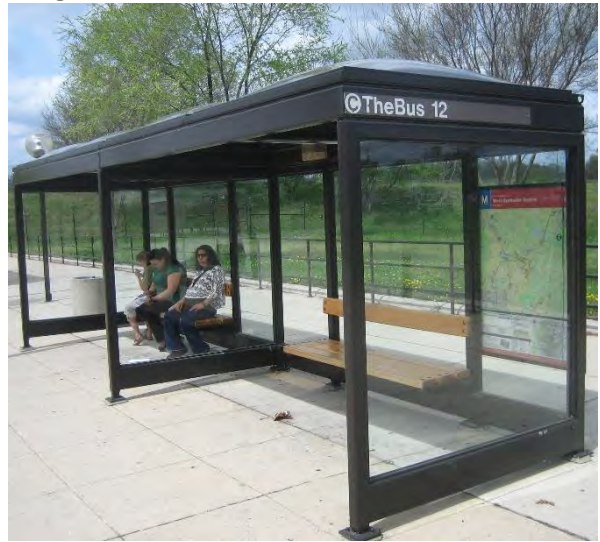
Figure 187: Good Frame Condition, Shelter C

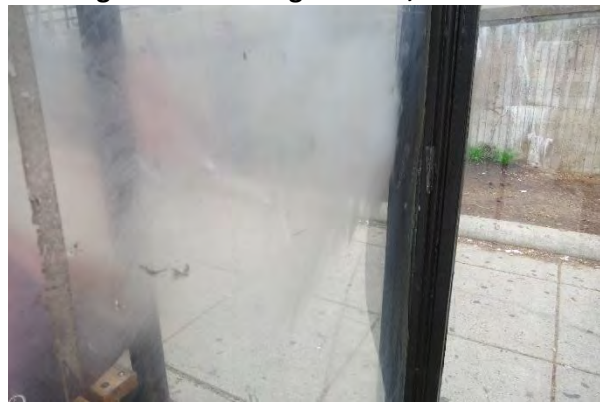
Figure 192: Damaged Panel, Shelter D

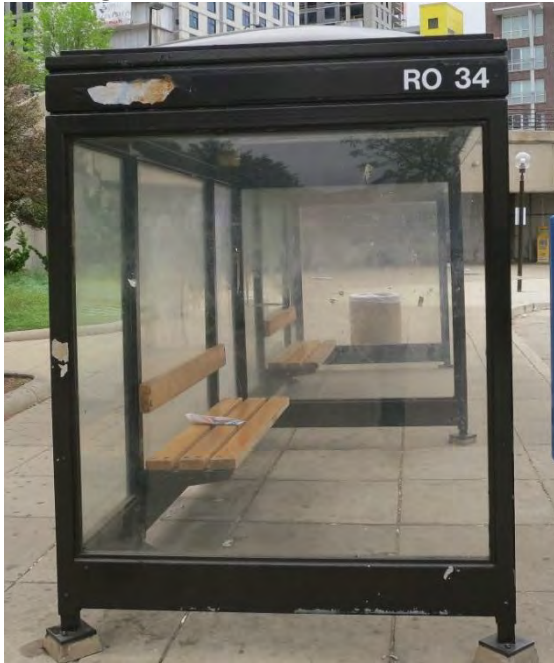
Figure 193: Frame Rust, Shelter F

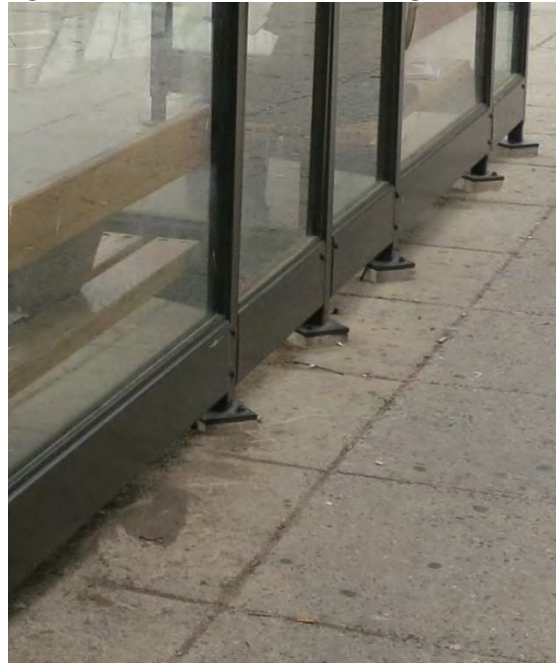
Figure 194: Cracked Pad & Footings, Shelter G

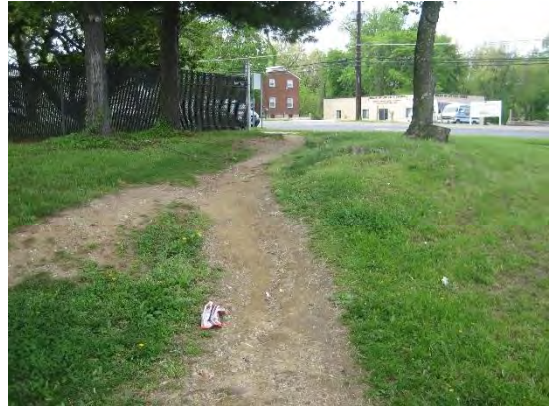
Southeast Corner of Addison Road Intersection Pedestrian Path

pedestrian signals that serve each crosswalk. A well-defined pedestrian path that “cuts” the southeast corner of the intersection exists. **Figures 6 and 7** picture this intersection.

Sidewalk across southeast corner of Addison Road intersection.

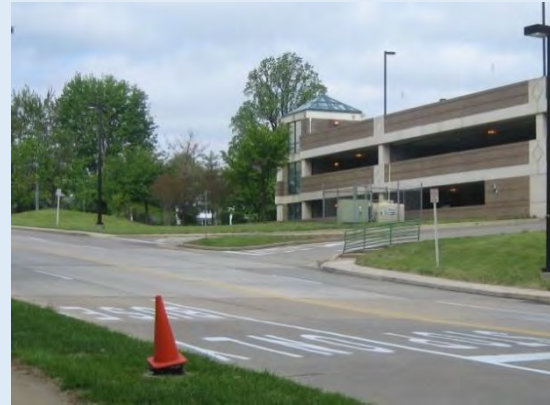
Park-and-Ride Garage Driveway

sidewalks on both sides that lead into the garage. The curb ramps lack detectable warning panels, however. There are no crosswalks that traverse the driveway at all. There is a “Park & Ride Left Lane” sign west of the Park-and-Ride garage entrance, followed by a second directional sign pointing drivers left into the Park-and-Ride garage or straight into the Kiss-and-Ride lot. The eastbound right lane becomes a bus only lane as it approaches the Central Avenue driveway and is marked as such on the pavement. The eastbound center left lane has a stop line and stop lettered pavement markings and provides access to both the Central Avenue driveway (left turn) and the Kiss-and-Ride lot (thru movement). **Figures 8 through 10** show this driveway.

Crosswalk traversing Park-and-Ride garage driveway and detectable warning panels on curb ramps there.

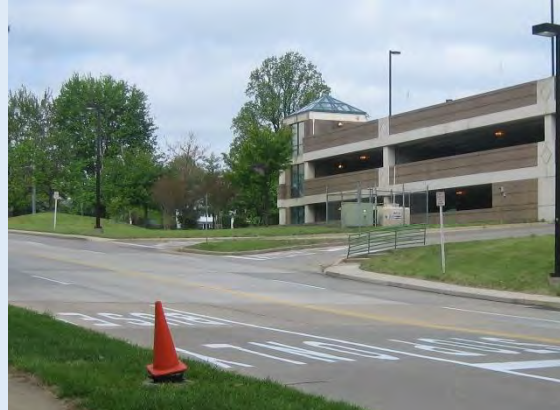
Entrance on Addison Road Entrance Driveway

Crosswalk traversing Park-and-Ride garage driveway and detectable warning panels on curb ramps there.

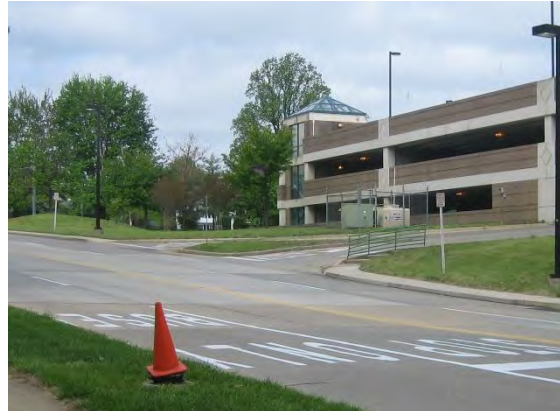
Entrance on Addison Road Entrance Driveway

Stop signs at the Park-and-Ride garage driveway exit
