ASSET (BUS SHELTER) IMPROVEMENT EVALUATION STUDY

Final Report

June 2013

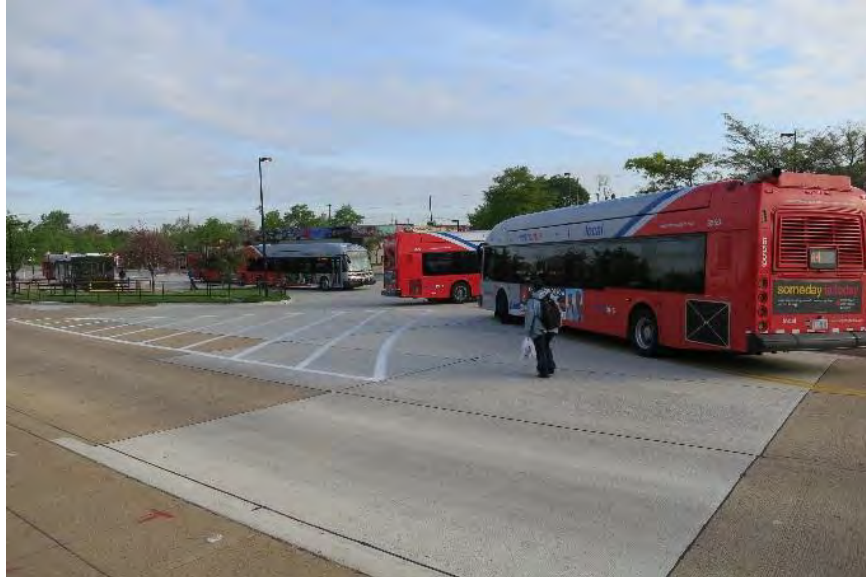
Figure 41: Intersection of the Three Busways at the Station and Pedestrian Walking in Middle of Busway

Reconfiguration with one-way circulation, traffic islands, additional crosswalks and fencing in order to minimize jaywalking between the A-E bus bays and the Metrorail station entrance and walking in the Martin Luther King Jr. Avenue entrance busway.

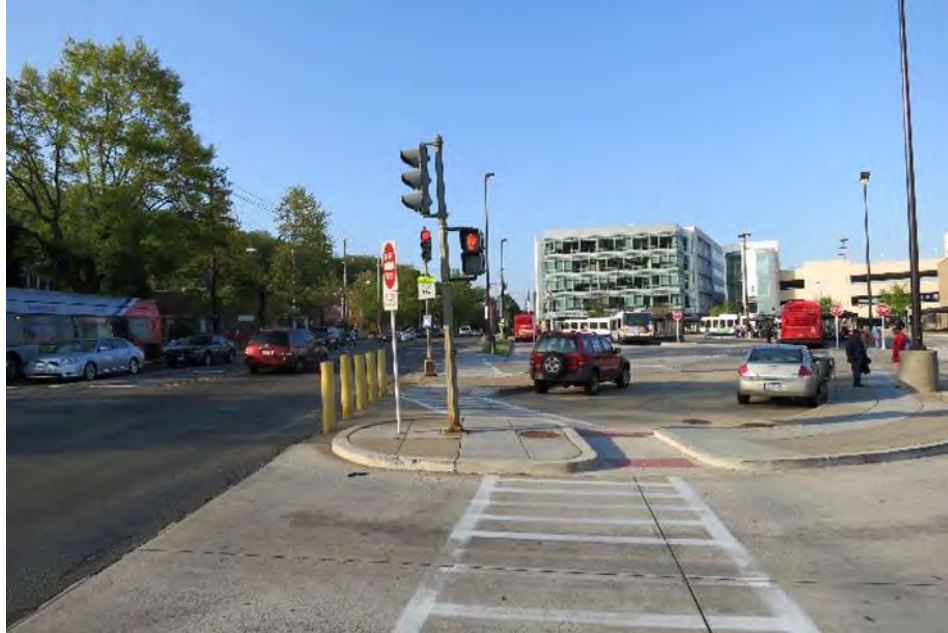
There is a median, curb ramps, pedestrian signal, and a crosswalk in the east-west direction on the northern side of the intersection. The curb ramps lack detectable warning panels with the exception of the west curb ramp. During school start and end periods, there is a crossing guard at this crosswalk that assists children in crossing Minnesota Avenue. There is a crosswalk and pedestrian signal in the north-south direction on the west side (station side) of the intersection. The north side of this crosswalk has a curb ramp with a detectable warning panel and the south side has a median cut-through with detectable warning panels. The crosswalk does not properly line up with the cut-through, however, and the cut-through does not have a ramp up to the platform so people in wheelchairs can access the J and K bus bays. There is also a crosswalk and curb ramps in the north-south direction on the east side of the intersection (Grant Street), however, the curb ramps lack detectable warning panels. **Figures 52 and 53** picture this entrance.

Figure 53: Crosswalk and Median Across Minnesota Avenue at Center Entrance Lacking Ramp onto Median

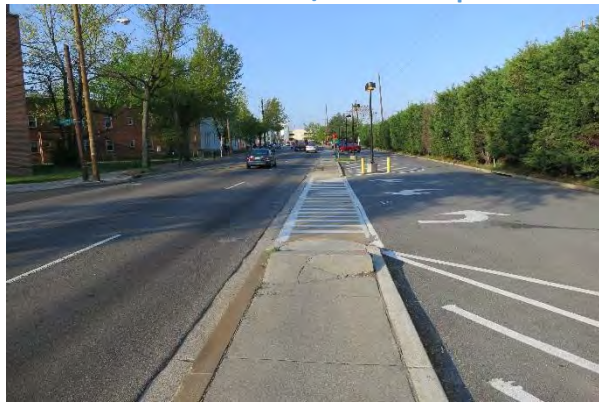
Figure 60: Kiss-and-Ride Center Entrance/Exit & Poor Sidewalk Condition/Lack of Stop Controls

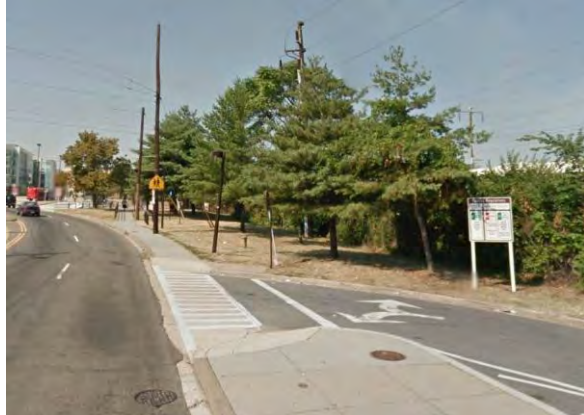
Figure 62: Kiss-and-Ride South Exit & Lack of Stop Sign

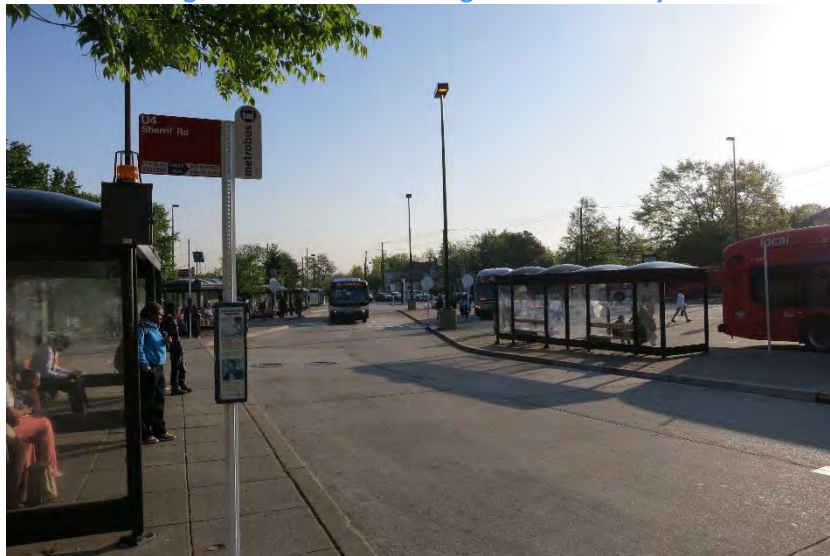
Figure 68: Lack of Fencing Behind Bus Bays

Fencing behind bus bays K and J and L and M, with breaks at the existing crosswalks serving each platform.

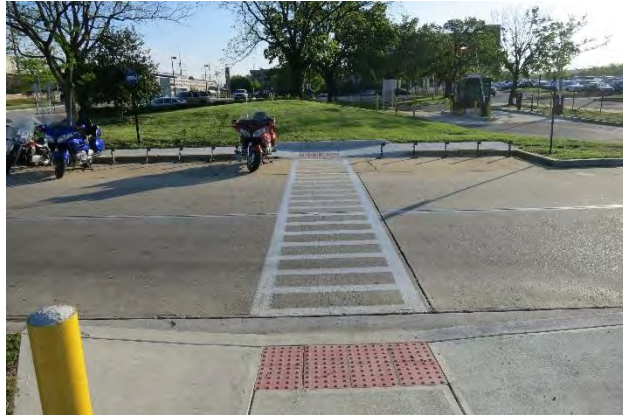
Figure 103: Egress Driveway Crosswalk at Motorcycle Parking Area

detectable warning panels and a pedestrian warning sign. The second crosswalk lacks a curb ramp on its south end entirely and is precariously located on the right side of a right-turn only exit. It appears that the first crosswalk was installed to replace the second crosswalk. **Figures 103 and 104** picture the egress driveway.

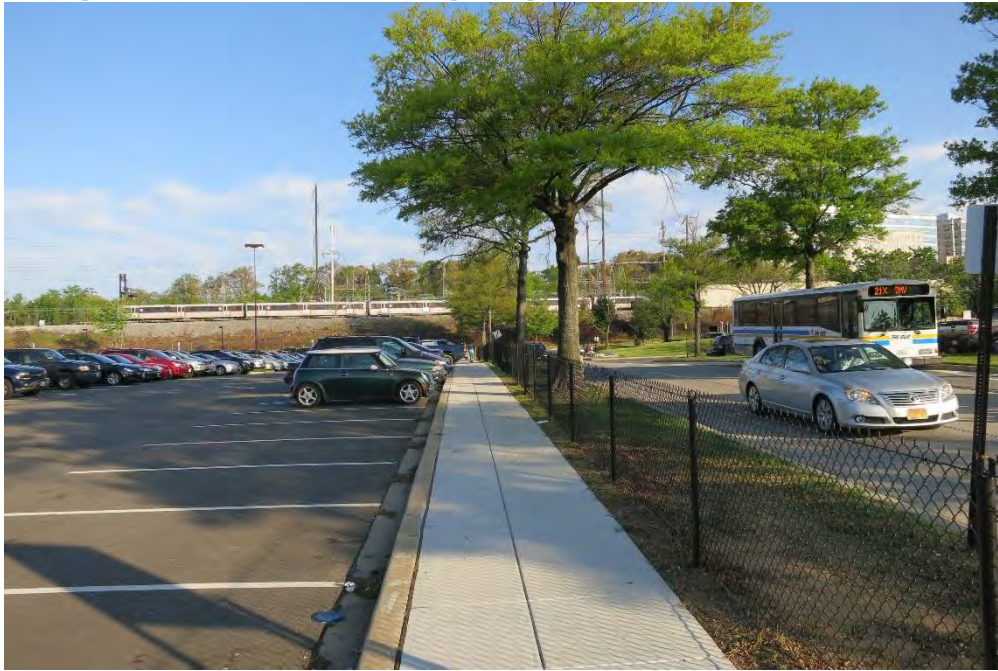
Figure 107: Sidewalk and Fencing Along North Side of Park-and-Ride Lot 3

The parking lot itself has bidirectional travel lanes and parallel parking spaces along its west, south and east sides. There are no traffic controls within the lot. Sidewalks exist along the north and west sides of the lot. The sidewalk along the north side is separated from the main station egress driveway with a fence. **Figure 107** pictures the north side of Lot 3.

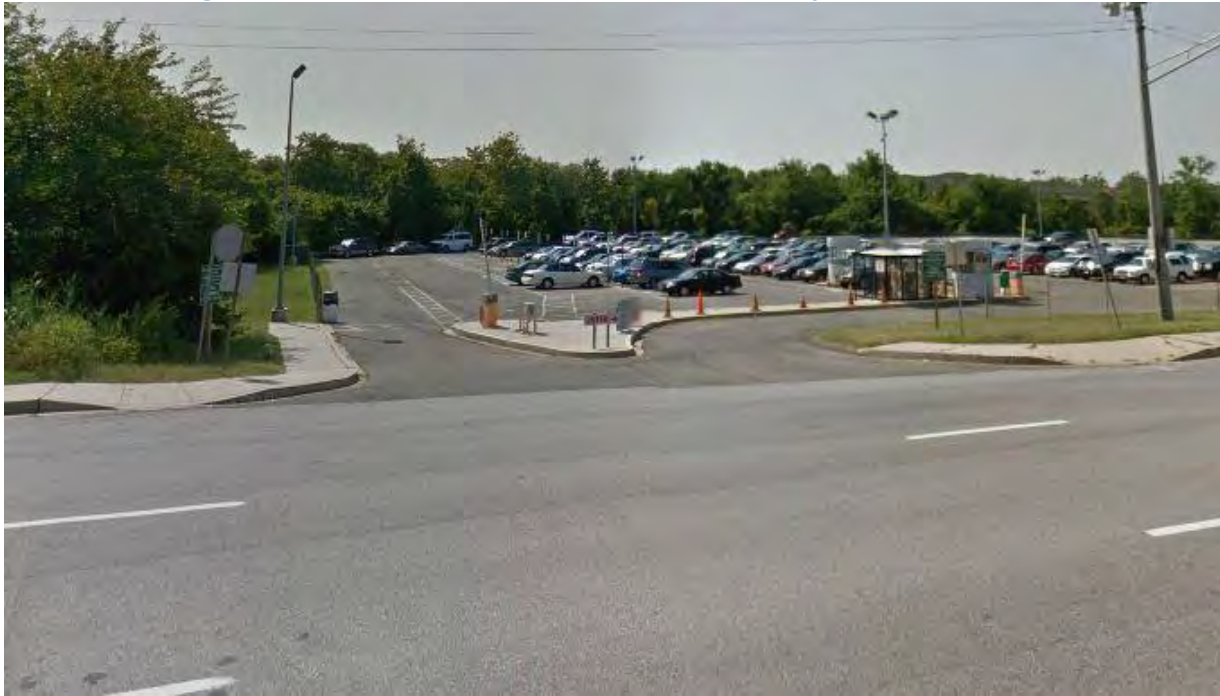
Figure 108: East Park-and-Ride (Amtrak)/Garden City Drive Intersection

The entrance to this lot forms an unsignalized T intersection with Garden City Drive with three thru travel lanes on Garden City Drive northbound and two thru travel lanes on Garden City Drive southbound. The driveway has a single access lane and a single egress lane. There is a north-south crosswalk that traverses the egress lane of the driveway with a single curb ramp that lacks detectable warning panels at its north end. There are sidewalks on both sides of Garden City Drive through this intersection. On the east side of Garden City Drive, there are two curb ramps oriented to the west, however, there are no corresponding crosswalks. In order for these curb ramps to be used by pedestrians traveling north-south on Garden City Drive, they would have to enter the northbound right travel lane, creating a potentially dangerous situation for someone with a disability.

There are Amtrak Parking signs and "\$4.00 Public Parking" signs on Garden City Drive in each direction. There is a stop sign and a "No Left Turn 4-6pm Monday-Friday" sign facing the driveway approach. There is no stop line at this approach. **Figure 108** pictures this approach.

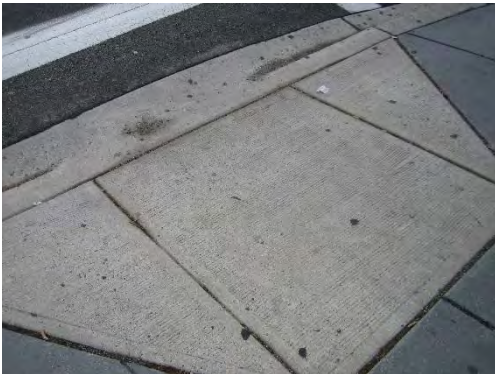
Figure 116: Curb Ramp at Northwest Corner

and have “State Law Stop for Pedestrians” break-away signs on their small medians in the middle of the crosswalk, along with apex curb ramps. There are no detectable warning panels on the curb ramps at this intersection. The crosswalk across the busway is rarely used by bus patrons, unless buses drop off passengers at bus bay G. It is regularly used by patrons entering the station via Cedar Street, however. The crosswalk across Cedar Street is regularly used by station patrons and has good overall compliance with vehicles. This crosswalk also has pedestrian warning signs and crosswalk arrow signs in both directions on Cedar Street. There are two “no Right Turn Except Buses” signs in the westbound direction on Cedar Street as well as one “No Left Turn/U-Turn” sign on Cedar Street in the eastbound direction. There is also a “Do Not Enter” sign on the busway itself. Buses had relatively little difficulty entering and exiting the busway at this intersection due to breaks in traffic along Cedar Street from the signalized intersections to the east and west of the station. **Figures 115 through 117** illustrate signage and overall layout at this intersection.

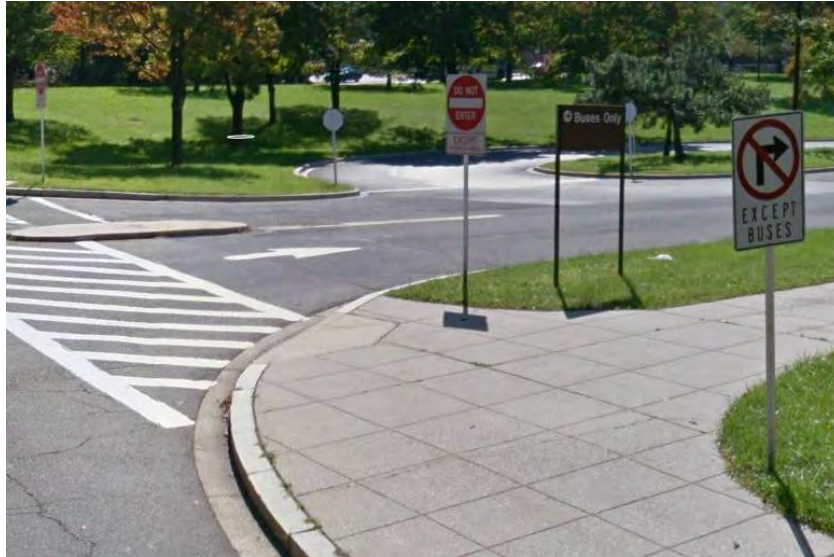
Figure 118: Eastern Avenue Southbound Signage at Busway

The Eastern Avenue busway entrance is also a T-intersection with a stop sign on the busway approach and a crosswalk crossing the busway. There are apex curb ramps at this crosswalk but no detectable warning panels on them. There is a “No Right Turn Except Buses” sign on Eastern Avenue in the southbound direction along with two “Do Not Enter Except Buses” signs on the busway itself. There is

no signage on Eastern Avenue in the northbound direction indicating the busway, however. **Figure 118** illustrates signage at this intersection.
