Washington Metropolitan Area Transit Authority

# Metrorail Structural Inspections

## QICO Internal Review

June 9, 2017

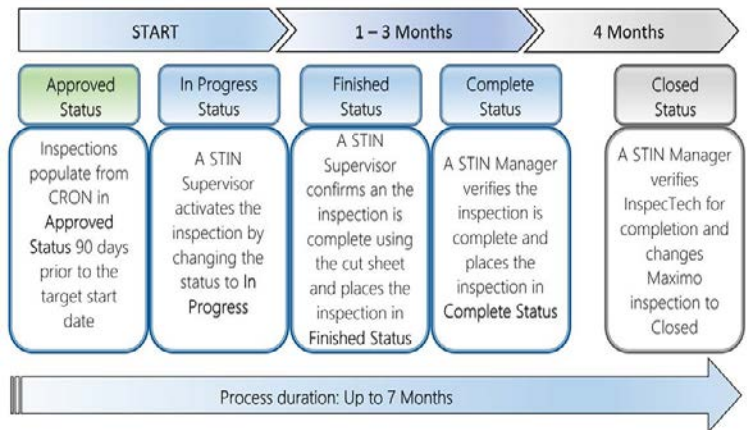
**F-SIM-02:**  
QICO observed that reports can be completed up to six months after inspections are performed.

- The current bottleneck in the process seems to be inputting the data (comments and photos) into [InspectTech](#) and generating the report.
- The figure below shows the steps in Maximo for a typical inspection, although timelines can be significantly longer or shorter than the 7 months shown.

**Recommendation:** Establish written requirements to complete/finalize inspection reports, in coordination with engineering.

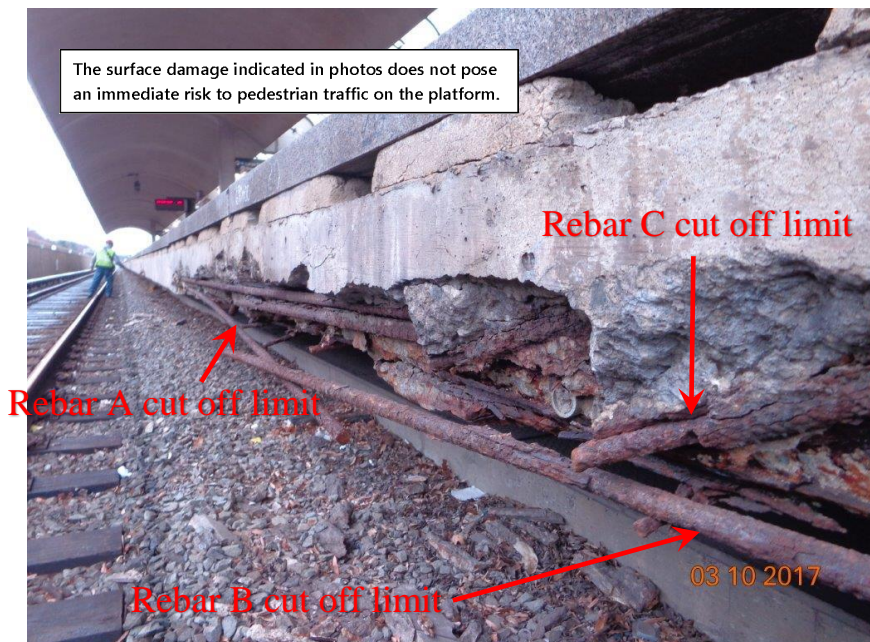
Figure 6: Close-up view of the surface as shown in Figure 2. The rebars (A, B and C) as marked intrude into the track bed area and should be cut off for safety.

However, for displaced rebars A, B and C (Figures 5 and 6) which intrude into the IB track bed should be addressed. Cutoff of rebar A, B and C and their cutoff limits are shown in Figure 6. Rebars A and B should remain some portions not cut off in order to overlap with a new rebar in the future repair. The cutoff limits may be adjusted on the site by site supervisor. The cutoff limits should keep all rebars not go beyond the edge of the platform concrete.

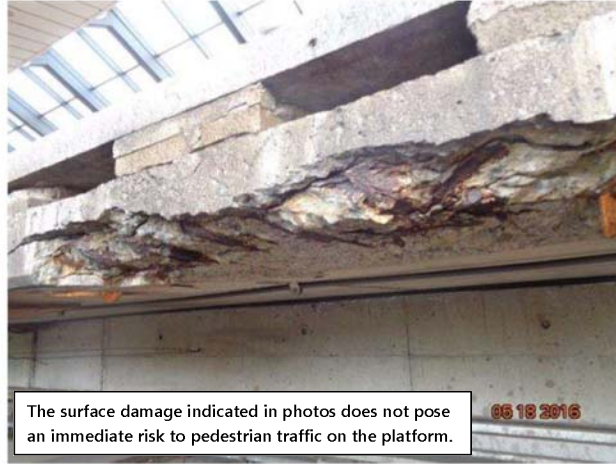
**King Street. TYP defects encountered on both tracks within the platform**

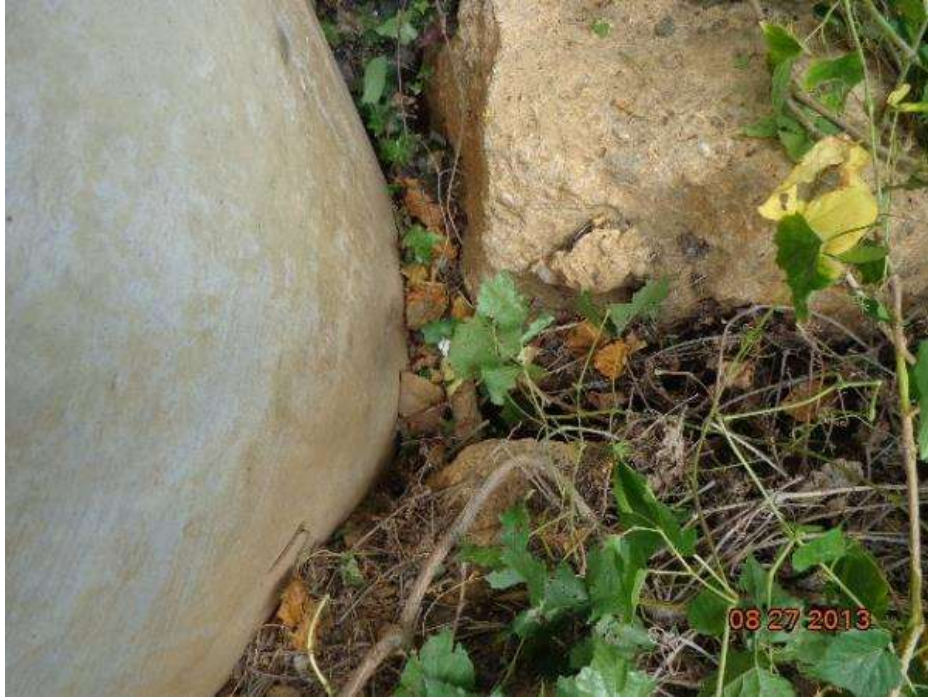
Photo 1

Erosion on the North side of the pier.

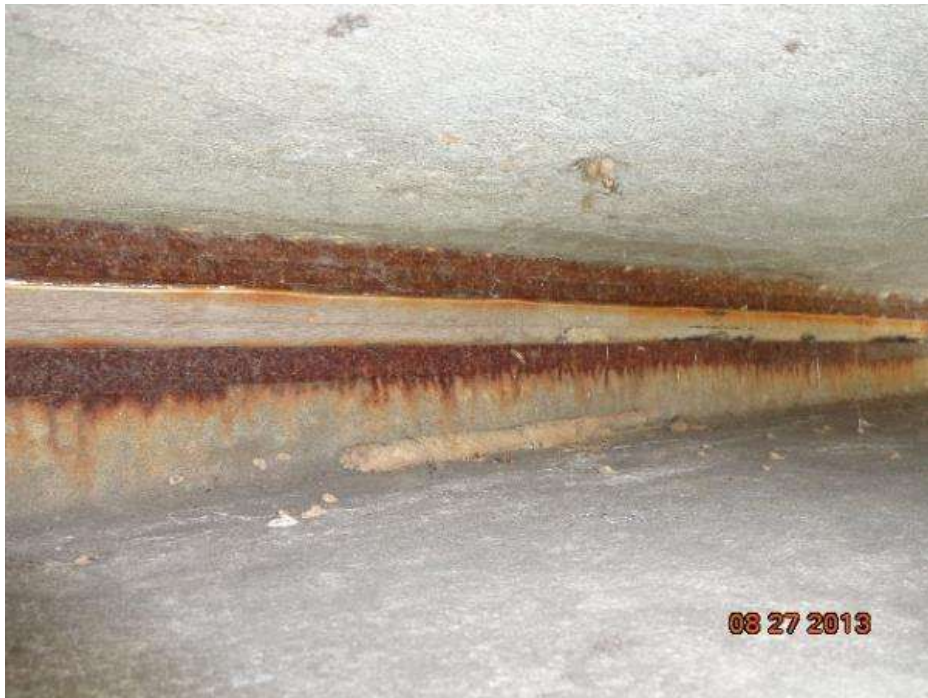
Photo 2

Frabreeka bearing
