Safety and Service Delivery Committee

April 12, 2018

Rail Safety Initiatives

Washington Metropolitan Area Transit Authority

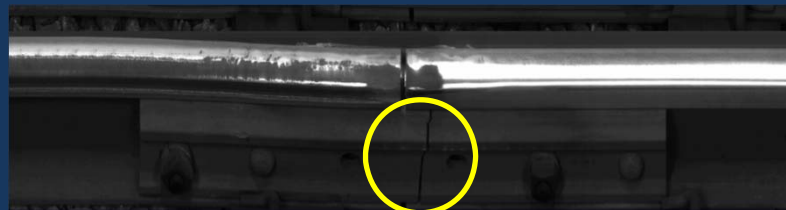
High Resolution Camera System

- High resolution cameras identify defects while moving at normal train speed
- Images archived similar to inspection reports

- Pilot included ENSCO technology as add-on to TGV run
 - Three defects identified: two cracked joint bars, one occurrence of consecutive missing stud bolts
- Update track asset management database
- RFI being issued to explore:
 - Purchasing equipment vs contracting services
 - Data management and industry best practices

High Definition Track Scanning

High definition track scanning uses high resolution cameras to identify defects while moving at high speed. The images are then archived like inspection reports. A pilot using this technology occurred early this year.

The final report from this pilot will be used to update the track asset management database with more detailed condition information, particularly on the grout pad condition and rail inventory (e.g., rail manufacturer and roll date, which is important for trend analysis for rail breaks).

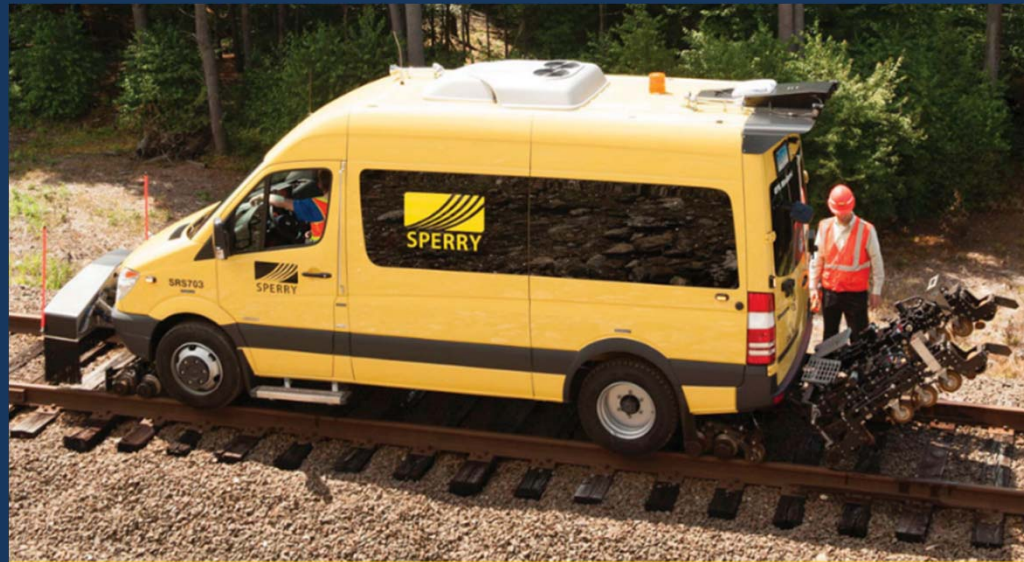
Increasing Frequency of TGV & UT

- Three UT tests will be conducted, with two by contractor
- RFI being issued to explore:
 - Benefits of new UT technology
 - Contracting strategies (vehicle and/or services)
 - Industry best practices for frequency of UT and TGV

Ultrasonic testing (UT) tests the running rails and is used to identify internal defects that could cause rail breaks. One pass of the entire system takes two months. It was previously conducted twice a year; starting in FY19, testing will occur three times a year.

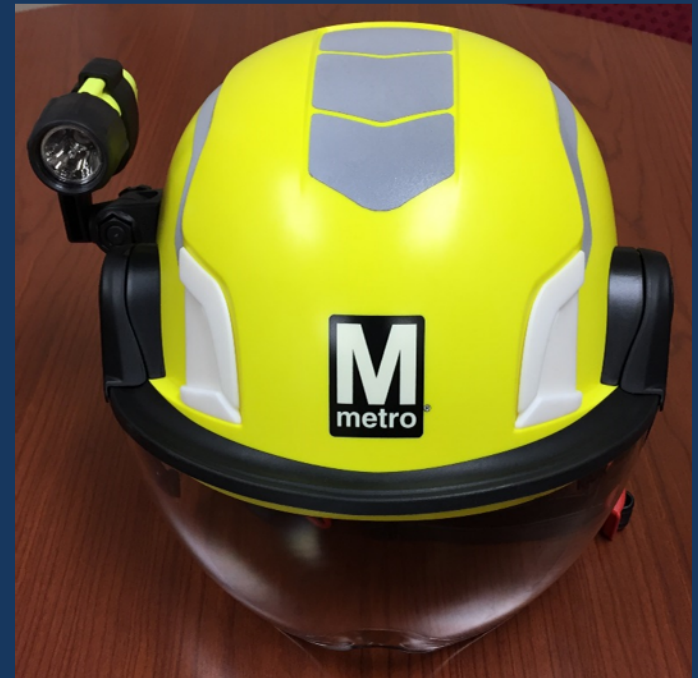
- Hard Hat Pilot (100 helmets)
 - Current helmets require protection only from falling objects
 - Pilot project expands coverage for lateral impact protection
 - Helmet stays on head during tumbling and multi-impacts via strap system

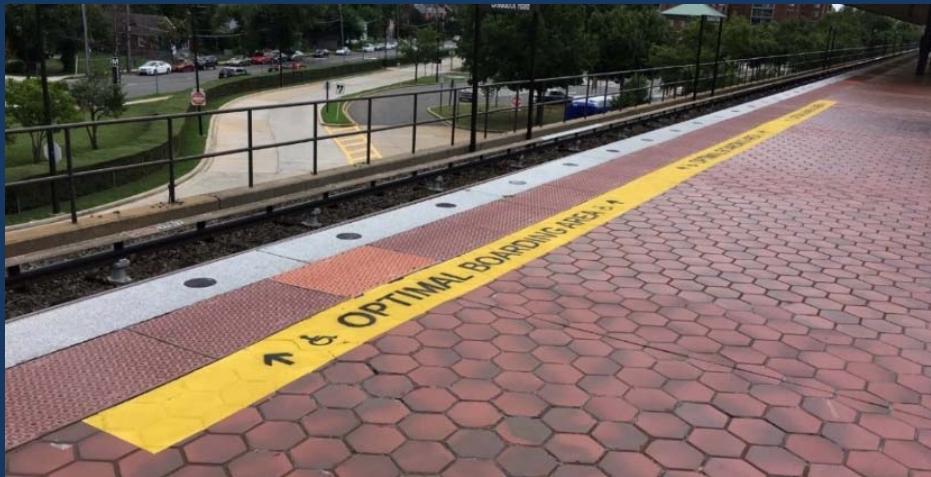
- Pilot train boarding area signage
 - Identifies level platform boarding areas
 - Alerts customers to optimal areas to board the train
 - Braddock Road and Rhode Island Avenue Stations

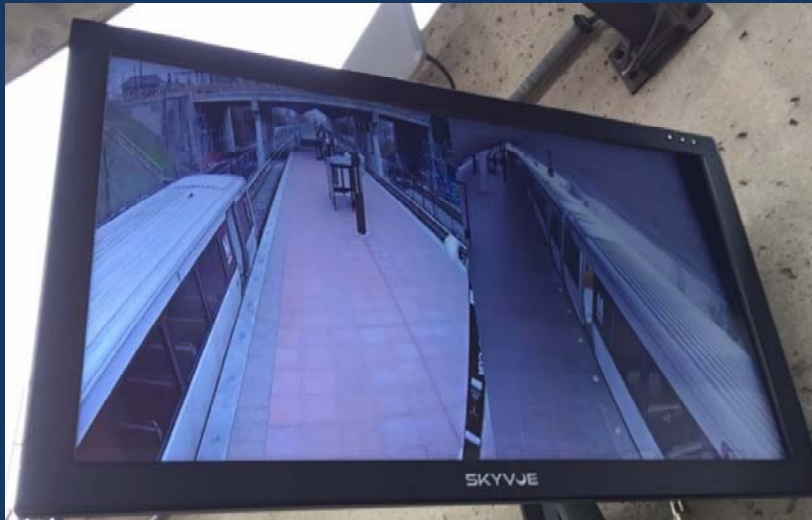
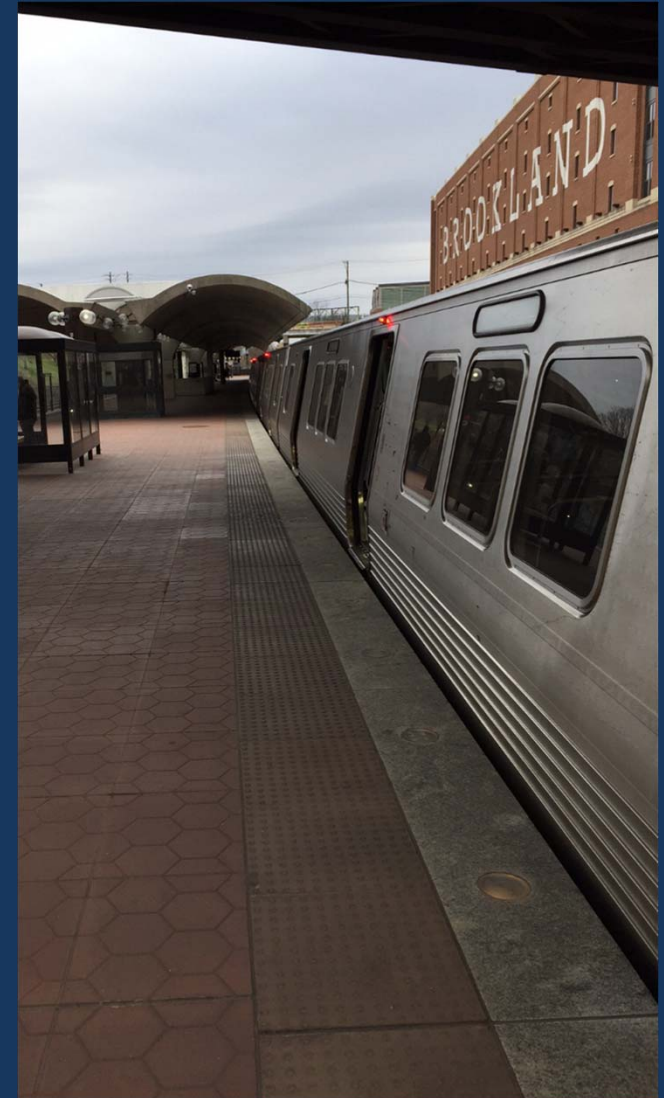
- CCTV
 - Installed at curved stations
 - Brookland
 - Silver Spring
 - Improves opportunity for operators to see customer boarding rear cars of the train

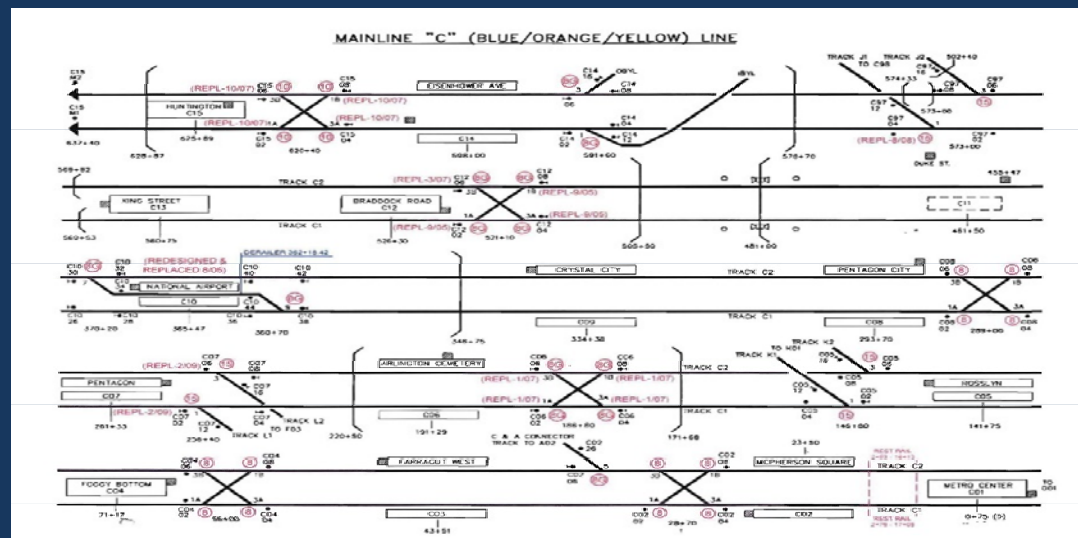
- Roadway Worker Protection Access Guide
 - Improved format and layout, includes:
 - Updated hot spot survey
 - System maps
 - Protection step-by-step instructions
 - Consolidates RWP documents into one source

The Roadway Worker Protection Access Guide has been updated to reflect the changes noted in the most recent hot spot survey. The Guide will also include detailed system maps, as well as step-by-step instructions on how to call for specific levels of protection based on the section of track being accessed. There were two separate documents that covered the same type of RWP processes and language; the new Guide will consolidate all RWP references into one document.

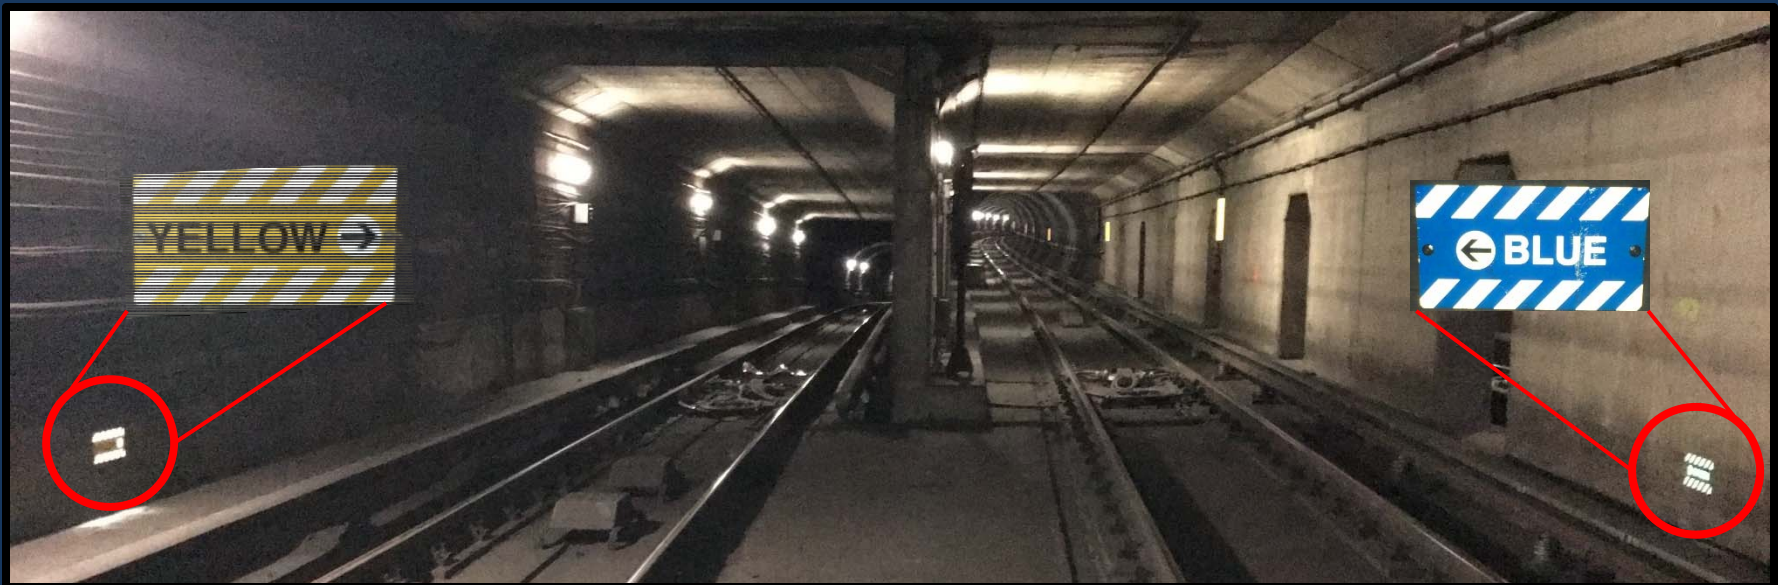
Location: Outside Pentagon Station

- Improved Tunnel Signage
 - NTSB Recommendation R-16-27
 - *"Install line identification and direction at tunnel entrances and inside tunnels"*
 - Status: Submitted; Under NTSB Review

Track and tunnel signage has also been improved. This was a result of National Transportation Safety Board (NTSB) Recommendation R-16-27, with the goal of reducing directional confusion in the tunnels, especially near diverging tracks/lines. Plain, color coded signage has been placed throughout the system. All actionable items assigned to this CAP were completed and submitted to the NTSB for closure.
