## **KEYED NOTES BY DEFICIENCY**

| K08 - VIENNA STATION - NORTH PARKING GARAGE<br>ARCHITECTURAL KEYNOTES BY DEFICIENCY | | | | | | |

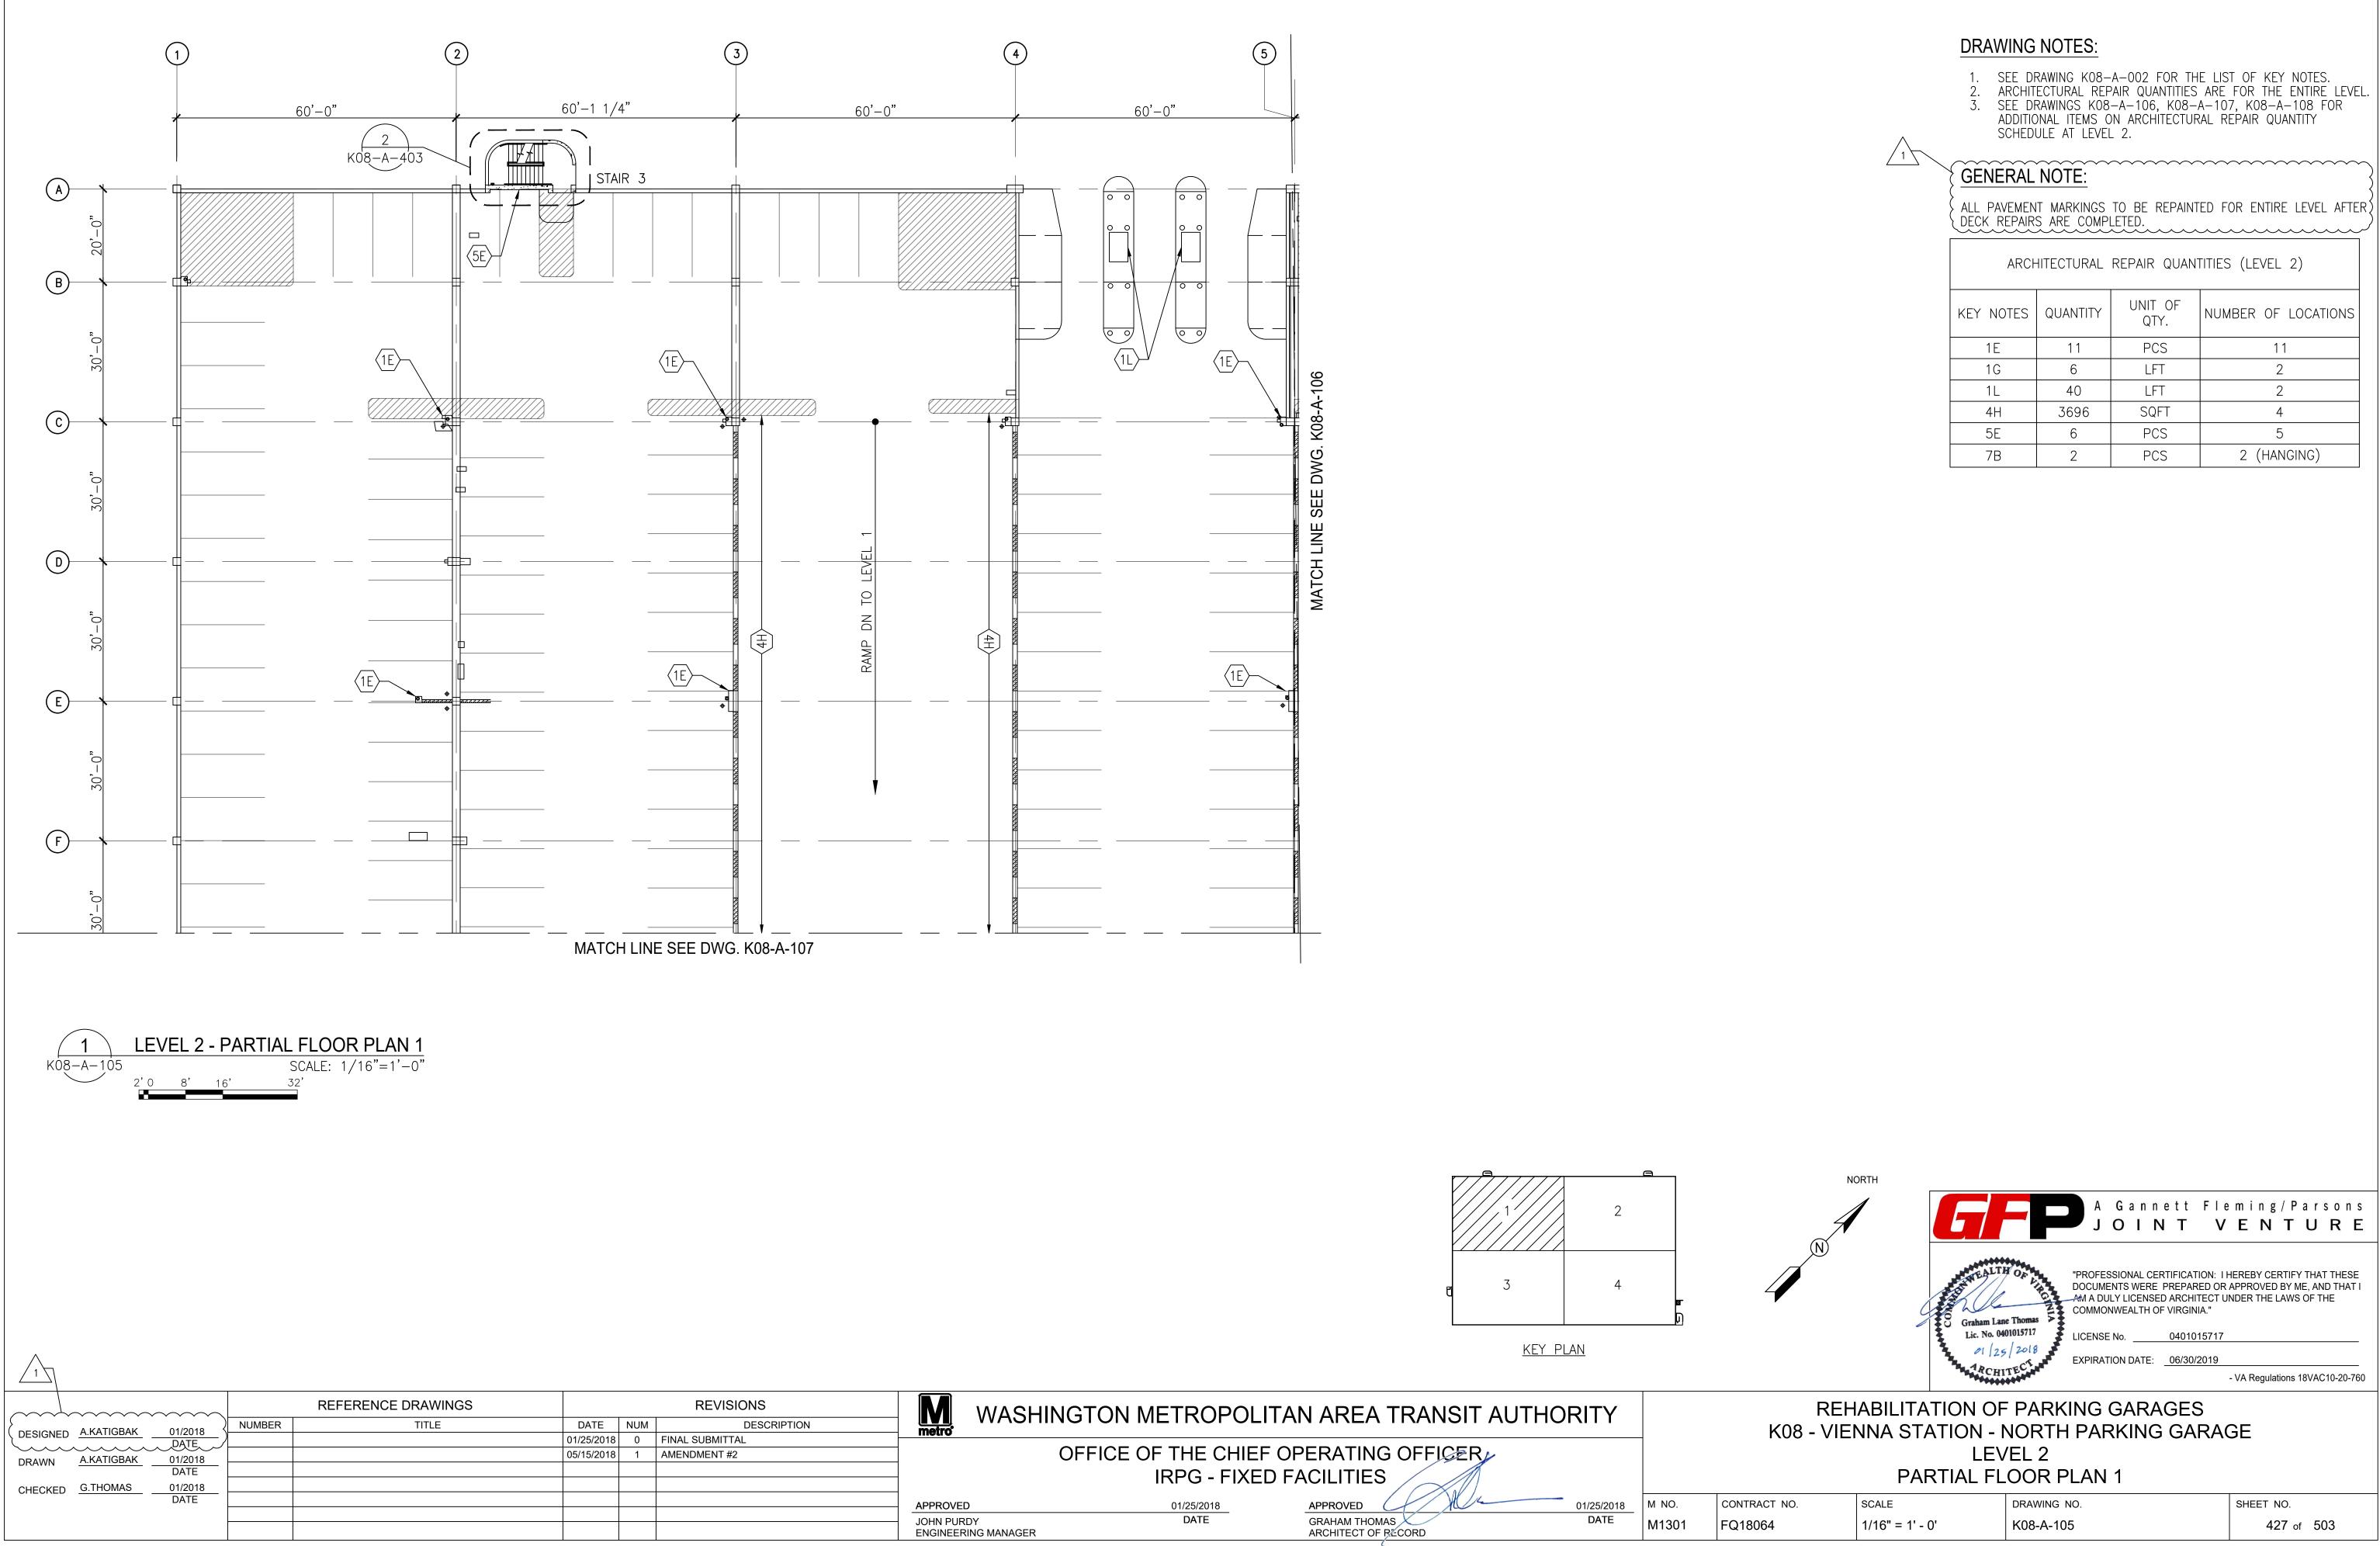
| ARCHITECTURAL REPAIR QUANTITIES (LEVEL 2) | | | | | | | |

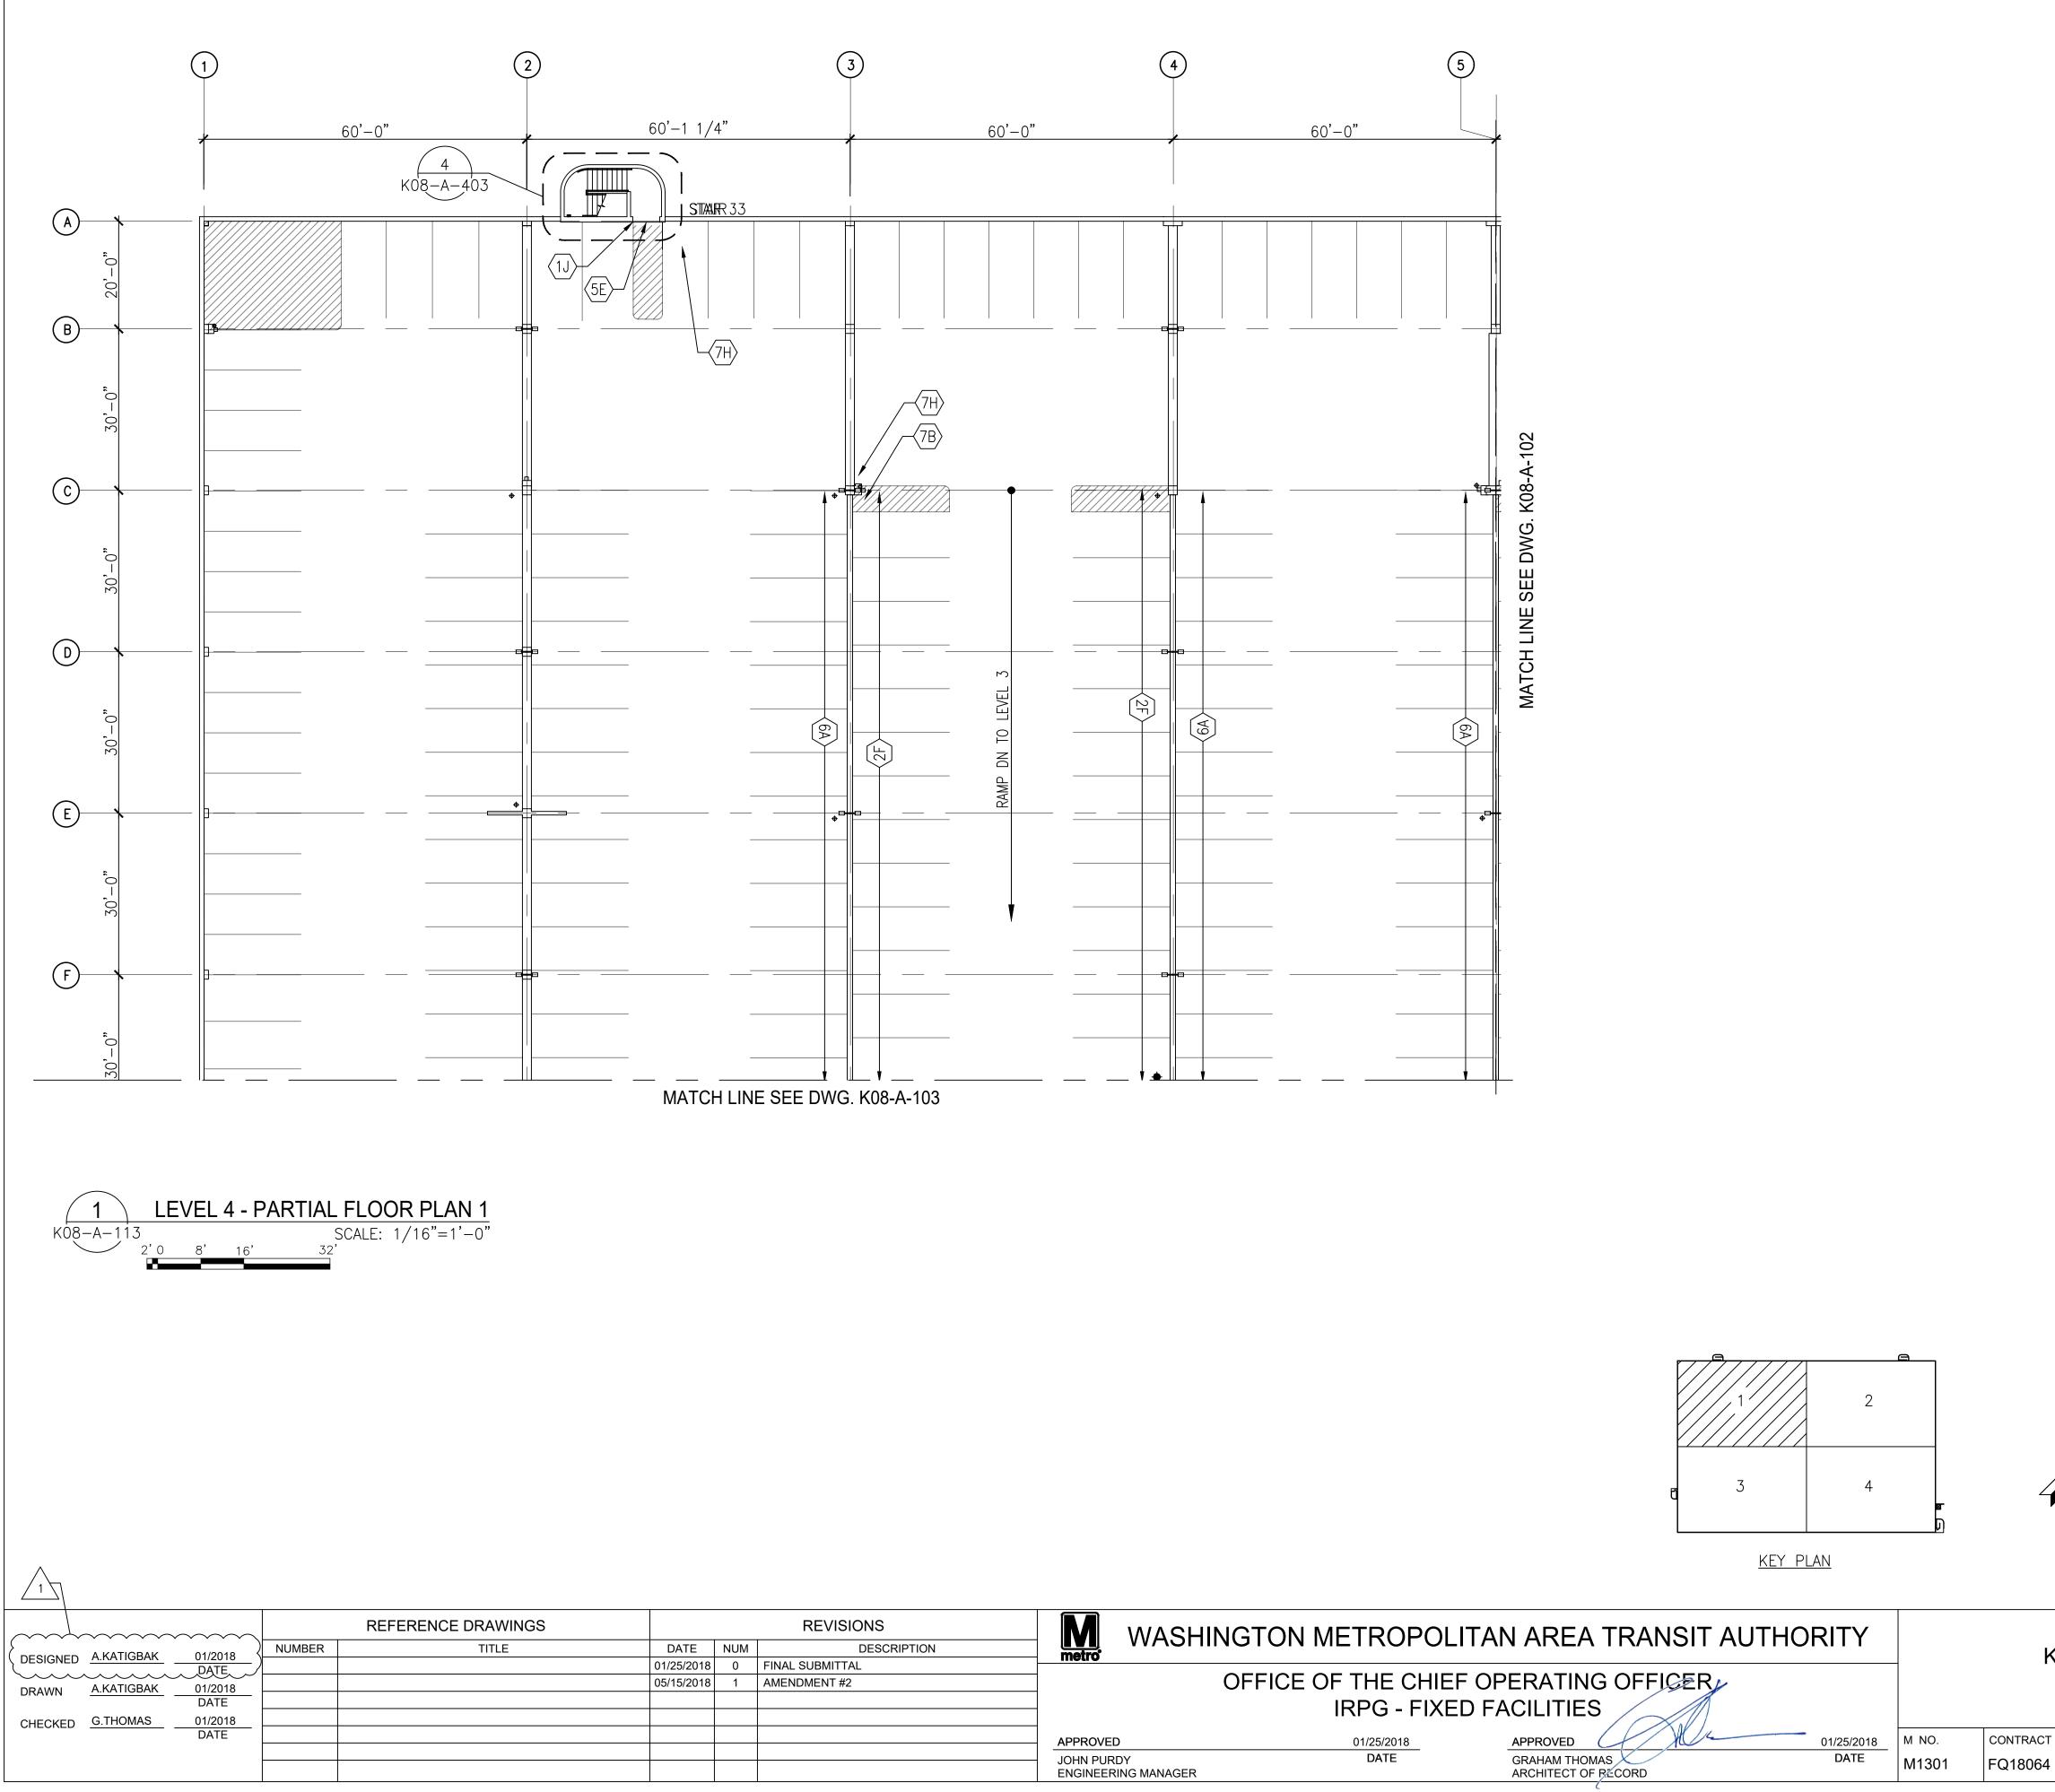
- 1. SEE DRAWING K08-A-002 FOR THE LIST OF KEY NOTES.
- 2. ARCHITECTURAL REPAIR QUANTITIES ARE FOR THE ENTIRE LEVEL. 3. SEE DRAWINGS K08-A-114, K08-A-115, K08-A-116 FOR ADDITIONAL ITEMS ON ARCHITECTURAL REPAIR QUANTITY
- SCHEDULE AT LEVEL 4.

- SEE DRAWING K08-A-002 FOR THE LIST OF KEY NOTES.
  SEE DRAWING K08-A-113 FOR ARCHITECTURAL REPAIR
- QUANTITIES.
- 3. SEE DRAWINGS K08-A-113, K08-A-114, K08-A-115 FOR ADDITIONAL ITEMS ON ARCHITECTURAL REPAIR QUANTITY SCHEDULE AT LEVEL 4.
