### Planning, Development and Real Estate Committee

Alkali-Silica Reaction (ASR) Rehabilitation for Various Rail Structures

### Washington Metropolitan Area Transportation Authority Board Action/Information Summary

# Alkali-Silica Reaction (ASR) Rehabilitation for Various Rail Structures

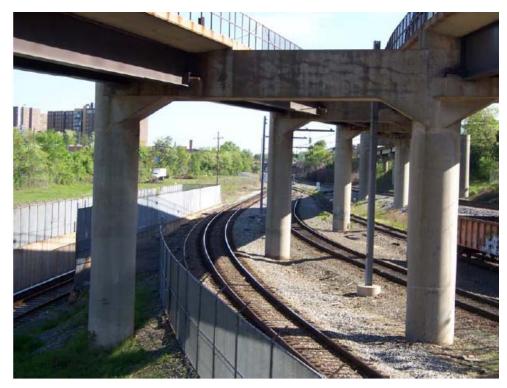
Rhode Island Avenue Aerial Structure – Pier Cap over CSX

Alkali-Silica Reaction (ASR) is produced from the reaction of silicacontaining aggregates and alkalis in the portland cement resulting in cracking on the exterior of reinforced concrete structures.

- Preventive measures are necessary to achieve expected life of structures:
  - Coat concrete surfaces with Corrosion Inhibitor followed by a silicone-based breathable elastomeric coating
  - Remove and replace badly deteriorated concrete prior to application of coatings

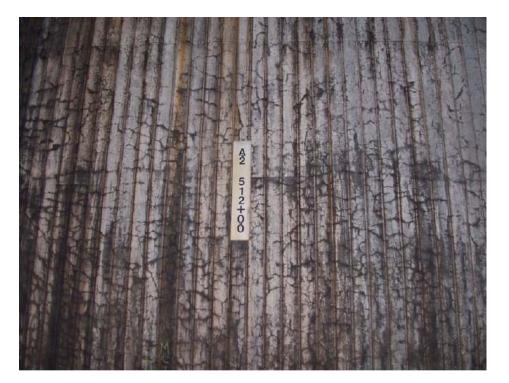
Medical Center Portal Wall

• Prior to mid 1980's silica containing river run aggregates were used in concrete. Crushed stone has been used since.

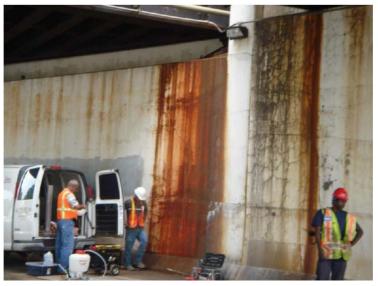
First Street Bridge South Abutment

- Presence of ASR has been verified by Petrographic Analysis of concrete samples collected from various structures on the Red, Blue and Orange Lines:
  - Entrance, portal and common walls
  - Vent and fan shaft walls
  - Pier caps and abutments
