Washington Metropolitan Area Transit Authority
Board Action/Information Summary

Derailment near East Falls Church Metro Station

Interlocking Derailment Near East Falls Church Metro Station

Safety Committee
December 15, 2016

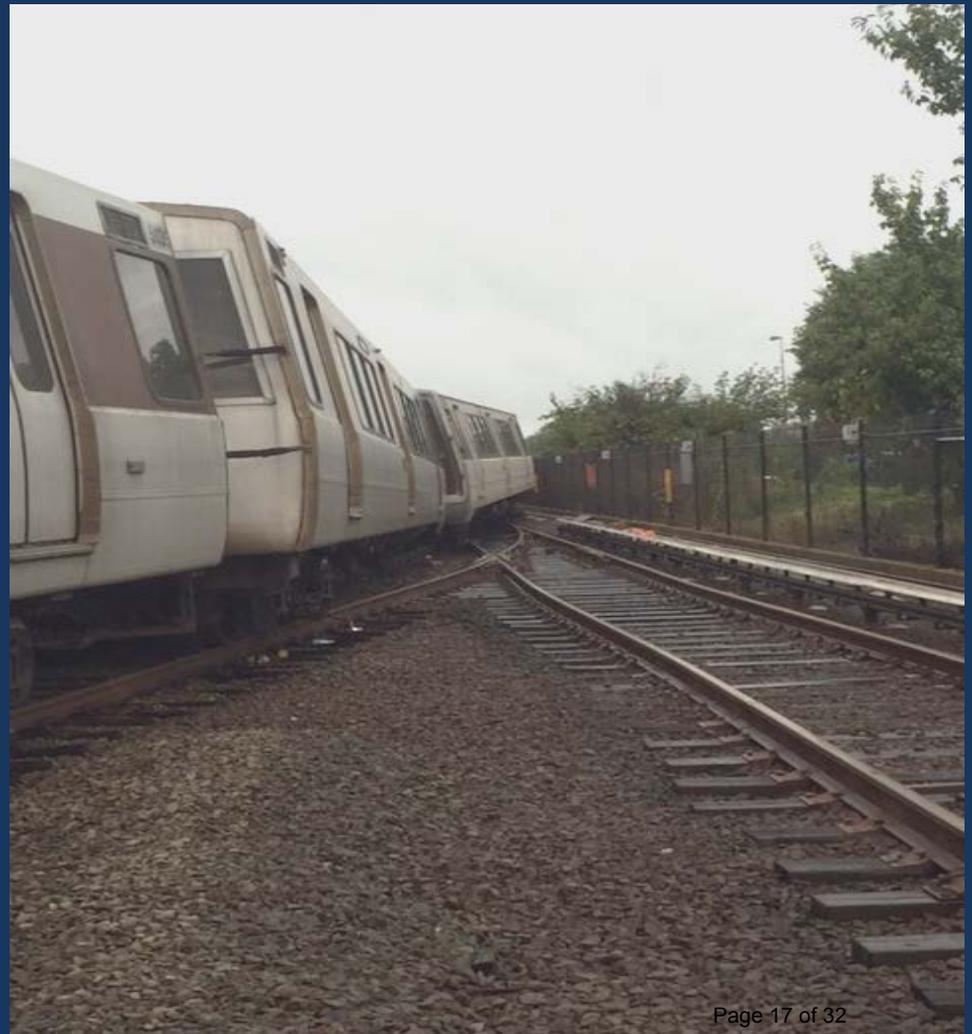
- 63 passengers safely evacuated to the roadbed
- Three passengers reported injuries, one transported
- Damage cost approximately \$860,000

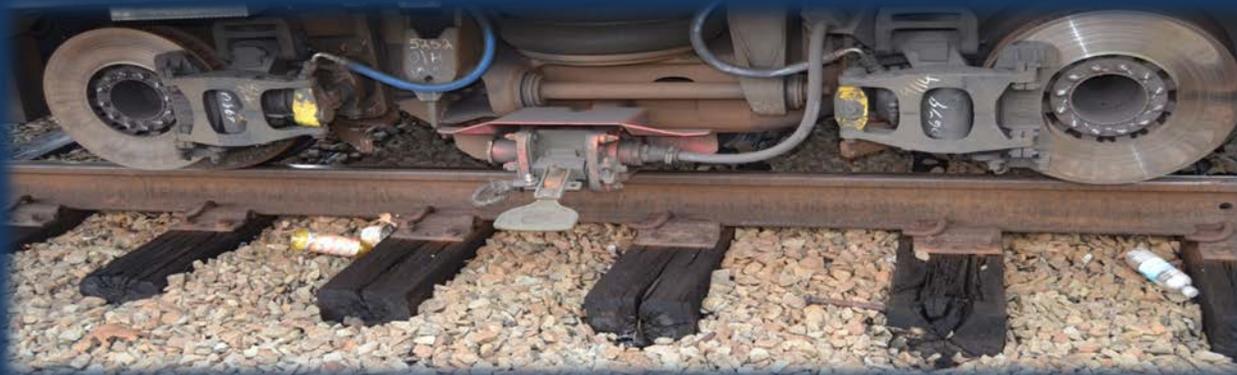
Findings – Immediate Cause

- Wide Gauge track defect
- Track ties deteriorated and unable to restrain lateral forces

As part of post-incident investigation, it was observed that the affected trucks of car 3238 and 5134 had all four wheels of each truck derailed to the south. Track gauge measurements were taken beneath the stationary train at the Point of Derailment (POD), which identified a wide gauge track defect of 58". Standard gauge for this track is 56 1/2". A measurement of 57 3/4" requires that portion of track be removed from service. This condition resulted in the #4 wheel of the trailing truck of car 3238 to drop into the gauge of the track. This action caused car 3238 and 5134 to derail, climb the opposite running rail, and come to rest in a ballast pile after causing significant damage to the third rail, crossover tracks, and running rail on track 2. As Train 602 continued its forward progress toward East Falls Church station, the derailed trucks were redirected back towards their intended route on Track K2 and damaged the track, third rail and vehicle components in its path. Costs to repair the track and rail cars were approximately \$860,000.

SAFE's investigation found that the immediate cause was the condition of the ties within the crossover tracks, which were deteriorated to the point where they were no longer effective in restraining the dynamic lateral forces transferred to the track by Train 602. The investigation reviewed all areas of the derailment and the passenger evacuation; however it became apparent that the track maintenance and inspection areas required an in-depth assessment. Additional causal and contributing factors were identified and are listed below:

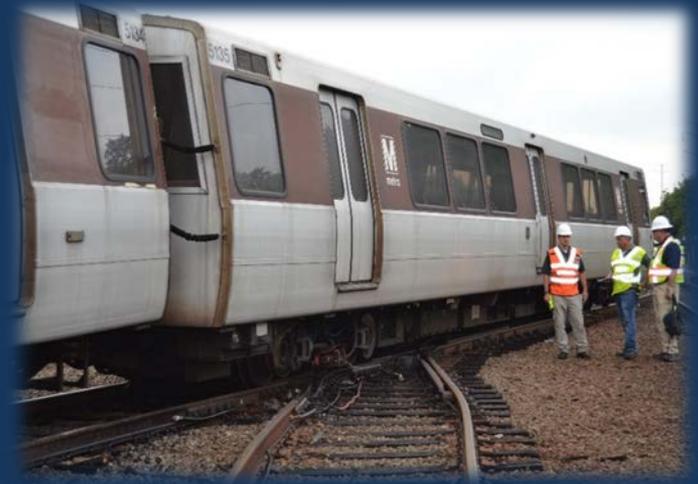
Findings – Causal Factors

- Failure to maintain the interlocking to Track and Structures standards
- Failure to effectively assign and supervise special trackwork inspections
- Failure to properly classify and escalate defects
