Washington Metropolitan Area Transit Authority
Board Action/Information Summary

Derailment near East Falls Church Metro Station

Interlocking Derailment Near East Falls Church Metro Station

Special Board Meeting
August 25, 2016

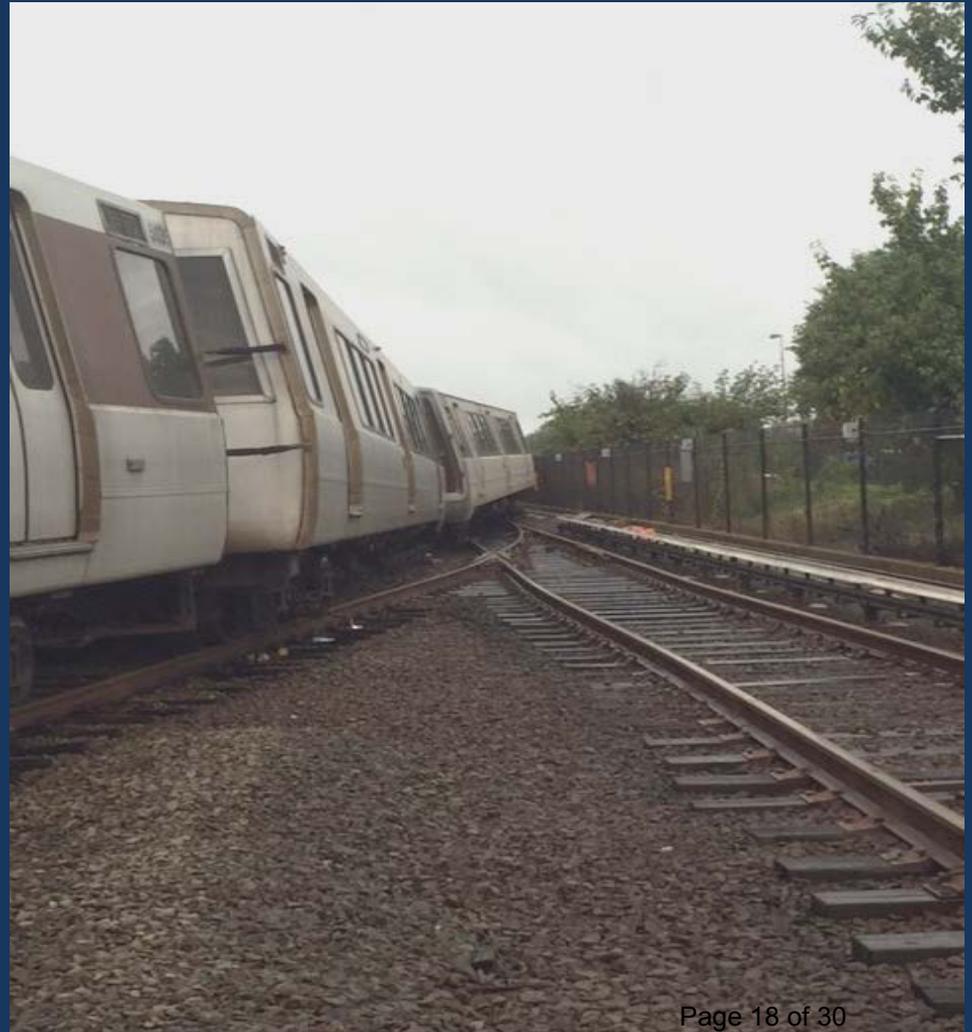
- Sixty-three (63) passengers safely evacuated to the roadbed
- Three passengers reported injuries, one transported
- Damage cost pending

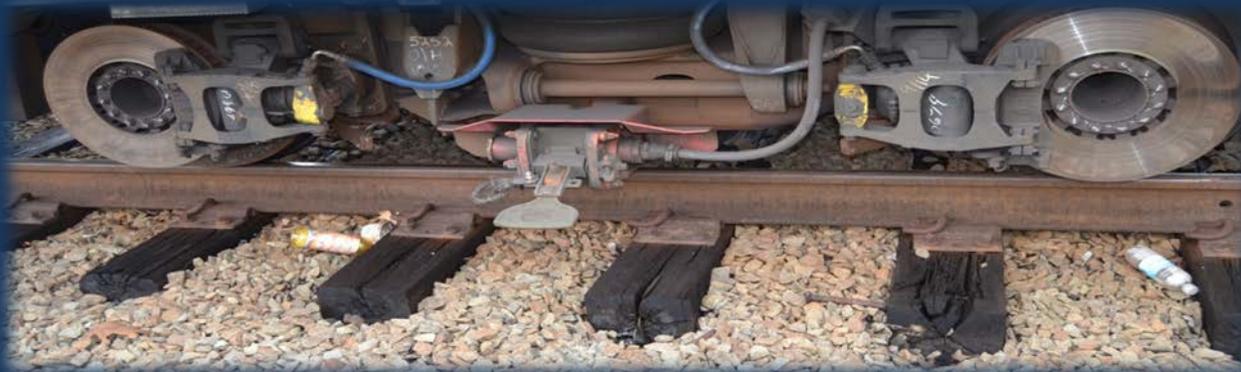
Investigation Findings

- Wide Gauge track defect
- Track ties deteriorated and unable to restrain lateral forces
- Ongoing investigation is focusing on track maintenance and inspections

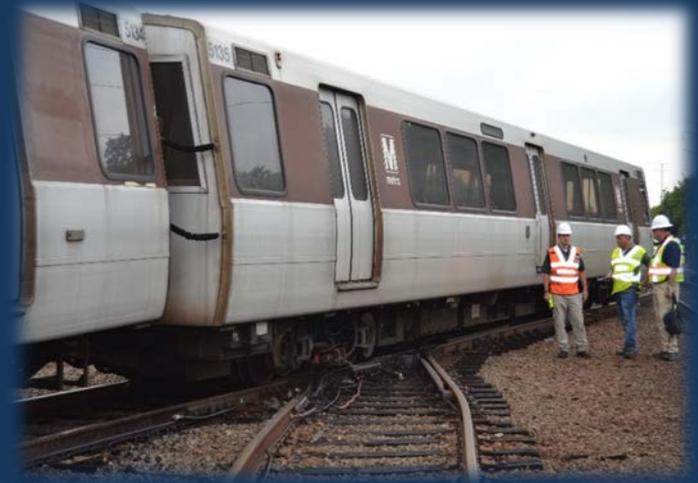
Causal Factors

- Failure to maintain the interlocking to Track and Structures standards.
- Failure to inspect track to internal standards
- Defects incorrectly classified
