Invitation For Bid

Electrical and Data Cable Installation

Project Name: 15-NEPP-01 In-Floor Duct Inspections
Task: Mezzanine Inspection Reports
Date of Inspection: August 22, 2014
Mezzanine Inspected: A01 - Metro Center East
Report Includes:
- Mezzanine Inspection Checklist
- Field Photos
- Existing AFC Installation Plan with field notes

Mezzanine Inspection Report (Scoping)

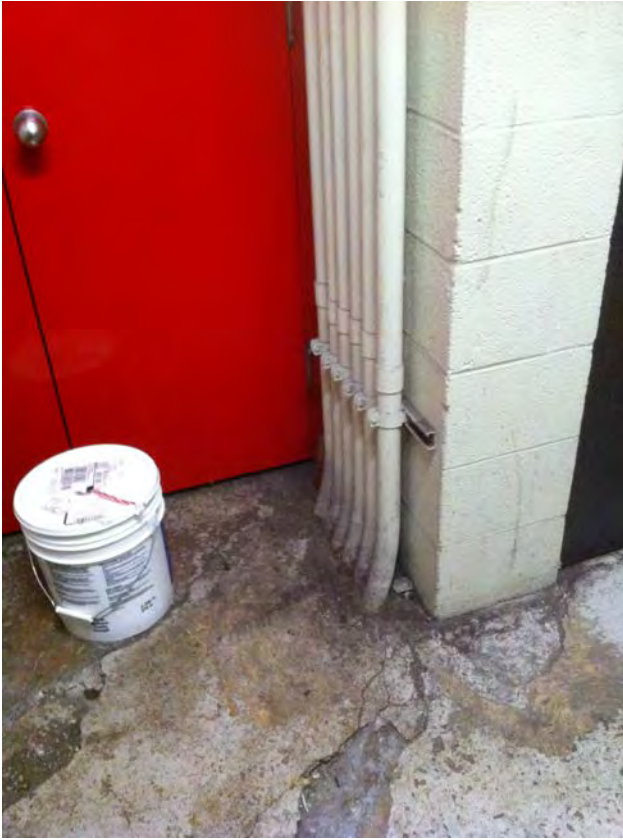
Observations / Issues / Next Steps		
<p>Obstruction was found at 90 degree bend where power conduits sweep into the ground from overhead junction box before proceeding to the kiosk. Access to the power conduits from kiosk is not possible due to apron skirt obstruction within the kiosk.</p> <p>Proposed conduit run is approximately 70 feet total between the Kiosk and the junction box. Refer to attached as-built plan for additional details.</p>		
Sign Off		
	GFP Representative	WMATA PRGM
Name:	Mike Butler	
Signature:

Farragut North NW Photo # 1 – 90 degree bend where conduit sweeps underground to junction box

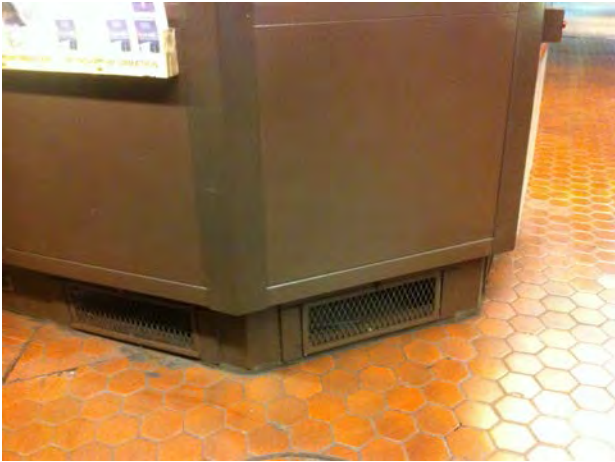
Farragut North NW Photo # 3 – Kiosk apron skirt

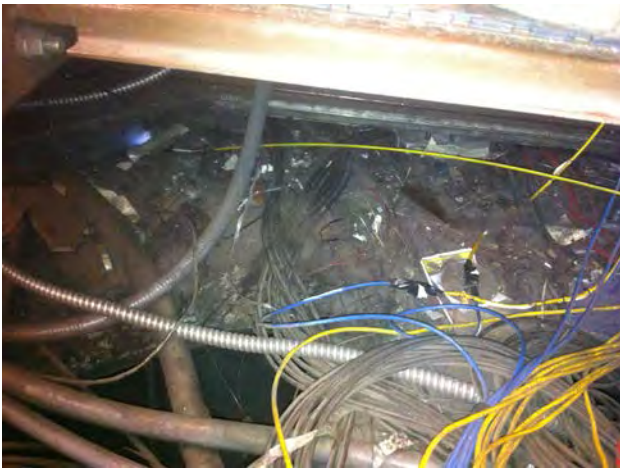
Farragut North NW Photo # 4 – Kiosk floor, there is a skirt obstruction inside Kiosk and a narrow gap for wires

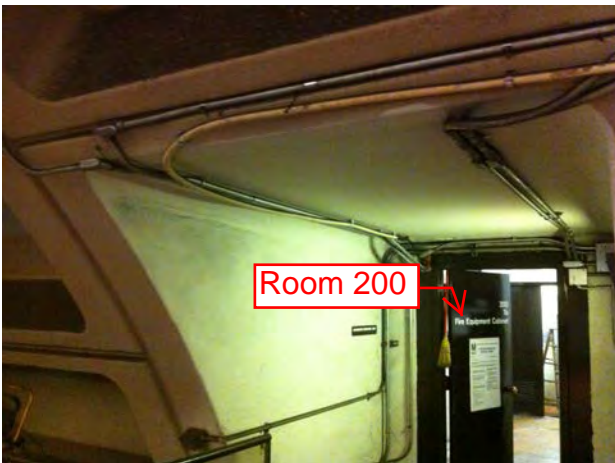
Farragut North NW Photo # 5 – Entrance to Room 200, junction box located behind door

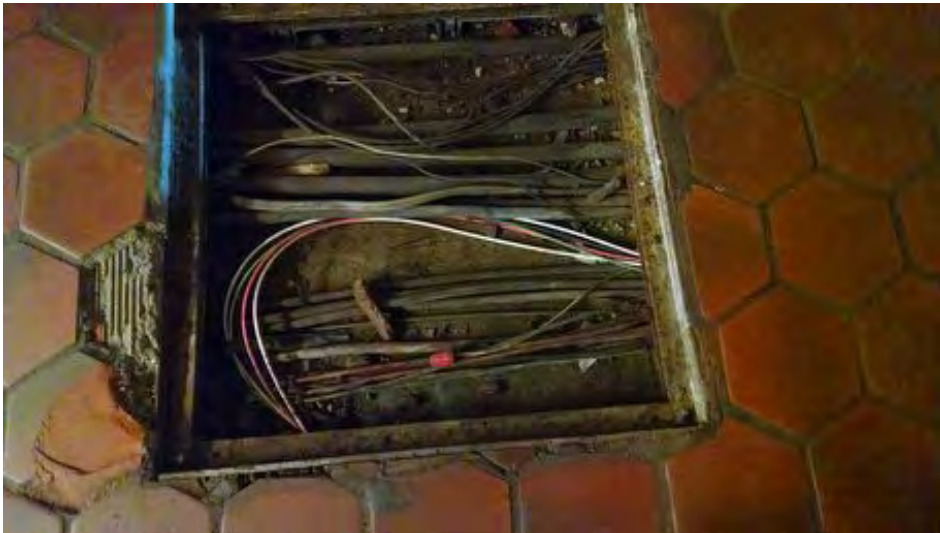
Scoping of Power Duct - Kiosk to AFC Panel		
Task	Yes/No	Notes
Kiosk to Handhole 1 (Distance: 16')		
Was video scoping completed for the entire duct / conduit run?	Partially	Refer to "WMATA Farragut North SE Handhole to Kiosk Video.avi"
Was pull string installed?	Yes	
Were there any obstructions or blockages? Provide details of type and specific location.	No	There were no other obstructions or blockages other than the 45-degree bend in walker duct, although corrosion was clearly evident.
Is the duct / conduit at capacity? Provide additional details about the dimensions of duct / conduit and number of wires.	No	4" walker duct with less than 15 wires
Handhole 1 to Handhole 2 (Distance: 15')		
Was video scoping completed for the entire duct / conduit run?	No	Not possible due to collapse.
Was pull string installed?	No	
Were there any obstructions or blockages? Provide details of type and specific location.	Yes	Duct is heavily corroded and collapsed in multiple locations. Handhole 2 is also collapsed and in poor condition.

Photo #2: Handhole 1

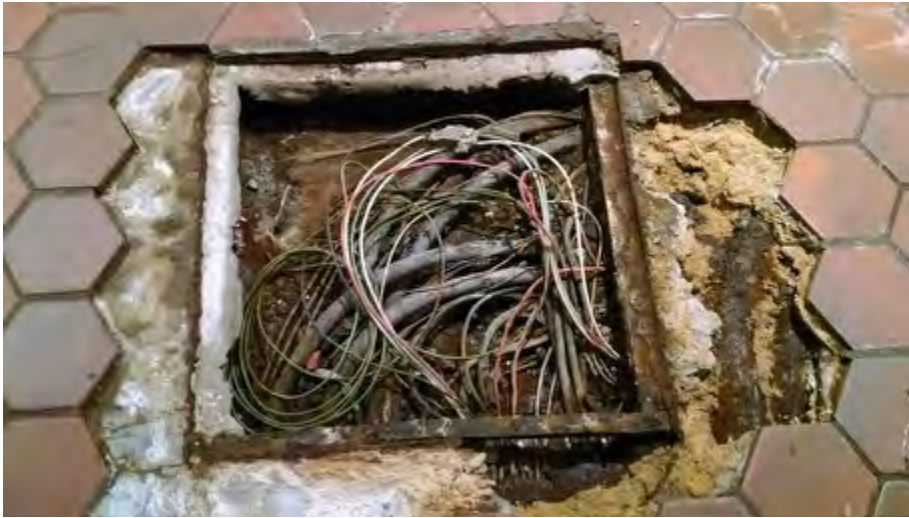
Photo #3: Handhole 2

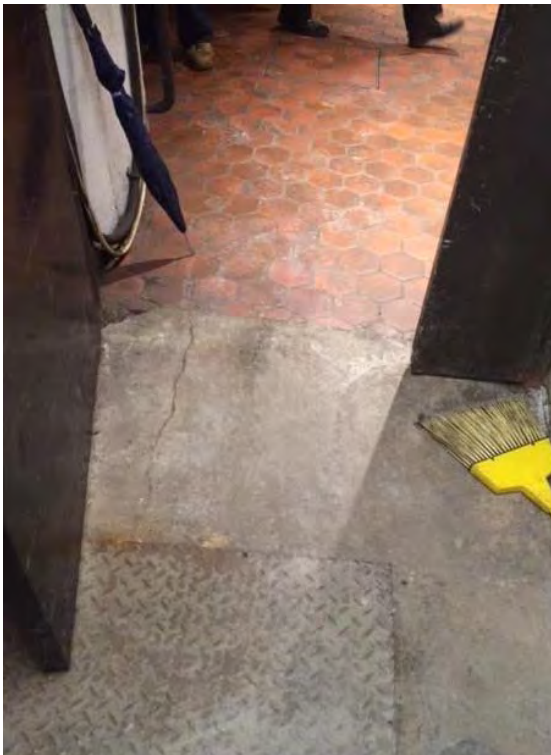
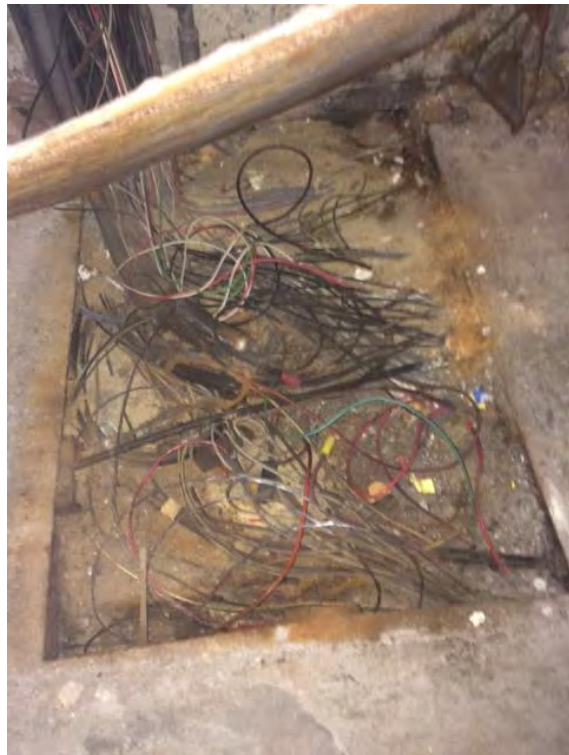
Photo #4: Entrance to backrooms and shared raceway

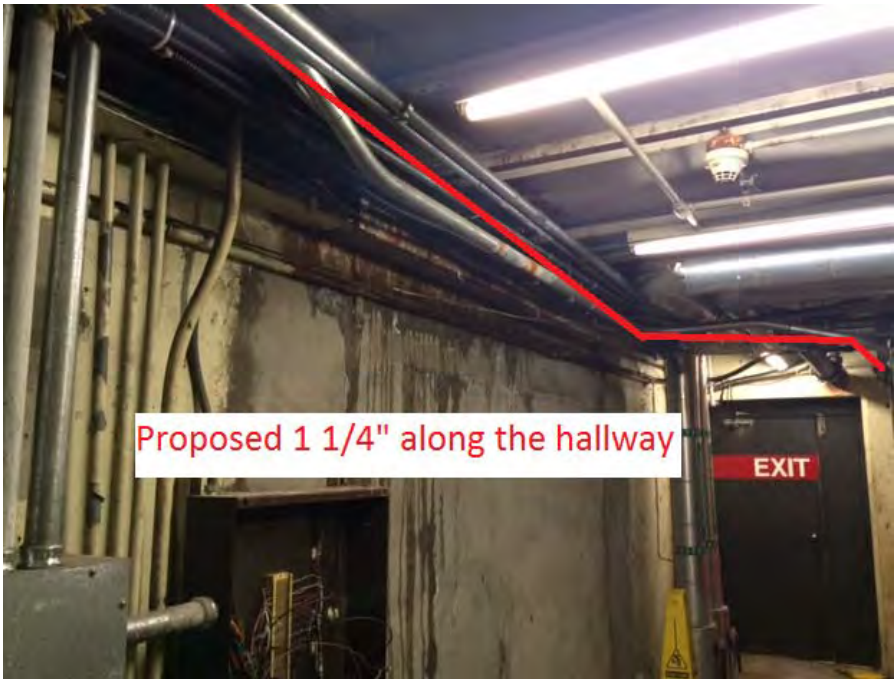
Photo #6: Proposed overhead conduit run from Kiosk to AFC Panel (continued)

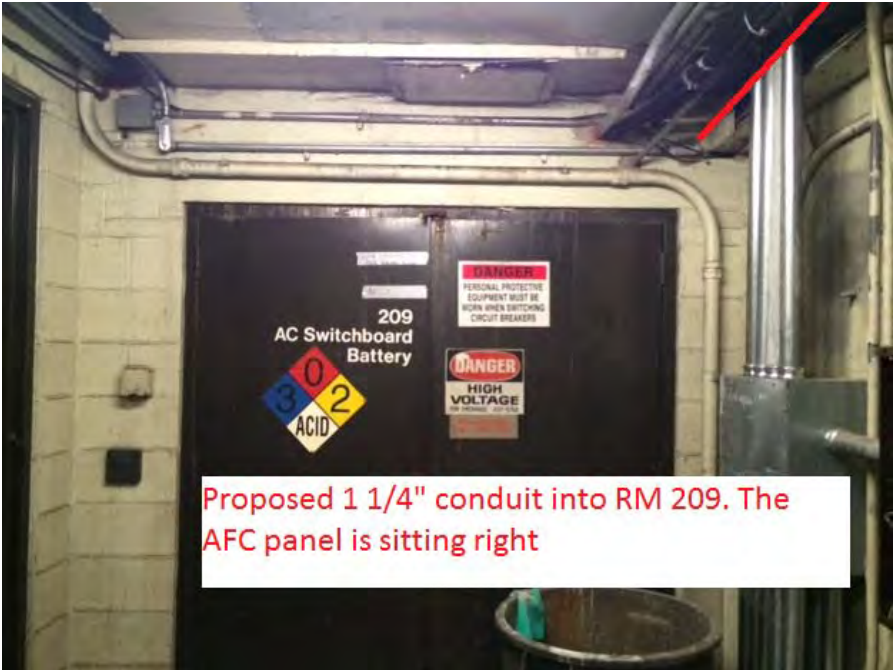
Photo #7: Proposed overhead conduit run from Kiosk to AFC Panel (continued)

Proposed 1 1/4" conduit into RM 209. The AFC panel is sitting right

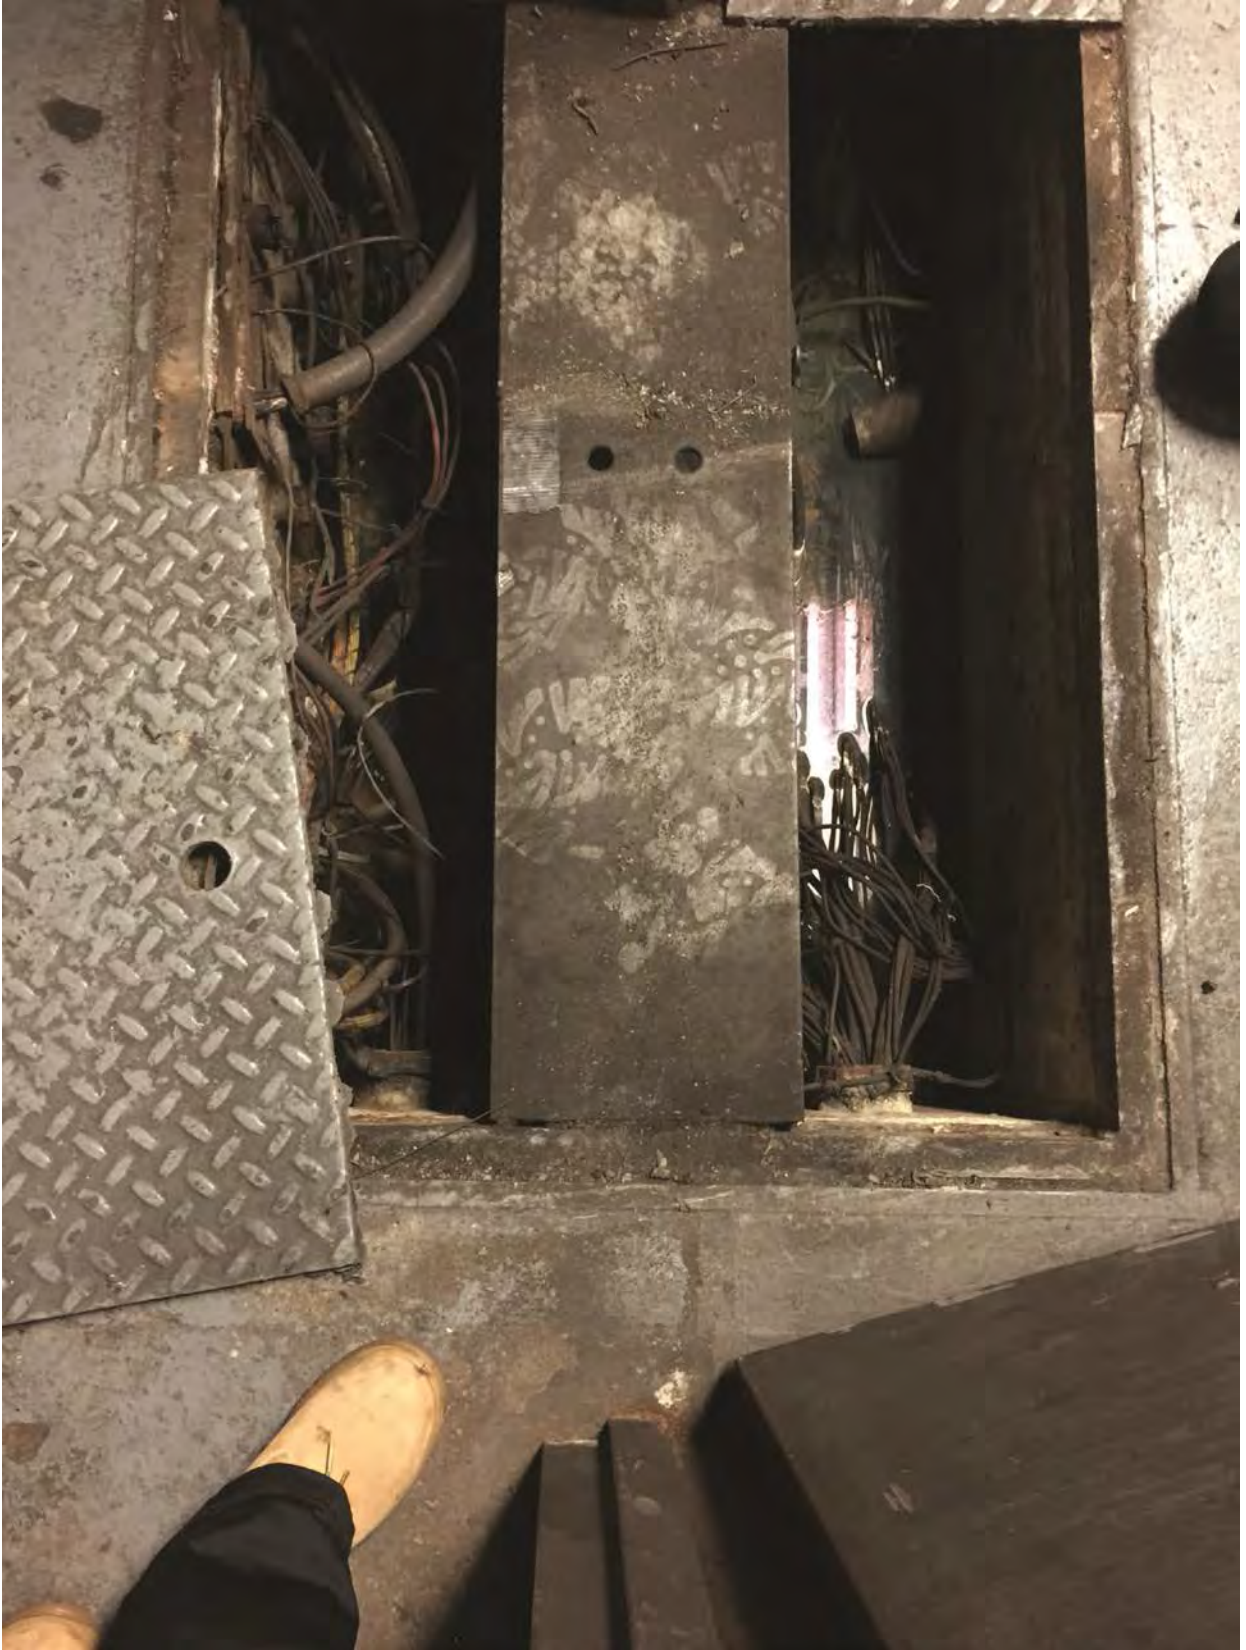
It was not possible to install pull string in the remaining section from Shared Trench to AFC Panel (Room C208), due to standing water and hot wires. Therefore, a proposed overhead conduit is recommended for the remaining section as shown in the attached drawing and photos.

Photo #3 – A04 Woodley Park: Standing water in electrical trough

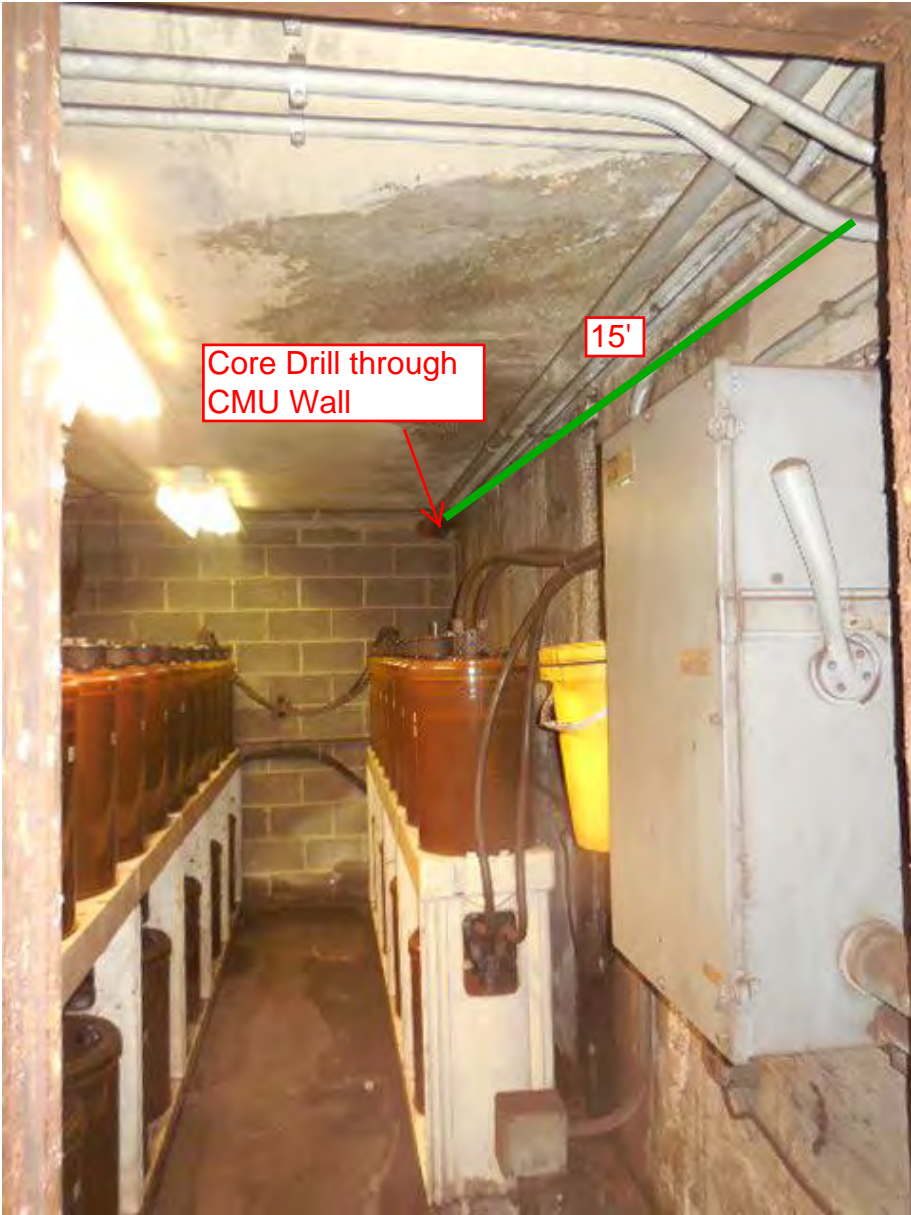
Photo #8 – Proposed Overhead Conduit in Battery Room 218

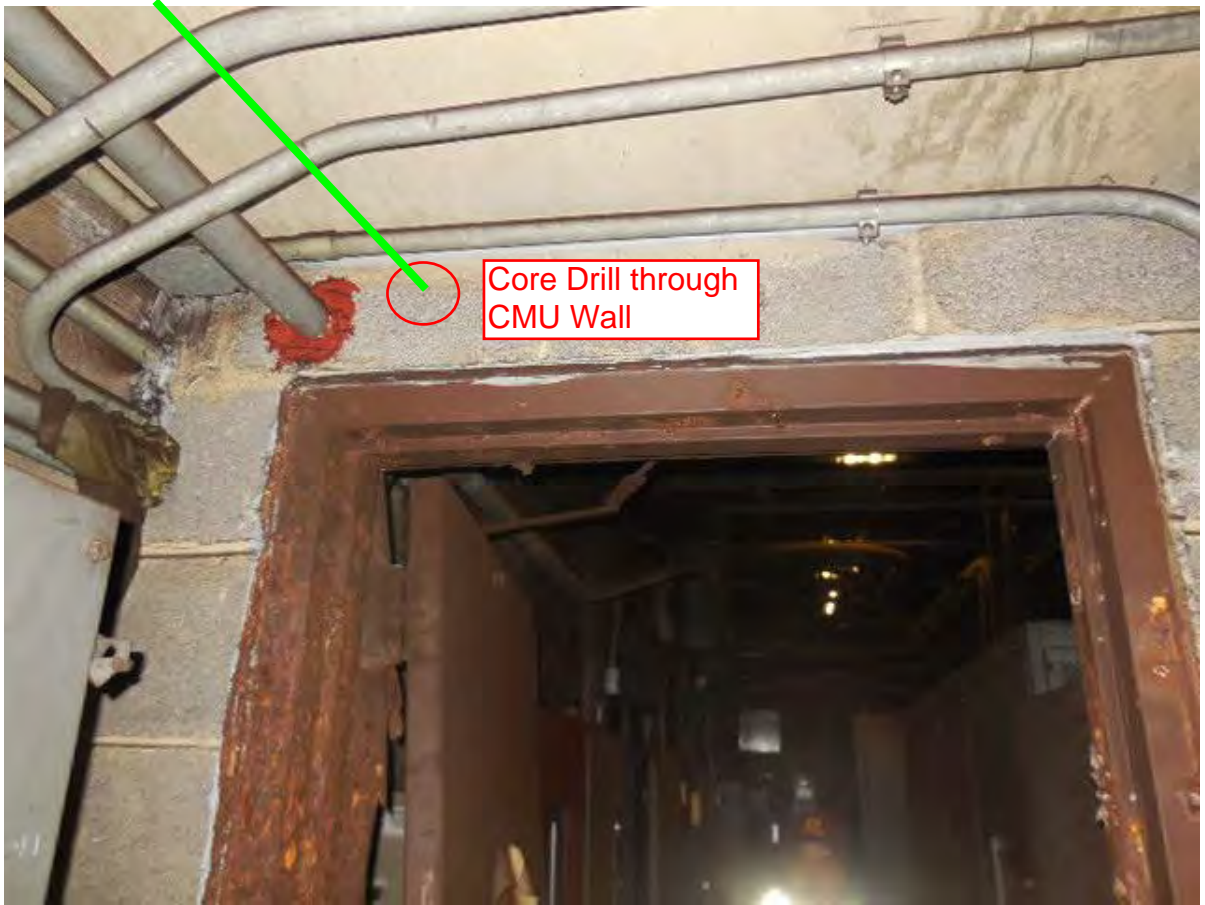
Photo #9 – Proposed Overhead Conduit in Battery Room 218

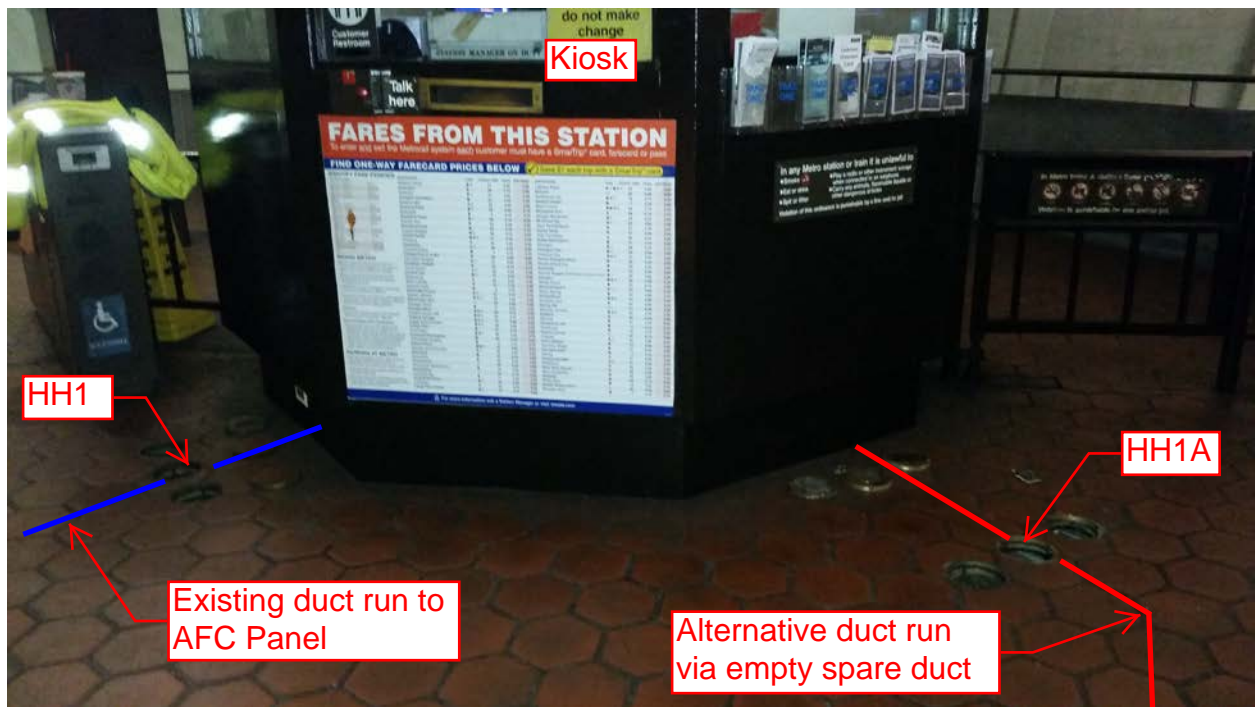
Photo #2: Existing & alternate power duct from to Kiosk to handholes.

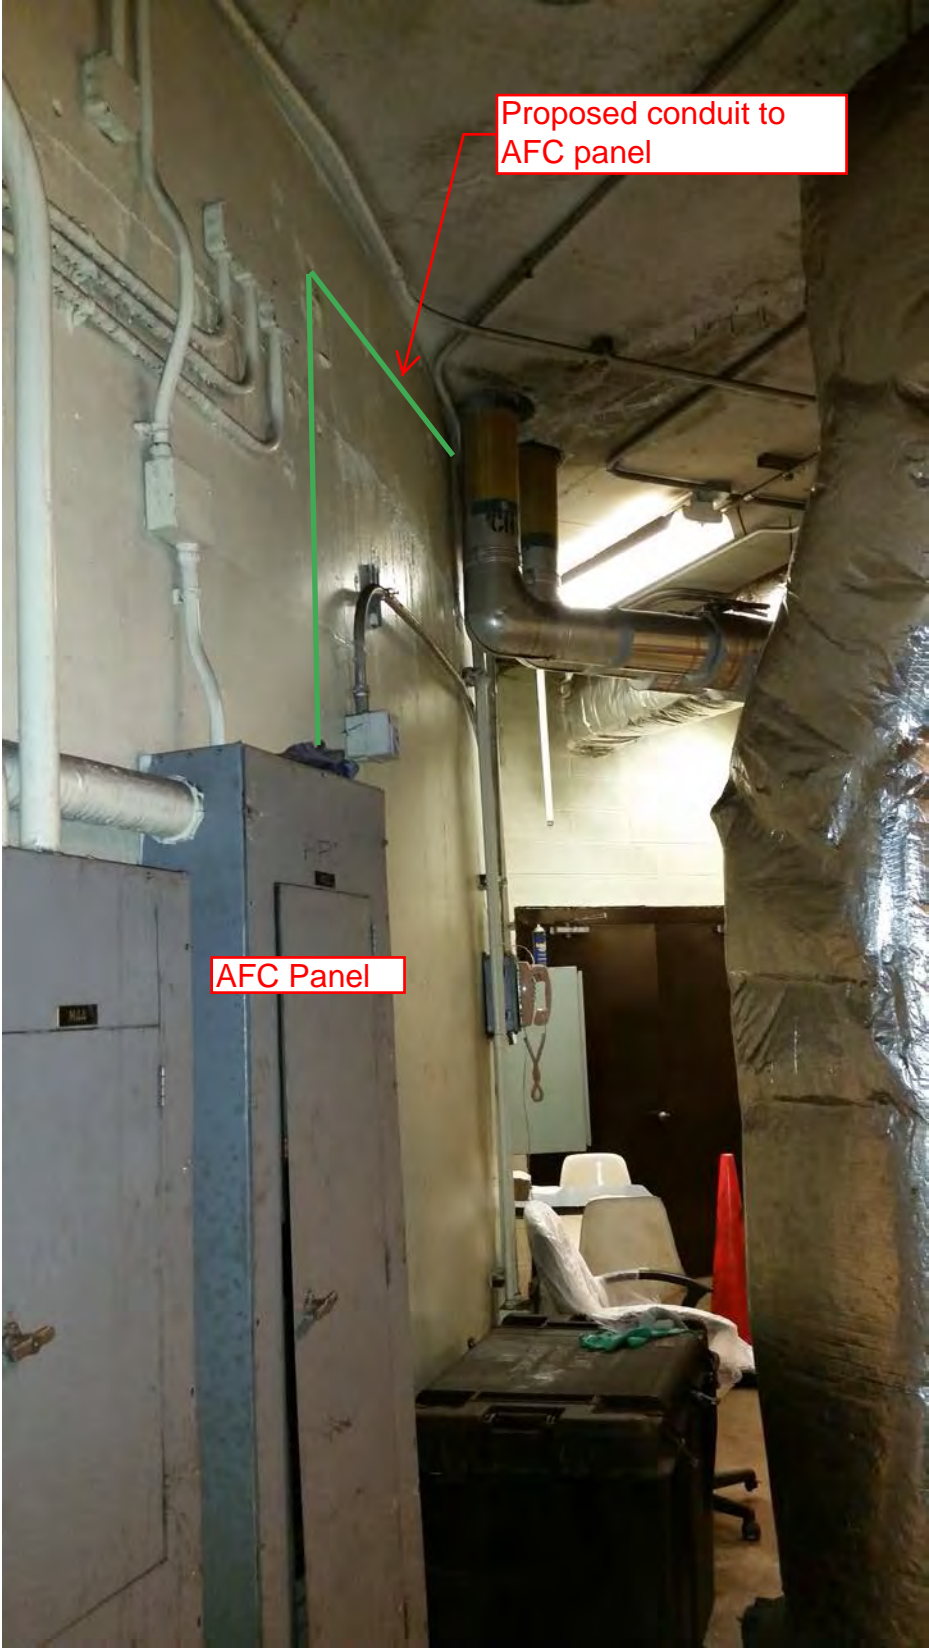
Photo #6: Proposed conduit run to AFC panel

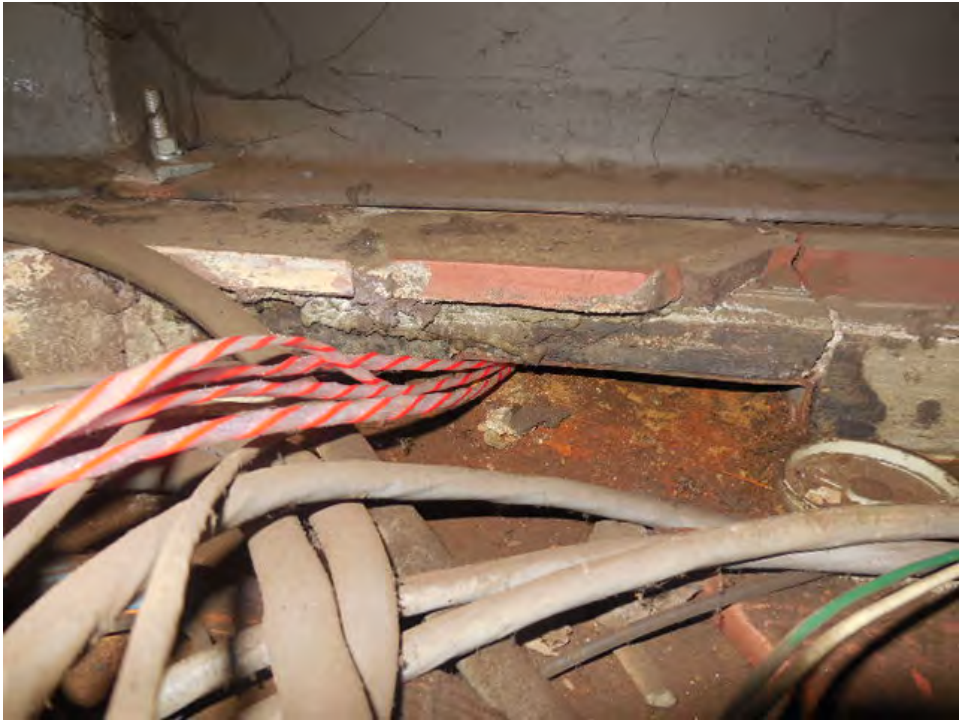
Photo #2: A12 White Flint – Pull string installation in faregate array duct

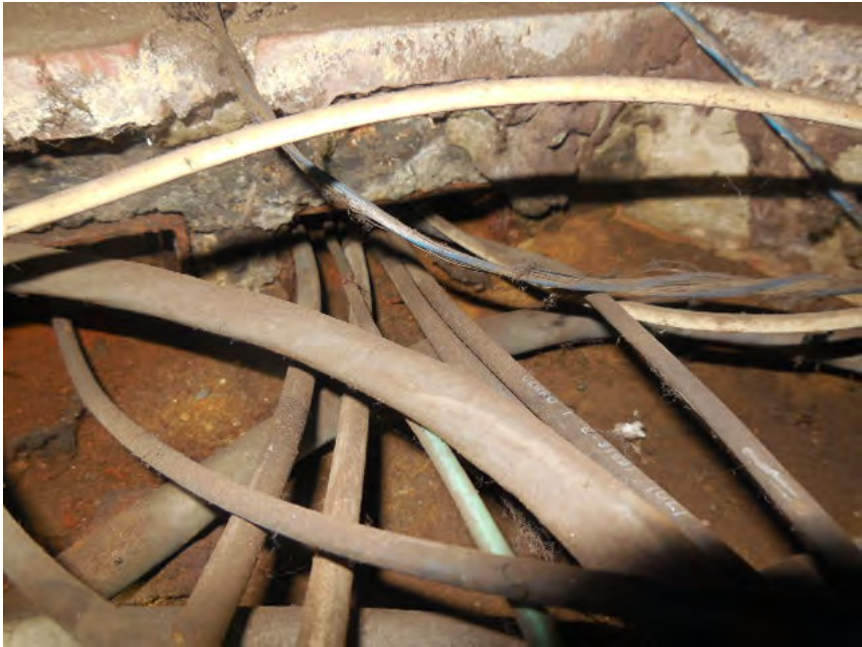
Photo #3: A12 White Flint – Power duct under kiosk floor under capacity

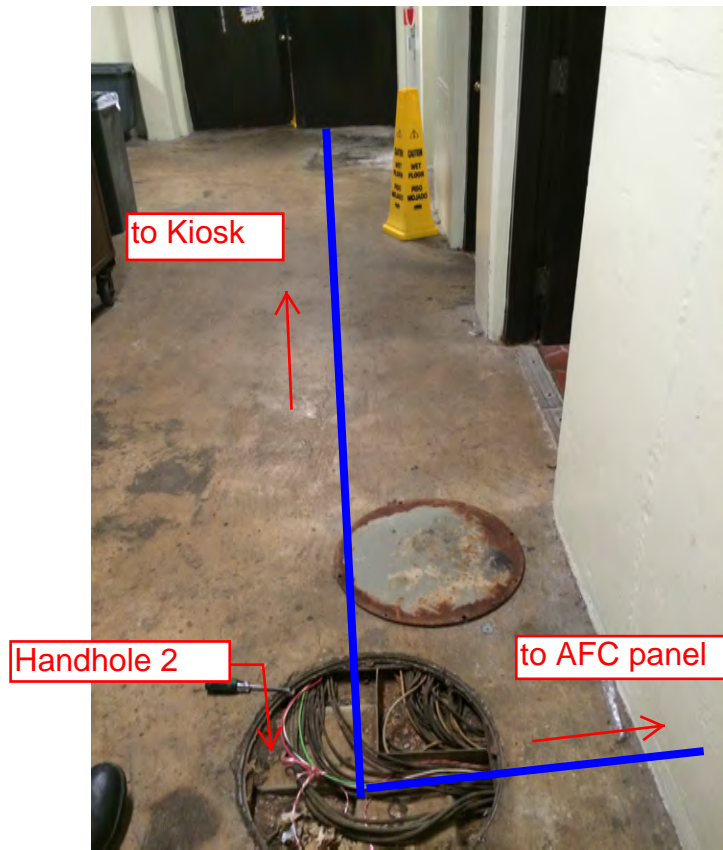
Rockville Photo #2 – Duct route between Kiosk and Electrical Room

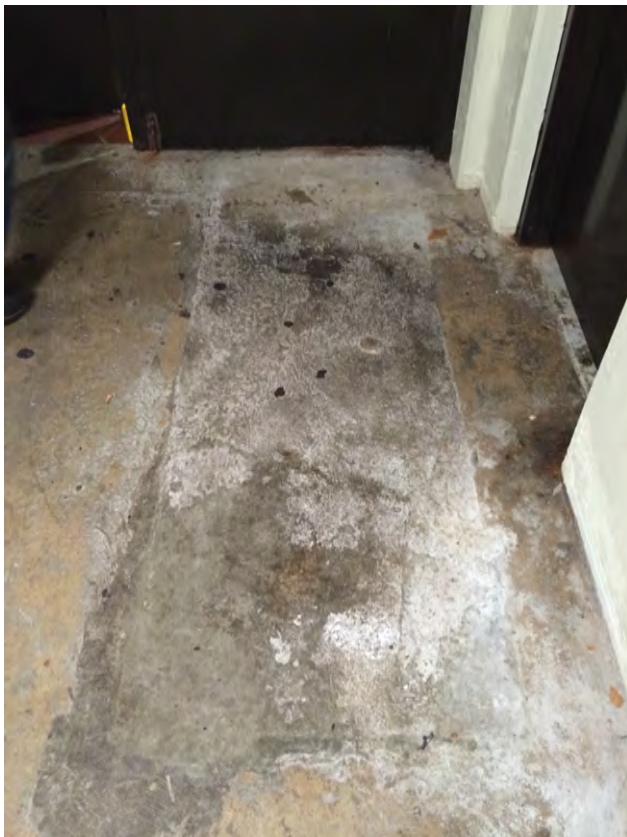
Rockville Photo #3 – Concrete repair to floor in back hallway outside Room C113

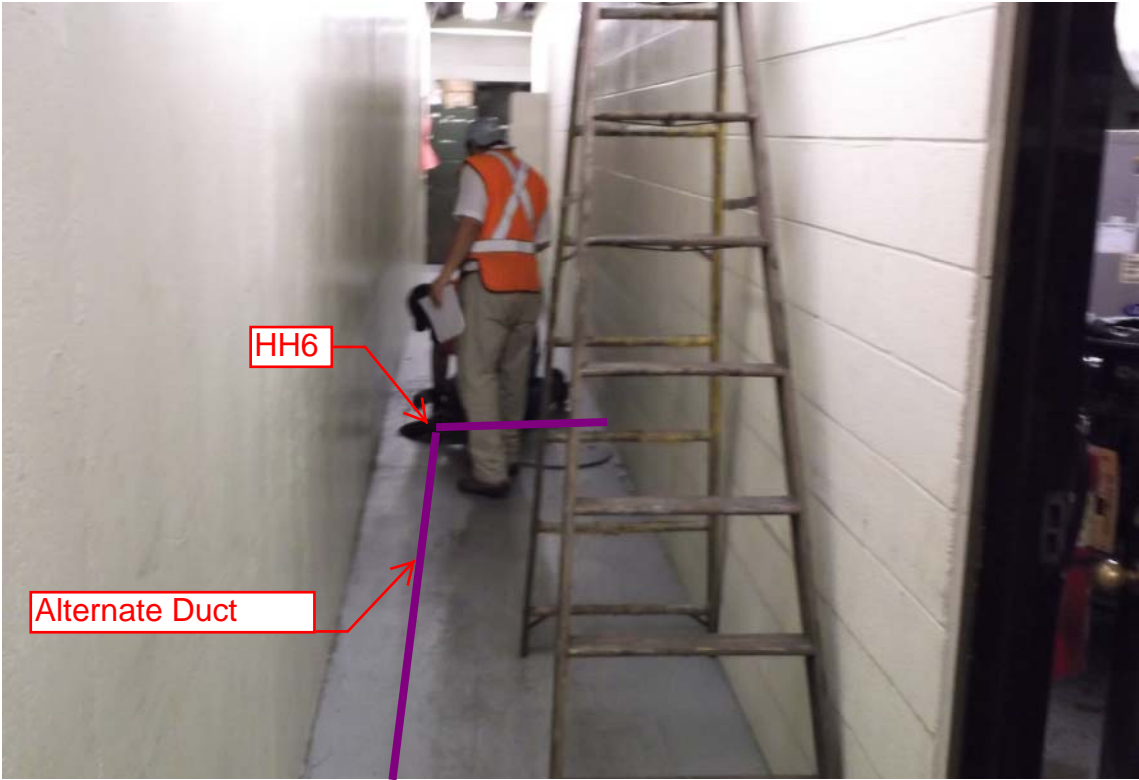
Photo #3: Alternate duct path in Room W200.

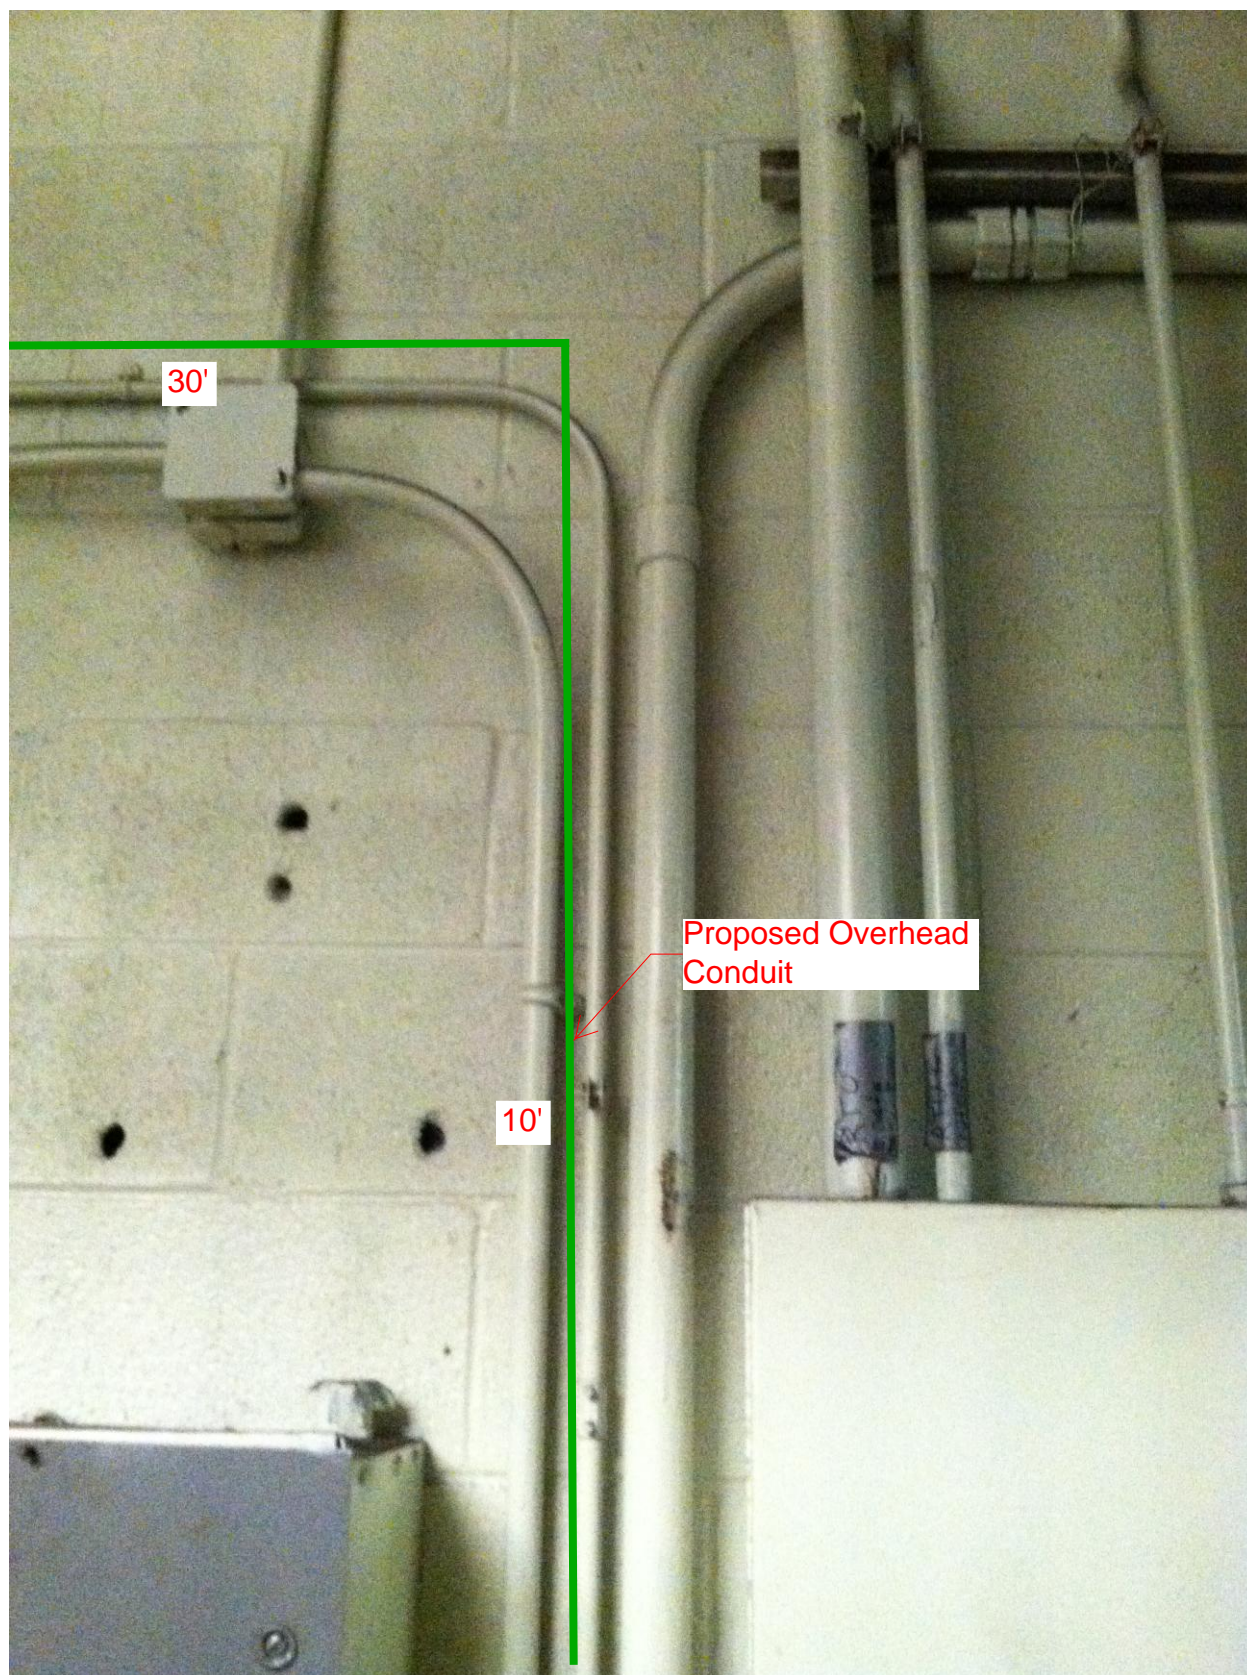
Photo #8: Proposed Overhead Conduit in Room W202.

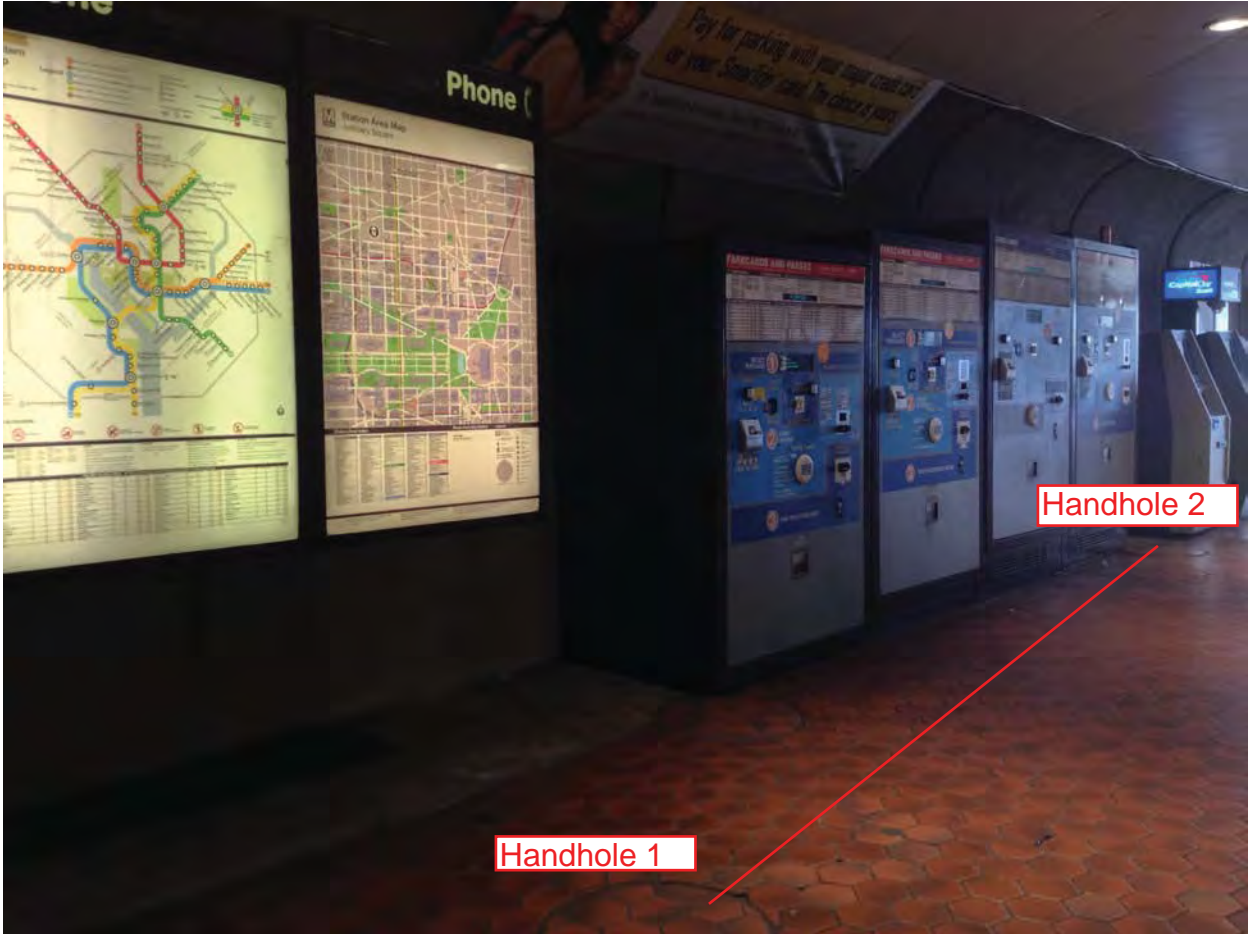
Photo #3: B02 Judiciary Square (East) – Mezzanine level handholes. Power duct run is through handholes at the bottom center and center-right of photo. Handhole near the center of photo is not part of power duct run.

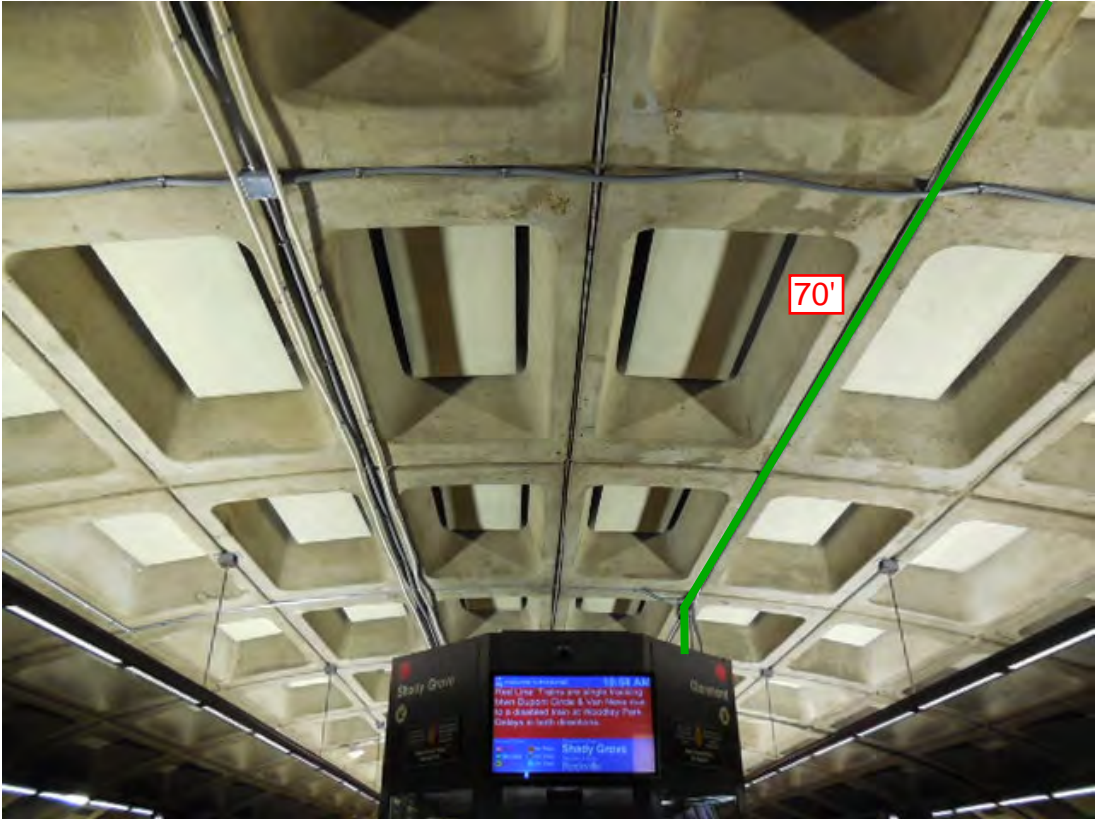
Photo # 3 – Proposed Conduit Run

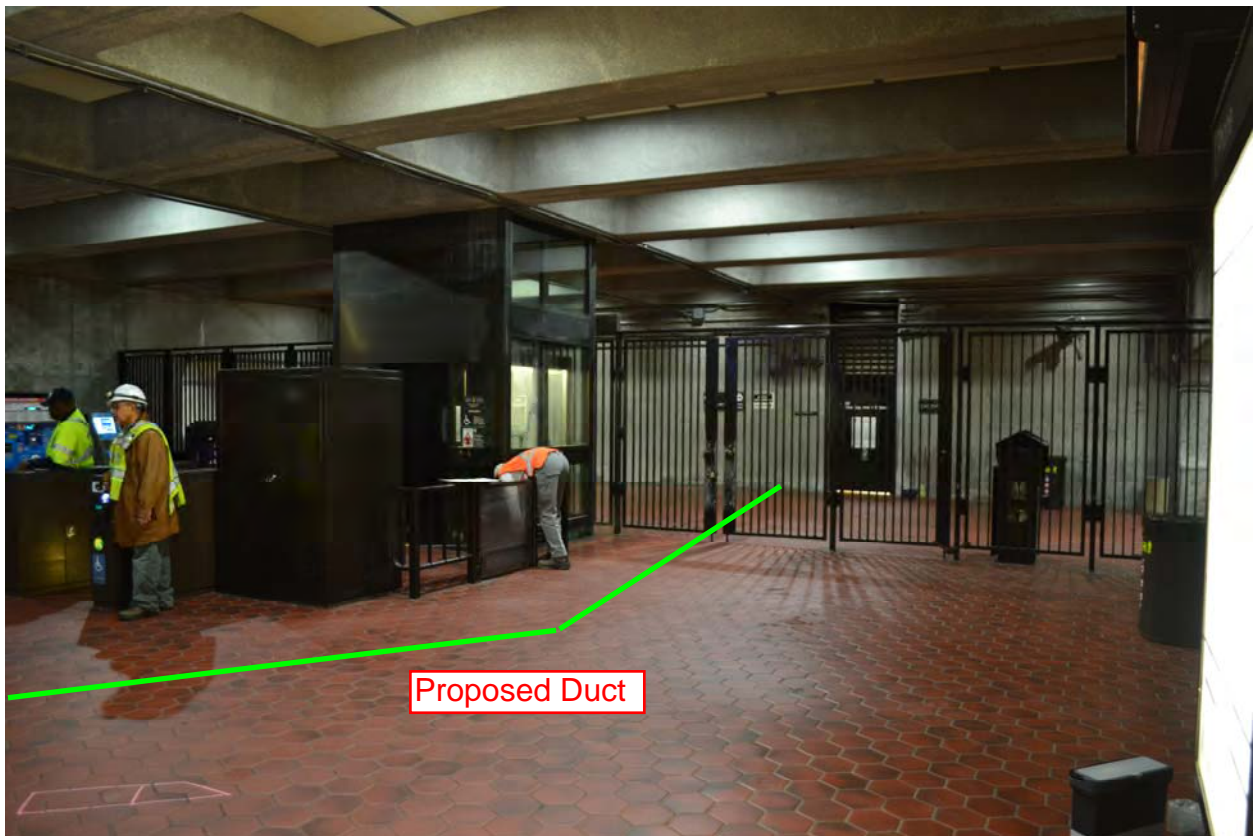
Photo # 5 – Proposed duct approach to back rooms

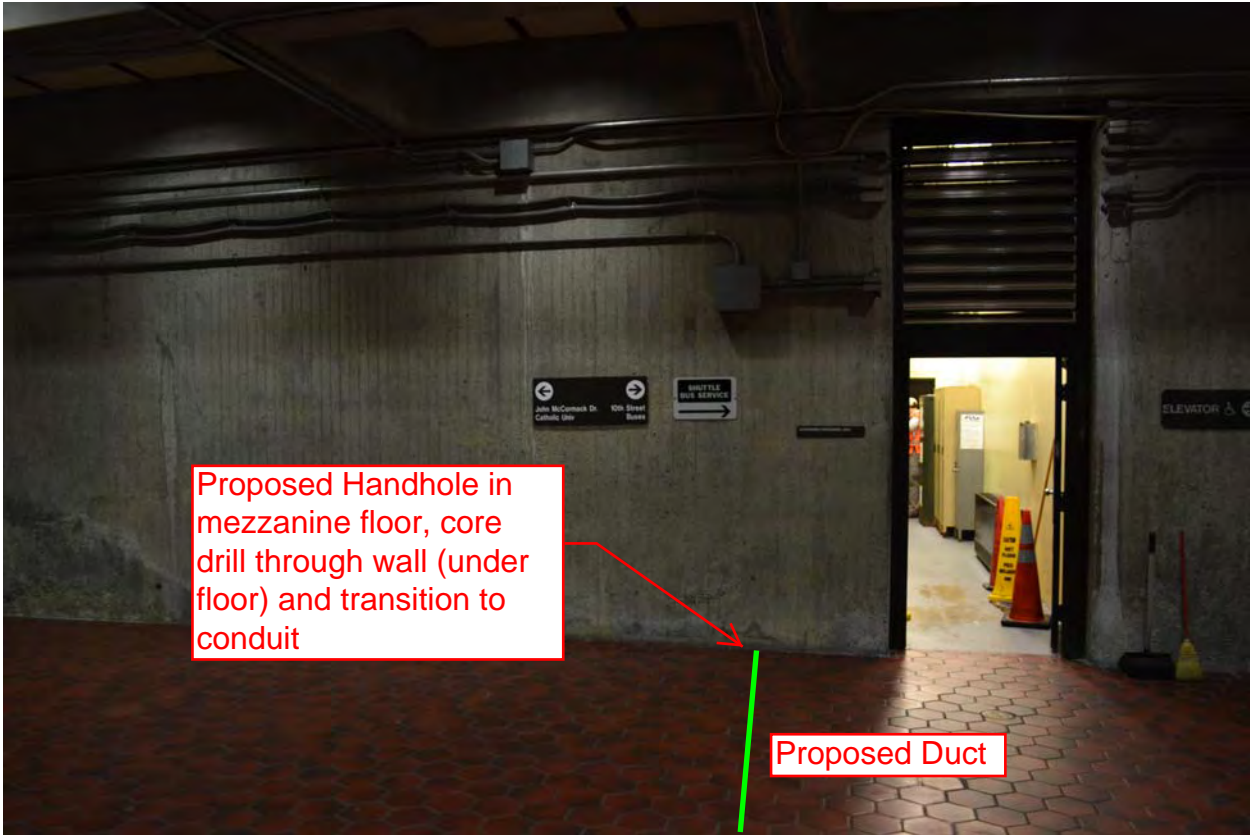
Photo #6 - Proposed conduit from Elevator Machine Room C101

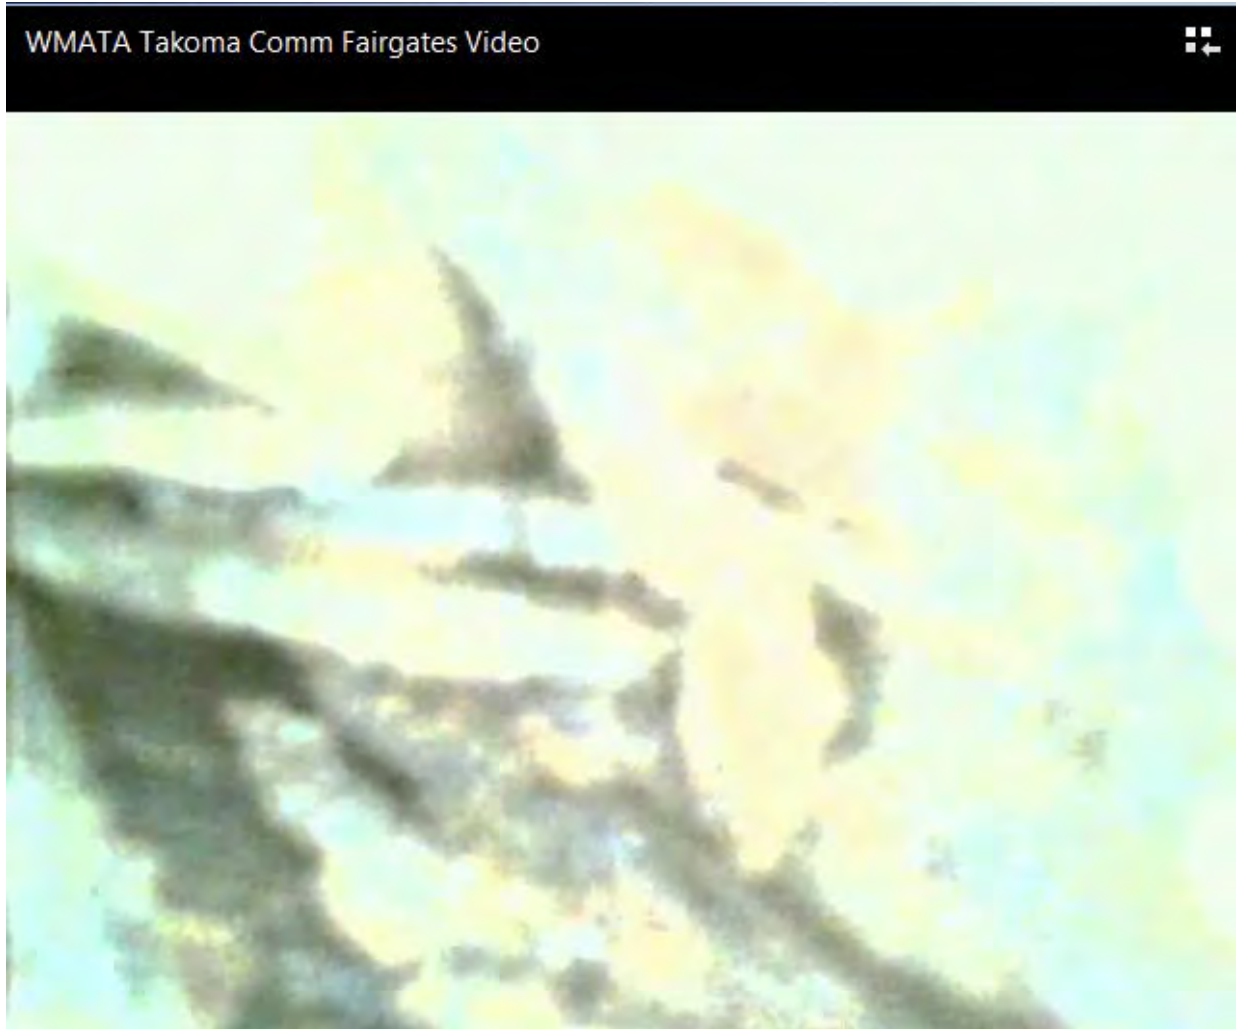
Scoping was completed as much as possible with multiple obstructions found in all walker ducts. Due to the obstructions and substantial corrosion from water intrusion, it was not possible to fully complete any scoping or pull string installation. Obstructions are shown in the attached photos.

Photo #1: B07 Takoma - Still image of obstruction in faregate array comm. duct
