Invitation For Bid

Electrical and Data Cable Installation

Project Name: 15-NEPP-01 In-Floor Duct Inspections
Task: Mezzanine Inspection Reports
Date of Inspection: August 22, 2014
Mezzanine Inspected: A01 - Metro Center East
Report Includes:
- Mezzanine Inspection Checklist
- Field Photos
- Existing AFC Installation Plan with field notes

Mezzanine Inspection Report (Scoping)

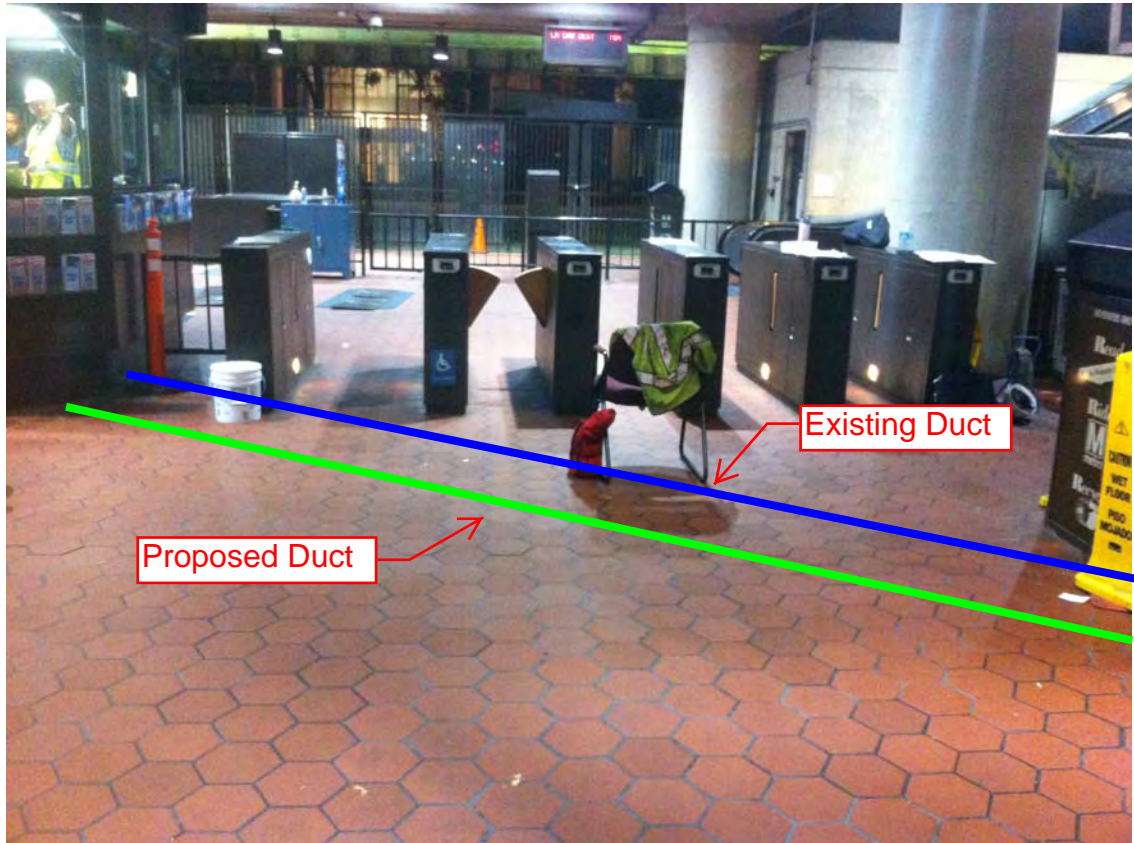
Photo #1 – Proposed and existing ducts on mezzanine floor

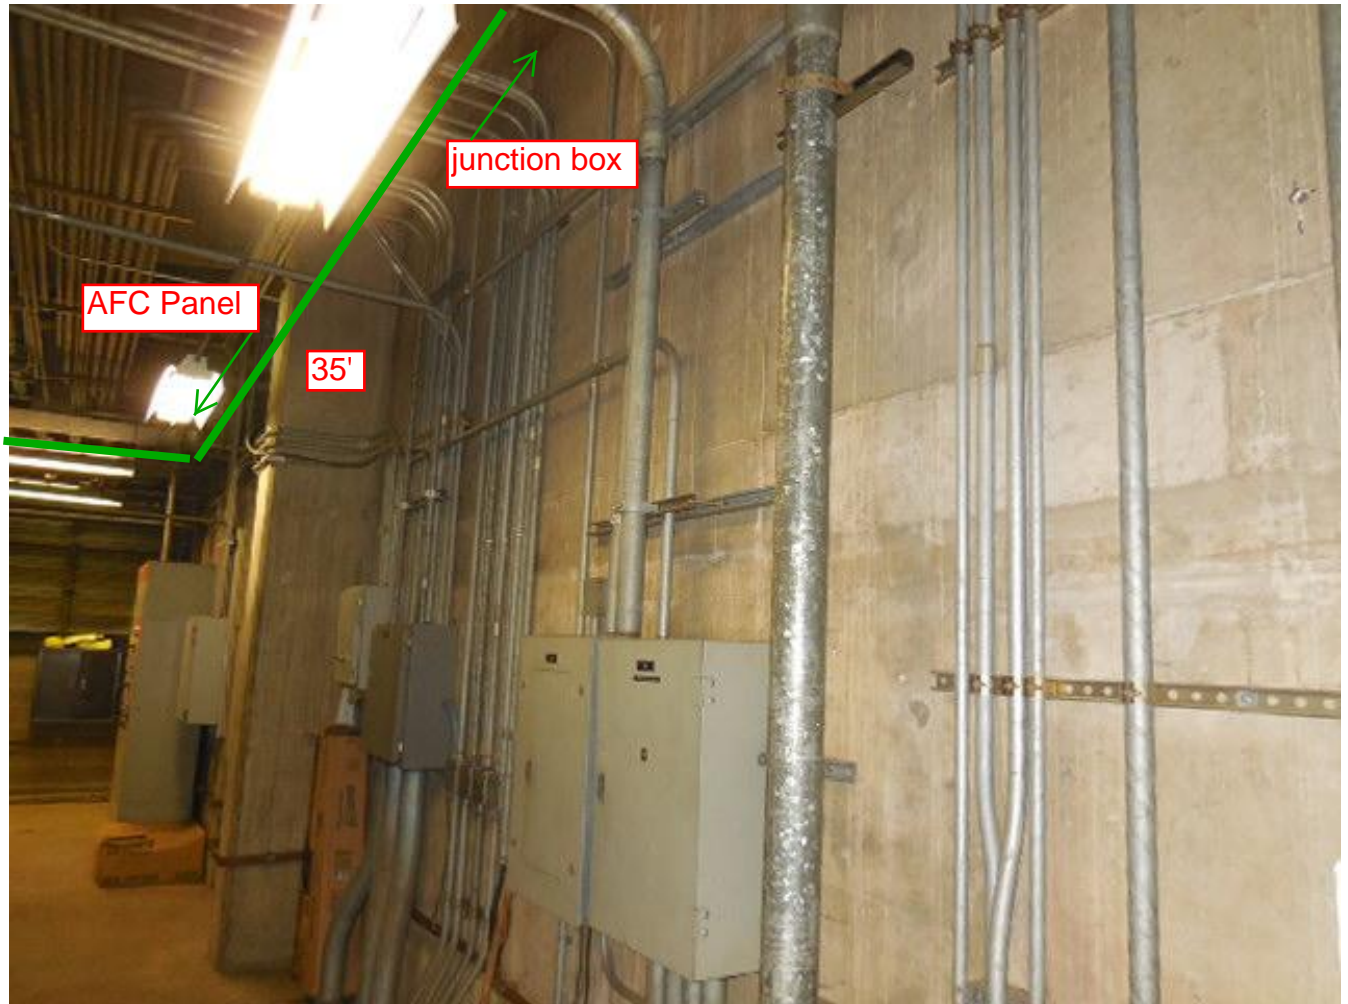
Photo #9 - Proposed conduit run inside Room C106

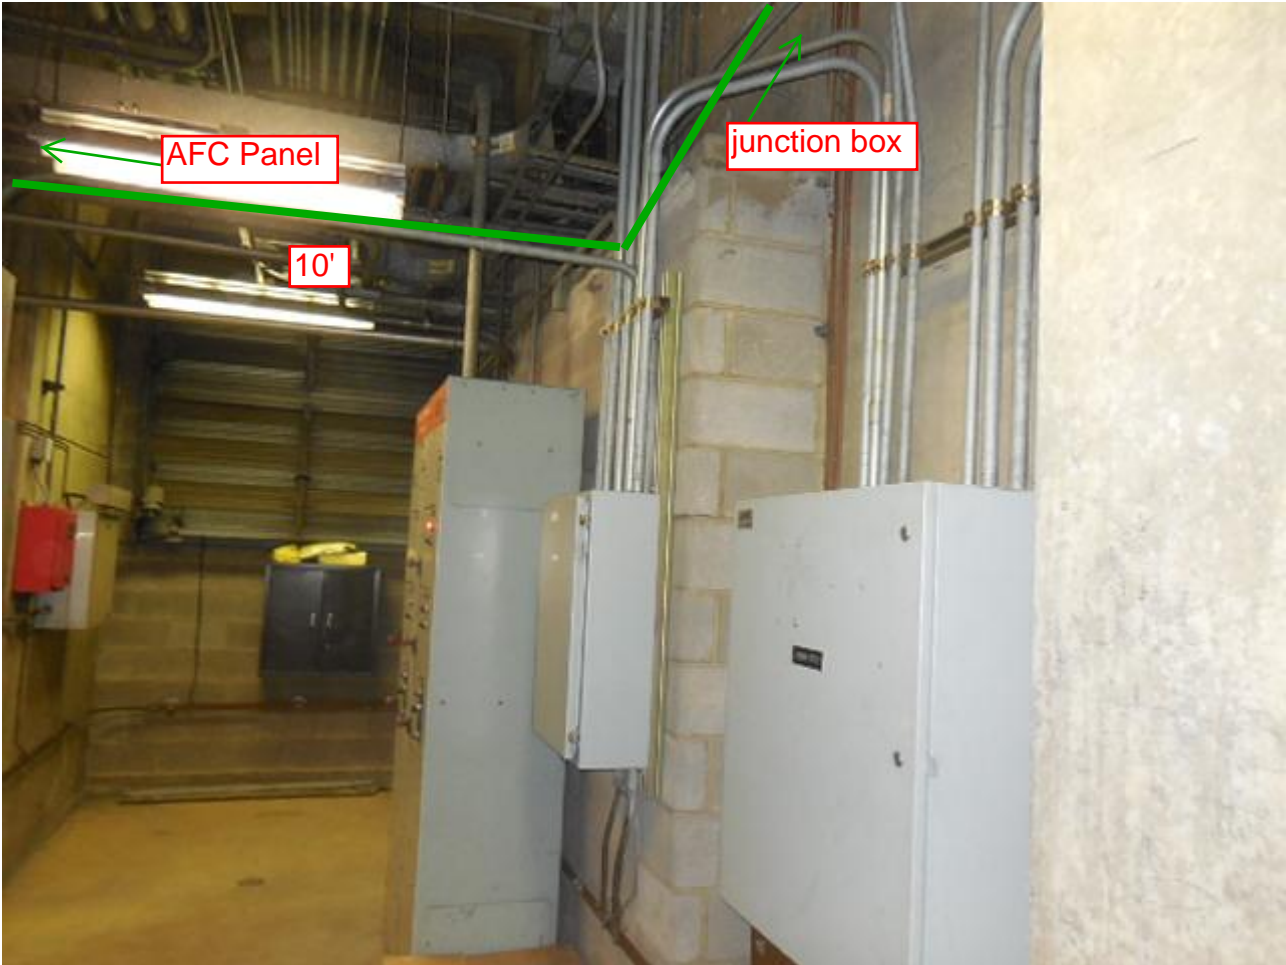
Photo #10 - Proposed conduit run inside Room C106

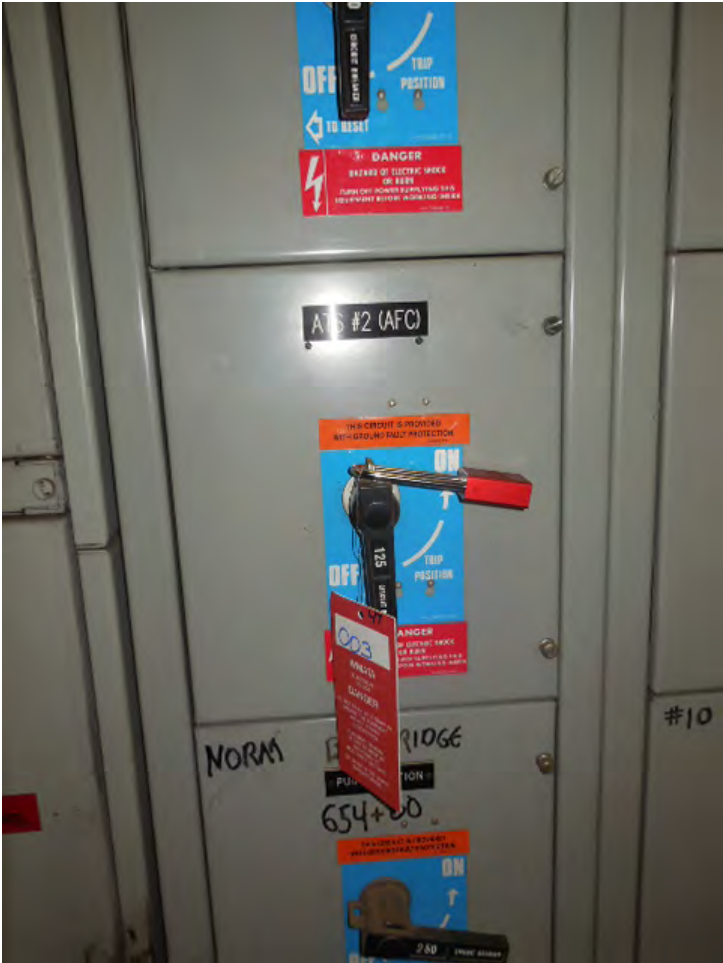
Photo #1: B10 Wheaton: Lock-out Tag-out of the feed breakers for the AFC Panel

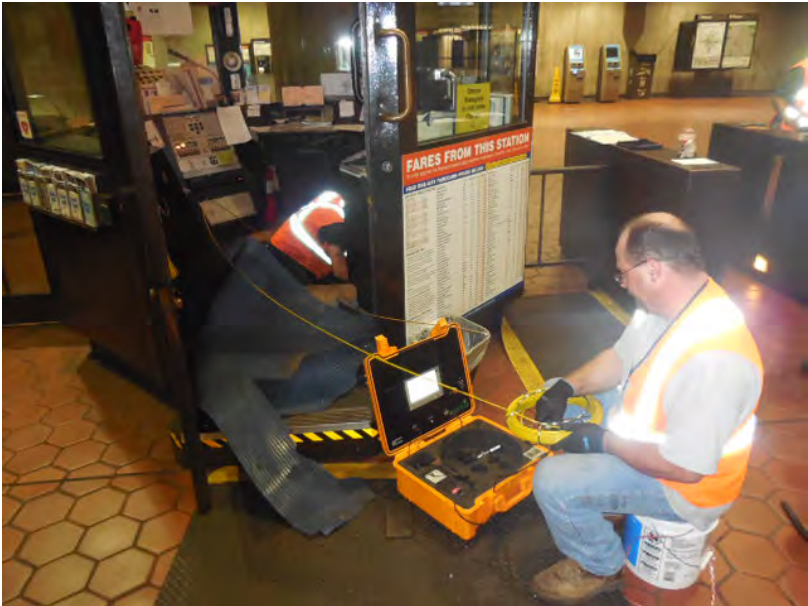
Photo #4: B10 Wheaton: Attempting to video-scope the faregate array ducts

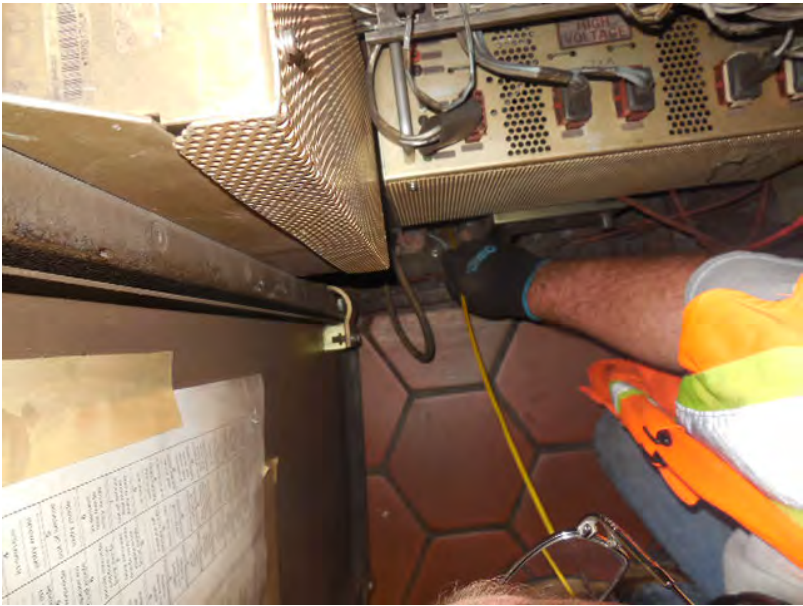
Photo #5: B10 Wheaton: Attempting to rod the faregate array ducts

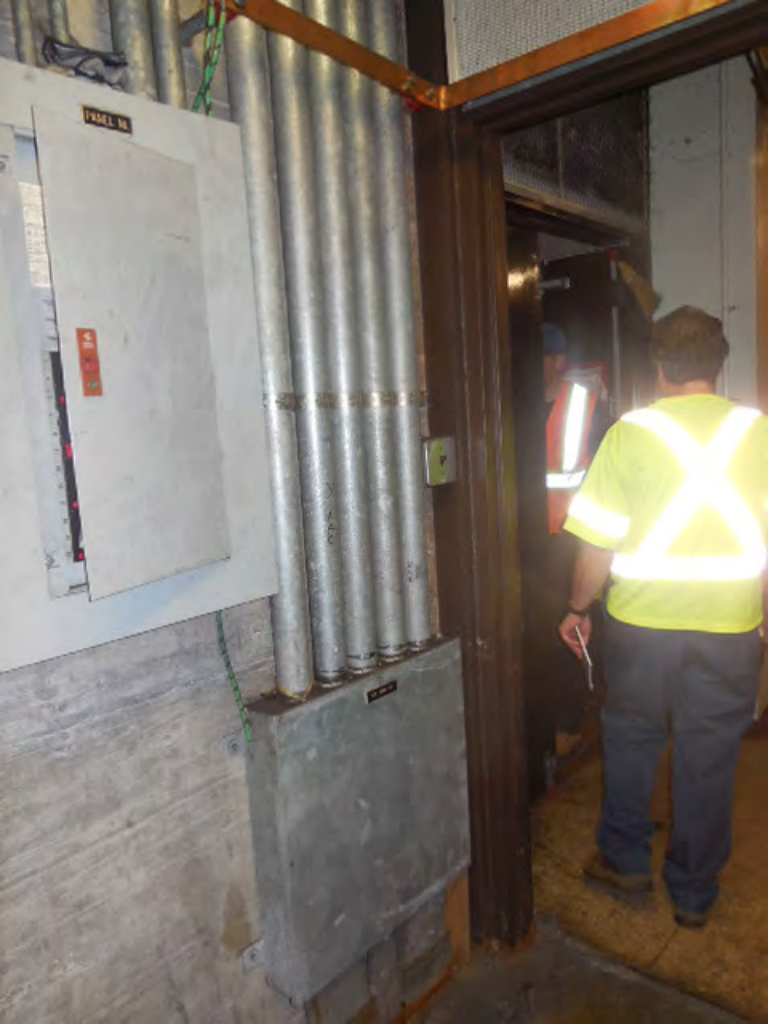
Photo #10: B10 Wheaton: Installing the pull string in the junction box near the AFC panel

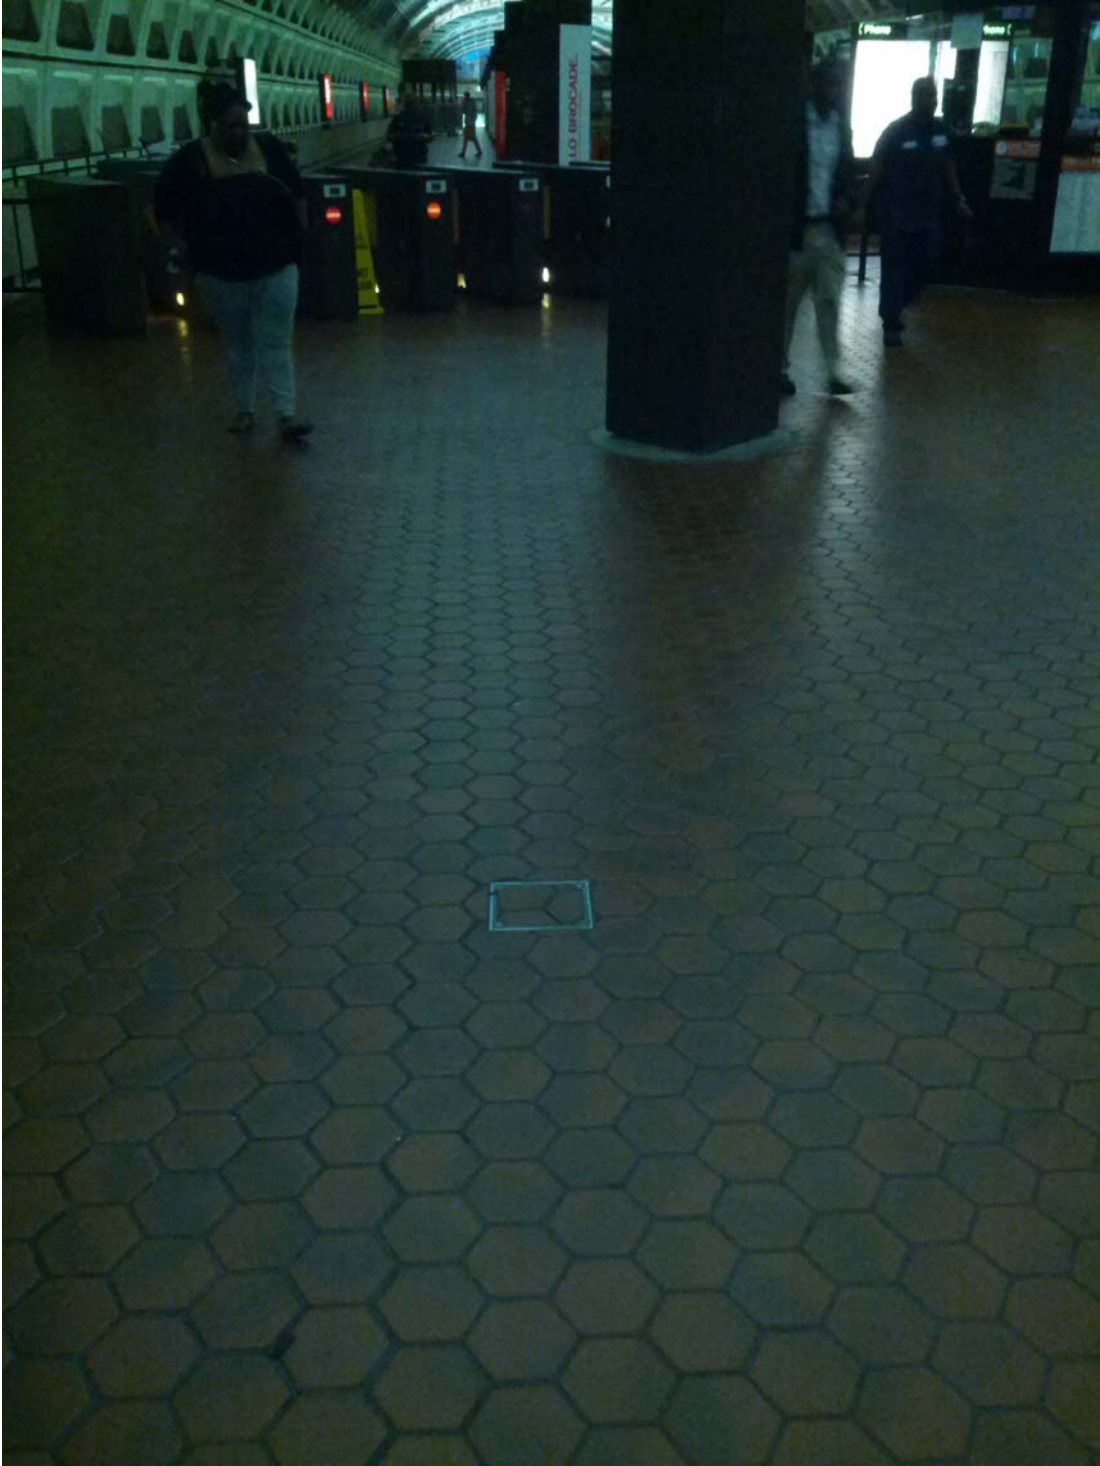
Photo #2 – Kiosk and faregates on mezzanine level.

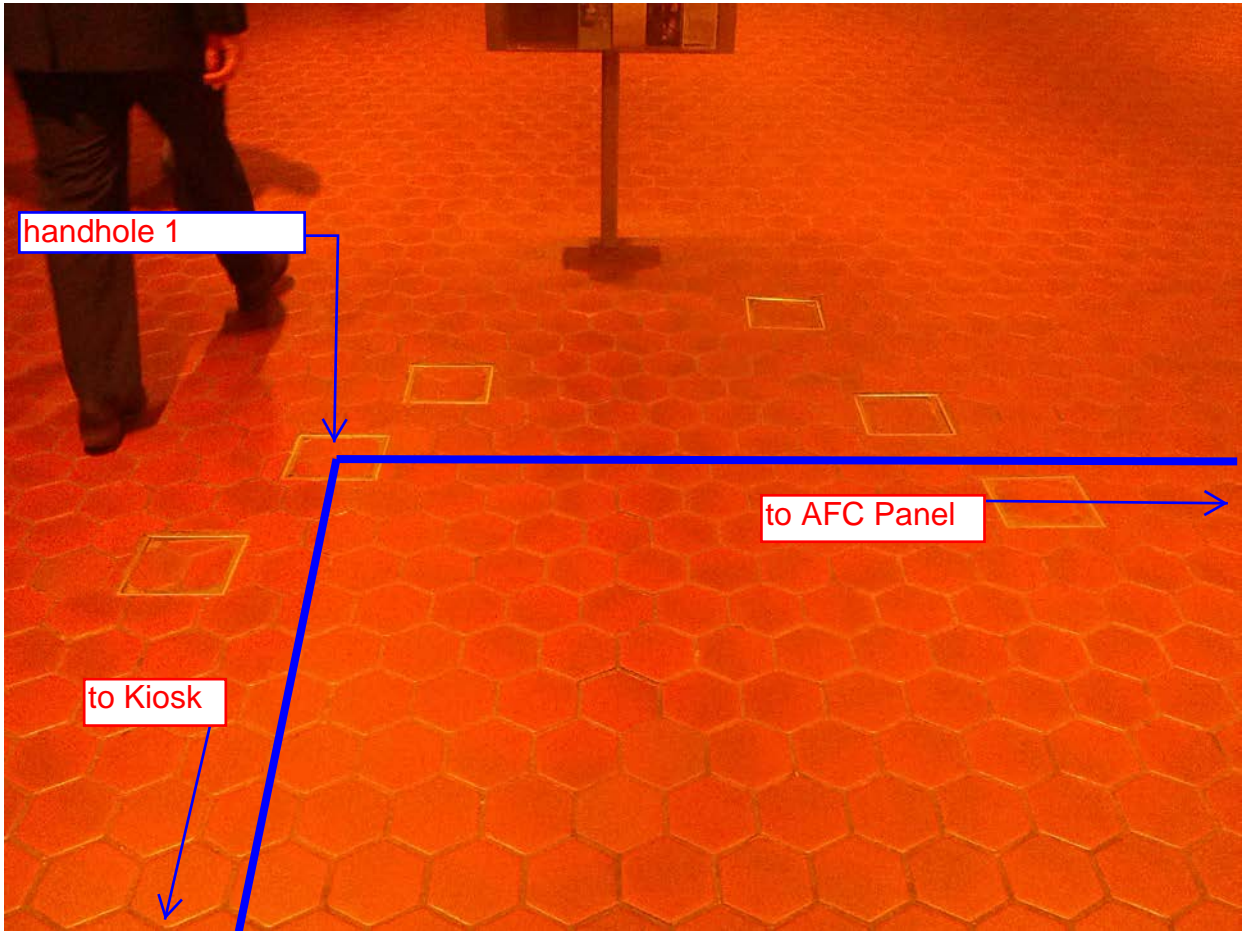
Photo #1 – A01 Metro Center West: Mezzanine level handholes

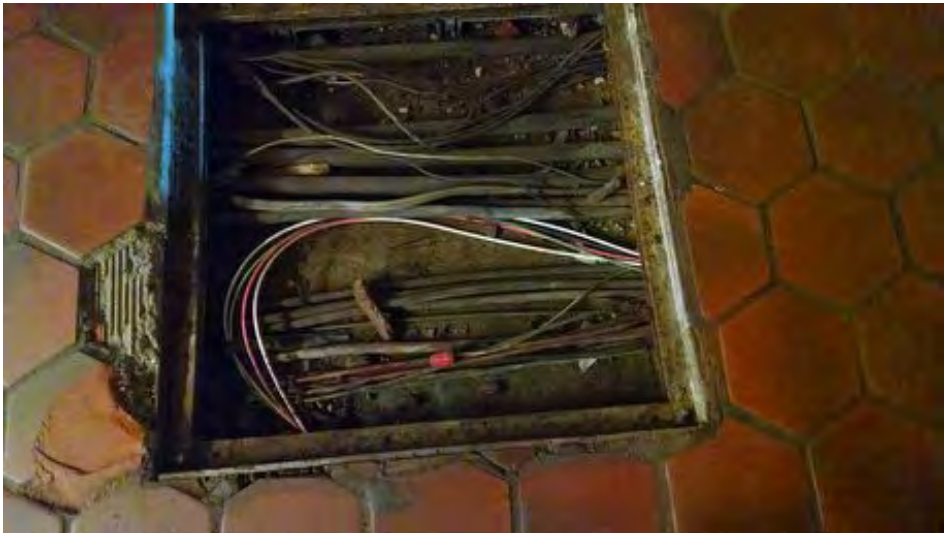
Photo #2: Handhole 1

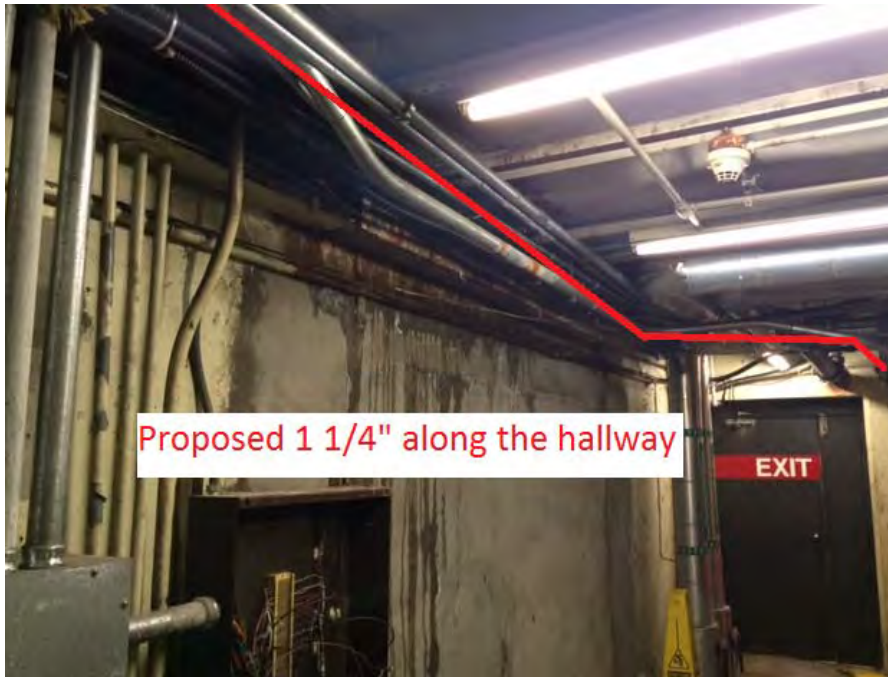
Photo #6: Proposed overhead conduit run from Kiosk to AFC Panel (continued)

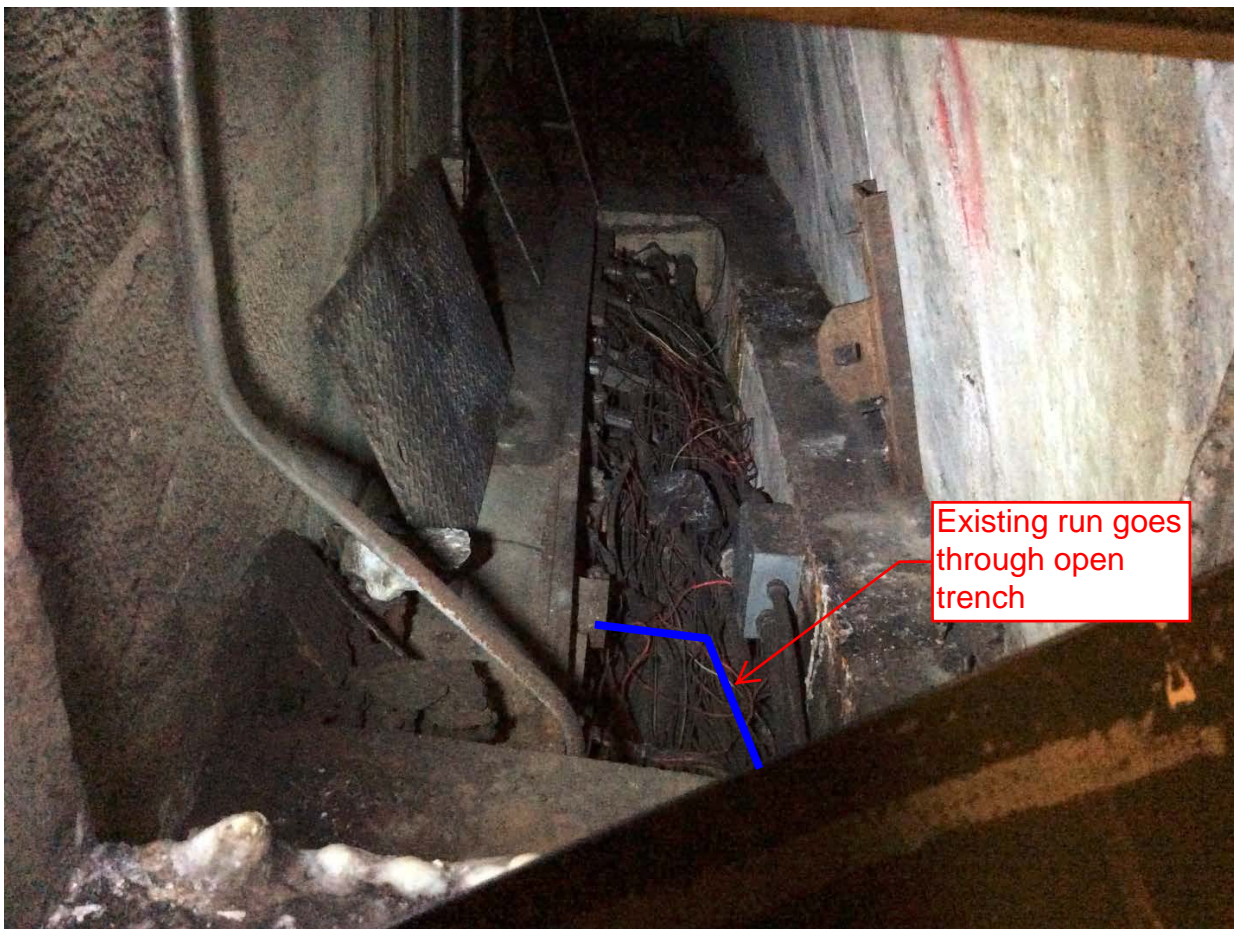
Photo #3 – A05 Cleveland Park: Existing power run in open trench

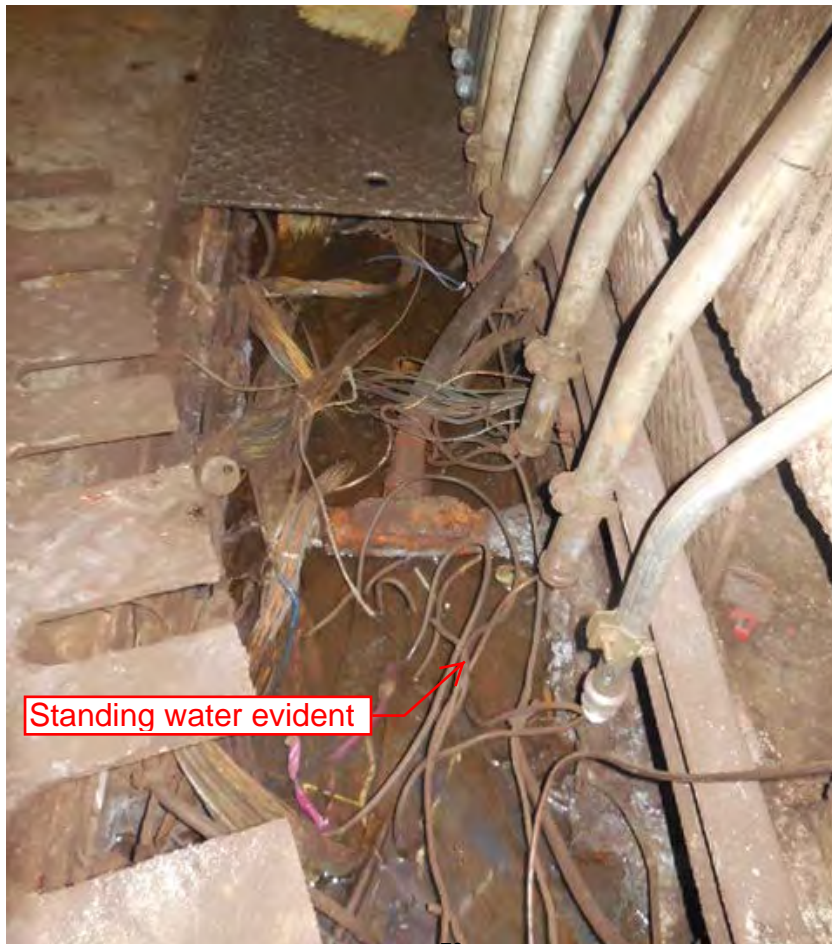
Photo #4 –Trench 1 in Room # 200 with overhead conduit transition, standing water evident.

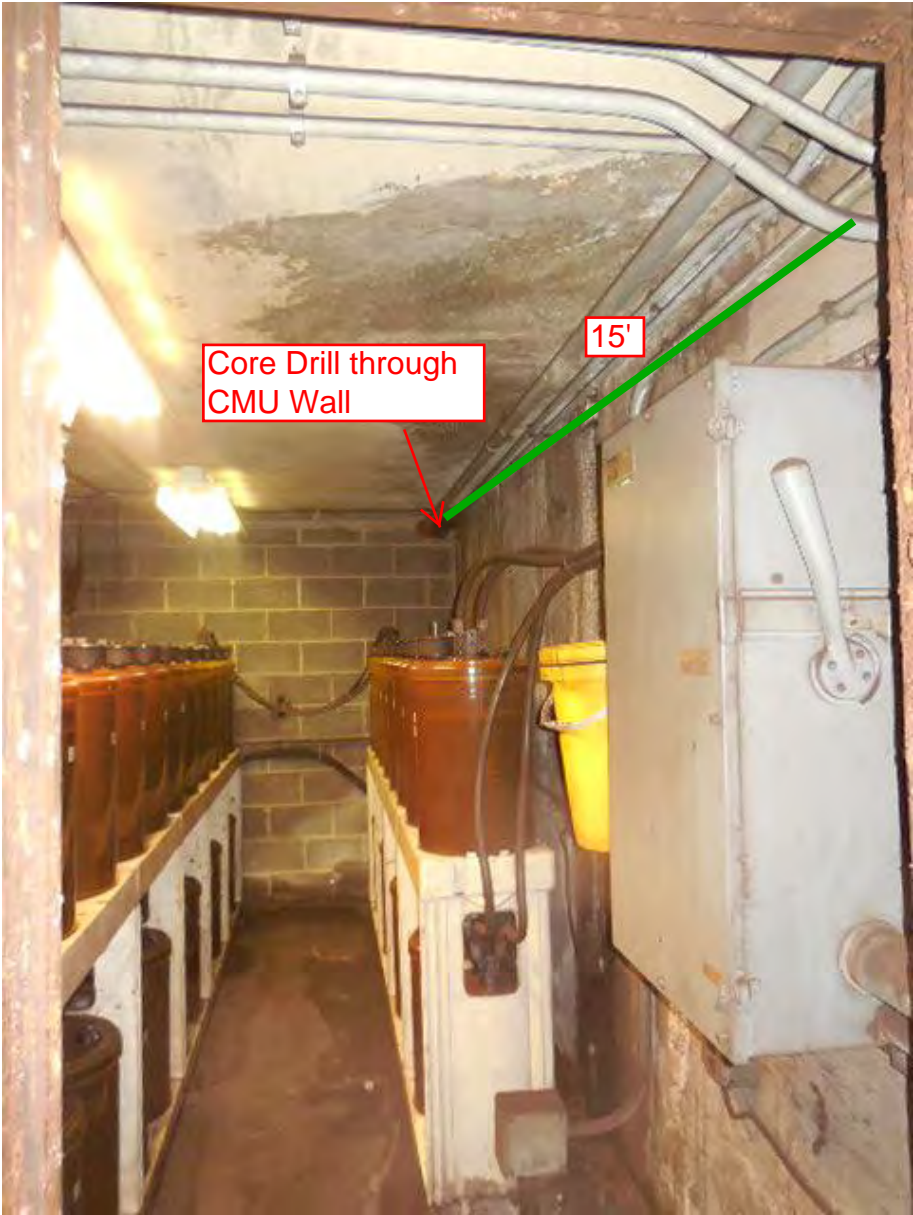
Photo #8 – Proposed Overhead Conduit in Battery Room 218

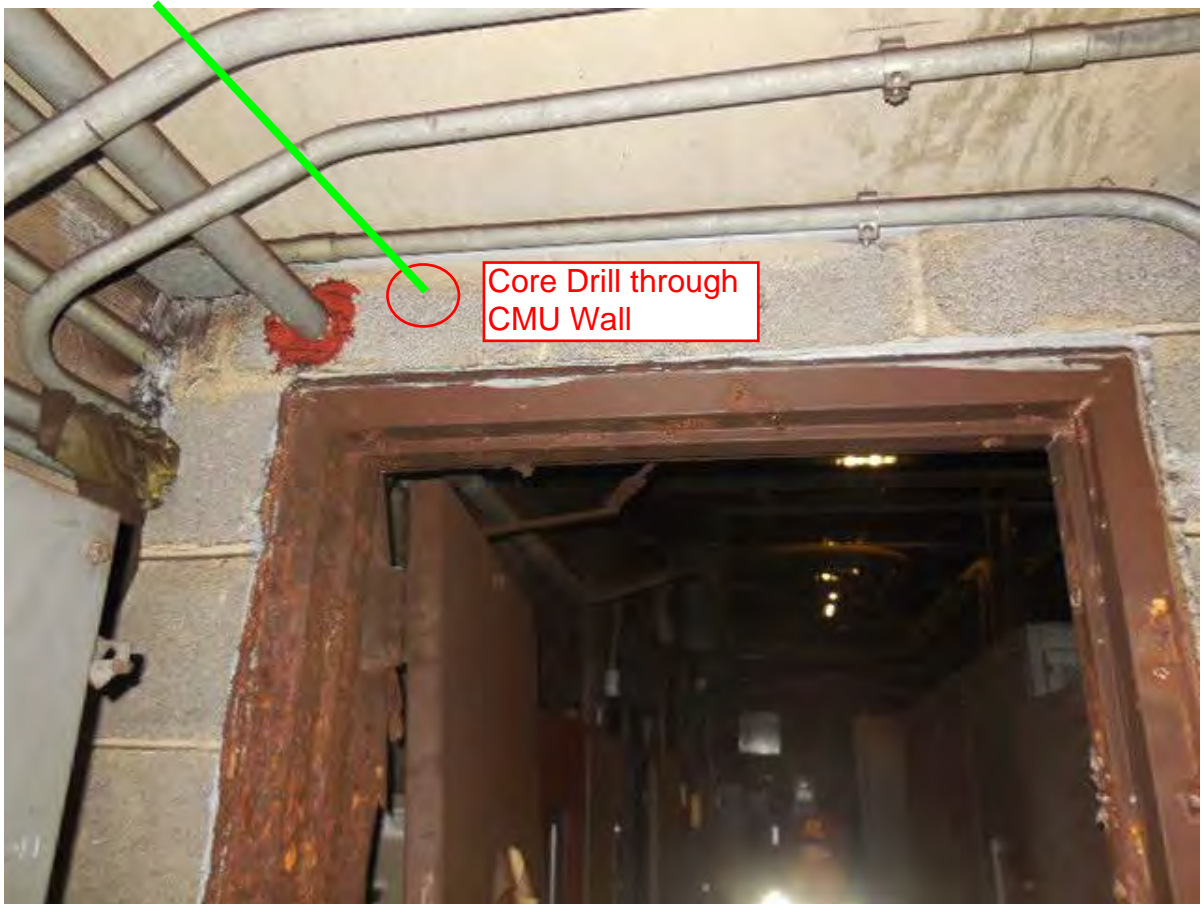
Photo #9 – Proposed Overhead Conduit in Battery Room 218

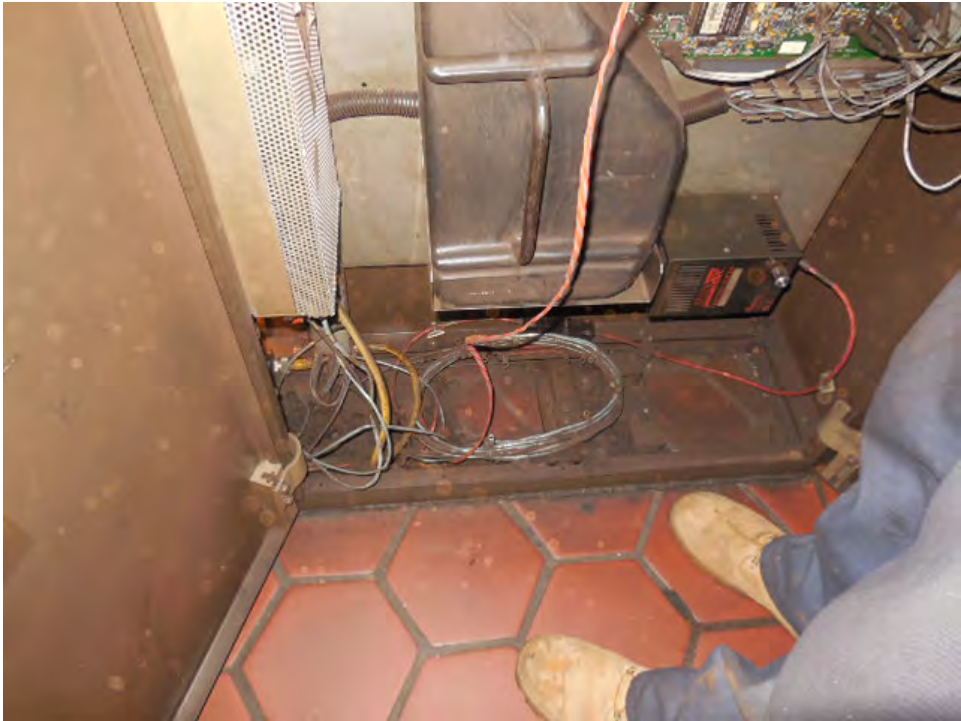
Photo #3: A08 Friendship Heights – Pull string installed in faregate array duct

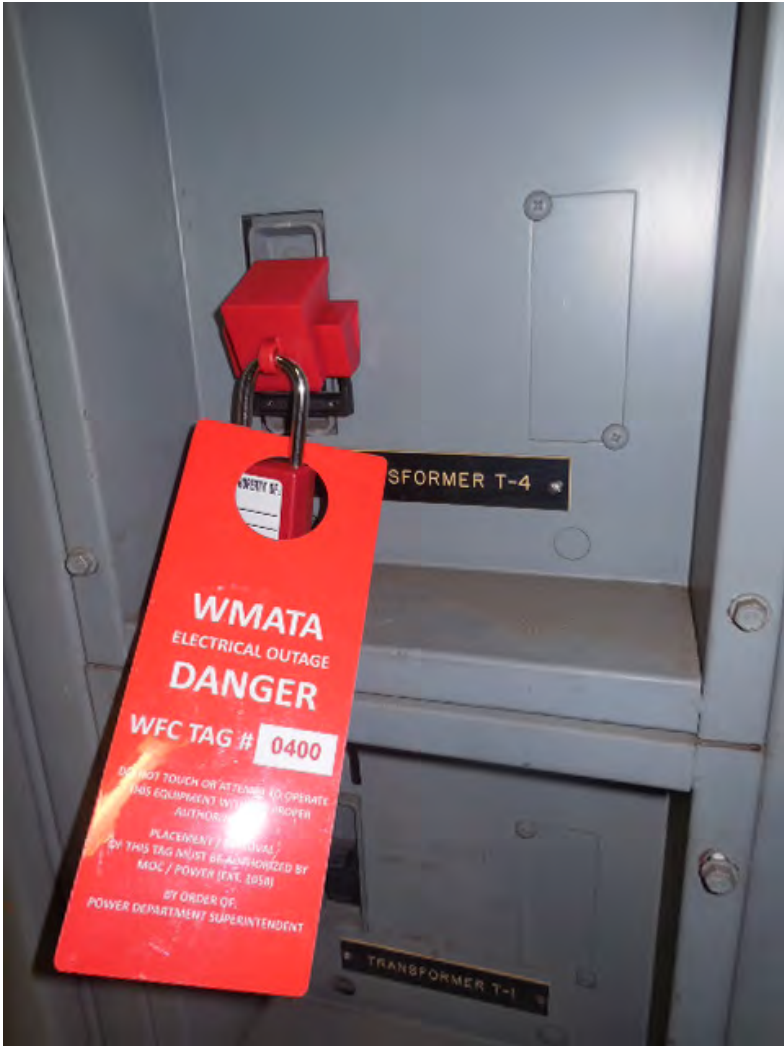
Photo #1: A13 Twinbrook – Lock-out tag-out of feeder breaker to AFC Panel

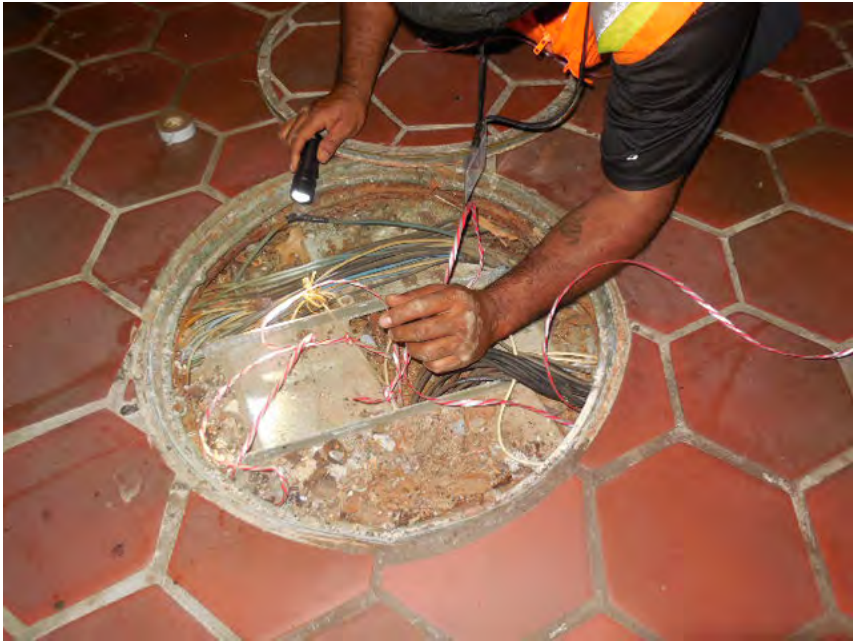
Photo #5: A13 Twinbrook – Pull string installation to mezzanine handhole

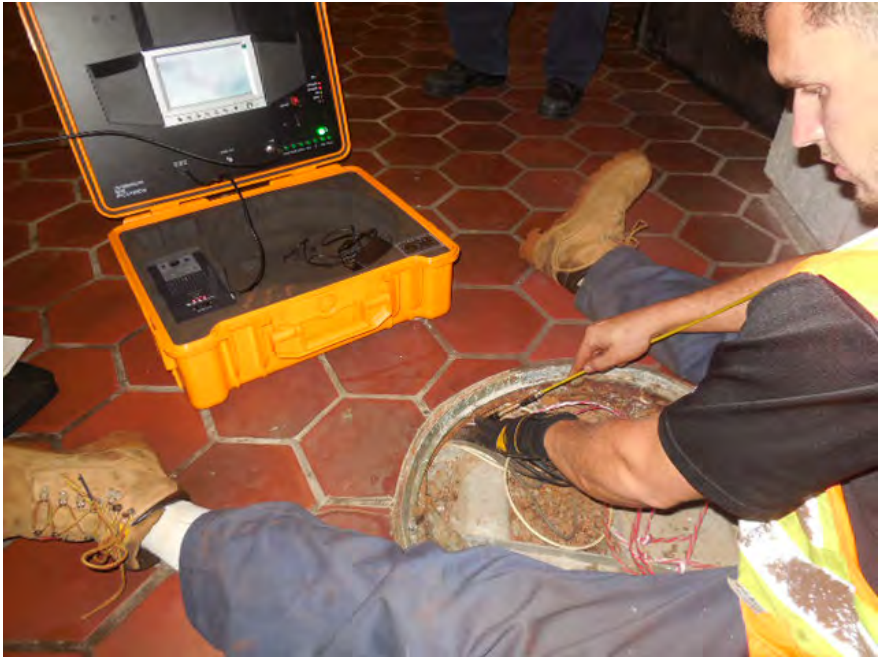
Photo #6: A13 Twinbrook – Video-scoping between kiosk and mezzanine handhole

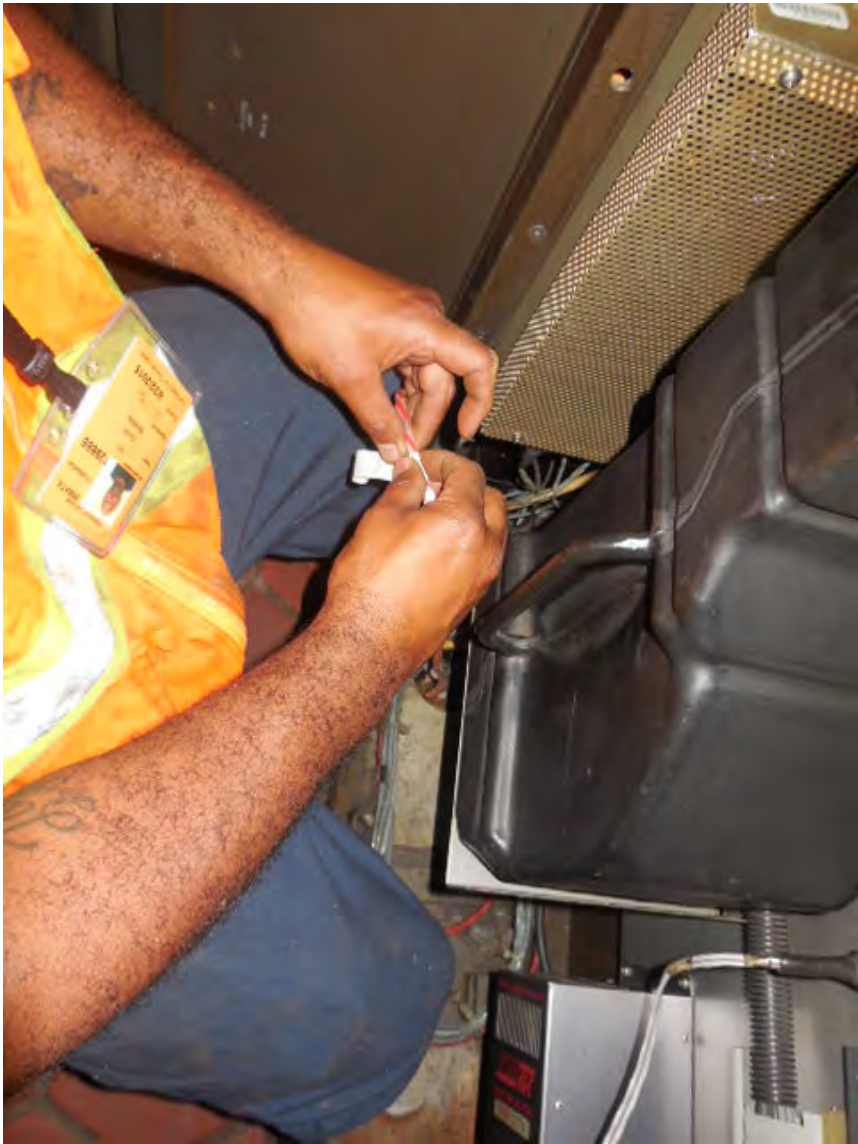
Photo #9: A13 Twinbrook – Installation of pull string in faregate array ducts

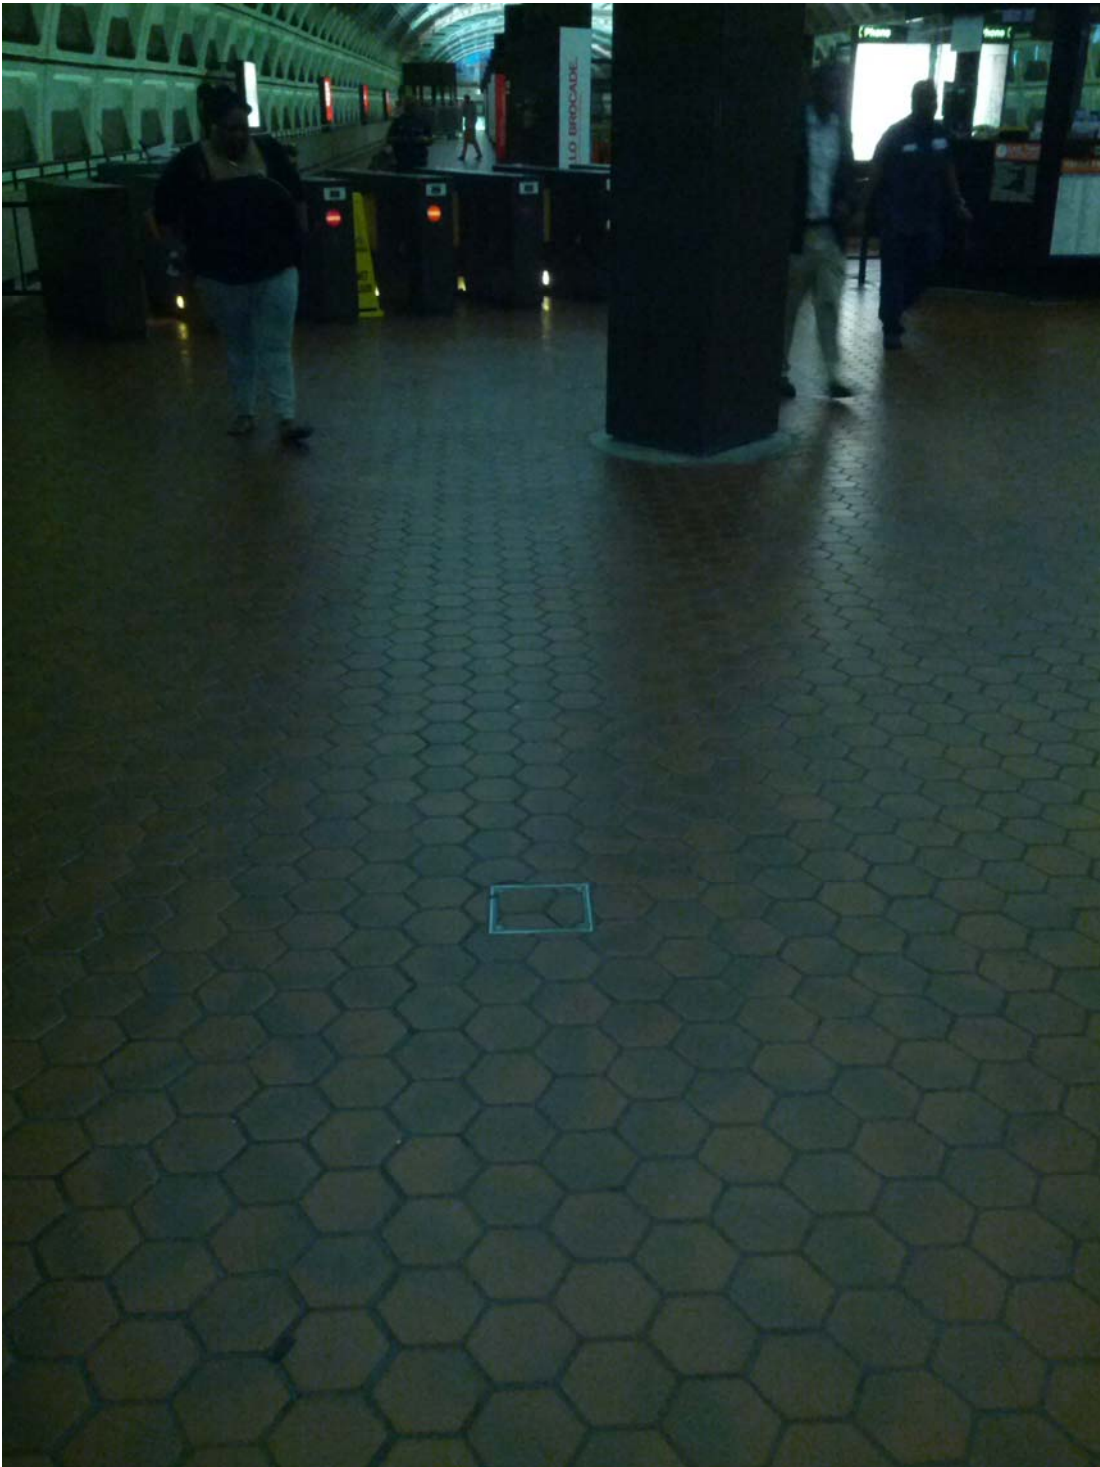
Photo #2 – Kiosk and faregates on mezzanine level.

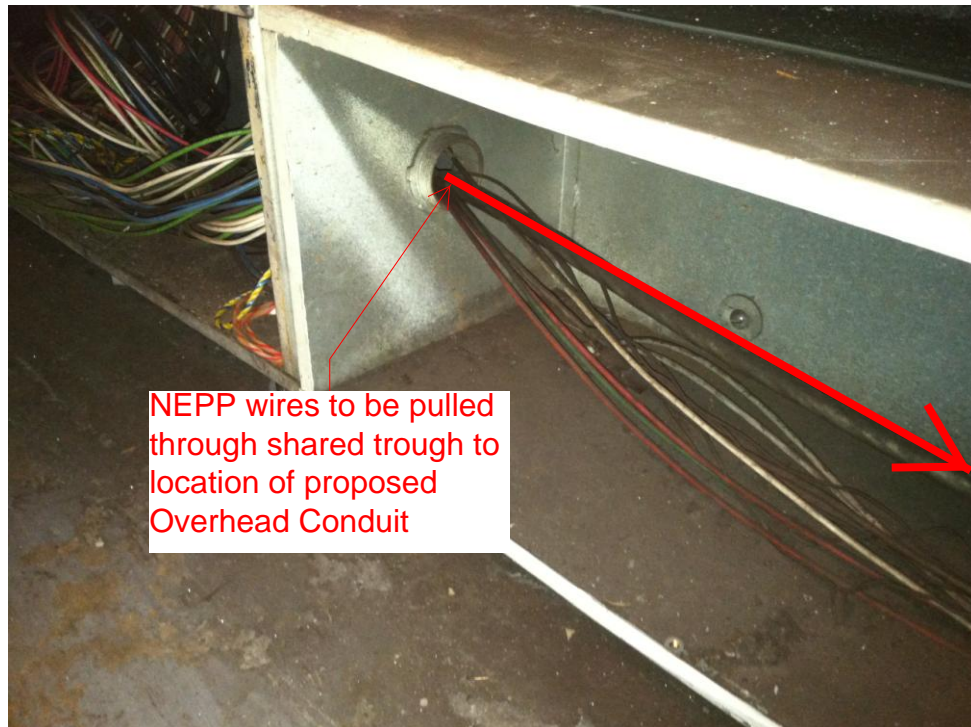
Photo #6: NEPP wires to be pulled through Shared Trough in Room W202.

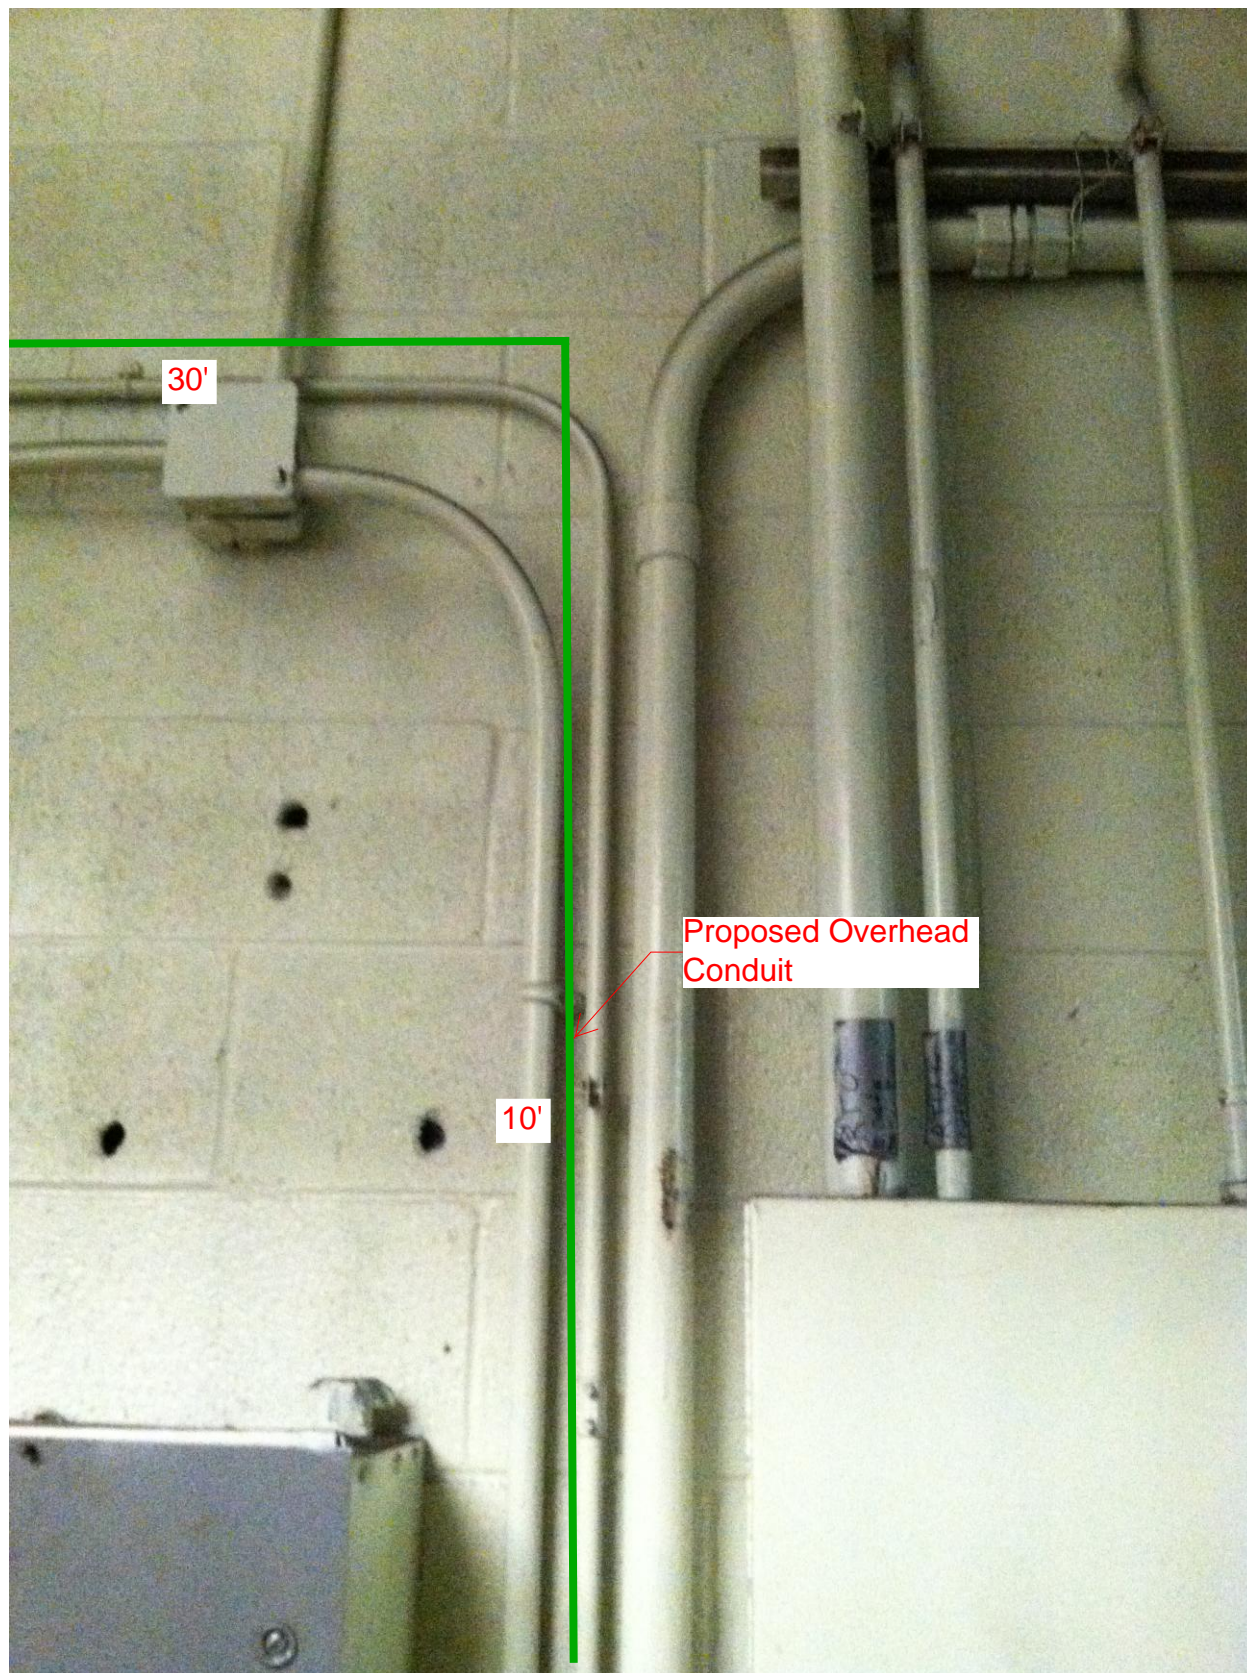
Photo #8: Proposed Overhead Conduit in Room W202.
