Invitation For Bid

Electrical and Data Cable Installation

Project Name: 15-NEPP-01 In-Floor Duct Inspections
Task: Mezzanine Inspection Reports
Date of Inspection: August 22, 2014
Mezzanine Inspected: A01 - Metro Center East
Report Includes:
- Mezzanine Inspection Checklist
- Field Photos
- Existing AFC Installation Plan with field notes

Mezzanine Inspection Report (Scoping)

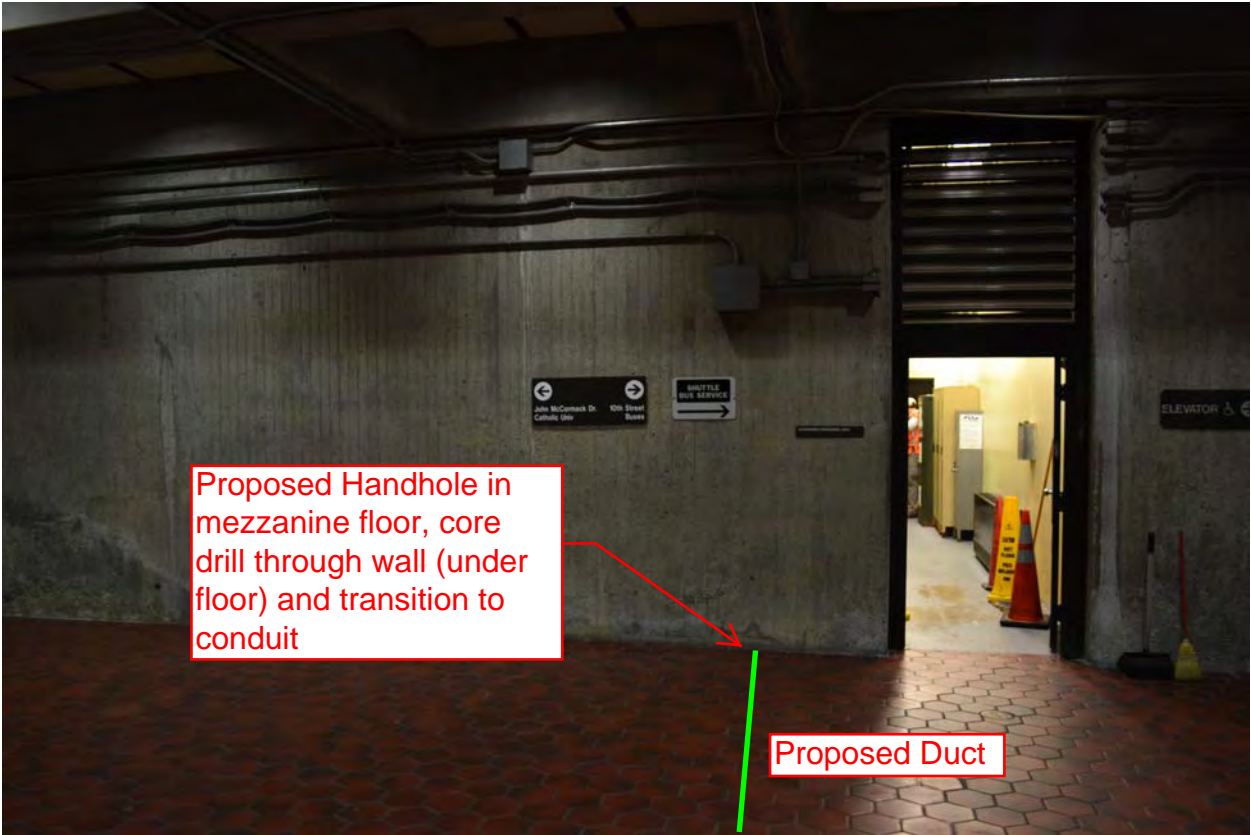
Photo # 5 – Proposed duct approach to back rooms

Proposed Handhole in mezzanine floor, core drill through wall (under floor) and transition to conduit

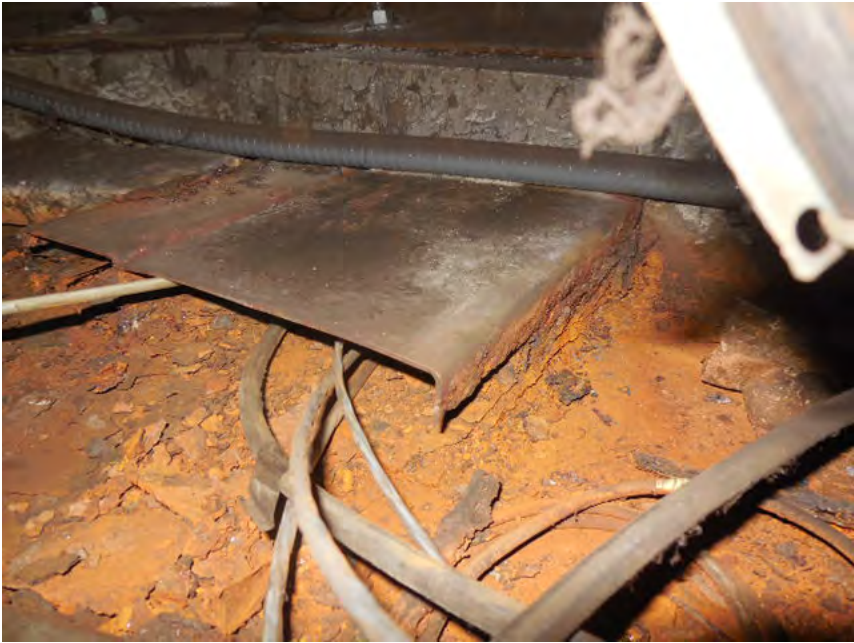
Photo #6: B10 Wheaton: Corroded communications duct opening in kiosk

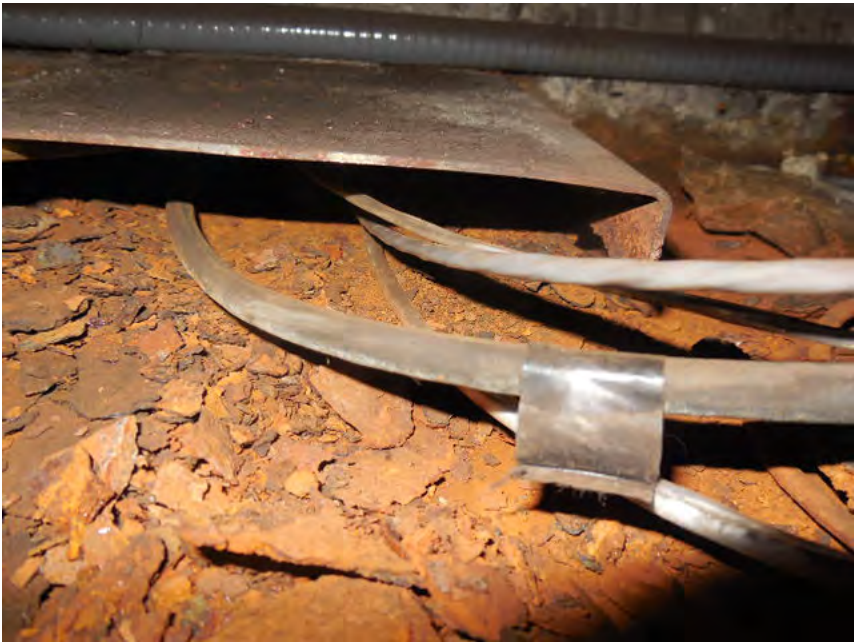
Photo #7: B10 Wheaton: Corroded communications duct opening in kiosk
