**Asset Management Plan
WMATA Parking Garages
Volume 1 of 3
February 2015
Walker Restoration Consultants**

ASSET MANAGEMENT PLAN

WASHINGTON AREA
METROPOLITAN TRANSIT
AUTHORITY PARKING GARAGES

FEBRUARY, 2015
VOLUME 1 OF 3

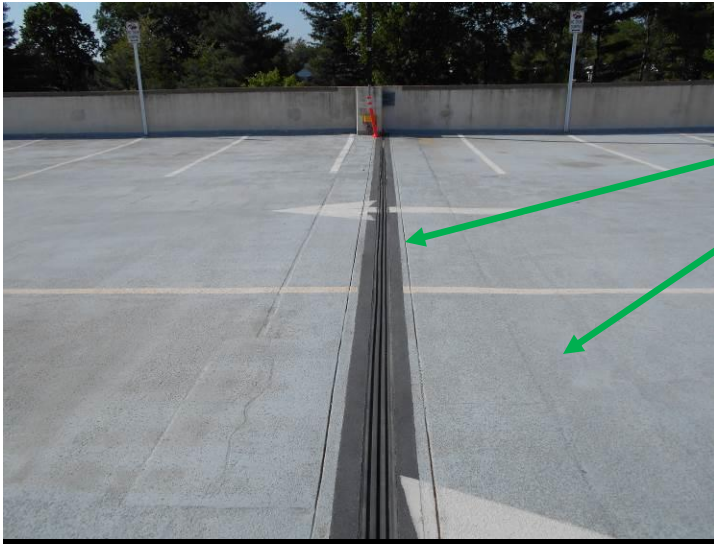
Photo 1

Expansion joint and roof level traffic topping in good shape.

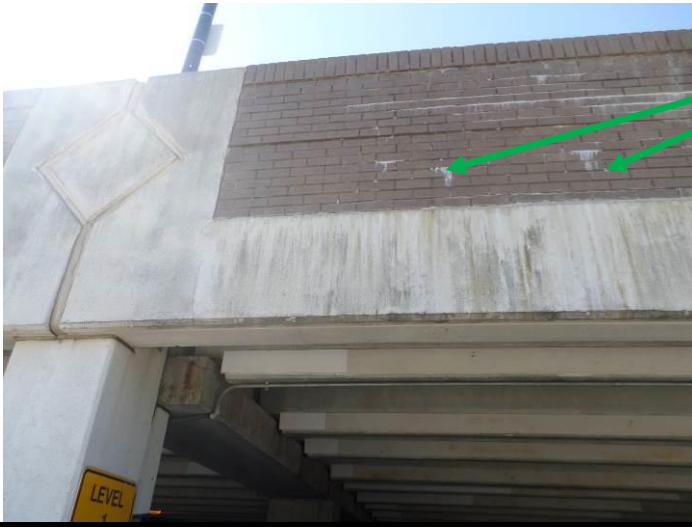
Photo 7

Leaching through mortar joints on the spandrel.

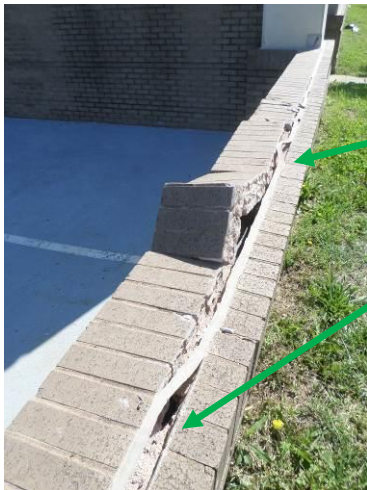
Photo 8

Buckled bricks on header course of spandrel

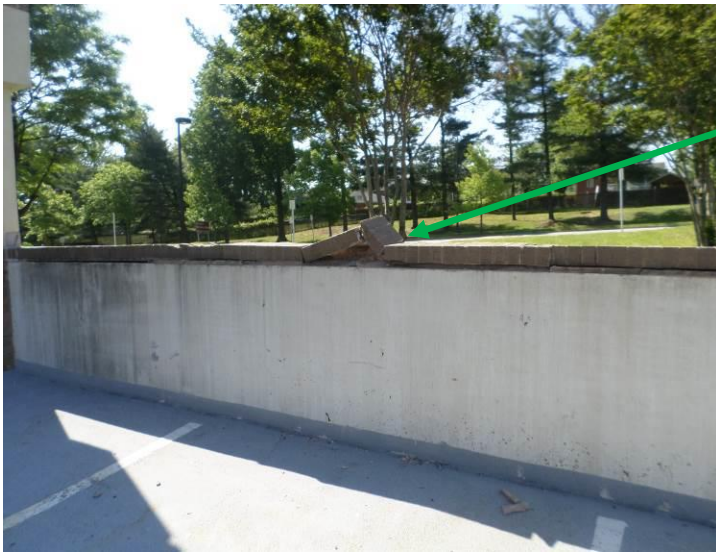
Photo 9

Buckled bricks on header course above concrete spandrel. Same location as photo 9.

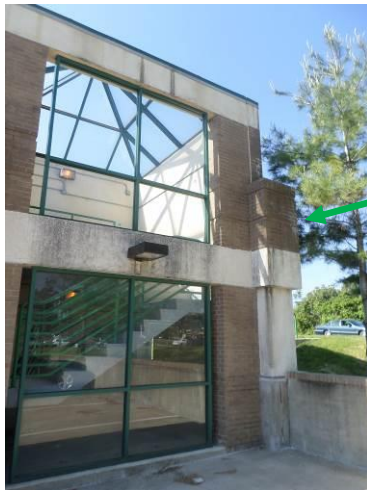
Photo 11

11. Some of the stairtower brick cladding is extensively leaching and requires header course replacement now. (Photos 11,12)
12. A moderate amount of localized ponding was observed and new supplemental drains need to be installed. (Photo 3)
13. At several stairs, a trip hazard exists at the door opening. The trip hazard is a change in elevation between the inside and outside of the stair. A landing and railing should be installed outside the stair tower to alleviate the trip hazard. (Photo 14)
14. At the bottom of several stairs, an area beneath is open which creates a potential area for trash accumulation or a hiding place for assailants. (Photo 14)

Stair tower façade.

Leaching through mortar joints at stair tower.

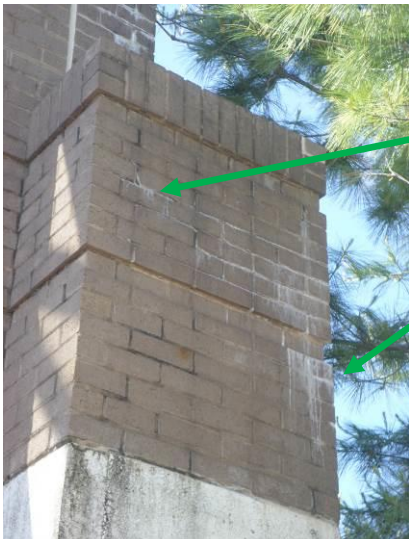
Photo 12

Close-up of leaching through mortar joints at stair tower.

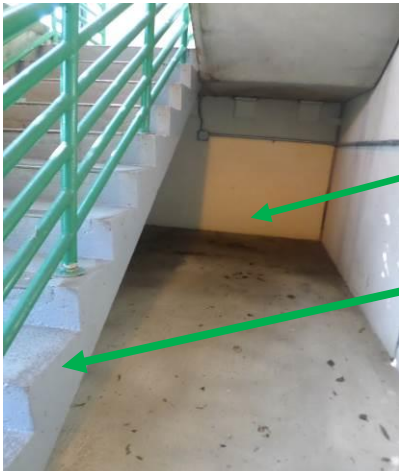
Open area underneath stairs is a potential area for trash accumulation or assaults.

Stair landing and treads are traffic topped.

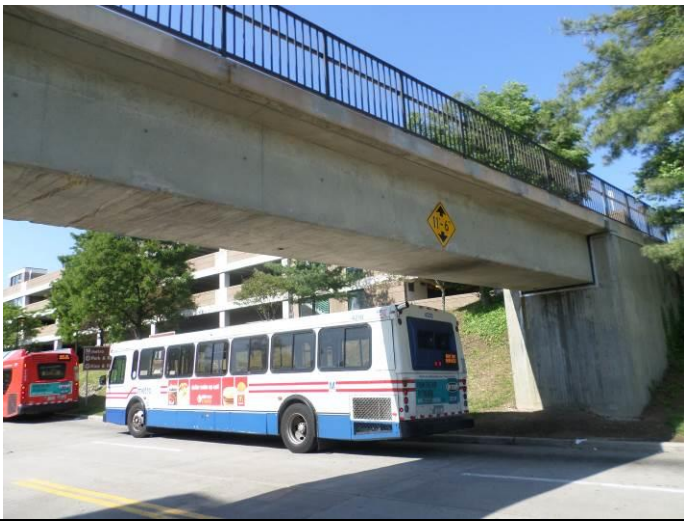
Photo 17

Pedestrian Bridge.

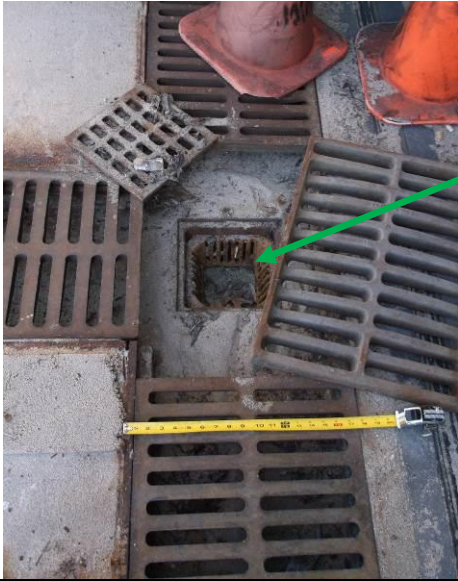
Photo 7

Concrete trench drain at bottom of roof level ramp collects storm water but significant quantities of water remain ponded within this uncoated trench.

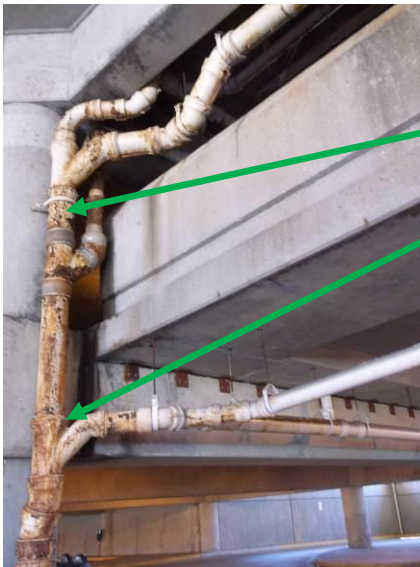
Photo 9

Rusted drain piping from trench drain shown in Photo 7.

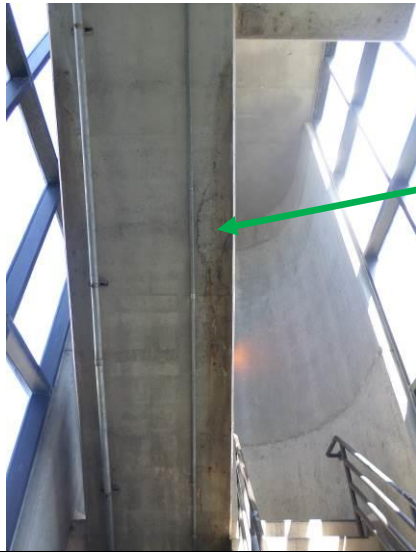
Photo 10

7. Significant stair soffit leaching/delaminations was observed and loose concrete requires removal now. (Photo 10)
8. Stair landings were observed to have metal plates and unusual leaching which require repair within 5 years. (Photo 12)

Spall within stair landing soffit.

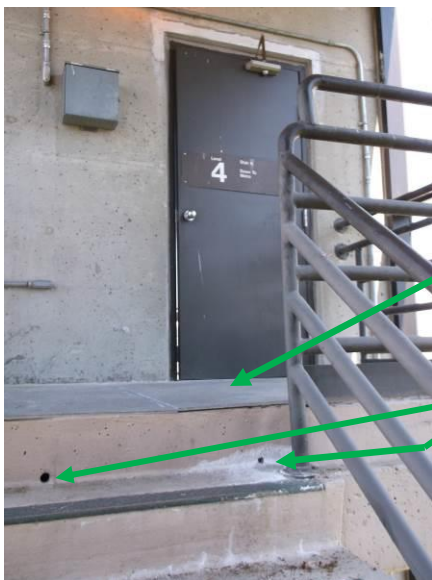
Photo 12

Metal floor plate above top level of landing in stairs is typical.

Holes drilled into stair riser to permit water to drain out of landing.

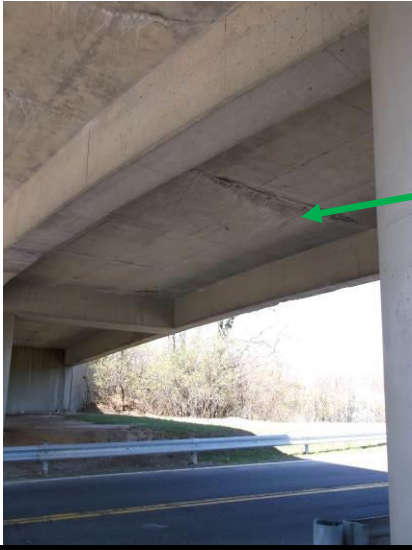
Photo 16

Spalls on bridge soffit over entrance drive.

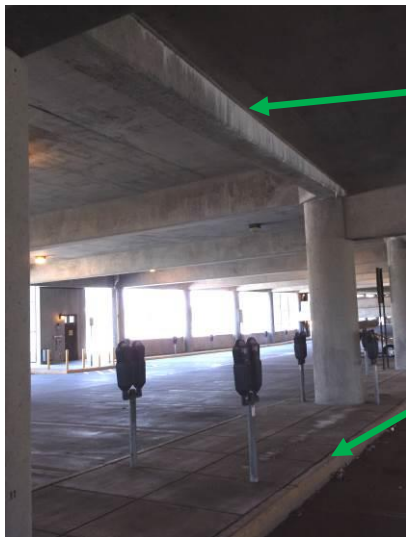
Photo 17

13. Beams were observed to have significant localized leaching which should be repaired within 5 years. (Photo 17)
14. Expansion joint repairs at slab to beam bearing are performing well. (Photo 5)

Leaching along edge of beam.

Curb is unpainted. Curbs are recommended to be painted yellow.

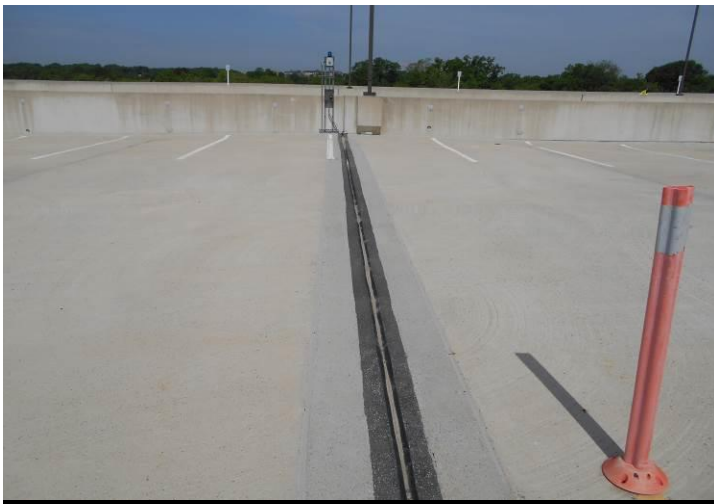
Photo 2

Expansion joint in good condition.

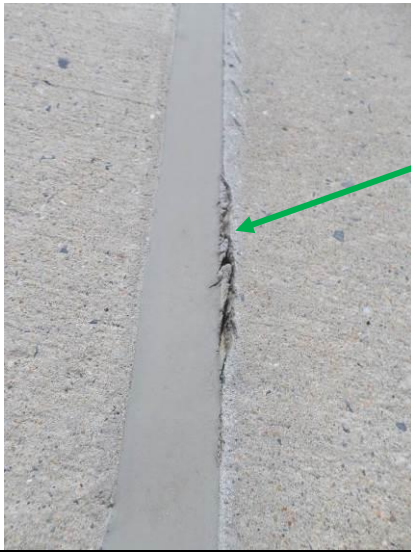
Photo 4

Typical sealant failure at tee to tee joint.

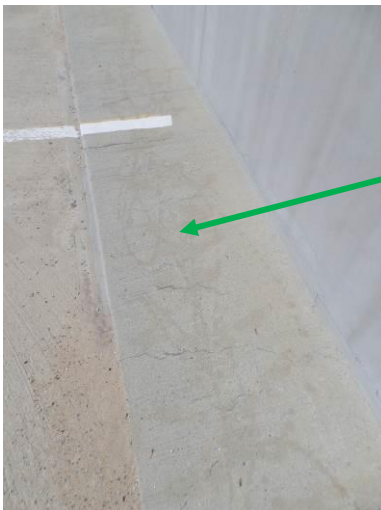
Photo 8

Cracked cast-in-place perimeter wash.

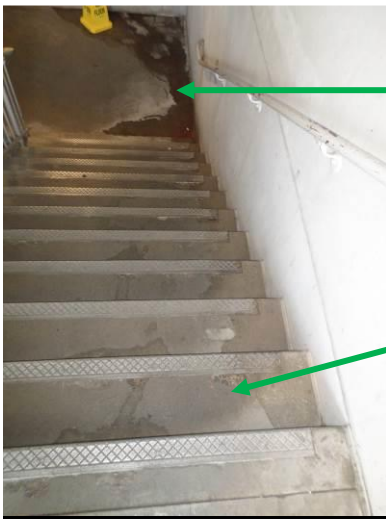
Ponding on stair landing.

Spalls on stair treads. Black stair nosings provide color contrast so no yellow paint is recommended.

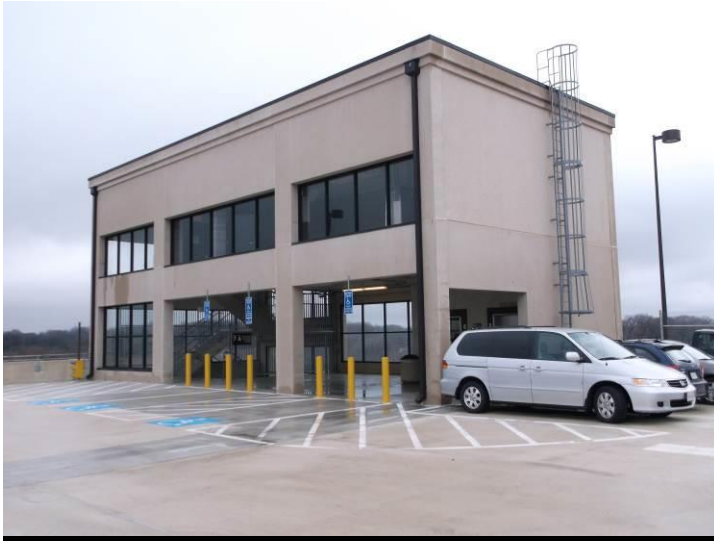
Photo 1

Stair tower at top level.

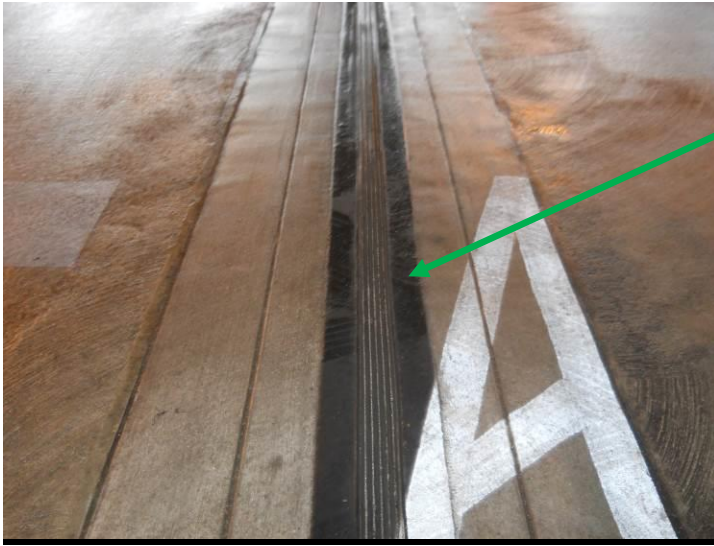
Photo 4

Expansion joint in good condition.

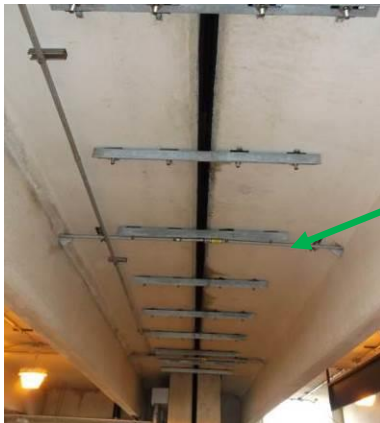
Photo 5

Expansion joint shear transfer devices in good condition.

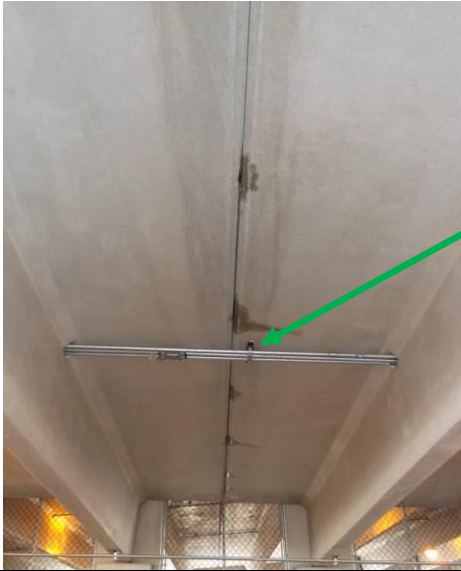
Photo 7

Joint leaks at double tee welded connection.

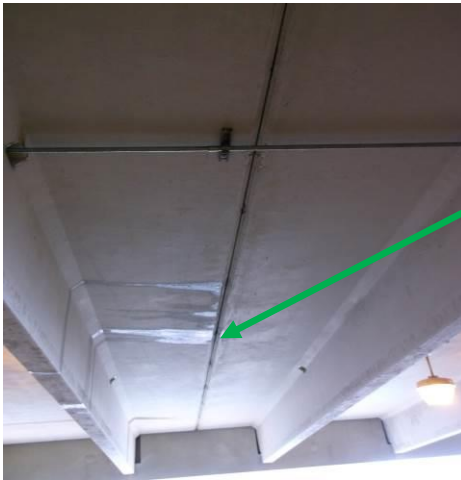
Photo 8

Joint leaks at double tee welded connection.

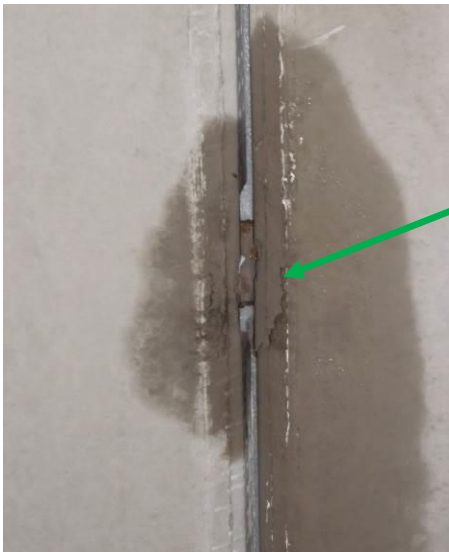
Photo 9

Close up of joint leaking at double tee welded connection showing cracked concrete.

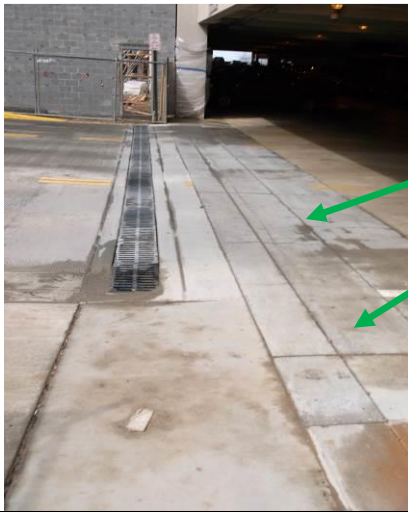
Photo 11

7. A few concrete washes at the main entrance were observed to be cracked/spalled which requires structural repair. (Photo 10,11,12)
8. The roof level stair tower landings are open without any storefront and were extensively wet during our visit the day after a hard rain. Install storefront to dramatically reduce water into elevator shafts and onto adjacent landing to reduce slipping hazards in freezing weather (Photos 1,2,3). If storefront is not acceptable, provide traffic topping to protect slab from deicing salts which will be necessary during freezing weather to eliminate slipping on ice.

Cracked concrete L-beam and wash at main entrance.

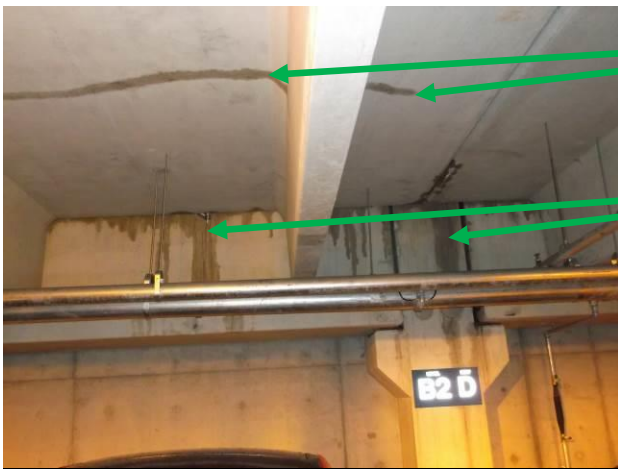
Photo 12

Leaking at cast-in-place wash to tee boundary.

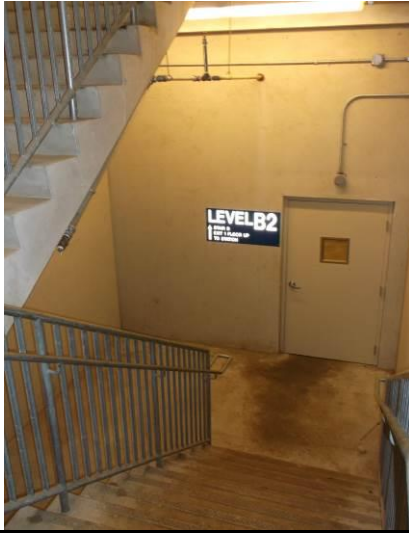
Photo 13

Interior of stair tower at level B2

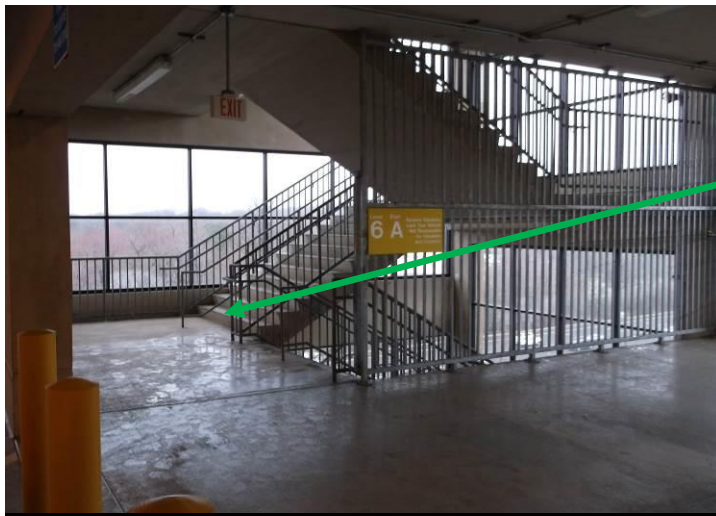
Stair tower at level 6A.

Black stair nosings provide color contrast so no yellow paint is recommended.

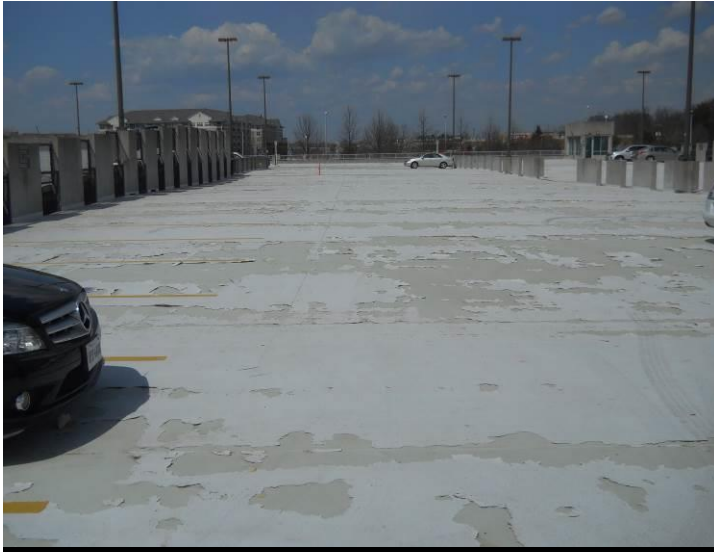
Photo 1

1. Roof level floor sealants are in good condition beneath traffic topping and require replacement beyond 10 years. (Photo 1,5)
2. Interior floor sealants are in good condition and require replacement within 10 years. (Photo 8)
3. Roof level expansion joints are in fair condition and require replacement within 5 years.
4. Interior level expansion joints are in good condition and require replacement within 10 years.
5. A moderate portion of the roof level traffic topping is delaminating which requires repair. (Photo 1,2)
6. Changes in floor elevation, curbs and handicap ramps, are not readily visually apparent and require painting now with safety yellow paint to emphasize elevations changes
7. Significant slab ceiling (soffit) leaching was observed at tee to inverted tee beam locations and loose

Delaminating traffic topping at several bays at roof level.

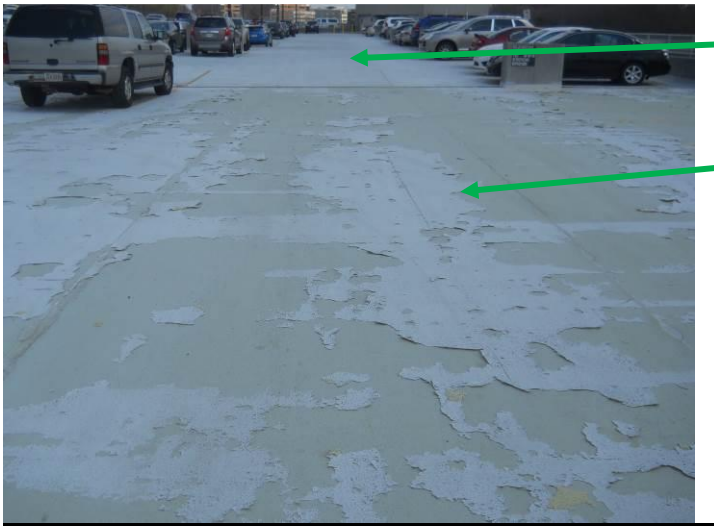
Photo 2

Well bonded traffic topping.

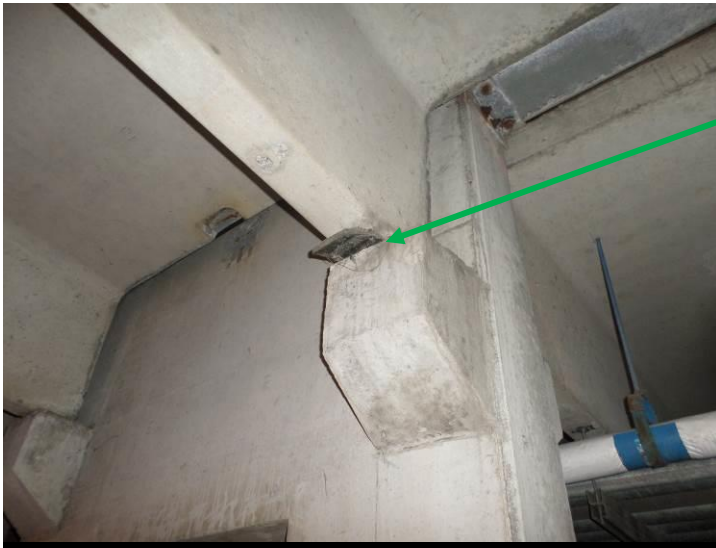
Photo 4

- concrete requires removal now. (Photo 7)
8. Spandrel beams were observed to have moderate crazing crack patterns indicative of ASR and an investigation to determine if ASR is underway is recommended. (Photo 9)
 9. Many double tee stem bearing pads beneath the expansion joints have moved which requires replacement with slide bearing joints. (Photo 4)
 10. Roof level expansion joint glands were observed to be discontinuous at the light wall and are recommended to be modified to be continuous. (Photo 5)
 11. The interior fencing is damaged and require repair now. (Photo 6).
 12. A minor amount of localized ponding was observed and clogged drains need to be cleared of debris. (Photo 8)
 13. At most bridge expansion joints, there is uneven tile, a tripping hazard, that needs to be repaired now. (Photo 12)

Slipping bearing pad adjacent to expansion joint indicates excessive movement for joint.

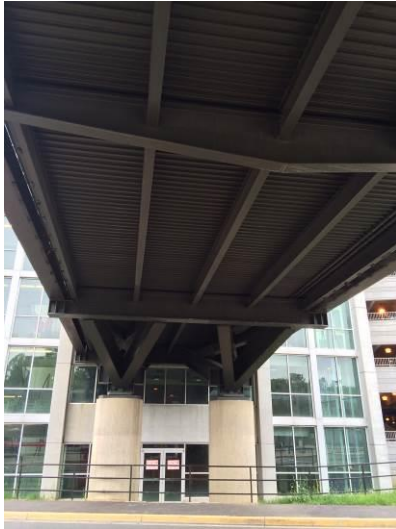
Photo 10

Pedestrian bridge connection to garage.

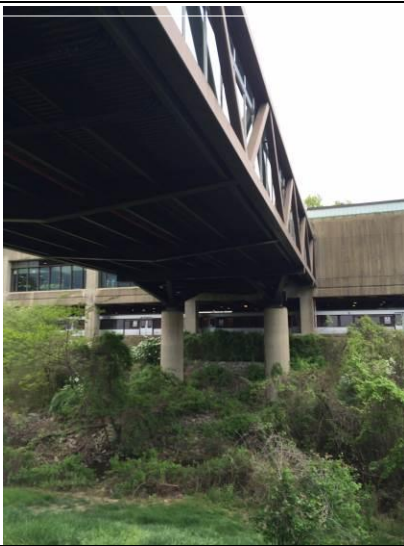
Photo 11

Pedestrian bridge connection to station.

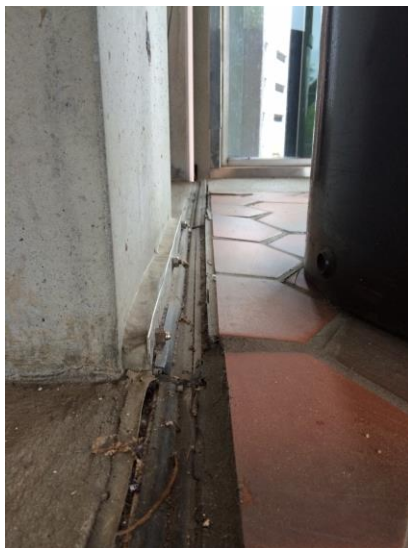
Photo 12

Pedestrian bridge trip hazard at joint with garage.

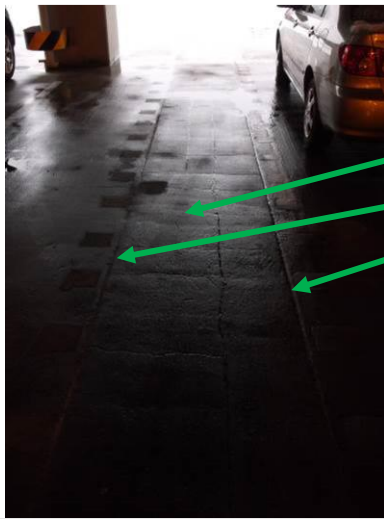
Photo 2

1. Roof level floor sealants are in good condition beneath traffic topping and require replacement beyond 10 years.
2. Interior floor sealants are in fair condition and require replacement within 10 years. (Photo 2)
3. Many P/T pourstrips were observed to have indications of leakage which requires waterproofing repair now (Photo 2,3)
4. The roof and interior level stairtower doors' hinges are deformed which require replacement (Photo 18).
5. A moderate amount of localized ponding was observed and new supplemental drains need to be installed as well as swales ground into the floor slab modified. (Photo 1,4,10,12,16,17)

Lower level p/t pourstrip.

Unsealed pourstrip boundaries.

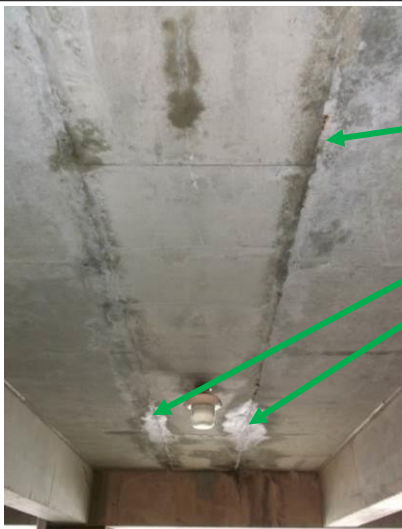
Photo 3

Leaking and leaching cracks in soffit at pourstrip boundaries.

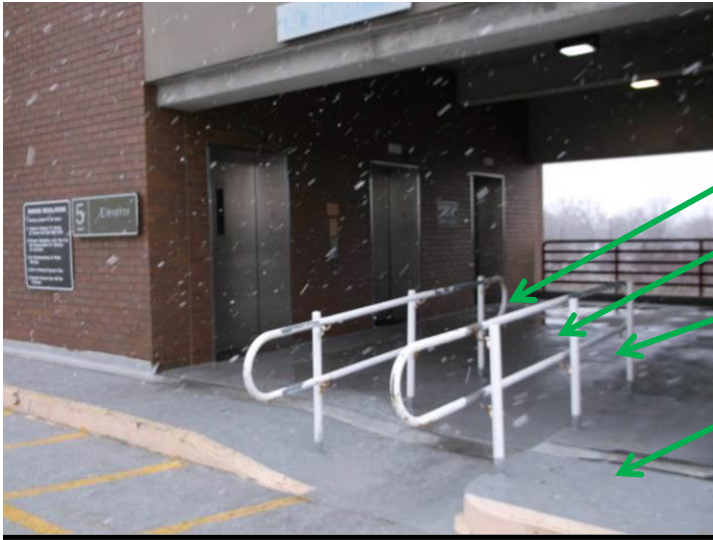
Photo 7

Handrail gap too large.

Rusting handrails.

Failed expansion joint glands at stair tower.

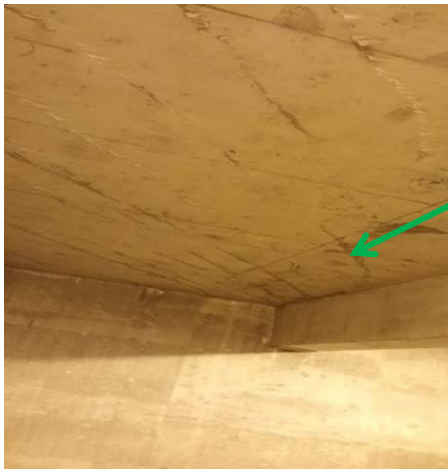
Photo 8

8. Floor slab soffits, particularly at the lowest supported level in the northeast corner, were observed to have minor leaching cracks with efflorescence which require waterproofing to address deterioration (Photo 8)

Leaching through numerous cracks in supported slab.

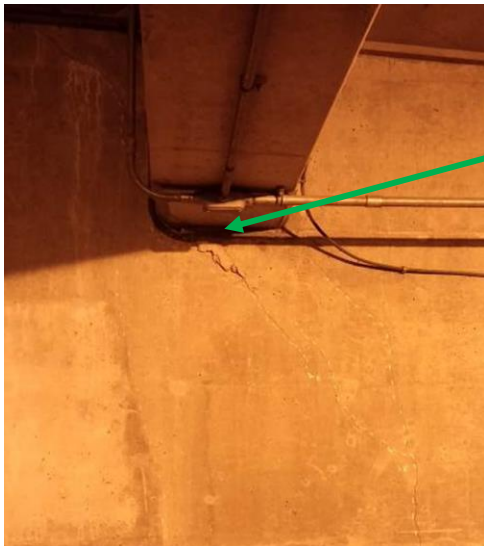
Photo 9

Crack in wall and leaching at beam connection.

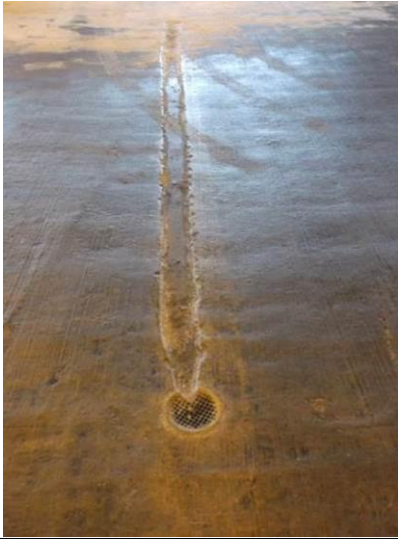
Photo 10

Swale ground into floor slab to drain water into floor slab is common near main stair tower. Several of these swales were clogged with debris and should be cleaned and rough edges ground smooth.

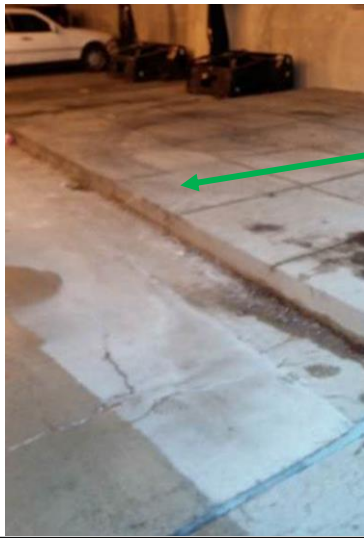
Photo 11

6. A minor portion of the roof level floor traffic topping is damaged by scrapes and wear which requires repair.
7. Changes in floor elevation, curbs and handicap ramps, are not readily visually apparent and require painting now with safety yellow paint to emphasize elevations changes (Photo 11,20)

Unpainted curb. Curbs are recommended to be painted yellow.

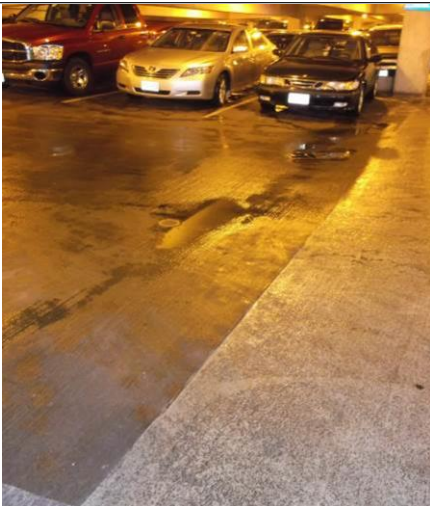
Photo 12

Ponding adjacent to floor drains at slab on grade.

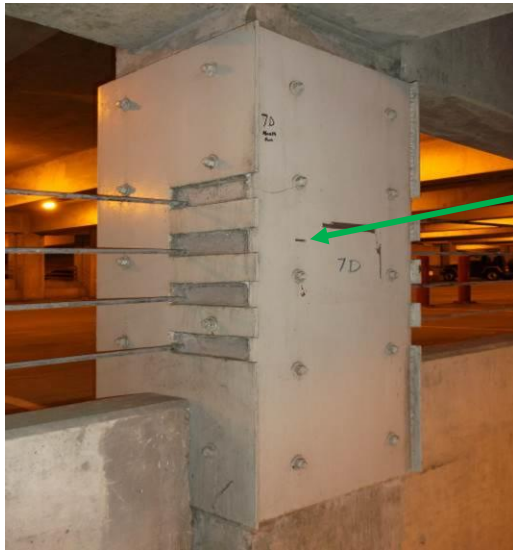
Photo 13

Previous repair

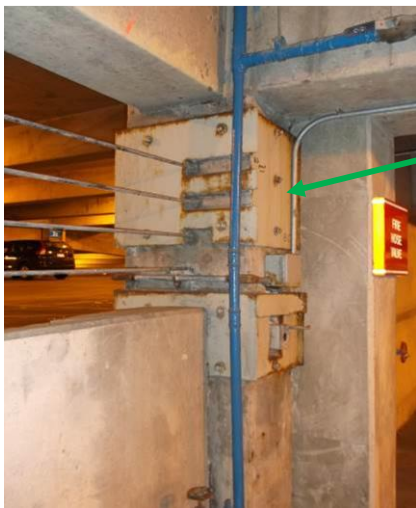
Photo 14

Previous repair

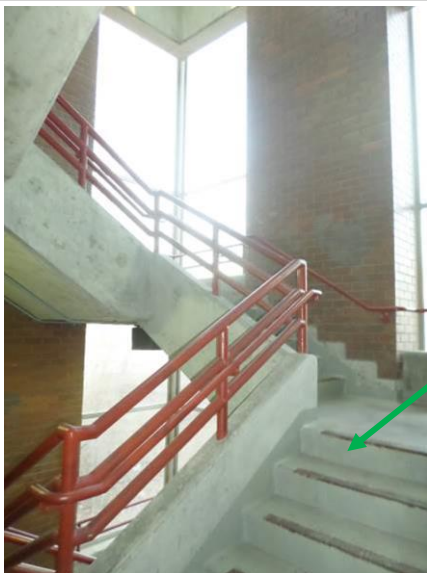
Photo 15

Typical stair landing riser configuration. Black stair nosings provide color contrast so no yellow paint is recommended.

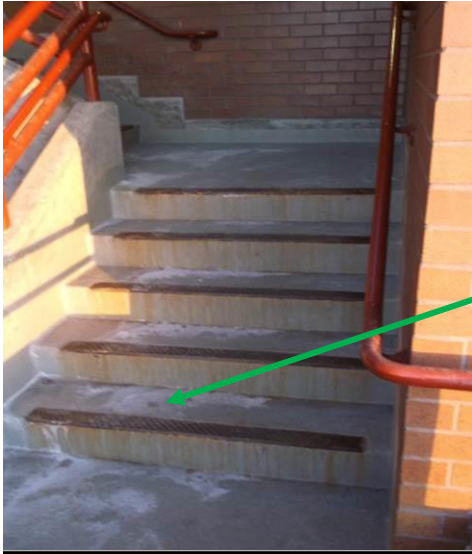
Photo 16

Ponding and salt staining on stair treads.

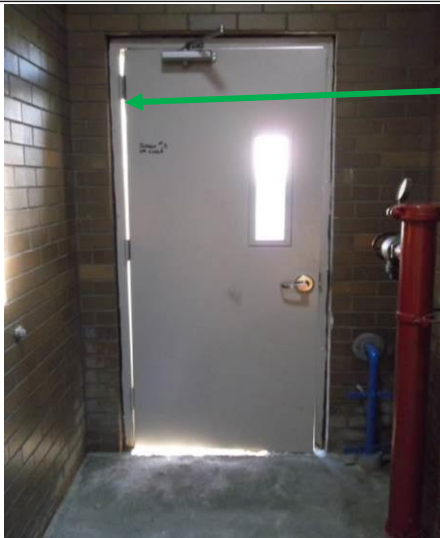
Photo 18

Door hinges are damaged.

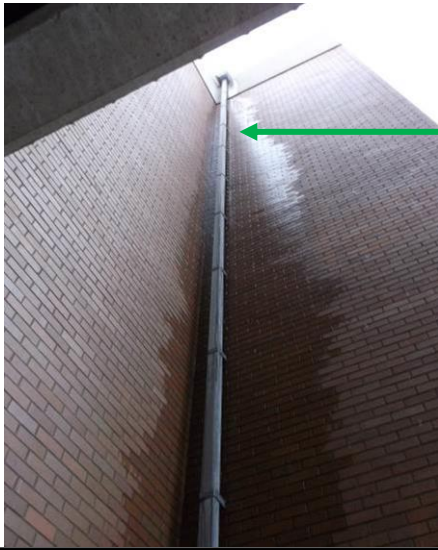
Photo 19

11. A roof drain on the main elevator/stair is clogged and should be unclogged (Photo 19).
12. Expansion joints at secondary stairtowers only partially isolate the stairs from the garage, but no cracking was observed at areas without the expansion joint (Photo 21).

Clogged roof drain.

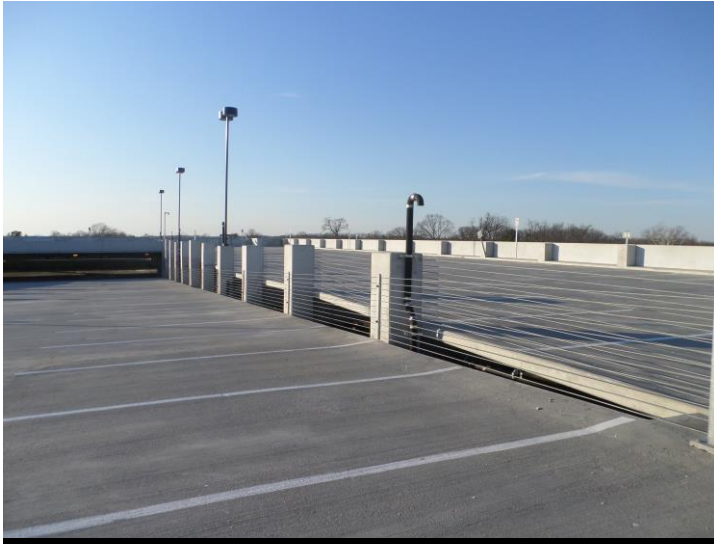
Photo 1

Top level.

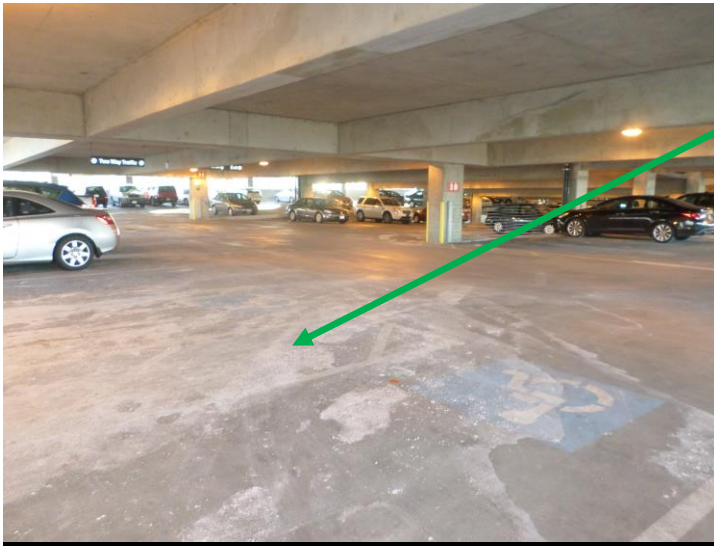
Photo 4

Interior of garage shows excessive salt use.

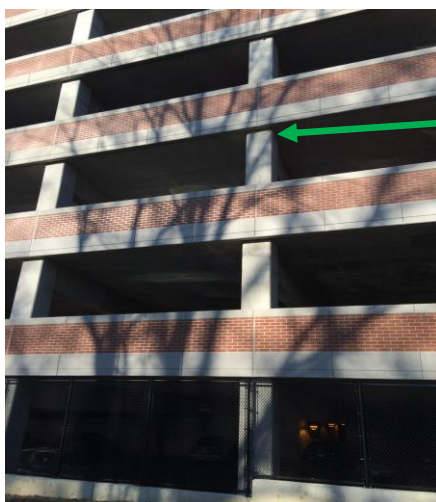
Photo 6

Spall on column beneath 3rd level.

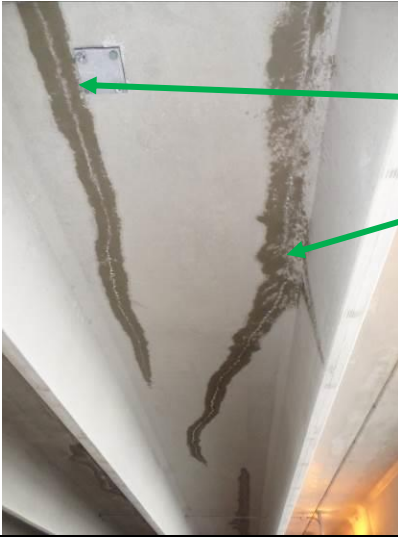
Photo 1

Leaking and leaching through tee flange cracks.

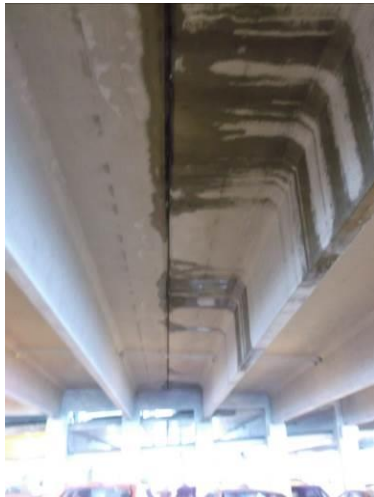
Photo 2

Leaking beneath tee to tee joint

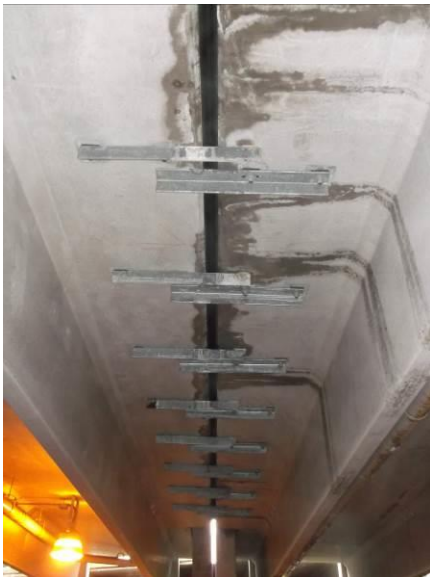
Photo 3

Leaking beneath expansion joint

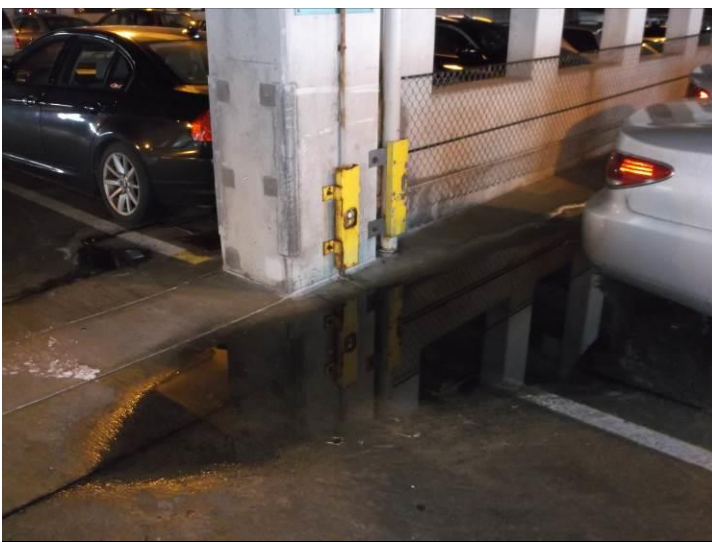
Photo 6

14. A minor amount of localized ponding was observed and clogged drains need to be cleared of debris now. (Photo 6)
 15. A moderate portion of the existing spandrel guardrail anchor connections are rusted and require cleaning, sealant installation and painting. (Photo 19)

Ponding at clogged drain.

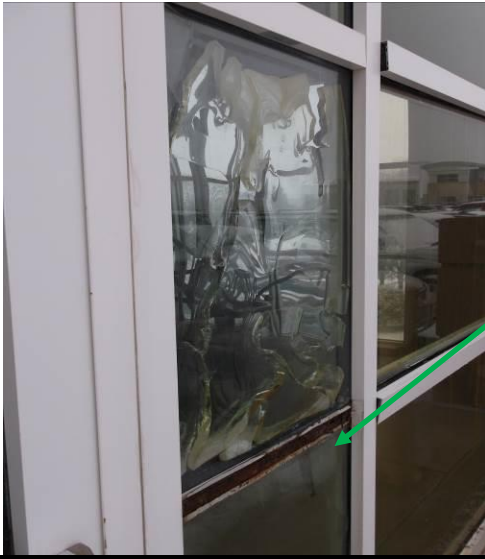
Photo 10

Heavily rusting cold rolled carbon steel frame beneath aluminum cladding at transom in storefront system.

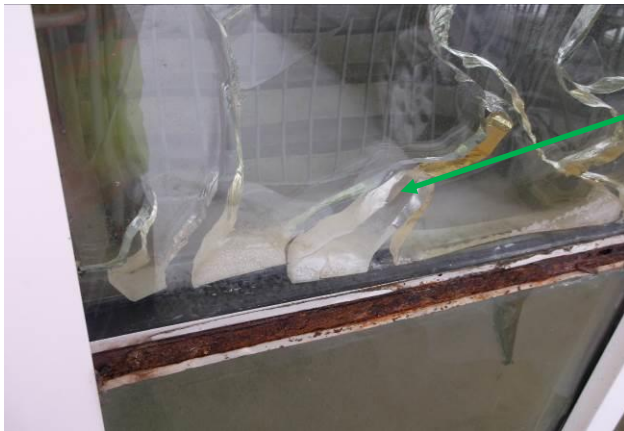
Photo 12

Failed plastic infill between glass panes above transom.

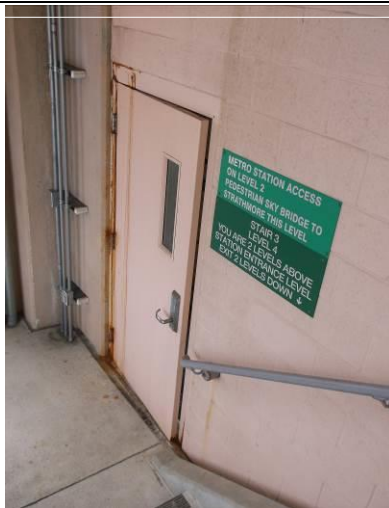
Photo 15

13. A few of the existing stairtower door hinges are damaged due to water leaking through expansion joints and require replacement and expansion joint gland repair. (Photo 15)

Damaged door hinges at leaking stair tower expansion joint.

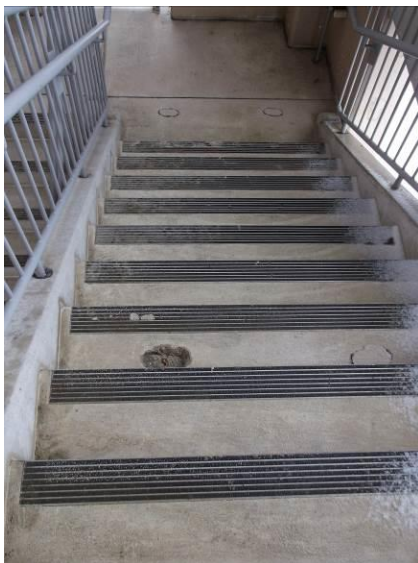
Spall on stair tread at lifting lug patch.

Black stair nosings provide color contrast so no yellow paint is recommended.

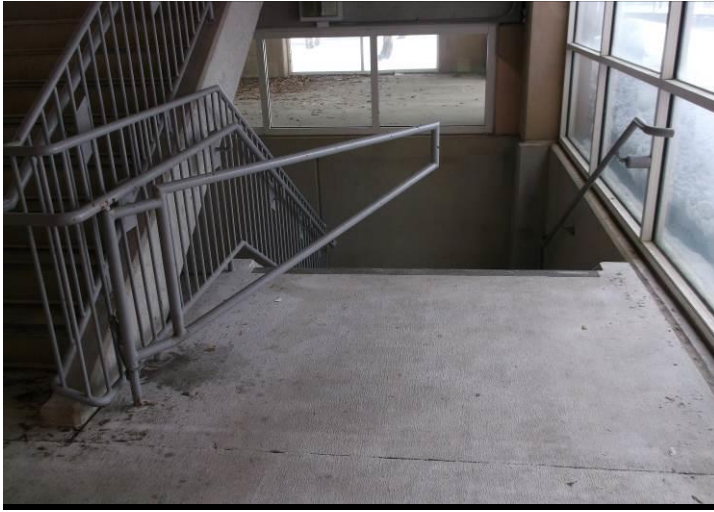
Photo 17

11. The stair tower interior gate to warn patrons in the event of a fire to exit at grade is damaged and requires repair now. (Photo 17)
 12. The perimeter fencing is damaged and requires repair now. (Photo 13)

Emergency exit egress barrier is inoperative.

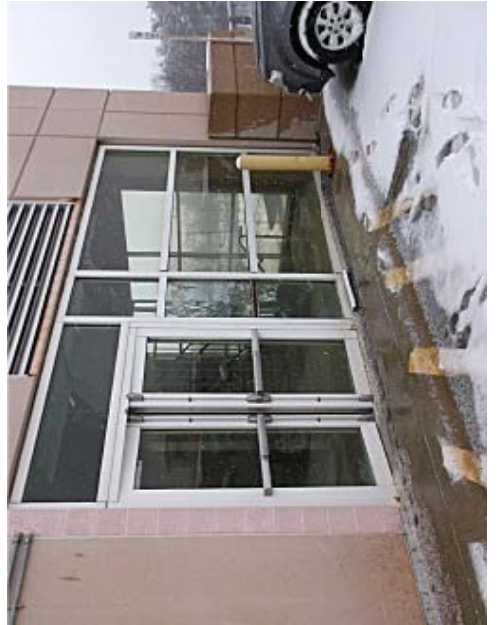
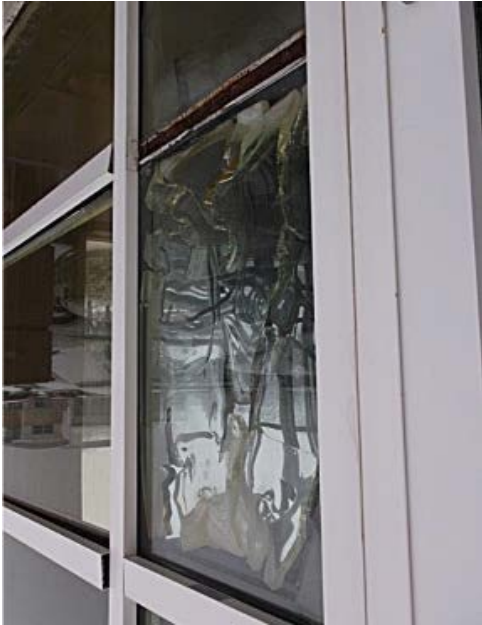
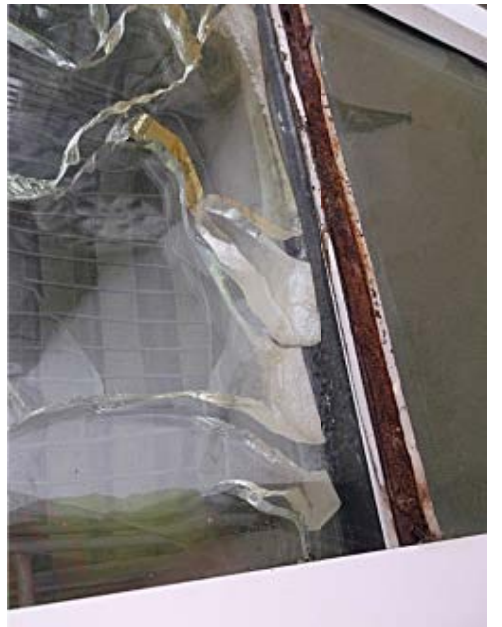
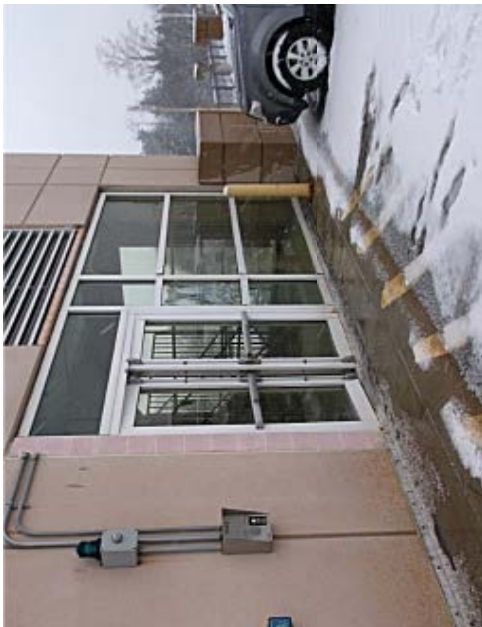
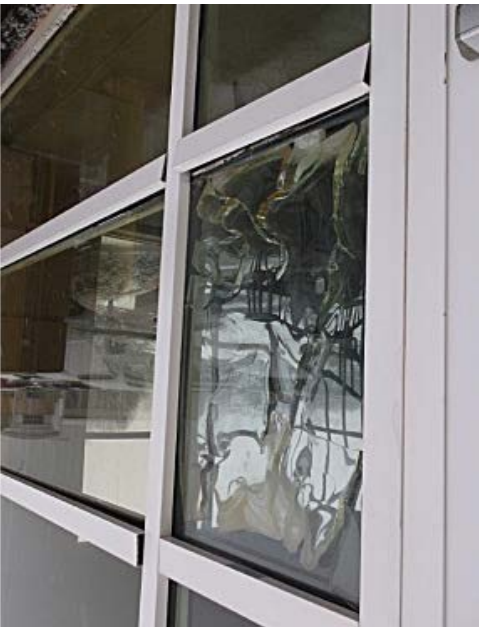
While at Grosvenor on Tuesday we observed at the roof level that both storefronts (adjacent to the train elevator/stair tower and adjacent to the Strathmore elevator/stair tower) are in poor shape, where the mullion interior - consisting of steel members - was heavily corroded and literally falling apart as shown in the attached photos. We recommend you remove the loose mullion parts promptly and that a permanent repair occur this summer.
