**Asset Management Plan  
WMATA Parking Garages  
Volume 2 of 3  
February 2015  
Walker Restoration Consultants**

ASSET MANAGEMENT PLAN

WASHINGTON AREA  
METROPOLITAN TRANSIT  
AUTHORITY PARKING GARAGES

FEBRUARY, 2015  
VOLUME 2 OF 3

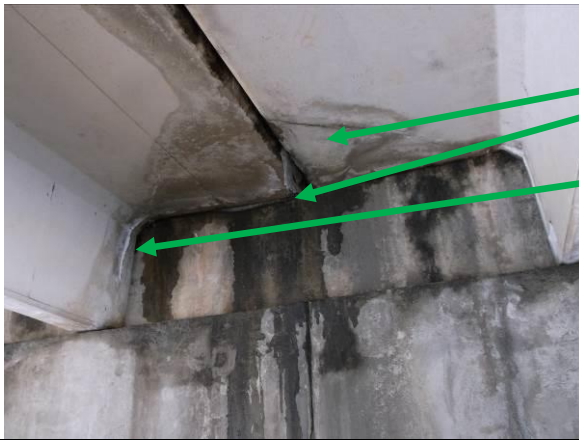
Photo 5

Damaged tee flange corner.

Leaching on end of tee stem.

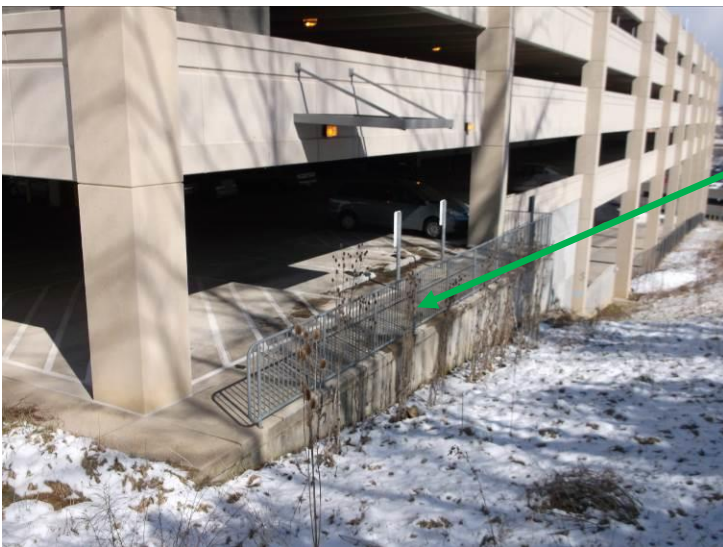
Photo 6

No vehicular impact bumper.

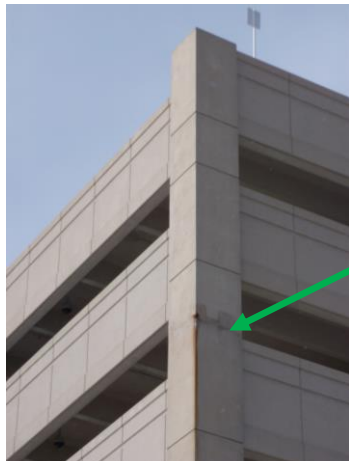
Photo 9

Spall on exterior column.

1. Remove and replace spalled overhead concrete found on bridges and columns with repair concrete anchored with supplementary embedded steel pins. Monitor this condition at least every 6 months until replacement and remove loose concrete.
2. Remove and replace stair tread and landing spalled concrete with repair concrete.
3. Repair stair railing anchor points
4. Remove and replace concrete floor slab cracks and spalls on the south entrance bridge
5. Replace roof level floor sealants

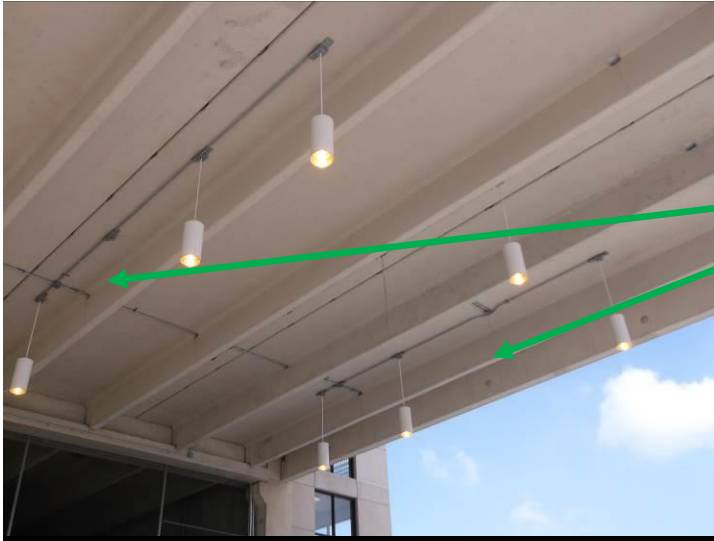
Photo 10

10. Many pendant mounted lights at the north entrance have fallen the large distance to grade and as these will be replaced shortly, need to have modified anchoring to properly support the lights. (Photo 10)
11. A minor amount of localized ponding was observed and new supplemental drains need to be installed. (Photo 16, 17, 18)

Soffit showing locations of lights fallen from electrical junction boxes beneath north entrance.

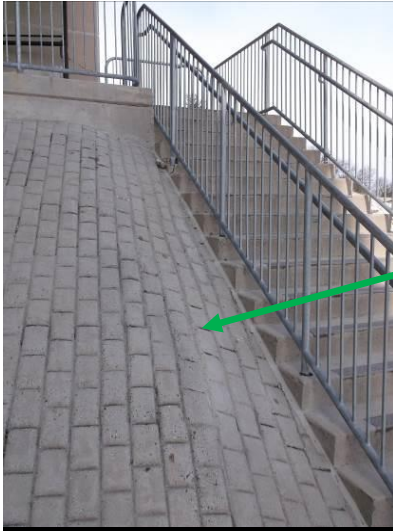
Photo 13

garage are damaged and require repair now. (Photo 13, 14, 15)

Damaged railing to stair connection.

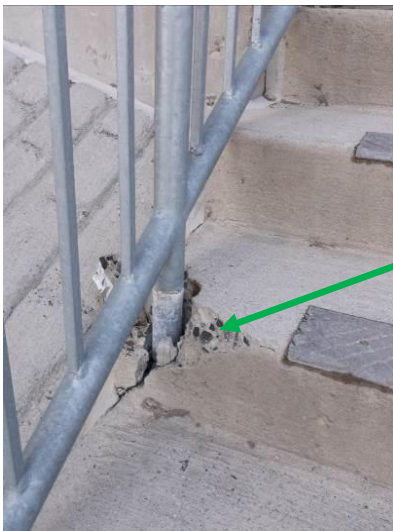
Photo 14

Damaged railing to stair connection.

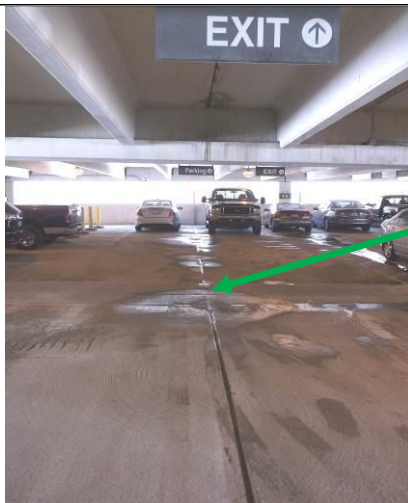
Photo 18

1. Roof level floor sealants are in fair condition and require replacement within 5 years. (Photo 16, 17, 18)
2. Interior floor sealants are in fair condition and require replacement within 10 years.

Ponding at locations of leaking joints between double tees.

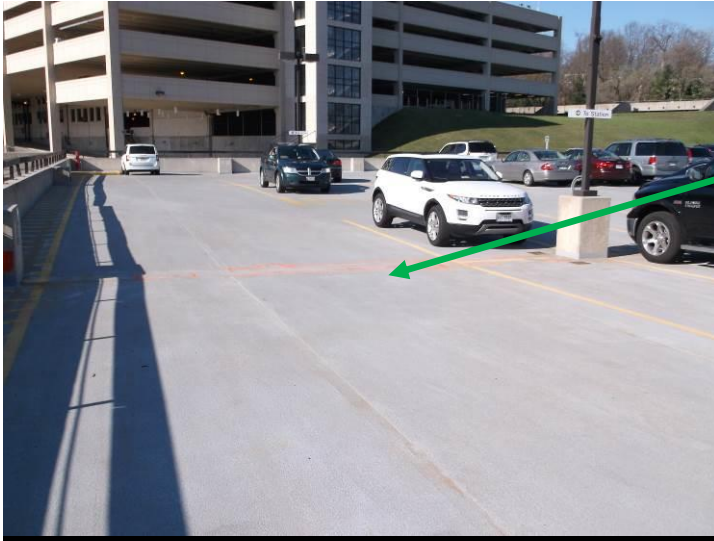
Photo 1

1. Roof level floor sealants are in good condition beneath traffic topping and require replacement beyond 10 years. (Photo 1,2,4,5,8)
2. Interior floor sealants are in fair condition and require replacement within 10 years. (Photo 21)
3. Roof level expansion joints are in good condition and require replacement within 10 years. (Photo 3,7)
4. Interior level expansion joints are in good condition and require replacement within 10 years.
5. A minor portion of the roof level traffic topping is damaged by delaminations of tee to tee connections which requires repair (Photo 1,2).
6. Changes in floor elevation- curbs, handicap ramps, steps and stair tread nosings, are readily visually apparent. (Photo 5,6)
7. Significant stair soffit delaminations were observed

Top level is traffic topped and exhibits delamination along inverted tee beam.

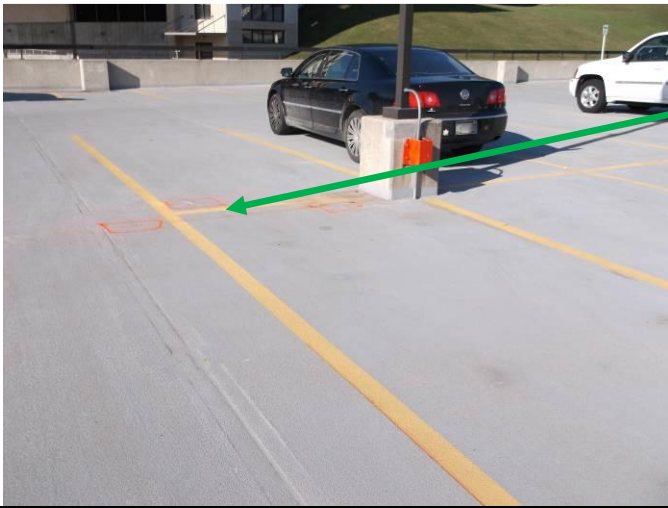
Photo 2

Areas of delamination along inverted tee beam.

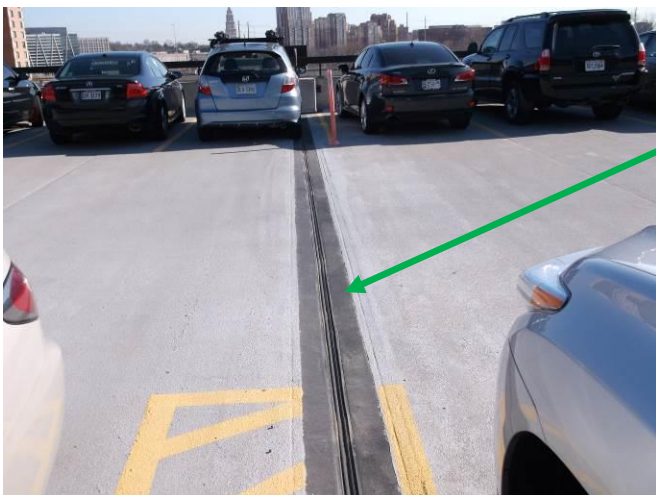
Photo 3

Expansion joint is in good condition.

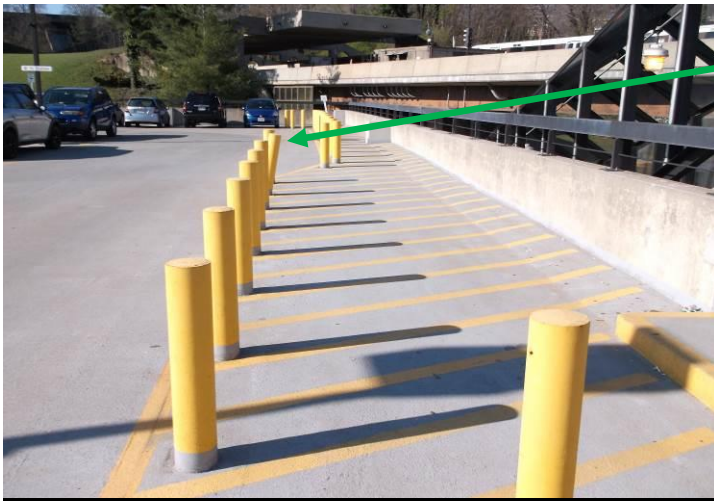
Photo 5

Damaged pipe bollard.

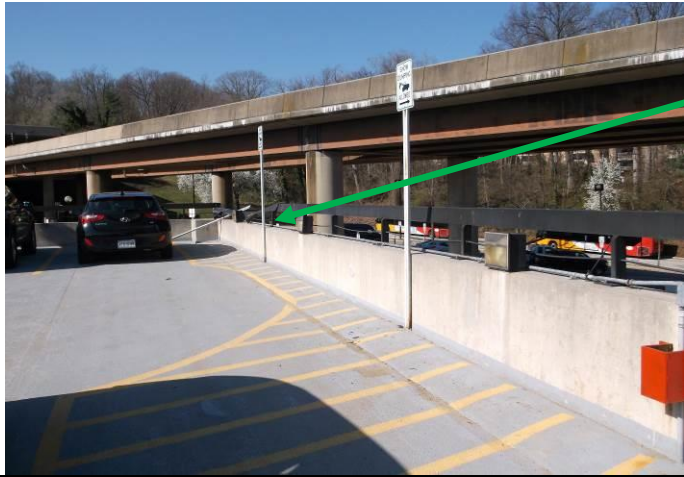
Photo 8

Damaged railing and sign.

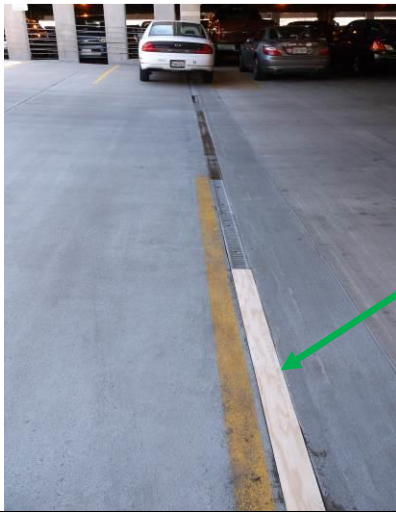
Photo 14

12. A number of trench drain grates are missing and require replacement now to eliminate trip hazards. (Photo 14,15)
  13. A number of lights have broken lenses that permits people to reach into fixture and requires replacement to eliminate danger. We understand these lights are already scheduled for replacement. (Photo 20)

Trench drain cover is missing.

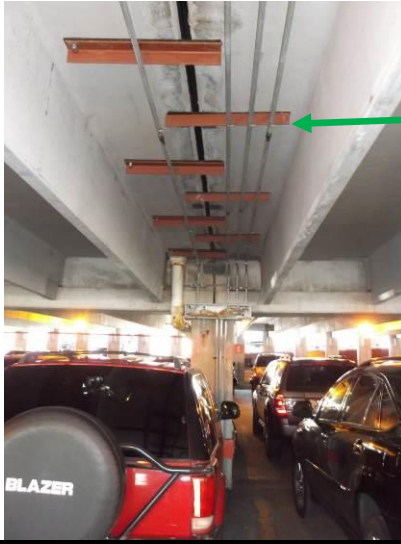
Photo 16

Shear transfer device.

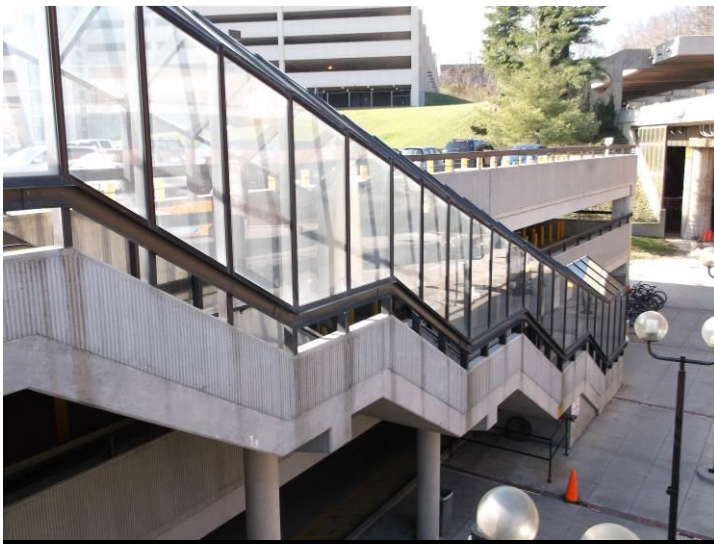
Photo 17

- and loose concrete requires removal now. (Photo 17,18,19)
8. A moderate number of the double tee to double tee welded connections were observed to be rusting which requires structural repair (Photo 13).

Exterior stair.

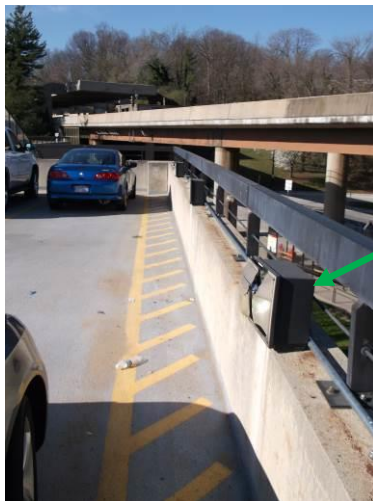
Photo 20

Broken light.

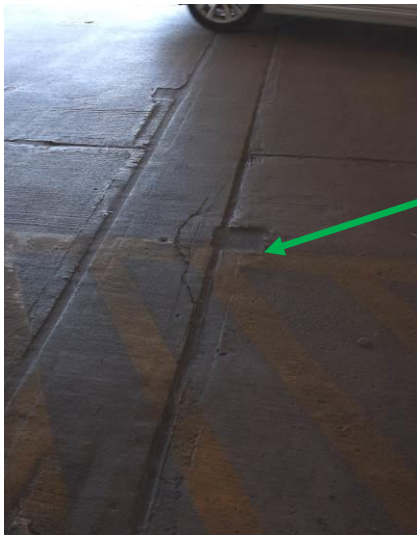
Photo 21

Typical previous repair at tee to inverted tee beam welded connection on lower levels.

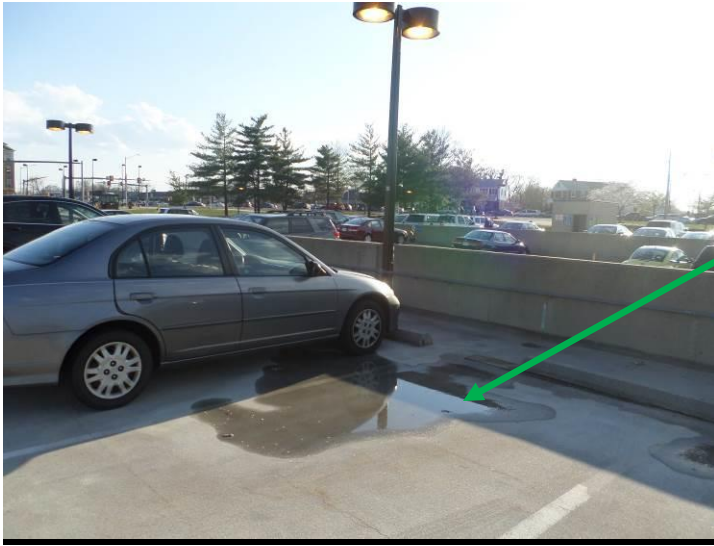
Photo 1

13. A moderate amount of localized ponding was observed and new supplemental drains need to be installed. (Photos 1, 2, 3)
14. A few light poles showed evidence of rusting requiring repair or replacement. We understand these are currently scheduled for replacement. (Photo 22)

Top level ponding.

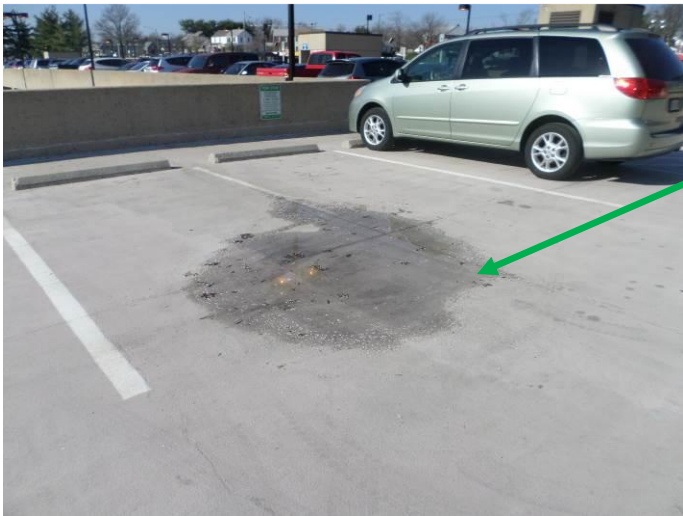
Photo 2

Top level ponding.

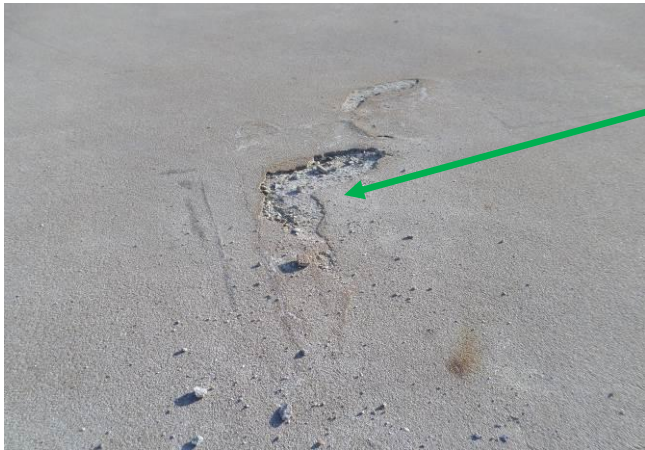
Photo 5

Spalling.

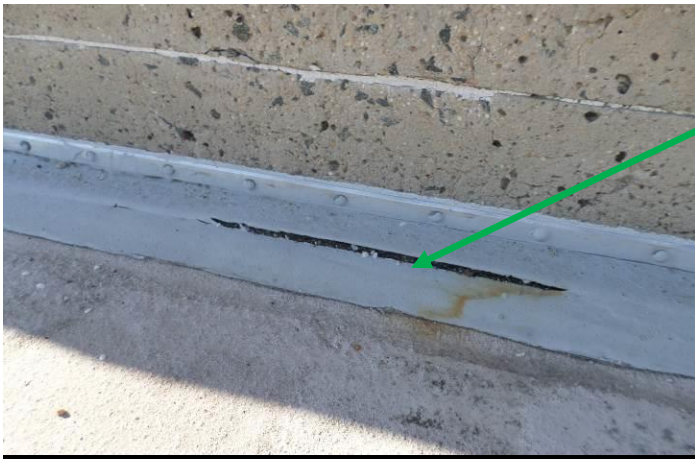
Photo 8

Deteriorated cove sealant.

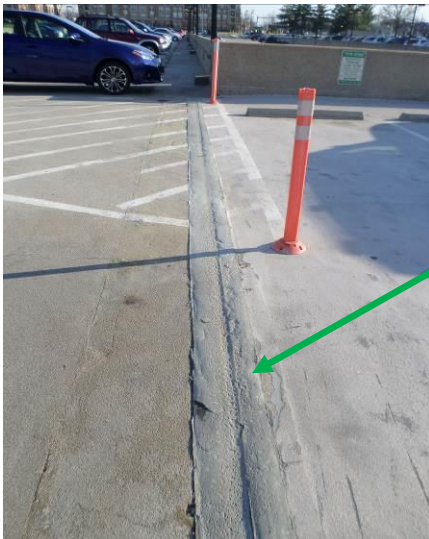
Photo 9

Deteriorated expansion joint.

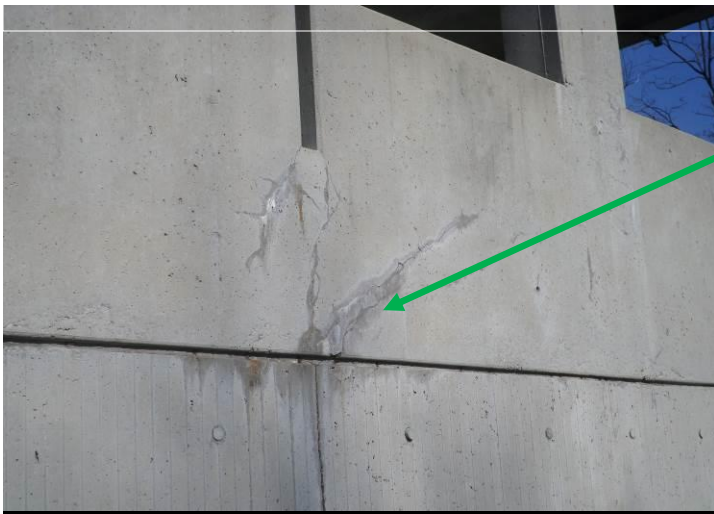
Photo 14

10. Many columns/column haunch/walls were observed to be cracked/spalled which requires structural repair. (Photos 11, 14, 16, 21)
11. A moderate number of beams showed leaching, spalling and cracking which requires structural repair. (Photos 19, 23)

Leaching and cracking on exterior.

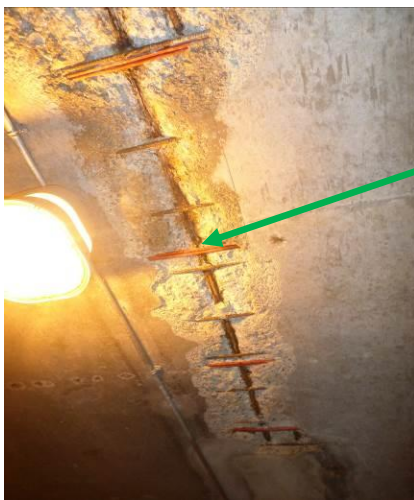
Photo 18

Spalling with exposed reinforcing and P/T tendons.

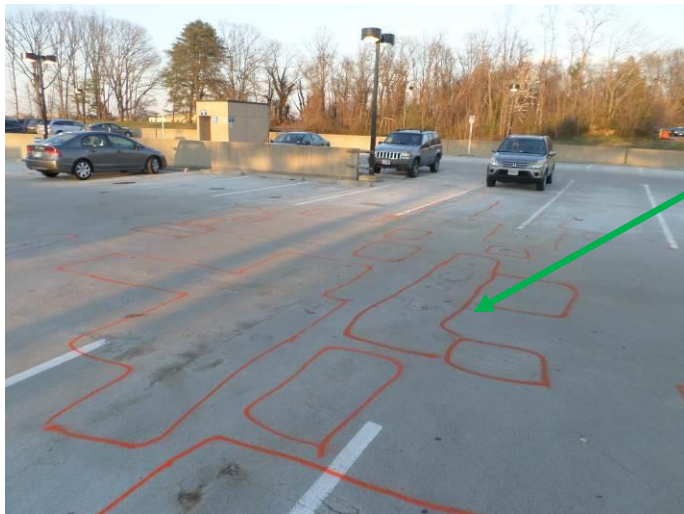
Photo 20

Floor delamination.

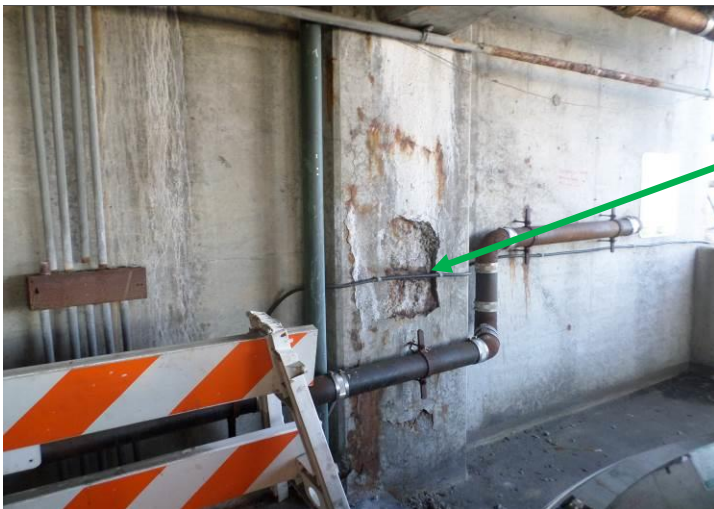
Photo 21

Spalling with exposed reinforcing on column.

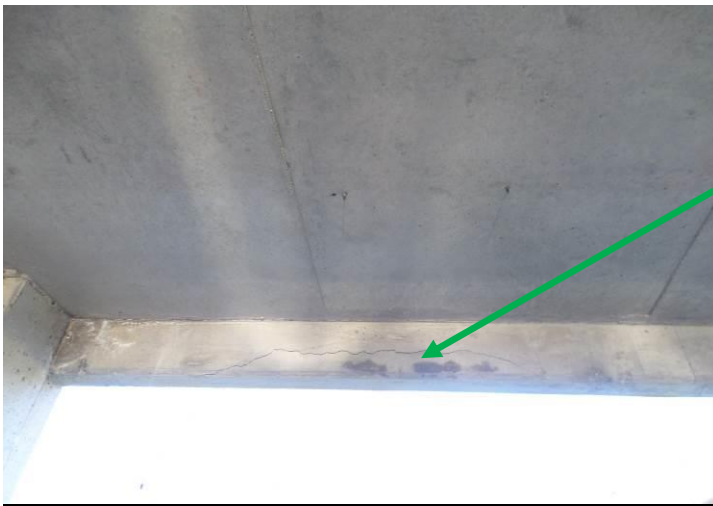
Photo 23

Cracking in perimeter beam.

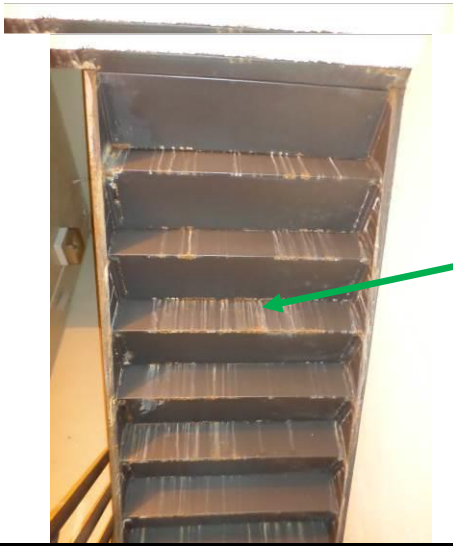
Photo 25

6. Significant slab ceiling (soffit) leaching/delaminations was observed and loose concrete requires removal now.
7. Significant metal painted stair soffit rusting was observed and requires repainting. (Photo 25)

Rusting on underside of stairs.

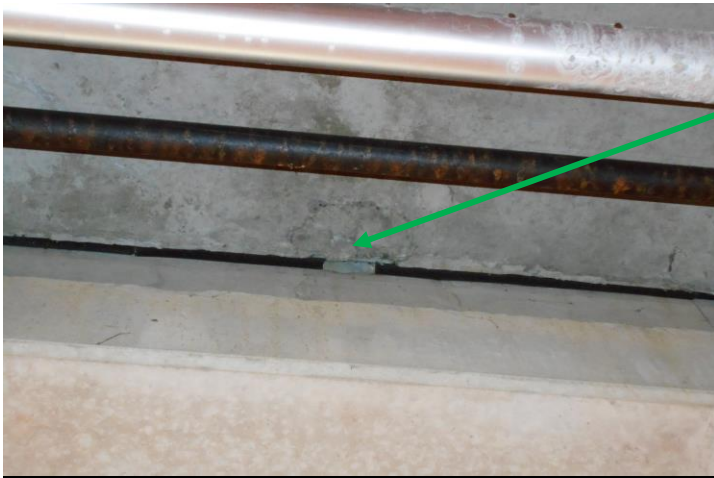
Photo 5

Spall at underside of welded connection

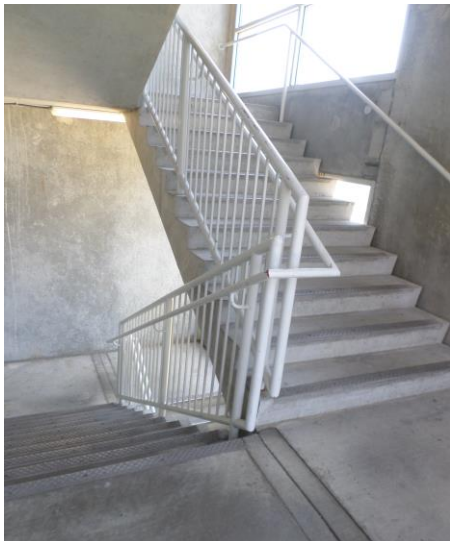
Photo 6

Stairs in fair condition. Black stair nosings provide color contrast so no yellow paint is recommended.

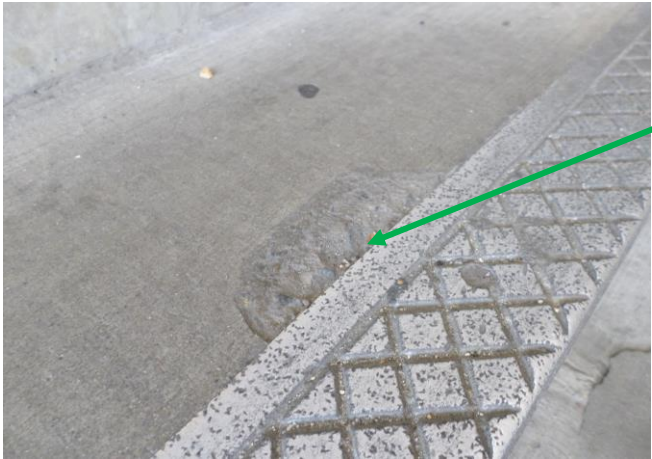
Photo 8

Stair nosing spall.

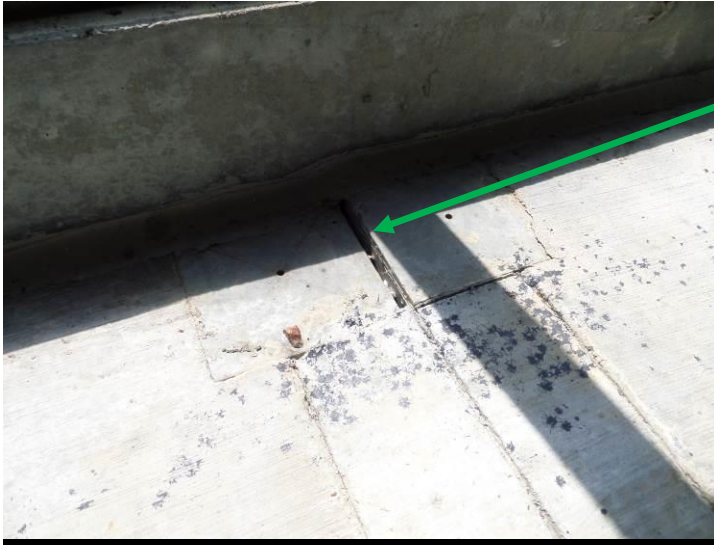
Photo 4

Uneven metal plates embedded into stair landing.

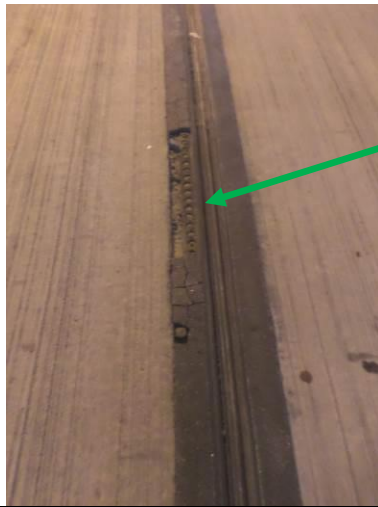
Photo 5

Damaged lower level expansion joint.

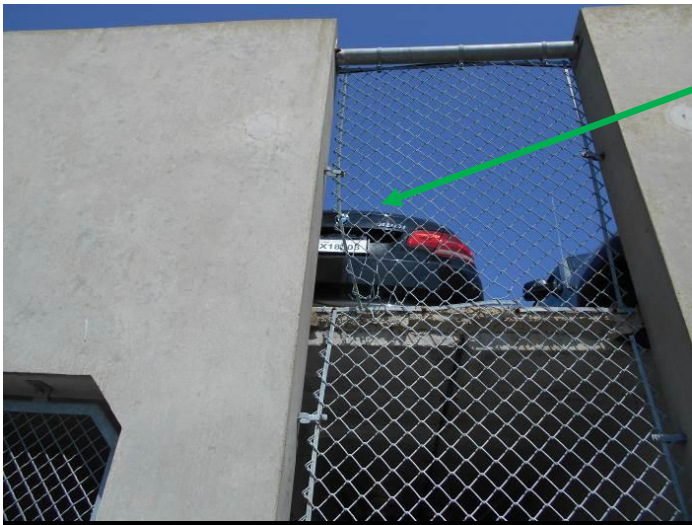
Photo 8

13. The fencing is damaged and require repair now. (Photo 8).
14. A minor amount of localized ponding was observed and supplemental drains need to be installed on stair landings. (Photo 13)

Damaged fencing.

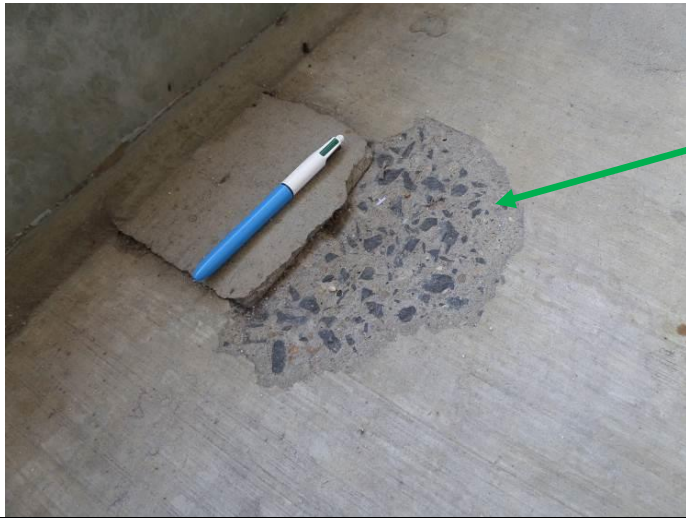
Photo 10

Spall on stair landing.

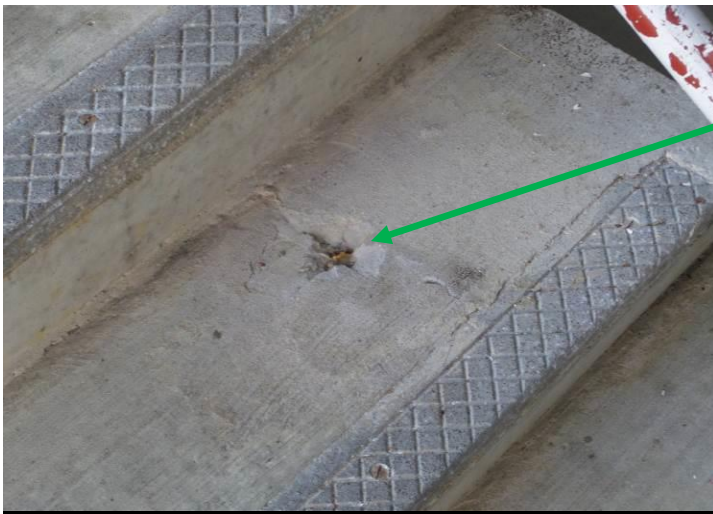
Photo 11

Spall on stair tread.

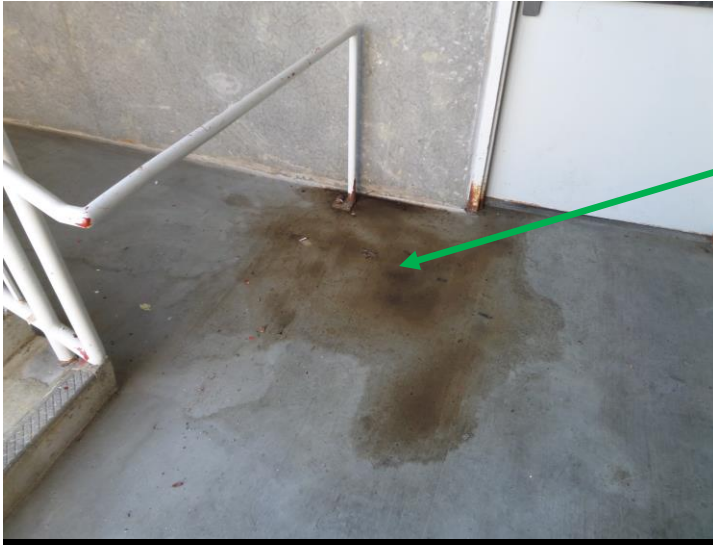
Photo 13

Ponding on stair landings

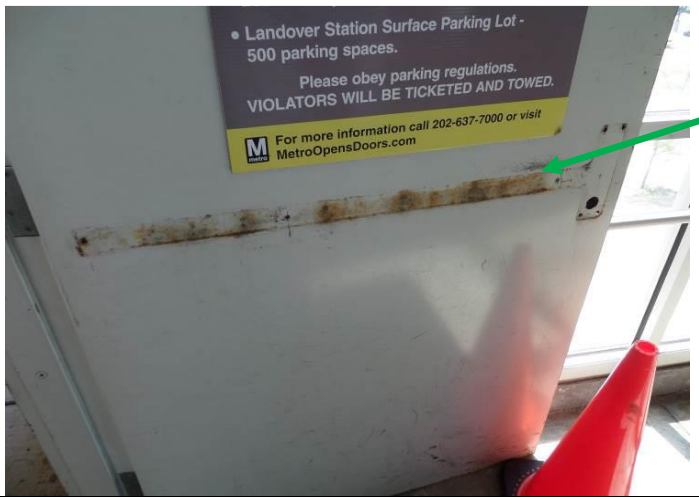
Photo 14

11. A few columns and walls were observed to be cracked/spalled which requires structural repair, as well as ASR investigation. (Photo 16, 17, 18)
12. The stairtower doors are corroded, damaged, and missing hardware which requires replacement (Photo 14, 15).

Missing panic hardware.

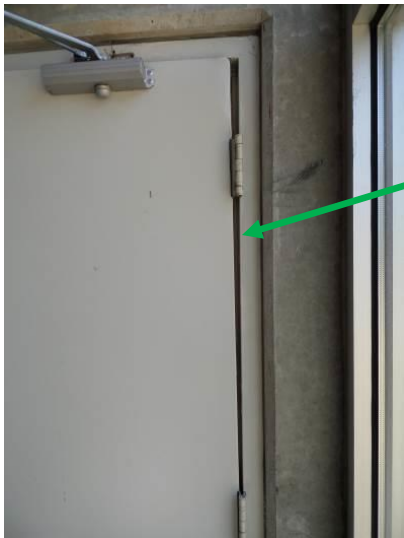
Photo 15

Damaged door frame.

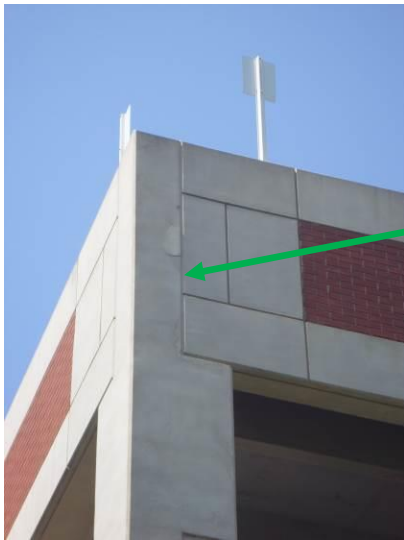
Photo 18

Spall in column.

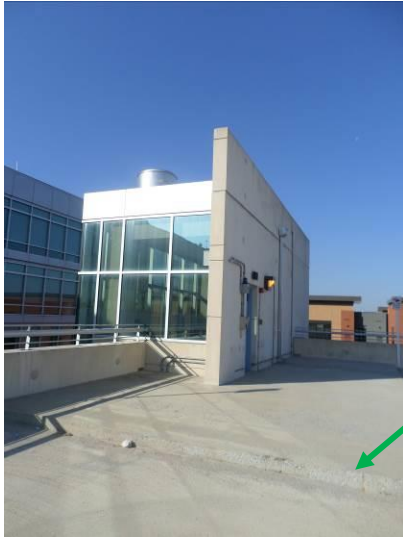
Photo 1

Unpainted curb. Curbs are recommended to be painted yellow.

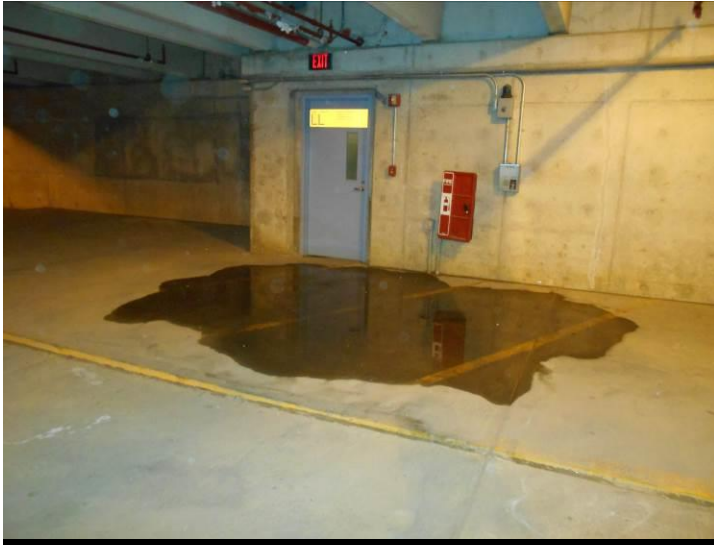
Photo 4

Ponding at stairtower doorway.

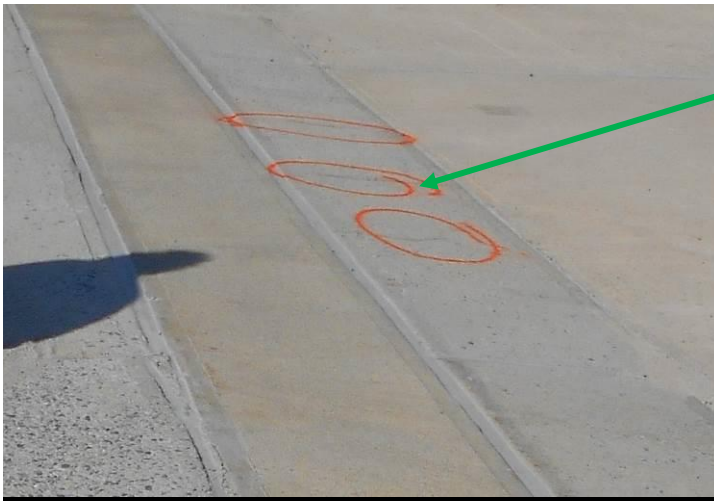
Photo 5

Delaminated topping.

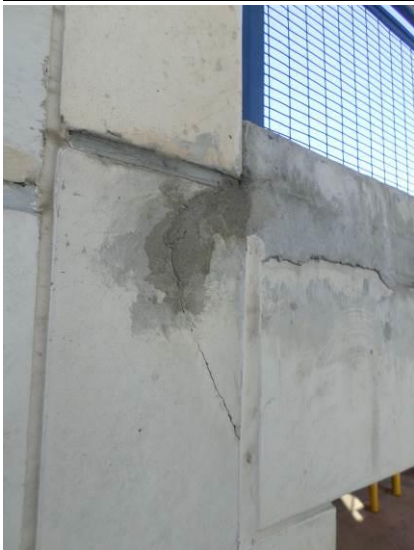
Photo 9

Crack in column with failing previous repair.

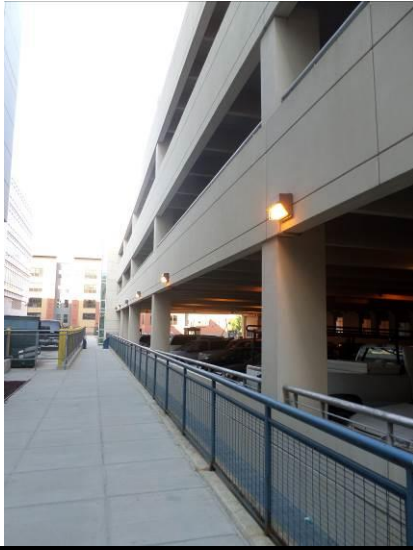
Photo 10

9. The fencing is rusting and requires repainting. (Photo 10,11).

Railing at ground level.

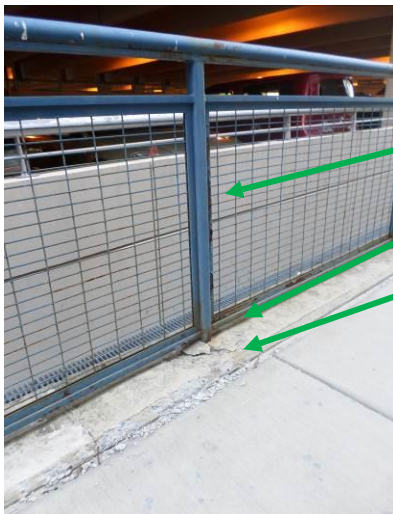
Close-up of rusting railing;  
spall at connection.

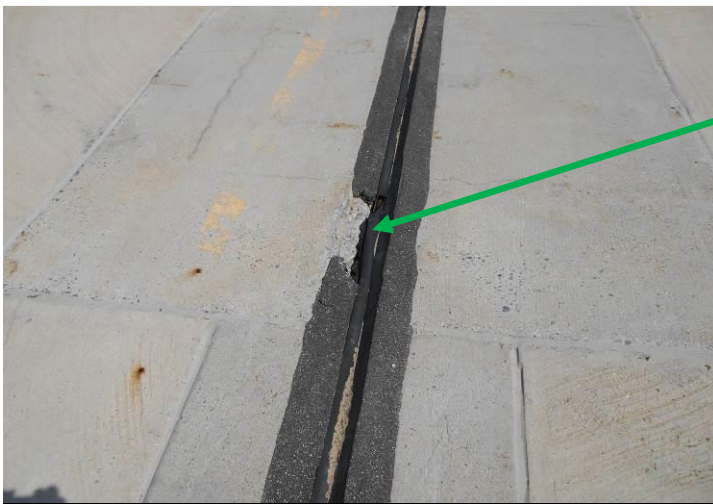
Photo 2

Damaged expansion joint.

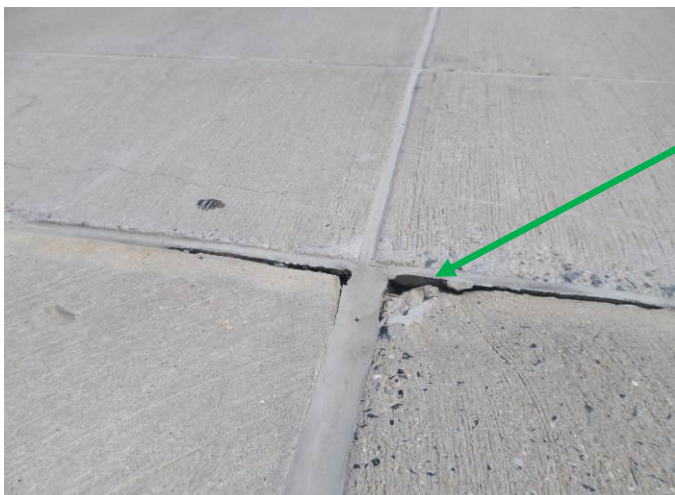
Photo 3

Failing sealant at tee to tee joint at precast to cast-in-place wash junction.

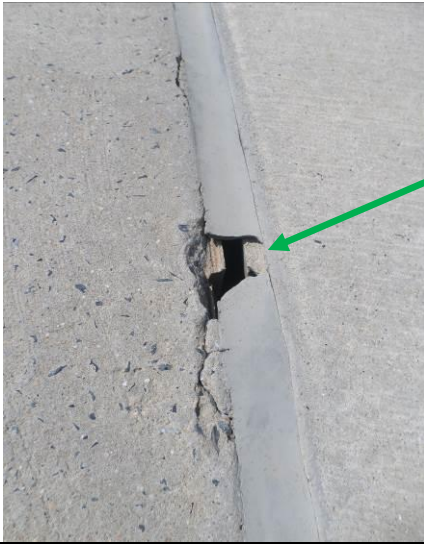
Photo 4

Missing sealant.

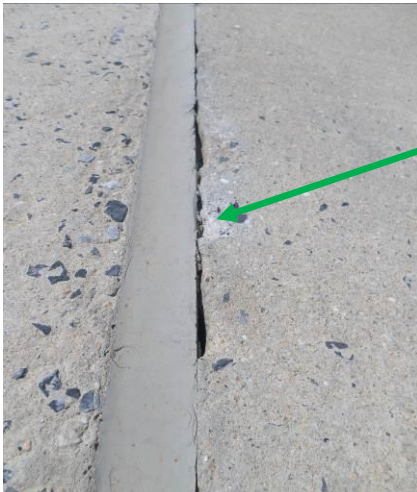
Photo 5

Adhesive failure of tee to tee sealant.

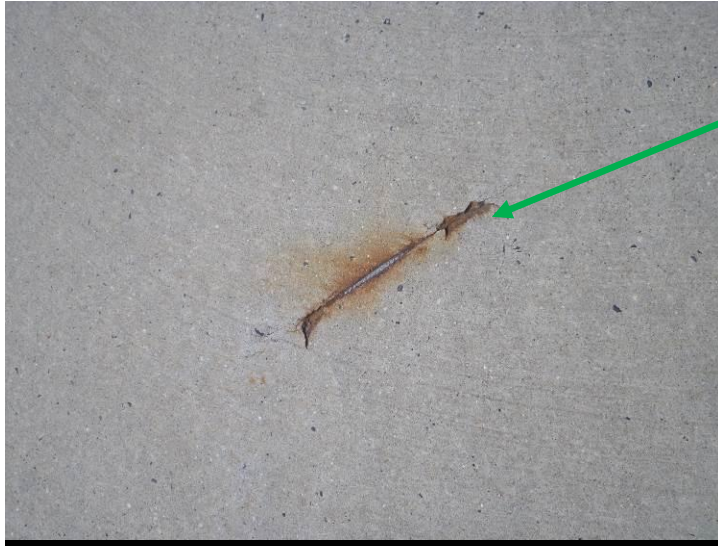
Photo 7

Exposed reinforcing due to lack of cover.

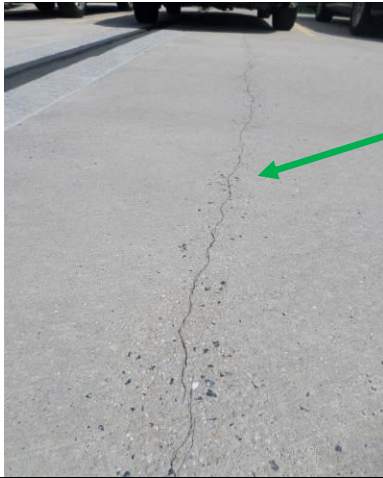
Photo 8

- observed to have cracking which requires structural repair and waterproofing (Photo 8).
8. A column splice connection was observed to be leaching and spalled which requires structural repair. (Photo 15)
  9. A spandrel to wall welded connection was observed to have been modified after construction. Upon investigation, it was confirmed that the modification was required. The original welded connection was found to be an inappropriate connection and was therefore cut and a slip joint was installed by the original precaster, High Concrete. (Photo 14,18)
  10. The roof and interior level stairtower door thresholds and hardware are moderately damaged or missing which requires replacement (Photo 9,10,11,12,13).
  11. An interior fencing barrier is damaged and requires repair now. (Photo 17)

Crack in tee to tee flange above tee stem.

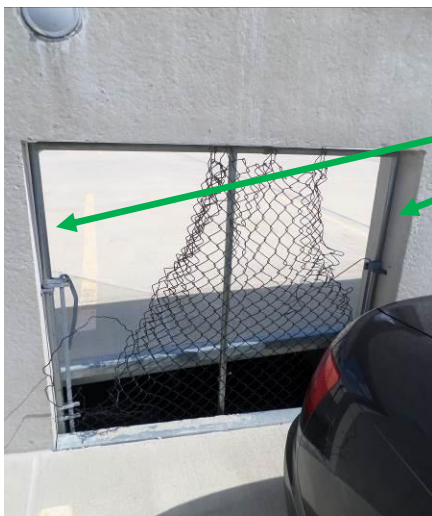
Photo 17

Fencing detached from frame.

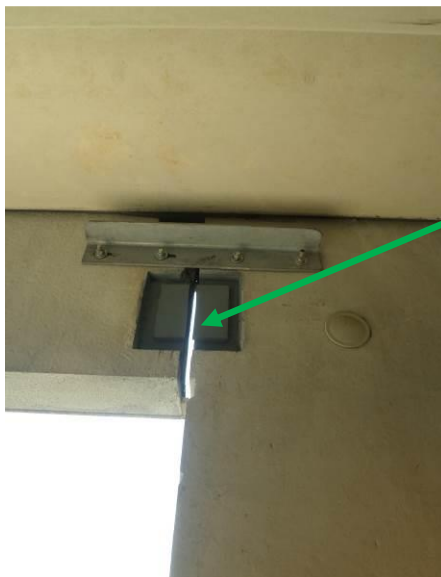
Photo 18

Spandrel cracked welded connection, which is opposite side of damage shown in Photo 14. This welded connection was replaced with slotted angle connection directly above it.

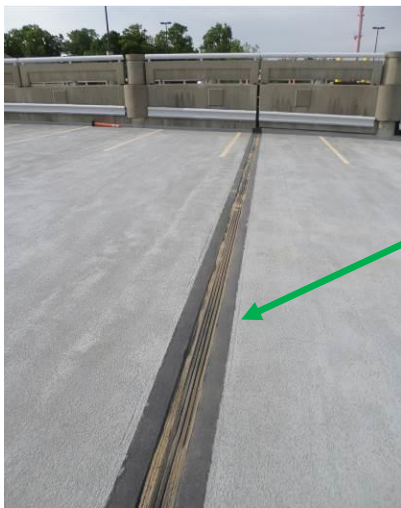
Photo 2

Expansion joint in fair condition.

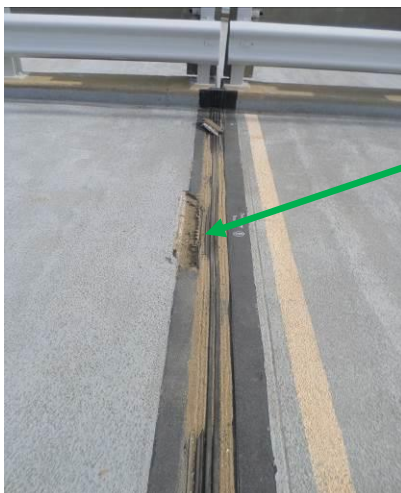
Photo 3

Damaged expansion joint.

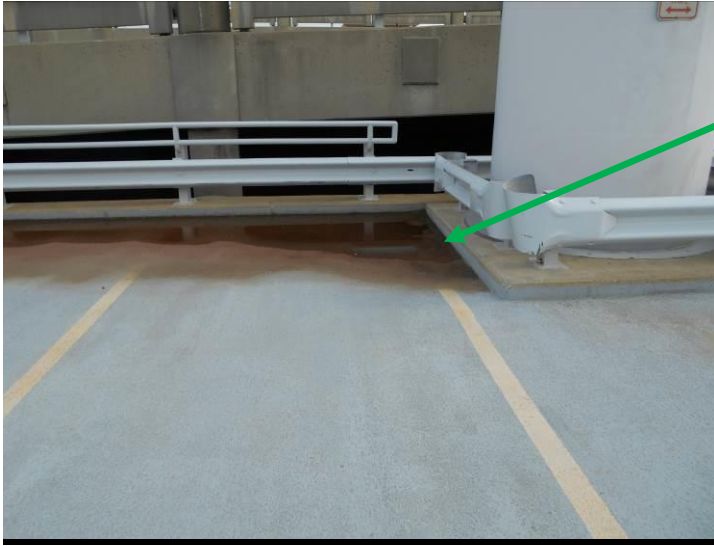
Photo 4

Ponding

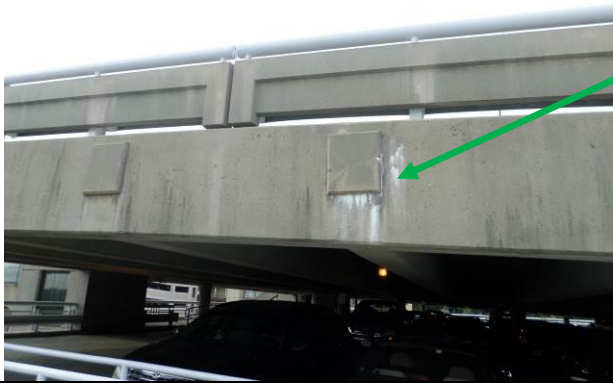
Photo 5

6. Significant but localized beam leaching was observed and requires repair now (Photo 5).
7. The stairtower roof slab soffits were observed to have minor leaching cracks and minor efflorescence which require structural repair and waterproofing to address deterioration (Photo 13)

Leaching at P/T tendon cap at end of beam.

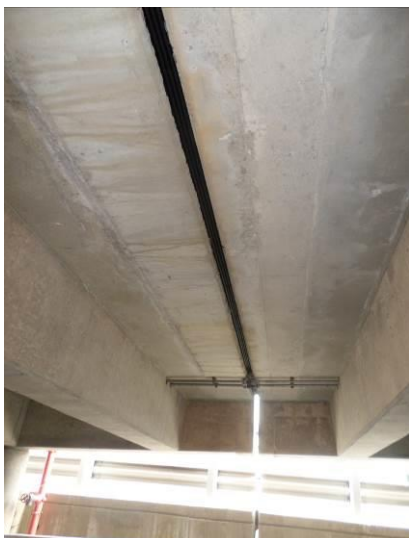
Photo 6

Expansion joint soffit shows no evidence of significant leaking.

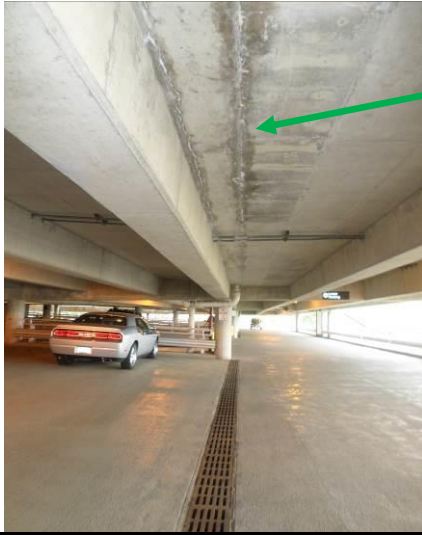
Photo 7

Leaching at trench drain soffit.

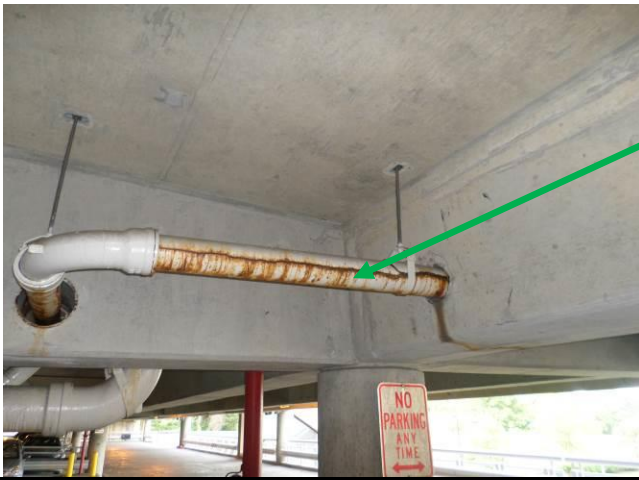
Photo 8

Rusted and split drain piping.

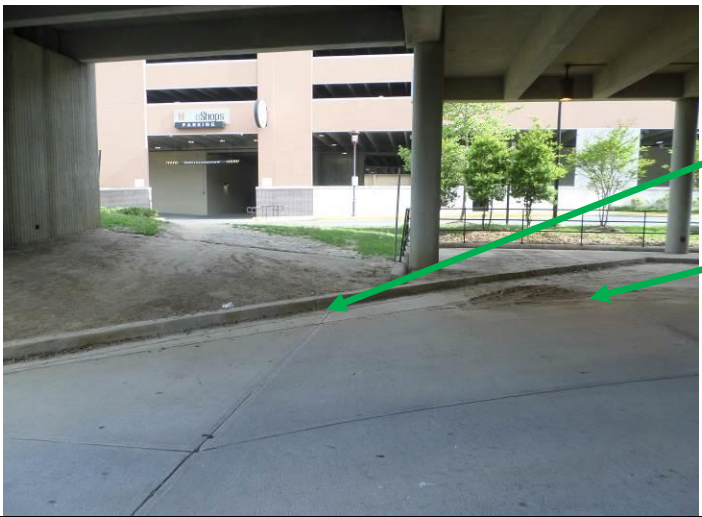
Unpainted curbs. Curbs are recommended to be painted yellow.

Dirt spills over curb and fills into vehicular and pedestrian travel paths.

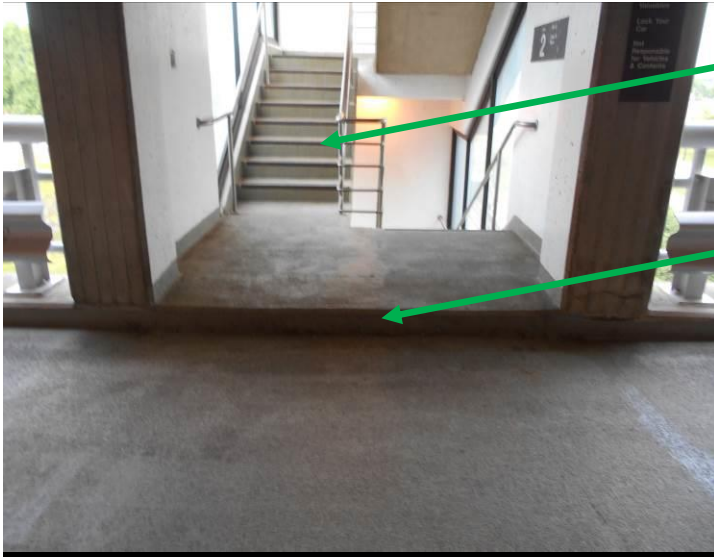
Photo 10

Black stair nosings provide color contrast so no yellow paint is recommended.

Unpainted curb at stair tower recommended to be painted yellow.

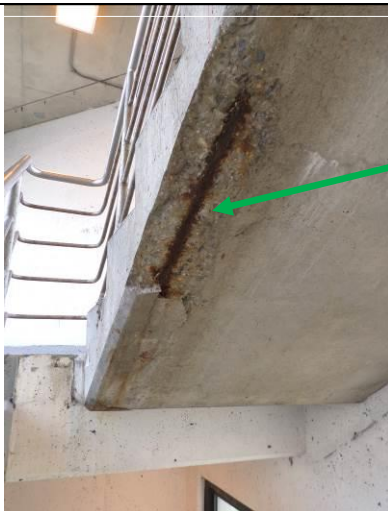
Photo 11

8. A few stair soffits were observed to have moderate cracking and spalling which require structural repair and waterproofing to address deterioration (Photo 11)

Spall at stair soffit with exposed reinforcing.

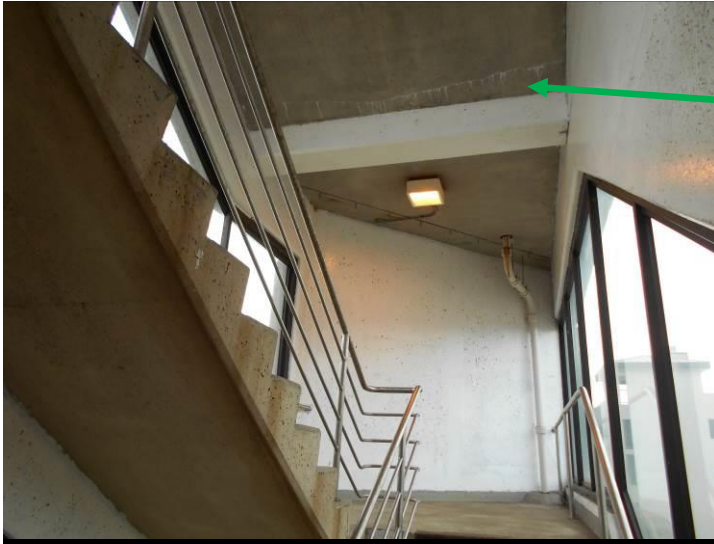
Photo 13

Leaching at stair tower soffit.

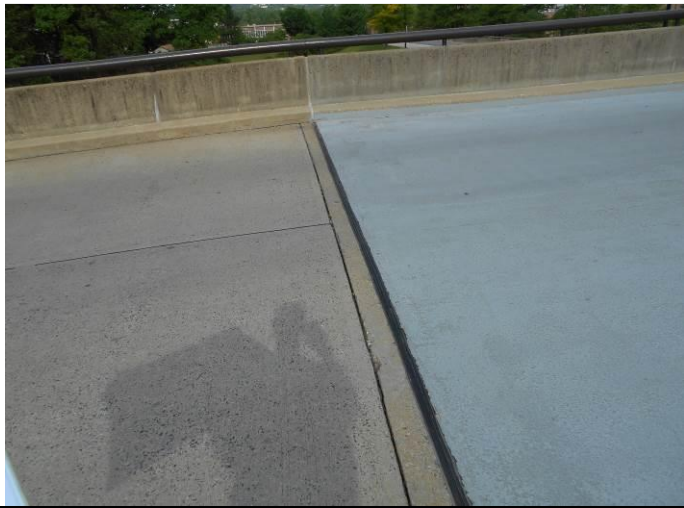
Photo 14

Transition between S.O.G. to bridge.

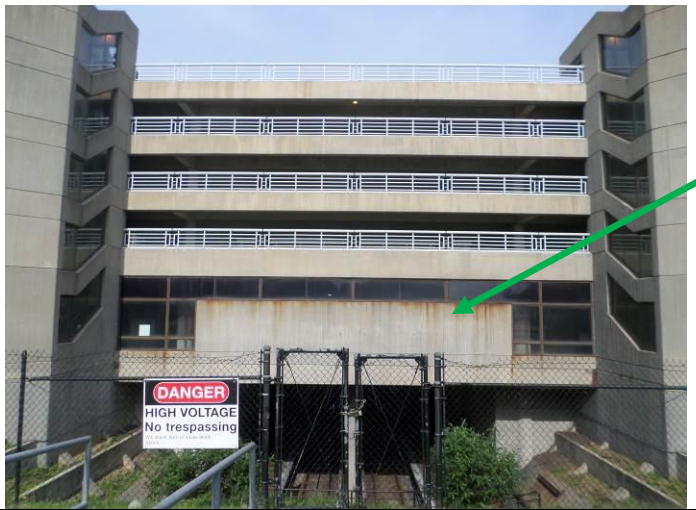
Photo 17

9. A moderate amount of the concrete bridge abutment was observed to be leaching and rusting which requires structural repair. (Photo 15)
10. The lowest level storefront is mildly corroded which requires repair now to forestall replacement (Photo 17).

Exterior façade showing rusting storefront.

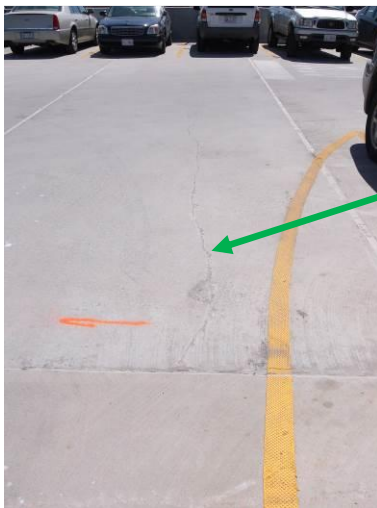
Photo 2

Cracked double tee floor slab.

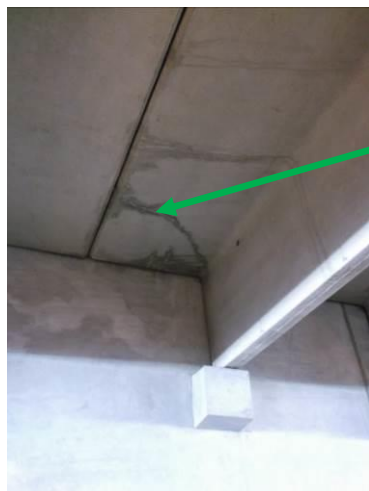
Photo 3

Leaching through cracked double tee floor slab.

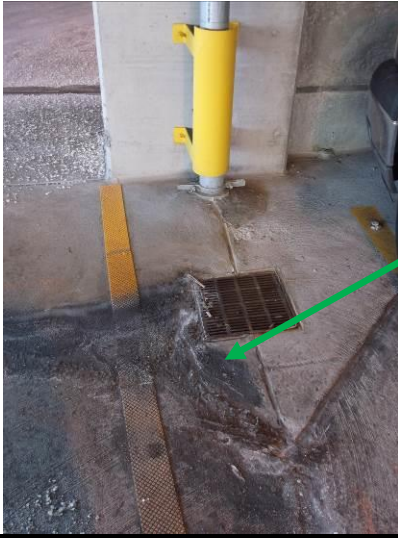
Photo 4

Ponding at floor drain.

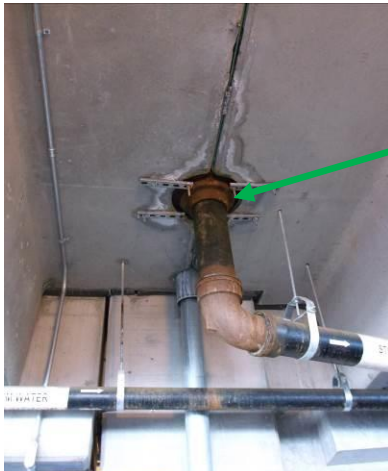
Photo 5

Rusting of floor drain and piping.

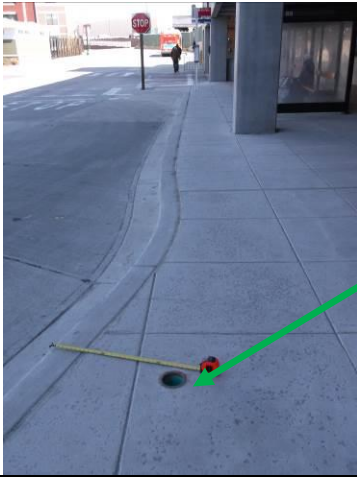
Photo 7

Uncovered hole in sidewalk, and unpainted curb. Curbs are recommended to be painted yellow.
