**Asset Management Plan  
WMATA Parking Garages  
Volume 2 of 3  
February 2015  
Walker Restoration Consultants**

ASSET MANAGEMENT PLAN

WASHINGTON AREA  
METROPOLITAN TRANSIT  
AUTHORITY PARKING GARAGES

FEBRUARY, 2015  
VOLUME 2 OF 3

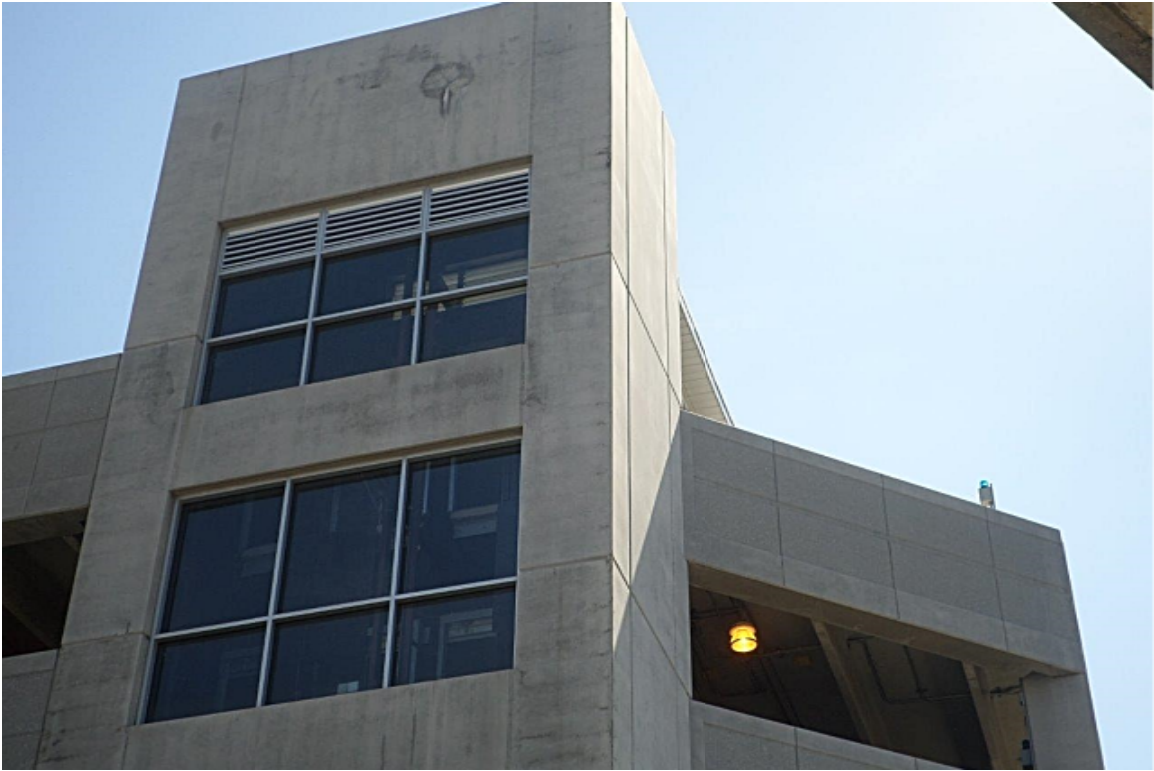
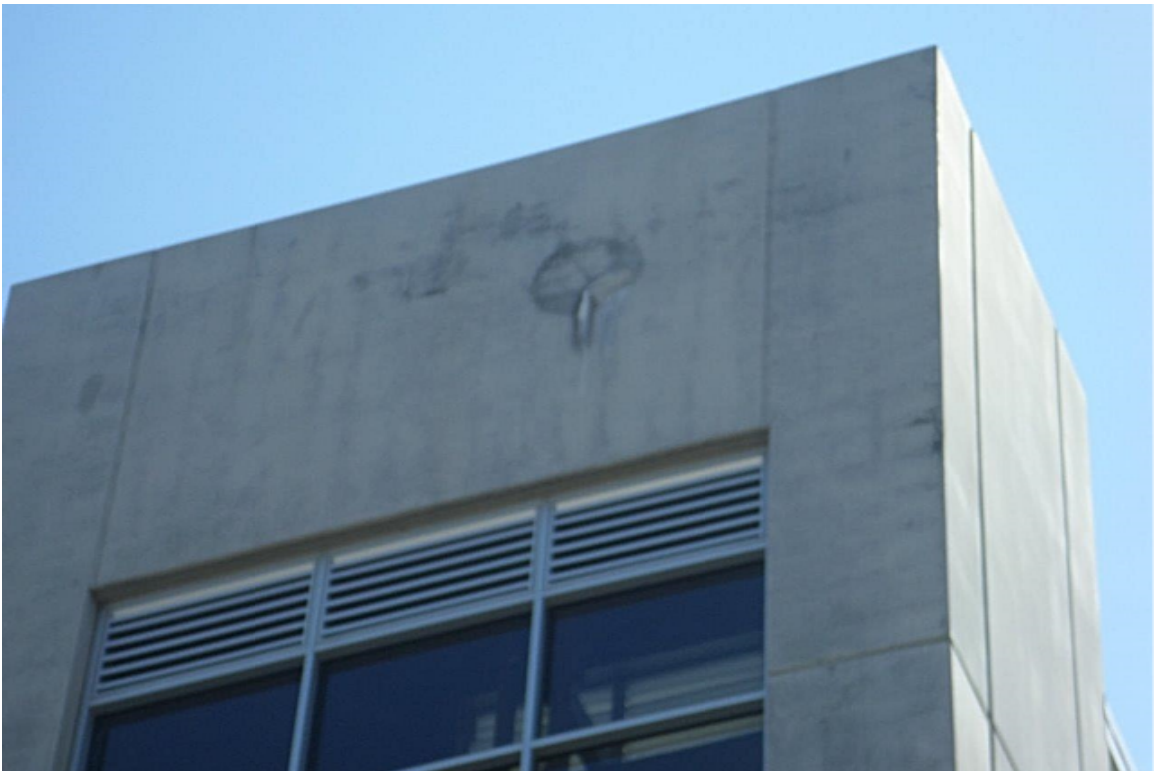
On Tuesday we observed a leaching spall on the star/elevator tower which, based on the visual information, is not an immediate hazard, but should be repaired this summer. The attached photos show the location of the spall.
