# ASSET (BUS SHELTER) IMPROVEMENT EVALUATION STUDY

**Final Report**

**June 2013**

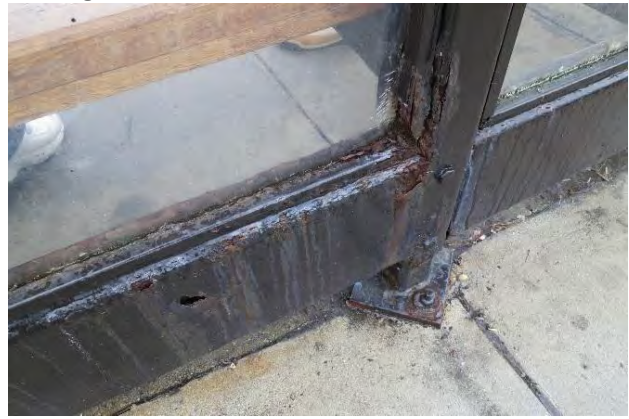
and panel condition, with most shelters showing rust and warped or broken panels. Shelters B and D are in the worst condition, with poor pads and significant rust on their frames. Shelter A is the only shelter without significant rust on its frame. Shelter E has damaged panels, including one popping out of the frame. Dome tops at the station are slightly below average, with fading and cracking present. **Figures 2 through 5** illustrate the different shelter conditions at the station, while **Figure 6** summarizes each shelter’s overall condition score.

**Figure 3: Shelter D Rust and Hole in Frame**

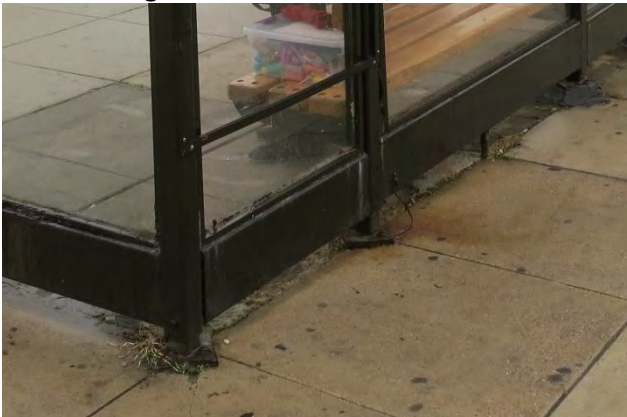
**Figure 4: Cracked Pad, Shelter B**

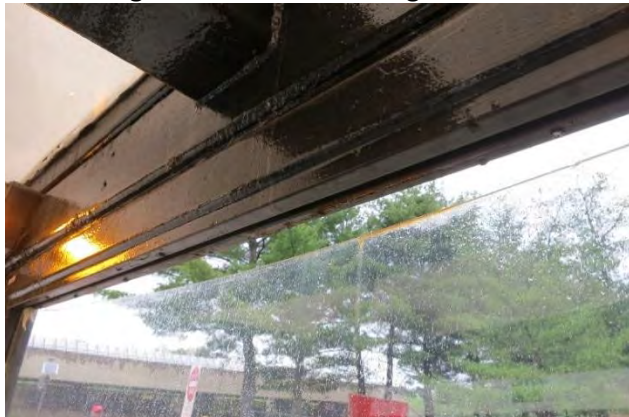
**Figure 5: Shelter E Damaged Panel**

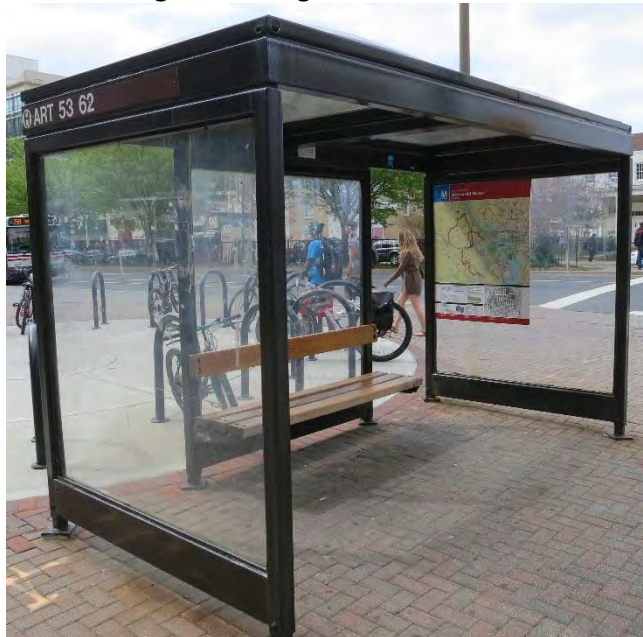
Figure 14: Single Frame Shelters

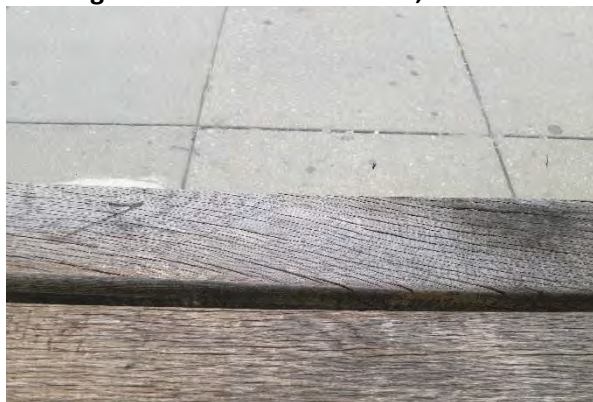
**Figure 28: Weathered Bench, Shelter B**

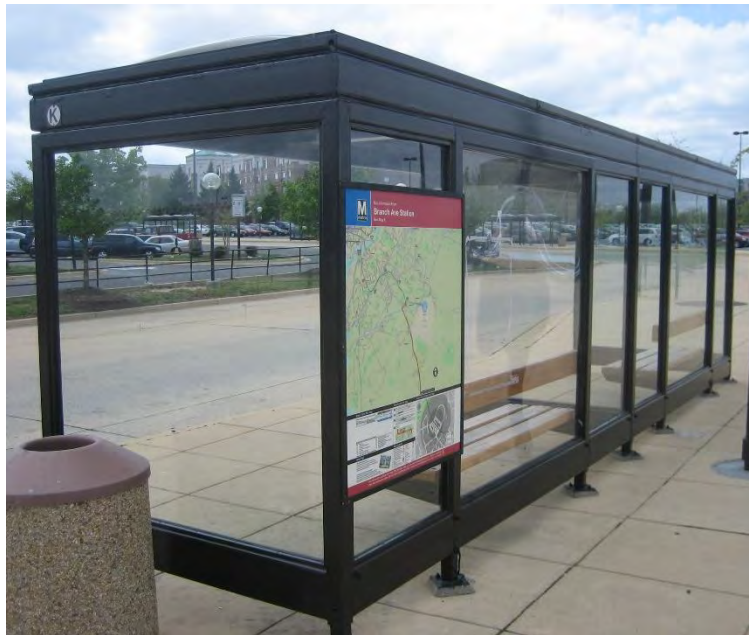
Overall, shelter conditions at the station are above average, with a station condition score of 3.8. **Table 6** summarizes conditions for each individual shelter. The shelters had notably good frame conditions and good dome top conditions, particularly shelters B, E, K, O, and P. There was very little visible rust on any of the shelters, though chipped or peeled frame paint was noticed on shelters E, F, and L. Shelters B and P each had a panel missing, though other panels on shelter B were in good condition. The east Kiss-and-Ride shelter had two panels missing and a worn/weathered bench. Of any element at the station, the shelter benches were in the worst condition overall.

Figure 32: Good Overall Shelter Condition, Shelter K

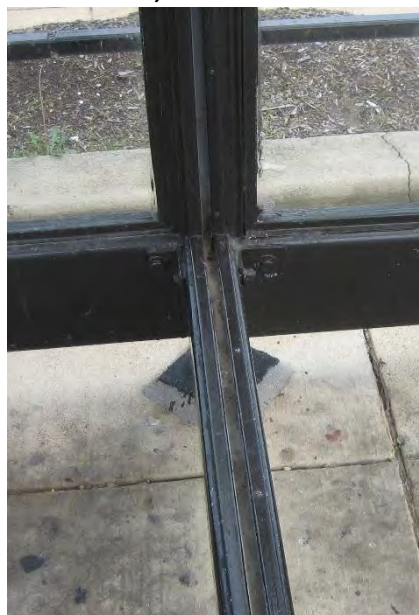
**Figure 35: One of Two Missing Panels, East Kiss & Ride**

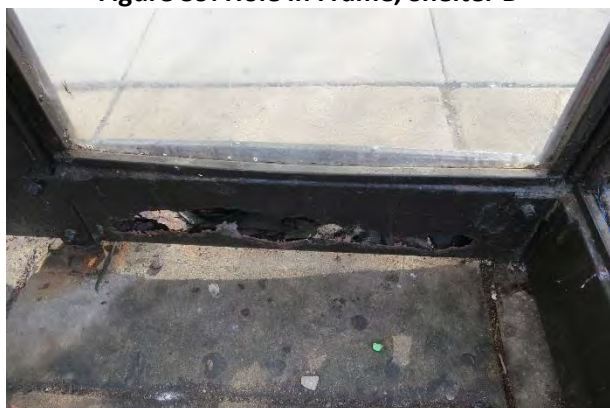
Overall, shelter conditions at the station are slightly below average, with a station condition score of 2.9. **Table 7** summarizes conditions for each individual shelter. The shelters, as a whole, scored the lowest in panel condition and dome top condition. Shelter A is in particularly bad condition, with two missing panels, a cracked dome top and a rusted frame with one leg missing entirely. Shelter D is also in poor condition, with a large hole in its frame. Shelter B and the Central Avenue shelter both have large cracks in their dome tops.

**Figure 39: Hole in Frame, Shelter D**

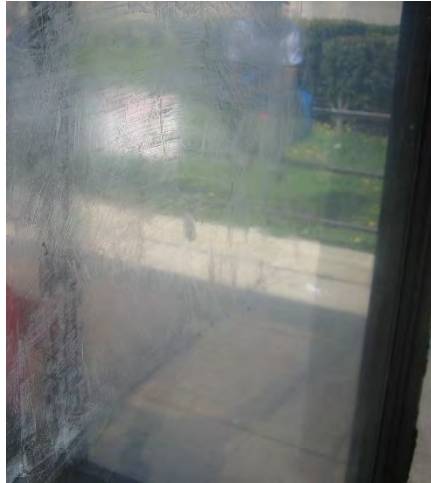
**Figure 45: Smeared/Scratched Panel, Shelter E**

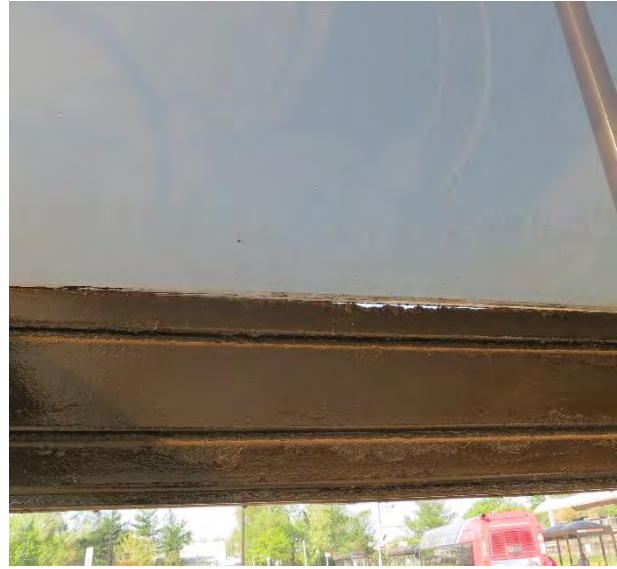
**Figure 58: Frame Rust and Separated Dome Top, Kiss & Ride Shelter**

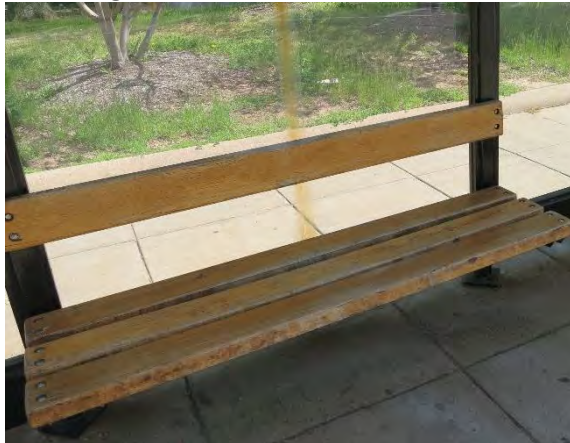
Overall, shelter conditions at the station are average, with a station condition score of 3.0. **Table 11** summarizes conditions for each individual shelter. The shelters as a whole scored the lowest in bench condition. Shelters A and B and the Kiss-and-Ride shelter all had worn benches. Shelter panels at the station were generally in average condition, with some rust stains, fading, and scratching on all of them.

**Figure 61: Worn Bench, Shelter B**

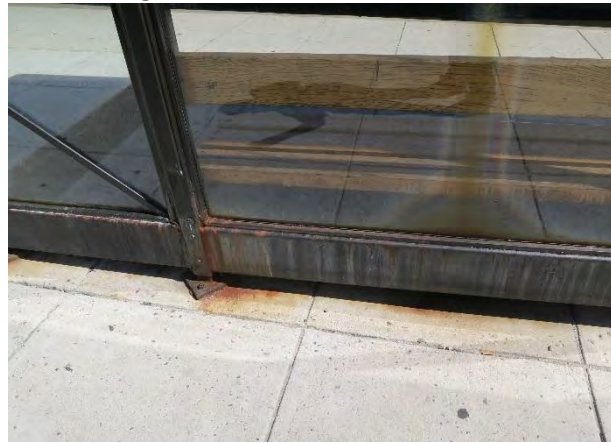
An average amount of rust was found on all the shelter frames with the exception of shelter A, which had little rust but had signs of past rusting on its pad and panels. Shelter C had significant rust on its frame.

**Figure 62: Frame Rust, Shelter C**

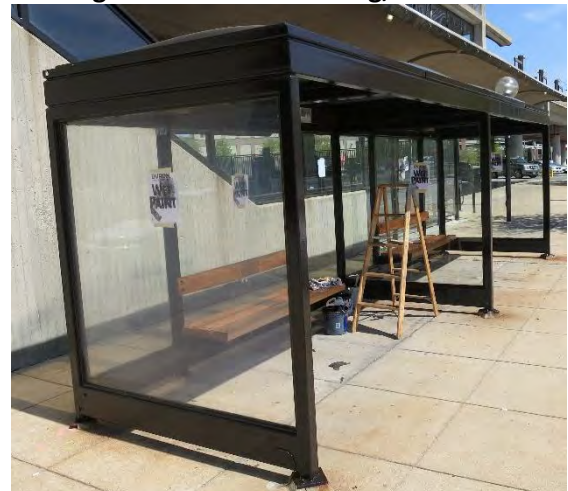
**Figure 67: Frame Painting, Shelter A**

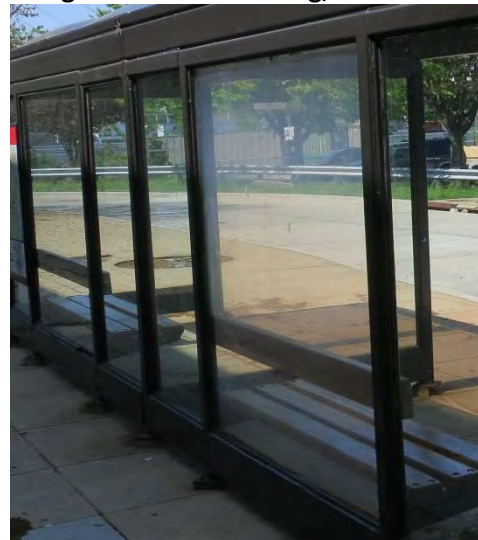
**Figure 69: Panel Fading, Shelter D**

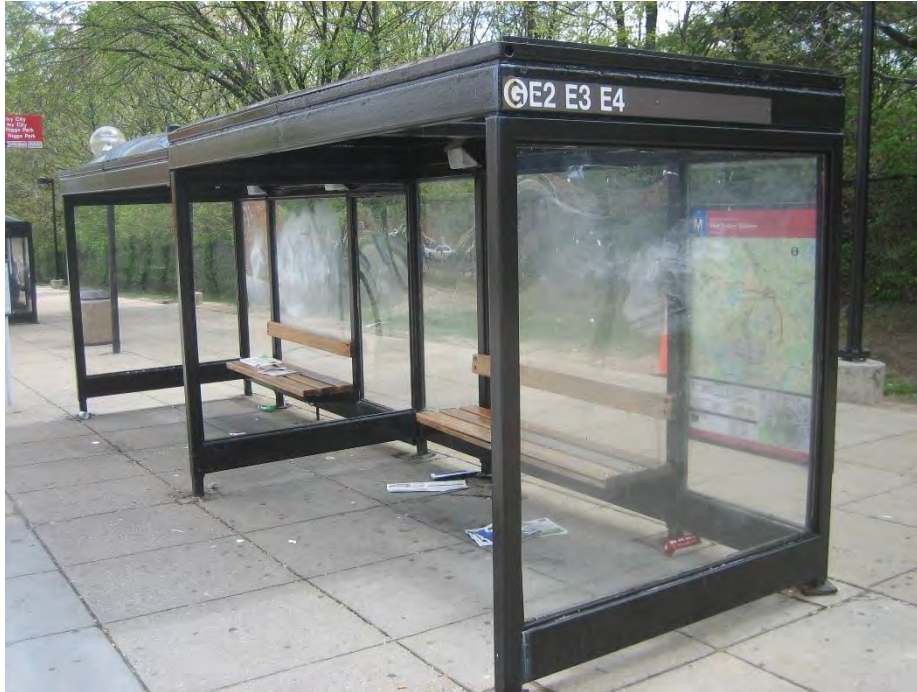
Figure 72: Poor Condition of Shelter G, Missing Panels, Rust and Missing Dome Top

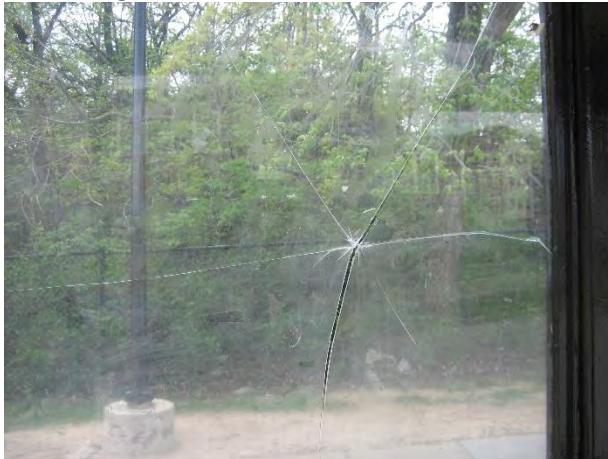
**Figure 73: Cracked Panel, Shelter H**

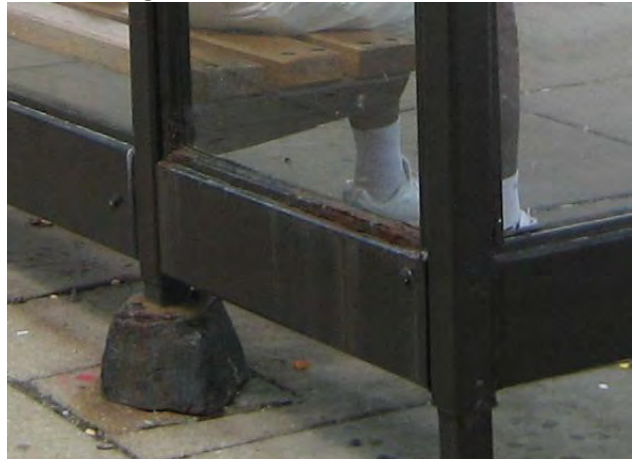
**Figure 74: Frame Rust, Shelter E**

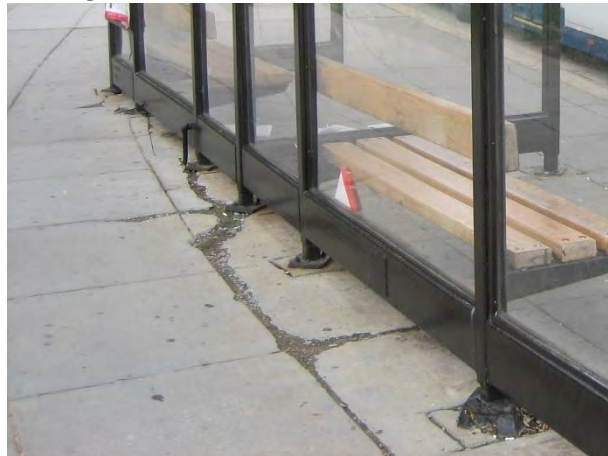
**Figure 75: Poor Pad Condition, Shelter A**

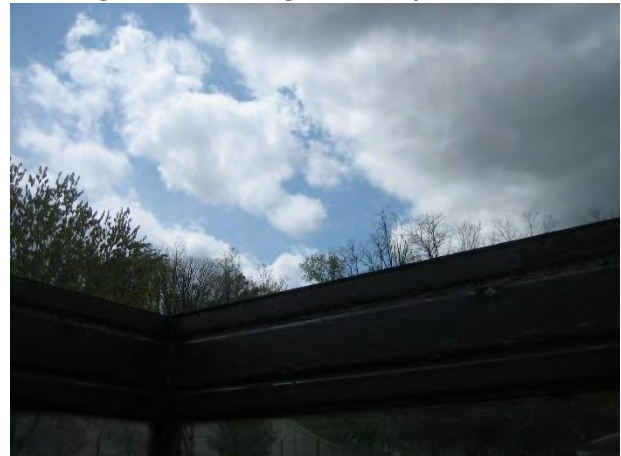
**Figure 76: Missing Dome Top, Shelter C**

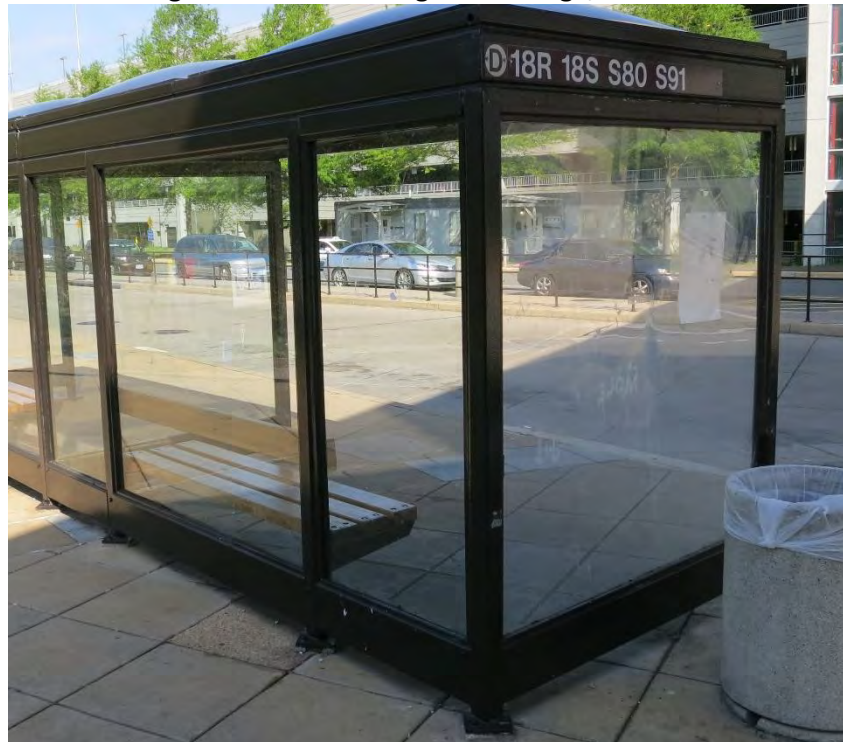
Figure 81: Panel Fading and Damage, Shelter D

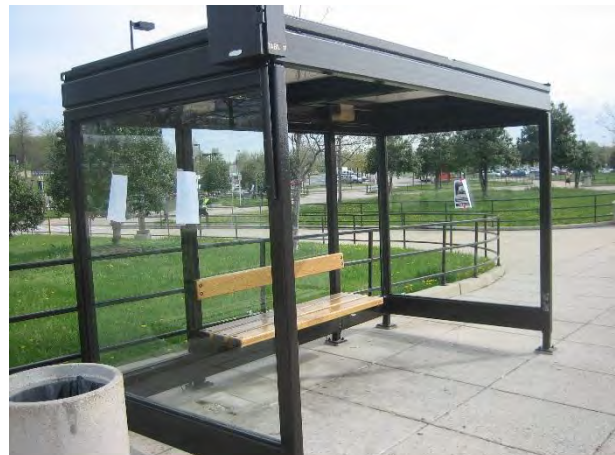
**Figure 85: Excellent Shelter Condition, North Kiss & Ride**

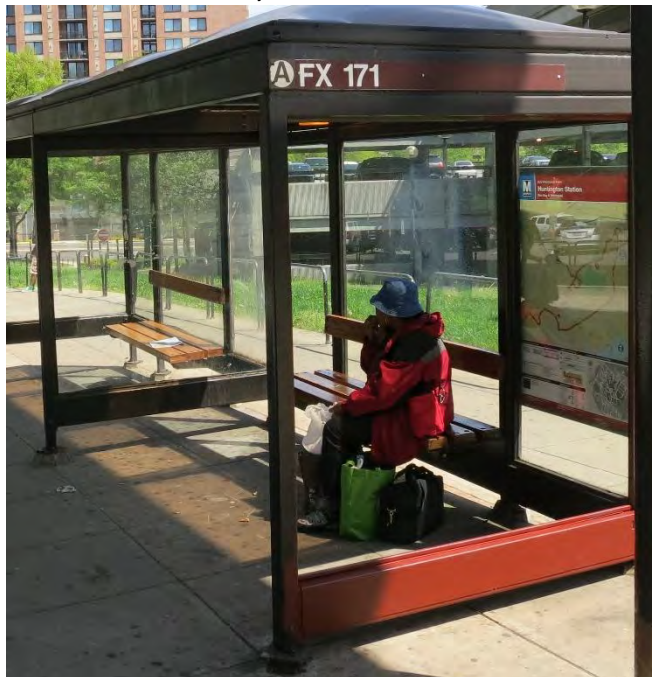
Figure 94: Missing Panel, Cracked Pad and Frame Rust, Shelter A North

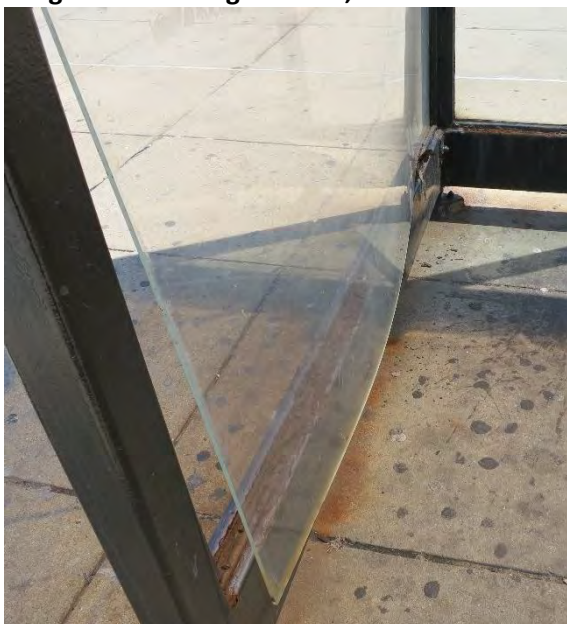
**Figure 96: Damaged Panel, Shelter C South**

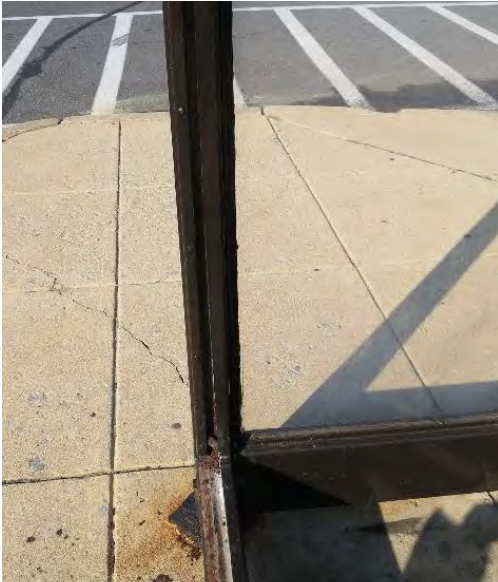
**Figure 101: Missing Panel, Kiss & Ride Shelter**

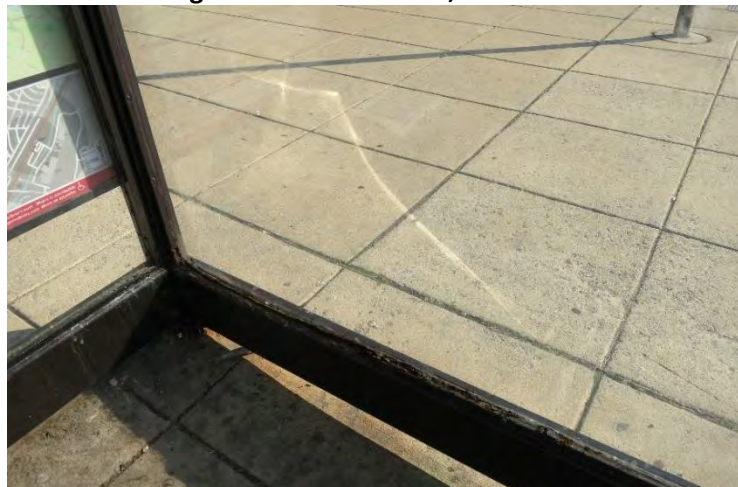
**Figure 103: Frame Rust, Shelter D**

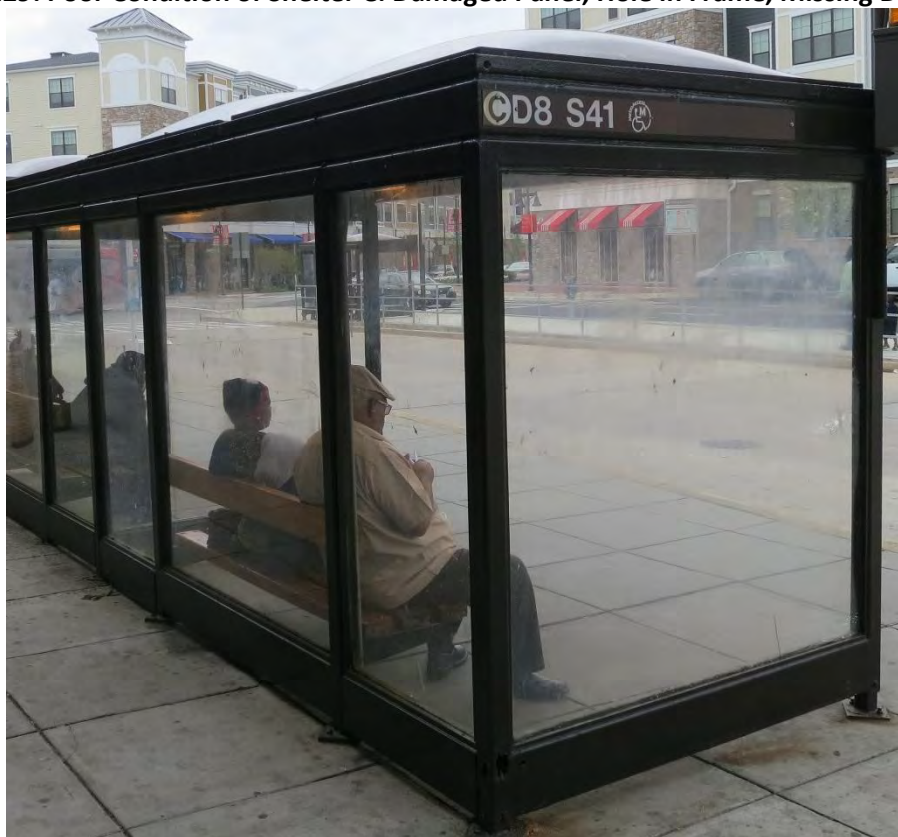
Overall, shelter conditions at the station are slightly below average, with a station condition score of 2.9. **Table 23** summarizes conditions for each individual shelter. The shelters as a whole scored the lowest in panel condition and dome top condition. Shelter C had a missing dome top while shelters A, D and E had damaged dome tops. Shelters C, D and F had damaged panels. Frames at the station all showed signs of rust with the exception of shelter F. Shelters C and E had a significant amount of rust on their frames, and shelter C even had a hole in its frame. Bench conditions were average at each shelter, while pad conditions were excellent, as the bus bays were recently reconstructed.

**Figure 129: Poor Condition of Shelter C: Damaged Panel, Hole in Frame, Missing Dome Top**

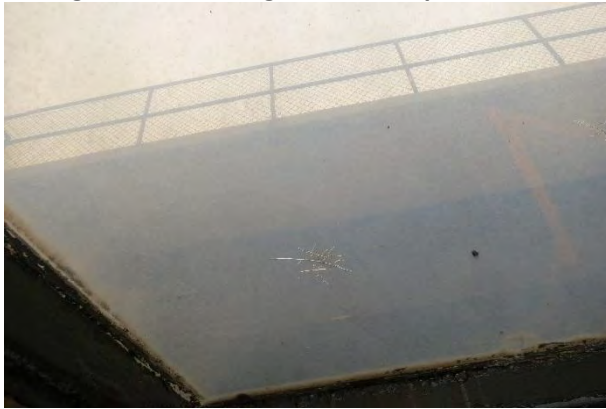
**Figure 132: Damaged Dome Top, Shelter D**

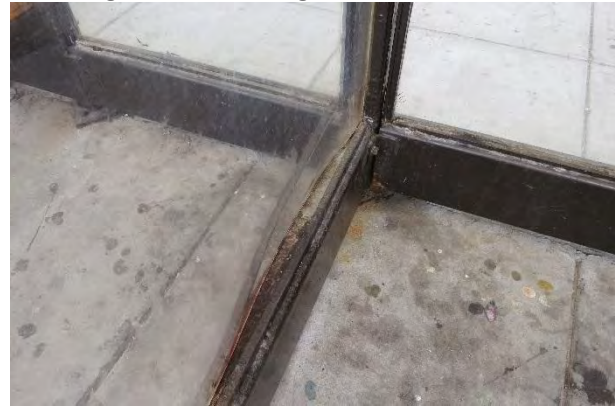
**Figure 133: Damaged Panel, Shelter D**

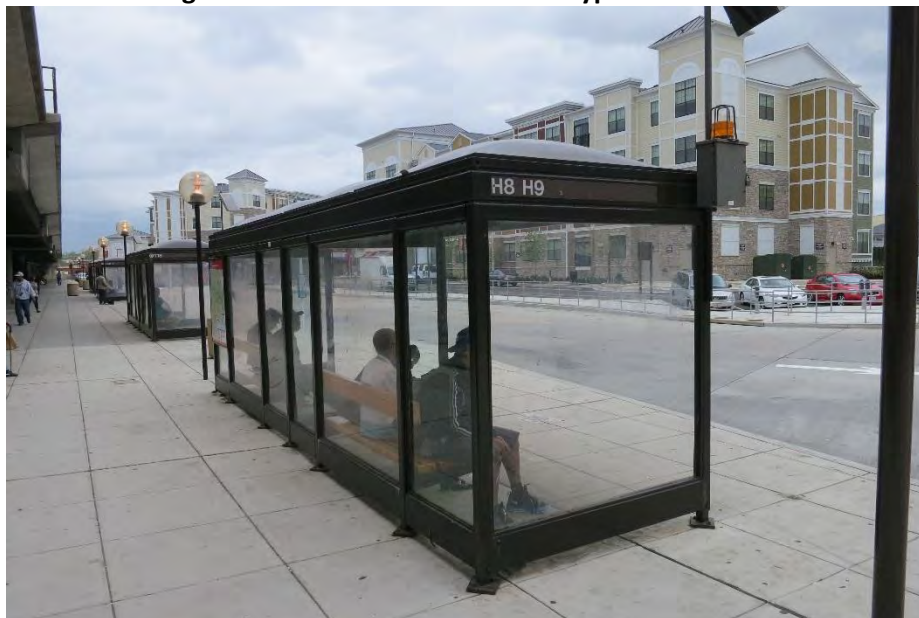
**Figure 134: Good Pad Conditions Typical at Station**

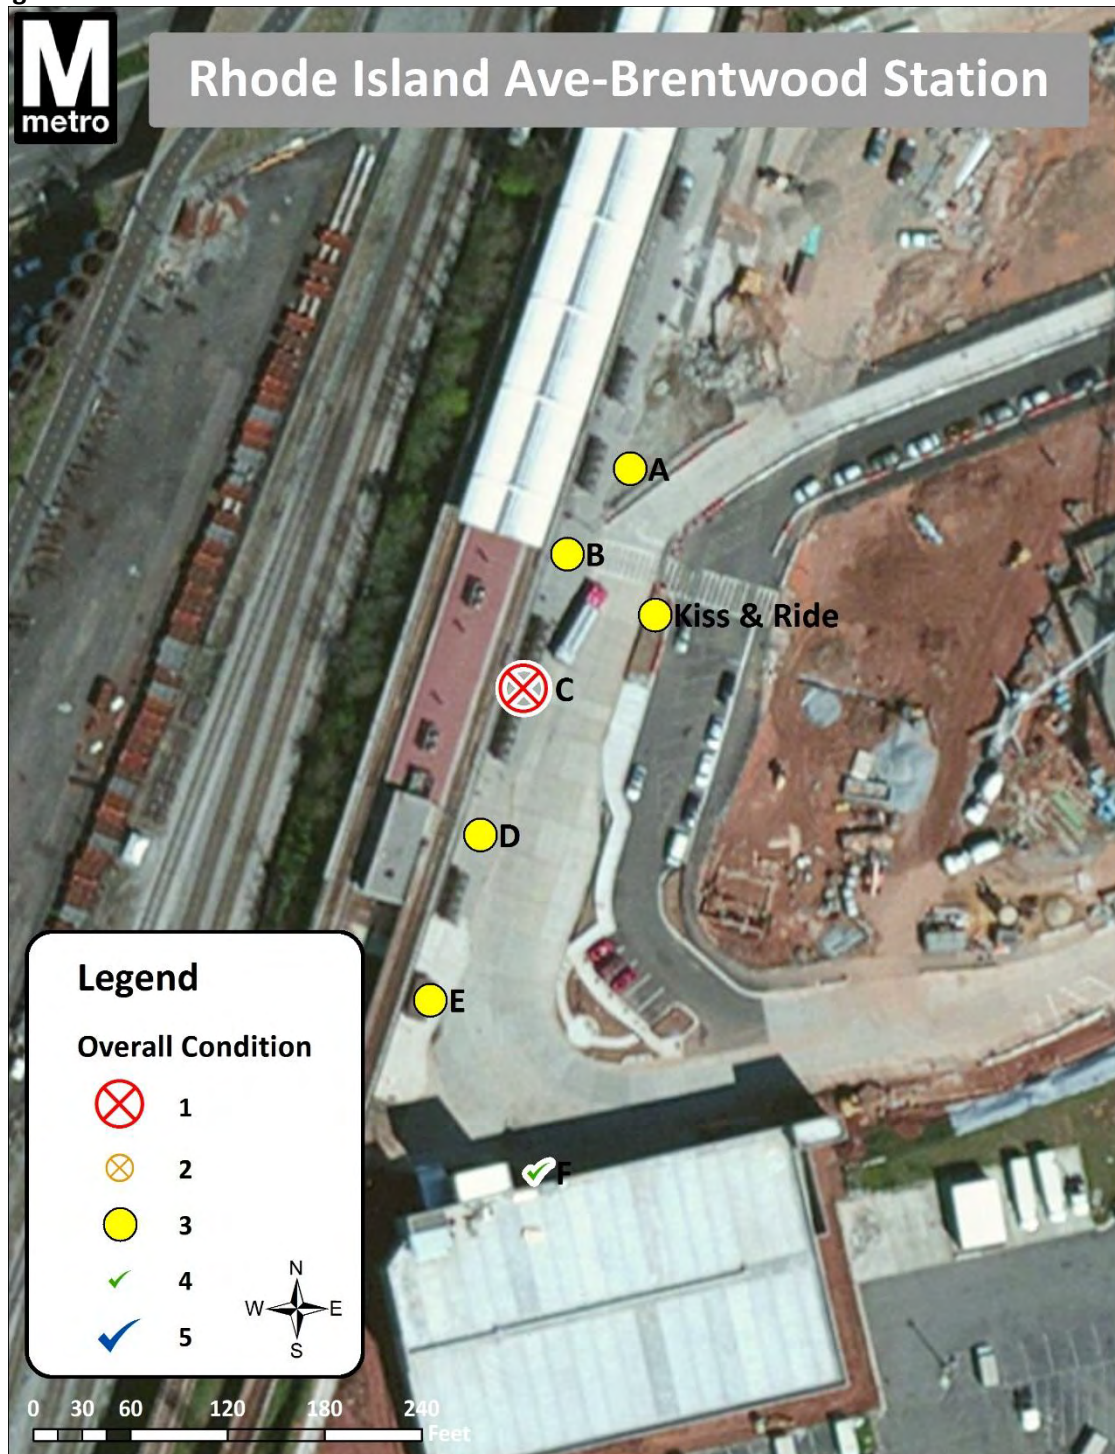
Figure 135: Overall Condition Score of Rhode Island Ave-Brentwood Metrorail Station Shelters

Overall, the station was ranked 5<sup>th</sup> for replacement based on shelter condition and demand. Based on shelter condition only, the station 12<sup>th</sup> ranked for replacement.

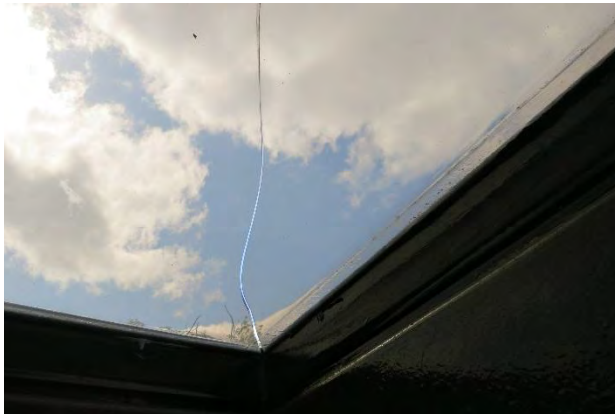
Overall, shelter conditions at the station are above average, with a station condition score of 3.5. **Table 27** summarizes conditions for each individual shelter. The shelters as a whole scored the lowest in bench condition, with worn benches at shelters C and L. Frame conditions were very good, with little to no rust on any of the shelters. Dome top conditions were above average, with only shelter C having damage. Panel conditions were also above average, with some smearing, scratching or fading present only at shelters A, J, K, L and the Kiss-and-Ride shelters. Shelter L also had some damage to one of its panels. Pad conditions were average, with some minor cracking at each shelter with the exception of A and K.

**Figure 155: Cracked Dome Top, Shelter C**

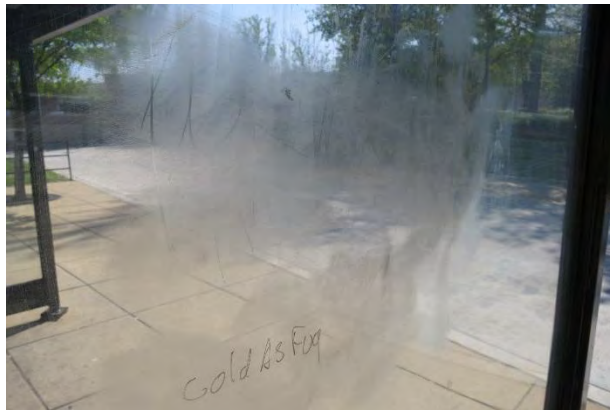
Figure 171: Faded/Smeared Panel, Shelter A

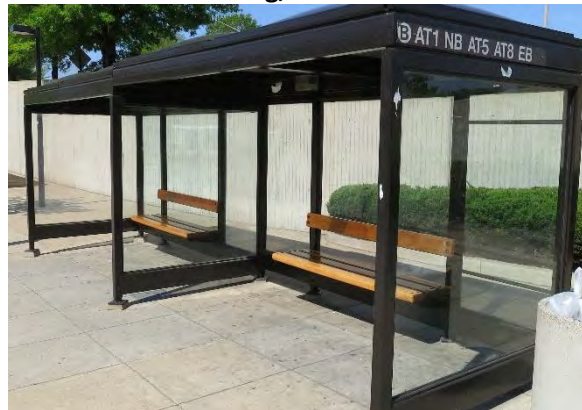
Figure 172: Good Frame Condition, Minor Paint Peeling, Shelter B

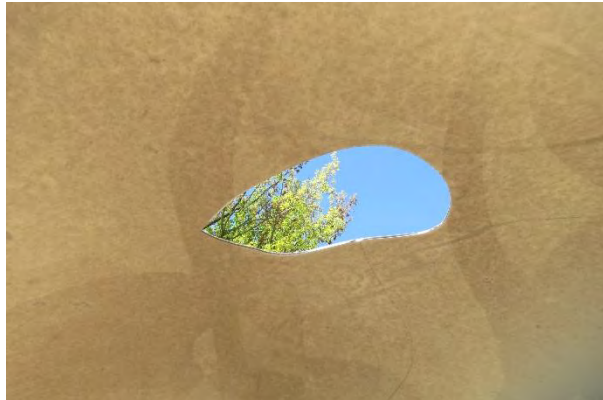
**Figure 180: Hole in Dome Top, Shelter G South**

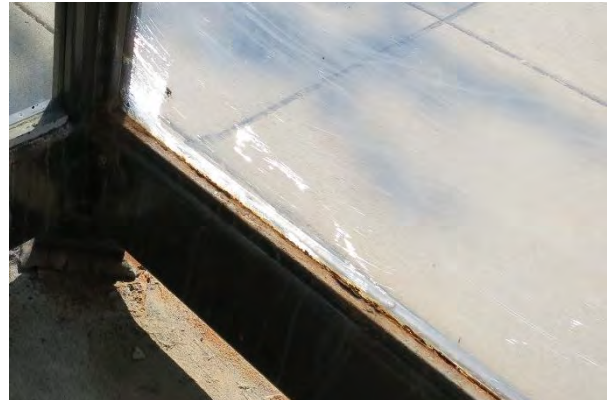
**Figure 181: Damaged Panel, Shelter A South**

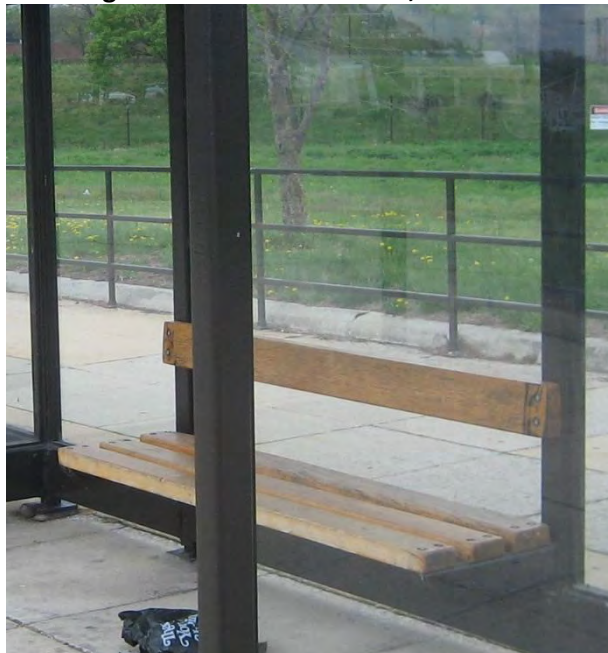
**Figure 186: Wear on Bench, Shelter A**

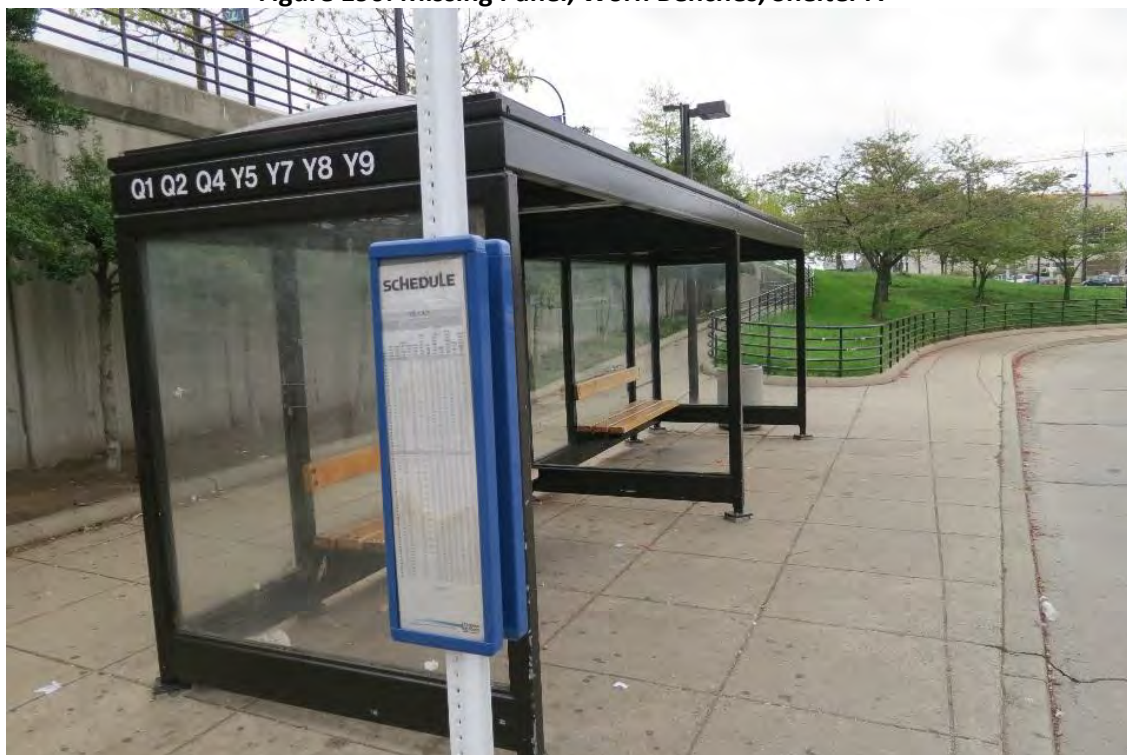
**Figure 190: Missing Panel, Worn Benches, Shelter A**

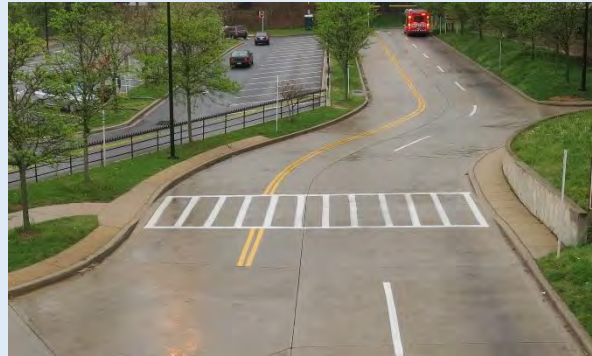
**Crosswalk Traversing Central Ave Entrance Driveway**

**Detectable Warning Panels on the Park-and-Ride Garage Entrance/Driveway curb ramps the Central Avenue/Driveway curb ramps.**

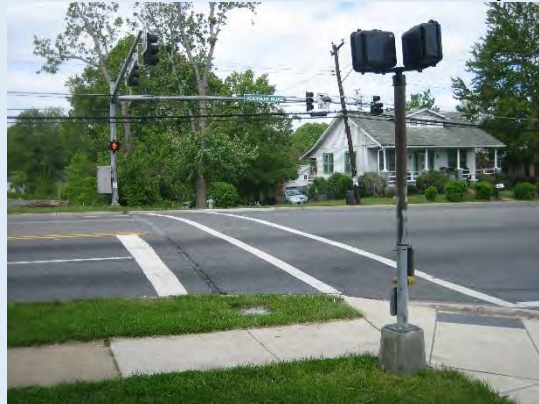
**Addison Road/Station Entrance Driveway**

**Sidewalk along the west side of Addison Road with a curb ramp at the station entrance driveway crosswalk.**

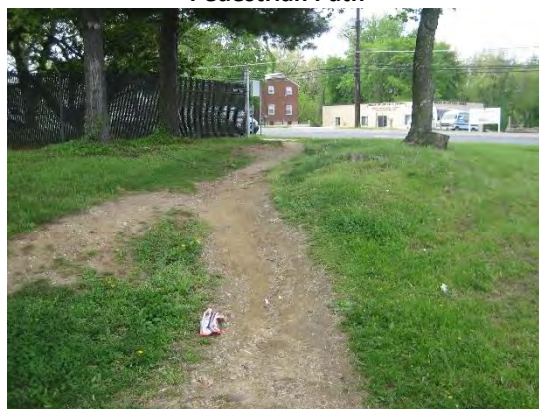
**Southeast Corner of Addison Road Intersection  
Pedestrian Path**

**Sidewalk across southeast corner of Addison Road intersection.**

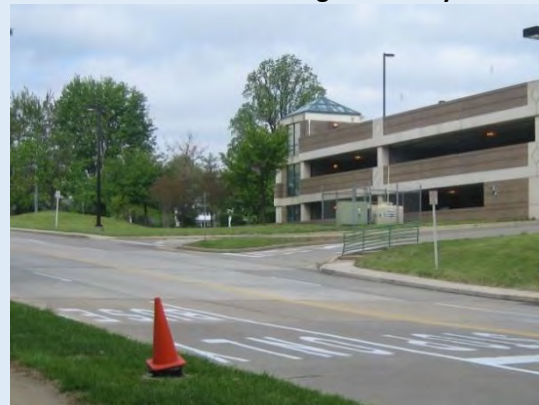
**Park-and-Ride Garage Driveway**

**Crosswalk traversing Park-and-Ride garage driveway and detectable warning panels on curb ramps there.**

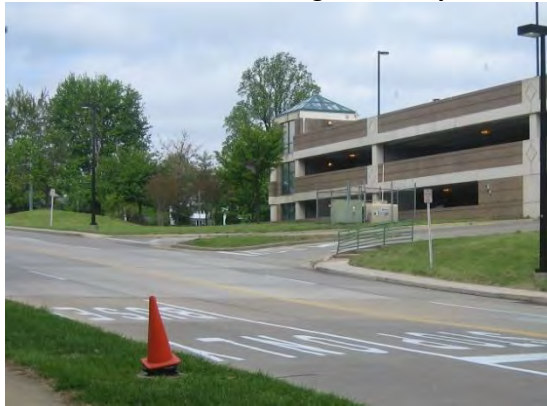
| <p><b>Stop signs at the Park-and-Ride garage driveway exit</b></p> | <p><b>Park-and-Ride Garage Driveway</b></p> |

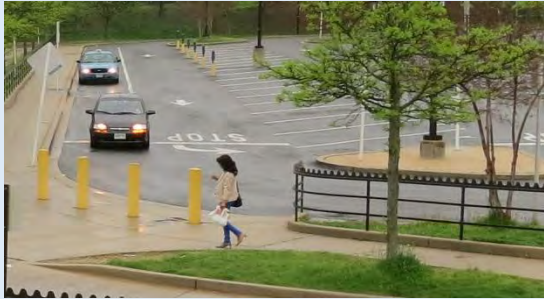
| Kiss-and-Ride Lot Issues and Recommendations: | |
|---|---|
| <p><b>Crosswalk traversing the east northbound travel lane, a curb ramp with detectable warning panel on the island there and a stop sign.</b></p> | <p><b>East Northbound Lane in Kiss-and-Ride</b></p> |

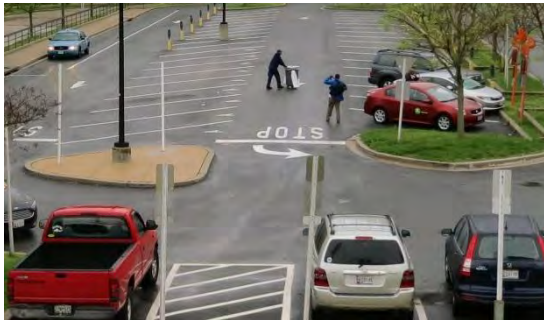
Enter” signs mark the end of the lane as a one-way. There is also a yield sign beyond the stop sign; however, this conflicts with the stop sign. **Figures 11 and 12** picture the Kiss-and-Ride lot and its travel lanes.

| Kiss-and-Ride Lot Issues and Recommendations: | |
|---|---|
| <p><b>Replace yield sign with a stop sign at the center northbound travel lane terminus.</b></p> | <p><b>Center Northbound Lane in Kiss-and-Ride</b></p> |

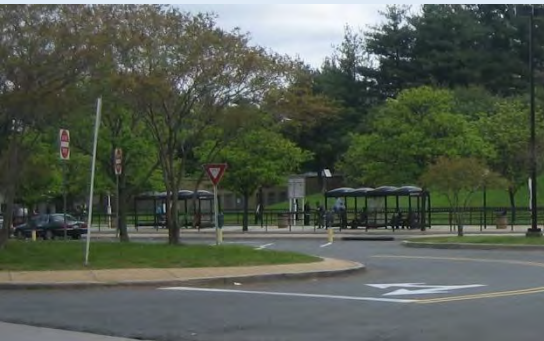
| Kiss-and-Ride Lot Issues and Recommendations: | |
|---|---|
| <p><b>Remove yield sign from southbound lane terminus.</b></p> | <p><b>Southbound Lane in Kiss-and-Ride</b></p> |

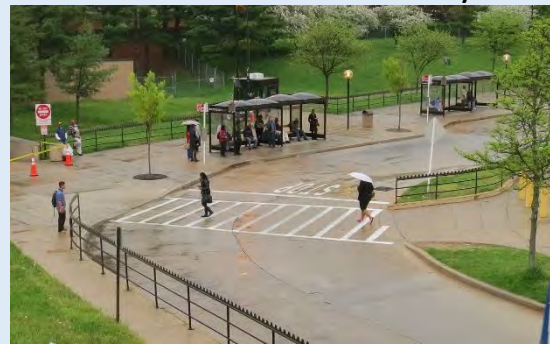
**Crosswalk at North End of Busway**

**Stop signs prior to the crosswalk that traverses the busway at its north end.**

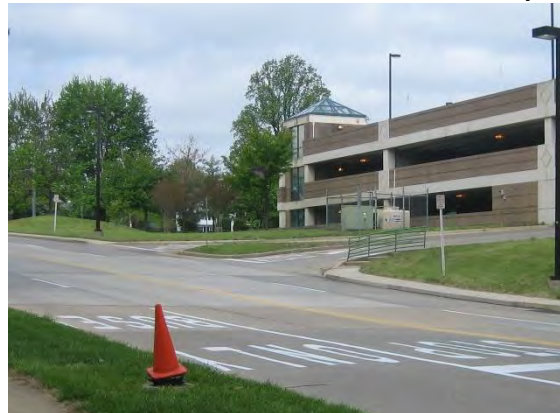
**Entrance on Addison Road Entrance Driveway**

**Stop signs at the Park-and-Ride garage driveway exit**

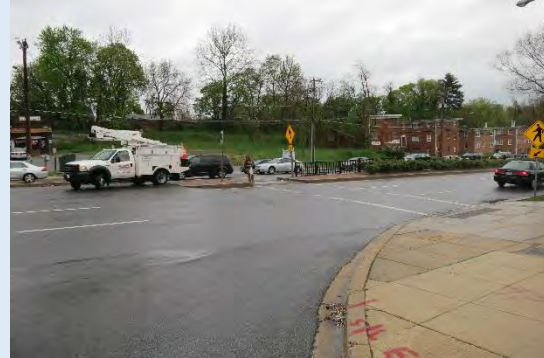
**Central Avenue Crosswalk**

**“State Law Stop for Pedestrians in Crosswalk” sign and stop lines in each direction on Central Avenue at crosswalk.**

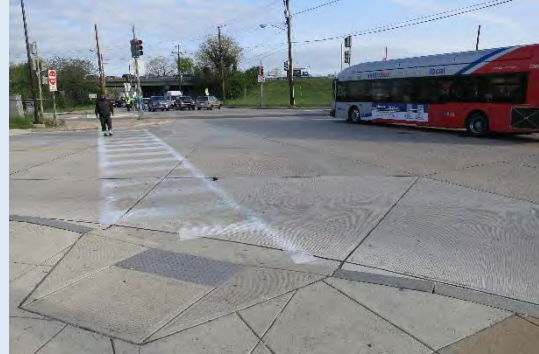
#### Stop Line Prior to Crosswalk at Howard Road.

#### Lack of Stop Line on Driveway Prior to Crosswalk

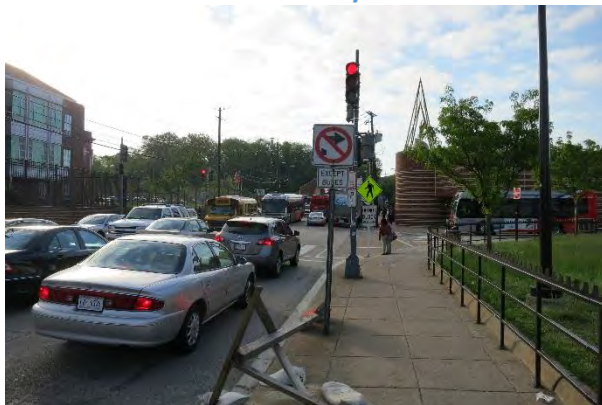
**Figure 29: Howard Road Eastbound at Signalized Driveway**

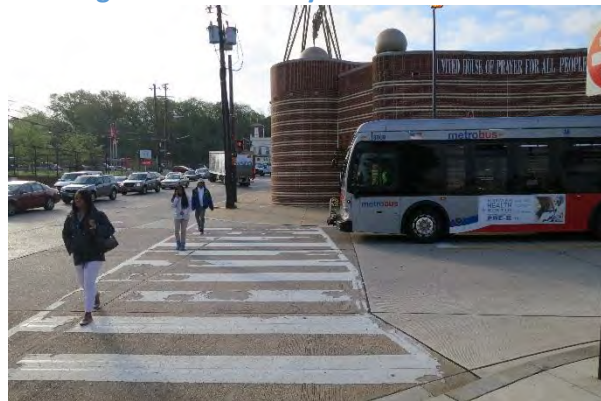
**Figure 30: East-West Crosswalk Traversing Signalized Driveway at Howard Road**

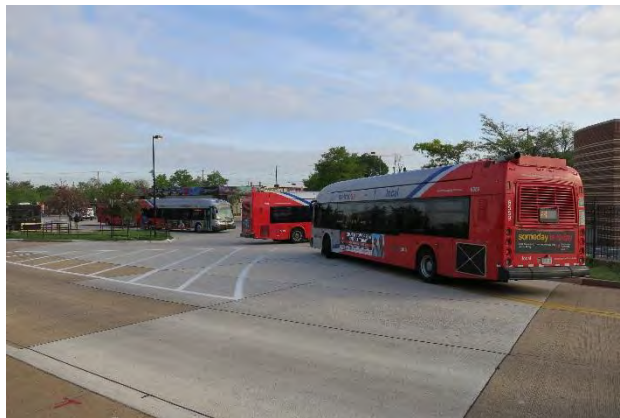
The east driveway on Howard Road serves as the main access/egress point for buses at the station. This driveway forms a signalized T intersection with Howard Road and experiences significant congestion during peak periods, with bus queues five to six buses long witnessed. Vehicles on Howard Road routinely block the intersection while vehicles often drop off station patrons in the right travel lane of the eastbound approach to the intersection as well, despite the “No Stopping or Standing” signs located there.

**Figure 31: Bus Queue During AM Peak Period from Howard Road/Signalized Driveway Intersection**

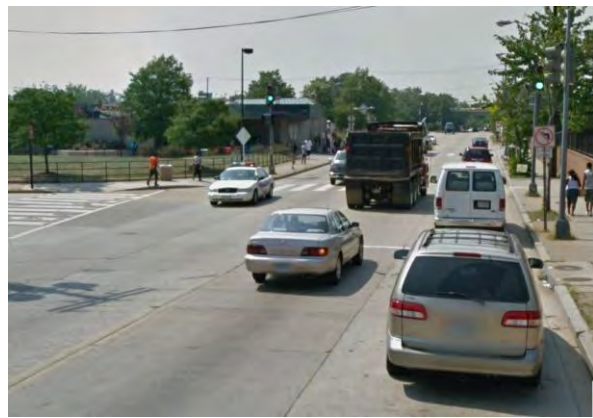
**Figure 32: Howard Road Westbound at Signalized Driveway**

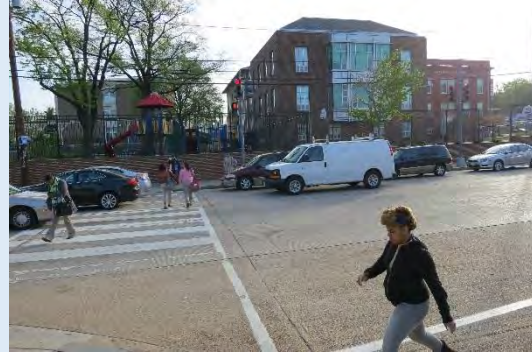
**Vehicles on Howard Road Blocking East Entrance**

**“Do Not Block Intersection” sign on Howard Road Westbound prior to the east entrance and “Do Not Block Intersection” pavement markings at the intersection.**

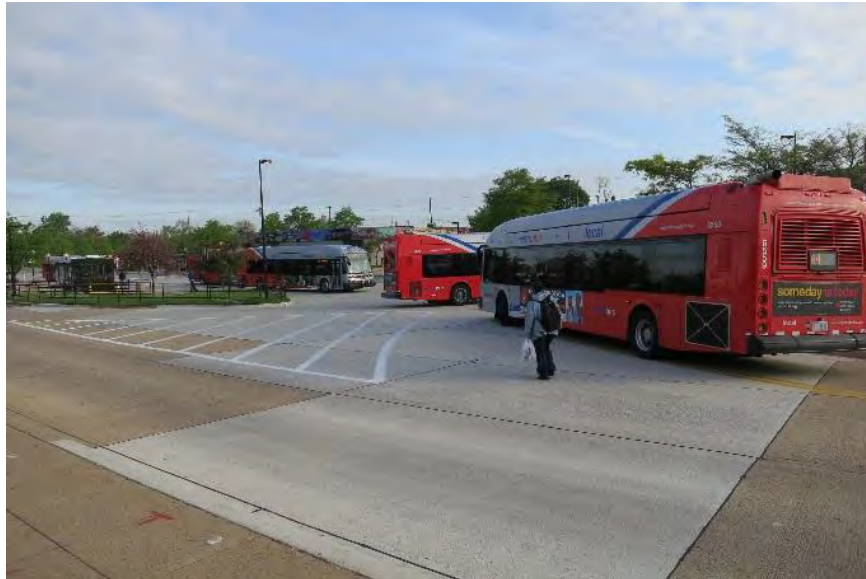
**Figure 41: Intersection of the Three Busways at the Station and Pedestrian Walking in Middle of Busway**

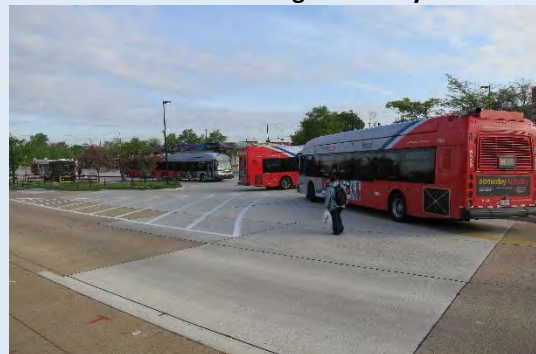
**Patrons Walking in Busway**

**Reconfiguration with one-way circulation, traffic islands, additional crosswalks and fencing in order to minimize jaywalking between the A-E bus bays and the Metrorail station entrance and walking in the Martin Luther King Jr. Avenue entrance busway.**

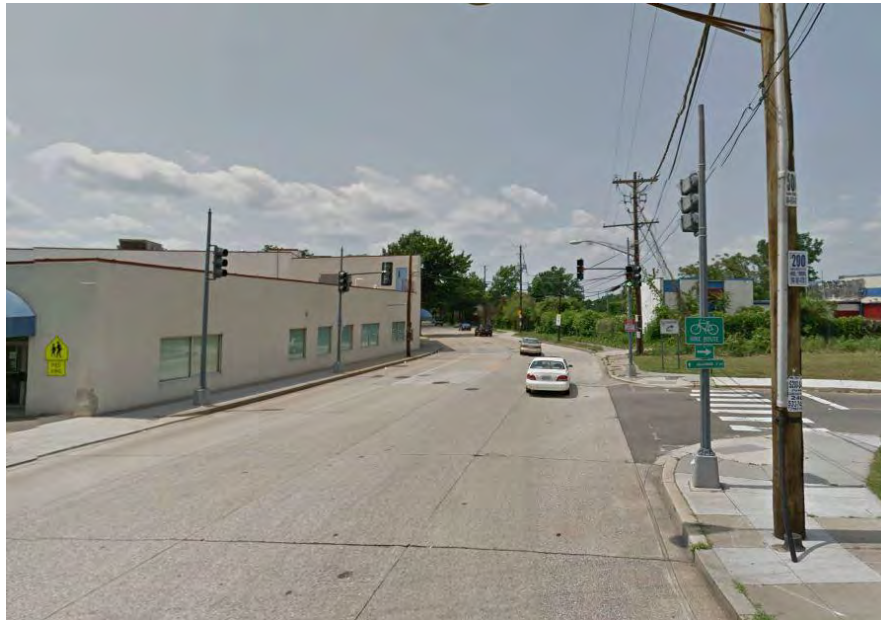
The entrance to this garage is through a driveway off of Howard Road north of I-295. The driveway's intersection with Howard Road is signalized and has an east-west crosswalk that traverses the driveway and curb ramps with detectable warning panels. The crosswalk does not properly line up with the curb ramps, however, and there is no pedestrian signal associated with it. Sidewalks exist on both sides of Howard Road and on the west side of the driveway. There is a "Metro Parking Only" sign on Howard Road in the westbound direction but no sign indicating the parking area in the eastbound direction. The intersection and driveway serve as a bicycle connection to the Anacostia Riverwalk Trail through Anacostia Park. **Figure 42** pictures this intersection.

**Figure 42: Kiss-and-Ride/Park-and-Ride Garage Intersection with Howard Road**

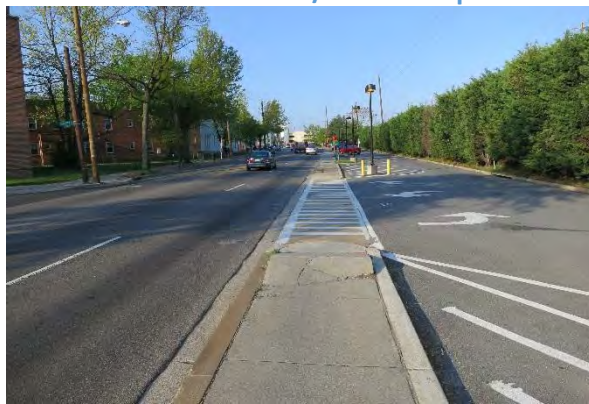
**Figure 60: Kiss-and-Ride Center Entrance/Exit & Poor Sidewalk Condition/Lack of Stop Controls**

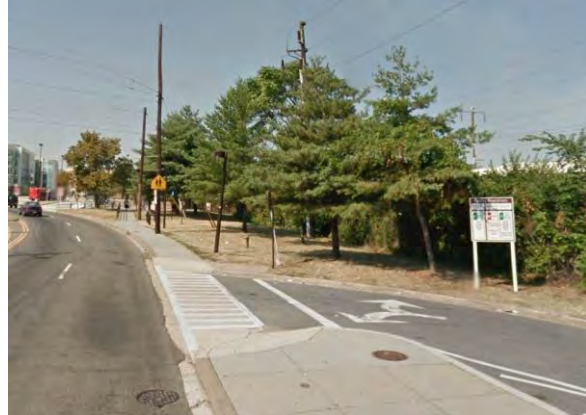
**Figure 62: Kiss-and-Ride South Exit & Lack of Stop Sign**

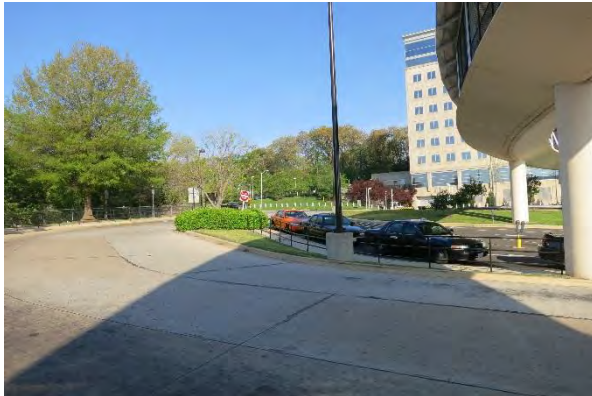
Figure 82: Taxicab Area Queue

| Table 4: Summary of Recommendations at the New Carrollton Station (West) | |
|---|---|
| Continued enforcement of the taxicab queue length at the Kiss-and-Ride entrance and the recommended “No Parking” signs there to ensure taxicabs do not block the busway entrance. | On |

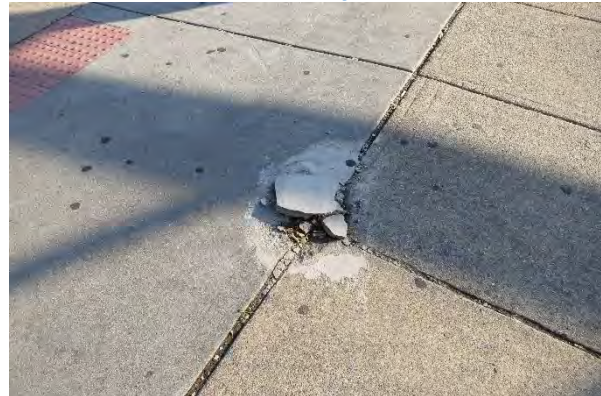
- The sidewalk on the east side of the busway crosswalk is uneven and has caused several patrons to trip
- Light maintenance is needed more regularly to keep bus bays safe at night

Figure 83: Uneven Sidewalk on East Side of Busway
