# ASSET (BUS SHELTER) IMPROVEMENT EVALUATION STUDY

**Final Report**

**June 2013**

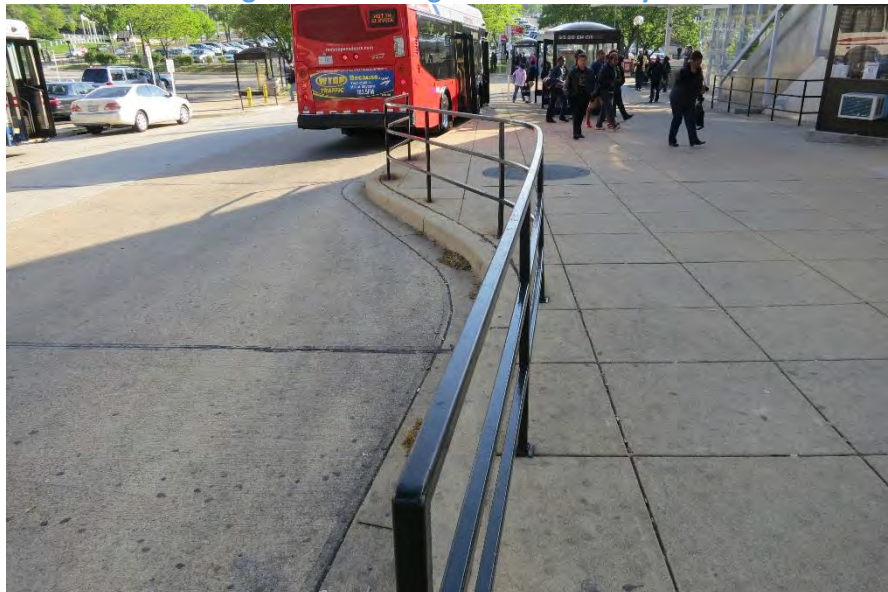
Figure 84: Fencing North of Bus Bay H

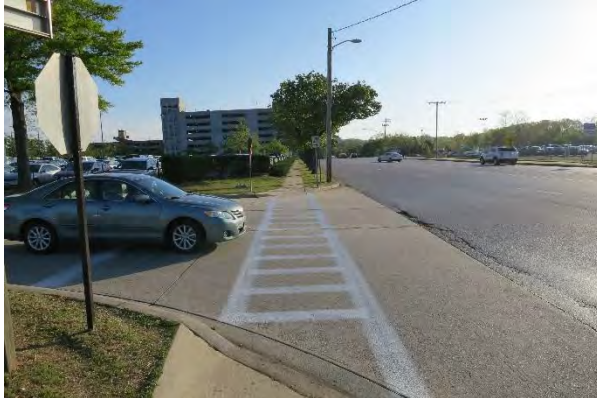
There is a north-south crosswalk that traverses the station egress driveway with corresponding curb ramps that lack detectable warning panels. There is a sidewalk on the west side of Garden City Drive north and south of the intersection and on the east side of Garden City Drive north of the US-50 off-ramp. The station egress driveway has a sidewalk on its south side with fencing separating it from the driveway itself. **Figures 100 through 102** illustrate this intersection and its pavement markings and signage.

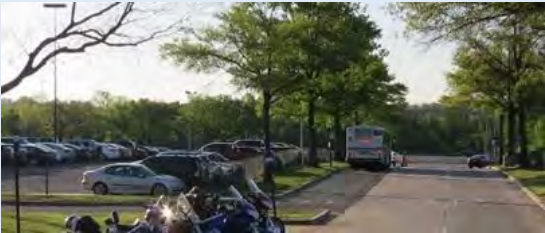
detectable warning panels and a pedestrian warning sign. The second crosswalk lacks a curb ramp on its south end entirely and is precariously located on the right side of a right-turn only exit. It appears that the first crosswalk was installed to replace the second crosswalk. **Figures 103 and 104** picture the egress driveway.

| <p><b>Elimination of the old crosswalk that traverses the egress driveway at the Park-and-Ride Lot 2 exit.</b></p> | <p><b>Hazardous Crosswalk</b></p> |

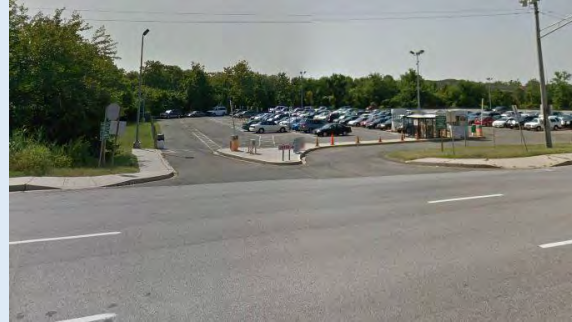
**Lot Entrance on Garden City Drive**

The entrance to this lot forms an unsignalized T intersection with Garden City Drive with three thru travel lanes on Garden City Drive northbound and two thru travel lanes on Garden City Drive southbound. The driveway has a single access lane and a single egress lane. There is a north-south crosswalk that traverses the egress lane of the driveway with a single curb ramp that lacks detectable warning panels at its north end. There are sidewalks on both sides of Garden City Drive through this intersection. On the east side of Garden City Drive, there are two curb ramps oriented to the west, however, there are no corresponding crosswalks. In order for these curb ramps to be used by pedestrians traveling north-south on Garden City Drive, they would have to enter the northbound right travel lane, creating a potentially dangerous situation for someone with a disability.

**Reconstruction of the curb ramps at the lot entrance so they are oriented north-south and install detectable warning panels, a crosswalk and stop line prior to it.**

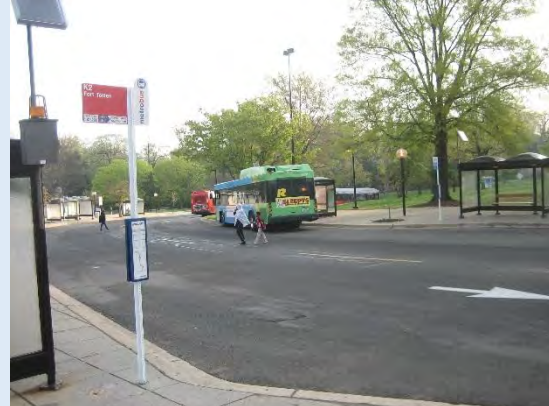
#### Jaywalking Across Busway

Discussion with the Takoma station manager confirmed the prevalence of jaywalking at the station, though it was noted that “near misses” and crashes between buses and pedestrians were non-existent or at least extremely rare. The need for a few “Pedestrians Use Crosswalk” signs between the G-J bus bays and the A-F busways was mentioned, along with some enforcement. When it came to internal pedestrian circulation at the station, the station manager declined the need for additional signage directing people to buses and the elevator, stating that she thought this was within the job duties of the

**Reconfiguration to minimize jaywalking across the busway. A widening of the busway coupled with the installation of a median and fencing down its center or a relocation of the G-J bus bays to the west side of the busway would be needed.**

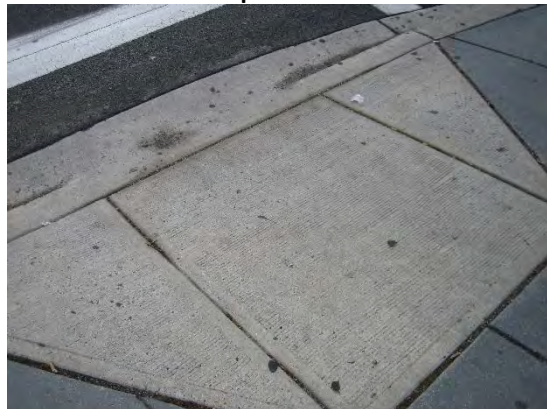
**Curb Ramp at Cedar Street**

and have “State Law Stop for Pedestrians” break-away signs on their small medians in the middle of the crosswalk, along with apex curb ramps. There are no detectable warning panels on the curb ramps at this intersection. The crosswalk across the busway is rarely used by bus patrons, unless buses drop off passengers at bus bay G. It is regularly used by patrons entering the station via Cedar Street, however. The crosswalk across Cedar Street is regularly used by station patrons and has good overall compliance with vehicles. This crosswalk also has pedestrian warning signs and crosswalk arrow signs in both directions on Cedar Street. There are two “no Right Turn Except Buses” signs in the westbound direction on Cedar Street as well as one “No Left Turn/U-Turn” sign on Cedar Street in the eastbound direction. There is also a “Do Not Enter” sign on the busway itself. Buses had relatively little difficulty entering and exiting the busway at this intersection due to breaks in traffic along Cedar Street from the signalized intersections to the east and west of the station. **Figures 115 through 117** illustrate signage and overall layout at this intersection.

**Detectable warning panels on the curb ramps at the Cedar Street/Busway intersection.**

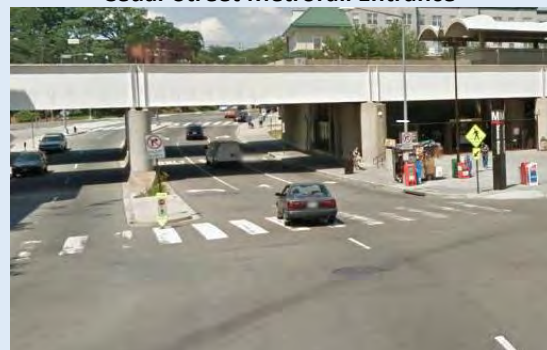
**Cedar Street Metrorail Entrance**

Drop-offs at the station typically occur on Cedar Street in the right-turn only lane directly in front of the station, despite the “No Stopping or Standing” signs on Cedar Street and the right-turn only pavement markings. No enforcement of these signs was observed. The Kiss-and-Ride was only utilized by those waiting to pick up patrons for a longer time period.

**Enforcement of “No Stopping/No Standing” signs on Cedar Street in front of Metrorail station entrance.**

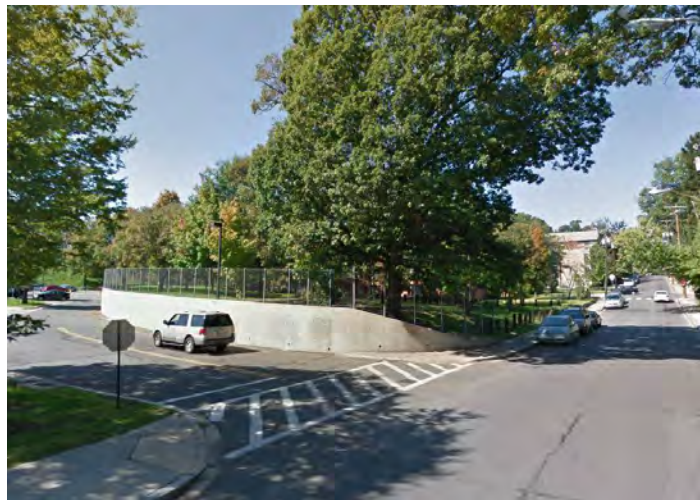
**Figure 119: Entrance to Kiss-And-Ride Lot from Eastern Avenue Northbound**

The station's Kiss-and-Ride lot entrance is on Eastern Avenue to the north and west of the busway. The lot is not clearly marked from the street and has no entrance signage. There is a stop sign on the lot driveway approach to Eastern Avenue along with a crosswalk and apex curb ramps across it. The curb ramps do not have detectable warning panels though are otherwise ADA-compliant. The lot itself has a crosswalk from the handicapped parking spaces to the sidewalk along the western side of the lot. **Figure 119** pictures the entrance to this lot.

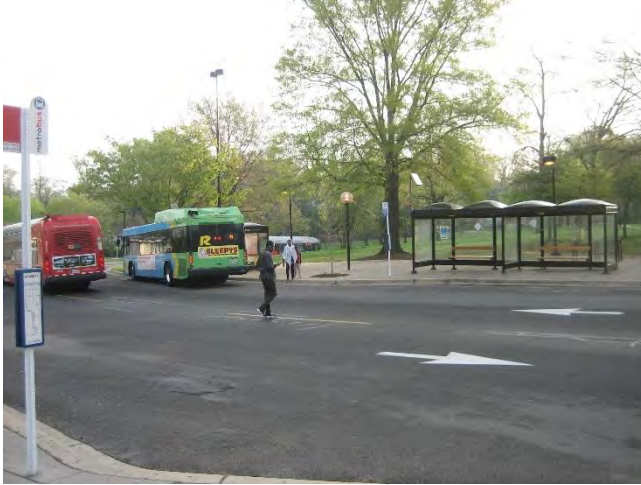
**Figure 121: Jaywalking across Busway to Station**

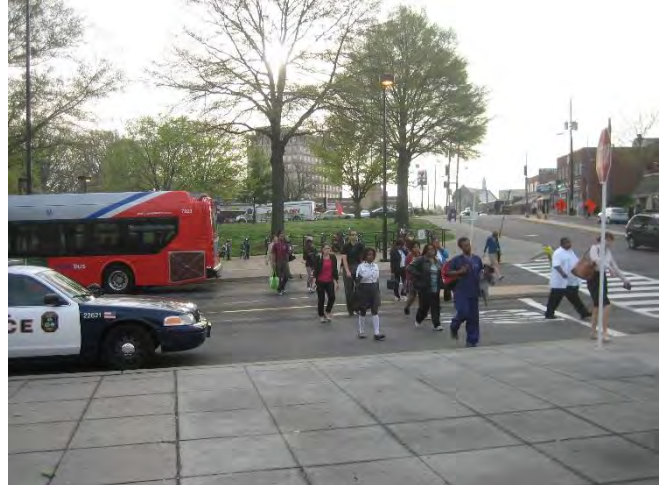
**Figure 122: Jaywalking across Busway Adjacent to Cedar St Crosswalk**

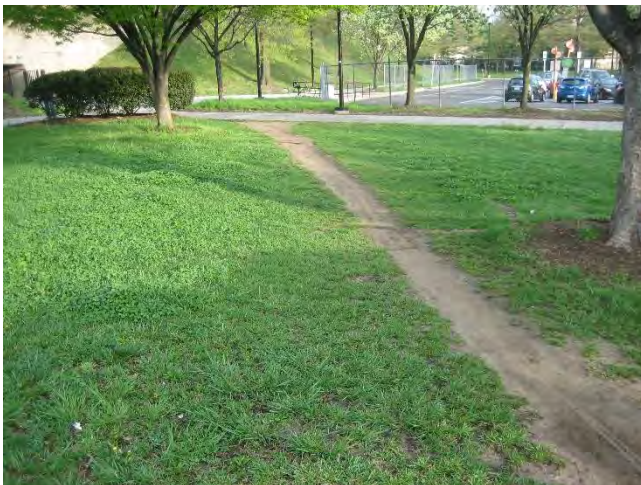
**Figure 123: Desire Line from Bus Bays to Elevator Tunnel**

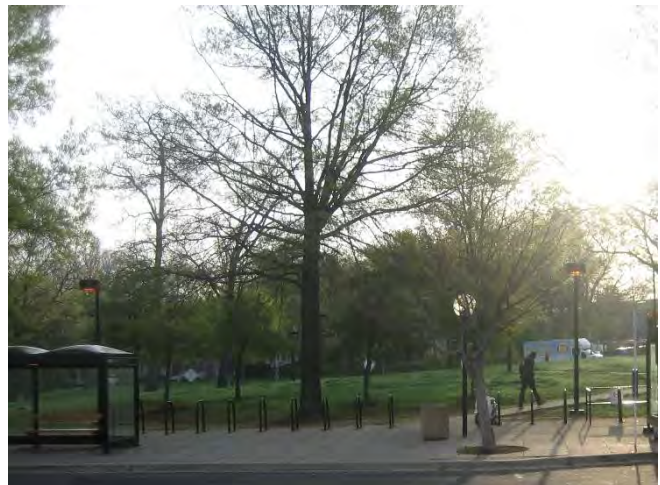
**Figure 124: Park Walkways to Station**
